**State Aquatic Resources Delineation Report
Phase 1
August 2021**

**State Jurisdictional Waters Delineation Report
Phase 2
December 2020**

Subject: *State Jurisdictional Waters Delineation Report for the Desert Peak Energy Center Project, City of Palm Springs, Riverside County, California*

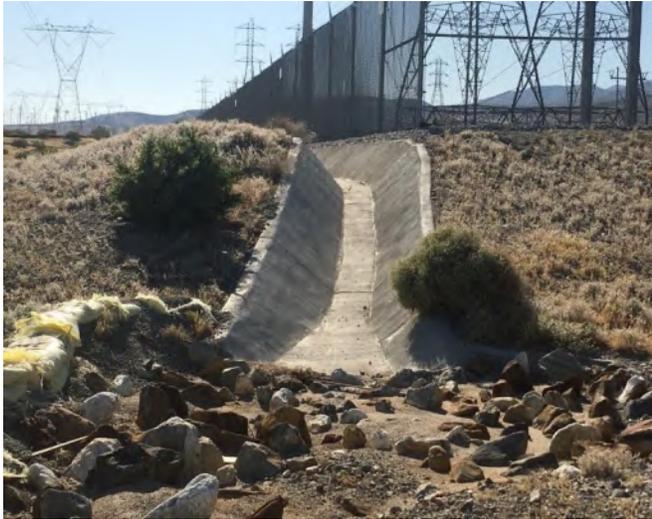
PP-1: Upstream, West-Facing View of v-ditch, outside of the Review Area west of the proposed generation tie line alignment. Upstream of Ordinary High Water Mark Data Point (ODP)-1

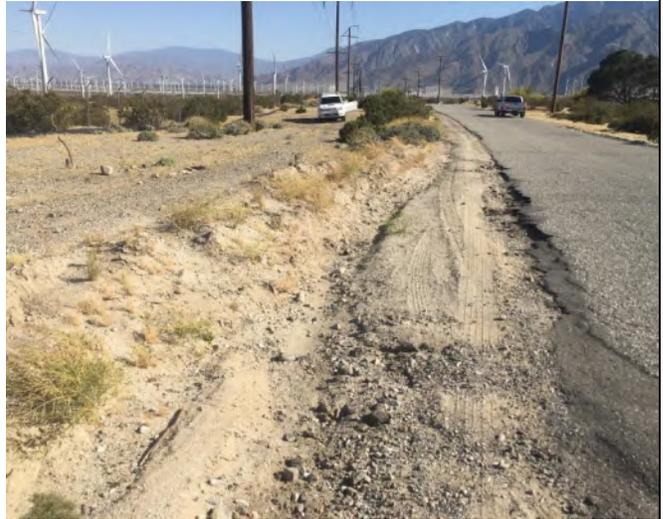
PP-2: Downstream, South-Facing View of Diablo Road and evidence of road-runoff along generation tie line alignment. Upstream of Ordinary High Water Mark Data Point (ODP)-1

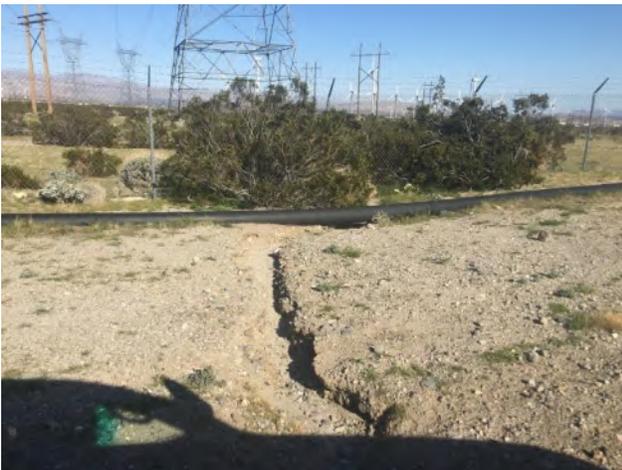
PP-3: Downstream, Southeast-Facing View of erosional feature at Ordinary High Water Mark Data Point (ODP)-1 along generation tie line alignment.

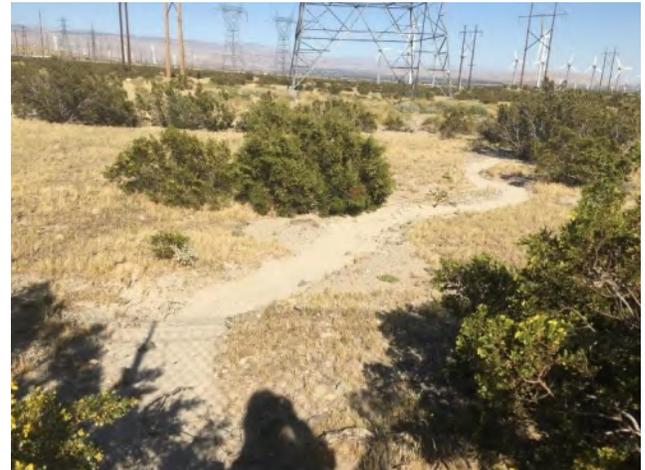
PP-4: Downstream, Southeast-Facing View outside of Review Area, downstream of Ordinary High Water Mark Data Point (ODP)-1 along generation tie line alignment.

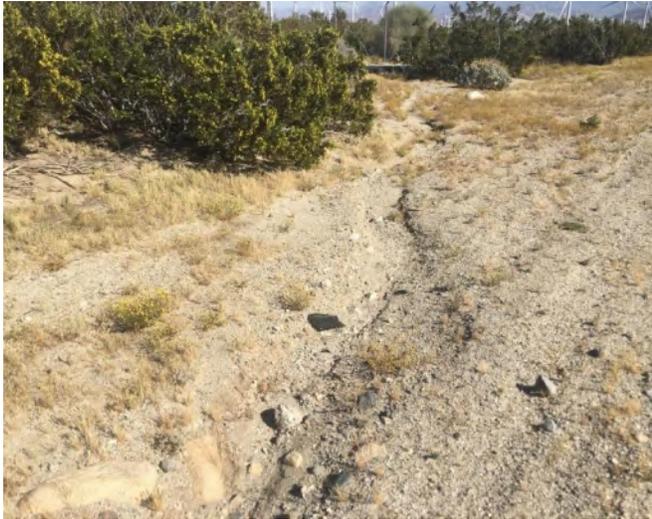
PP-5: Downstream, Southeast-Facing View of roadside ditch collecting runoff from Diablo Road along generation tie line alignment. Near Ordinary High Water Mark Data Point (ODP)-2

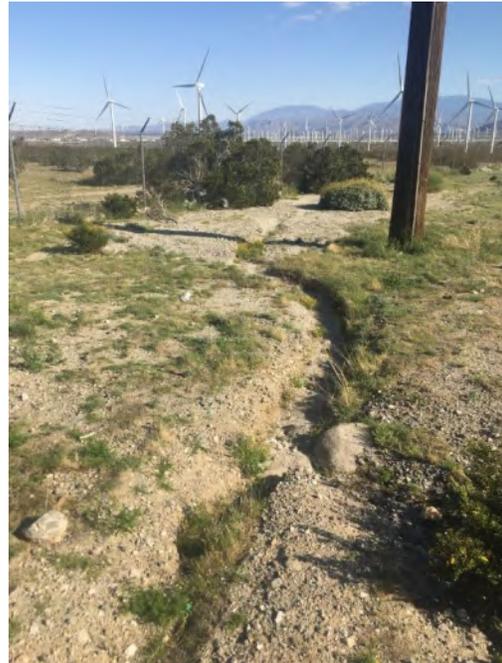
PP-6: Downstream, Southeast-Facing View of roadside ditch collecting runoff from Diablo Road along generation tie line alignment.. Near Ordinary High Water Mark Data Point (ODP)-3

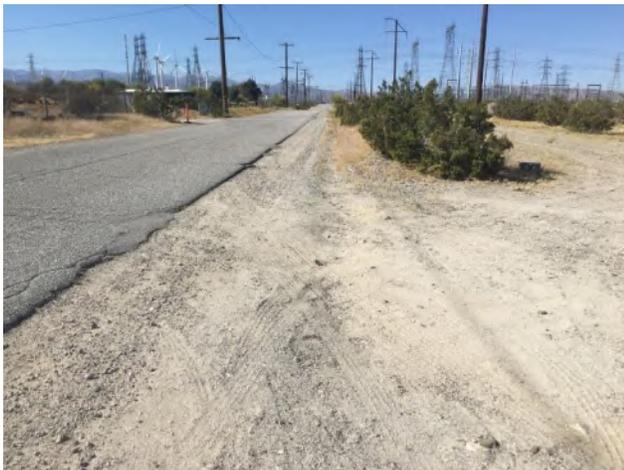
PP-7: Upstream, North-Facing View of Diablo Road and no signs of flow along generation tie line alignment.. Upstream of Ordinary High Water Mark Data Point (ODP)-3

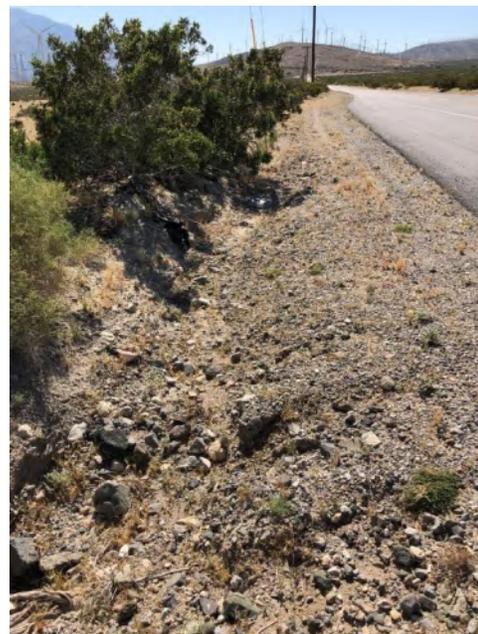
PP-8: Upstream, West-Facing View of roadside ditch outside of Review Area. Upstream of Ordinary High Water Mark Data Point (ODP)-4

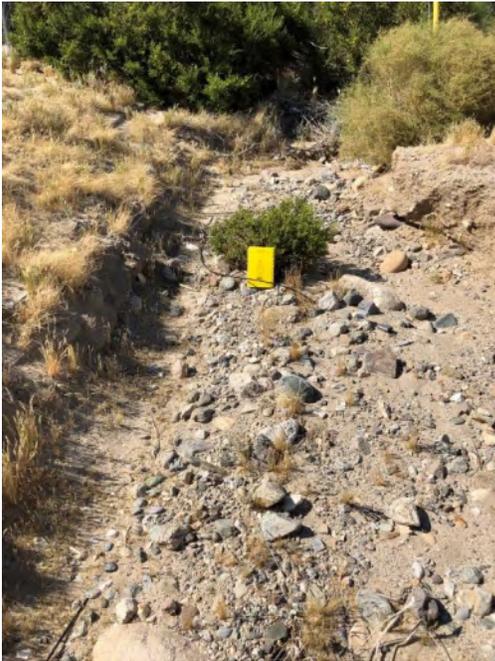
PP-9: Upstream, North-Facing View of roadside ditch outside of Review Area. Upstream of Ordinary High Water Mark Data Point (ODP)-4

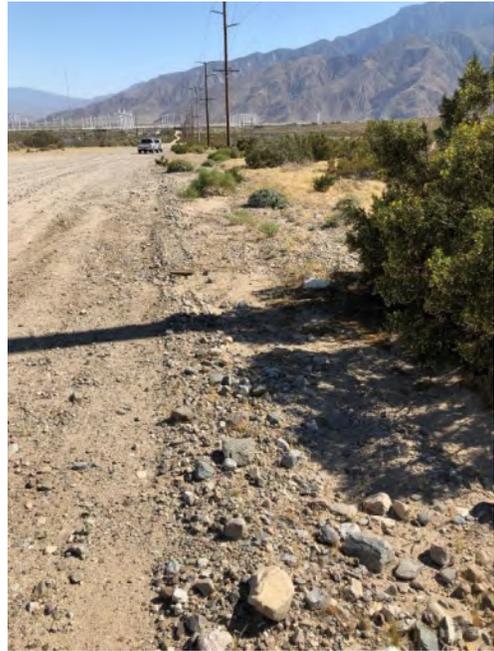
PP-10: Downstream, South-Facing View of roadside ditch that dissipates to runoff/sheetflow along generation tie line alignment. Upstream of Ordinary High Water Mark Data Point (ODP)-4

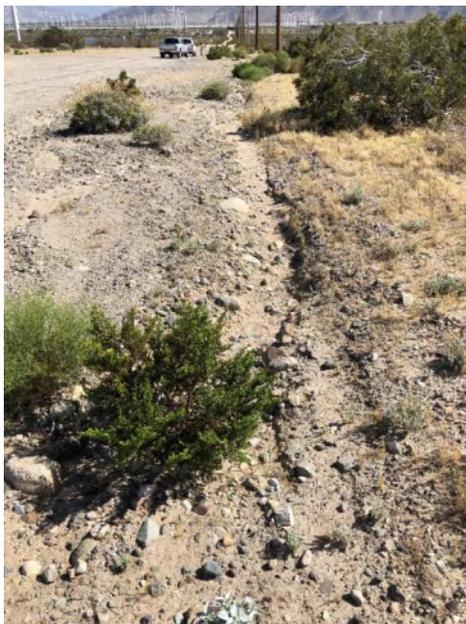
PP-11: Downstream, South-Facing View of roadside ditch near Ordinary High Water Mark Data Point (ODP)-4 along generation tie line alignment.

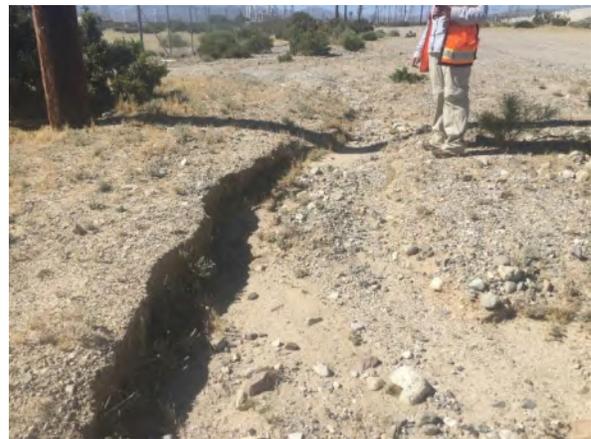
PP-12: Upstream, North-Facing View of roadside ditch south of Ordinary High Water Mark Data Point (ODP)-4 along generation tie line alignment.

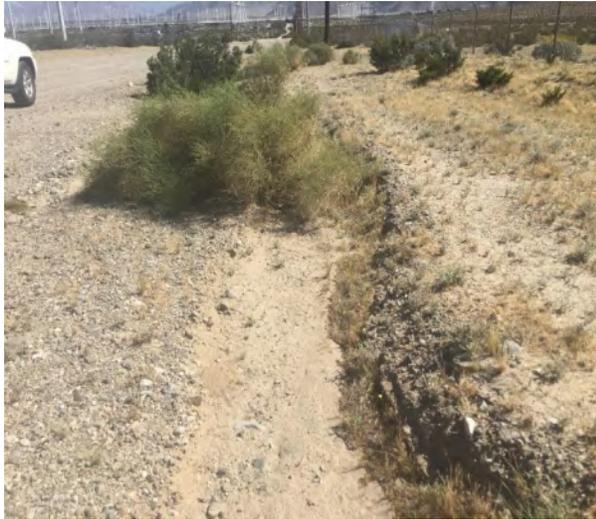
PP-13: Downstream, South-Facing View of roadside ditch south of Ordinary High Water Mark Data Point (ODP)-4 along generation tie line alignment.

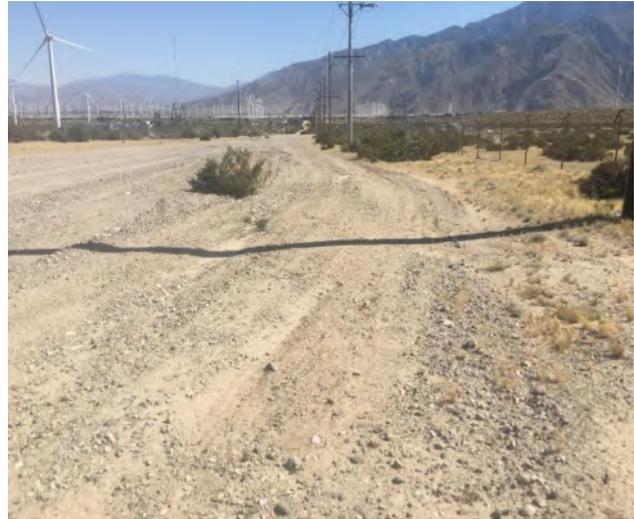
PP-14: Downstream, South-Facing View of where flows from roadside ditch dissipate to runoff/sheetflow, South of Ordinary High Water Mark Data Point (ODP)-4

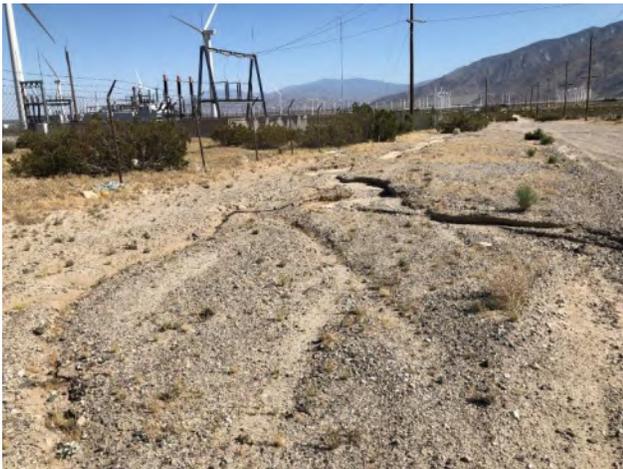
PP-15: Downstream, South-Facing View of roadside ditch south of Ordinary High Water Mark Data Point (ODP)-4 along generation tie line alignment.

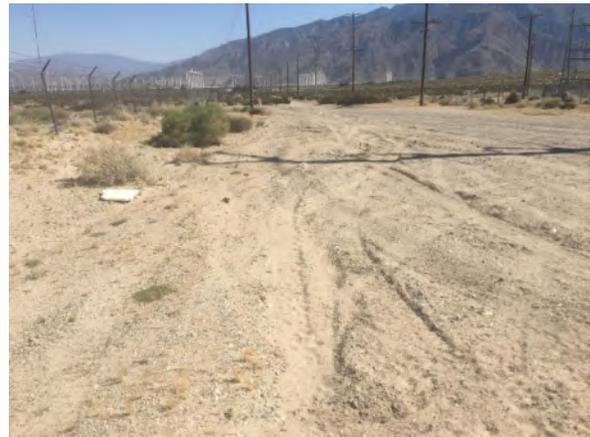
PP-16: Downstream, South-Facing View of roadside ditch where flows dissipates to runoff/sheetflow south of Ordinary High Water Mark Data Point (ODP)-4 along generation tie line alignment.

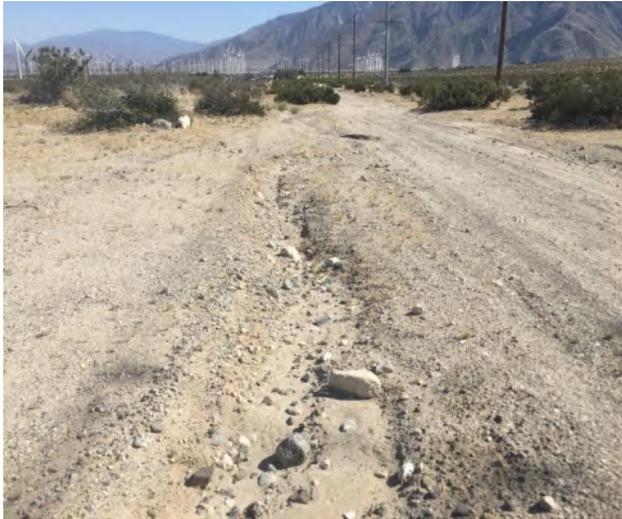
PP-17: Downstream, South-Facing View of roadside ditch where flows dissipates to runoff/sheetflow south of Ordinary High Water Mark Data Point (ODP)-4 along generation tie line alignment.

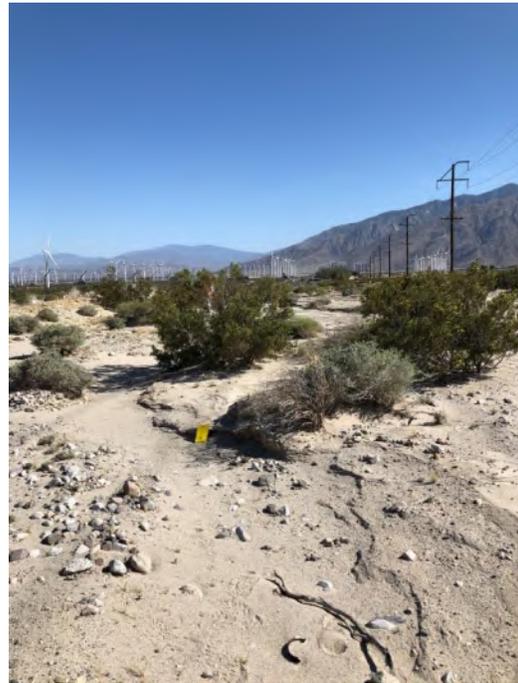
PP-18: Downstream, South-Facing View of NWW-1 (alluvial fan) Near Ordinary High Water Mark Data Point (ODP)-5 along generation tie line alignment.

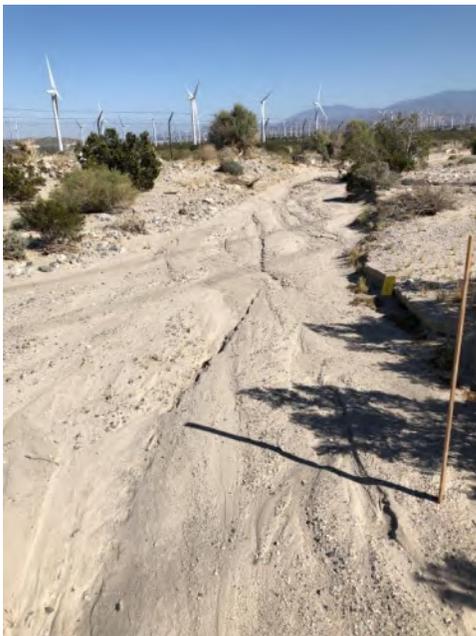
PP-19: Downstream, Southeast-Facing View of NWW-1 (alluvial fan) Near Ordinary High Water Mark Data Point (ODP)-5 along generation tie line alignment.

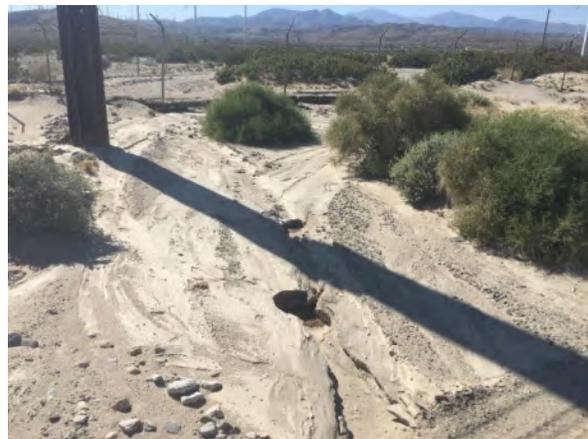
PP-20: Upstream, Northwest-Facing View, outside of Review Area, of NWW-1 (alluvial fan) Near Ordinary High Water Mark Data Point (ODP)-5 along generation tie line alignment.

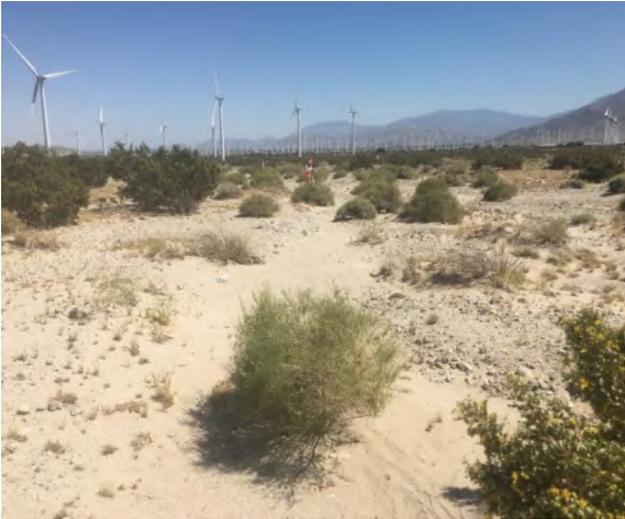
PP-25: Downstream, Southeast-Facing View of NWW-1 (alluvial fan) southeast of Ordinary High Water Mark Data Point (ODP)-6

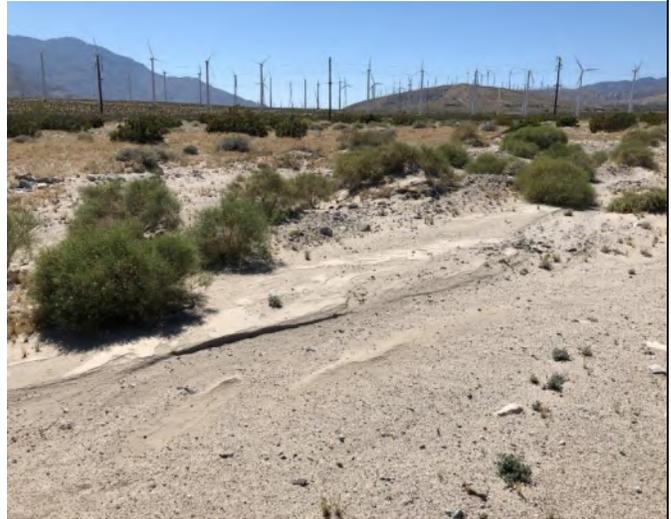
PP-26: West-Facing View of NWW-1 (alluvial fan) southeast of Ordinary High Water Mark Data Point (ODP)-6

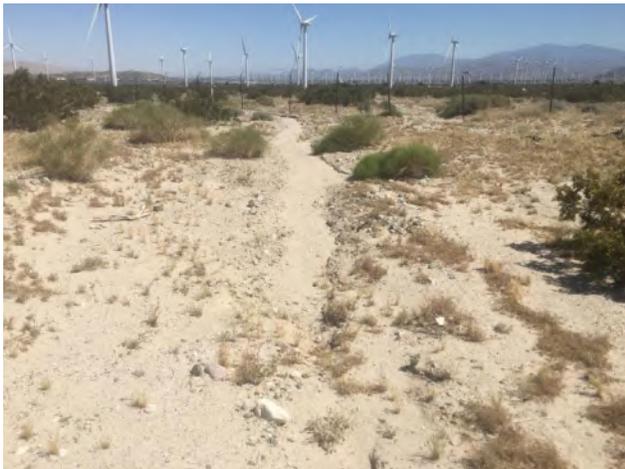
PP-27: Downstream, Southeast-Facing View of NWW-1 (alluvial fan) southeast of Ordinary High Water Mark Data Point (ODP)-6

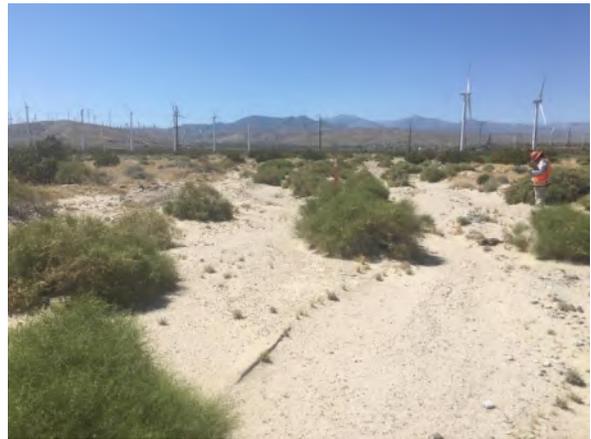
PP-28: Upstream, Northwest-Facing View of NWW-1 (alluvial fan) southeast of Ordinary High Water Mark Data Point (ODP)-6

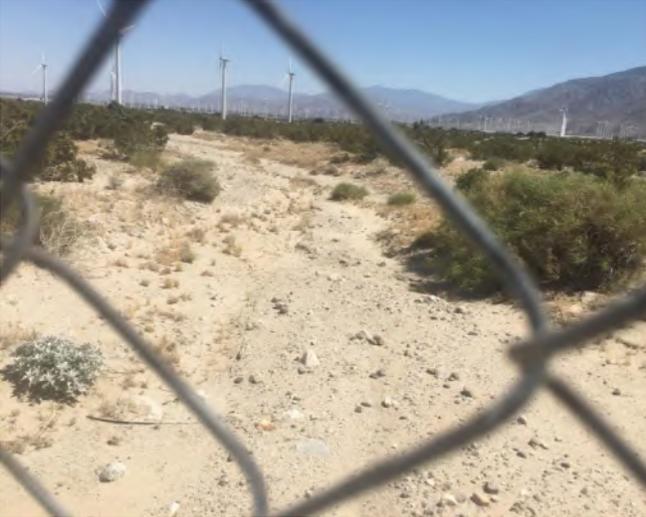
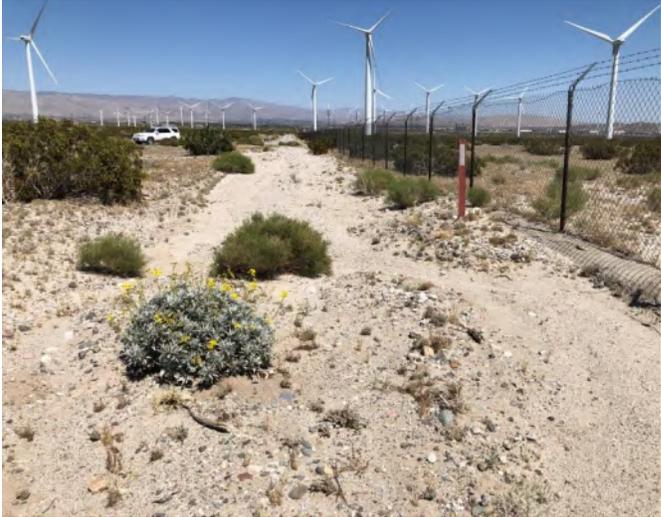
<p>PP-29: Downstream, South-Facing View of NWW-1 (alluvial fan) southeast of Ordinary High Water Mark Data Point (ODP)-6</p>	<p>PP-30: Downstream, East-Facing View of dirt road and NWW-1 (alluvial fan) southeast of Ordinary High Water Mark Data Point (ODP)-6</p>

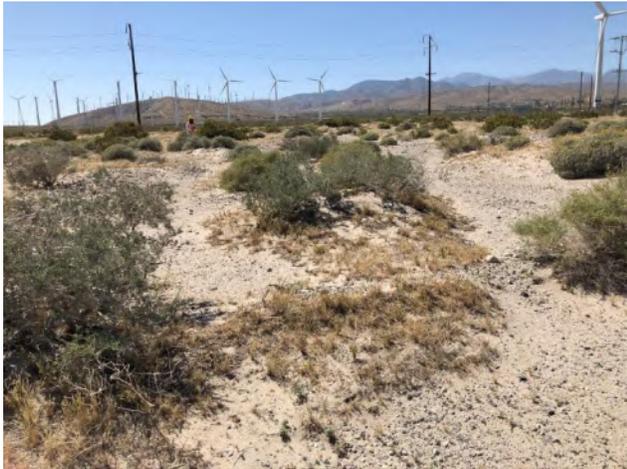
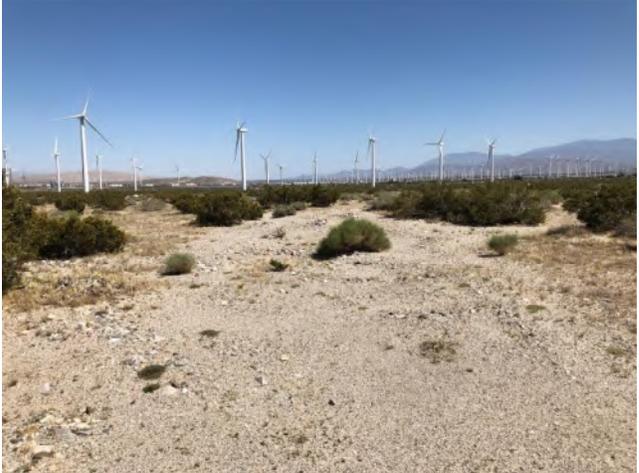
<p>PP-31: Upstream, Northwest-Facing View of NWW-1 (alluvial fan) north of Ordinary High Water Mark Data Point (ODP)-6</p>	<p>PP-32: Downstream, Southeast-Facing View of NWW-1 (alluvial fan) northwest of Ordinary High Water Mark Data Point (ODP)-6</p>

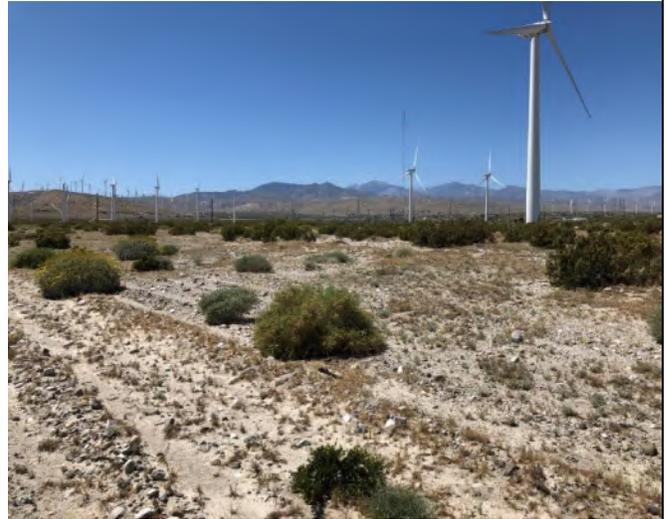
PP-34: Northwest-Facing View of disturbance area near Ordinary High Water Mark Data Point (ODP)-7

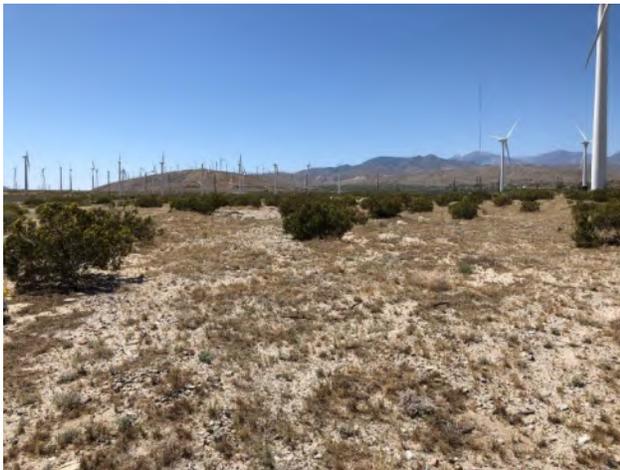
PP-35: Northwest-Facing View, east of Ordinary High Water Mark Data Point (ODP)-7

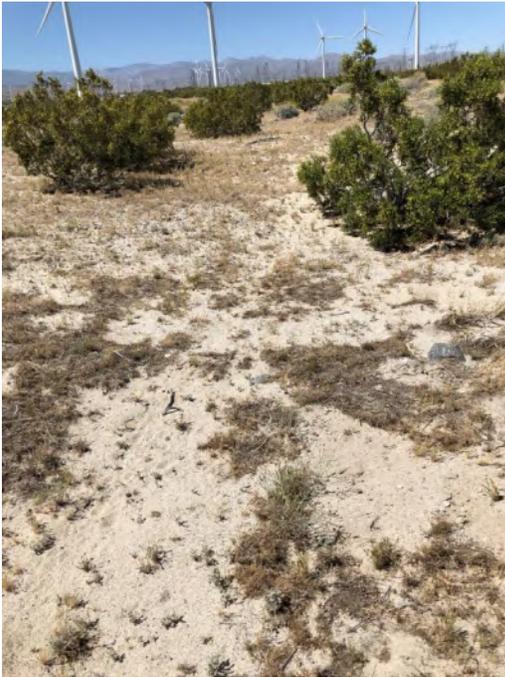
PP-37: Upstream, North-Facing View of sheeflow area, near Ordinary High Water Mark Data Point (ODP)-8

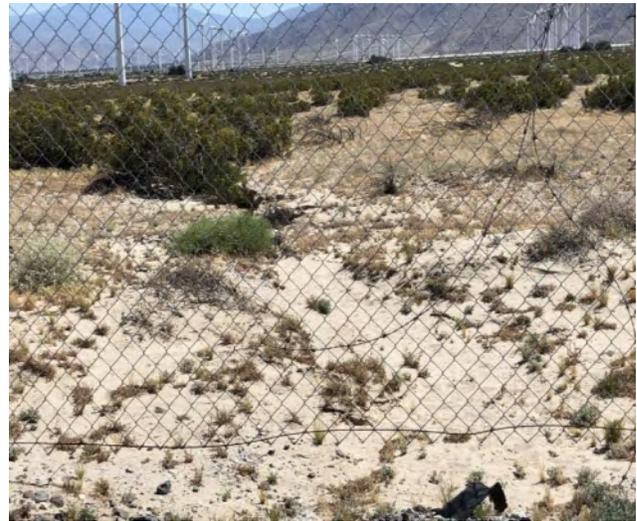
PP-38: Downstream, South-Facing View shetflow outside of Review Area south of Ordinary High Water Mark Data Point (ODP)-8

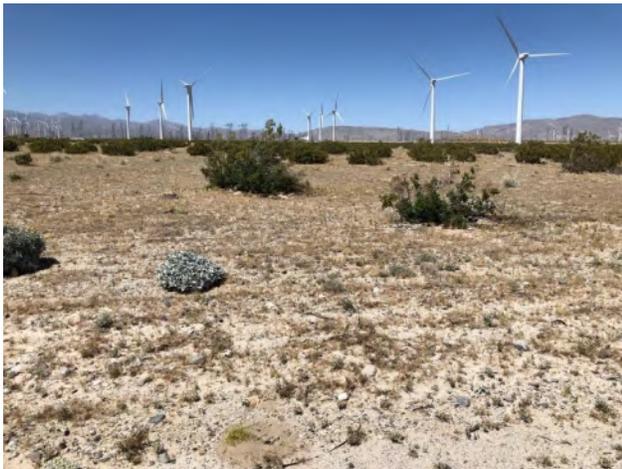
PP-39: Northwest-Facing View of disturbance area

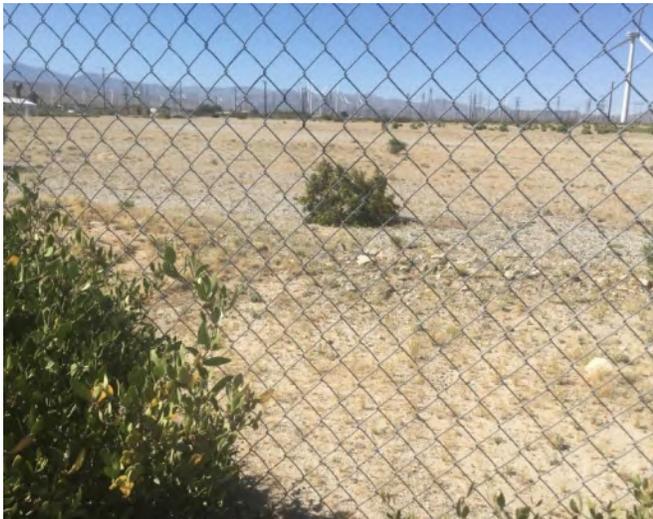
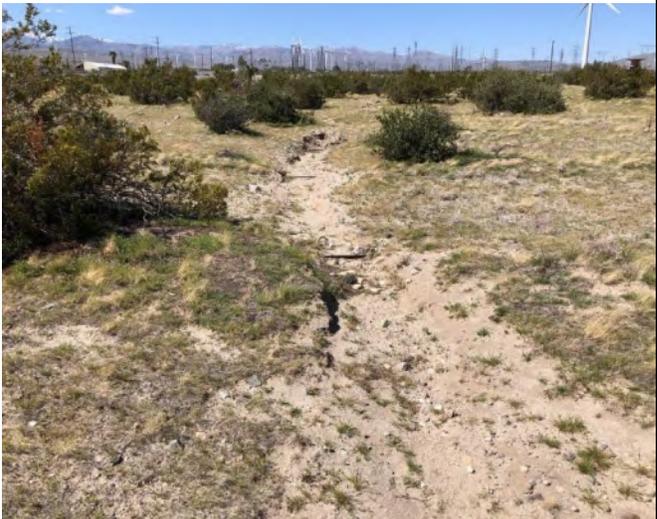
<p>PP-41: North-Facing View of Storage Yard, north of Ordinary High Water Mark Data Point (ODP)-9</p>	<p>PP-42: Upstream, North-Facing View of erosional feature near Ordinary High Water Mark Data Point (ODP)-9</p>

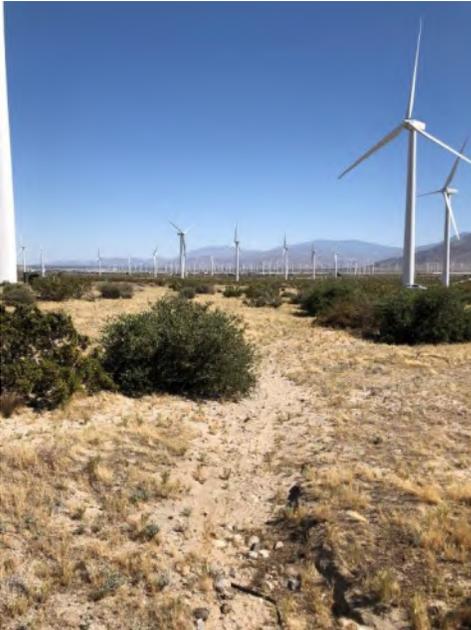
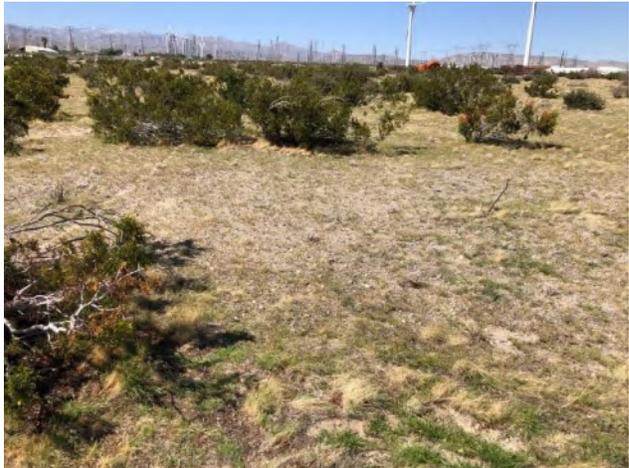
<p>PP-43: Downstream, South-Facing View of erosional feature near Ordinary High Water Mark Data Point (ODP)-9</p>	<p>PP-44: North-Facing View of uplands where erosional flows dissipate to sheeflow, south of Ordinary High Water Mark Data Point (ODP)-9</p>

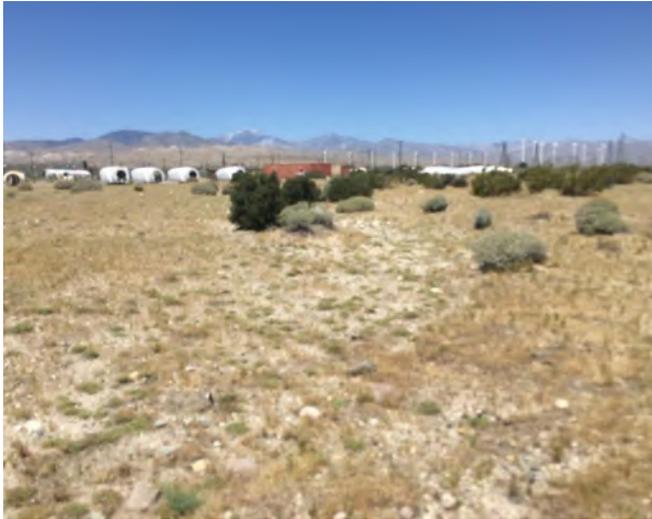
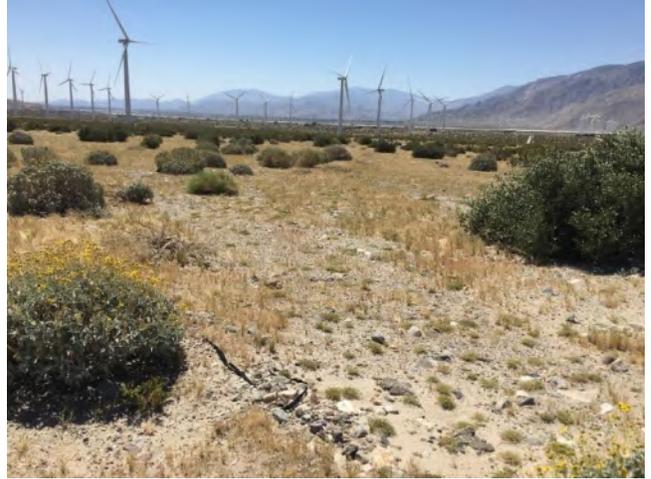
PP-45: Northwest-Facing View, northwest of Ordinary High Water Mark Data Point (ODP)-10

PP-46: Southeast-Facing View, Near Ordinary High Water Mark Data Point (ODP)-10

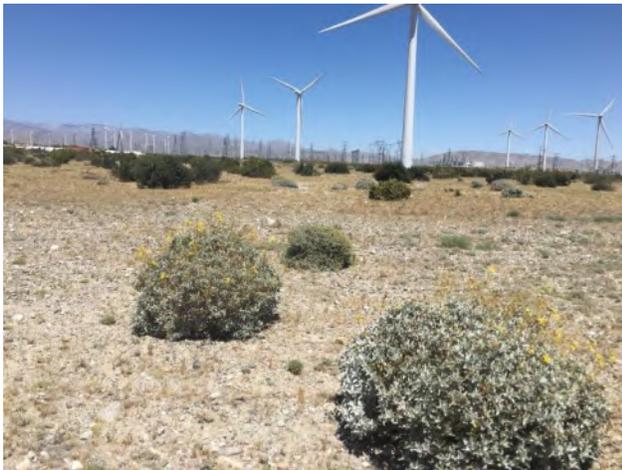
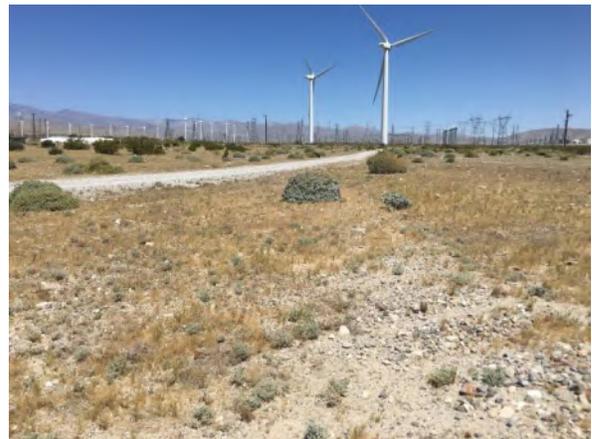
PP-47: South-Facing View, south of Ordinary High Water Mark Data Point (ODP)-10

PP-48: Upstream, Northwest-Facing View north of Ordinary High Water Mark Data Point (ODP)-11

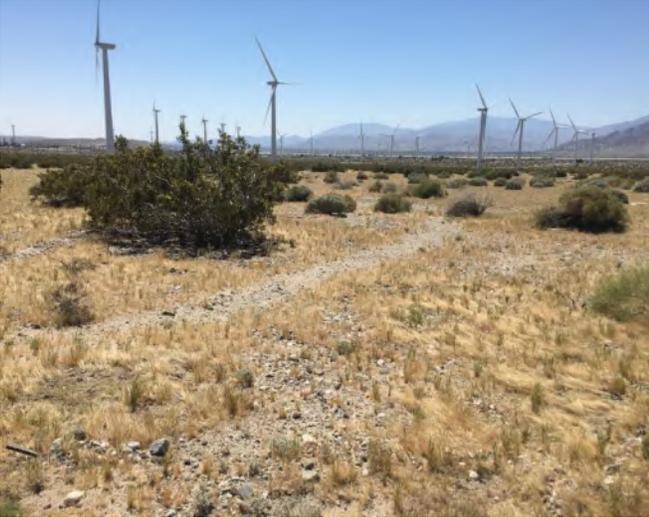
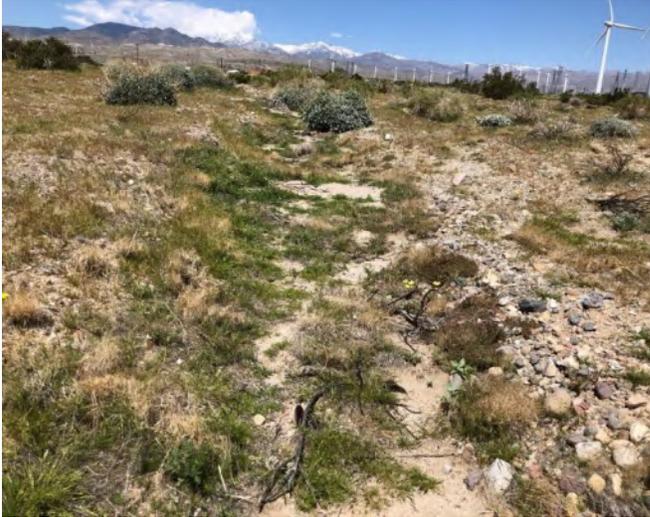
<p>PP-49: Downstream, Southeast-Facing View north of Ordinary High Water Mark Data Point (ODP)-11</p>	<p>PP-50: Upstream, Northwest-Facing View near Ordinary High Water Mark Data Point (ODP)-11</p>

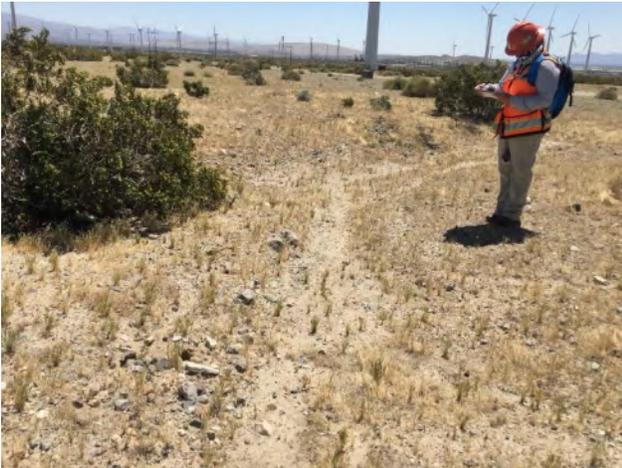
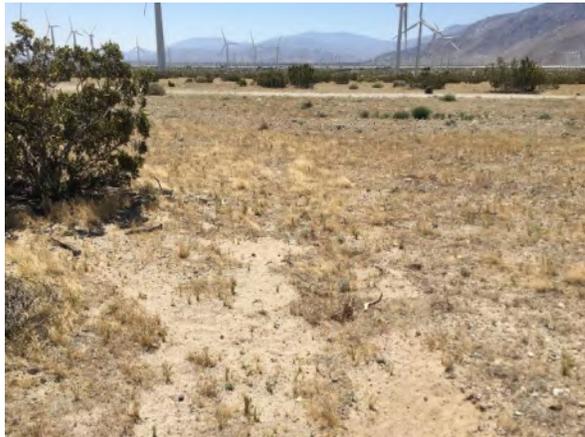
<p>PP-51: Downstream, Southeast-Facing View south of Ordinary High Water Mark Data Point (ODP)-11</p>	<p>PP-52: Downstream, South-Facing View south of Ordinary High Water Mark Data Point (ODP)-11</p>

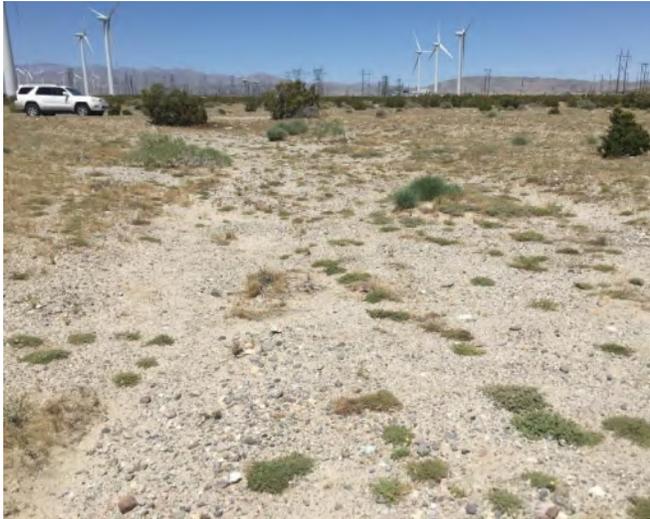
PP-53: Upstream, Northwest-Facing View of NWW-2 near Ordinary High Water Mark Data Point (ODP)-12

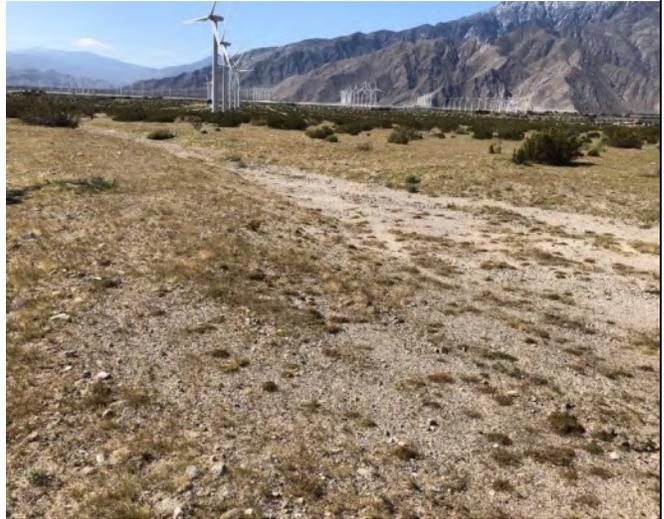
PP-54: Downstream, Southeast-Facing View of NWW-2 near Ordinary High Water Mark Data Point (ODP)-12

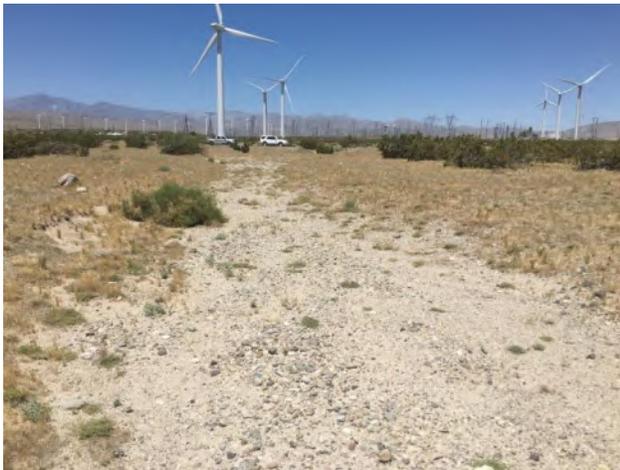
PP-55: Upstream, Northwest-Facing View of NWW-2 south of Ordinary High Water Mark Data Point (ODP)-12

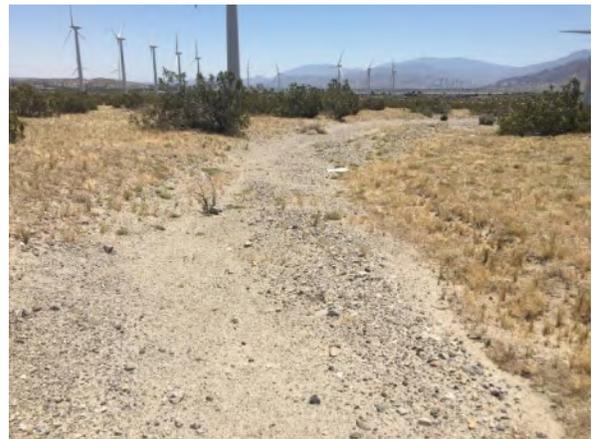
PP-56: Downstream, South-Facing View outside of Review Area of NWW-2 south of Ordinary High Water Mark Data Point (ODP)-12

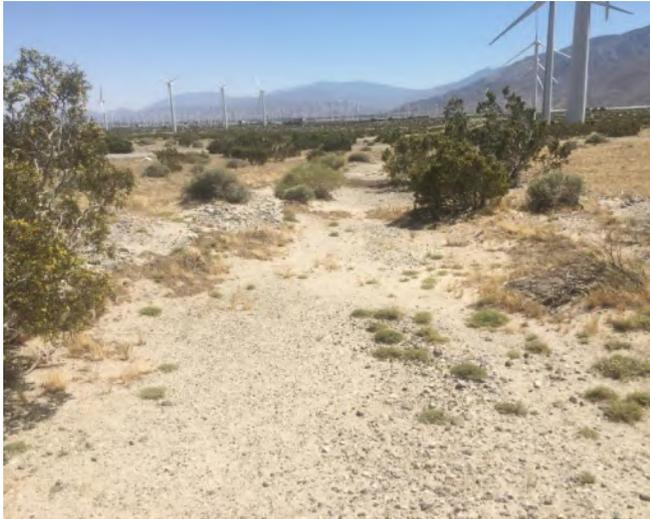
PP-57: Downstream, South-Facing View of NWW-2 near Ordinary High Water Mark Data Point (ODP)-13

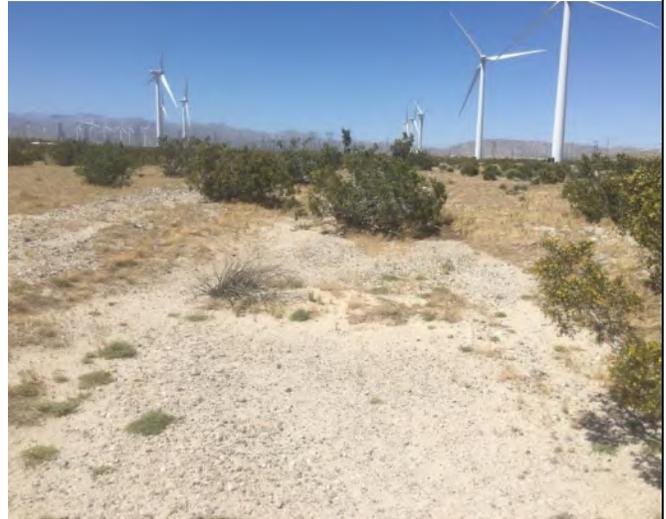
PP-58: Upstream, North-Facing View of NWW-2 near Ordinary High Water Mark Data Point (ODP)-13

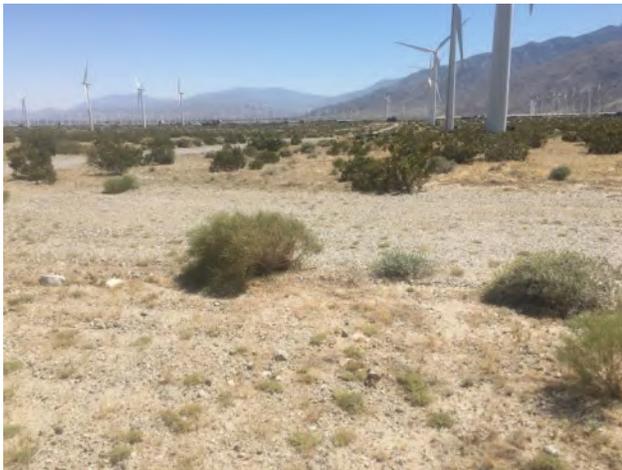
PP-59: Downstream, South-Facing View where flows dissipate as sheetflow, south of Ordinary High Water Mark Data Point (ODP)-13

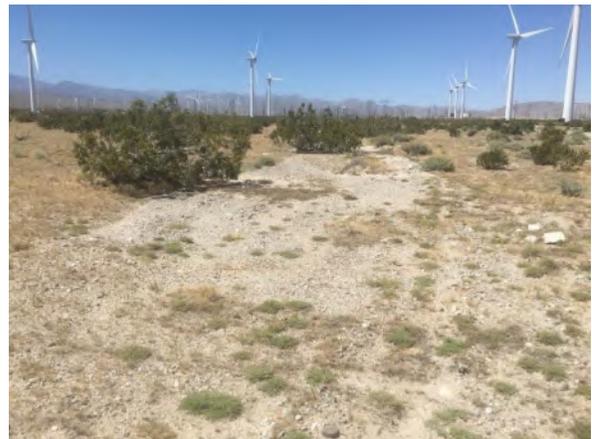
PP-60: Upstream, North-Facing View of NWW-2 south of Ordinary High Water Mark Data Point (ODP)-13

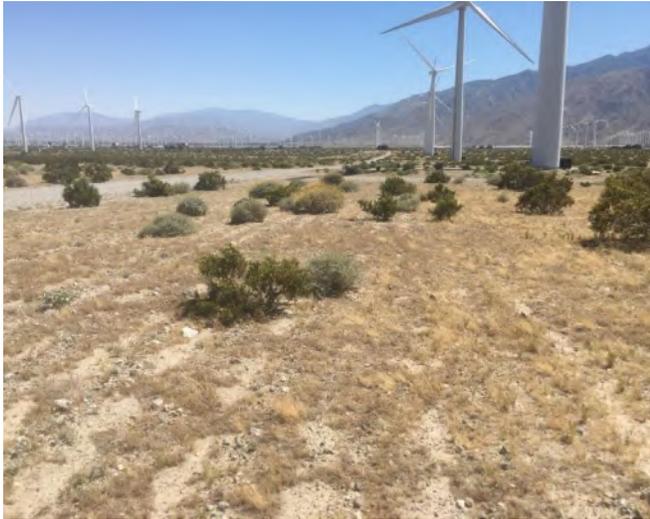
PP-61: South-Facing View, no evidence of hydrology or connectivity of NWW-2. South of Ordinary High Water Mark Data Point (ODP)-13

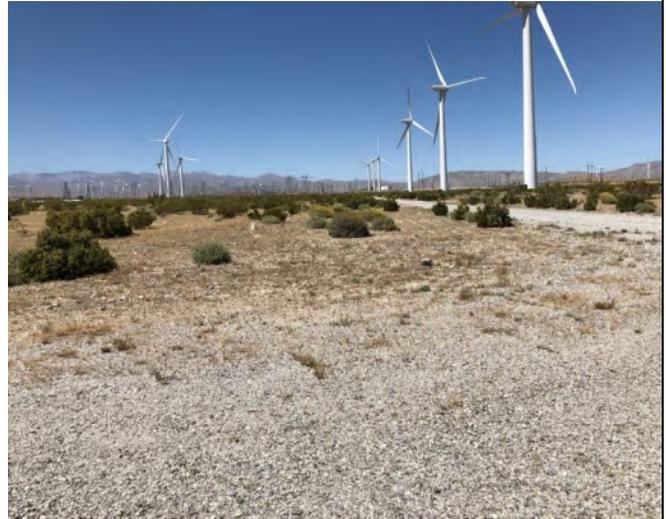
PP-62: Upstream, North-Facing View, no evidence of hydrology or connectivity of NWW-2, South of Ordinary High Water Mark Data Point (ODP)-13

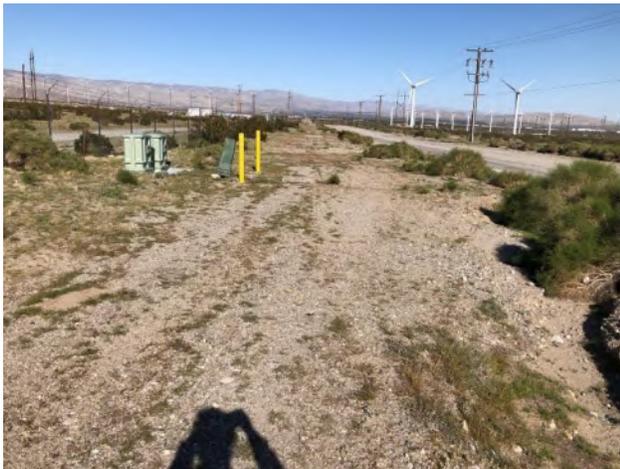
PP-63: East-Facing View, north of Dillon Road.

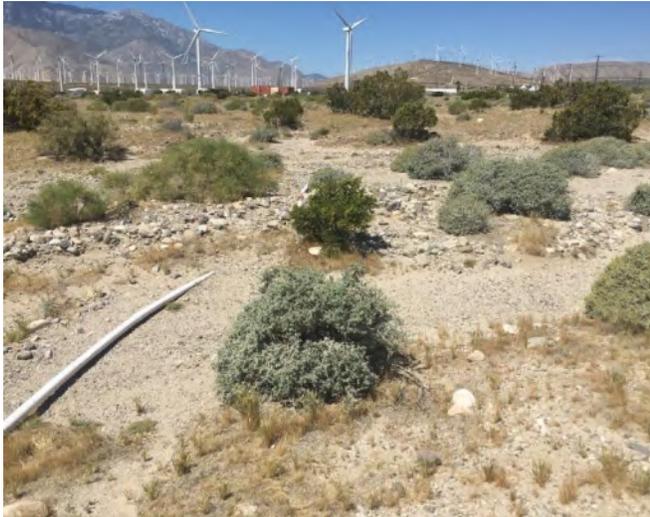
PP-65: West-Facing View of NWW-3 (alluvial fan), near Ordinary High Water Mark Data Point (ODP)-14

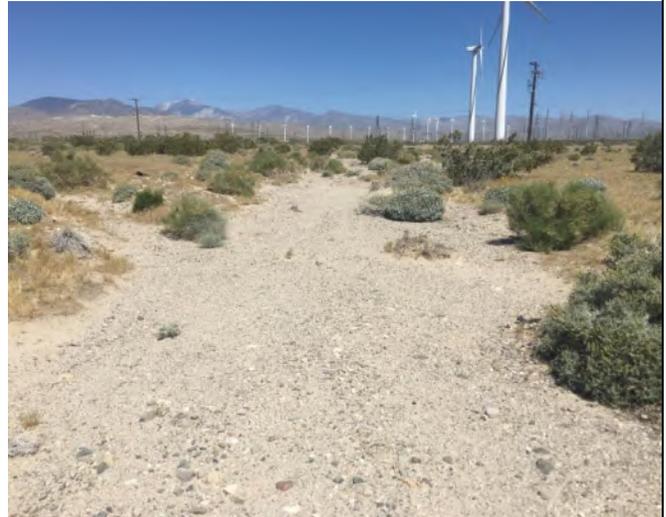
PP-66: Upstream, North-Facing View of NWW-3 (alluvial fan) near Ordinary High Water Mark Data Point (ODP)-14

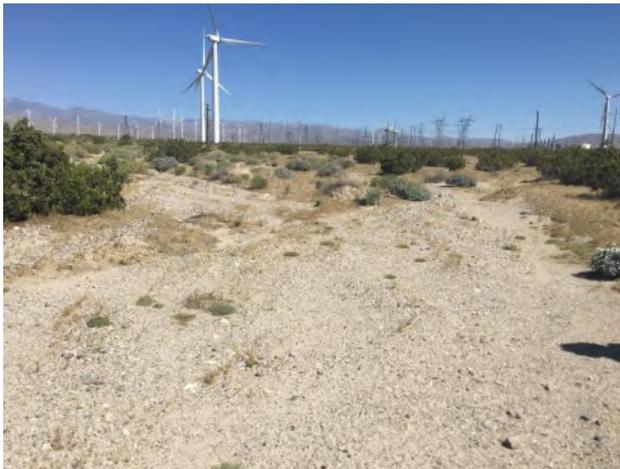
PP-67: Upstream, North-Facing View of NWW-3 (alluvial fan) south Ordinary High Water Mark Data Point (ODP)-14

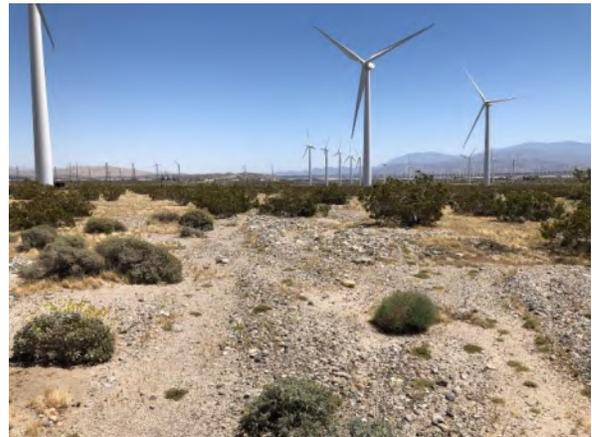
PP-68: Downstream, Southeast-Facing View of NWW-3 (alluvial fan) south of Ordinary High Water Mark Data Point (ODP)-14

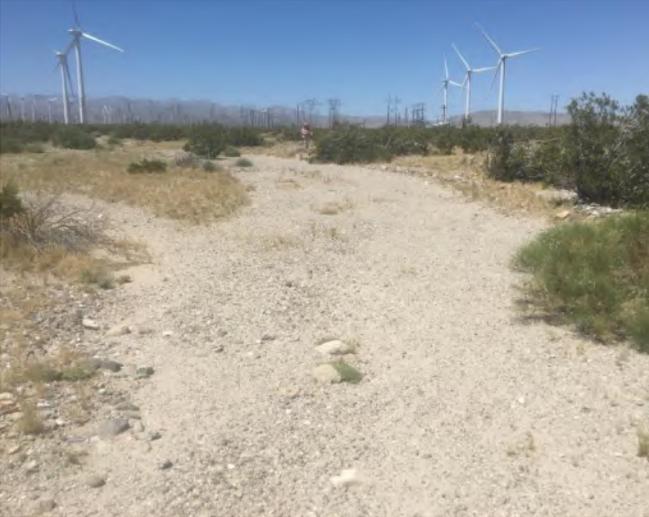
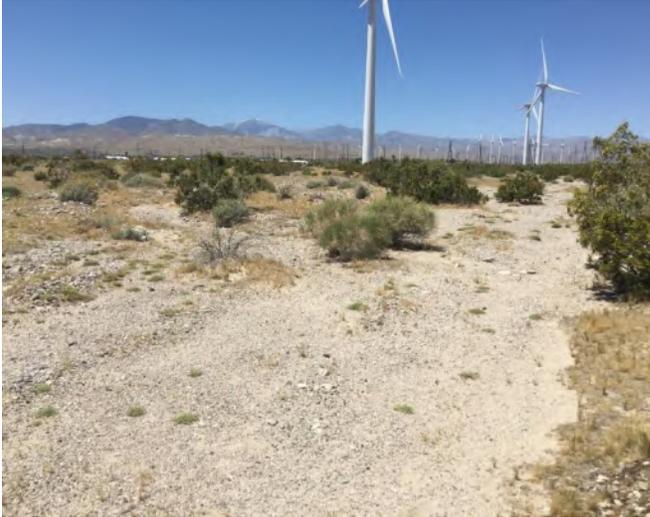
<p>PP-69: Upstream, North-Facing View of NWW-3 (alluvial fan) south Ordinary High Water Mark Data Point (ODP)-14</p>	<p>PP-70: Upstream, North-Facing View of NWW-3 outside of Review Area, south of Ordinary High Water Mark Data Point (ODP)-14</p>

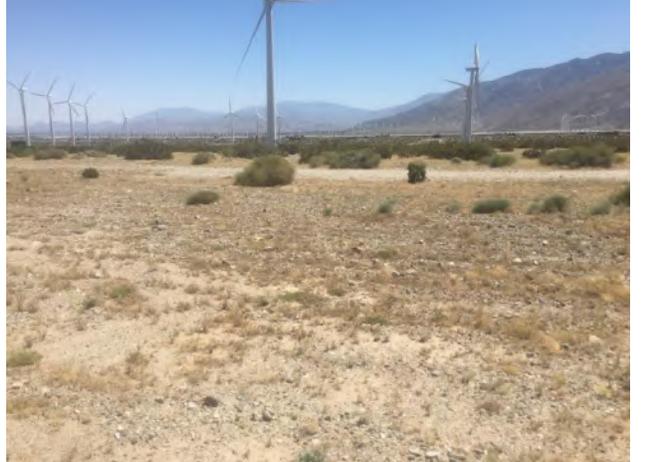
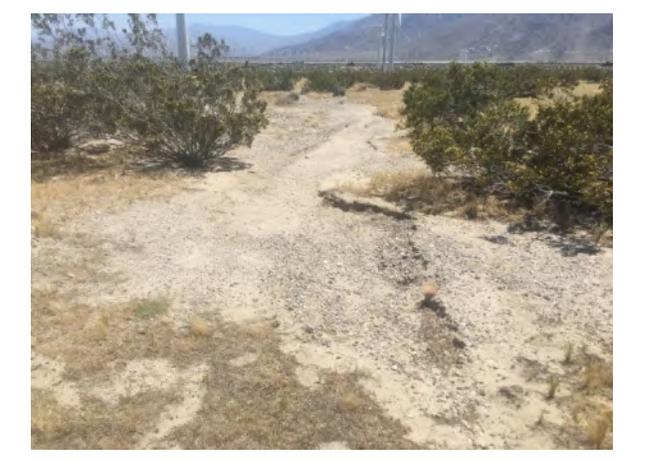
<p>PP-71: Downstream, Southeast-Facing View of NWW-3 outside of Review Area, south of Ordinary High Water Mark Data Point (ODP)-14</p>	<p>PP-72: Downstream, South-Facing View of NWW-3 outside of Review Area, south of Ordinary High Water Mark Data Point (ODP)-14</p>

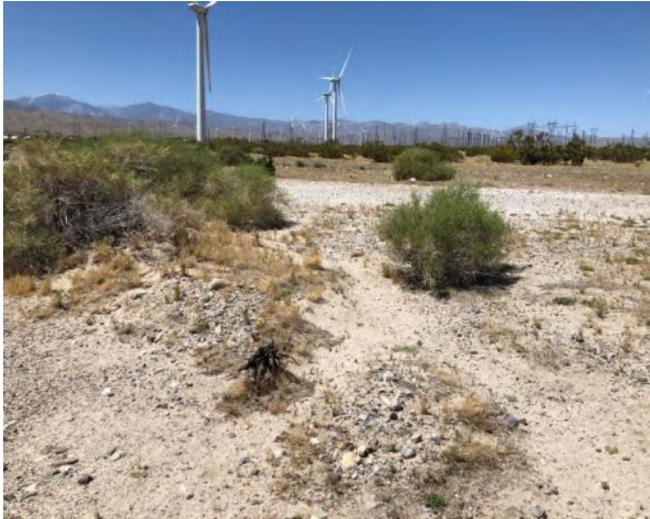
PP-73: Downstream, South-Facing View of NWW-3 outside of Review Area, south of Ordinary High Water Mark Data Point (ODP)-14

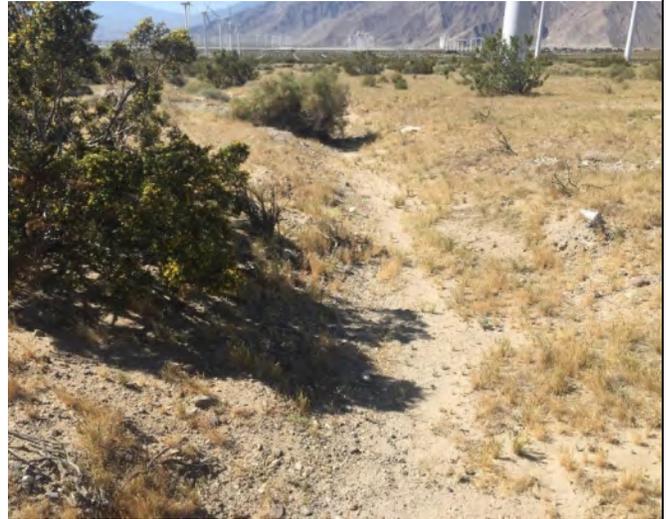
PP-74: Downstream, South-Facing View of tributary NWW-3a, near Ordinary High Water Mark Data Point (ODP)-15
