**State Aquatic Resources Delineation Report
Phase 1
August 2021**

**State Jurisdictional Waters Delineation Report
Phase 2
December 2020**

Subject: *State Jurisdictional Waters Delineation Report for the Desert Peak Energy Center Project, City of Palm Springs, Riverside County, California*

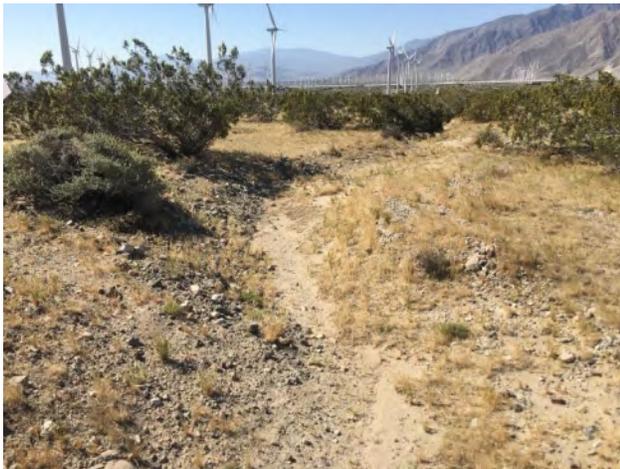
PP-75: Downstream, South-Facing View of tributary NWW-3b, near Ordinary High Water Mark Data Point (ODP)-16

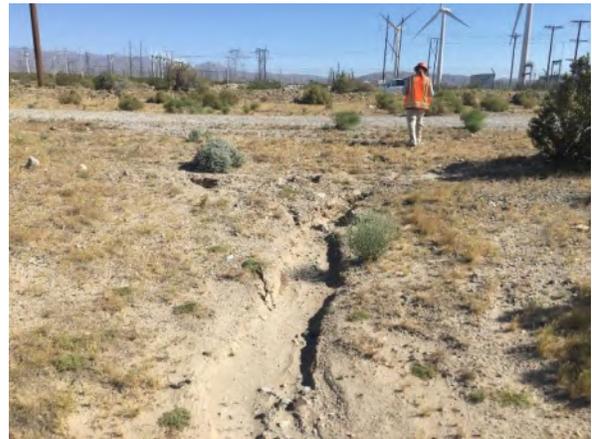
PP-76: Upstream, North-Facing View NWW-4 near Ordinary High Water Mark Data Point (ODP)-17

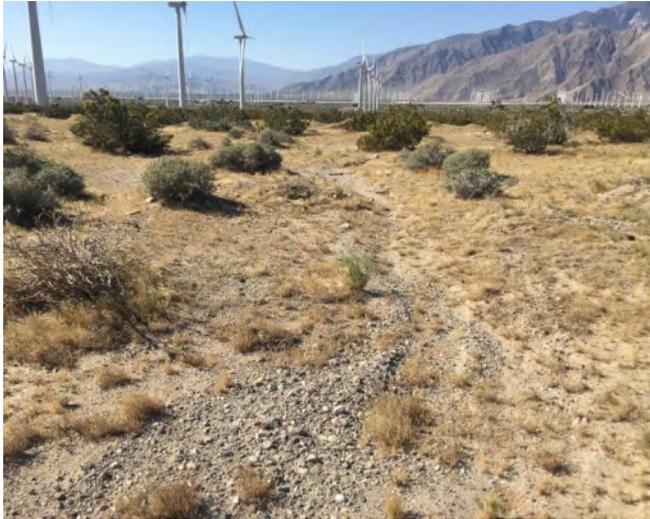
PP-77: Downstream, Southeast-Facing View of NWW-4 near Ordinary High Water Mark Data Point (ODP)-17

NWW-4 is an unvegetated ephemeral channel within the northeastern portion of the review area. This feature originates within the review area immediately south of a dirt road. This feature flows south approximately 466 feet, then exits the review area and continues approximately 1,169 feet south before dissipating as sheetflow. While there was no downstream connectivity observed during the 2020 site visit, based on 2004 Google Earth imagery this feature continued off site ultimately flowing to Garnet Wash to the south, which continues to flow southeast until its confluence with the Whitewater River (Google Earth 2020). Based on Google Earth imagery, sometime between June and September 2011, a north-south trending dirt road was constructed within the eastern portion of the review area. In June 2012, additional grading occurred along the road associated with installation of turbines and these events disrupted the hydrology within the southeastern portion of the review area. An OHWM is evident and characterized by break in bank and slope, change in average sediment size, absence of vegetation, change in vegetation cover, and sediment deposition (ODP-17). Average widths for the OHWM ranged from approximately 1 foot to 3 feet.

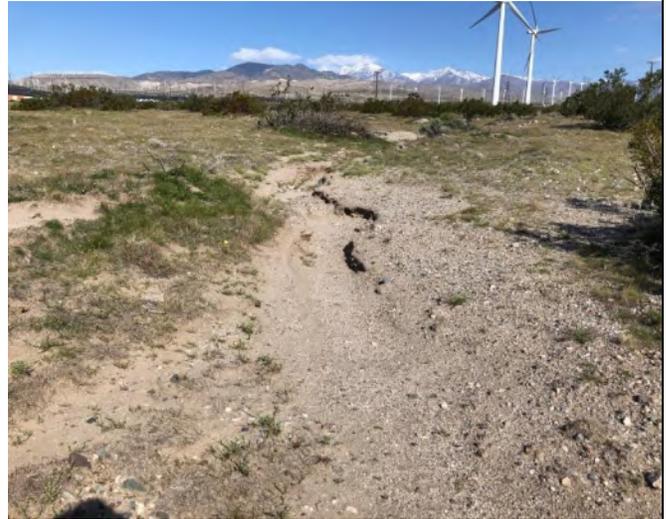
PP-78: Upstream, Northwest-Facing View of NWW-4 south of Ordinary High Water Mark Data Point (ODP)-17

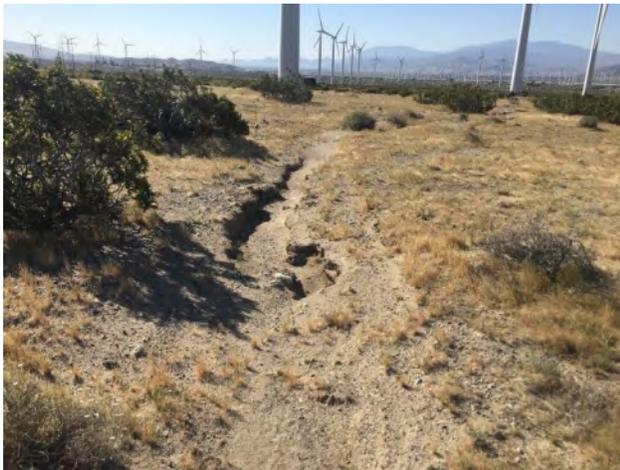
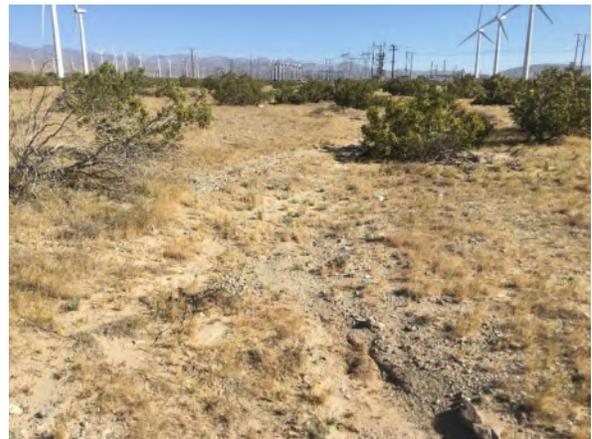
PP-79: Upstream, Northwest-Facing View of NWW-4 outside of the Review Area, south of Ordinary High Water Mark Data Point (ODP)-17

PP-80: Downstream, Southwest-Facing View of NWW-4 outside of the Review Area, south of Ordinary High Water Mark Data Point (ODP)-17

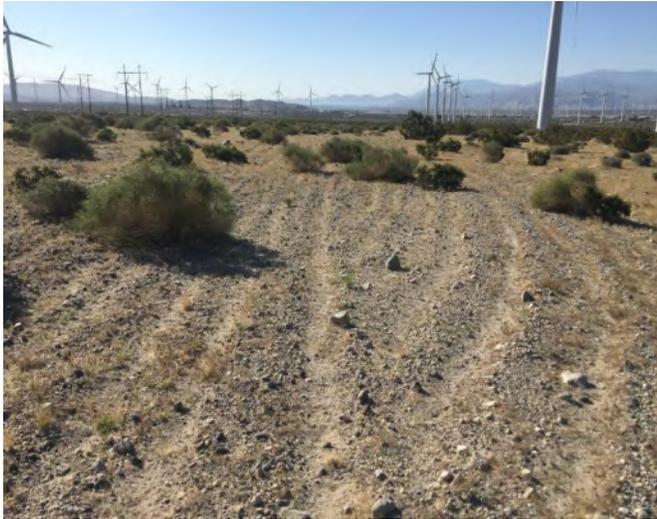
PP-81: South-Facing View of disturbance area

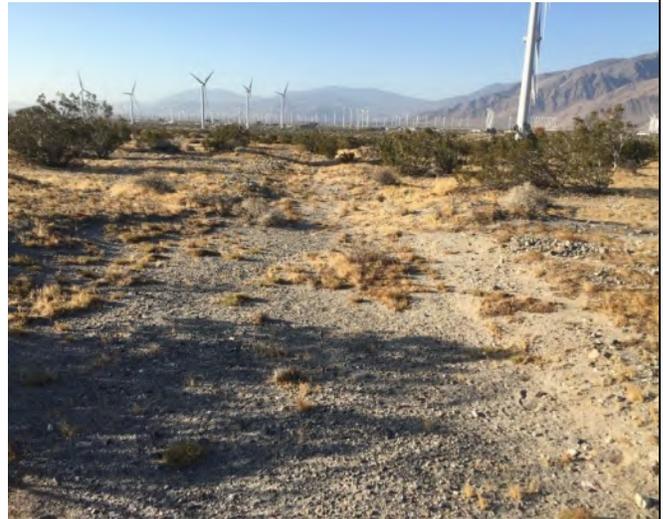
PP-82: Downstream, South-Facing View of NWW-2

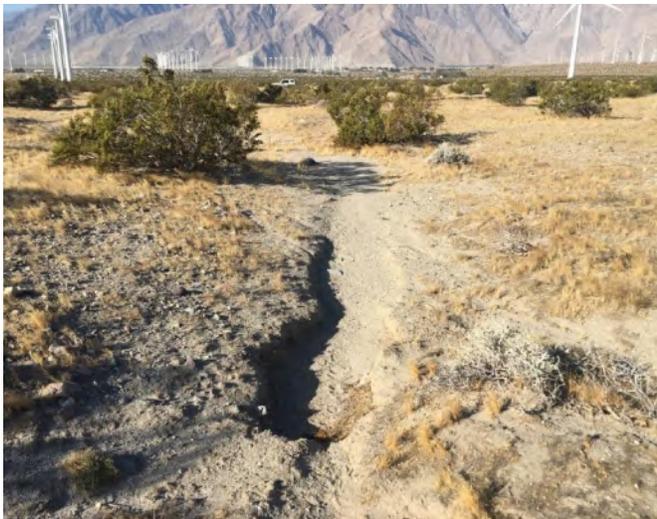
PP-83: Downstream, South-Facing View of NWW-4

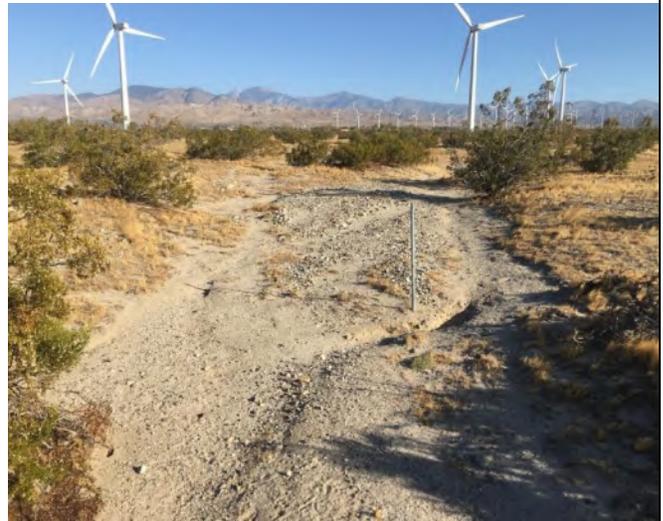
PP-84: Upstream, North-Facing View of NWW-3

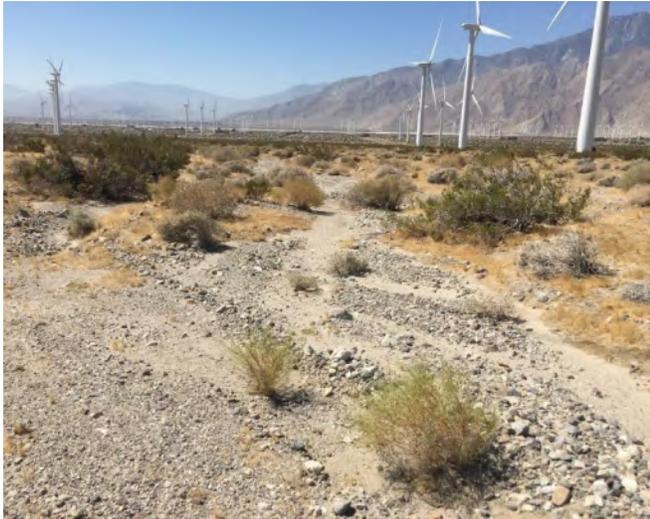
PP-93: Downstream, Southwest-Facing View of NWW-5, north of Ordinary High Water Mark Data Point (ODP)-21.

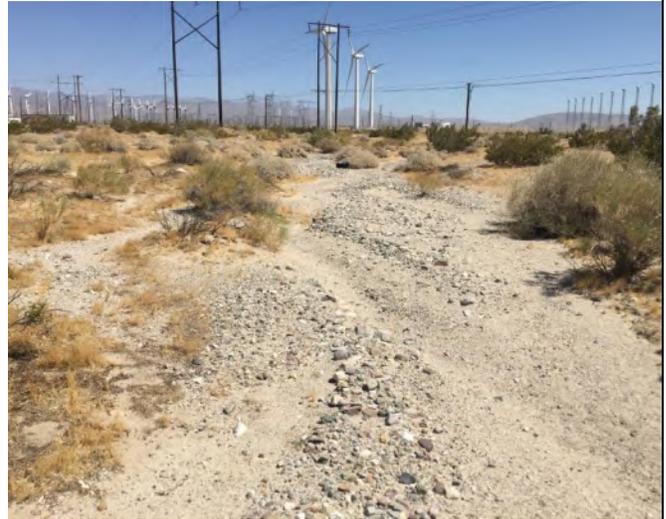
PP-94: Upstream, North-Facing View of NWW-5, north of Ordinary High Water Mark Data Point (ODP)-21.

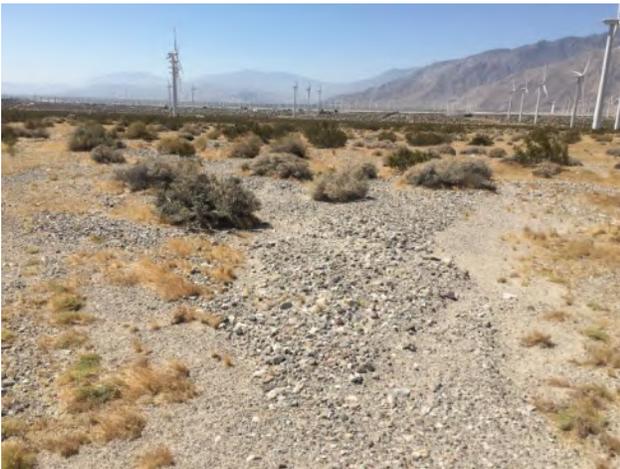
PP-95: Downstream, Southeast-Facing View of NWW-5, near Ordinary High Water Mark Data Point (ODP)-21.

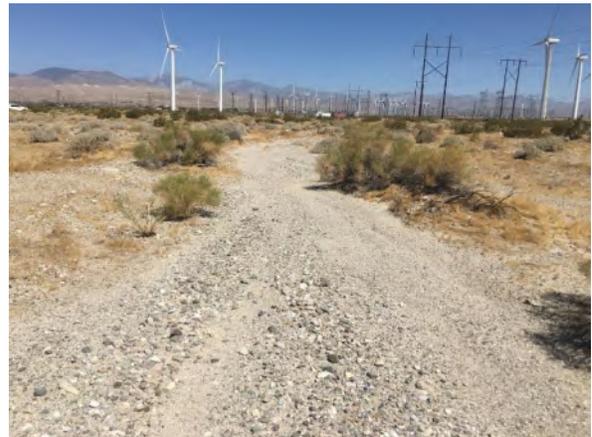
PP-96: Upstream, Northwest-Facing View of NWW-5, near Ordinary High Water Mark Data Point (ODP)-21.

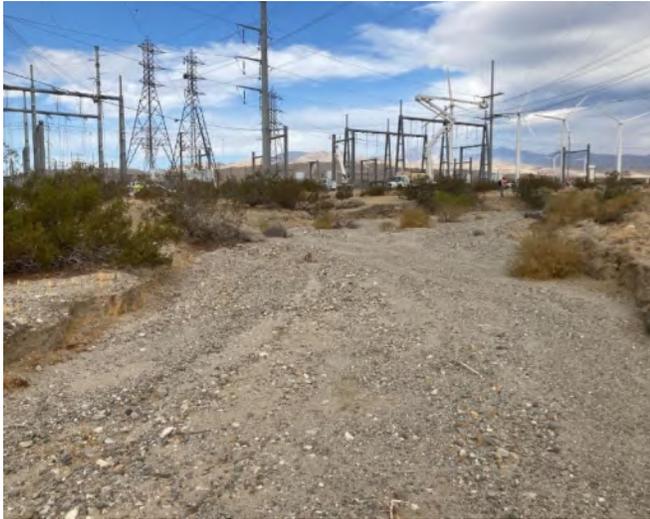
PP-97: Upstream, Northwest-Facing View of NWW-3 in northern portion of review area, north of Ordinary High Water Mark Data Point (ODP)-22.

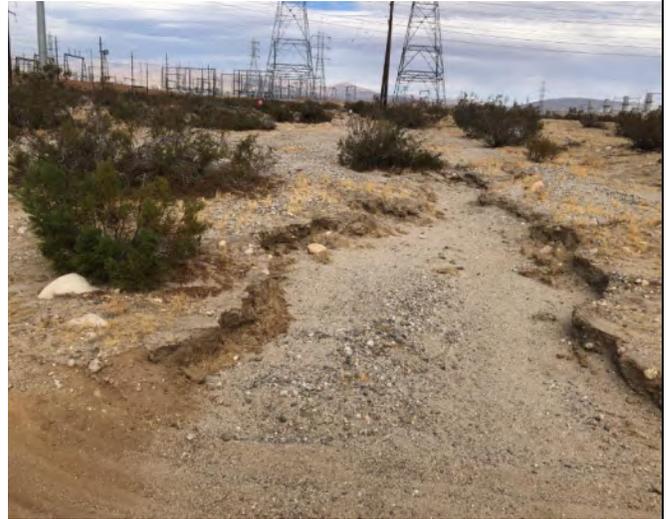
PP-98: Upstream, North-Facing View of NWW-6, south of Ordinary High Water Mark Data Point (ODP)-23.

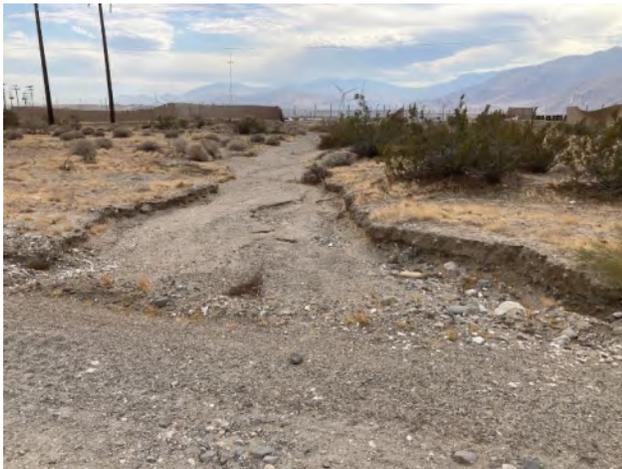
PP-100: Downstream, South-Facing View of NWW-7, near Ordinary High Water Mark Data Point (ODP)-24.
