Initial Study and Draft Mitigated Negative Declaration

Environmental Review of a Coastal Grading Permit

1. **Project Title:** Rhiannon Solem
Environmental Review of a Coastal Grading Permit – GP2022-01C
2. **Lead Agency Name and Address:** Del Norte County
Planning Commission
981 H Street, Suite 110
Crescent City, CA 95531
3. **Contact Person and Phone Number:** Jacob Sedgley
(707) 464-7254
Jacob.Sedgley@co.del-norte.ca.us
4. **Project Location and APN:** 16815 Oceanview Drive, Smith River, CA 95567
APN 101-010-009
5. **Project Sponsor’s Name and Address:** Rhiannon Solem
23828 Costa Mesa Way
Murrieta, CA 92562
6. **County Land Use:** Rural Residential – one dwelling unit per five acres (RR(1/5))
7. **County Zoning:** Rural Residential Agriculture – five acre minimum lot size (RRA-5)
8. **Description of Project:**

RESTORATION PLAN, HIGGS VIOLATION, 16815 OCEANVIEW DRIVE, DEL NORTE COUNTY (APN # 101-010-09)

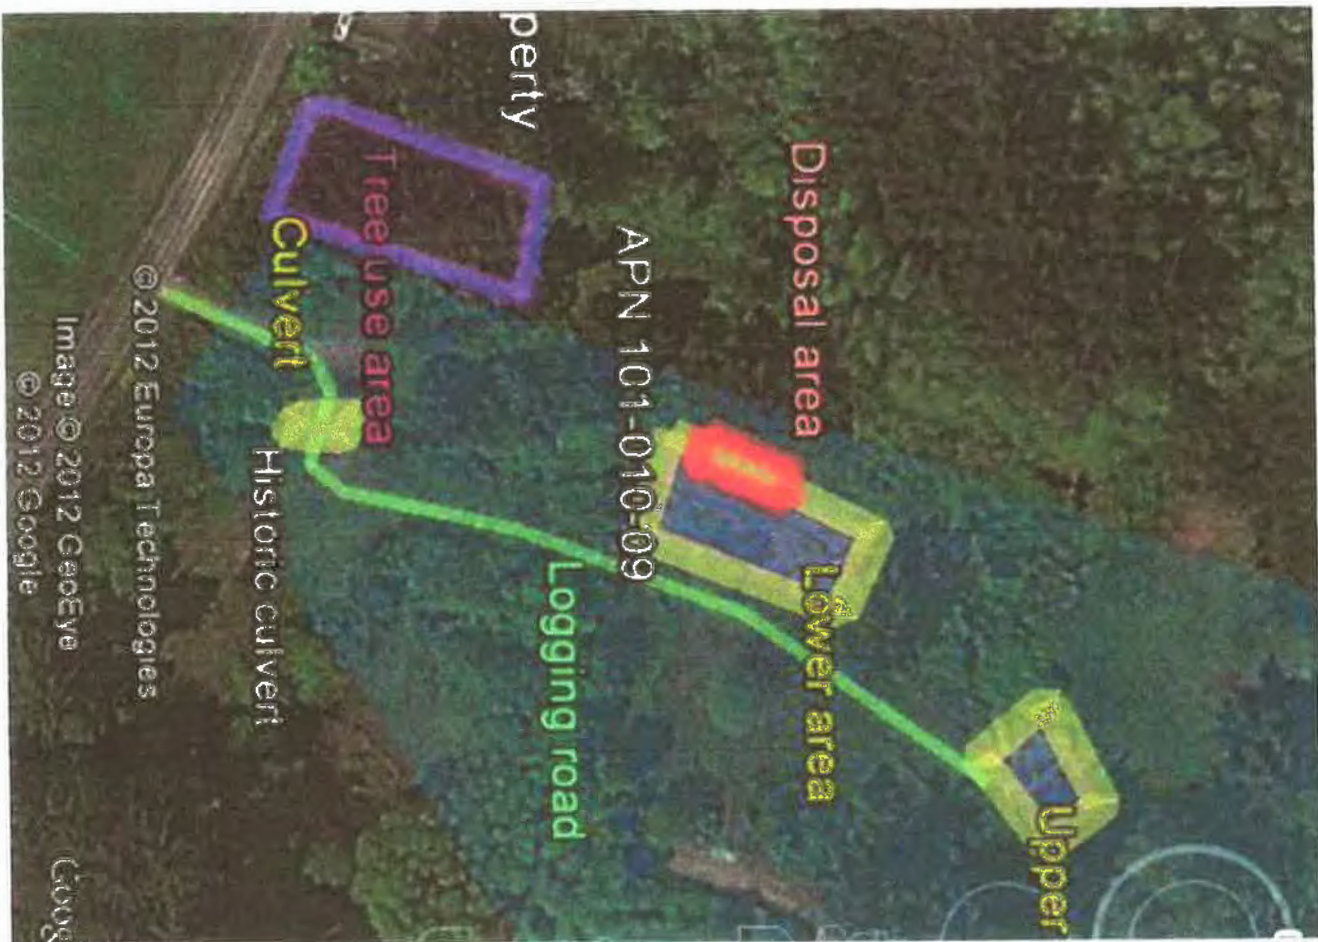
Woody debris would be removed from the stream channel and taken to a dry section of the property and discarded. Any sections of the stream channel which may have an overabundance of fill dirt would be

carefully excavated to remove fill and blockage. Debris and fill would be removed until the stream depth is returned to pre-violation depths, a depth decided upon by a monitoring biologist. Depth of the final channel for each segment will be dependent upon what is removed from the channel during restoration. All in-stream work would be supervised by a biologist from GBC.
