# **PHASE I ENVIRONMENTAL SITE ASSESSMENT AND SHALLOW SOIL INVESTIGATION**

**APPROXIMATELY 2.7-ACRE SITE ON EASTERN PORTION OF  
CAMBRIAN SCHOOL DISTRICT PROPERTY LOCATED AT:  
1975 CAMBRIANNA DRIVE  
SAN JOSE, CALIFORNIA**

Date  
**May 25, 2021**

Project Number  
**1690019586**

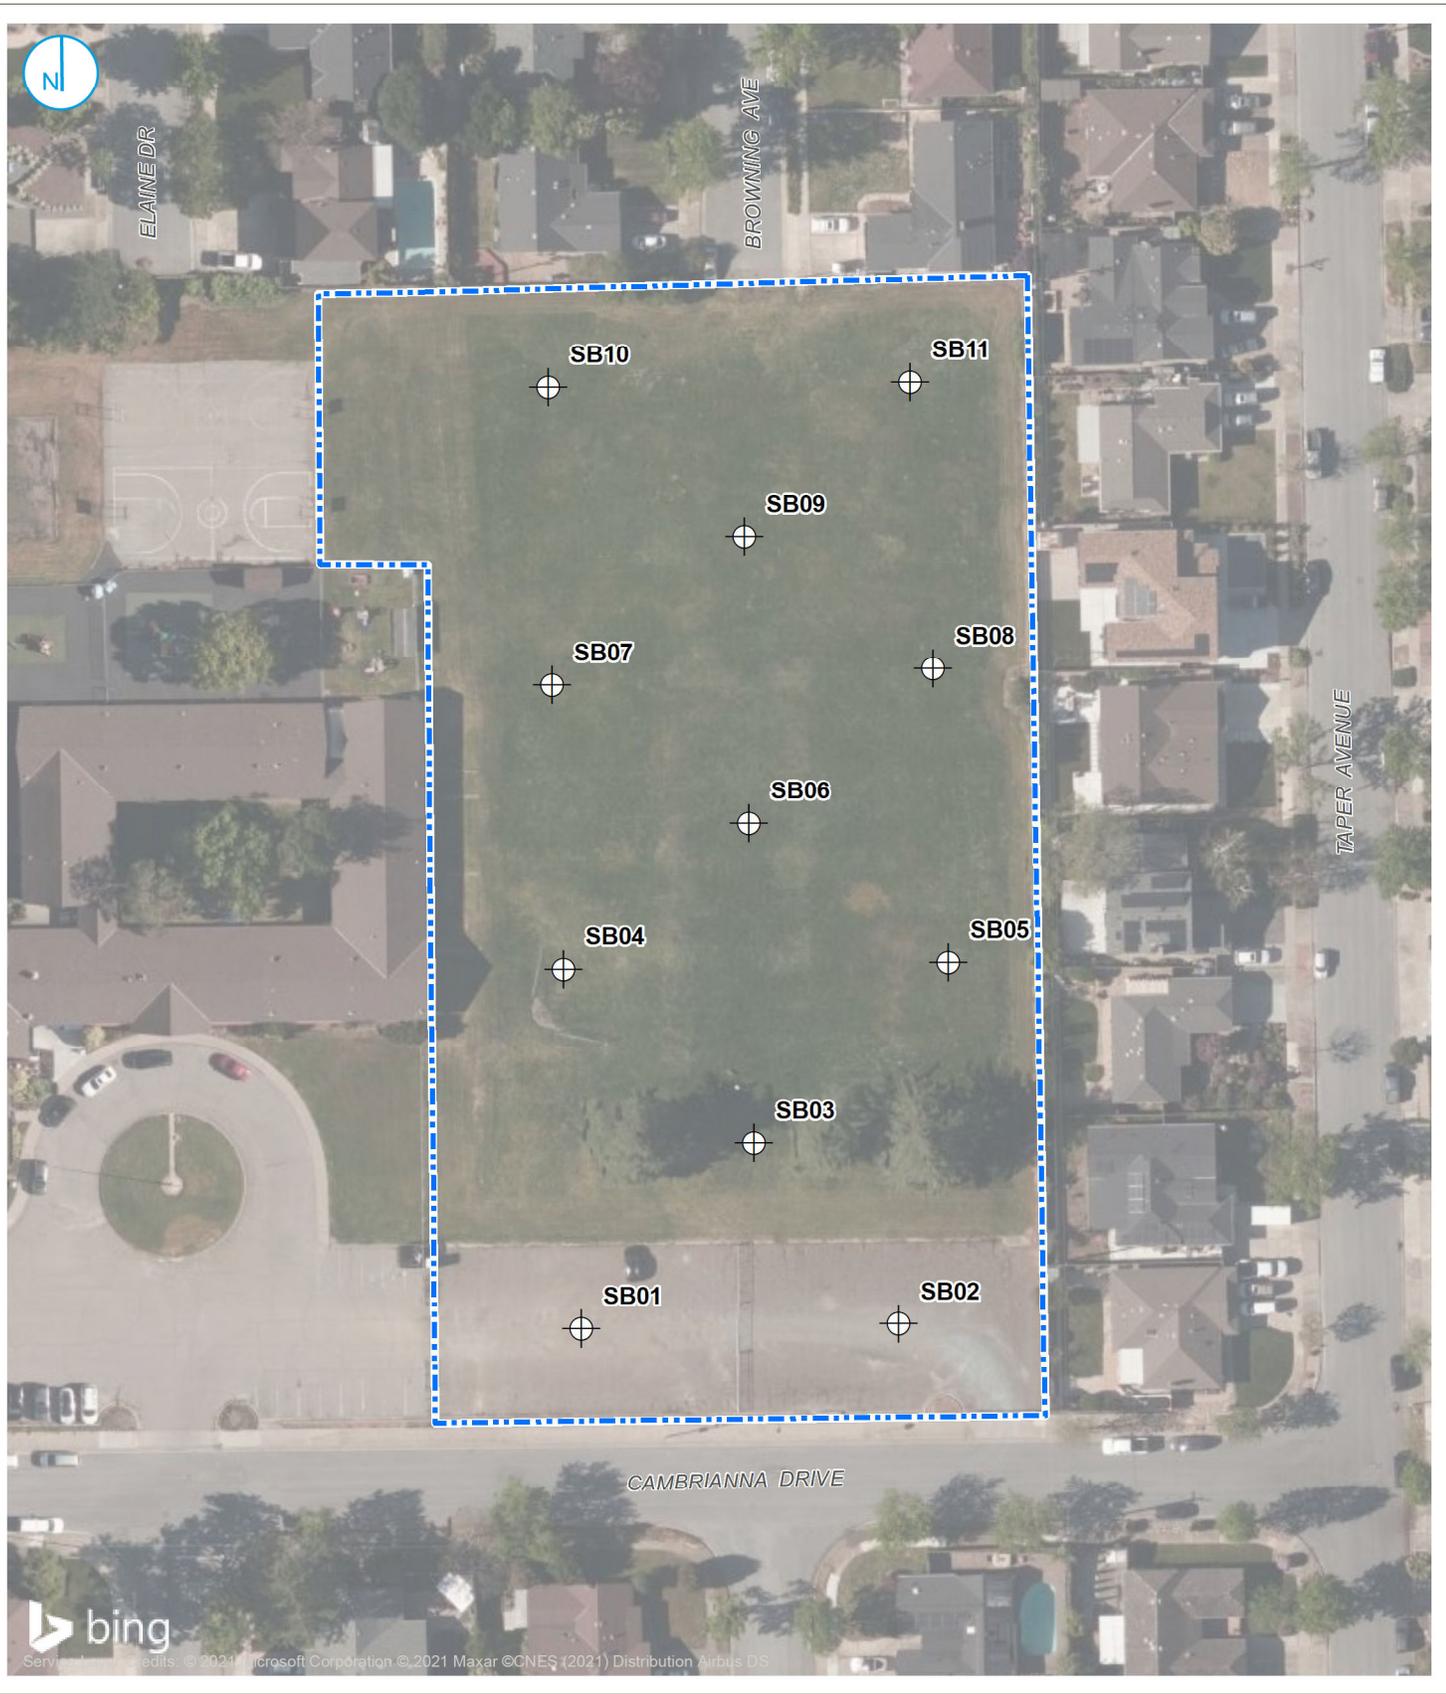
Soil borings SB01 and SB02 were located in the southernmost portion of the site within the gravel parking area and soil borings SB03 to SB11 were located in the grass field north of the parking lot. Soil boring locations are shown on Figure 3. No soil staining or odor was observed, and no PID readings indicative of a VOC-impacted soil were detected during soil screening activities.
