# 222 EAST SHILOH ROAD SONOMA COUNTY, CALIFORNIA

Phase I Environmental Site Assessment

Prepared for  
Confidential Client

August 2021

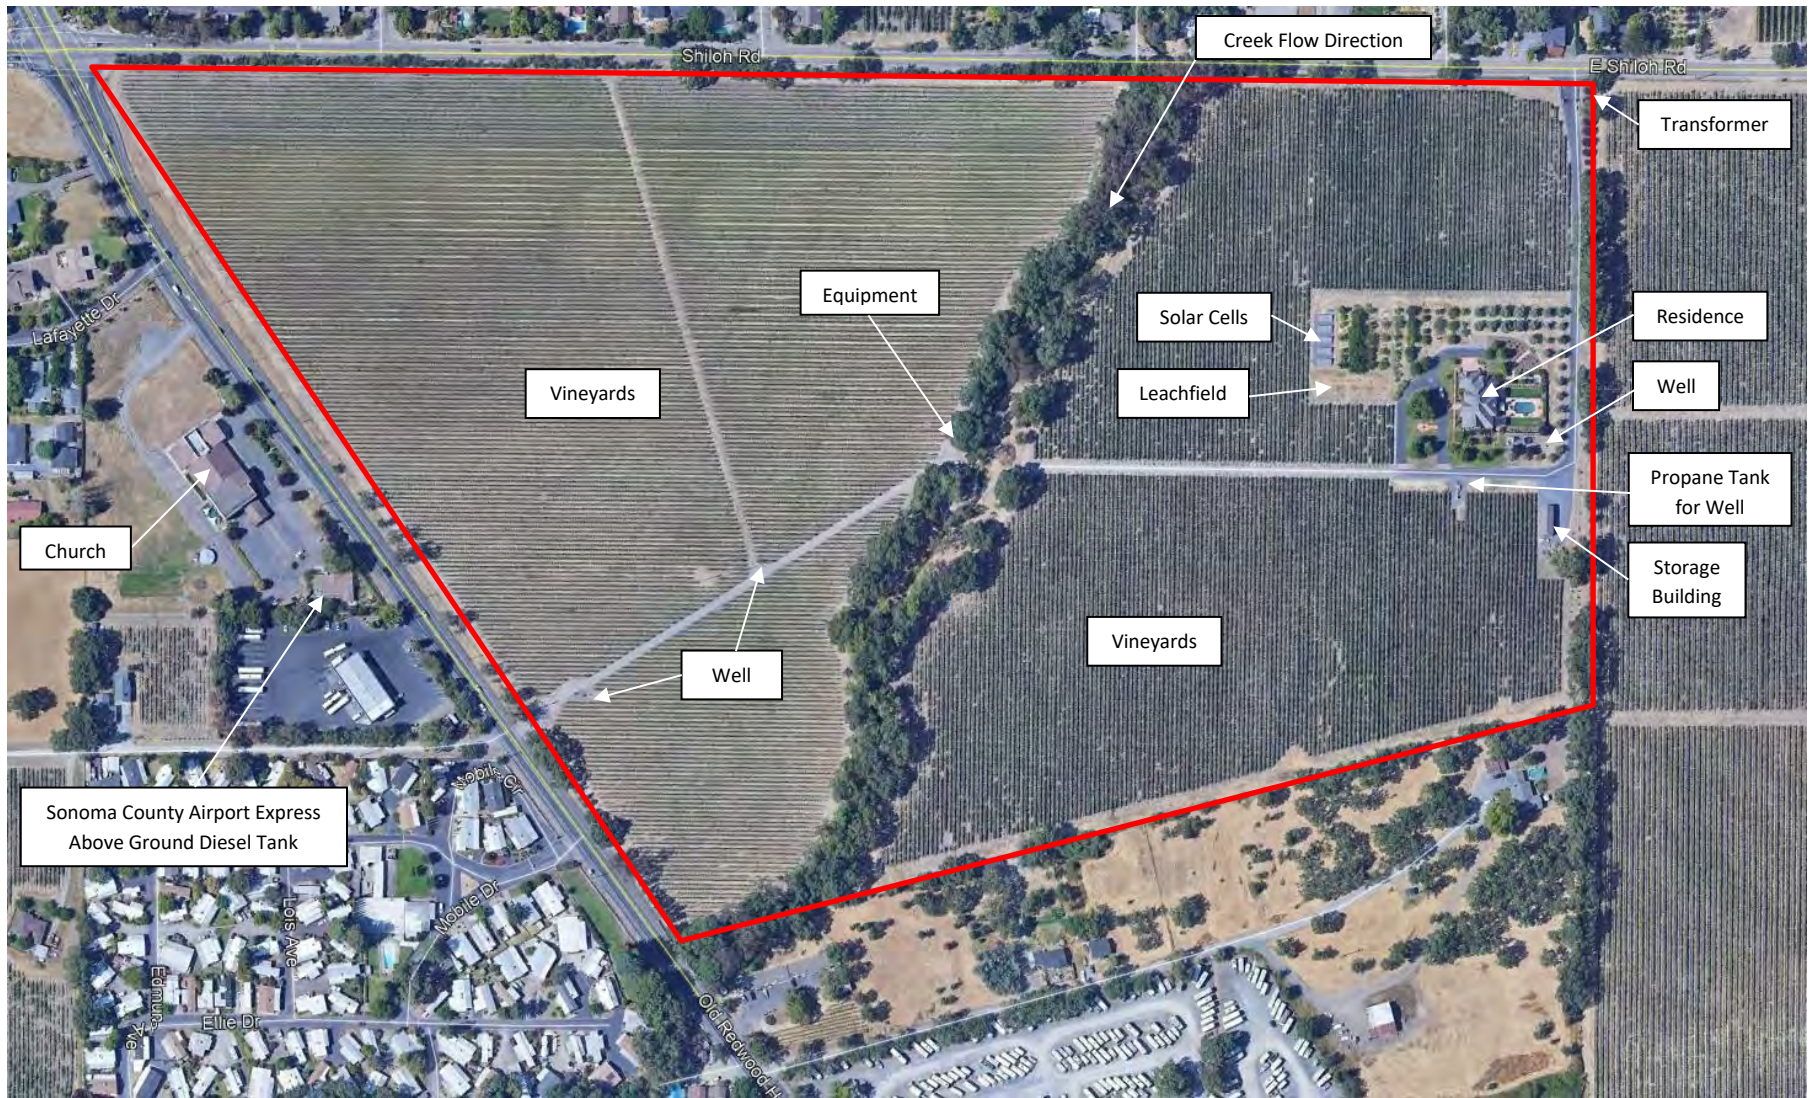
**Figure 1**  
Subject Property

The subject property is located adjacent to the southern border of the Town of Windsor and east of Highway 101 in unincorporated Sonoma County, California. Figure 1 shows the current conditions of the subject property, along with items of interest. The subject property consists of the 68.6-acre APN 059-300-003. The subject property is surrounded by Old Redwood Highway to the west, East Shiloh Road and residential properties to the north, residences to the south, and vineyards to the east. The subject property is developed with one residence, a storage building, and vineyards. **Table 3-1** summarizes the subject property acreage, and Sonoma County land use zoning and General Plan designations.

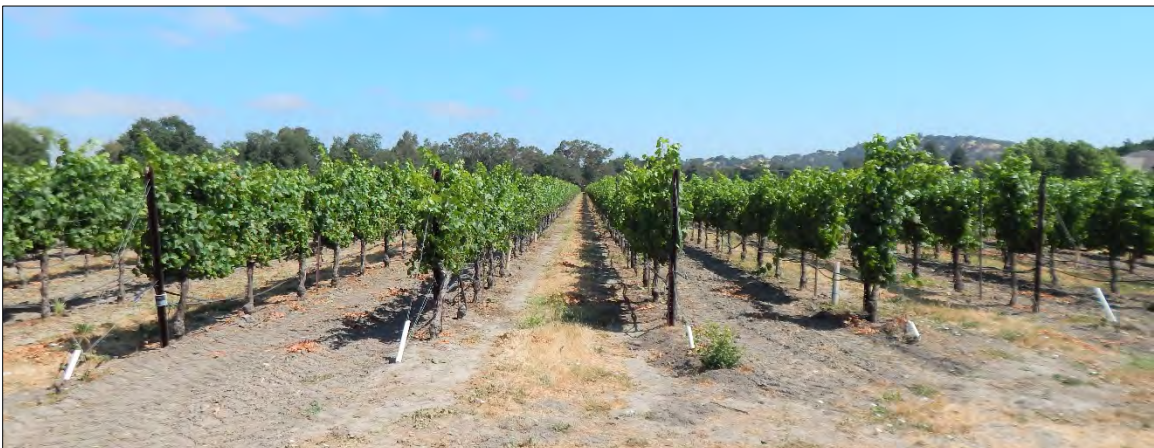
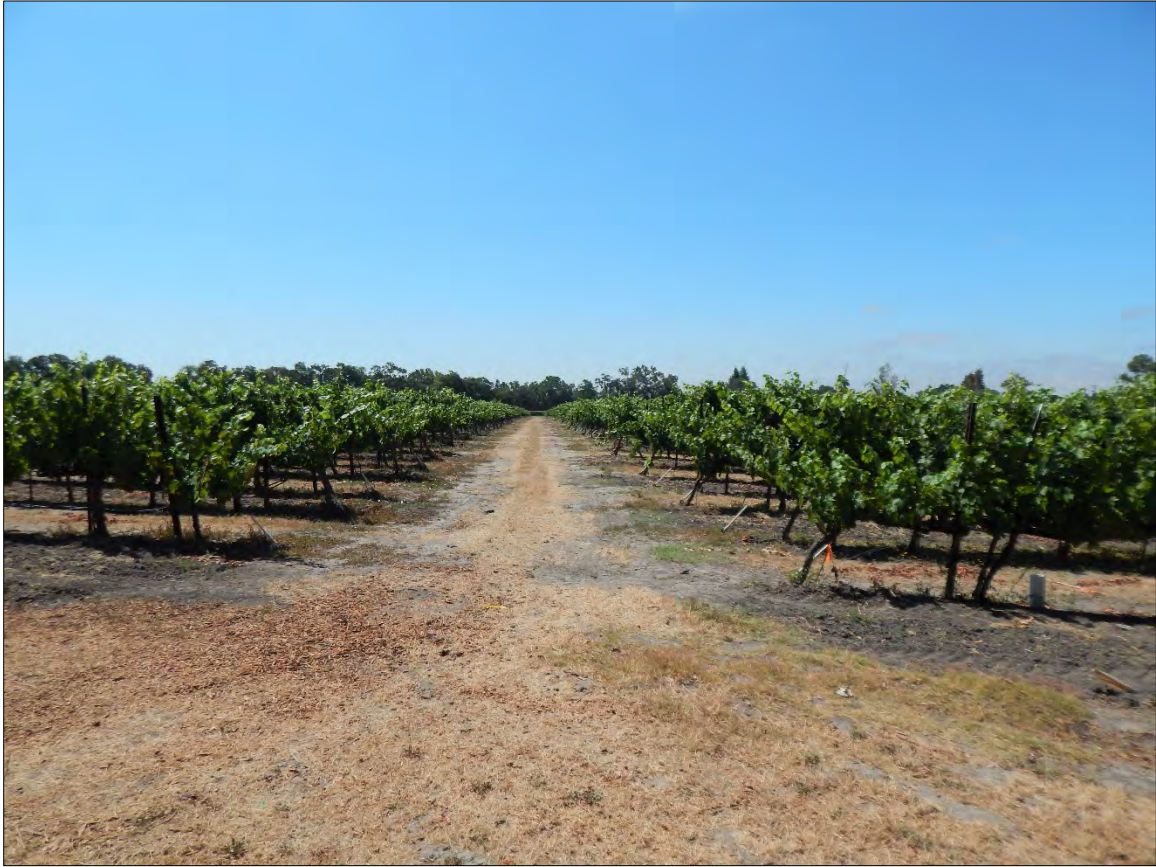
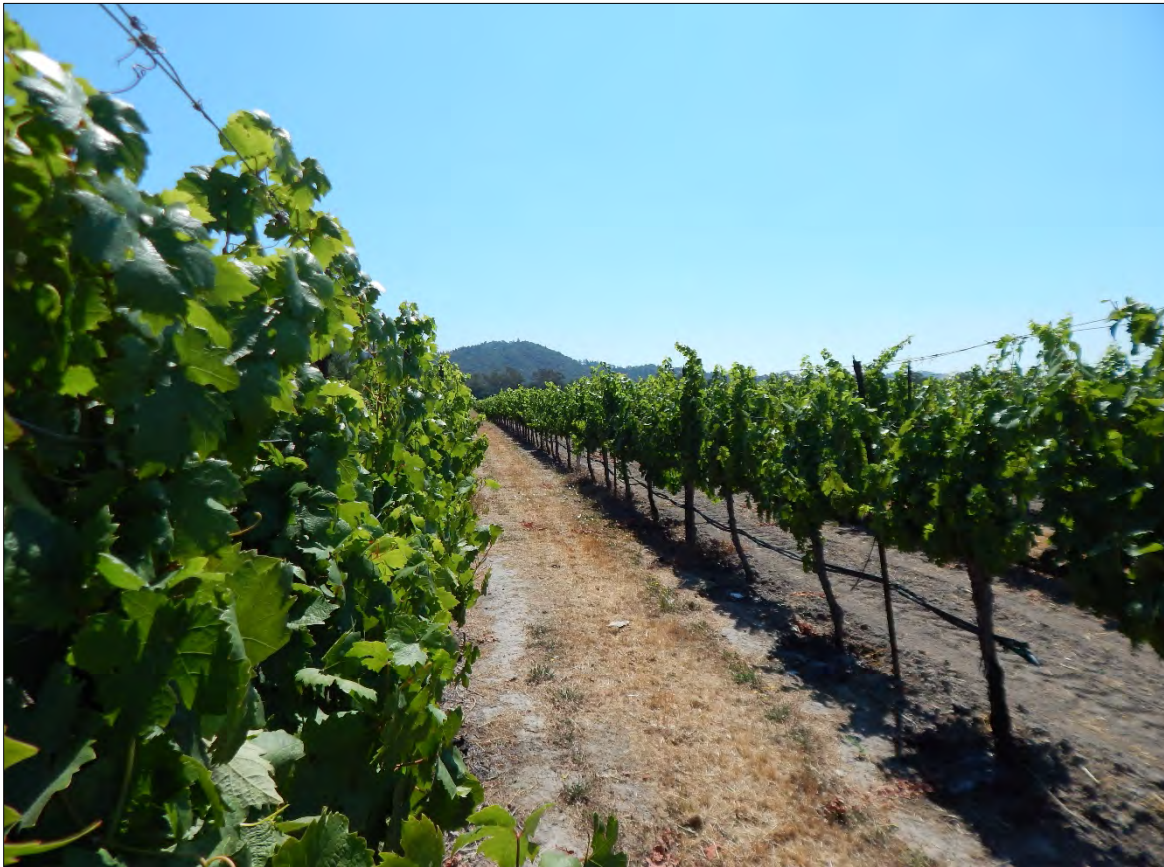
The vineyards cover most of the subject property. The vines are watered using drip irrigation. The photographs below and on the next page show typical views of the vineyards. No stained soil or stressed vegetation were observed anywhere in the vineyard areas.

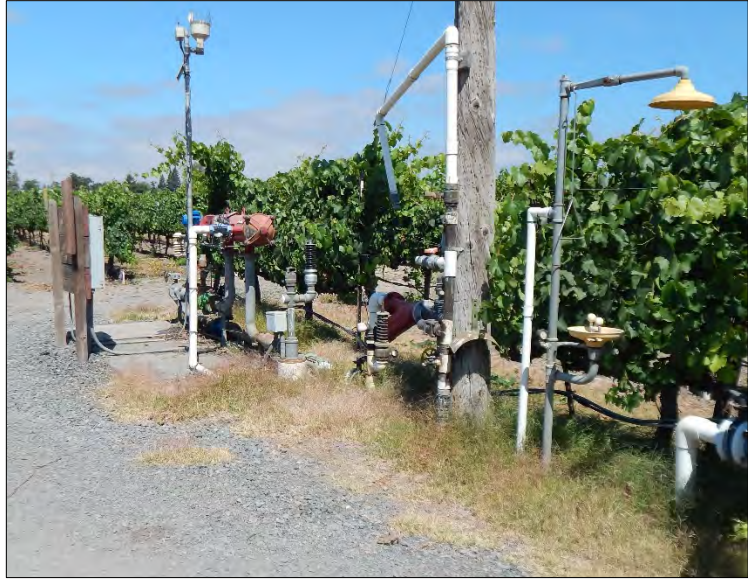
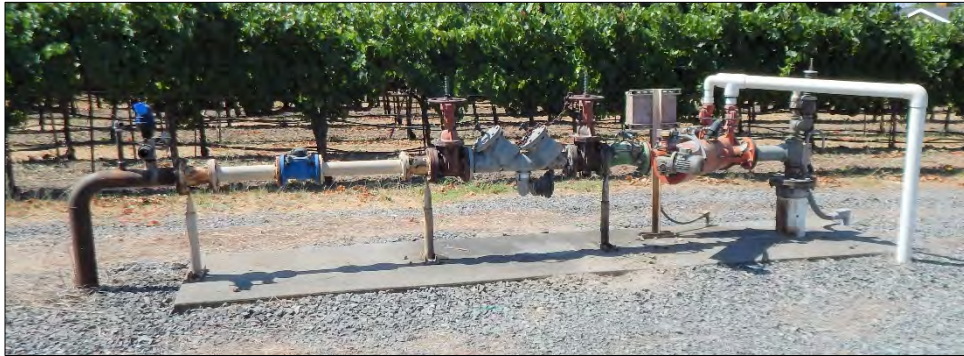
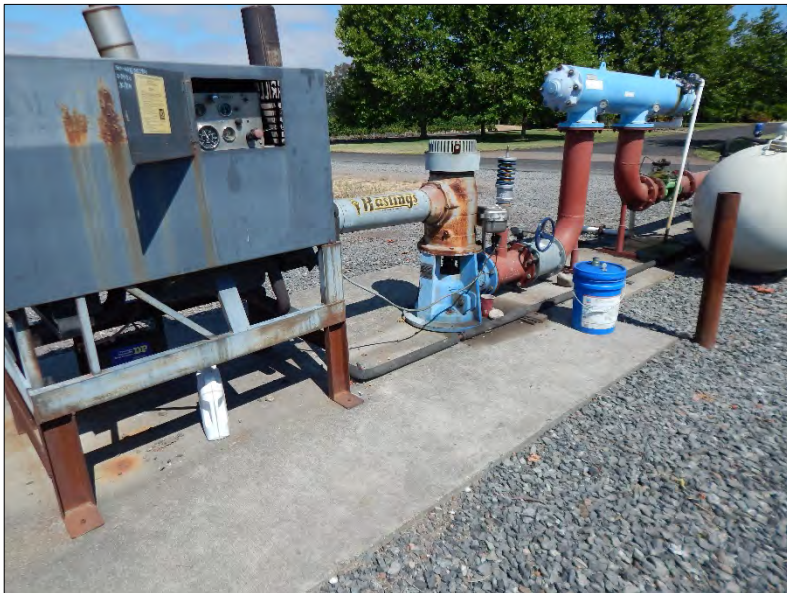
The subject property has three vineyard irrigation wells shown in the photographs below. The two irrigation wells on the western part of the subject property are powered by electricity. The one irrigation well on the eastern part of the subject property is powered by propane, as shown in the bottom photograph. Minor oil staining was observed by the propane-powered well pump. The staining is minor in extent, does not extend to the edge of the pad, and is considered a de minimus condition.

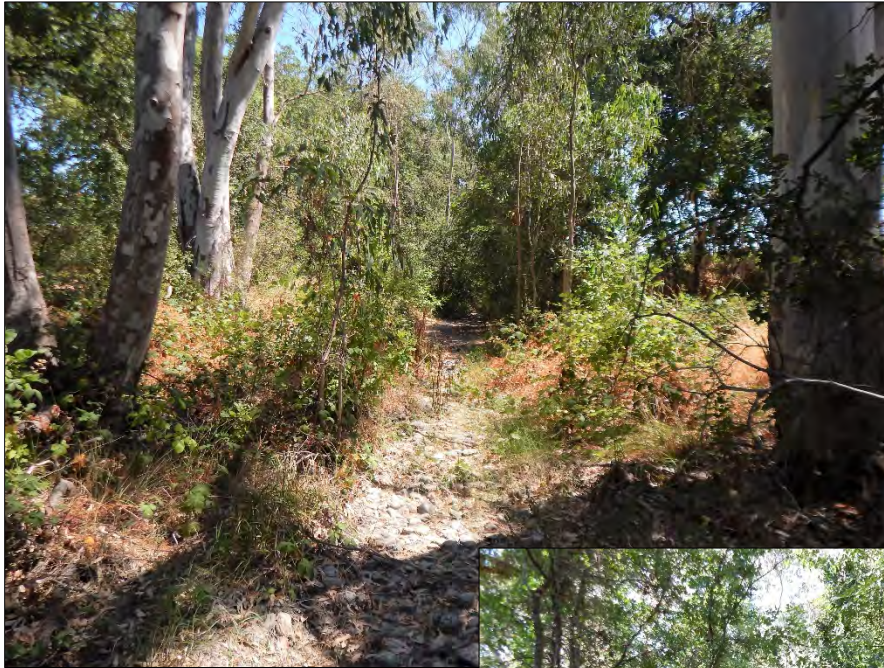
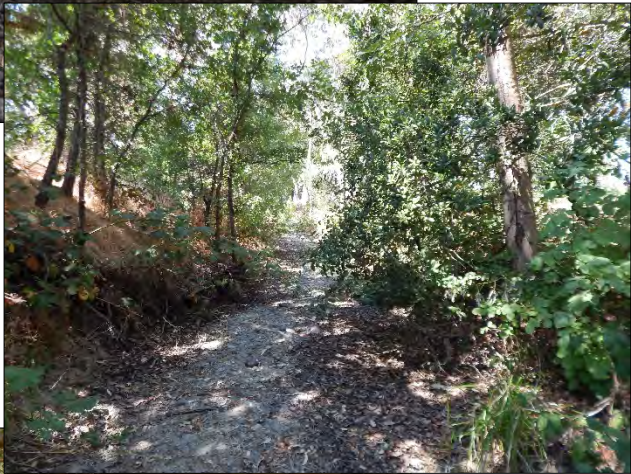
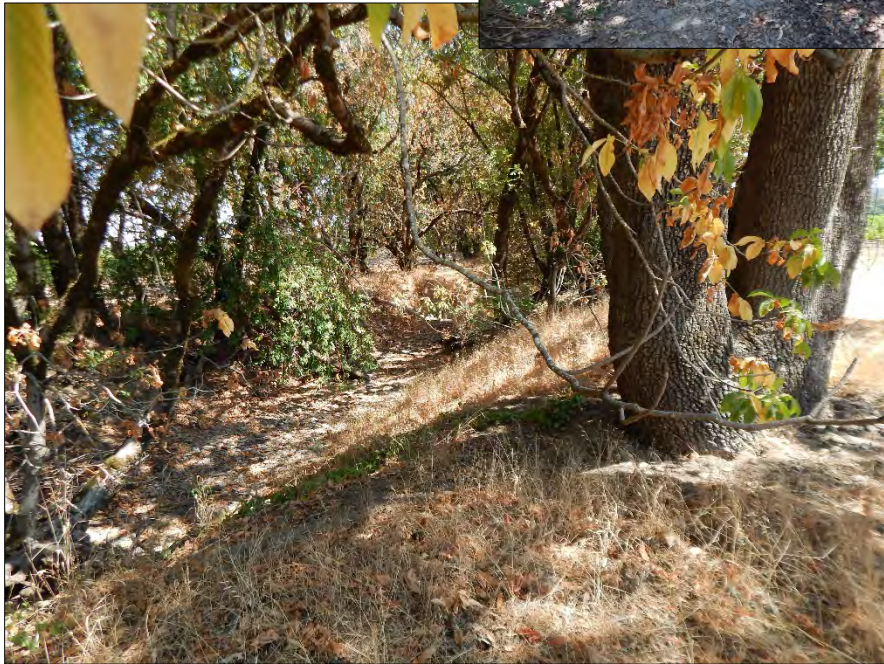
The creek bisecting the subject property is shown in the photographs below. The creek banks have thick vegetation. The property owner noted that the creek only flows in the winter and is typically dry by June. No trash, stained soil, or stressed vegetation were observed.

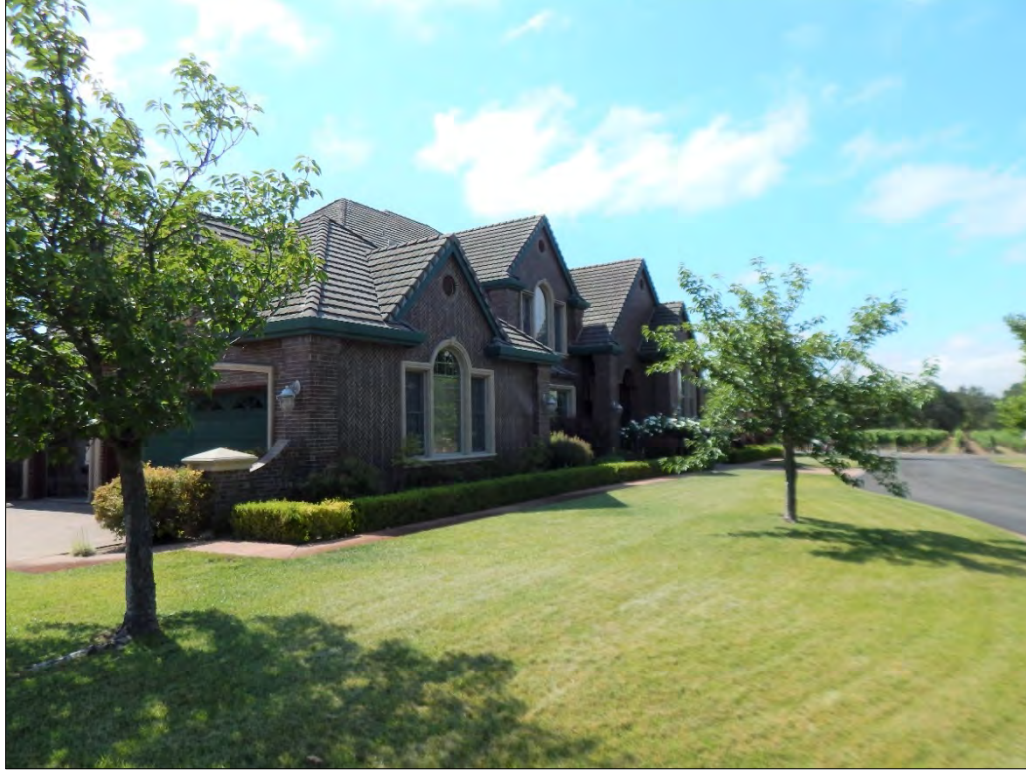
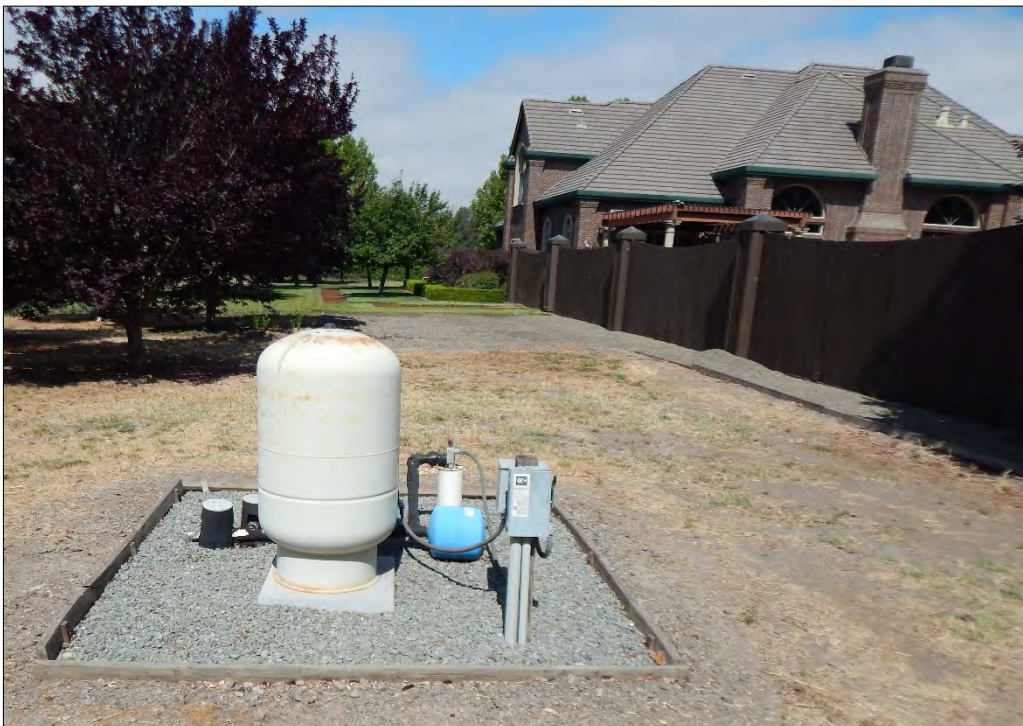
The photographs below show the owner's residence and the domestic well located by the southeast corner of the house. The interior of the home was not inspected and is assumed to contain minor small quantities of typical home cleaning products. The domestic well is electrically powered. No stained soil or stressed vegetation was observed around the home or domestic well.

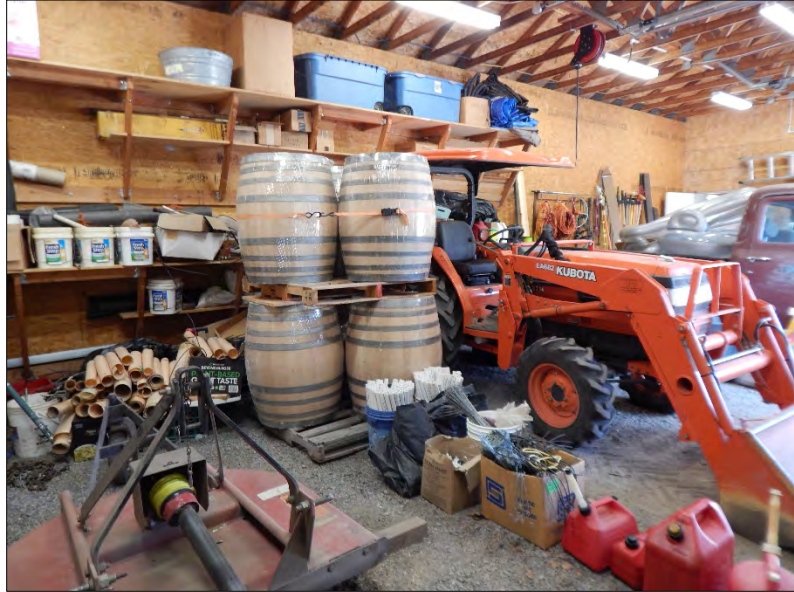
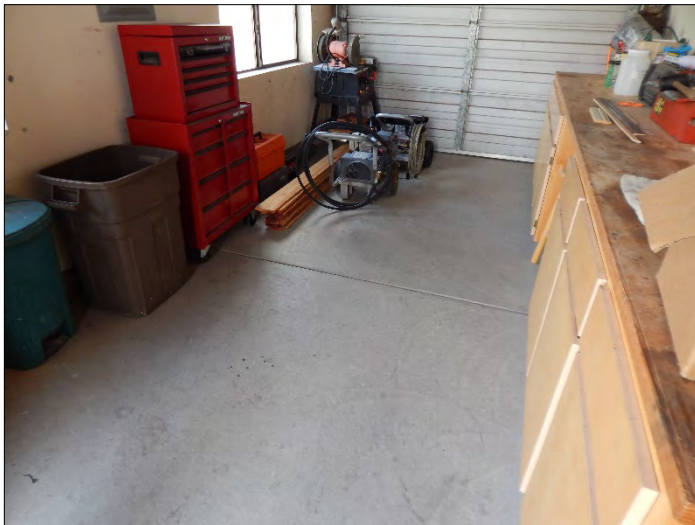
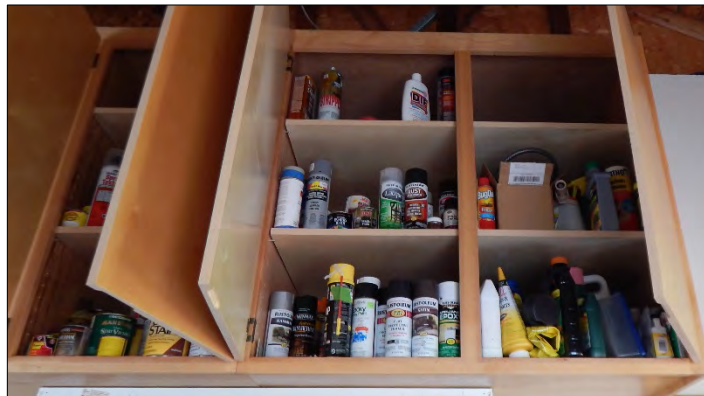
An equipment and materials storage building is located southeast of the residence and along the eastern border of the subject property. The building stores a tractor, a pickup truck, tools, irrigation materials, wine barrels, and small quantities of paints and thinners, pesticides, roofing patch tar, and chalking. No staining was observed on the floor or gravel areas.

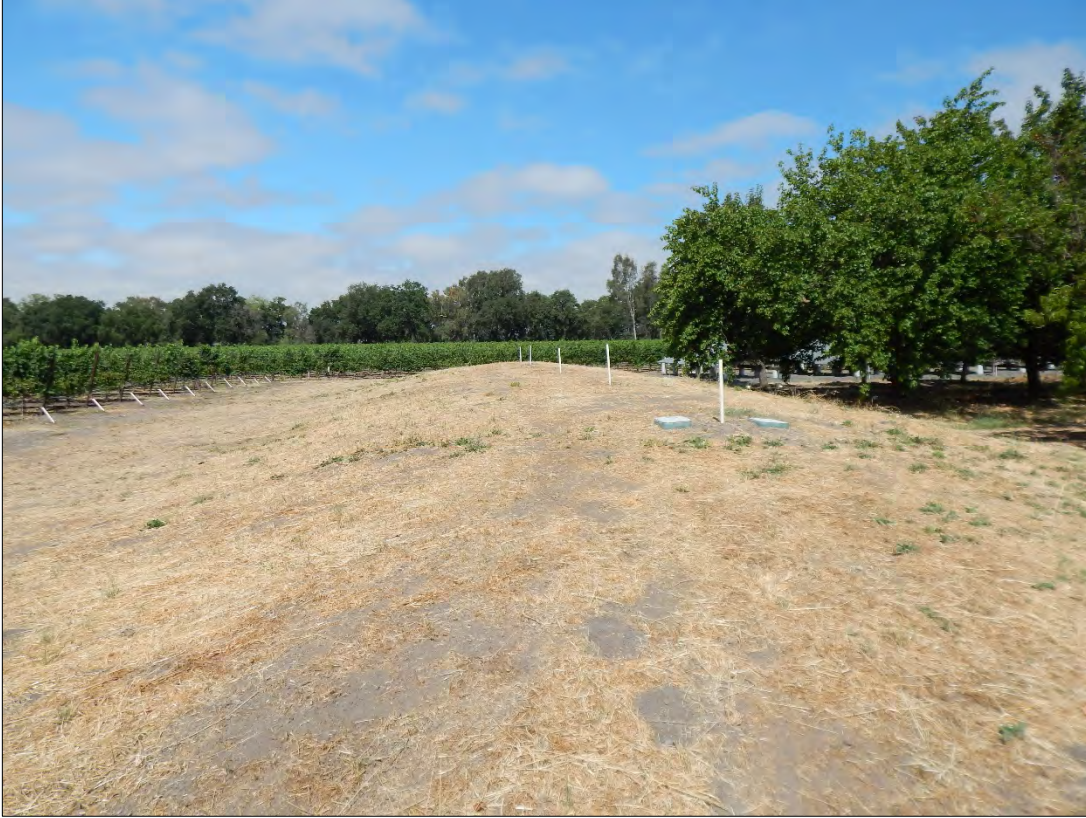
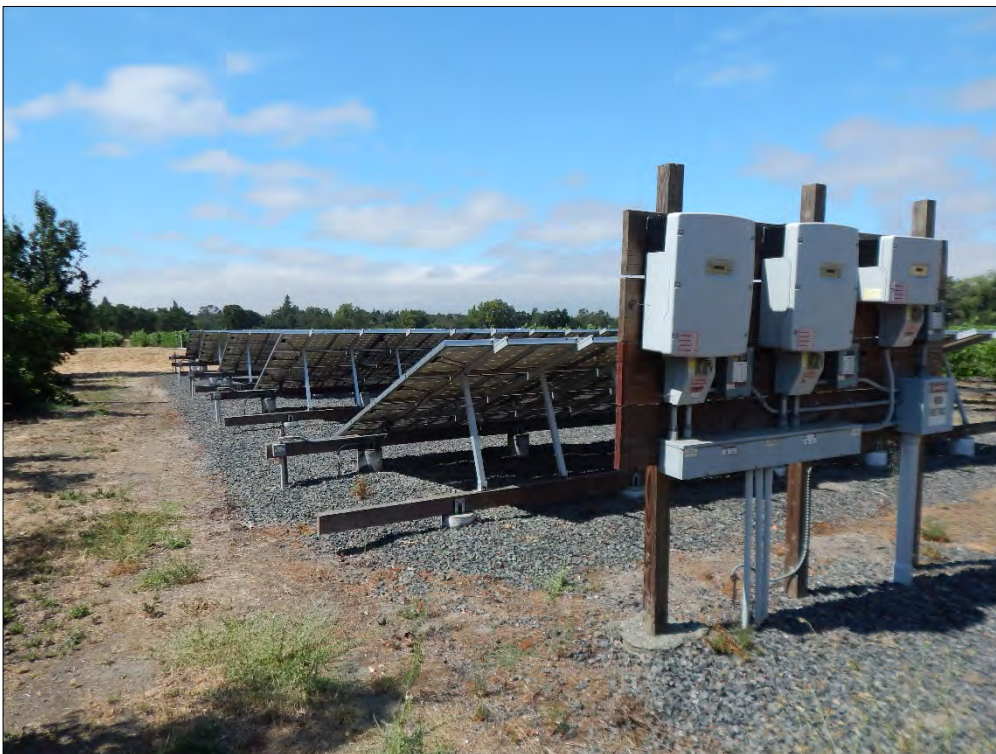
The septic system for domestic waste is located just west of the home and is raised to provide adequate distance to groundwater. The septic system appeared to be in good working order with no sagging or wet areas, as shown below. A solar panel array is located just north of the septic system. No stained soil was observed under the transformers for the solar panel array.

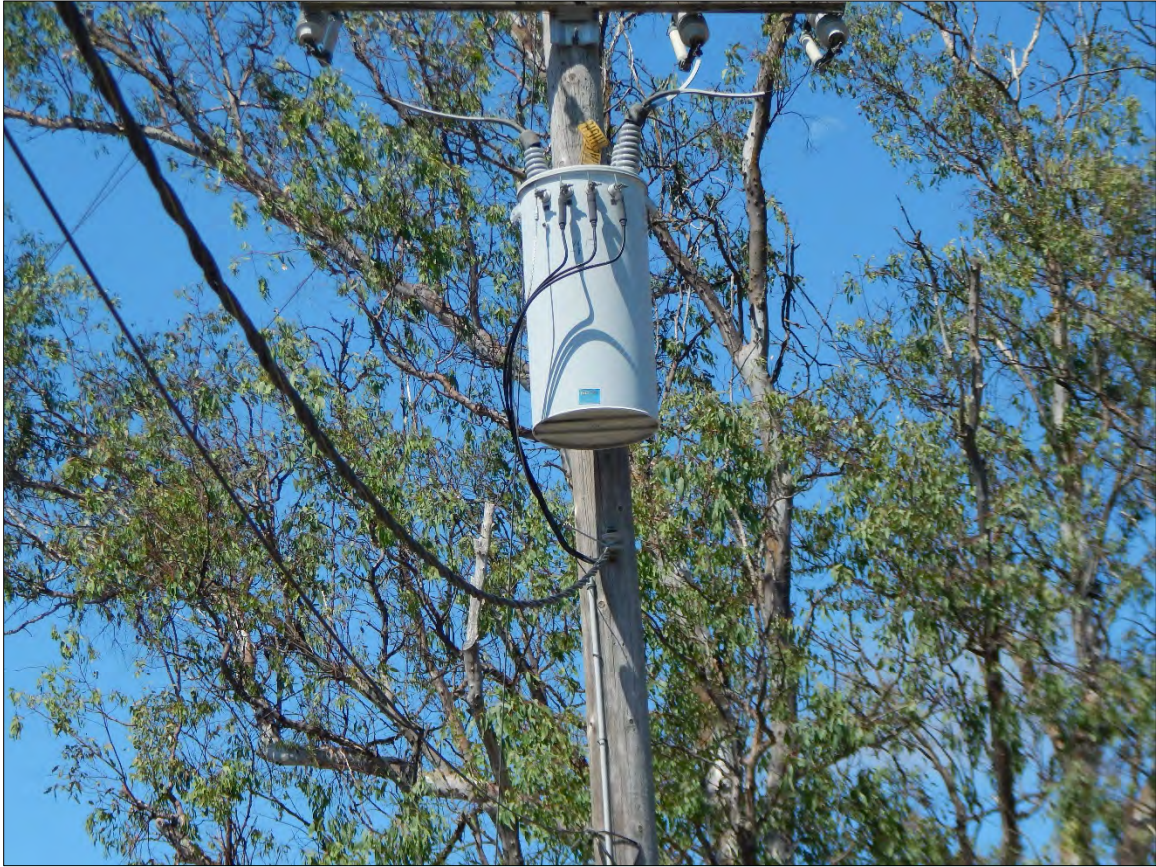
The transformer on a power pole shown below has a blue “No-PCBs” sticker, meaning that the oil in the transformer does not contain polychlorinated biphenyls (PCBs).

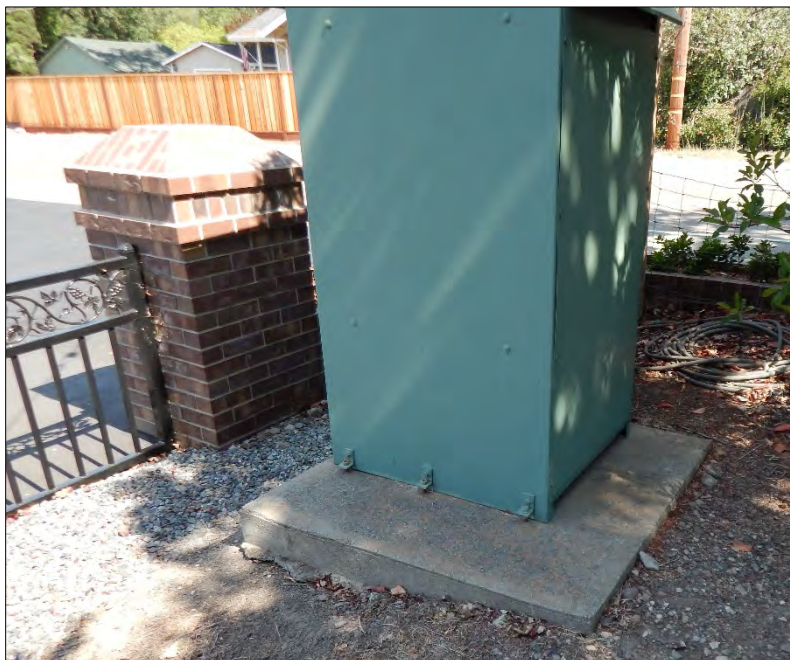
The transformer shown below is at the entrance at the northeast corner of the subject property. No oil staining was observed on its concrete pad.

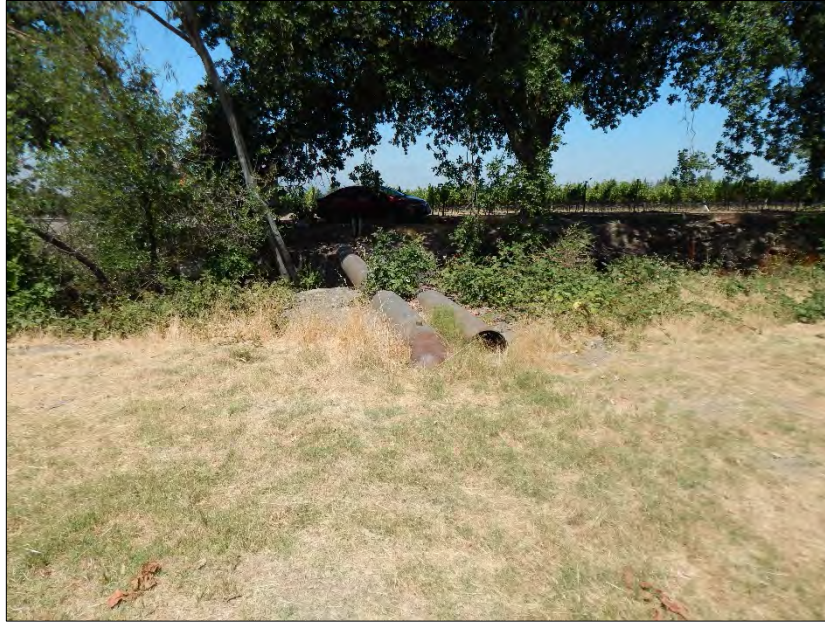
Two large-diameter metal pipes cross the creek near the center of the subject property, as shown below. However, the pipes are not connected to anything.

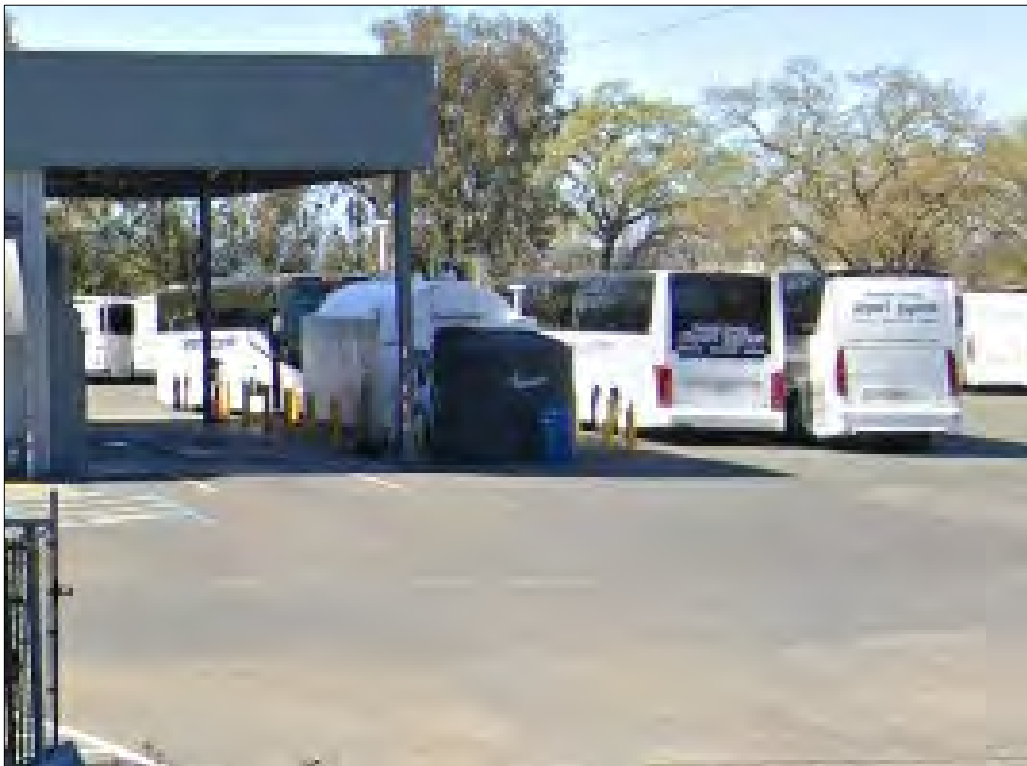
A driving reconnaissance of surrounding properties was conducted to look for adjacent properties that might have the potential to affect the subject property. The only property of interest is the Sonoma County Airport Express west and across Old Redwood Highway from the subject property. As shown below, this bus facility has a large above-ground diesel storage tank. The tank is in secondary containment, which would prevent spills from leaving the bus facility.
