INITIAL SITE ASSESSMENT

**County Road 96 Bridge Replacement
Over Dry Slough
Yolo County, California
Bridge No. 22C0127**

Project No. 18-474.2

May 17, 2021

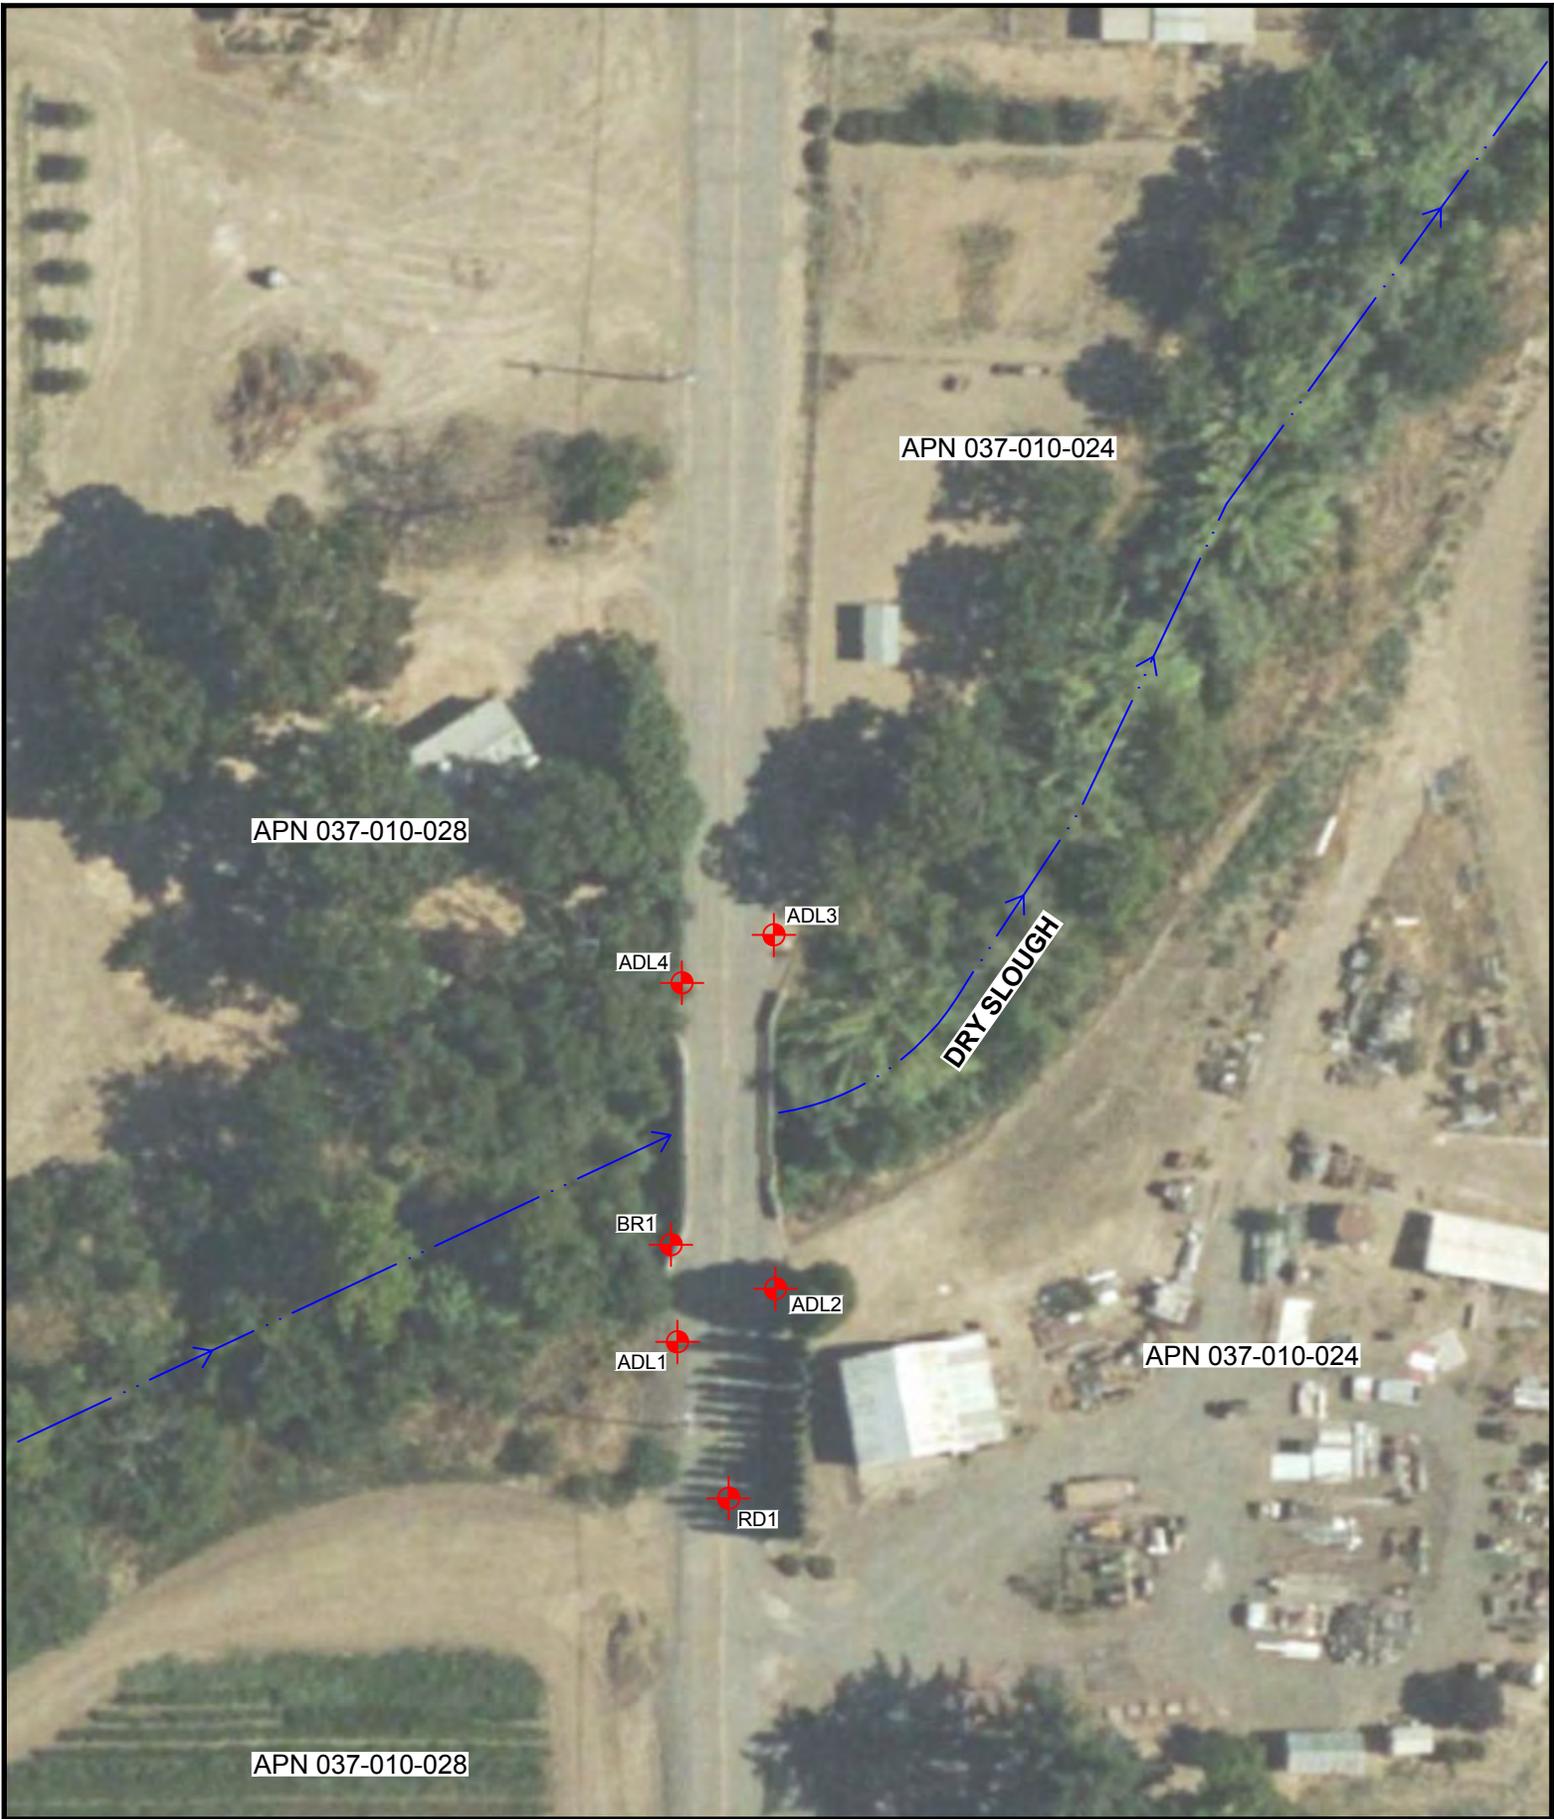
Figure 2
 Sample
 Location Map

Soil samples were collected on April 3, 2020 by CAInc. Soil samples were collected adjacent to each of the four corners of the bridge (ADL1 through ADL4) to assess if use of the bridge during the period of leaded gasoline use had impacted soil adjacent to the road with hazardous concentrations of ADL. Sample locations are presented on Figure 2 in Appendix A.

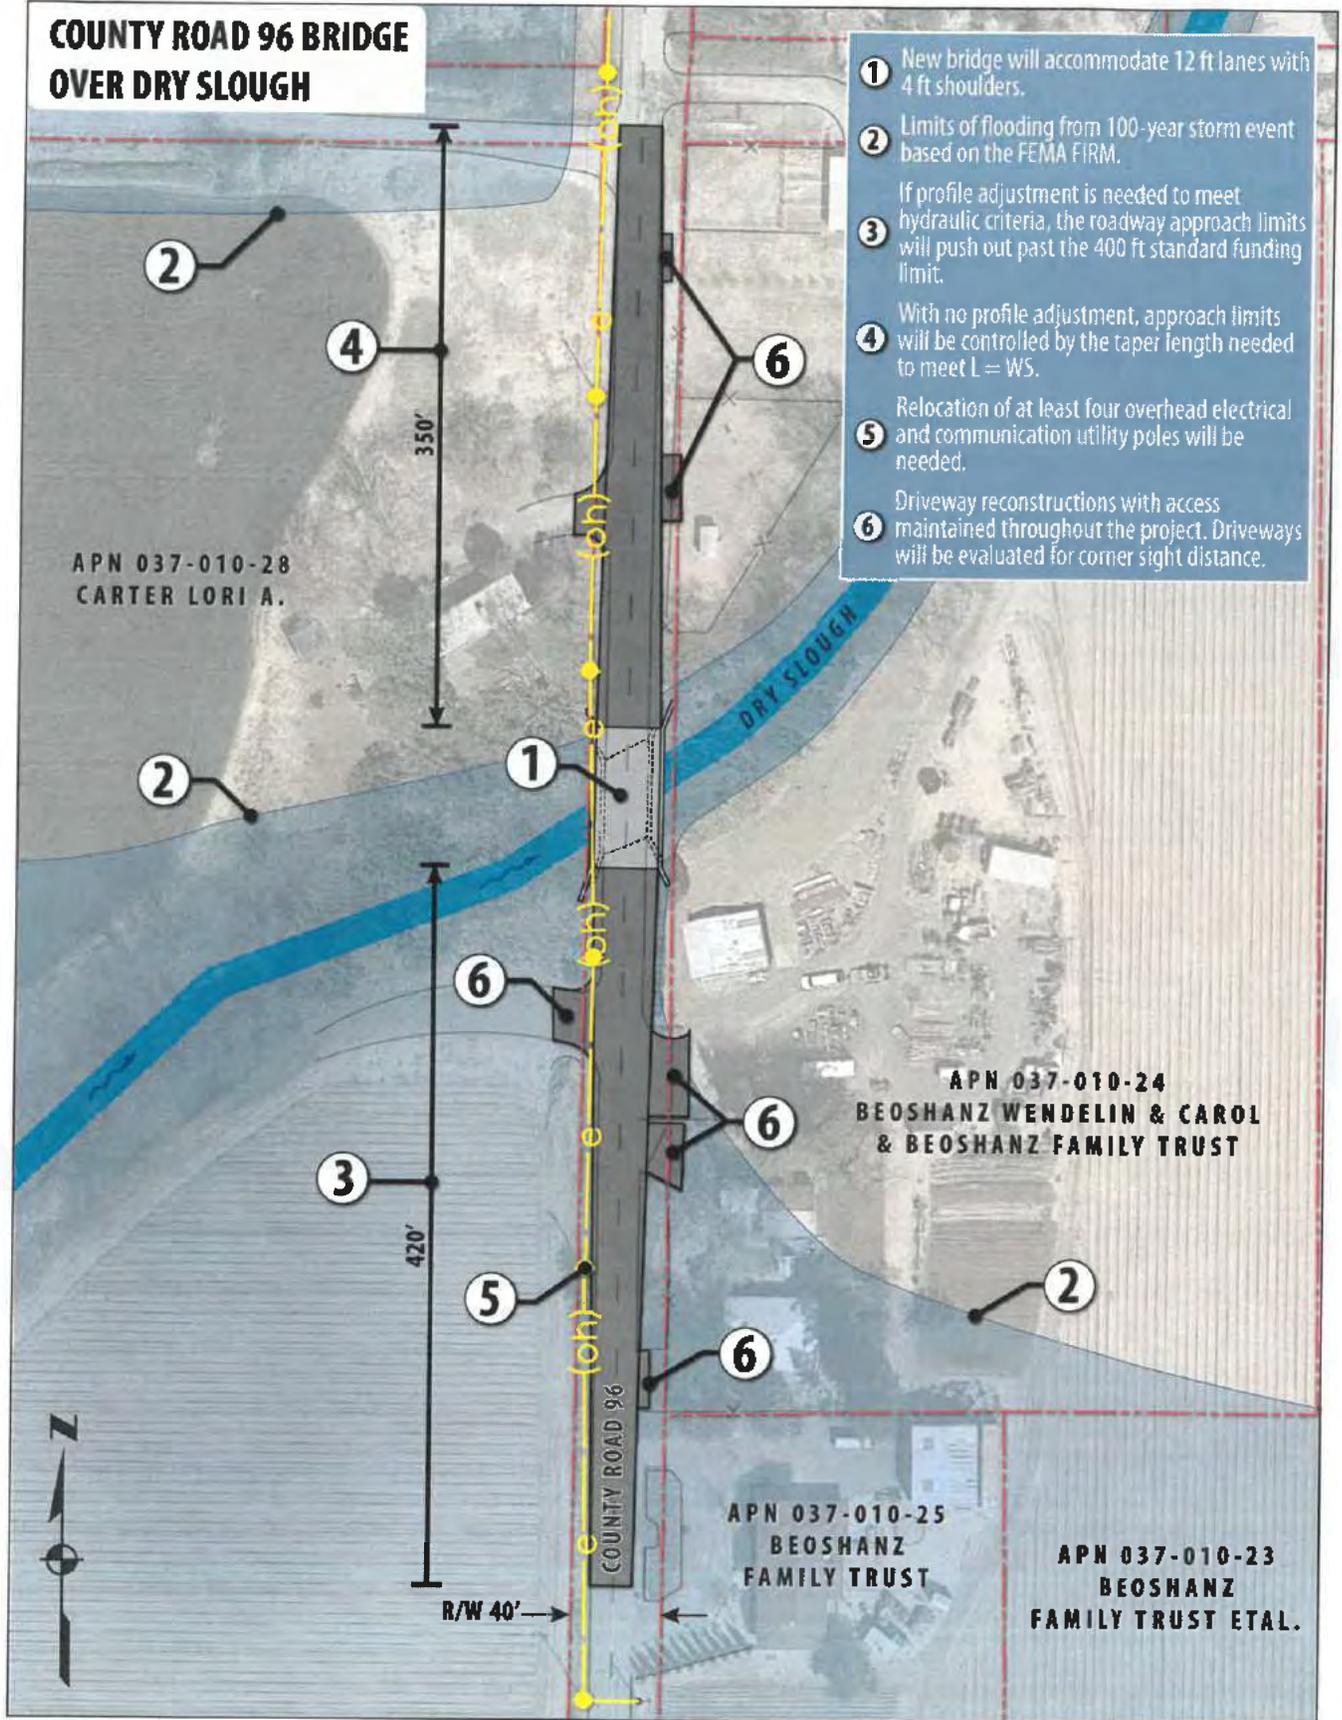
COUNTY ROAD 96 BRIDGE OVER DRY SLOUGH

- 1 New bridge will accommodate 12 ft lanes with 4 ft shoulders.
- 2 Limits of flooding from 100-year storm event based on the FEMA FIRM.
- 3 If profile adjustment is needed to meet hydraulic criteria, the roadway approach limits will push out past the 400 ft standard funding limit.
- 4 With no profile adjustment, approach limits will be controlled by the taper length needed to meet $L = WS$.
- 5 Relocation of at least four overhead electrical and communication utility poles will be needed.
- 6 Driveway reconstructions with access maintained throughout the project. Driveways will be evaluated for corner sight distance.

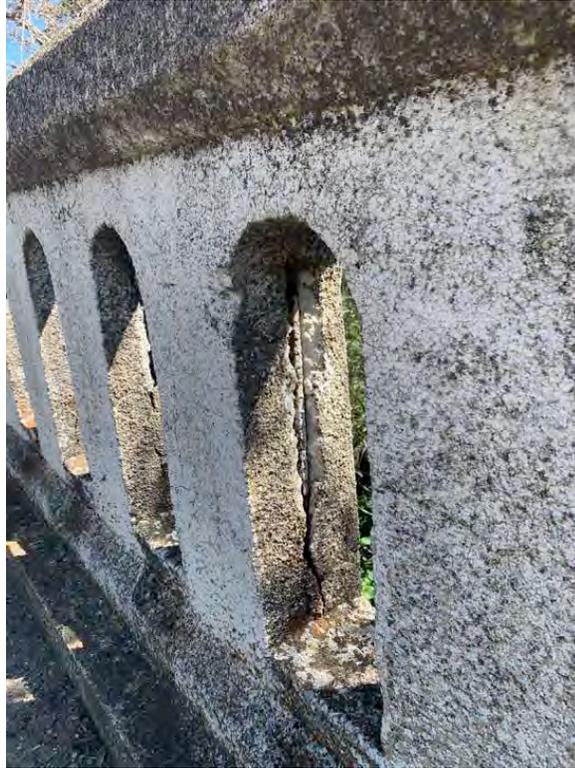
- Two-lane (22-feet wide), single-span, concrete bridge, with concrete abutments, wing walls, and guard rails, and an asphalt-paved deck.
- White paint on the guard rails was observed to be powdery.

White paint on the bridge guard rails was observed to be powdery. A sample of the bridge paint (BR1) and the yellow roadway striping paint (RD1) were collected by CAInc on April 3, 2020, from the guard rail at the northeast corner of the bridge to assess the lead content in the paint. Sample BR1 was collected using a stainless-steel putty knife and rock hammer; sample RD1 was collected using a rock hammer. The samples were placed in a new resealable plastic bags, labeled, and transported under chain of custody documentation to BCL. CAInc returned to the site on April 15, 2020, to collect additional sample from location BR1 to perform the soluble lead analyses.

1100 Corporate Way
 Suite 230
 Sacramento, CA 95831
 (916) 455-4225

A total lead concentration of 290 mg/kg was reported for bridge paint sample BR1; the soluble lead concentration in this sample was reported at 1.2 mg/l, below the hazardous waste threshold. TCLP analysis of the bridge paint sample BR1 was not performed due to insufficient sample volume. The total lead concentration in road paint sample RD1 was reported at 20 mg/kg, below the threshold requiring additional analysis. Further analysis of the bridge paint and roadway paint for lead does not appear warranted.

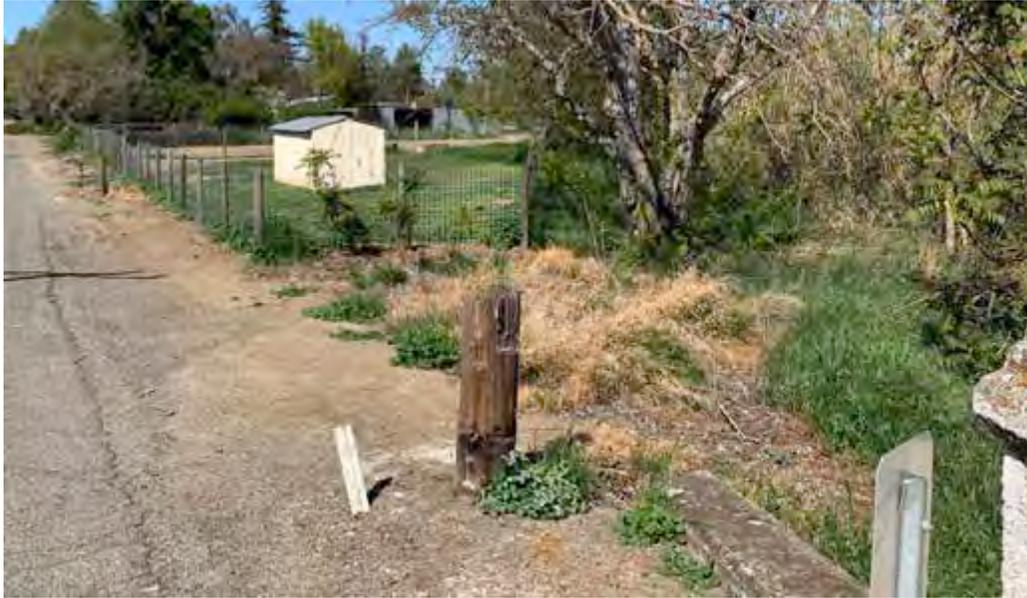
- What appeared to be a former utility pole stump was observed adjacent to the wing wall at the northeast corner of the bridge.

Quaternary Fault (Age)

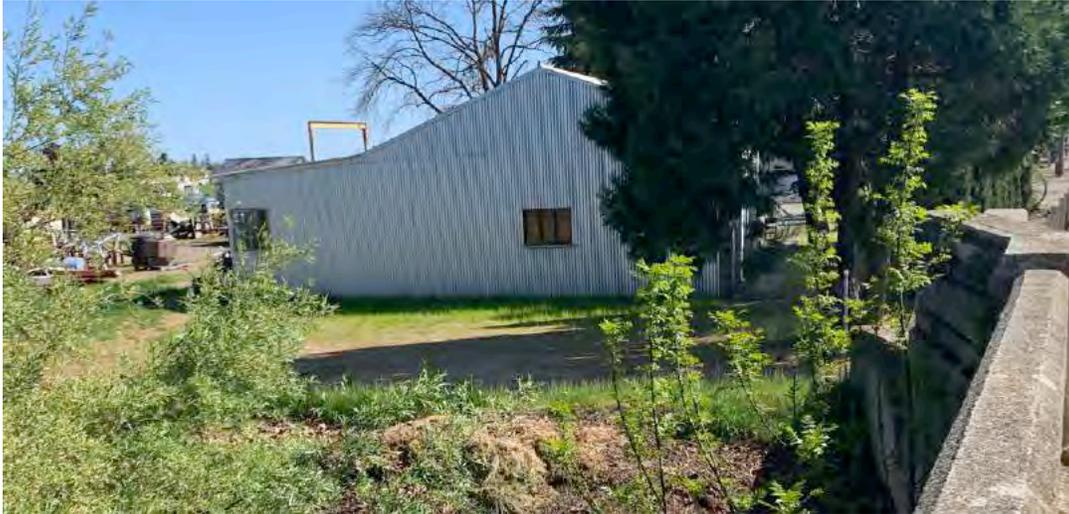
- Southeast corner (APN 037-010-024) – 25599 CR 96; residential, with outbuilding and agriculture equipment. Aboveground tank observed ± 150 feet east of east of CR 96, property owner said was not used, had never been operated at site.

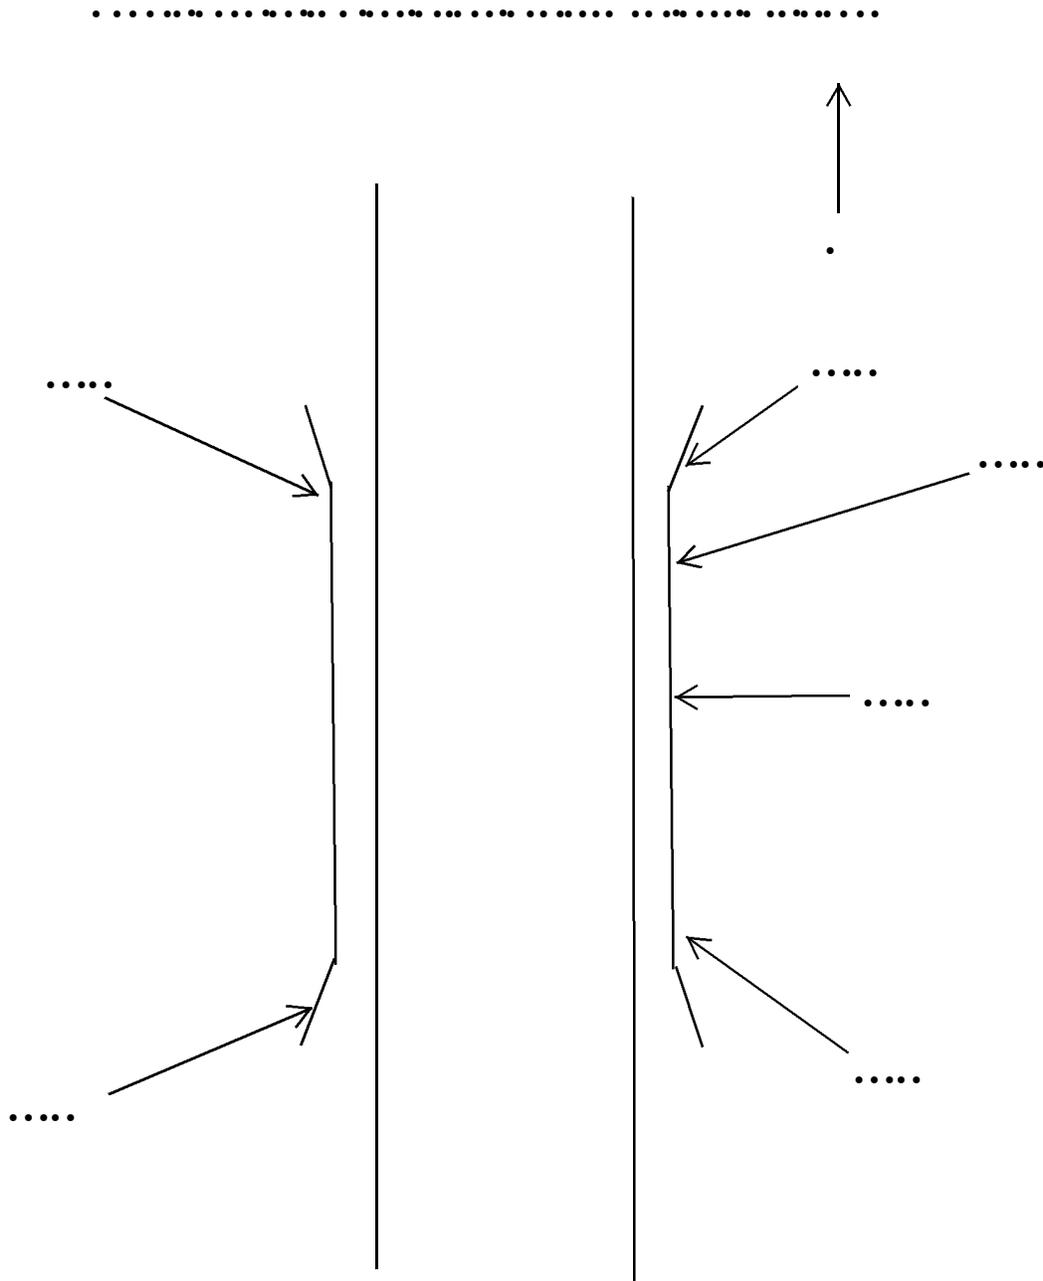
ASBESTOS SAMPLE LOCATION MAP	Site Name: Co. Rd. 96 Bridge over Dry Slough	Project #: 10371
