Aquatic Resources Delineation

Vega SES 6 Solar Project

Imperial County, California

December 2022

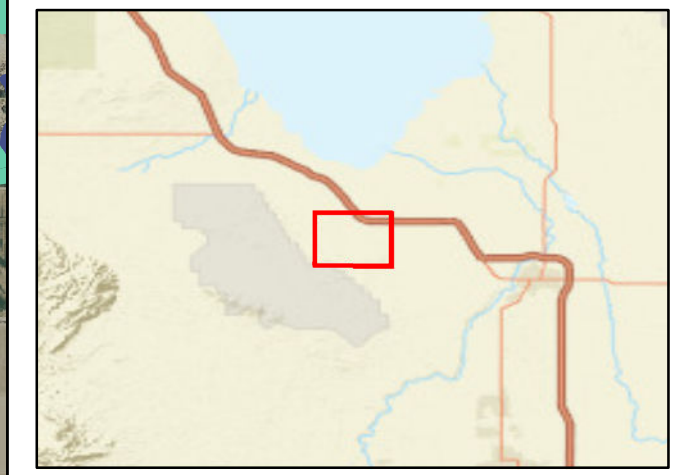
- Freshwater Emergent Wetland
- Freshwater Forested/Shrub Wetland
- Freshwater Pond
- Lake
- Riverine

Sources: NAIP(2020), NWI (2021)
 Service Layer Credits: Sources: Esri, HERE, Garmin, USGS, Intermap, INCREMENT P, NRCan, Esri Japan, METI, Esri China (Hong Kong), Esri Korea, Esri (Thailand), NGCC, (c) OpenStreetMap contributors, and the GIS User Community

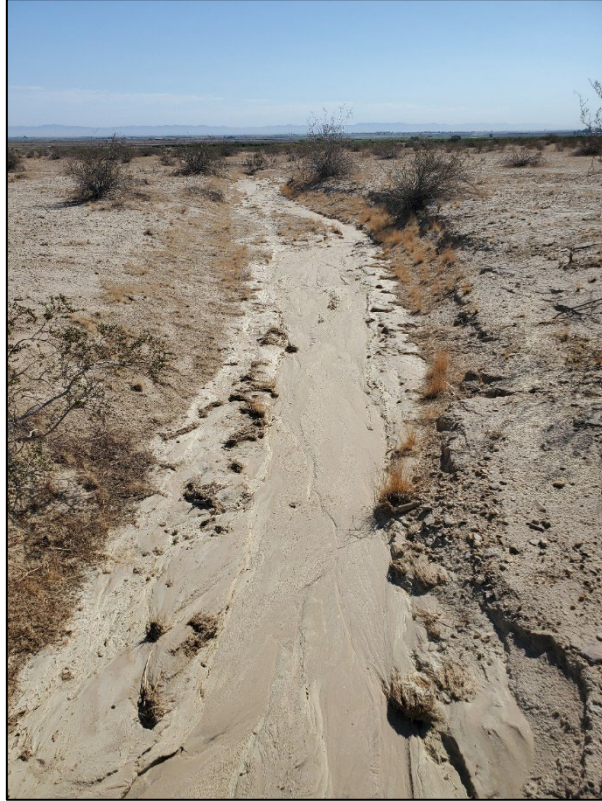
Photo 1. Representative photo of an ephemeral drainage within the proposed solar field parcel; photo facing northeast. (Photo coordinates: 33.011272°N, -115.697849°W, August 3, 2021).

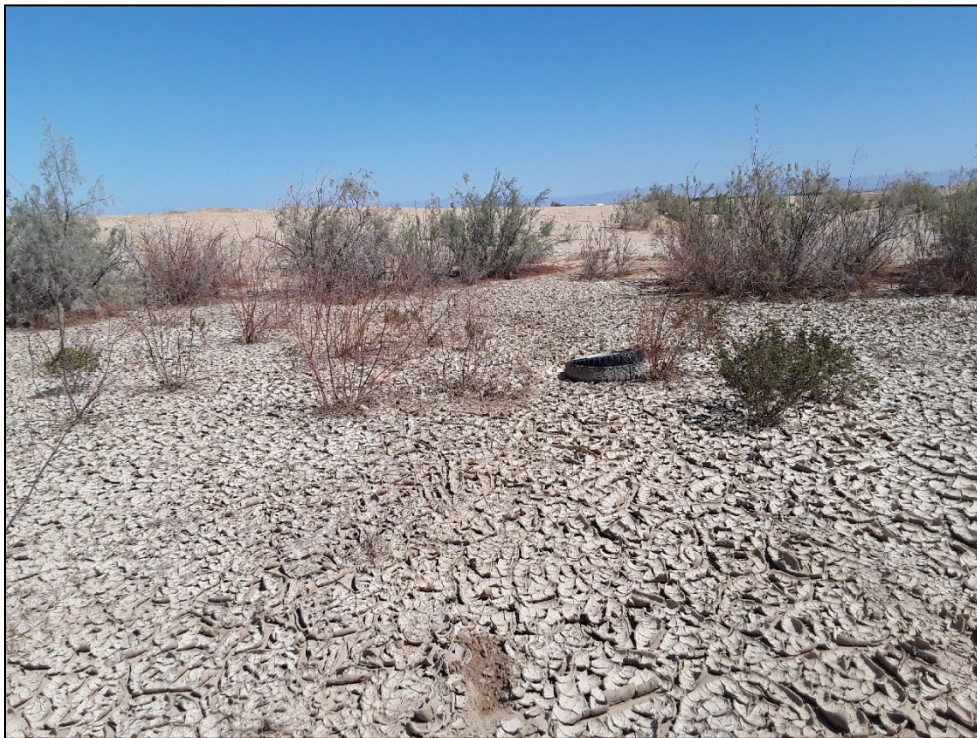
Photo 2. Detention Basin 201 within the northwestern portion of the proposed solar field parcel; photo facing northwest. (Photo coordinates: 33.014611°N, -115.701255°W, August 5, 2021).

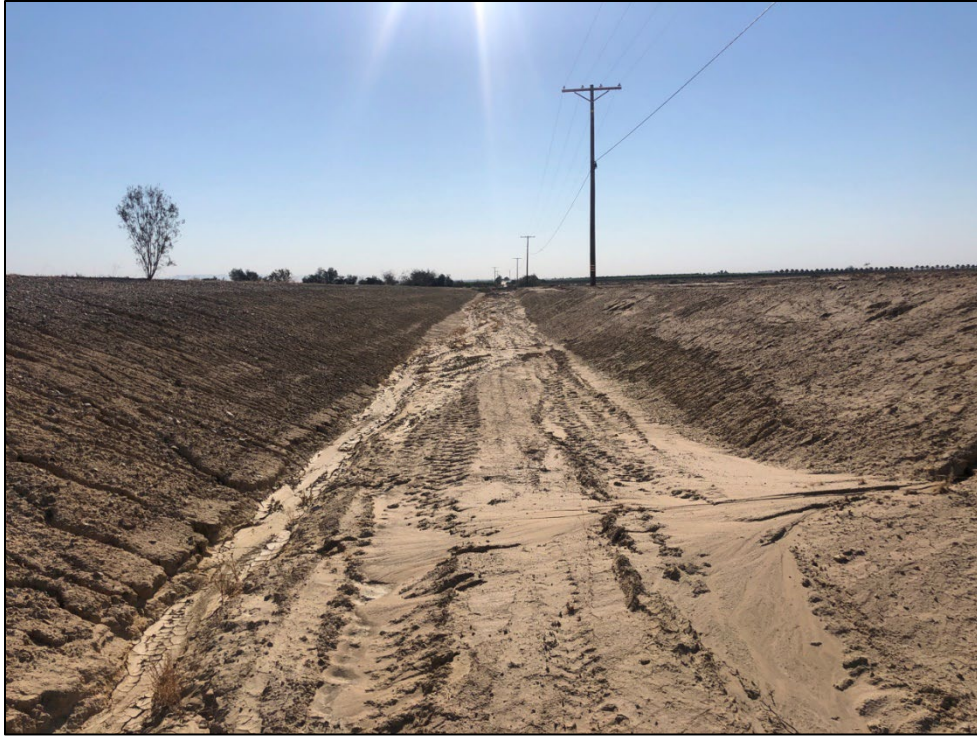
**Photo 3. Constructed Channel 2 within the western portion of the gen-tie line; photo facing east.
(Photo coordinates: 33.030496°N, - 115.722701°W, August 4, 2021).**

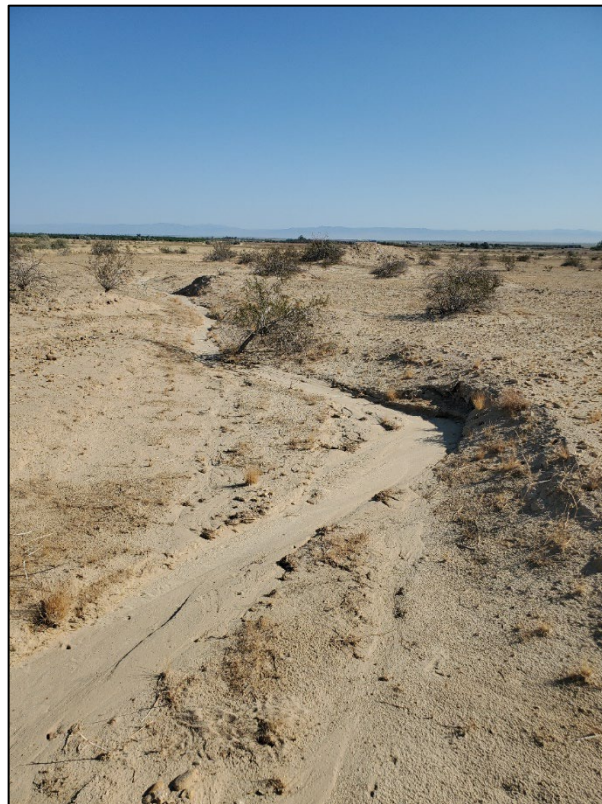
**Photo 4. Representative photo of an ephemeral drainage within the proposed solar field parcel;
photo facing north. (Photo coordinates: 33.012429°N, -115.700629°W, August 4, 2021).**

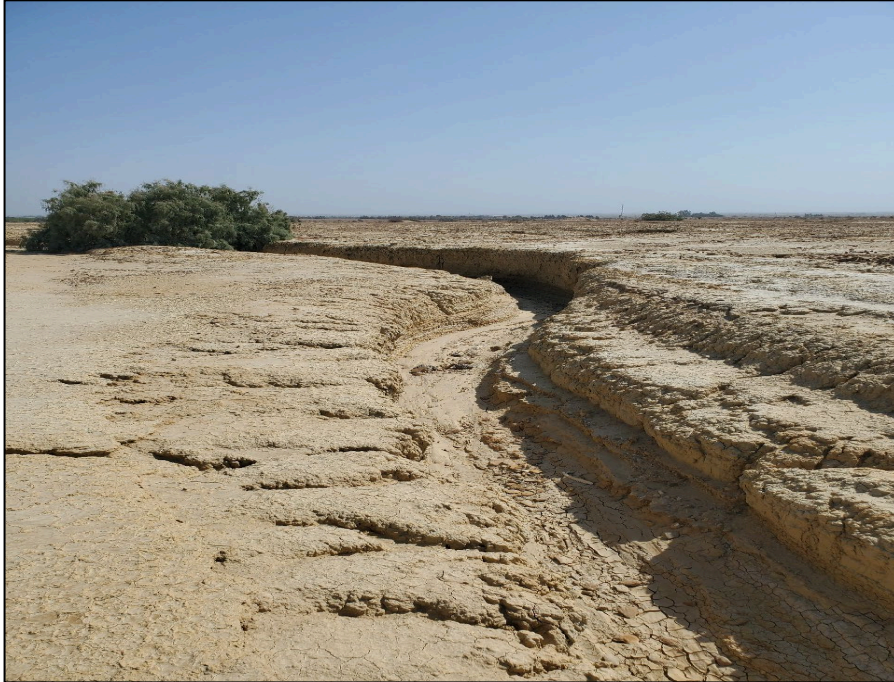
Photo 5. Representation of an ephemeral drainage with riparian tree (tamarisk) situated in the southeastern portion of the gen-tie line; photo facing northeast. (Photo coordinates: 33.015872°N, -115.707104°W, August 5, 2021).

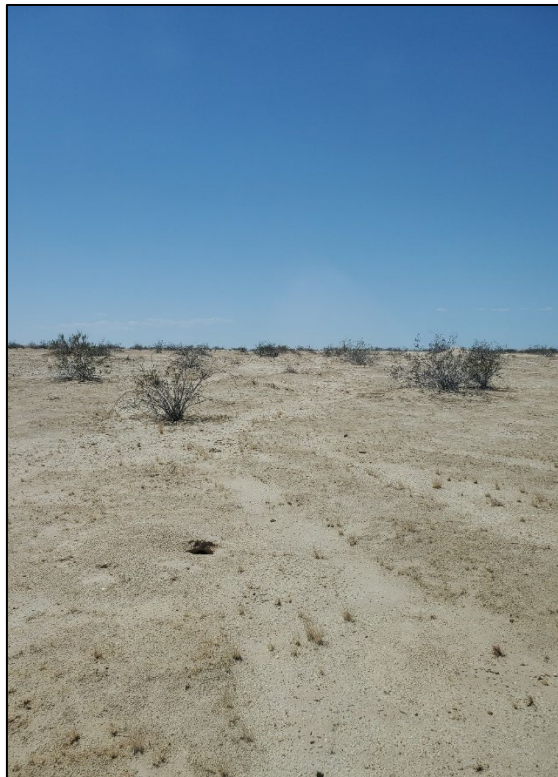
Photo 6. Feature determined to be non jurisdictional due to lack of OHWM indicators located in the southern portion of the proposed solar field parcel; photo facing southwest. (Photo coordinates: 33.007796°N, - 115.700369°W, August 4, 2021).
