**Appendix E Aquatic Resources Delineation Report:
Yucaipa Valley Wine Country Specific Plan**

Aquatic Resources Delineation Report

Yucaipa Valley Wine Country

Specific Plan

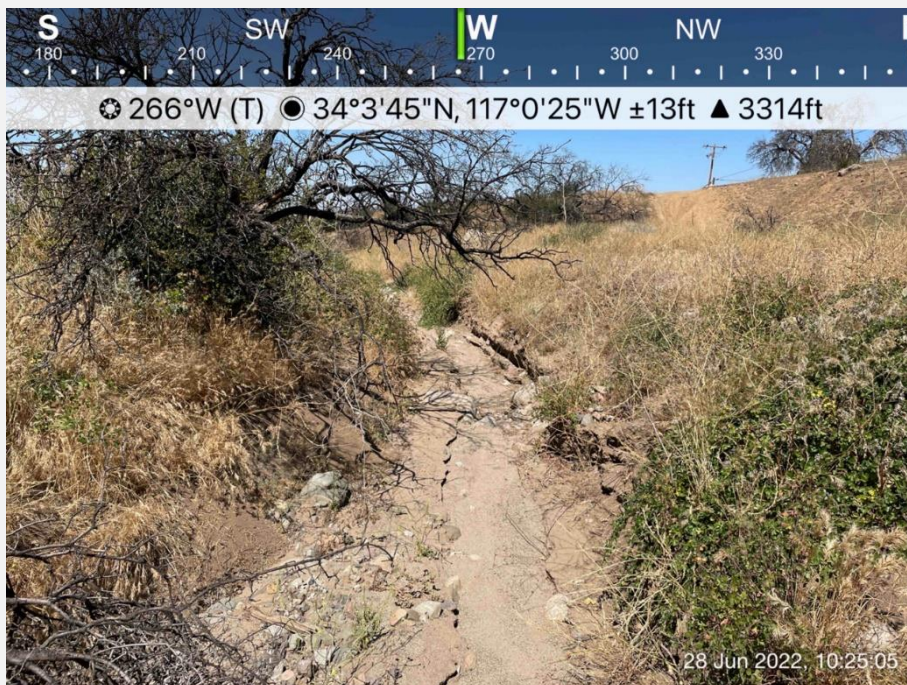
Photo Number 1. View of Transect (T)-01 collected at Non-Wetland Water (NWW)-04, facing west.

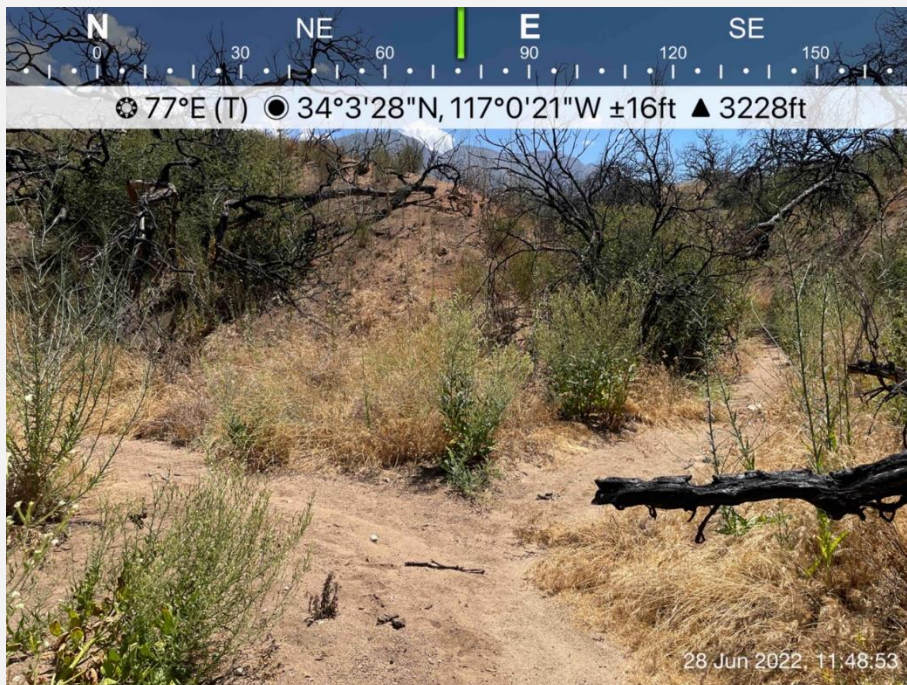
Photo Number 2. View of T-02 collected at NWW-01, facing east.

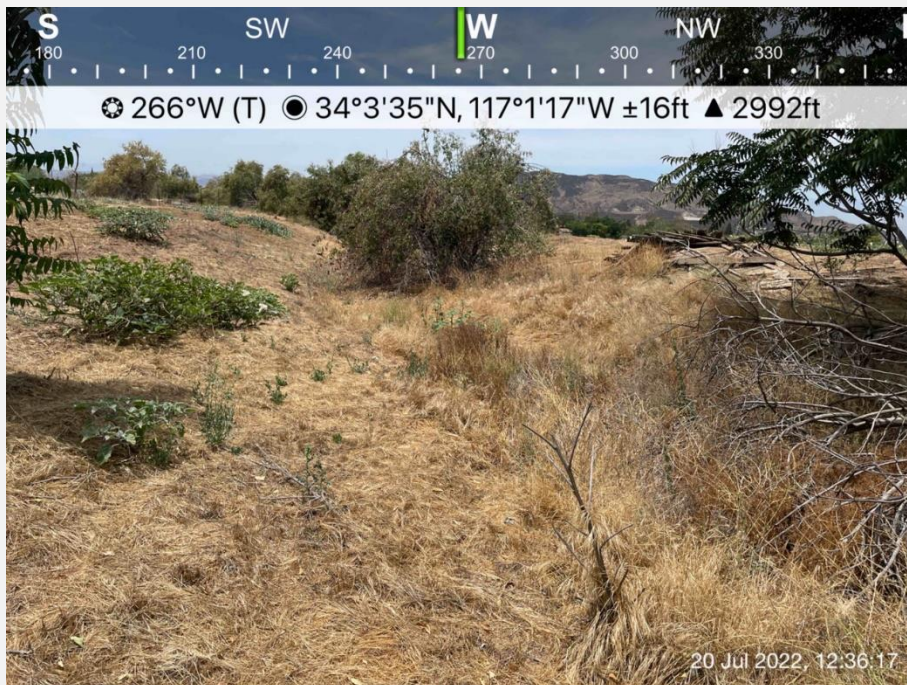
Photo Number 8. View of T-08 collected at a non-jurisdictional upland swale, facing west. Eastern edge of RIP-4 riparian habitat also shown.

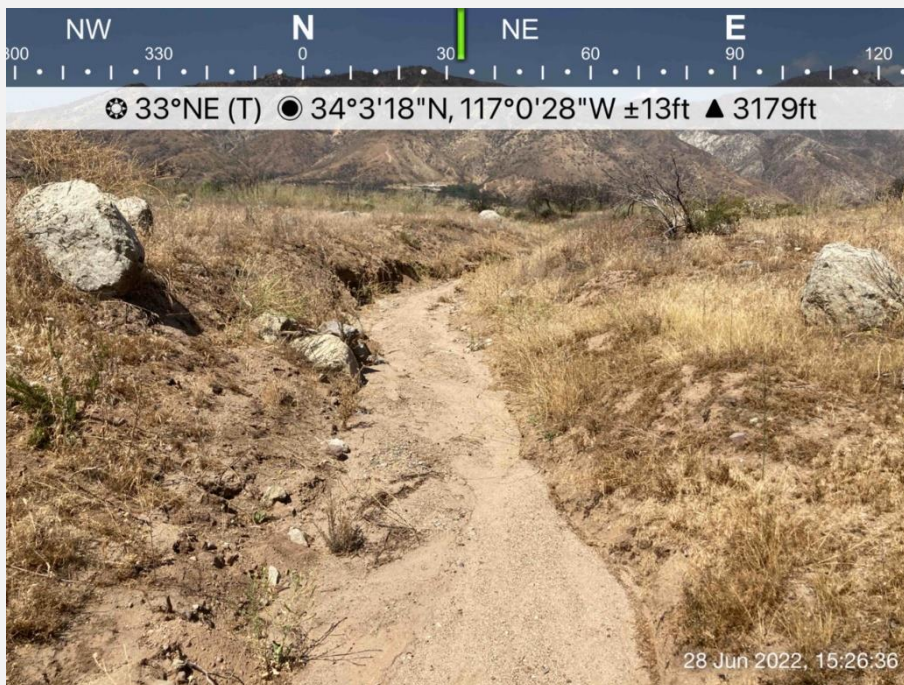
Photo Number 11. View of T-11 collected at NWW-01, facing northeast.

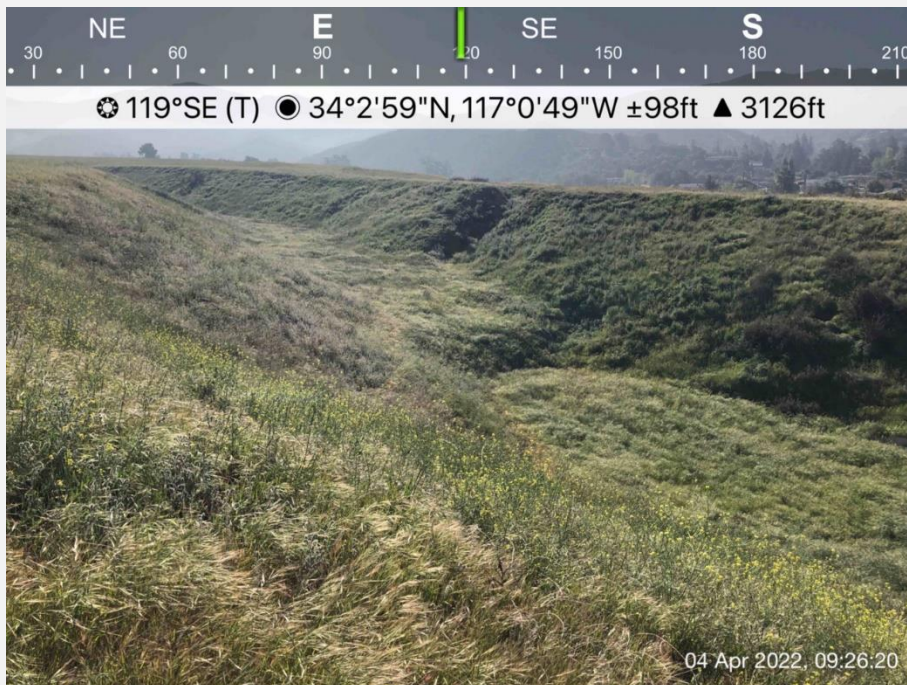
Photo Number 18. View looking towards south edge of review area, facing southeast. Sloped and terraced lands are remnant of historic agricultural uses.

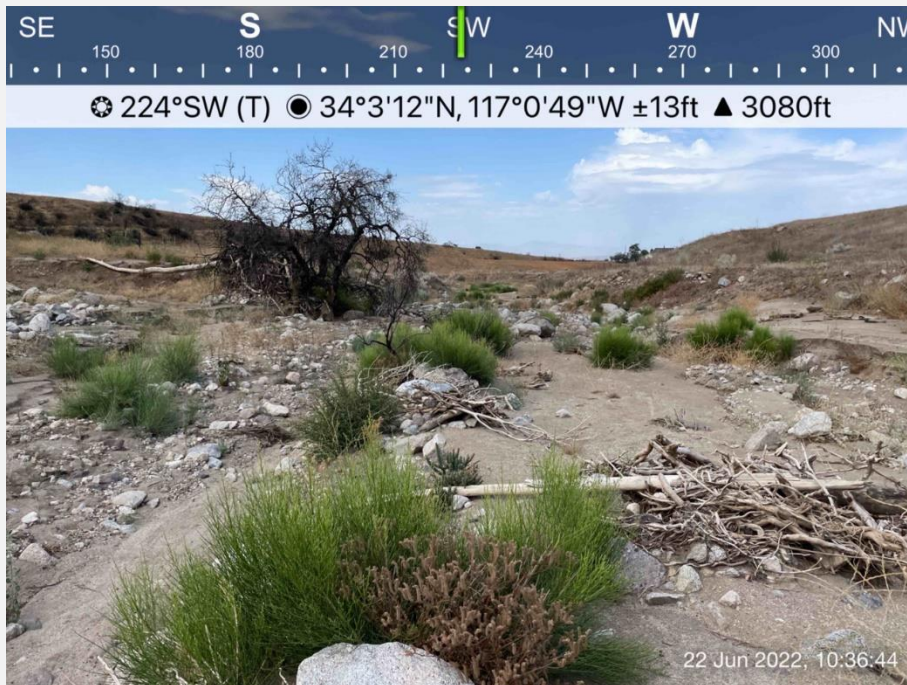
Photo Number 20. View of Wilson Creek taken in wider section of NWW-01, facing southwest. Drift and sediment deposits shown.

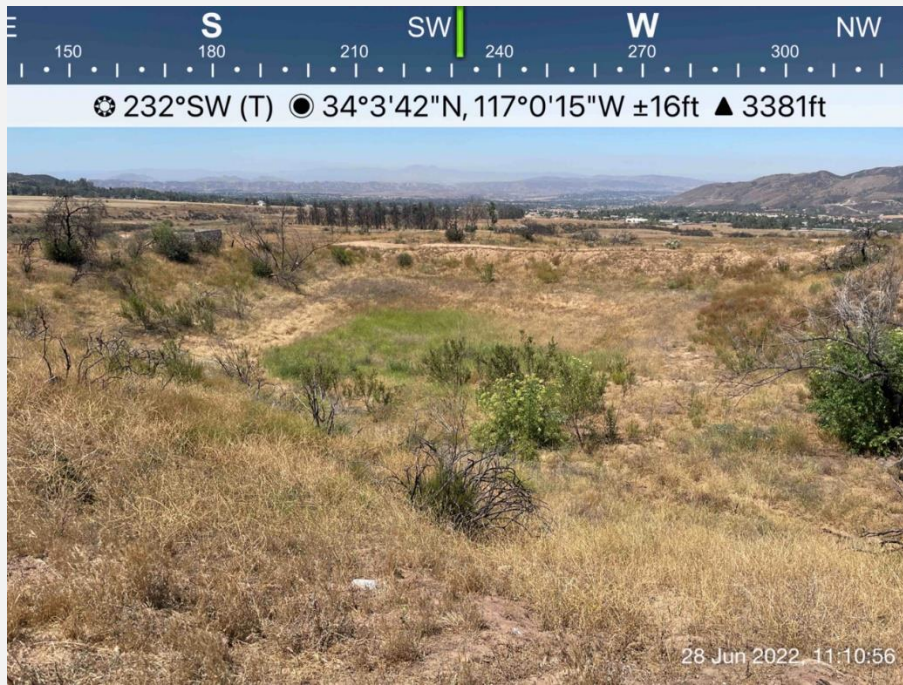
NWW-03 includes a human-made basin and a small section of ephemeral stream channel near the northeastern edge of the review area (Figure 4-2). The basin appears to have been constructed in the path of this unnamed stream in order to accumulate water for agricultural activities. In doing so, flows in the stream that would normally continue southwest remain in the basin; no clear outlet was observed. NWW-03 enters onto the review area via sheet flow across Carter Street from an adjacent private property less than 100 feet to the north. The stream channel portion of NWW-03 exhibited clear indicators of an OHWM as shown in cross section T-18, which describes a break in slope and changes in vegetation cover and soil texture. It flows for approximately 500 feet before reaching the basin. The basin has clear boundaries and is surrounded by sloped earthen walls. No water was observed in this feature during field investigations.

Photo Number 25. View of NWW-03 facing southwest. Berm shown at downstream end of feature, blocking and water from continuing southwest.

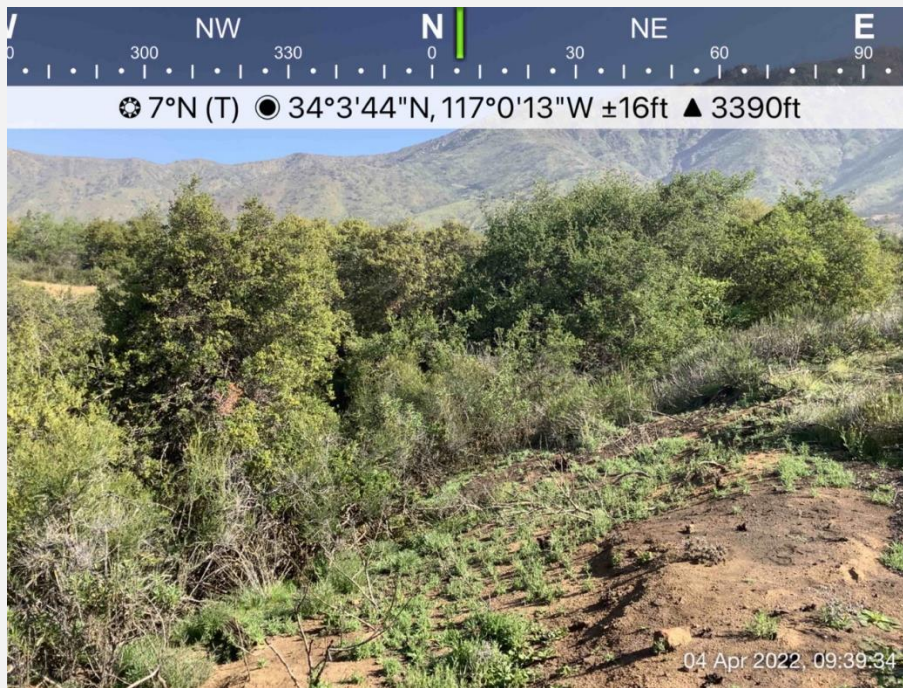
Photo Number 26. View of NWW-03 facing north. Vegetated portion of feature shown in this location.

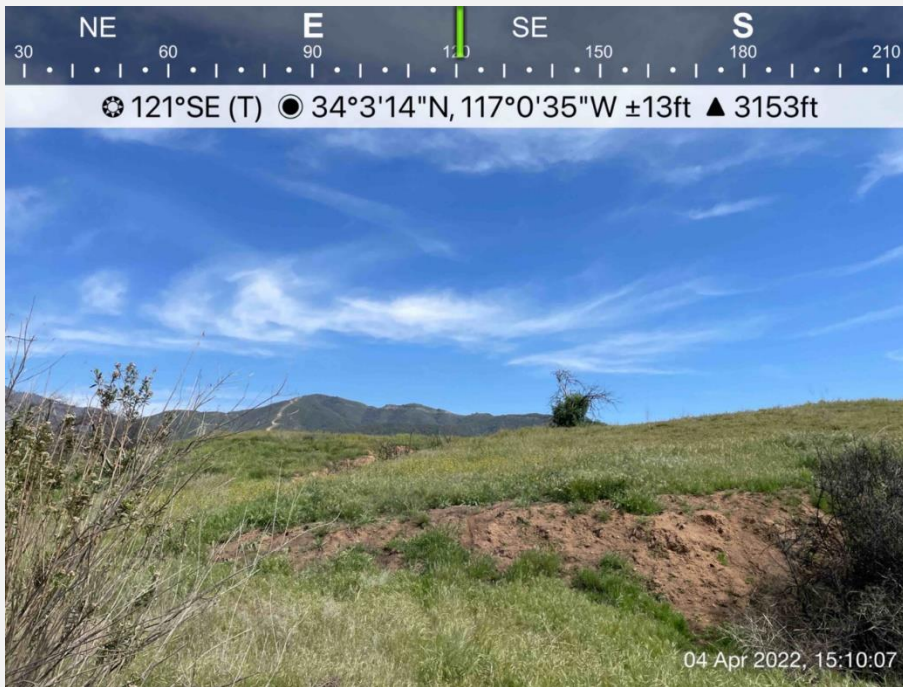
Photo Number 28. View of RIP-2 feature showing low coverage of mulefat and elderberry shrubs.

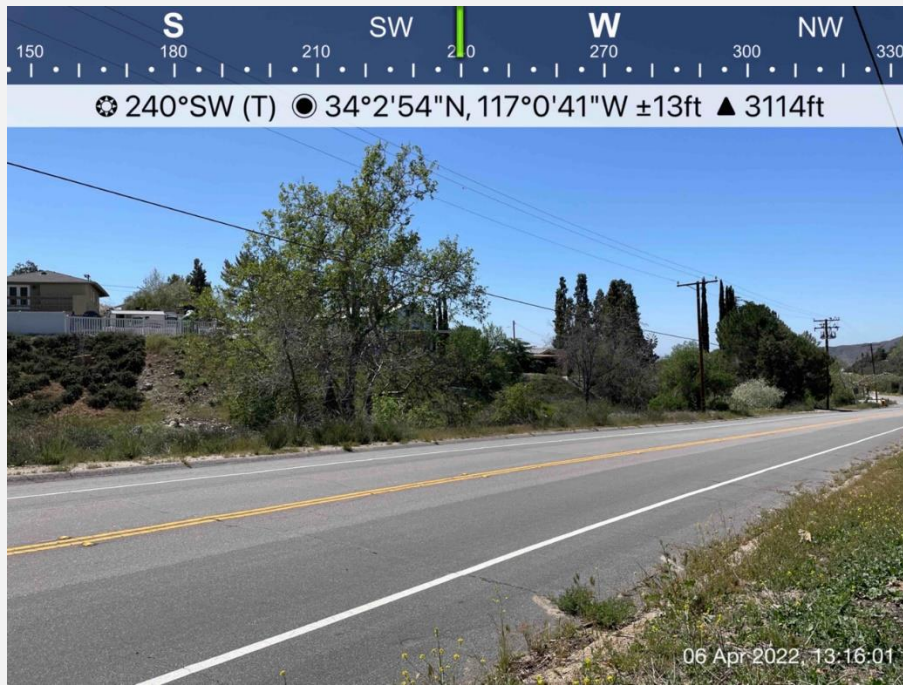
Photo Number 31. View of T-20 facing south-southwest. Inactive portion of streambed shown in this location, historically associated with NWW-01.
