B I O L O G I C A L A S S E S S M E N T

**21080 LOCONOMI ROAD [APN 014-140-12]
LAKE COUNTY, CALIFORNIA**

PROJECT № LAK052

DECEMBER 13, 2020

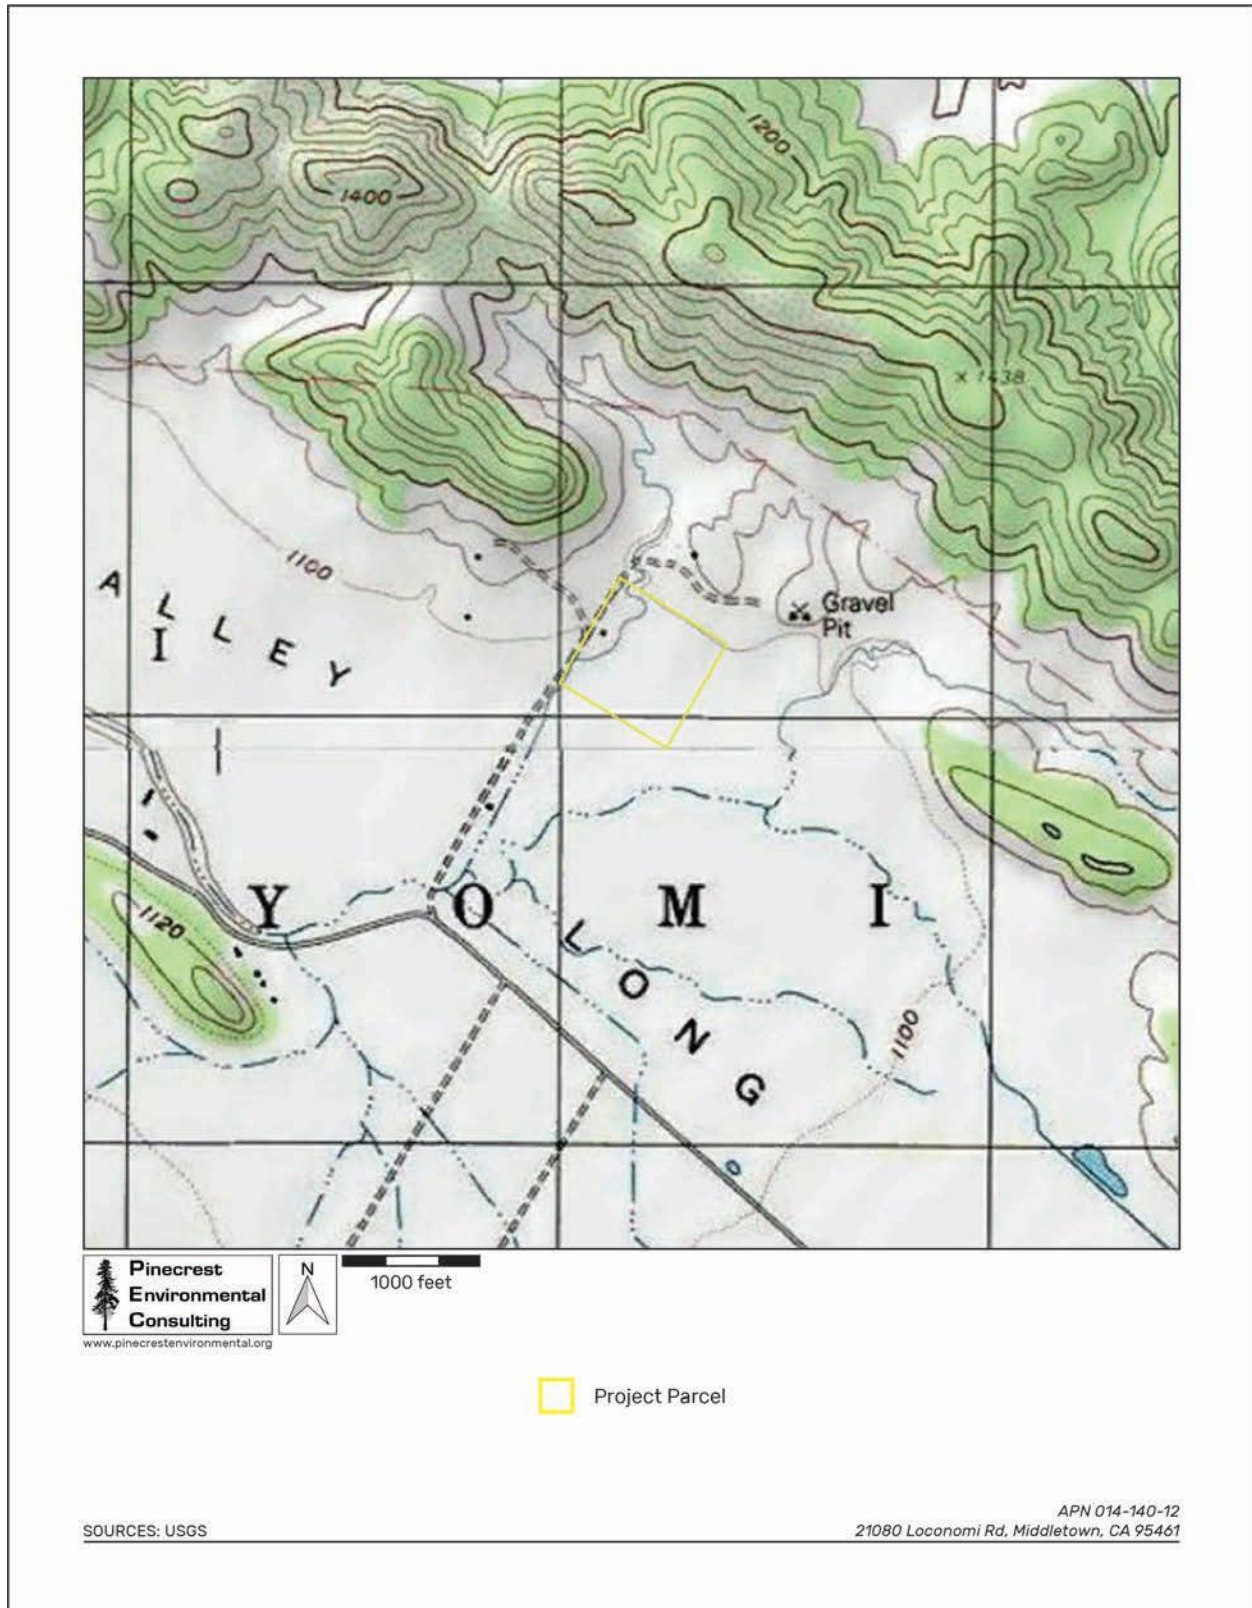
FIGURE 2: 40-FOOT CONTOURS

The maximum elevation of the parcel is 1,108 feet above sea level at the northern corner of the parcel line, and the minimum elevation is 1,102 feet above sea level at the western corner of the parcel (Figure 2). The topography of the parcel is flat, with grades between 2% and 5%, as measured by Suunto PM5 handheld clinometer (Figure 2).

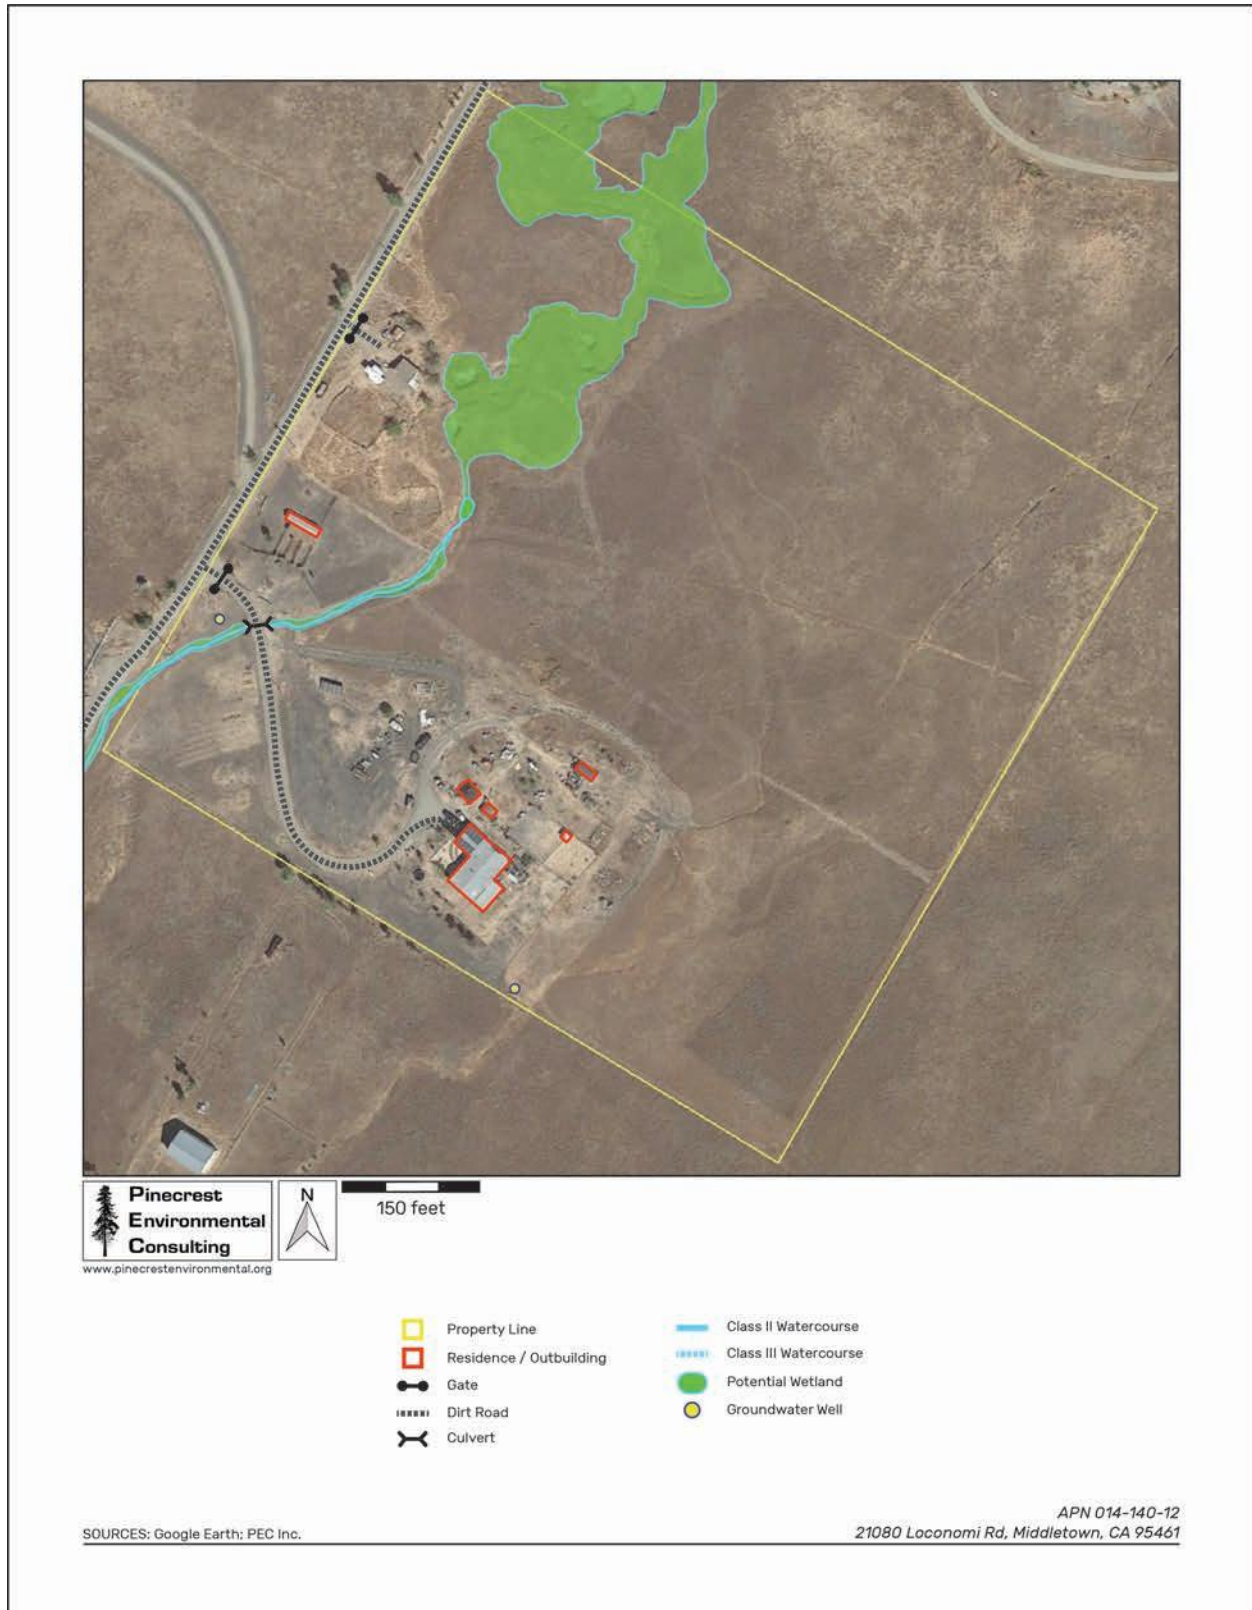
FIGURE 3: WATERCOURSES

Jurisdictional watercourses onsite were classified according to the three-tier method used by the California Department of Forestry & Fire Protection (CALFIRE 2017) and included as a reference in Appendix G. Based on these criteria there are no jurisdictional watercourses onsite. Potential wetlands onsite were assessed based on the likelihood to satisfy the three-tier wetland delineation criteria used by the Army Corps of Engineers *Wetland Delineation Manual* (ACOE 1987), however a protocol-level wetland delineation was not performed. Based on these criteria there is one Class II watercourse, with potential wetlands associated with it especially in the northwest portion of the parcel. Water enters the site in the northwest corner from the adjacent parcel to the north, and flows into the wetlands (Figures 15-16) eventually entering a series of small temporary pools (Figure 14), before that meandering along the western half of the parcel, becoming indistinct at times. Water coalesces into a single Class II channel near the culvert crossing (Figure 12) before turning into a vegetated swale with wetland vegetation that runs along the western fenceline and passes offsite as a roadside ditch along Loconomi Road.

There are several jurisdictional watercourses and seasonal wetlands onsite, and as long as 100-foot setbacks are observed off of the features mapped in Figure 3, and as long as intact native vegetation exists within the 100-foot setbacks, we do not anticipate any impacts to downstream water quality due to sedimentation. Despite this, the culvert that is required to access the proposed cultivation area may not be adequately sized to for a 100-year flood, and so consultation with a hydrologists is recommended. The area surrounding the culvert also contains wetland vegetation, and so a wetland delineation is recommended if culvert replacement is required. However, if development is to be limited entirely to previously disturbed areas, then no wetland delineation should be required. Anywhere revegetation after disturbance is required, only native vegetation should be used. A list of suitable species and nurseries/vendors can be provided by PEC on request. Sterile wheat is acceptable if no native species can be obtained.

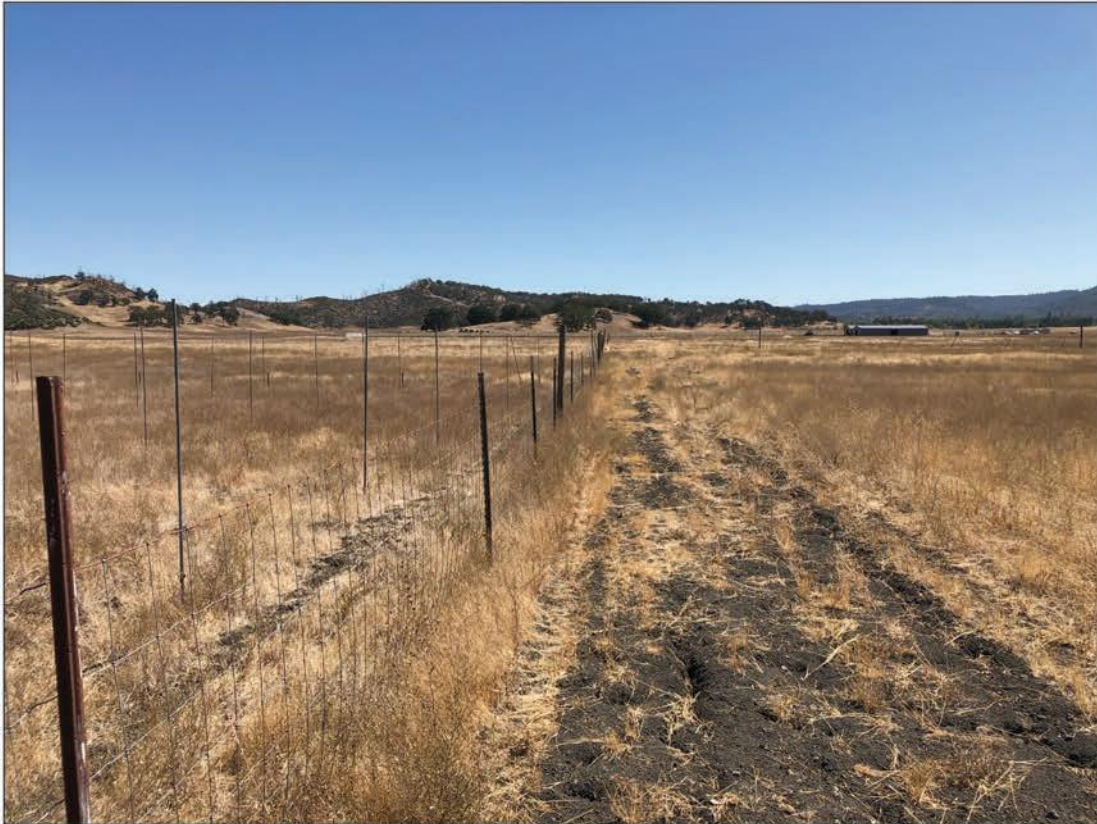
FIGURE 11: PHOTOGRAPH OF NORTH FENCELINE

visible in aerial photos (e.g. the one used in Figure 3) although it no longer exists (see Figure 11) also likely due to disking. In our opinion the disking returned the hydrology of the site to a more natural condition than existed with the trenches and so no remediation or further action should be necessary.

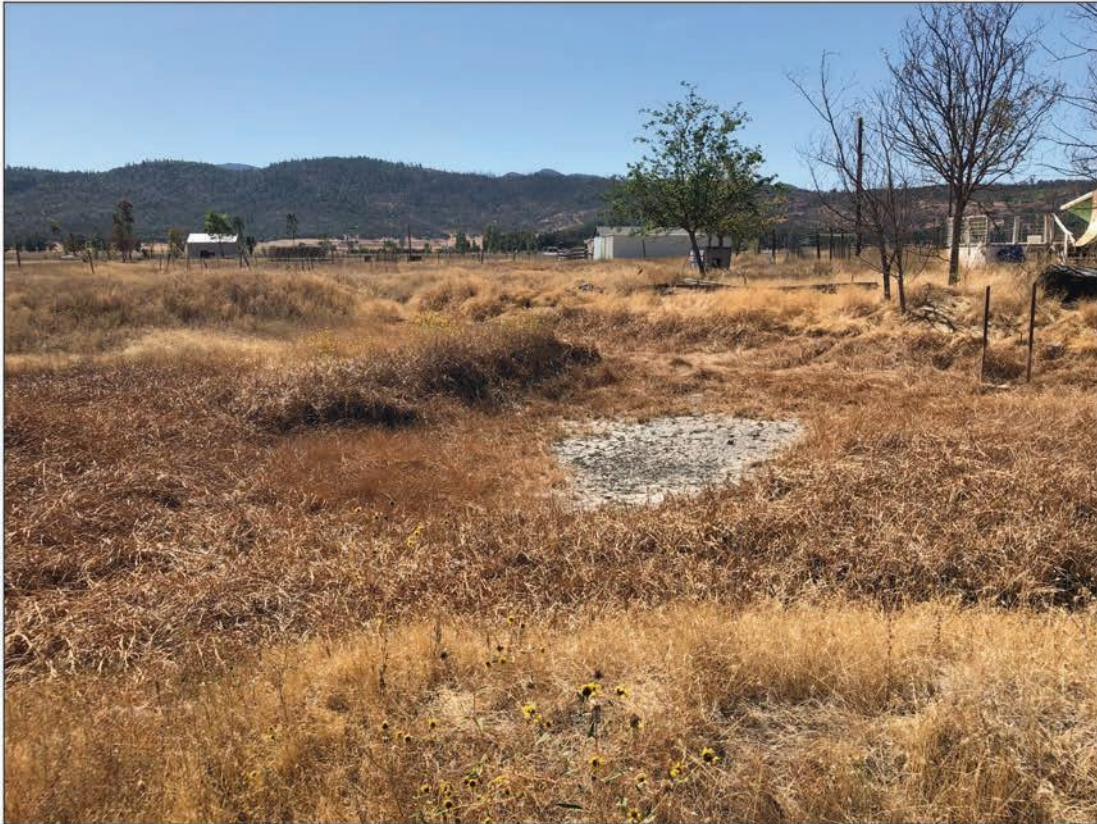
FIGURE 14: PHOTOGRAPH OF WETLAND

Water enters the site in the northwest corner from the adjacent parcel to the north, and flows into a series of wetlands (Figures 15-16) and small temporary pools (Figure 14) that meander southwest along the western half of the parcel. The channel becomes indistinct at times and contains several oxbow like formations. Water coalesces into a single Class II channel near the culvert crossing (Figure 12) before turning into a vegetated swale with wetland vegetation that runs along the western fenceline and passes offsite as a roadside ditch along Loconomi Road.

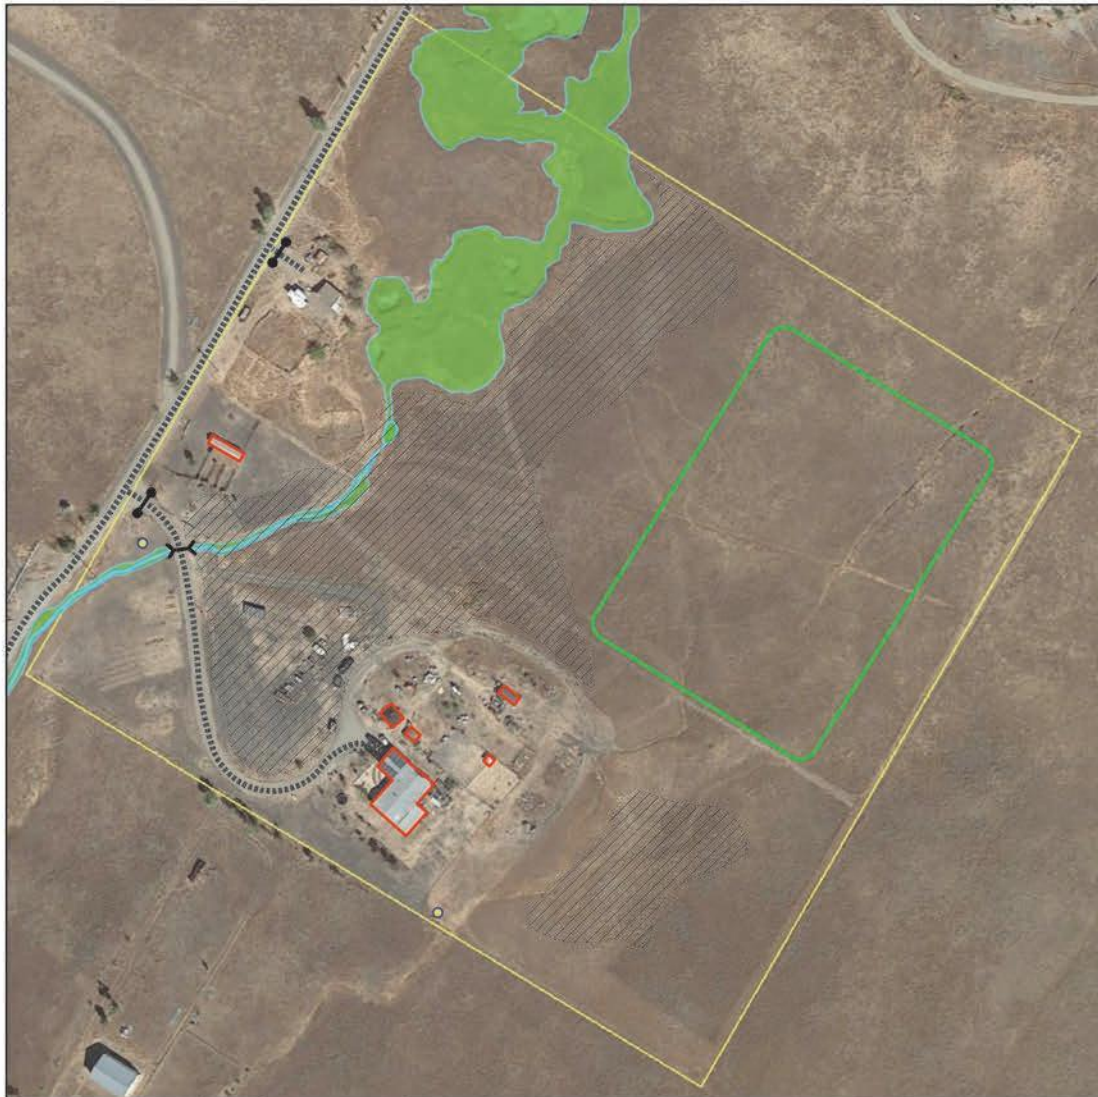
FIGURE 1

This plant was previously found onsite and entered into the CNDDDB database so this occurrence is not surprising. The extent of the population is shown in Figure 1.

Our recommendation is to avoid the areas shown in Figure 1 and to locate cultivation in the eastern portion of the property. This should avoid all wetlands and the populations of this species.
