# **Appendix C**

## **Biological Studies**

## **TERRESTRIAL BIOLOGICAL RESOURCES STUDY**

### **DECOMMISSIONING AND REMEDIATION OF THE CARPINTERIA OIL AND GAS PROCESSING FACILITIES CARPINTERIA, SANTA BARBARA COUNTY, CALIFORNIA**

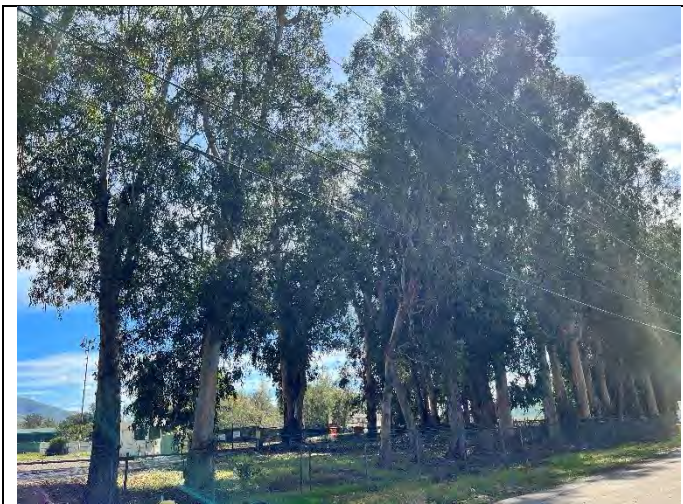
**Photo 1.** View to the southeast, showing Area #1 eucalyptus windrow along Dump Rd. March 3, 2023

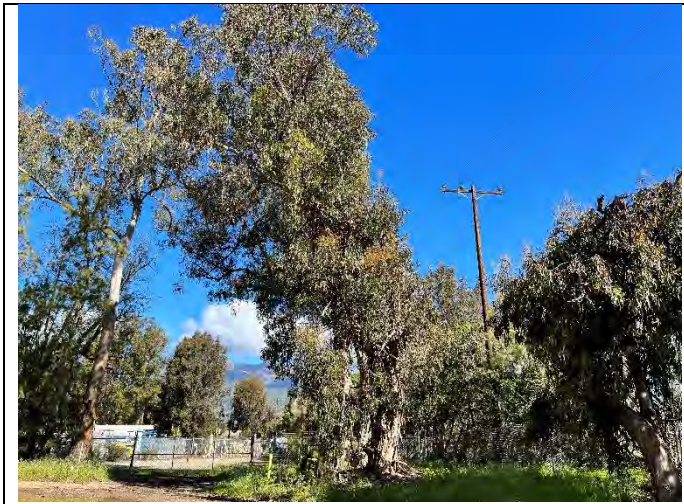
**Photo 5.** View to the north of Area #5, showing trees in proximity to high voltage cables. March 7, 2023

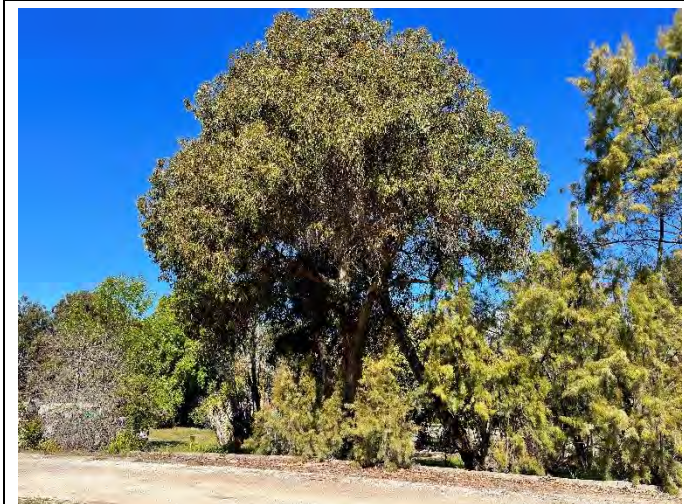
**Photo 7.** View to the northwest of Area #7, showing large eucalyptus with tamarisk proposed for removal leaning onto it. March 3, 2023

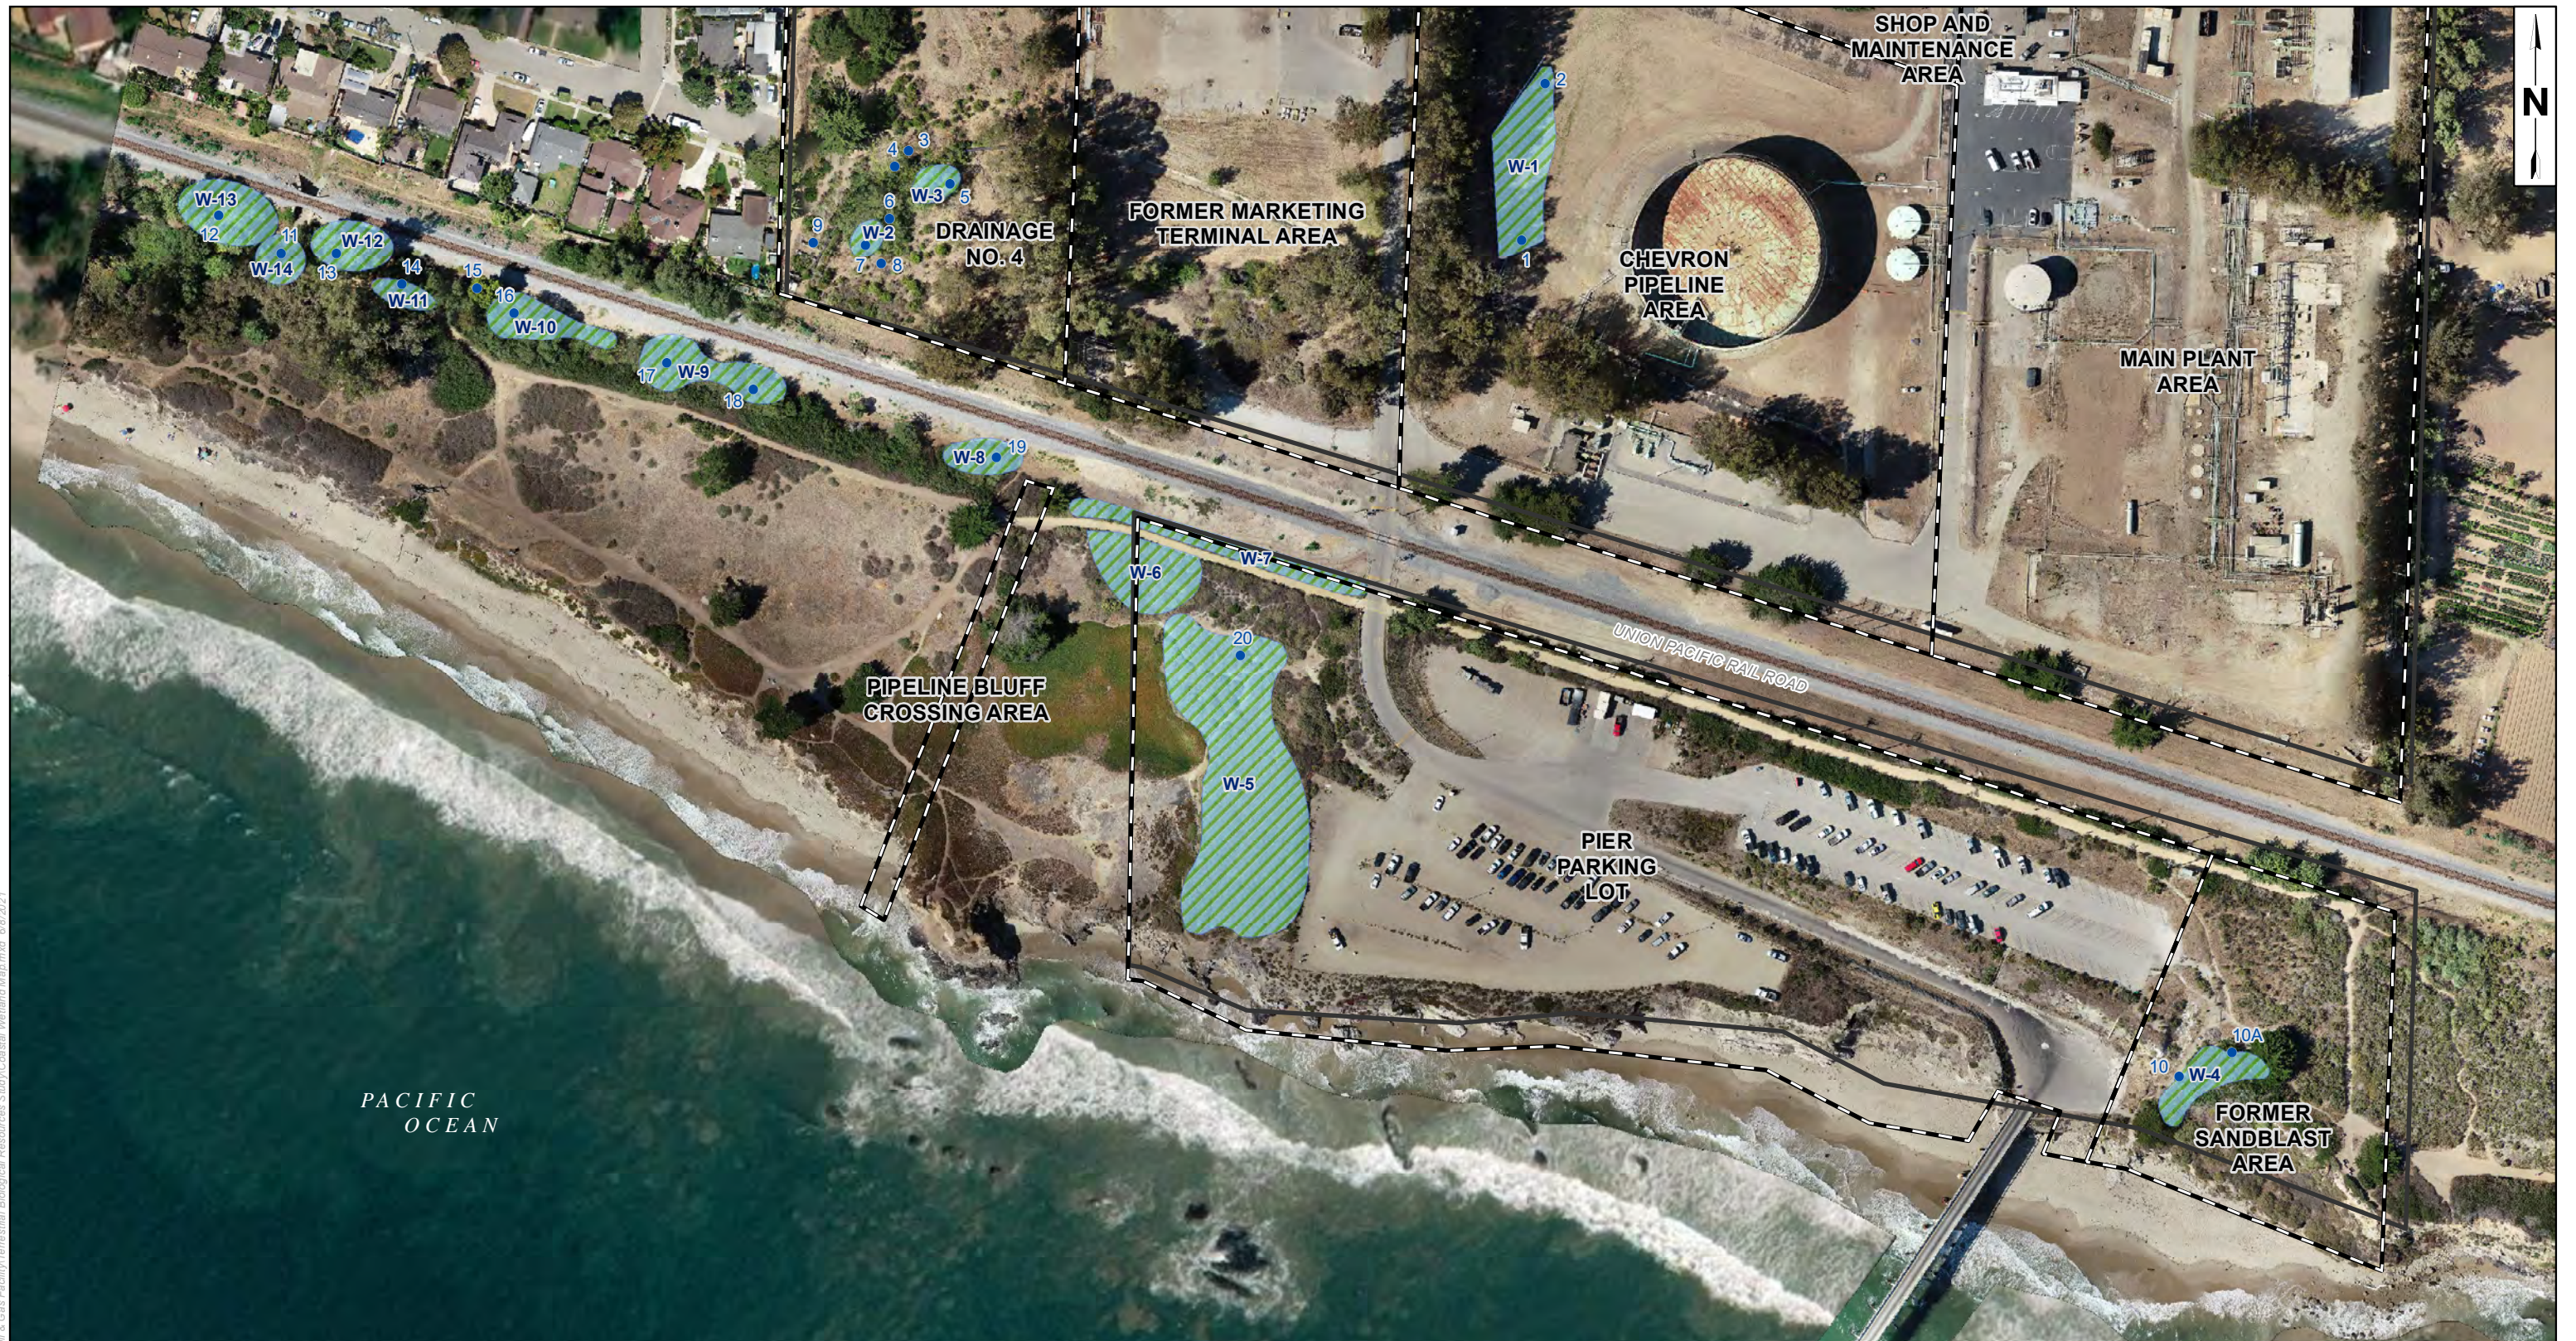
<b>Wetland no.</b>	<b>Location</b>	<b>Area (acres)</b>
W-1	Chevron Pipeline Area	0.17
W-2	Drainage No. 4 Area	0.02
W-3	Drainage No. 4 Area	0.03
W-4	Former Sandblast Area	0.08
W-5	Pier Parking Lot	0.65
W-6	Pier Parking Lot (in part)	0.13
W-7	Pier Parking Lot	0.11
W-8	Tarpits Park/Bluffs	0.05
W-9	Tarpits Park/Bluffs	0.11
W-10	Tarpits Park/Bluffs	0.08
W-11	Tarpits Park/Bluffs	0.03
W-12	Tarpits Park/Bluffs	0.07
W-13	Tarpits Park/Bluffs	0.10
W-14	Tarpits Park/Bluffs	0.04
<b>Total</b>		<b>1.67</b>

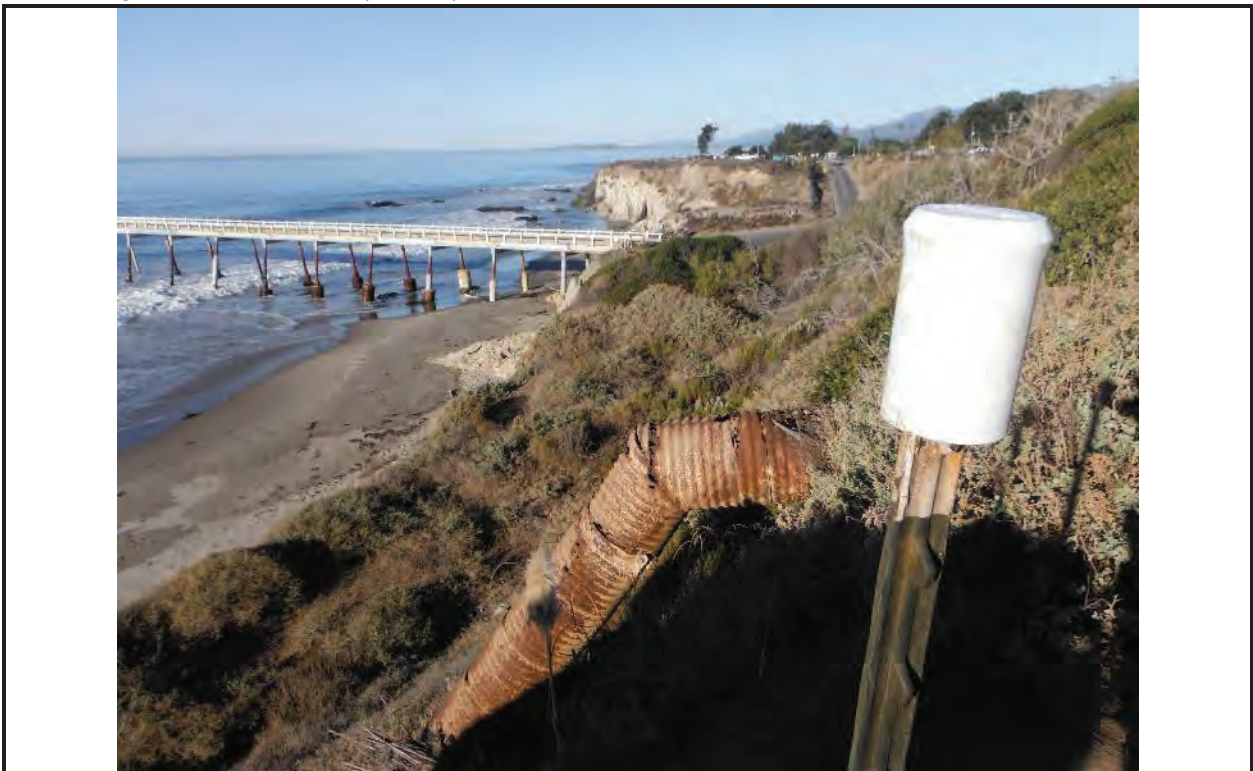
Photo 2. Study area on east side of Casitas Pier with Gail and Grace pipeline bundle (buried) and exposed concrete armament. Date: April 20, 2021, aspect west.

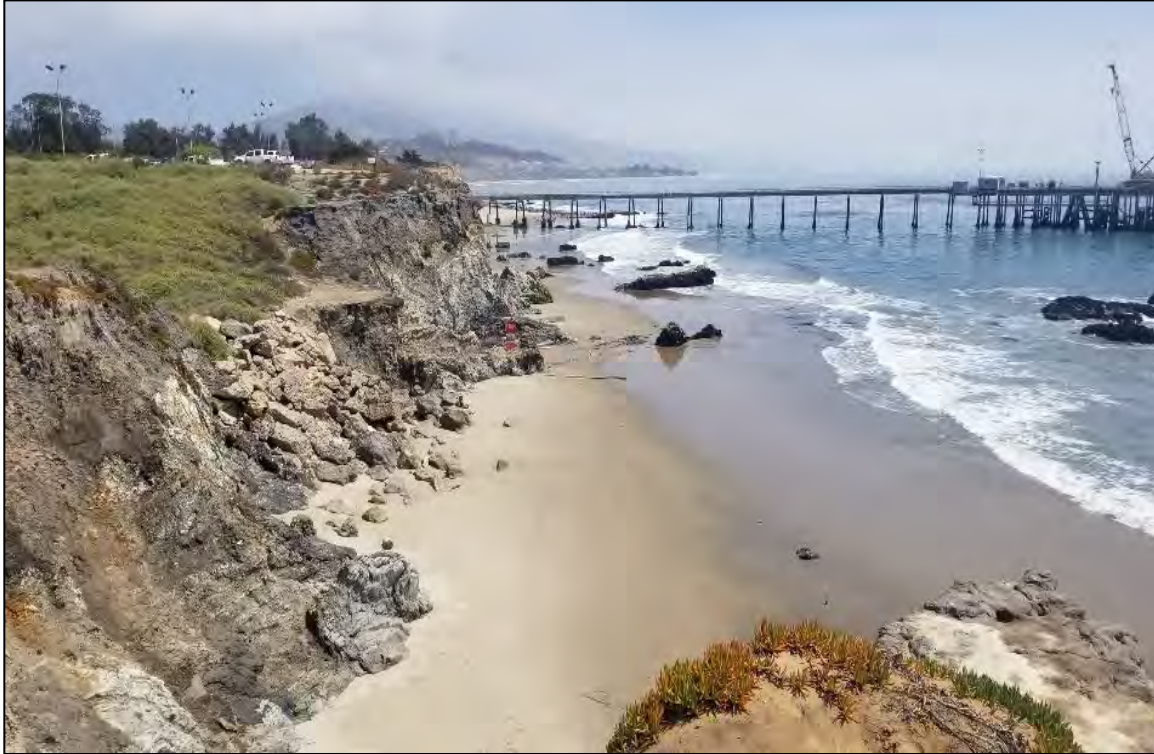
Photo 1. West side of Casitas Pier and Marketing and Marine Terminal pipeline bundle area (buried). Date: April 20, 2021, aspect east.

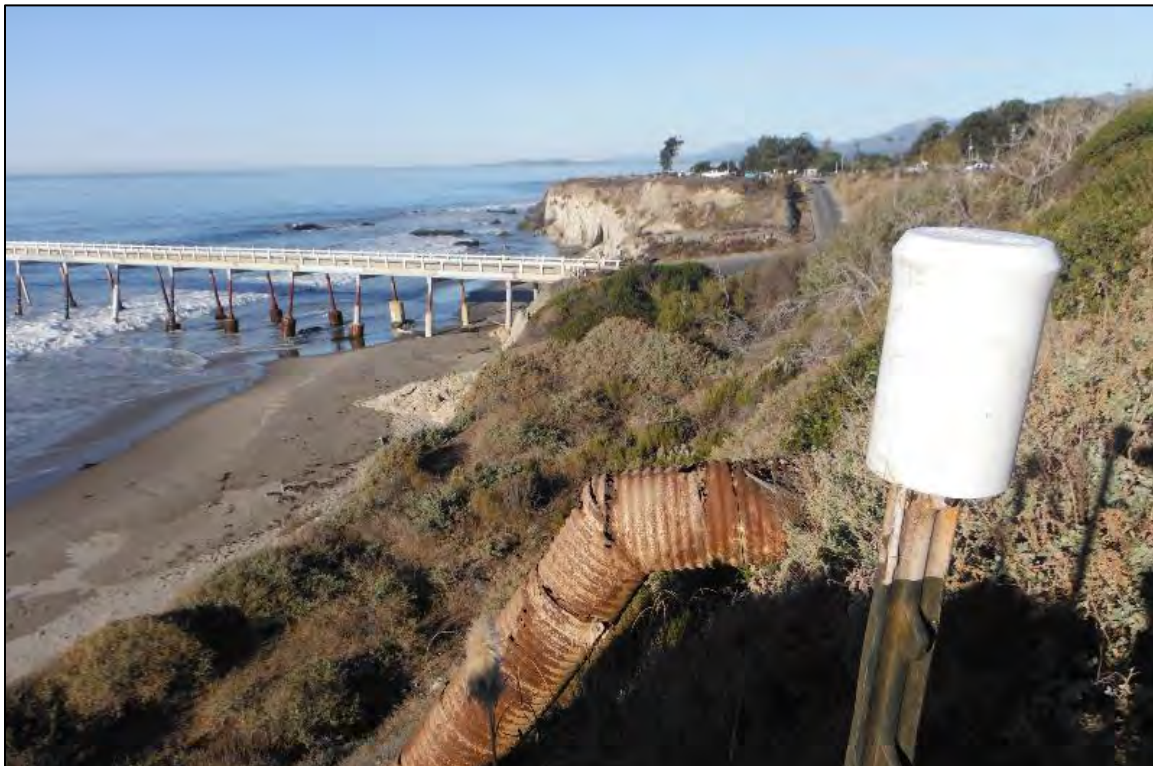
Photo 2. East side of Casitas Pier with Gail and Grace pipeline bundle (buried) and exposed concrete armament. Date: April 20, 2021, aspect west.

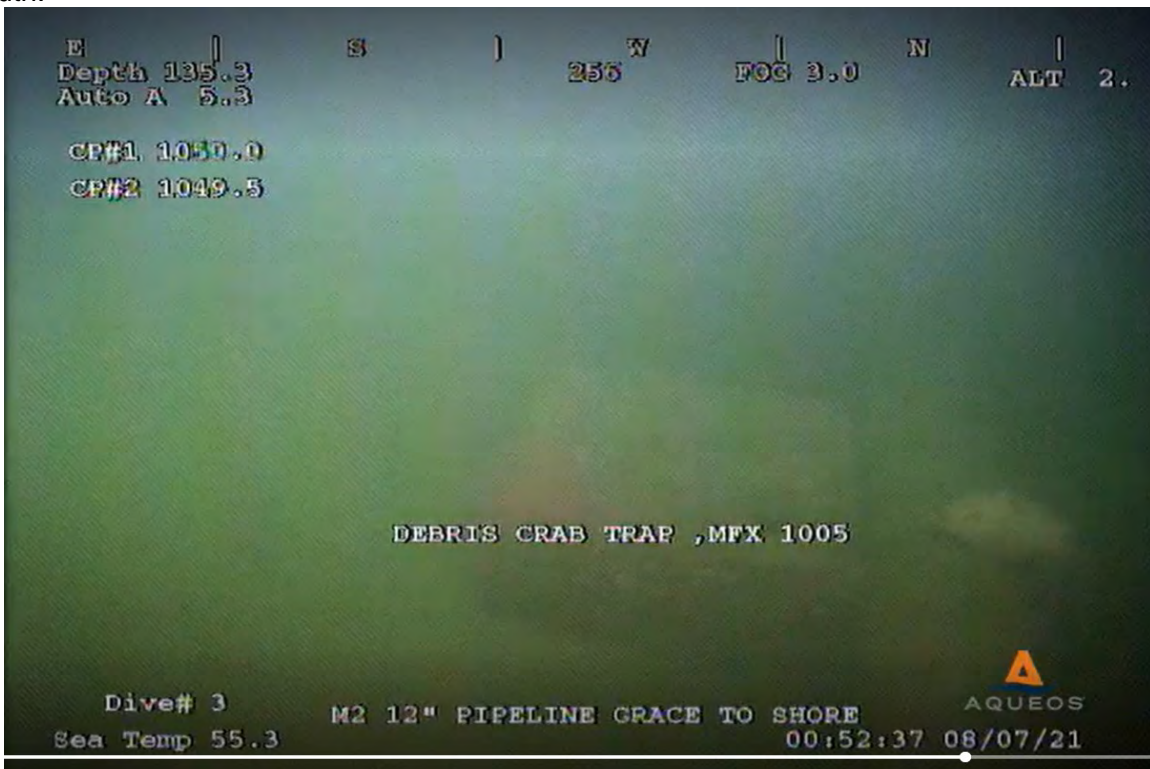
Photo 4. Imagery from 2021 Aqueos ROV survey. Debris crab trap noted adjacent exposed pipeline near State Waters boundary.

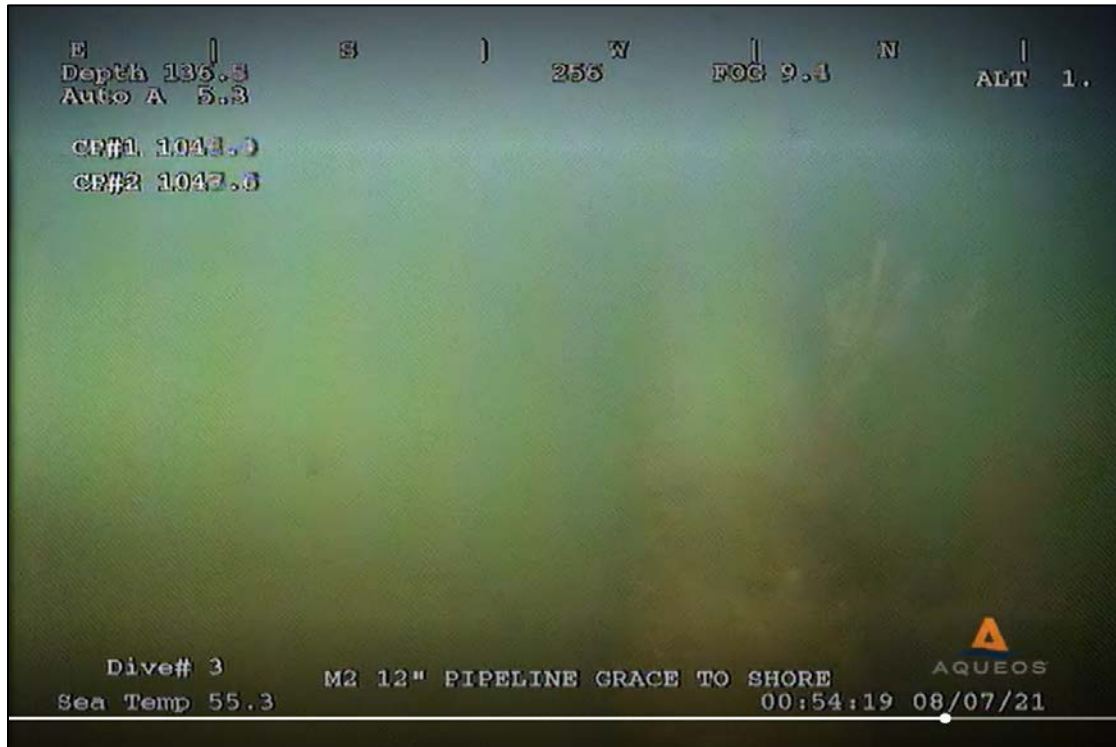
Photo 5. Imagery from 2021 Aqueos ROV survey. Exposed pipeline with minimal marine growth.

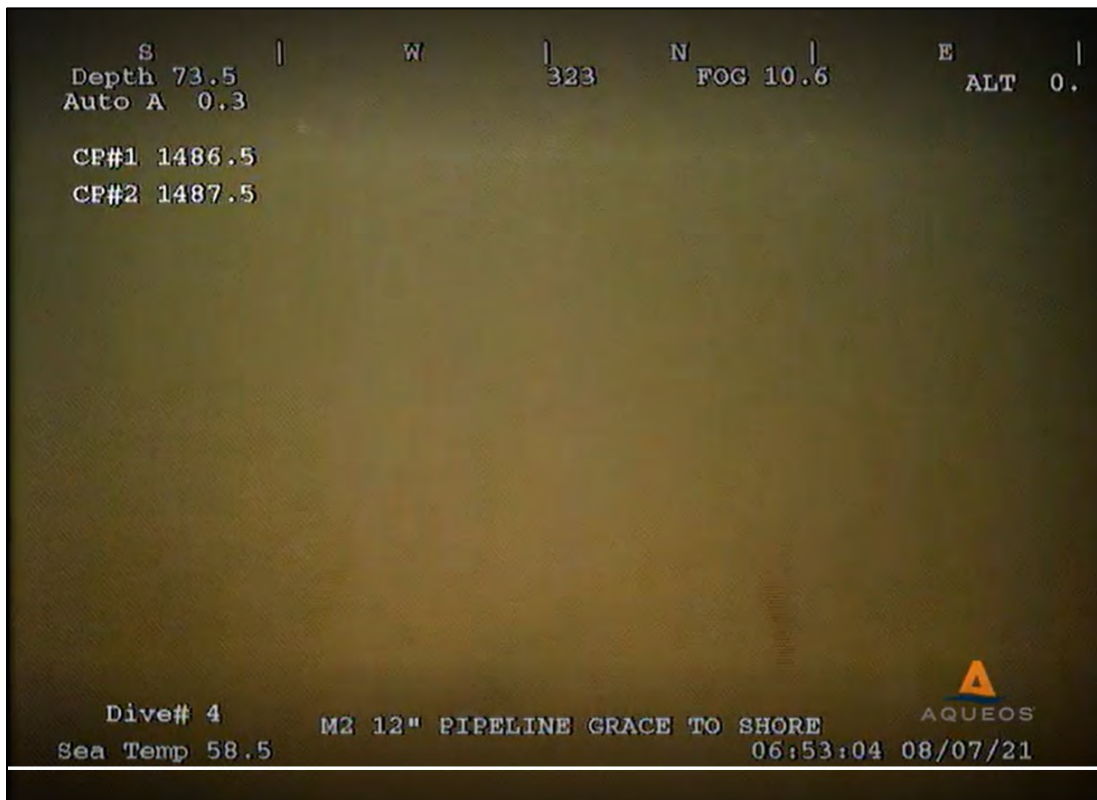
Photo 6. ROV imagery from 2021 Aqueos survey. Sand/mud bottom surrounding the area of buried pipeline at 73.5 feet.
