Biological Resources Inventory

NORTH CANYON RANCH RESIDENTIAL PROJECT

And Required
County Island Annexations

July 2023

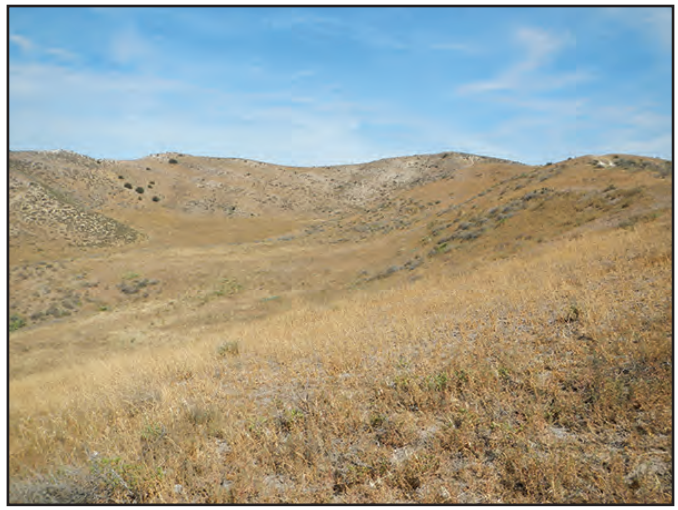
Photo 1A – Representative view centered on the large, previously graded areas in the southern portion of the site. Previously graded areas at the site are now highly disturbed and covered predominately by invasive weeds.

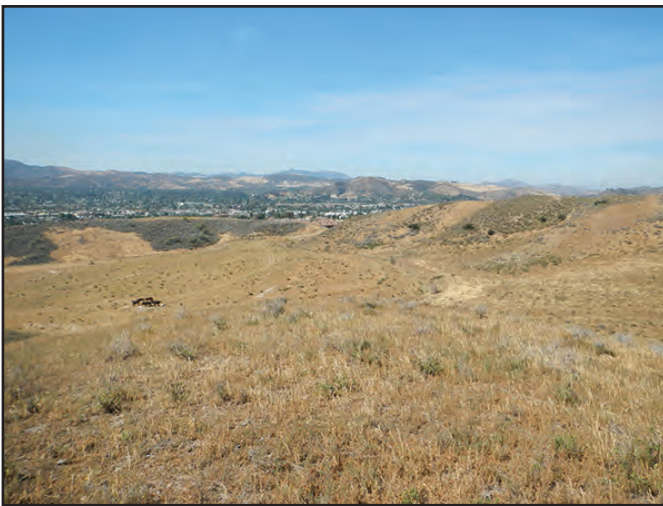
Photo 1C – Representative view of the previously graded areas and surrounding slopes in the south central portion of the site.

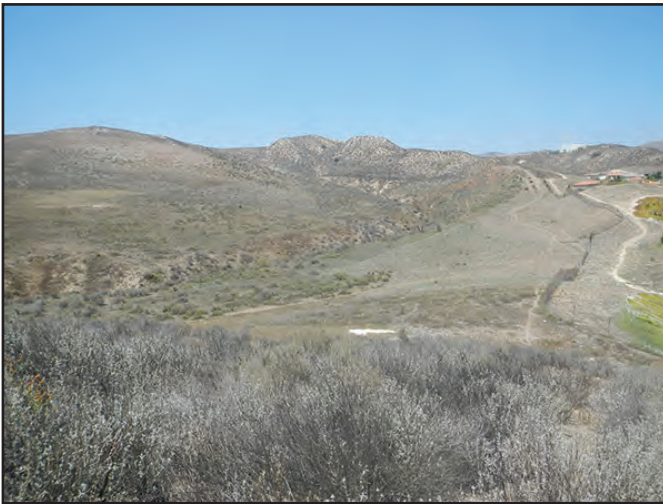
Photo 1E – View facing north of the prominent ephemeral drainage and surrounding slopes in the eastern portion of the site. The drainage flows south to a detention basin at the southern site boundary. Surrounding slopes consist of grazed open scrub and herbaceous habitats. The fuel modification zone protecting adjacent residential development along the eastern property boundary is also visible.

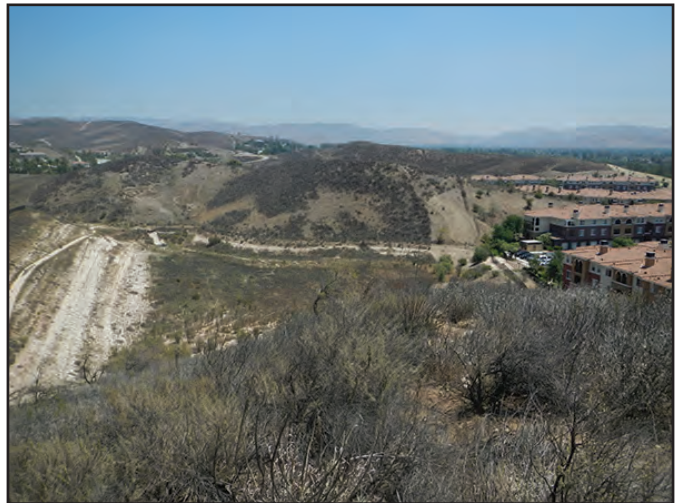
Photo 1F – View facing east of the eastern detention basin located near the site's southern boundary. The basin contains minor amounts of mulefat scrub. Coastal sage scrub consisting of purple sage and California sagebrush is visible in the foreground and on the steep slope just east of the basin in the background.

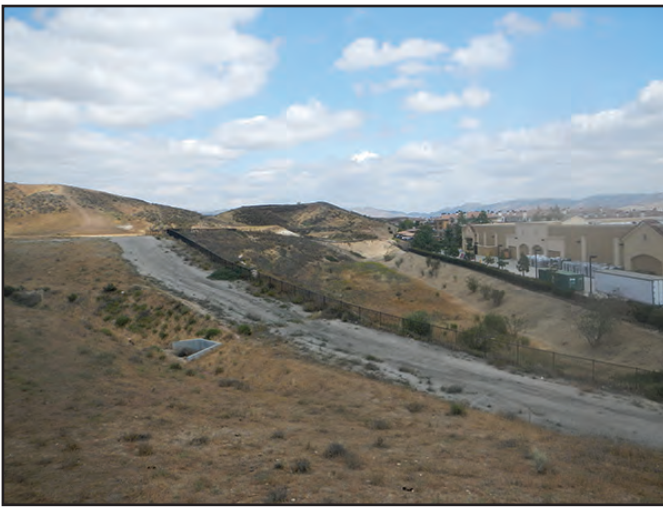
Photo 2A – View facing east of the western detention basin, previously graded level areas, and an unimproved dirt access road in the southwestern portion of the site. The Simi Town Center and the Archstone Apartments complex are visible on the right.

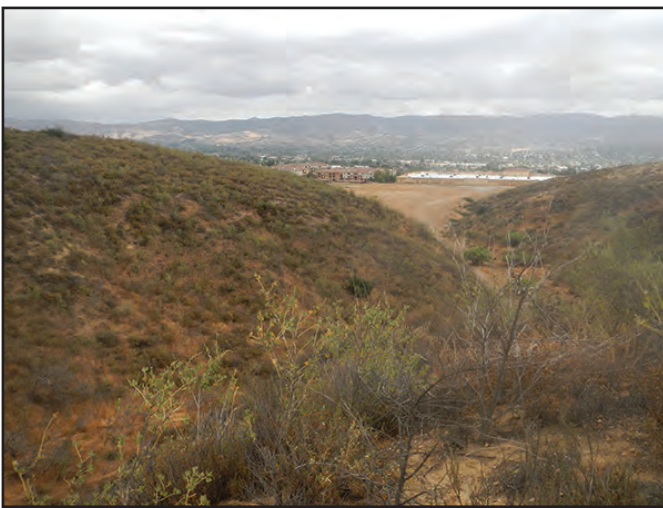
Photo 2C – Another view of steep topography and scrub habitats in the western portion of the site. Level, graded areas at the site are visible in the background.

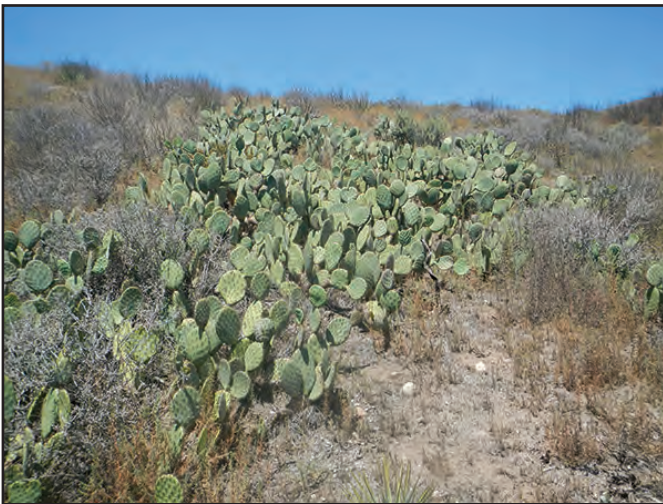
Photo 2E – Patches of sensitive prickly-pear cactus scrub such as the one shown in this photo occur at a few locations within coastal sage scrub.

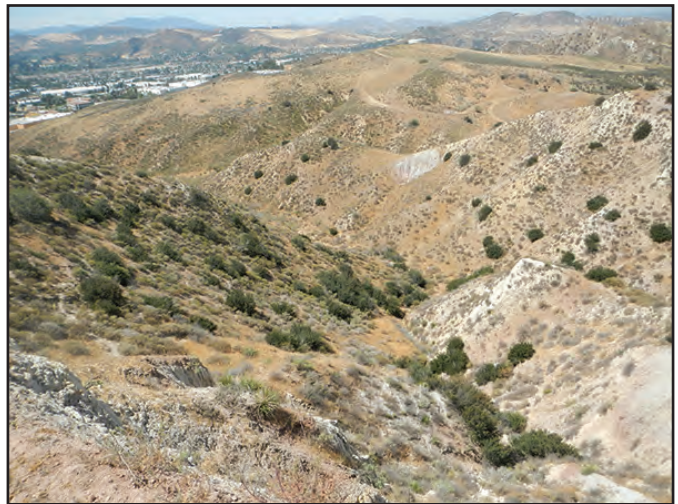
Photo 2F – This photo shows a stand of sensitive lemonade berry, black sage, and California sagebrush scrub (visible at center left), near the northwestern boundary of the site. Surrounding slopes to the right and in the background are off-site.

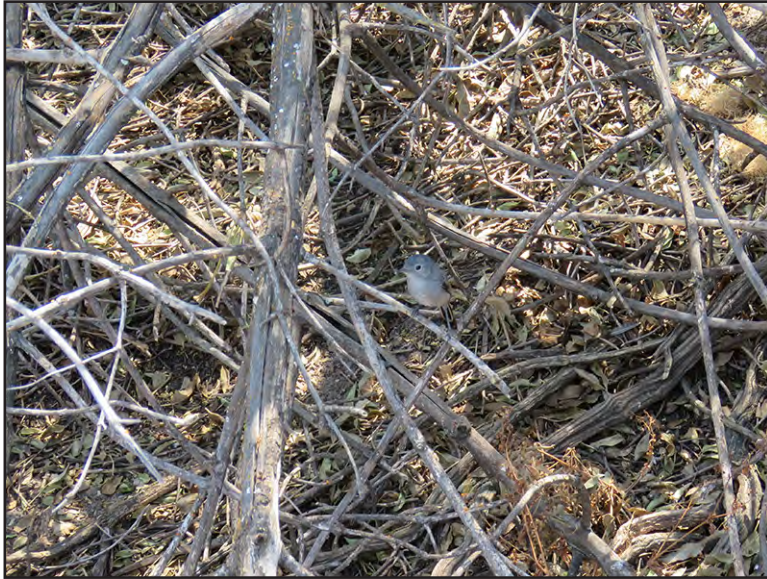
Photo 3A – One of the California gnatcatchers observed at the site in July 2017 is shown. The California gnatcatcher is listed as Threatened under the Federal Endangered Species Act and is also a California Species of Special Concern.

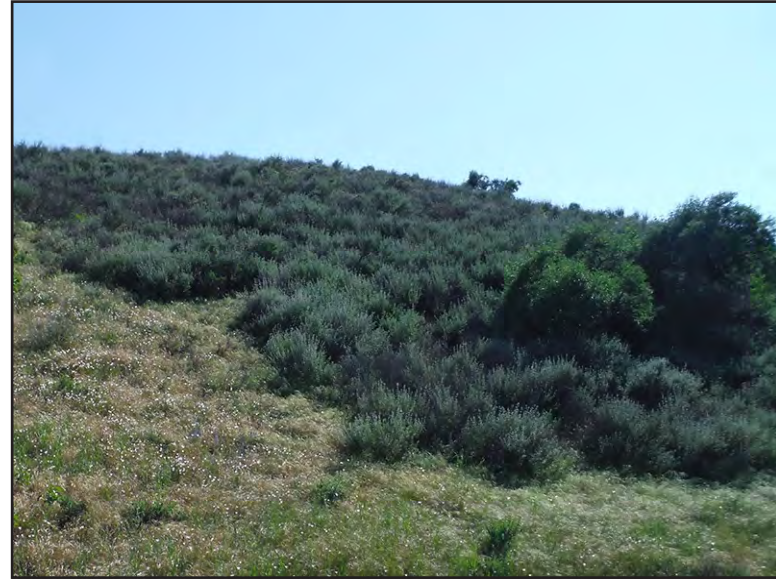
Photo 3B – California gnatcatchers were observed in coastal sage scrub habitats such as the scrub shown in this photo in 2015, 2017, 2019, and 2023.

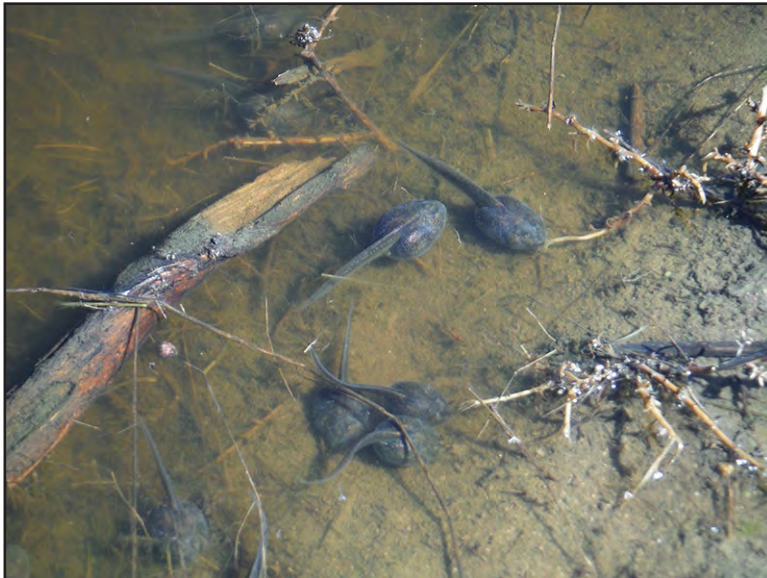
Photo 3C – Western spadefoot bred in a seasonal, or temporary, pond near the southern boundary of the site in 2017. The western spadefoot is a California Species of Special Concern. A few of the several hundred spadefoot tadpoles that were observed in the pond are shown in this photo.

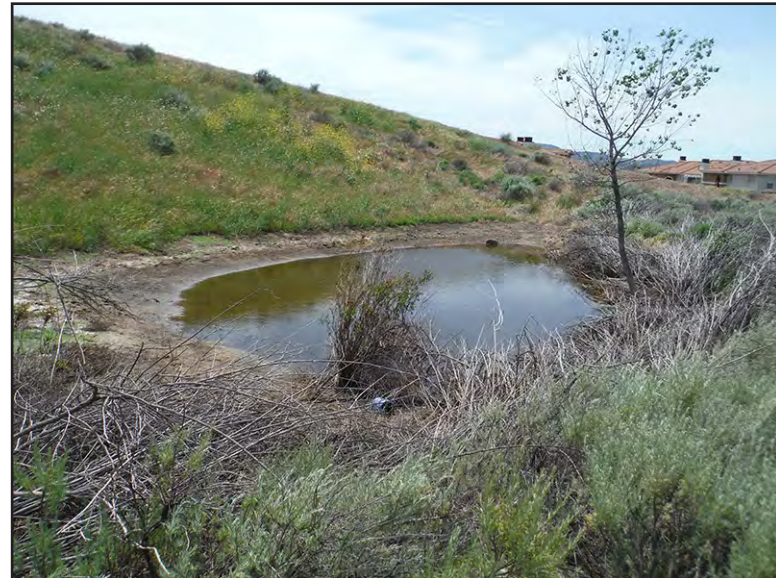
Photo 3D – The temporary pond where western spadefoot bred at the site is shown. This photo was taken in early April 2017 and the pond was dry by May 2017. The pond appears to be man-made or a result of former grading which created an artificial berm along its western edge.

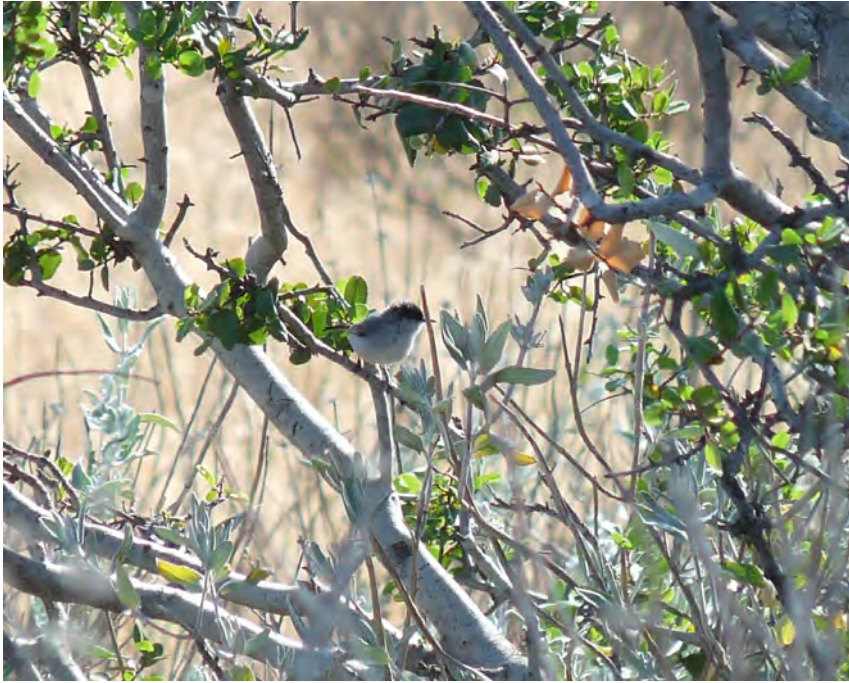
Figure 4. California Gnatcatcher (adult male) photographed near Location “D” (see Figure 5a) on 19 April 2015, and presumably the same bird as was detected on all subsequent visits during the survey.

Table 1 summarizes each observation by date, and locations of California Gnatcatcher activity are shown in Figure 5a. All detections were made in areas of intact coastal sage scrub (green areas on Figure 5b). Except for the final survey day when a likely territorial display was observed (described below), all detections involved a single male California Gnatcatcher seen/heard briefly, usually calling frequently but moving quickly with long flights, moving either well off the site, or disappearing deep into scrub vegetation. Once on 12 May I observed it making a very long flight high above the large debris basin at the southeastern corner of the site, from one area of coastal sage scrub to the other (Location F to E; see Figure 5a). This supported the theory that only a single male was present during each visit, moving between the two main patches of intact coastal sage scrub or venturing off the site to the east. After each observation of this male, I would walk quickly over to other areas of coastal sage scrub and try to find additional birds, but never did.

While this individual occasionally responded to recordings of vocalizations, it would typically begin calling spontaneously, sometimes from up to 100 meters away. However, on the final survey day, I observed what was presumably this same male performing an apparent territorial display, repeatedly flying back and forth between two shrubs separated by less than 20 meters (Locations “C” and “D” in Figure 5a), remaining perched for several minutes at a time, preening, and at least once, flying with somewhat slower, more exaggerated wingbeats while calling. This indicated that it was trying to define or defend a territory nearby.

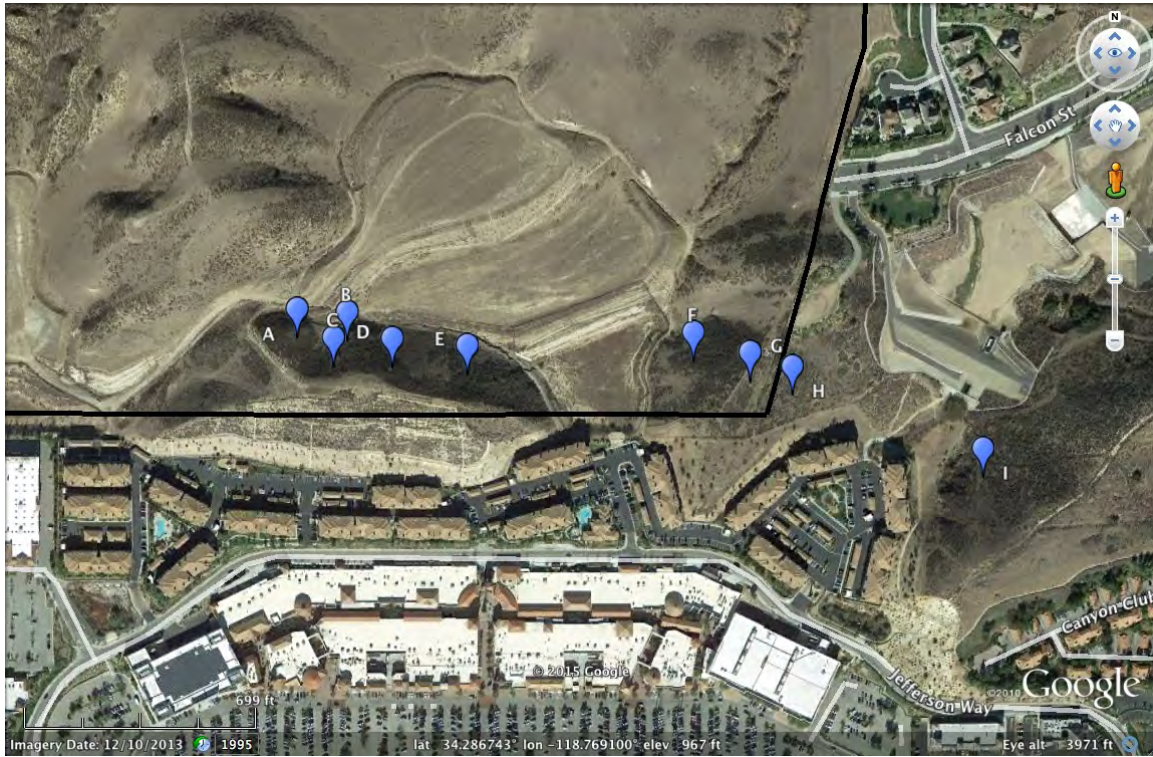
Figure 5a. Map of California Gnatcatcher activity at North Canyon Ranch site, April-May 2015 (see Table 1). Blue pins are detections, presumably of the same adult male. The black line denotes the subject property boundary. Detections outside the black line were made while standing on the subject property, and were of birds moving to or from the study area.

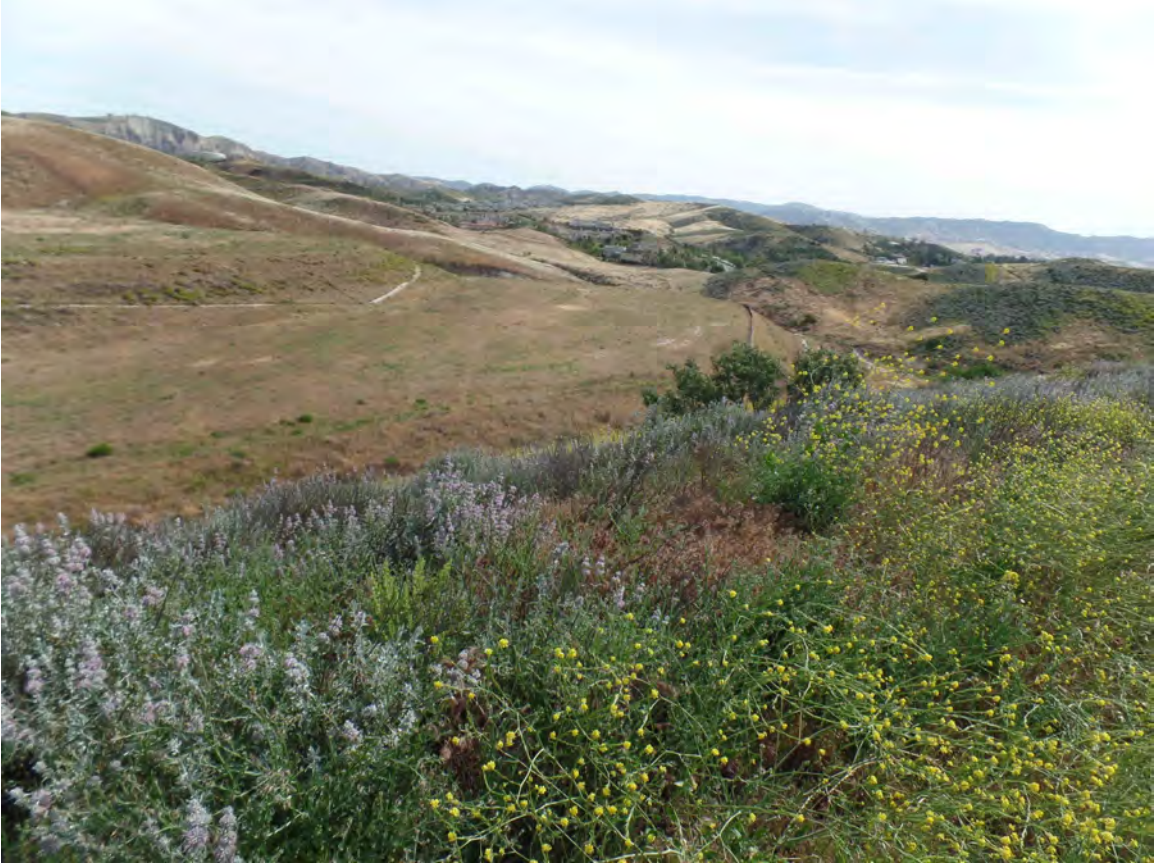
Figure 3b. View (east) near the southern border of the property, showing patches of intact coastal sage scrub patches (at left) and grazed grassland/disturbed habitat at left.

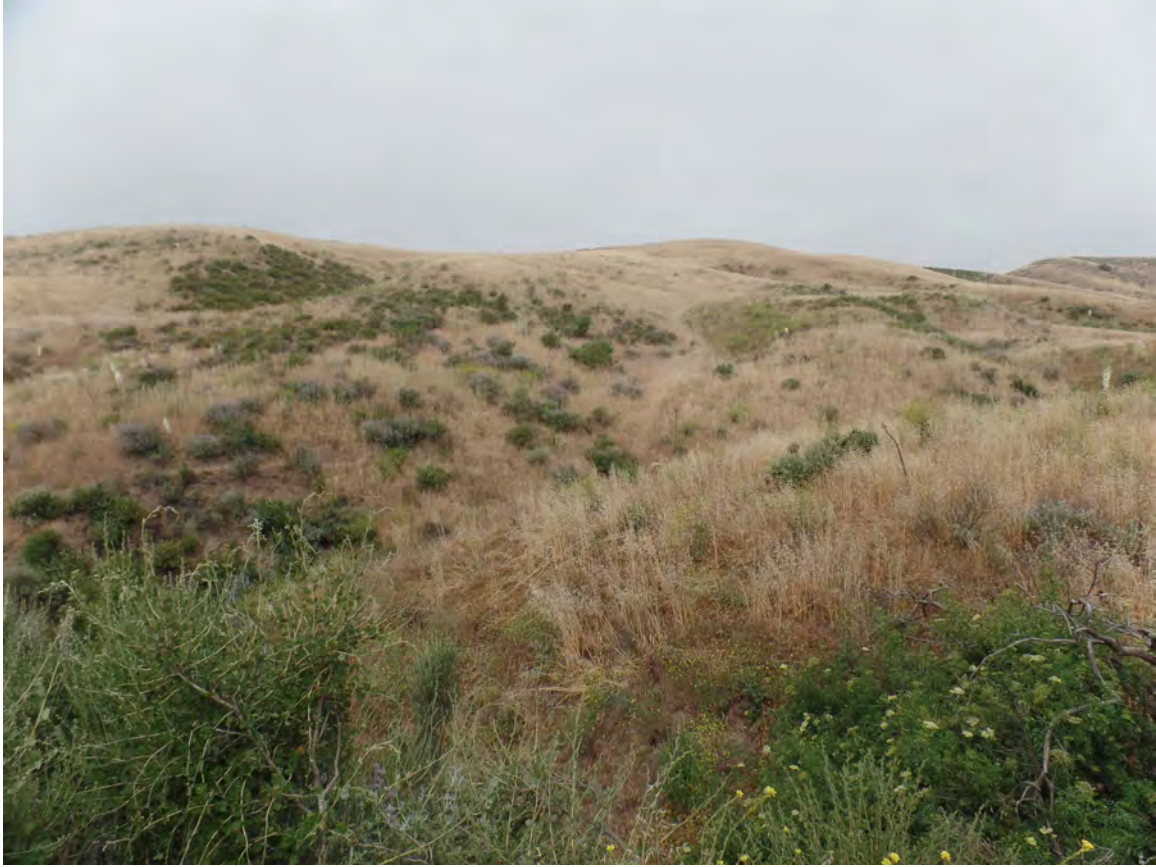
Figure 3c. Typical view of sparse coastal sage scrub mixed with annual grassland near center of property.

Roughly 11 acres of intact, ungrazed/unburned scrub suitable for California Gnatcatcher was again found to be present on the entire property, located on two separate slopes along the southern boundary of the site, and separated by a debris basin (see areas shown in green in Figure 3a). The remaining scrub at the site is patchy and sparse, and does not appear to be suitable for the species (Figure 3c).

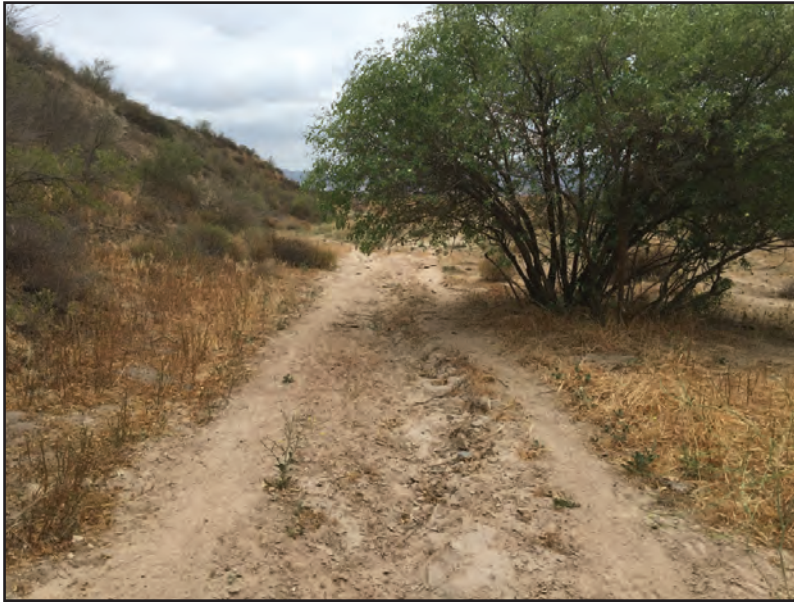
Photo 1A – View to the south illustrating hydrology indicators of ephemeral Drainage 2 north of Ditch 1.

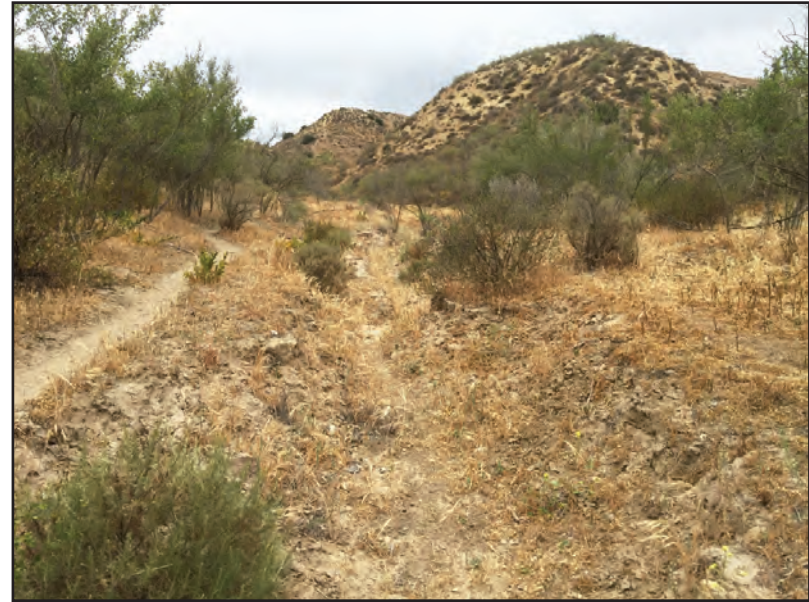
Photo 1B – View to the northwest of Drainage 3 illustrating the incised channel and dominance of non-hydric vegetation.

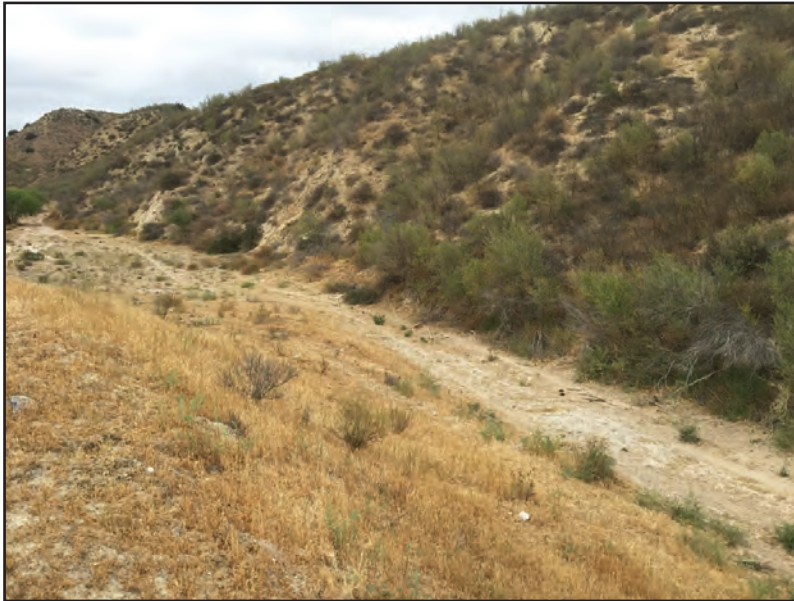
Photo 1C – View to the northeast from the berm above Ditch 1 looking at the overland sheet flow area associated with Drainages 2 and 3 and Ditch 1.

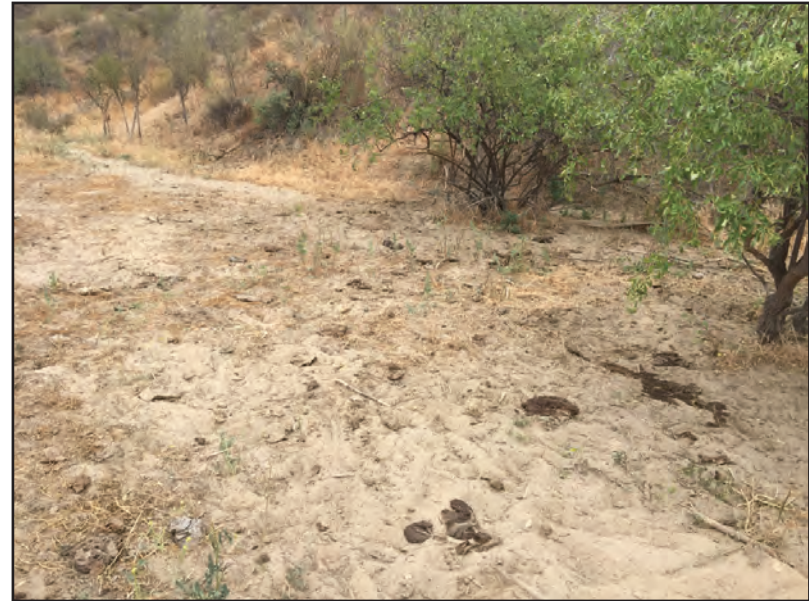
Photo 1D – View to the east of overland sheet flow area at southern terminus of Drainage 7. Stream hydrology degraded by cattle grazing.

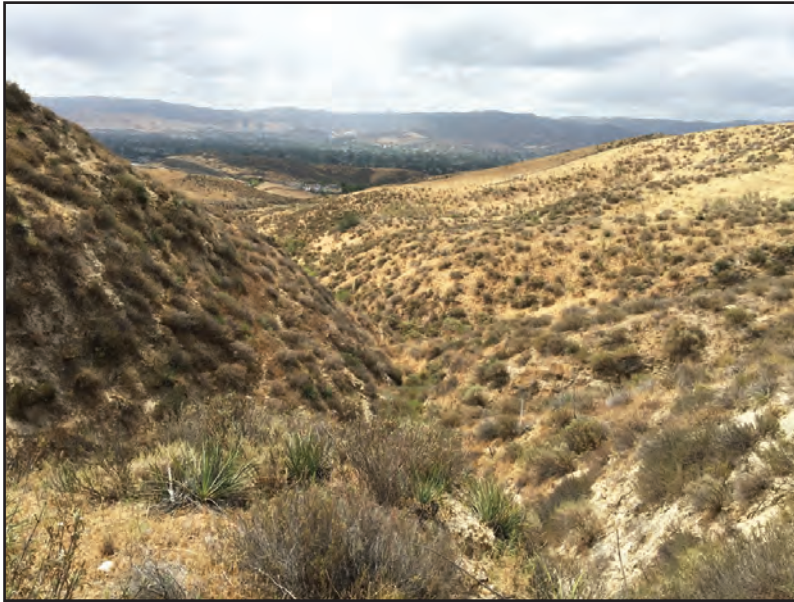
Photo 2A – View to the south from the headwaters of Drainage 9.

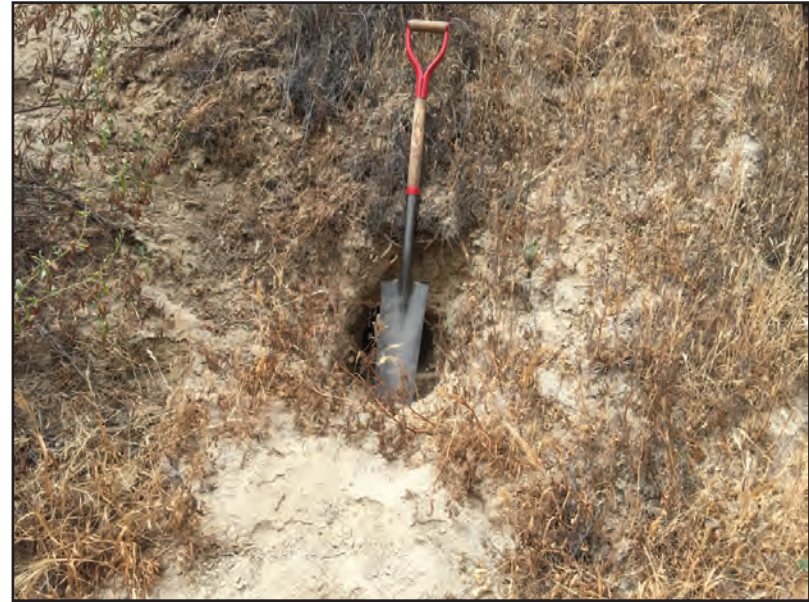
Photo 2B – Mammal dens were frequently encountered along the drainages. This den was located in Drainage 9 and used to define the limits of ordinary high water.

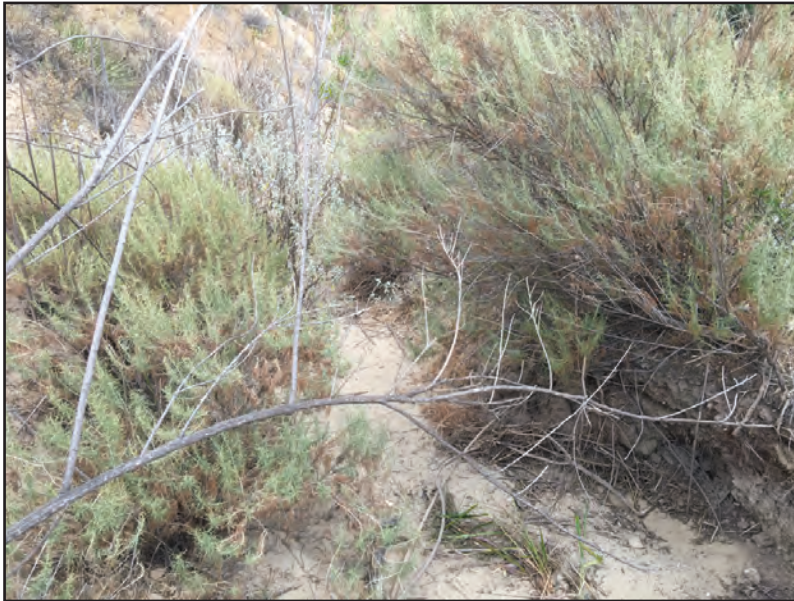
Photo 2C – View to the northeast illustrating the incised channel of Drainage 9 overtopped by sagebrush scrub.

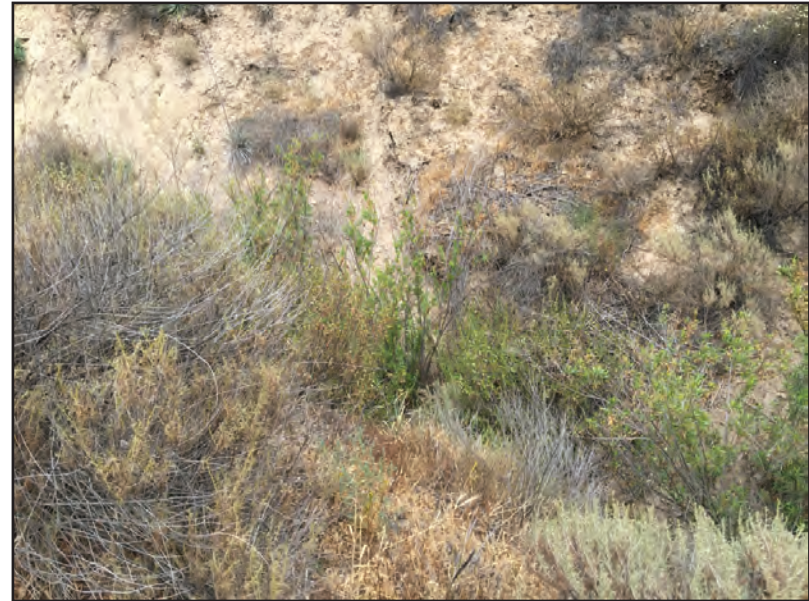
Photo 2D – View to the east of the limit of riparian vegetation and the transition to upland vegetation within Drainage 9.

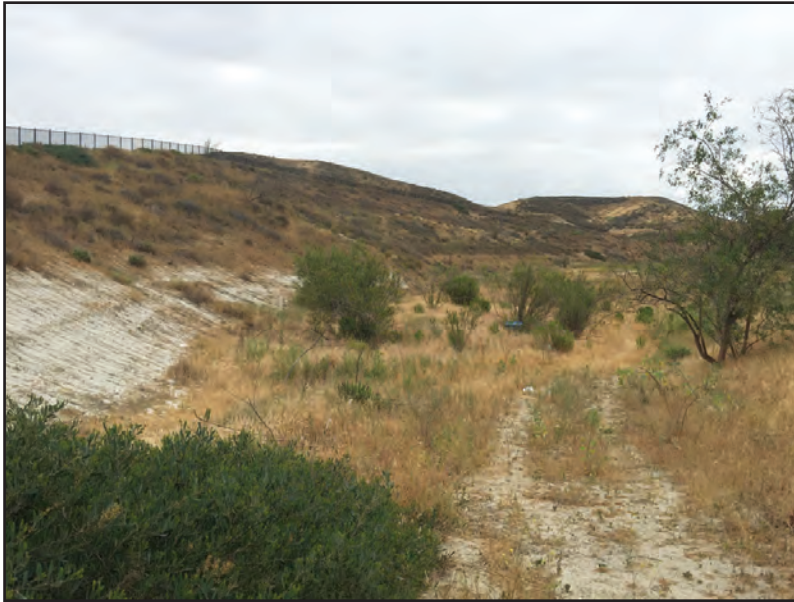
Photo 3A – View to the northeast of Debris Basin 1.

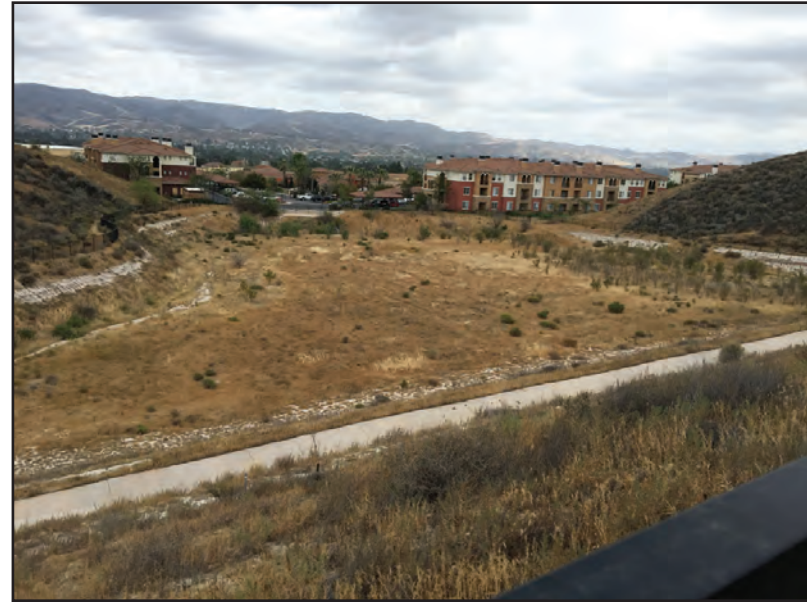
Photo 3B – View to the south of Debris Basin 2.

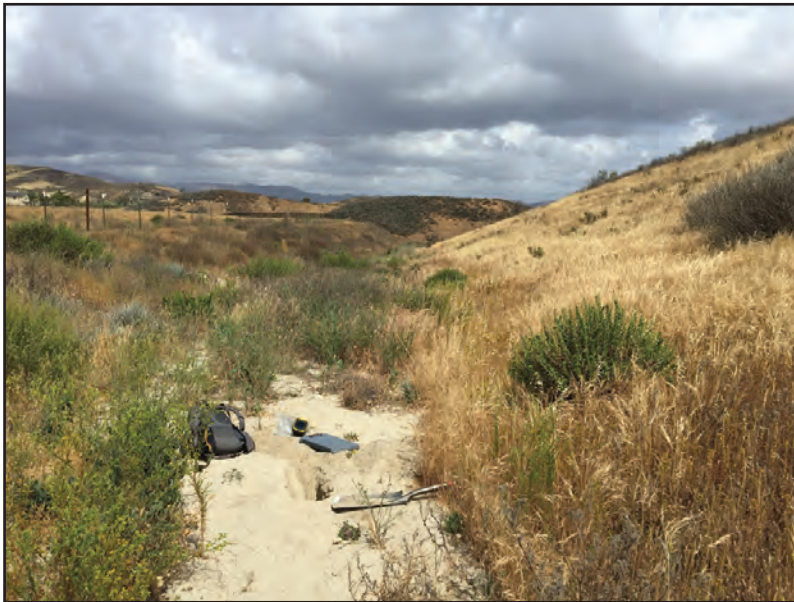
Photo 3C – Photo of test plot located in alluvial area of Drainage 10.

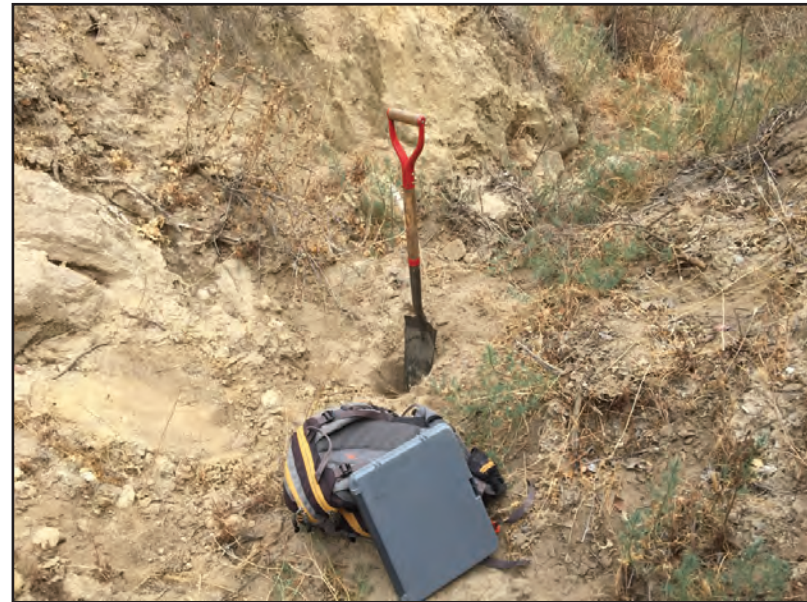
Photo 3D – Photo of the test plot located in low flow channel of Drainage 7. The plot lacked hydric vegetation and wetland soils.

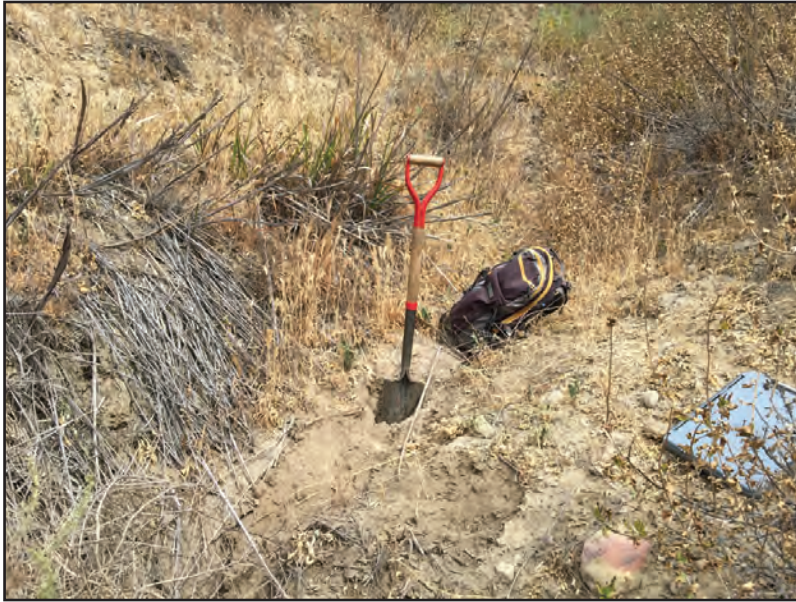
Photo 4A – Photo of test plot located in alluvial area of Drainage 9 where hydrology was present but other indicators were lacking.

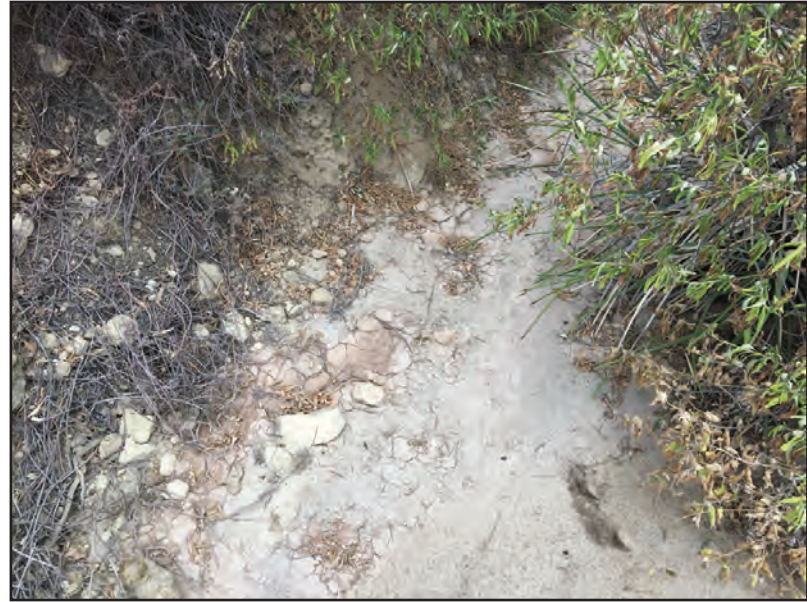
Photo 4B – View to the northwest of surface cracks within Drainage 9 in an area previously delineated as flowing water.

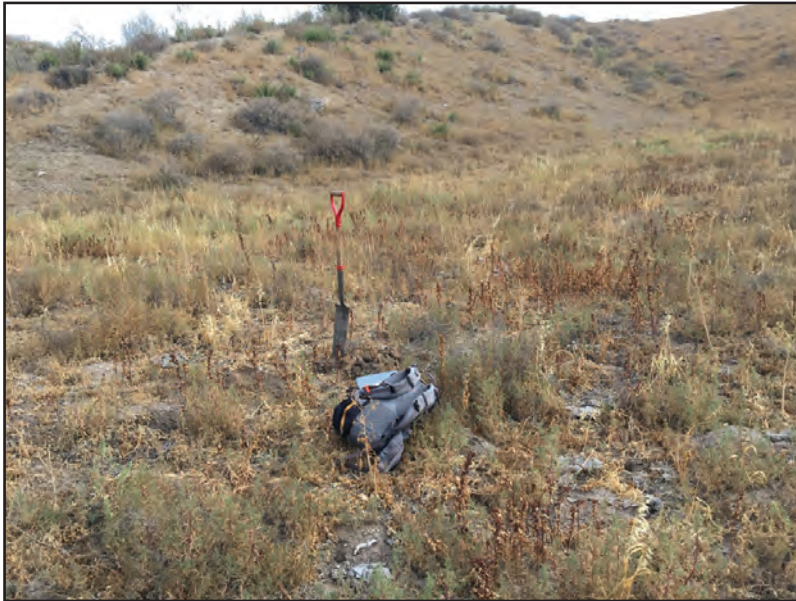
Photo 4C – View to the northwest of Test Plot 5, where hydric vegetation was identified. No other wetland indicated were located in this area.

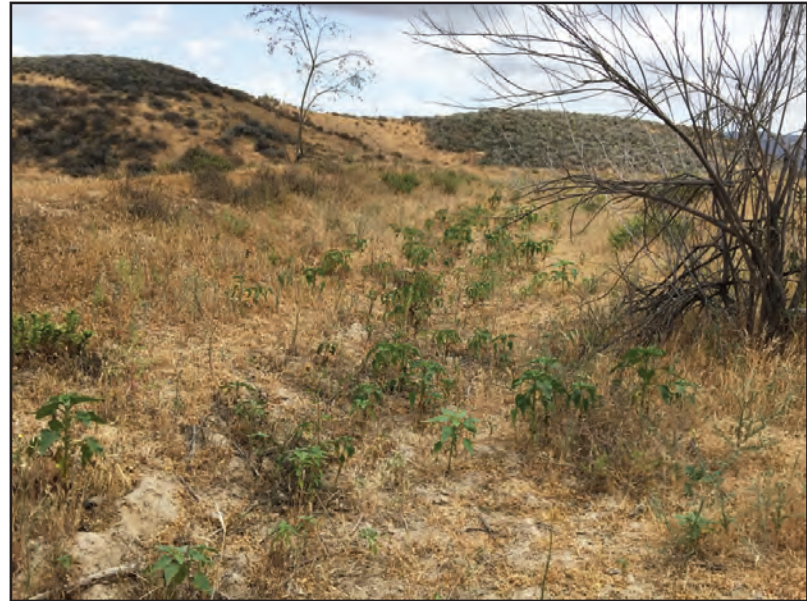
Photo 4D – View to the east of vegetation within Ditch 2.

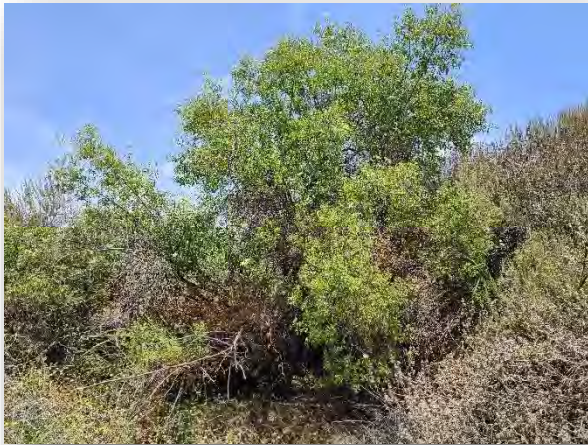
Plate 1. This is a view of a small tree with minor dieback in the lower canopy (#601).

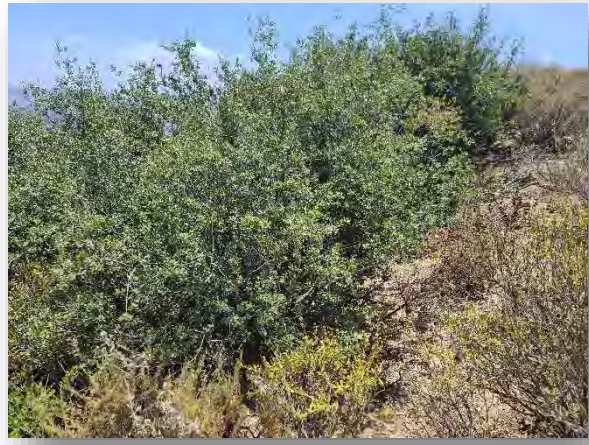
Plate 2. This is a view of a small community of scrub oak within the northeastern portion of the project (not tagged).

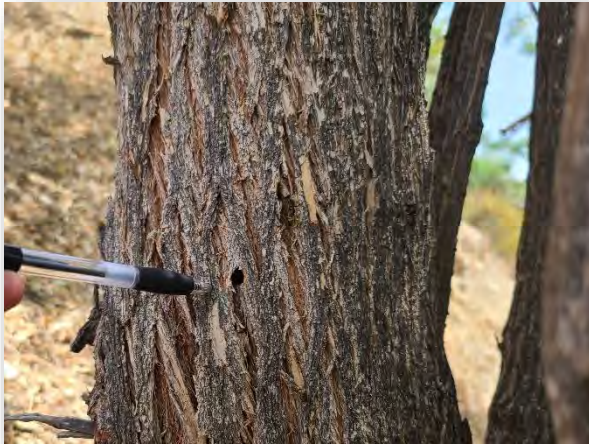
Plate 3. This is a view of boreholes within the lower stem of a tree (#602).

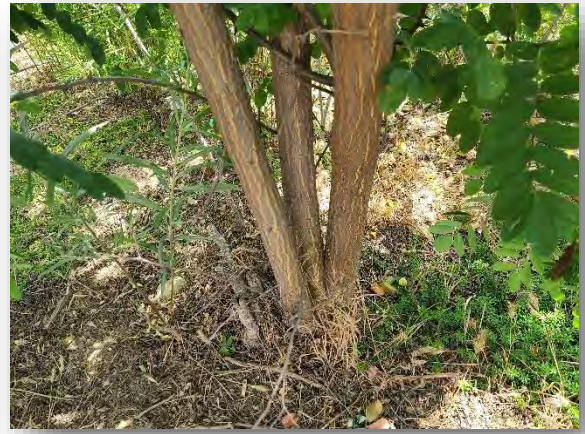
Plate 4. This is a view of a multi-stem configuration with included bark (#603).

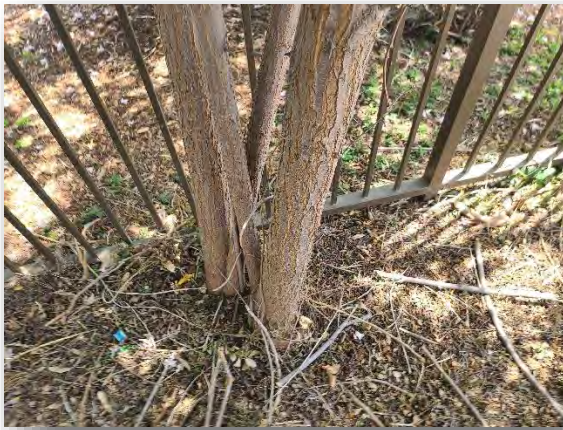
Plate 5. This is a view of adventitious sprouting from root suckering (#607).

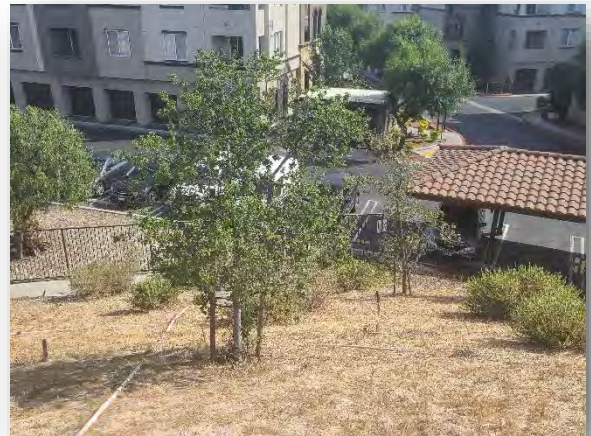
Plate 6. This is a view of a coast live oak outside (CLO) of the project site on a landscaped slope above a neighboring development (labelled CLO on Figure 2).

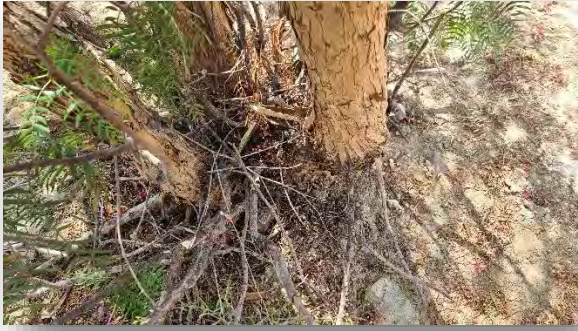
Plate 7. This is a view of a multi-stem tree with lower epicormic sprouting (#613).

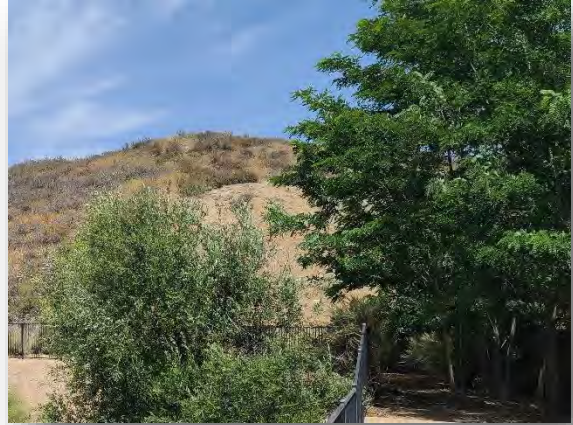
Plate 8. This is a view of a cluster of trees (on the right) from aggressive sprouting.

Common Name Botanical Name	Species Profile	Qty.
<p>Black Locust ** <i>Robinia pseudoacacia</i></p>	<p>This species tolerates smog. Its seeds, leaves and bark are poisonous. Has become established in natural areas (undisturbed, undeveloped environments) in California. Cal-IPC (California Invasive Plant Council) classifies the invasiveness of this plant as limited. Has thorns. This species is native to eastern and central united states. Its form is erect or spreading and requires ample growing space. It has an oval shape with deciduous foliage. Height: 40 - 70 feet. Width: 25 - 35 feet. Growth Rate: 36 Inches per Season.</p> <p>Longevity 50 to 150 years. Wet to dry soil composed of clay, loam or sand texture. Its branch strength is rated as medium weak to medium and its root damage potential is rated as high.</p>	<p>5</p>
<p>This species was primarily observed along the southern boundary of the project area along the fence line. Rhizomous sprouting has led to an isolated community of young trees adjacent to the catch basin within the site (see Plate 8 below).</p>
