BIOLOGICAL TECHNICAL REPORT

OMNI LA COSTA CHAMPIONS COURSE RENOVATION PROJECT

September, 2022

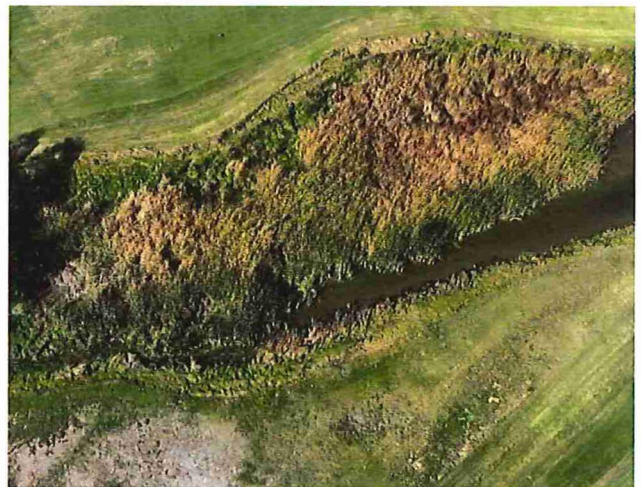
Photo of emergent cattails growing in one of the golf course ponds.

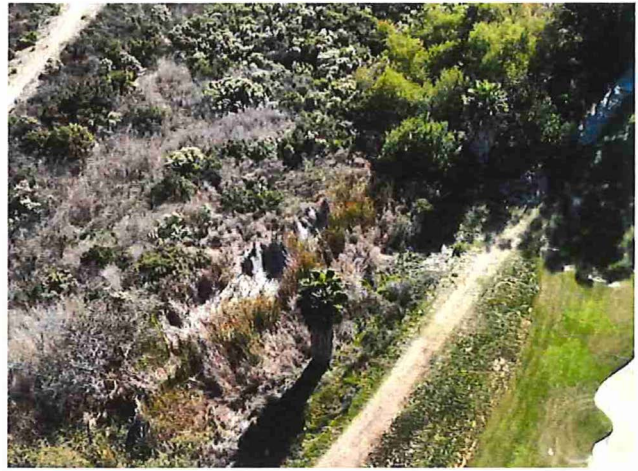
Photo of the FWM just offsite [east] of the golf course renovation area.

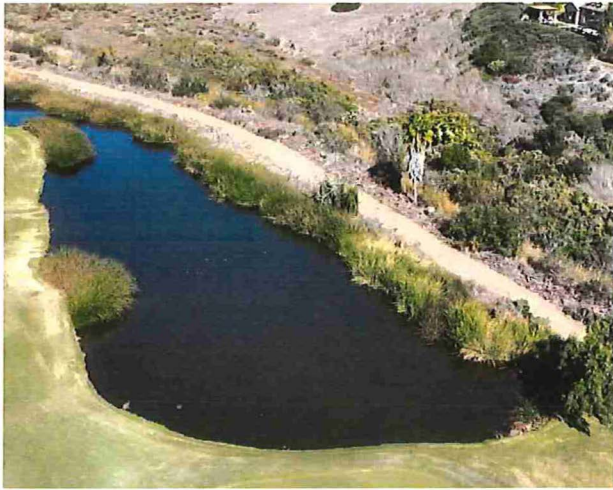
Photo of golf course ponds with emergent growth of cattails and California bulrush.

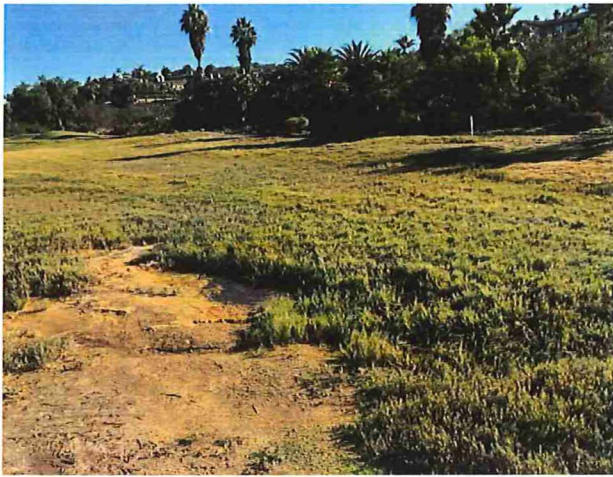
Photo of saltgrass grassland (*Distichlis*) invading areas that had previously been active golf course play area.

Saltgrass Grassland (42130) (0.12 acres). Saltgrass grassland is a very low growing (less than 2 inches in height) grassland dominated by Saltgrass (*Distichlis spicata*). It is found on approximately 0.12 acres of the Golf Course property, sandwiched between the golf play area and the CVFM drainage. Although it is not connected to the CVFM due to the placement of a soil berm between the two many years ago, the saturation of the clay soil from the CVFM has been sufficiently wet for the Saltgrass to dominate a small area previously covered with domestic course grasses. Saltgrass is considered a wetland indicator, native to southern California.
