RINCON ISLAND CAUSEWAY MARINE BIOLOGICAL SURVEY REPORT

RINCON PHASE 2 DECOMMISSIONING PROJECT VENTURA COUNTY, CALIFORNIA

Project No. 2002-7861

FEBRUARY 2023

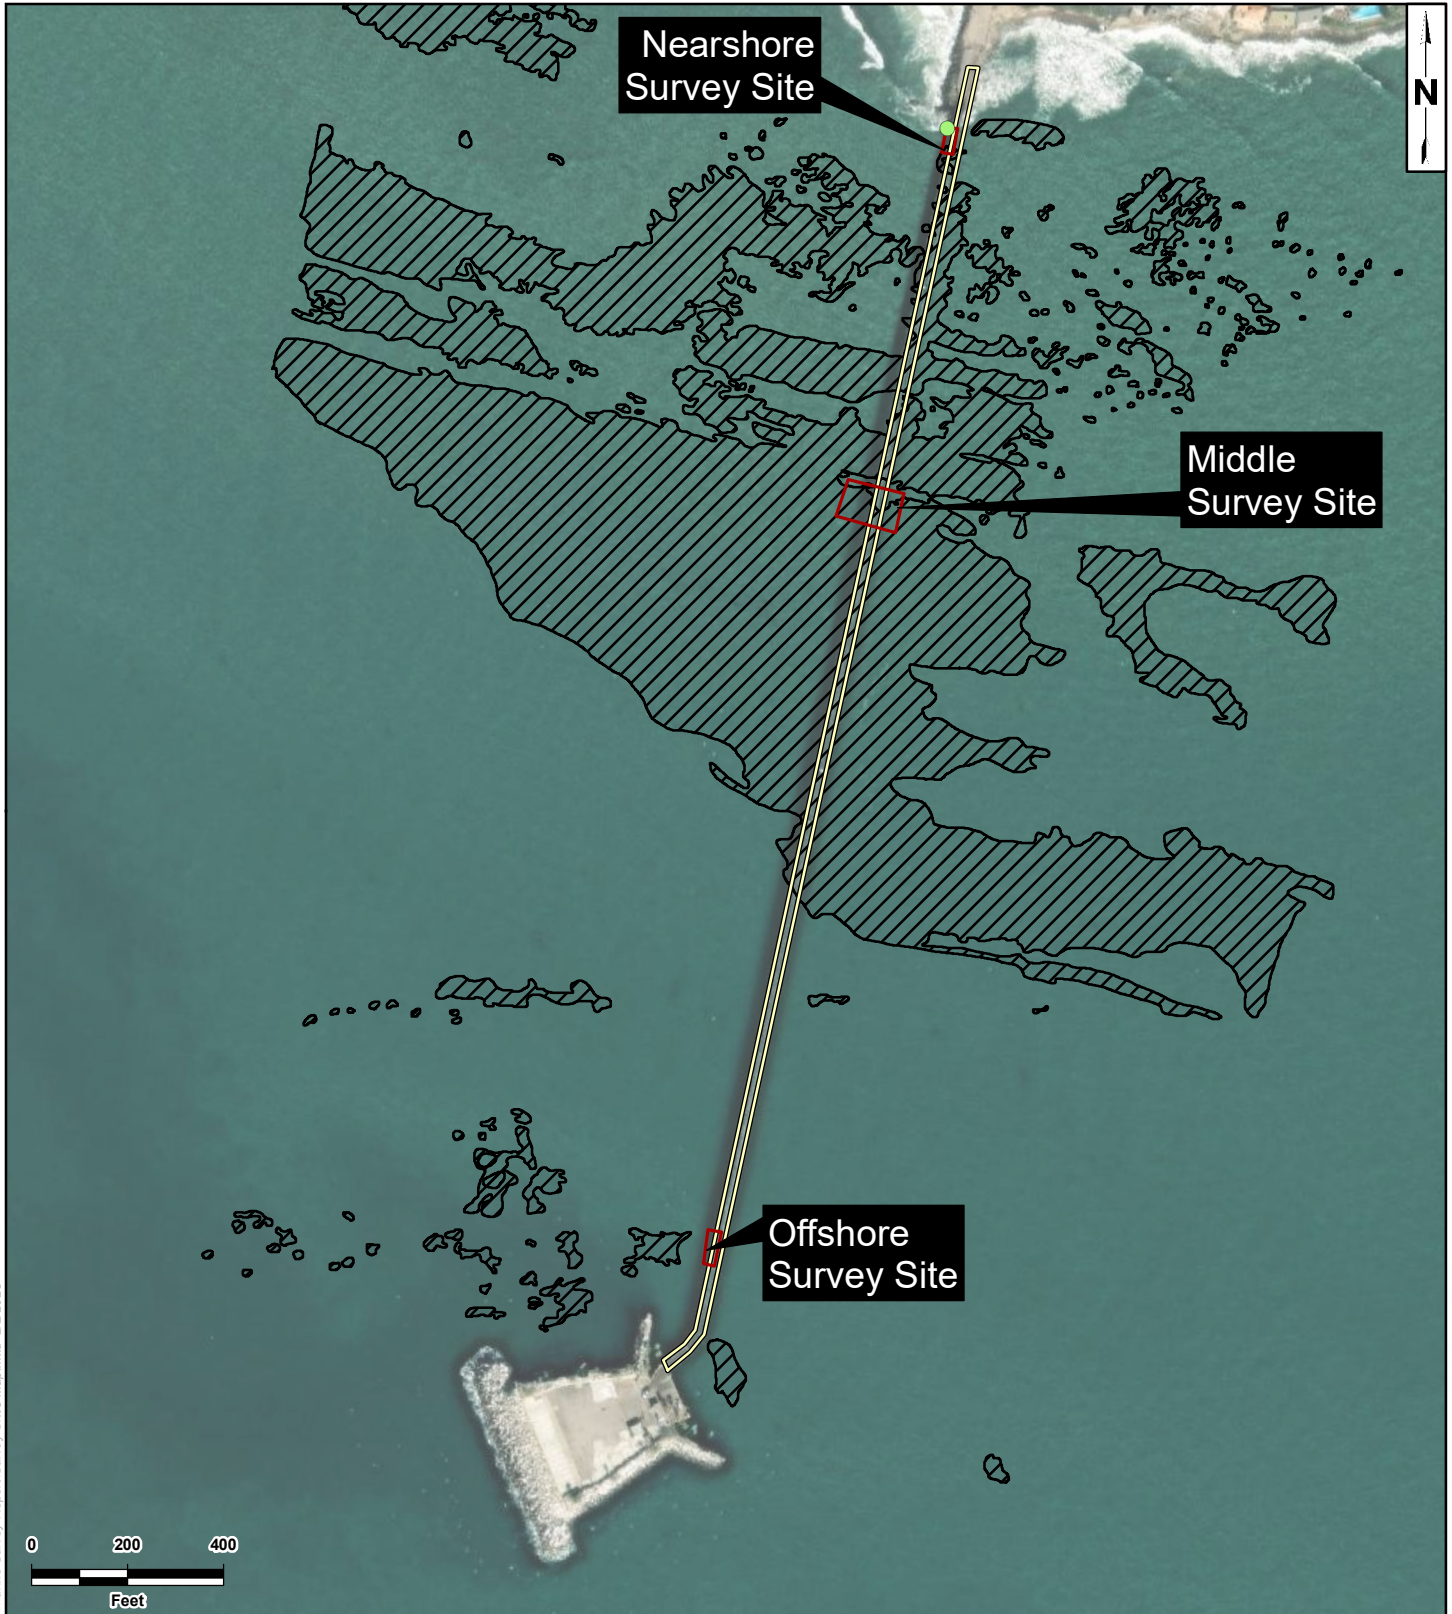
FIGURE
3-1

SURVEY SITES MAP

Twelve pilings in total were surveyed: four offshore pilings closest to Rincon Island (Offshore Survey Site), four pilings approximately halfway along the causeway and intersecting with known areas of rocky seafloor (Middle Survey Site), and four nearshore pilings in the surf zone (Nearshore Survey Site). At the Middle Survey Site, the divers swam approximately 50 feet on either side of the causeway to document habitat and species composition within the natural rock outcropping area. Divers swam along paths of opportunity using flashlights to inspect crevices and ensure 100 percent coverage of the Study Area

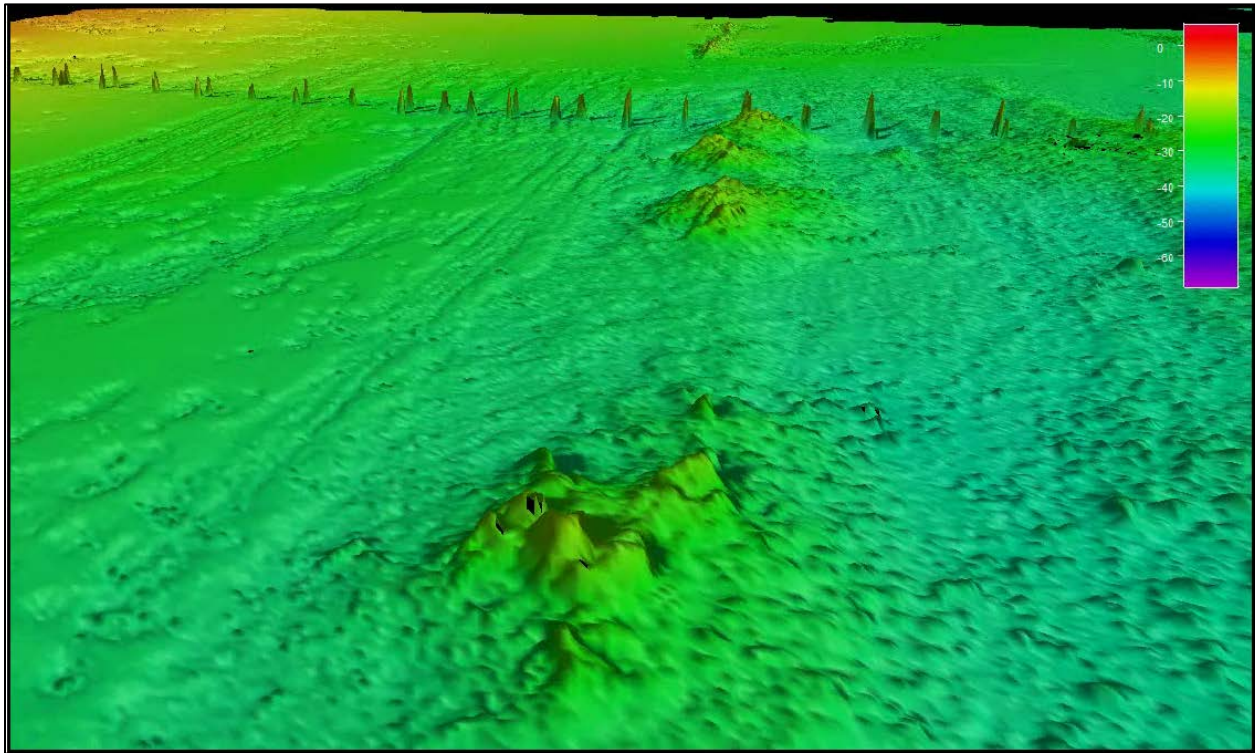
To survey the rocky outcropping in the Middle Survey Site, divers swam on approximately 50 feet of either side of the causeway to characterize the rocky habitats at the Middle Survey Site. Figure 4-1 illustrates the extent of the rocky outcropping that extends west of the survey site.

Figure 4-1. Bathymetry at Middle Survey Site with Surrounding Rock and Boulder Fields West of Rincon Island Causeway (Etrac, 2021)

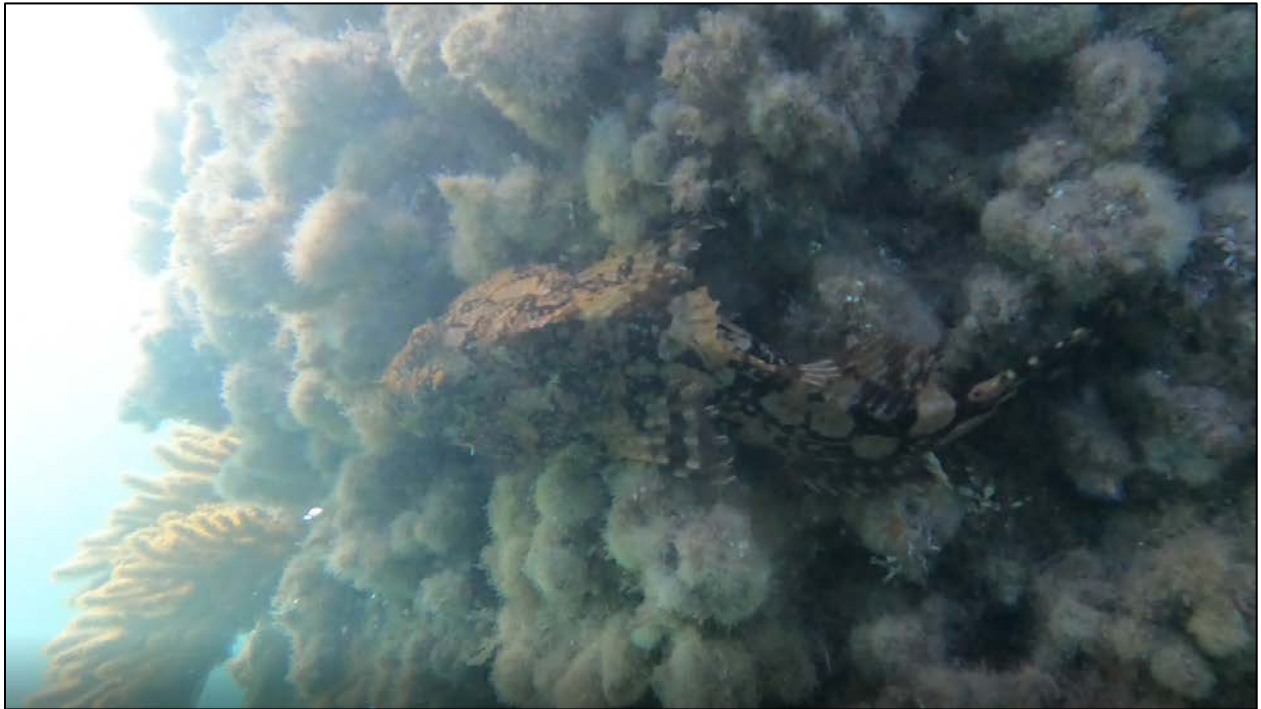
Photo 1: Cabezon (*Scorpaenichthys marmoratus*) resting on a piling within the Offshore Survey Site.

Fish observed in the Offshore Survey Site included kelp bass (*Paralabrax clathratus*) swimming near the piling, barred sand bass (*Paralabrax nebulifer*) near the seafloor, and topsmelt silverside (*Atherinops affinis*) and sargo (*Diplodus sargus*) throughout the water column. In addition, cabezon (*Scorpaenichthys marmoratus*) were observed using dense bryozoans on the piling for refuge.

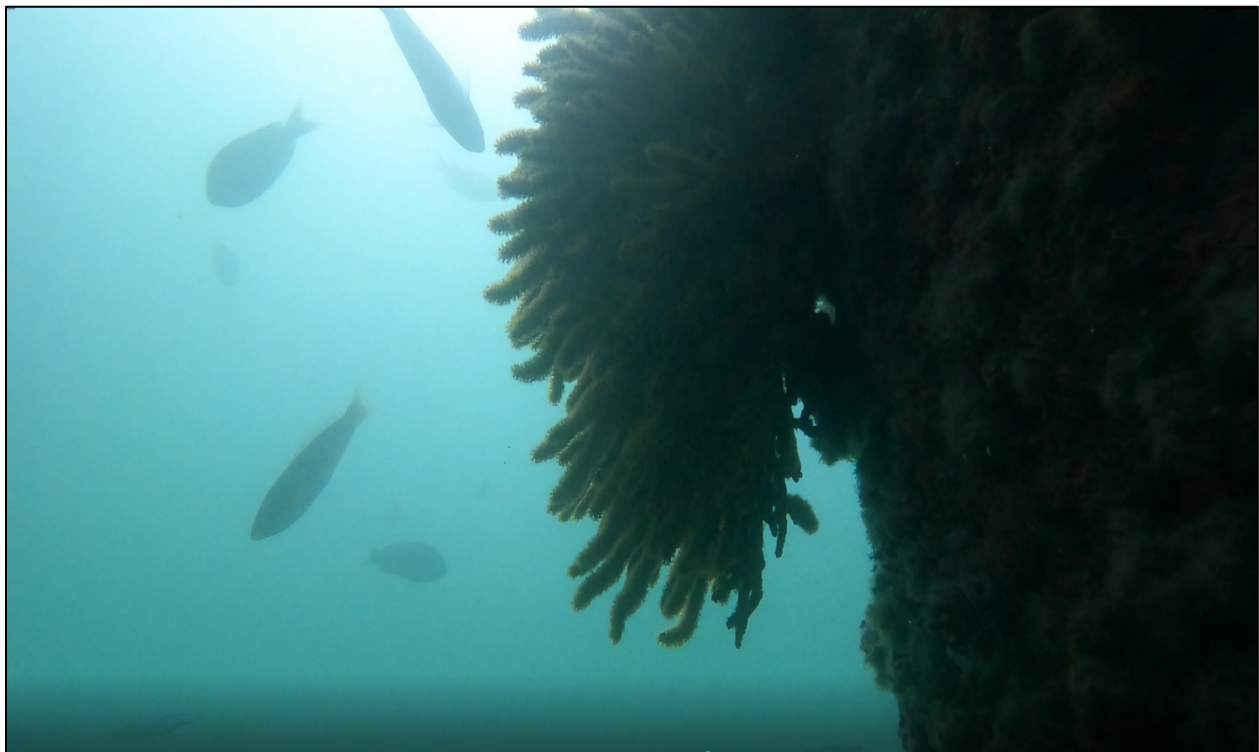
Photo 2: Golden gorgonian (*Muricea californica*) as epifauna on a piling within the Offshore Survey Site.

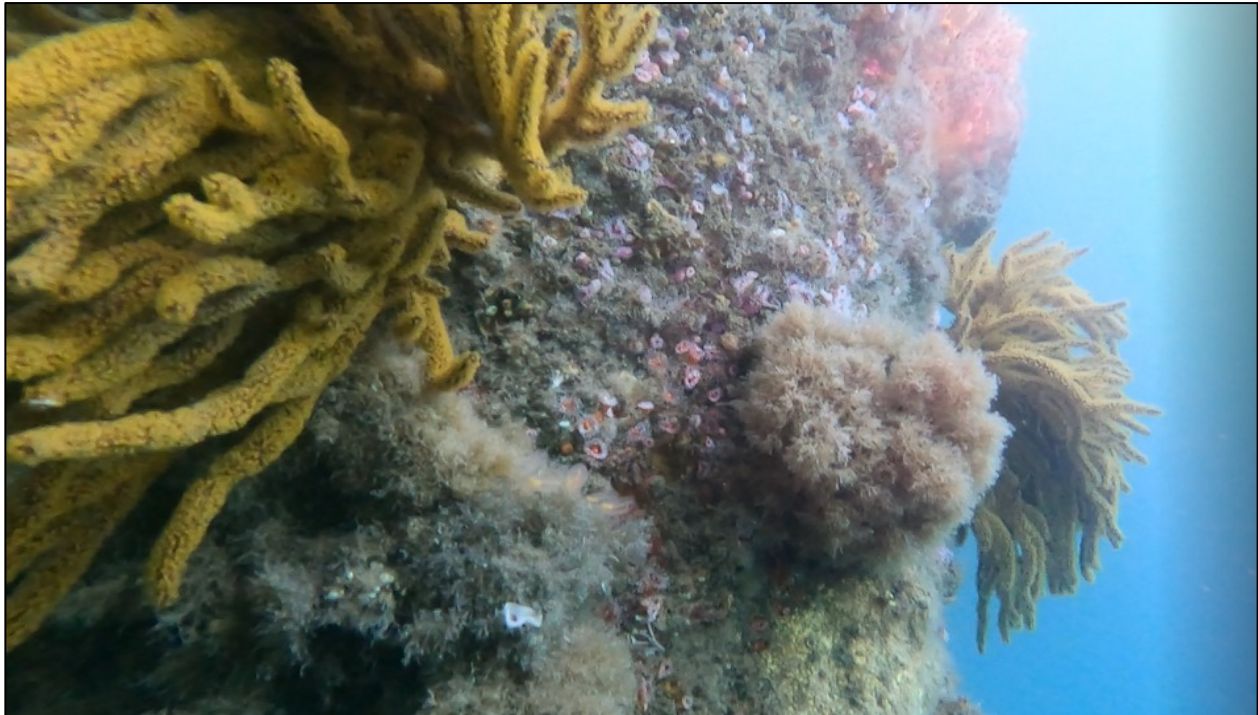
Photo 3. Golden gorgonians (*Muricea californica*), strawberry anemone (*Corynactis californica*), and brown bryozoan (*Bugula* sp.) on a piling within the Middle Survey Site.

Four pilings were surveyed within the Middle Survey Site in a maximum water depth of 29 feet. In general, epifauna communities were similar among each piling surveyed within the Middle Survey Site. The seafloor immediately surrounding the pilings consisted of sand with scattered shell debris and small to medium sized cobble within the larger rocky outcropping (see Section 4.2.1). Epifauna and algae species that characterized the piling community near the seafloor, within the 29-foot depth range, included brown and golden gorgonians, sessile anemone, warty cucumber, and bat stars (*Patiria miniate*). As depth decreased, there was a noticeable increase of species like red-rust bryozoan, gooseneck, acorn and California barnacles, and California mussels. Within these mussel and barnacle beds, two, giant spined sea stars (*Pisaster giganteus*) were observed on two separate pilings, both measuring approximately 1 foot in diameter. Fish observed within the Middle Survey Site were primarily associated with rocky outcropping and are discussed below.

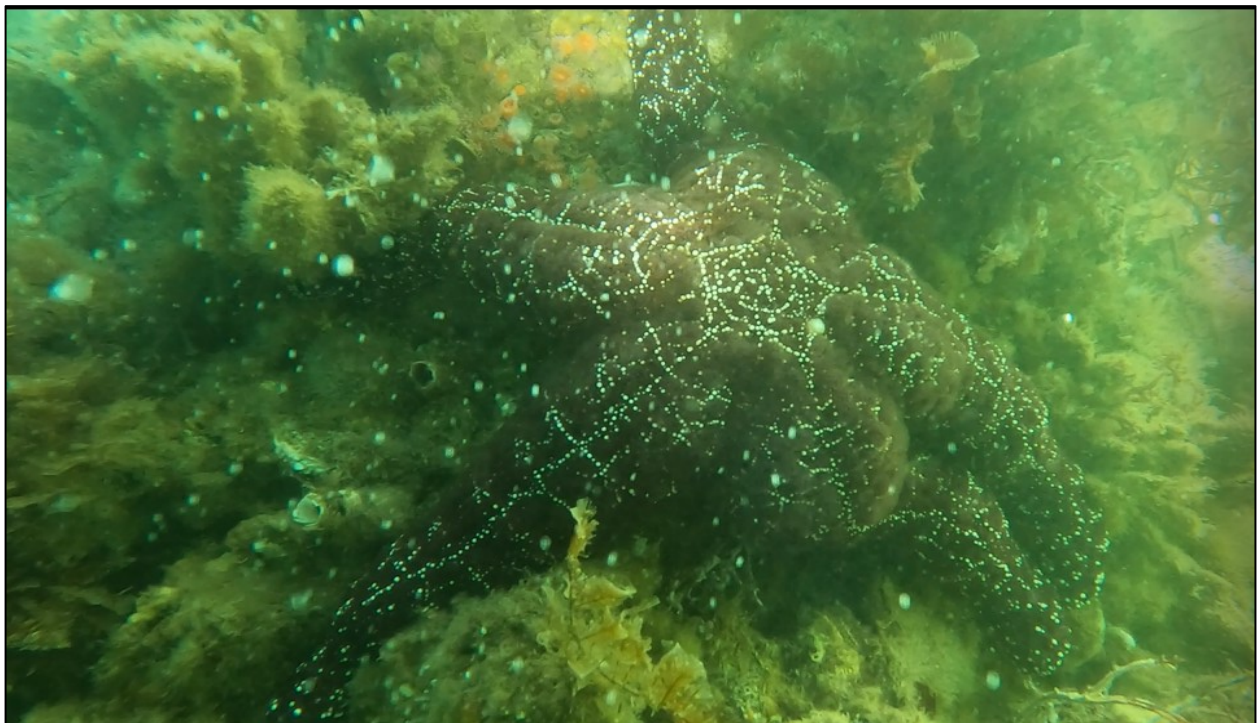
Photo 4. Ochre sea star (*Pisaster ochraceus*) feeding on piling epifauna within the Middle Survey Site.

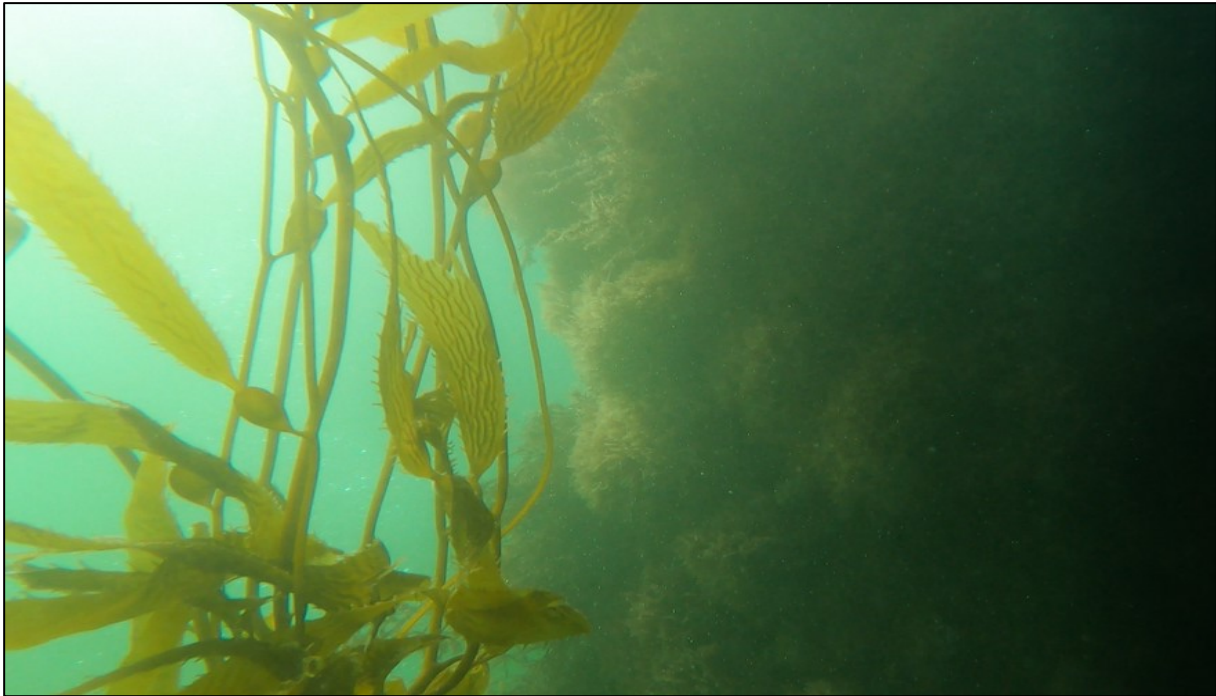
Photo 5. Giant kelp (*Macrocystis pyrifera*) immediately adjacent a piling within the Middle Survey Site.

Giant kelp was sparse throughout the middle survey site but was primarily attached to rocky substrate and not directly attached to with the causeway pilings. Two individual kelp plants (holdfasts) were counted within the survey area, in addition to several small kelp recruits that were attached to the natural bedrock. Various types of red and brown algae (Genus *Undaria* and classes Phaeophyceae and Florideophyceae, respectively) were also observed throughout the rock outcropping.

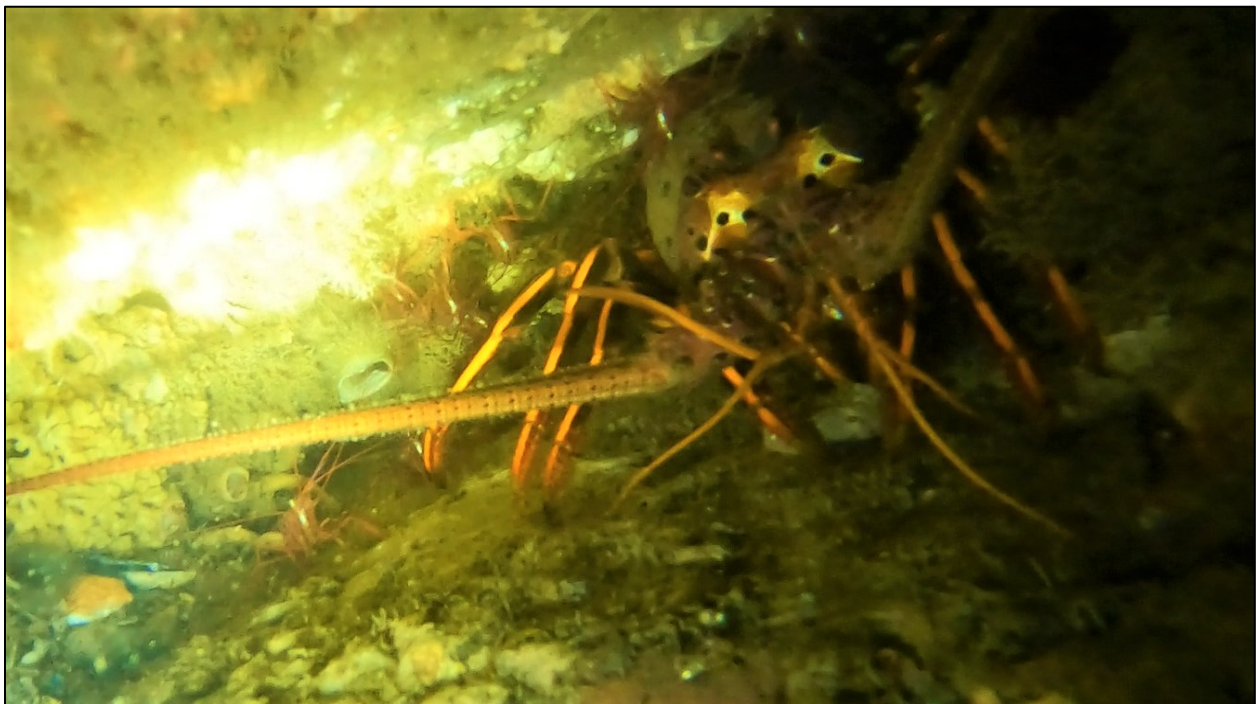
Photo 6. California spiny lobster (*Panulirus interruptus*) with multiple juveniles in a crevice within the rocky outcropping in the Middle Survey Site.

Macroinvertebrates within the rocky outcropping consisted of dense patches of bryozoans (*Watersipora* sp. and *Bulgaria* sp.), stalked tunicates, stripped sea slug (*Navanax inermis*), sponges, golden and brown gorgonians, purple gorgonians (*Egorgia rubens*), limpits (*Lottia* sp.), giant keyhole limpet (*Megathura crenulate*), bat stars, kellet's whelk (*Kelletia kelletii*), ochre sea stars, rock scallops, giant spined sea stars, warty sea cucumbers, chitons (*polyplacophora* spp.) and Spanish shawl nudibranchs (*Flabellina iodine*). An occasional solitary anemone and purple sea urchin (*Strongylocentrotus purpuratus*) were observed underneath and between bedrock. Extensive mussel beds were present at a depth of approximately 26 feet. In addition, numerous California spiny lobster (*Panulirus interruptus*), and a horn shark (*Heterodontus francisci*) were observed within high relief (3 to 5 feet) rock crevices.

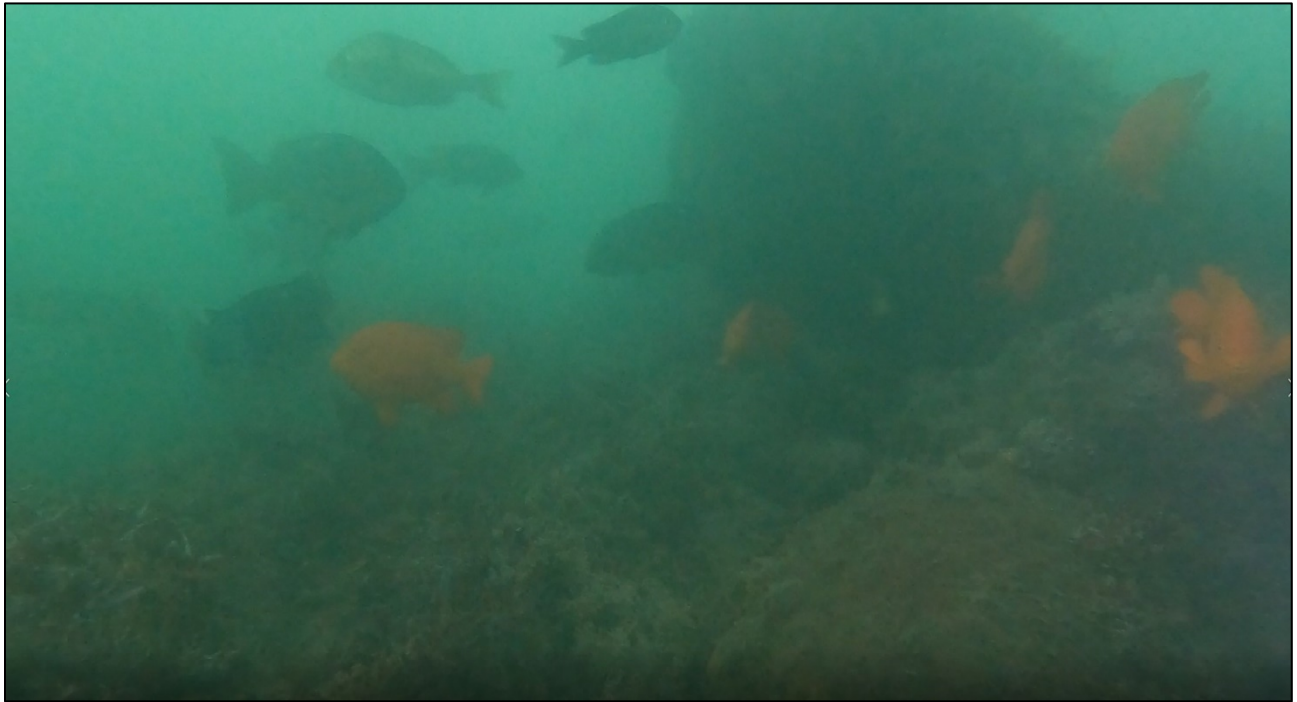
Photo 7. Garibaldi (*Hypsypops rubicundus*), sargo (*Diplodus sargus*) and opaleye (*Girella nigricans*) within the rocky outcropping in the Middle Survey Site.

Although various fish species were observed throughout the Study Area, the water column above the rock outcropping yielded the highest diversity and abundance of fish species. Observed species within this site included black rockfish (*Sebastes mealops*), kelp rockfish (*Sebastes atrovirens*), cabezon, kelp bass, barred sand bass, topsmelt silverside, painted greenling (*Oxylebius pictus*), kelp greenling (*Hexagrammos decagrammus*), sheephead (*Semicossyphus pulcher*), garibaldi (*Hypsypops rubicundus*), blacksmith (*Chromis punctipinnis*), opaleye (*Girella nigricans*), and sargo.

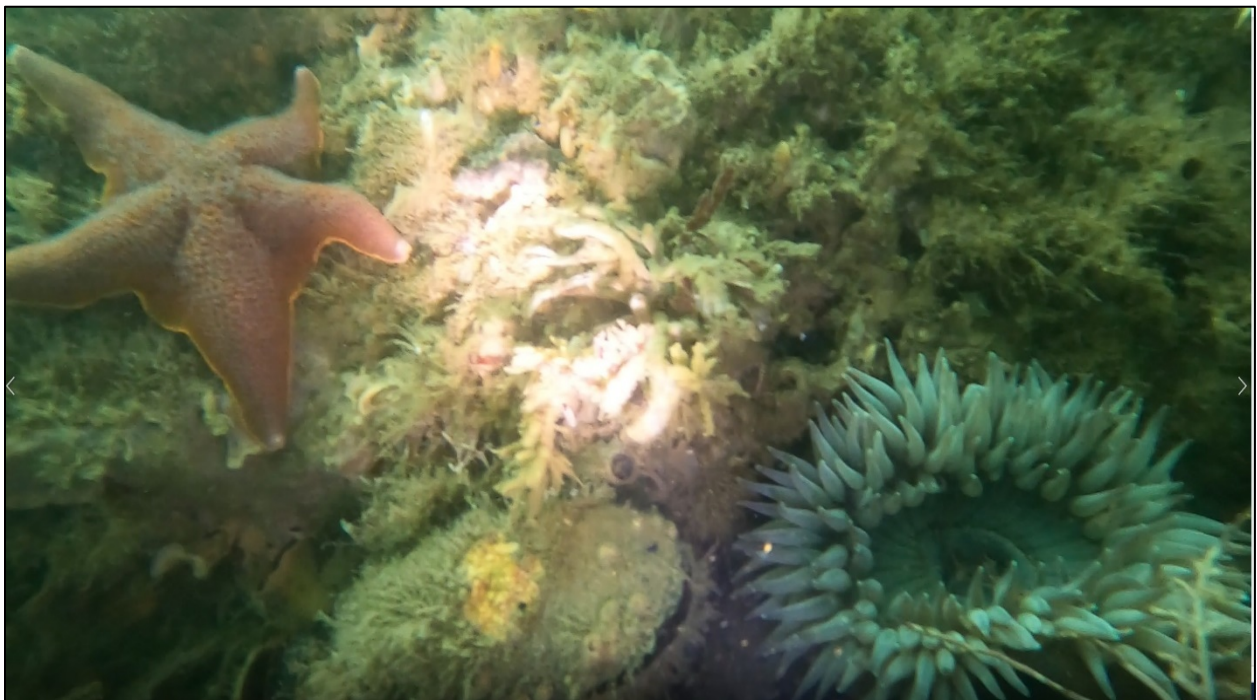
Photo 8. Bat star (*Patiria miniate*), rock scallop (*Crassodoma gigantea*) and solitary anemone (*Anthopleura sola*) within the rocky outcropping in the Middle Survey Site.

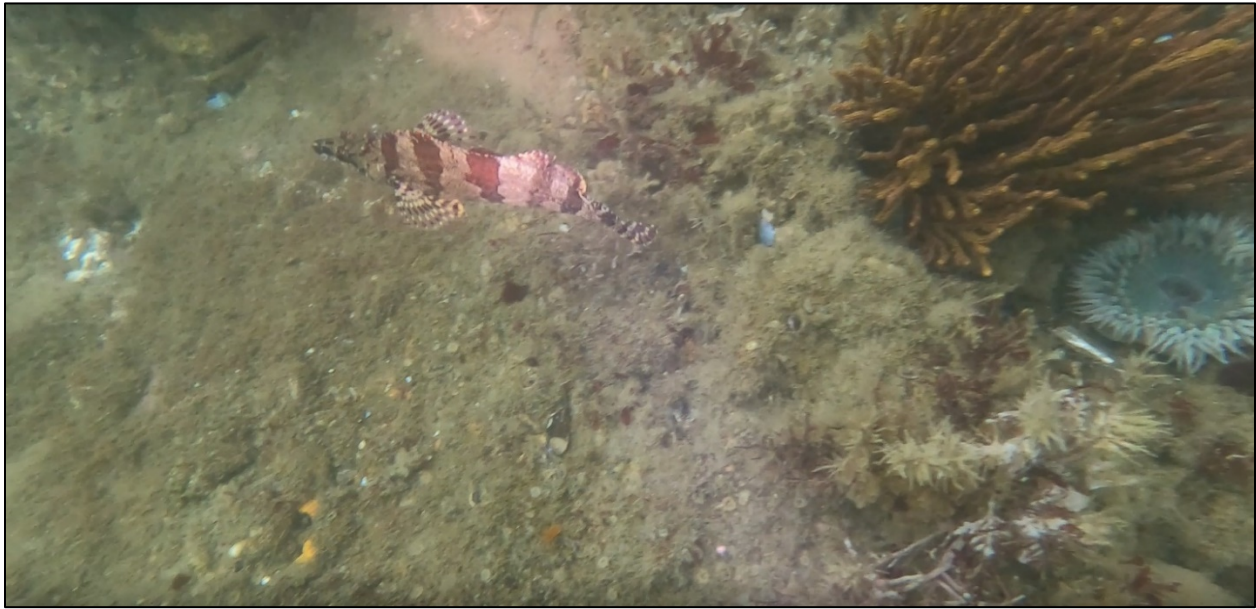
Photo 9. Painted greenling (*Oxylebius pictus*) within the rocky outcropping in the Middle Survey Site.

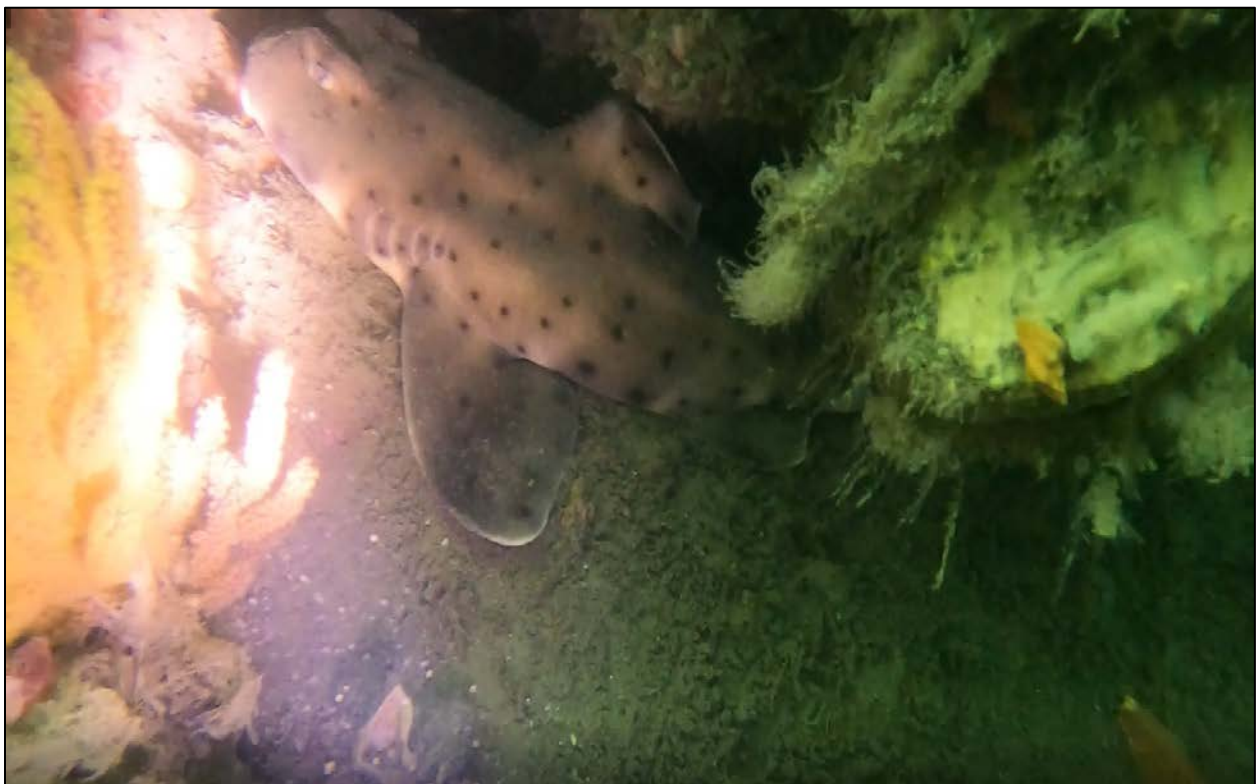
Photo 10. Horn shark (*Heterodontus francisci*) resting in a crevice within the rocky outcropping in the Middle Survey Site.

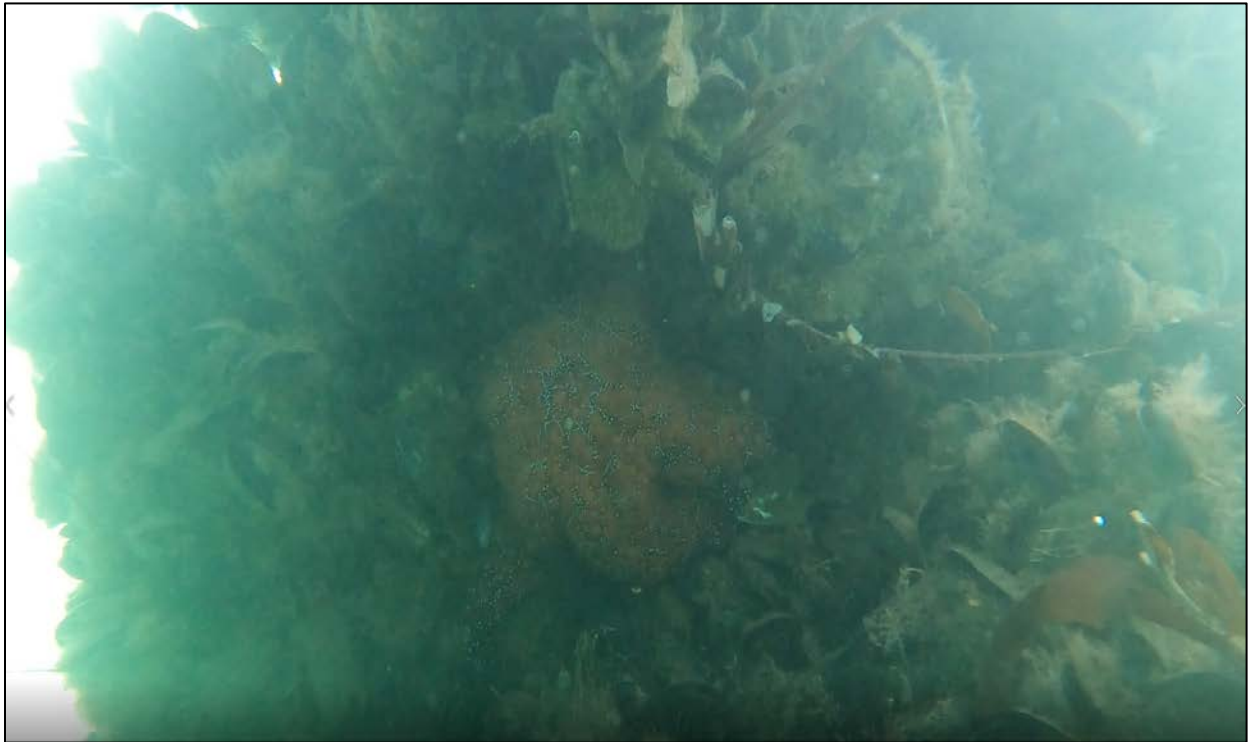
Photo 11. Ochre sea star (*Pisaster ochraceus*) feeding on piling epifauna within the Nearshore Survey Site.

Four pilings were surveyed within the Nearshore Survey Site with a maximum survey depth of 15 feet. The seafloor immediately surrounding the nearshore pilings included 1 to 2-inch sand waves with 1 to 2-foot circular depressions surrounding the base of each piling, presumably resulting from dynamic ocean conditions and currents of the surf zone at the Nearshore Survey Site. Clusters of long metal and wooden debris were also present and were colonized by sessile invertebrates (bryozoans and tunicates) and low growing red and brown algae. Calm seas allowed divers to survey into water depths of approximately 5 feet. Due to the shallow and inshore nature of the pilings, species composition remained relatively uniform throughout the water column and was characterized primarily by red-rust bryozoan, brown bryozoan, gooseneck, acorn and California barnacles, California mussels, tube worms, stalked tunicates and sponges. Less abundant species included solitary anemones and two sea star species, ochre star and giant spined sea star, which were present on individual pilings. Kelp and other marine flora present within the Nearshore Survey Site included an approximately 1 square meter patch of surfgrass (*Phyllospadix torreyi*), feather boa kelp (*Egregia menziesii*), sea lettuce (*Ulva spp.*), Laminaria (*Laminaria sp.*) and Turkish towel (*Chondracanthus exasperates*). Fish species were sparse in the Nearshore Survey Site; however, topsmelt silversides were observed near the water's surface.

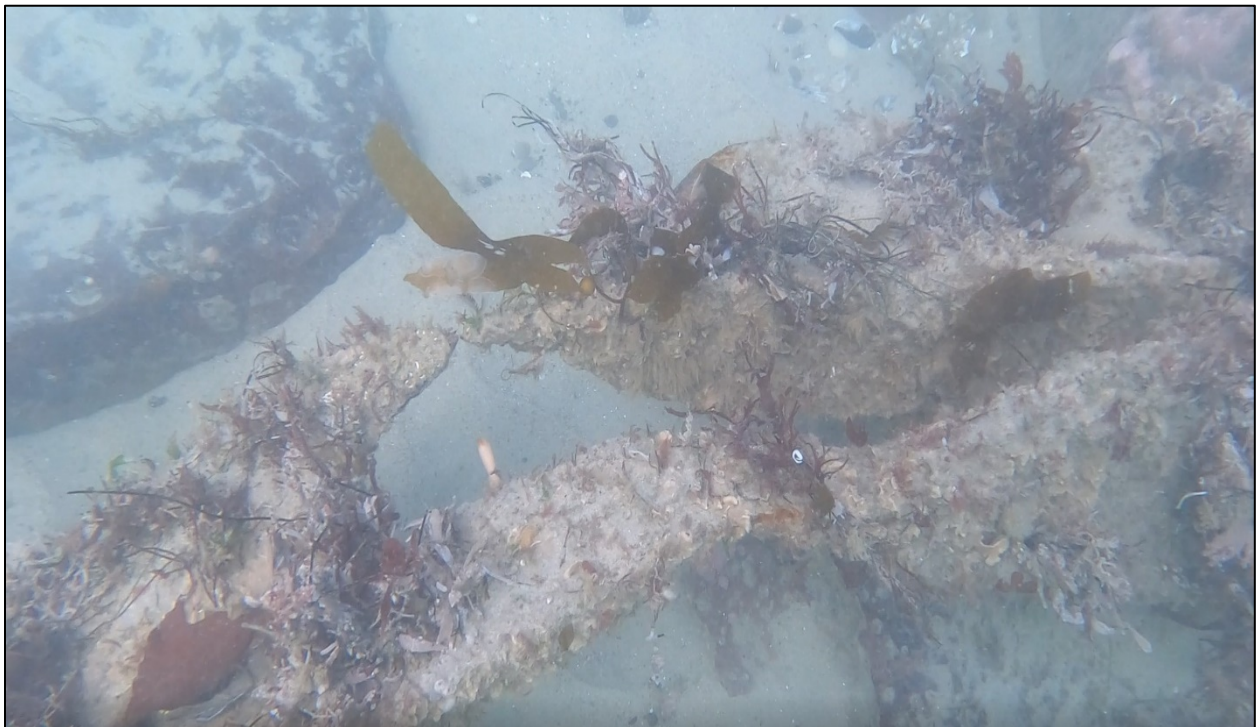
Photo 12. Giant kelp (*Macrocystis pyrifera*) recruit on metal debris within the Nearshore Survey Site.

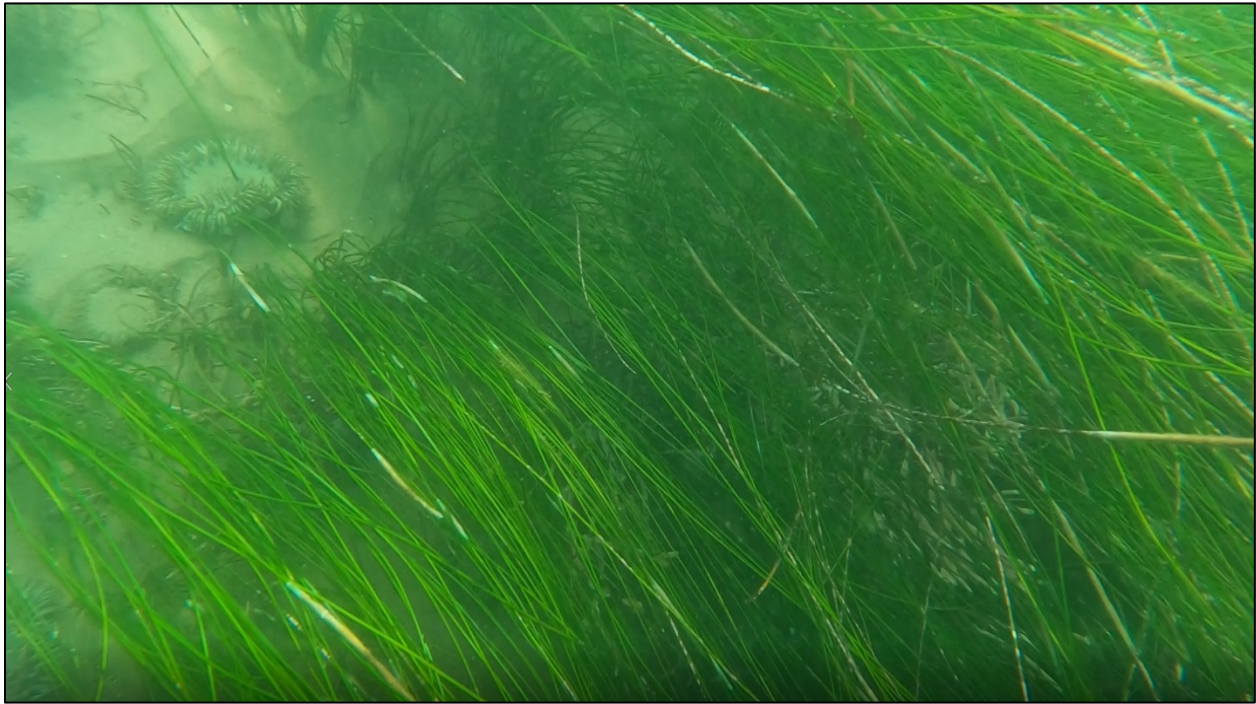
Photo 13. Anemones (*Anthopleura sola*) and surfgrass (*Phyllospadix torreyi*) within the Nearshore Survey Site.

Survey Site was less abundant due to its location within the surf zone where relatively few specialized species can live in the dynamic sand habitat. The Nearshore Survey Site supported a small area of surfgrass within the surf zone where the revetement meets the causeway; however, no eelgrass species were observed in the Nearshore Survey Site or anywhere else in the Study Area.
