# **RINCON ISLAND PHASE 2 DECOMMISSIONING PROJECT**

**ASSESSMENT OF POTENTIAL PROJECT IMPACTS ON THE SURFBREAK**

March 2023

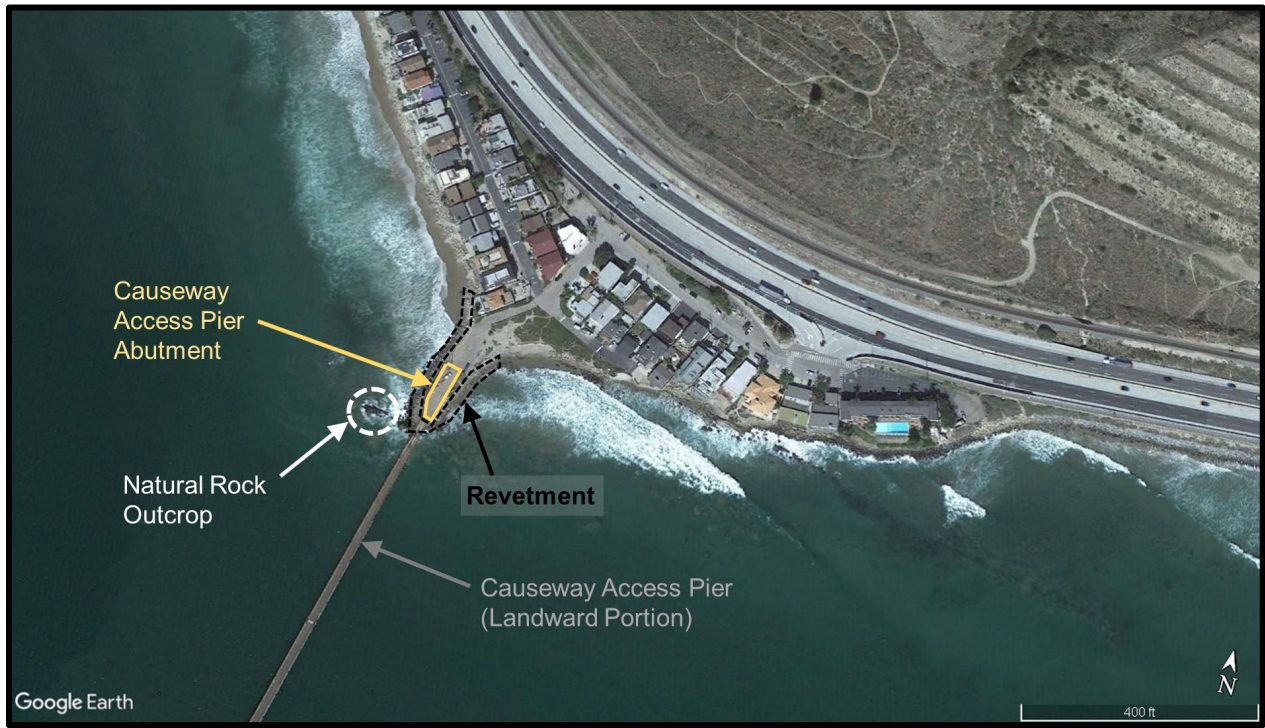
**Figure 1-2. Causeway Access Pier Abutment and Revetment**

Figure 1-2 provides a detailed view of the relevant landside features including the abutment and revetment. Figure 1-3 shows a profile view of the causeway. The term “causeway” typically refers to a structure supported mostly by earth or stone, which is not the case with the Rincon Island access structure. The access structure is better described as a “bridge” or “pier,” which are structures supported by pilings. Because a key focus of this investigation is the impact of this structure on waves and sediment movement, which are directly affected by the “hydraulic transparency” or “permeability” of the structure, this report will refer to the structure as the “causeway access pier.”

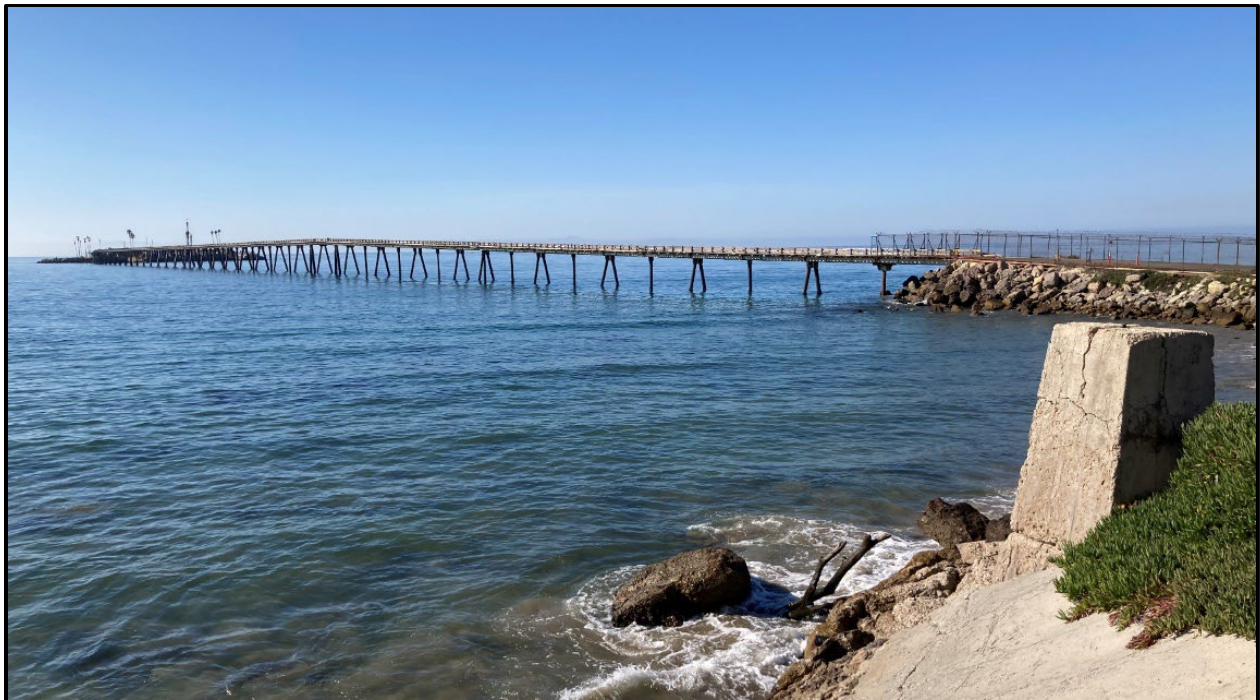
**Figure 1-3. Profile View of Causeway Access Pier**

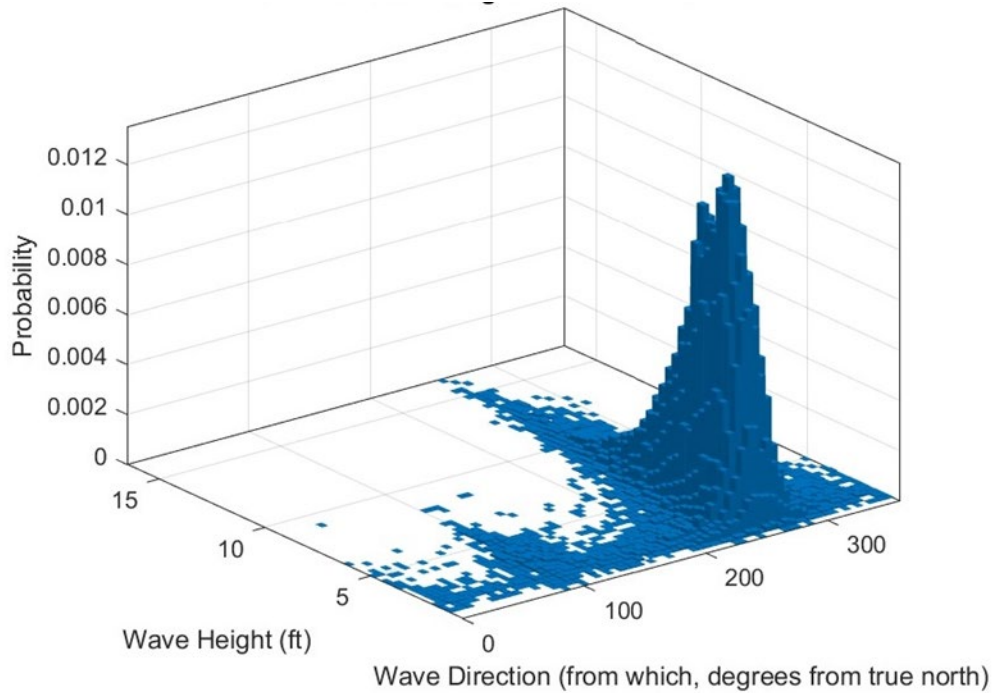
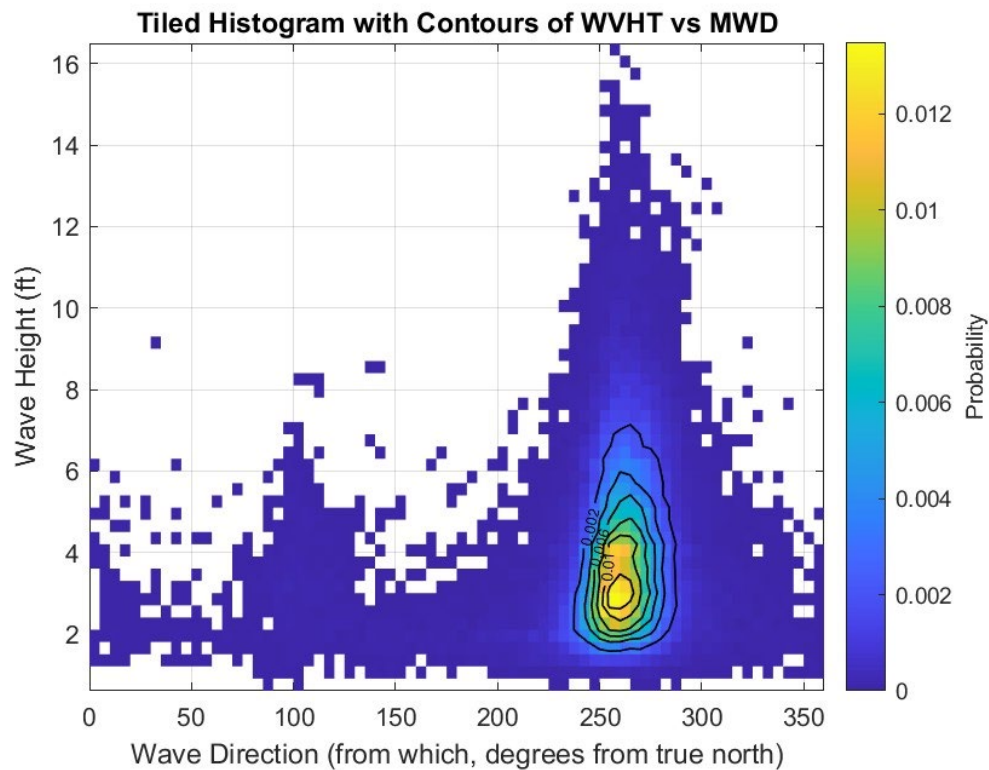
**Figure 2-2. Joint Histogram (A) and Probability Tile Plot (B) of Significant Wave Height and Mean Wave Direction from NDBC Wave Buoy #46053**

Analysis of the NDBC Buoy #46053 data provides valuable insight into the frequency of high-quality surf conditions at Little Rincon. Figure 2-2 presents both a three-dimensional and contour “heat map” plot of the probability of occurrence for the various combinations of wave height and direction. The plots show spectral significant wave height versus mean wave direction (in degrees as measured clockwise from true north). Both plots confirm that most waves that reach the buoy arrive through the window bound by 230° and 280° (*i.e.*, the “window” of wave approach between Point Conception and the Channel Islands as shown in Figure 2-1). A very minor portion approach from 85° to 120°, indicating that these waves were generated locally by offshore winds. Under such conditions, one would expect “flat” surf at Little Rincon, because the winds that likely generated these waves would be blowing from the land.

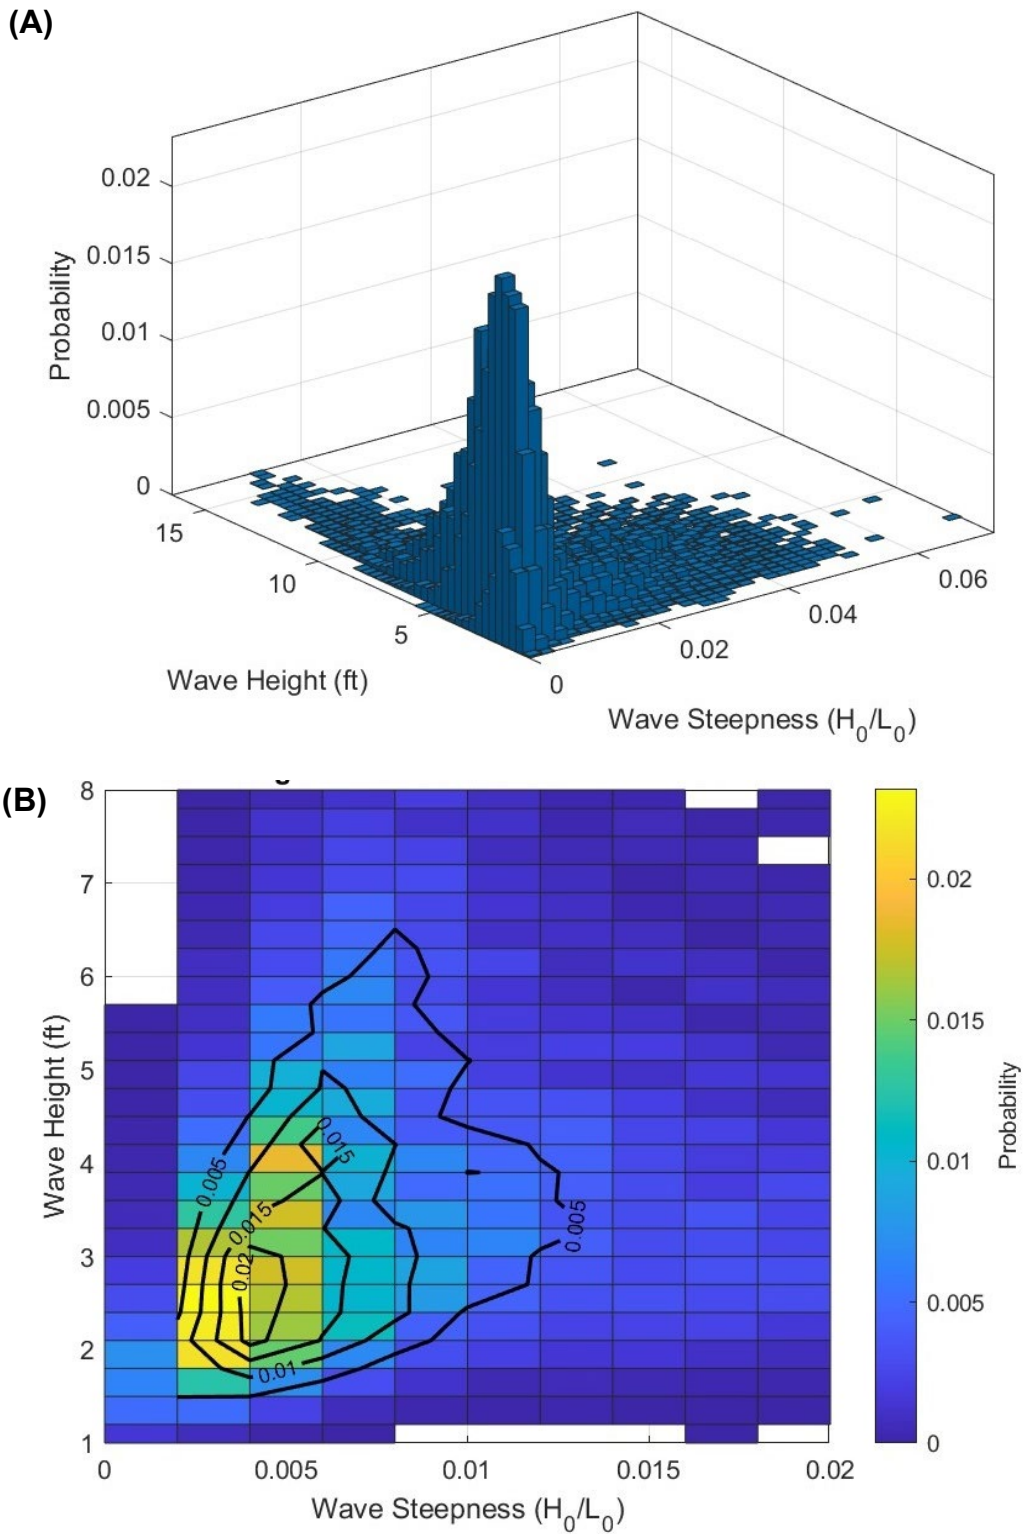
**Figure 2-3. Joint Histogram (A) and Probability Tile Plot (B) of Significant Wave Height and Wave Steepness from NDBC Wave Buoy #46053**

As the best surfing at the Project site is likely to result from large, long-period swell approaching from the west-southwest, Figure 2-3 presents two plots of the physical parameters that generally represent the quality of a surfing wave. These are wave height and wave steepness, where wave steepness is defined as  $H_{m0}/L_0$ <sup>1</sup>. Assuming that “good” surfing conditions can occur when the significant wave height is greater than or equal to 5 ft, and the wave steepness is less than or equal to 0.015, it was found that approximately 16% of the over 75,000 wave data measurements have the potential to produce “good” surfing conditions at Little Rincon (not accounting for local water level and wind conditions that can influence surf quality). “Epic” wave conditions were assumed to occur when the significant wave height was 12 ft or greater and the wave steepness was less than or equal to 0.015. Such “epic” events occurred only about 0.15% of the time (again, not accounting for local water level and wind conditions).

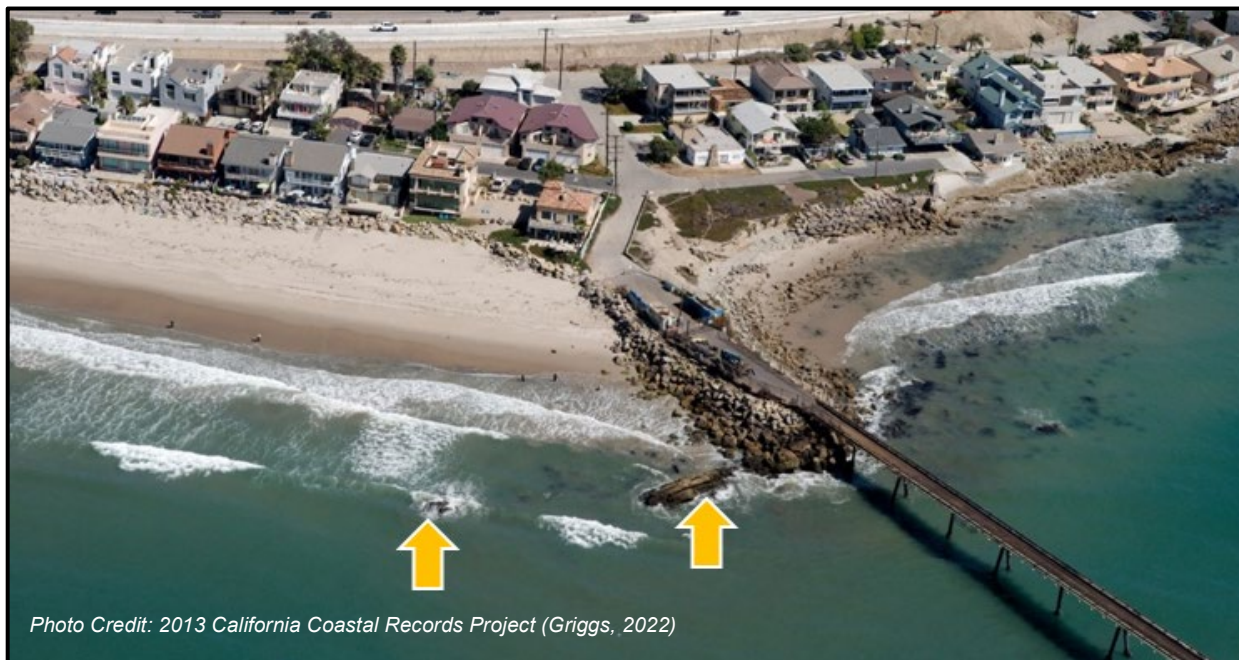
**Figure 2-5. Nearshore Bedrock Outcrops Forming Punta Gorda Adjacent to Updrift Side of Abutment**

The Project site is located in the middle of the 144-mile-long Santa Barbara Littoral Cell, which extends from the mouth of the Santa Maria River to the Mugu Submarine Canyon. The net littoral drift volume along the Punta Gorda shoreline is approximately 300,000 cy/yr toward the southeast (Griggs, 2022). Griggs discusses how littoral drift can be impounded by natural and/or man-made features to create beaches, and how these features can create high-quality surfbreaks by bending or refracting the waves as they approach the shoreline. Punta Gorda is identified as a major “salient,” or bulge in the shoreline, on an otherwise nearly linear shoreline that extends into the nearshore zone to such an extent that it traps sediment moving to the east to form a long beach on its north (updrift) side (Figure 2-4). Griggs (2022) indicates that the seaward protrusion of the shoreline at Punta Gorda exists in part because of the resistant bedrock that outcrops along the shoreline (Figure 2-5).

Task 2.3 of this study includes an assessment of the influence of the causeway access pier, abutment, and revetment on waves and littoral processes based on available studies and historical aerial photos. It is clear from the preceding discussion that the bedrock outcrop that provides the foundation for the abutment plays an important role in stabilizing the updrift sand beach. A key question is whether the abutment structure enhances the sediment-trapping function of this bedrock. As discussed in Griggs (2022), there was a pre-existing bedrock “point” at Punta Gorda prior to construction of Rincon Island in 1959. He found that the rock outcrop in the surf zone was visible in many of the pre-1959 island construction photographs, and clearly acted as a natural groin retaining sediment on its updrift side. Figure 2-6 shows a 1945 aerial photograph illustrating this phenomenon. Figure 2-7 shows the Pico Formation outcrop in November 1945, with the identical bedrock appearing in 2013 in Figure 2-5.

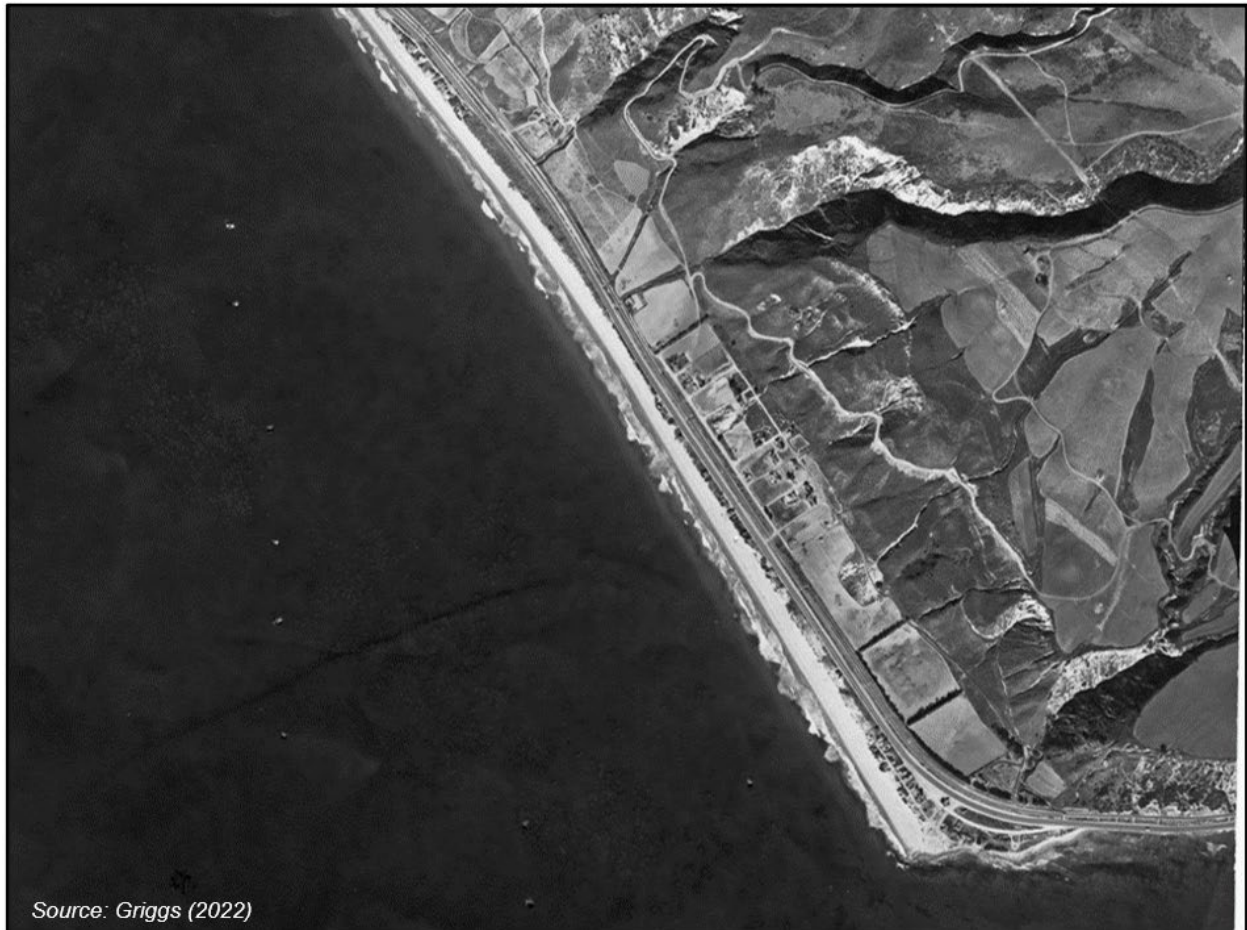
**Figure 2-6. Wide Sand Beach Retained Upcoast of Punta Gorda (October 1945)**

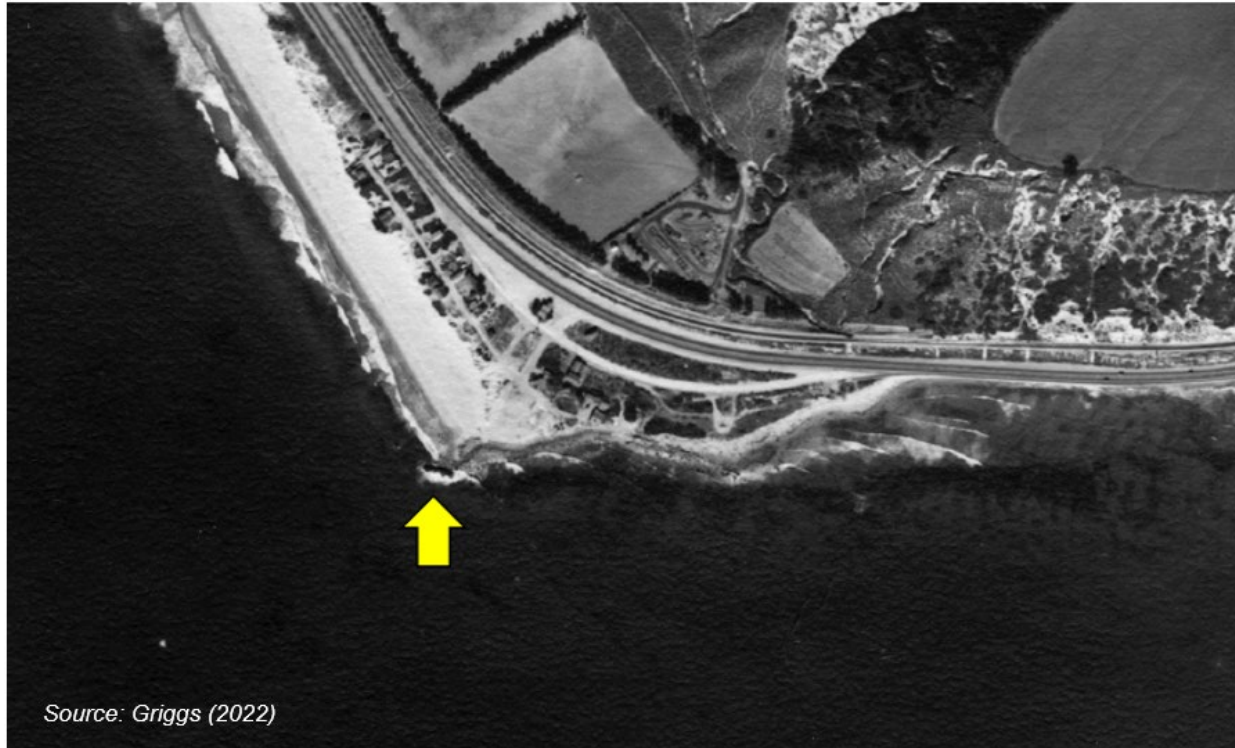
**Figure 2-7. Punta Gorda in November 1945 Showing Pico Formation Bedrock**

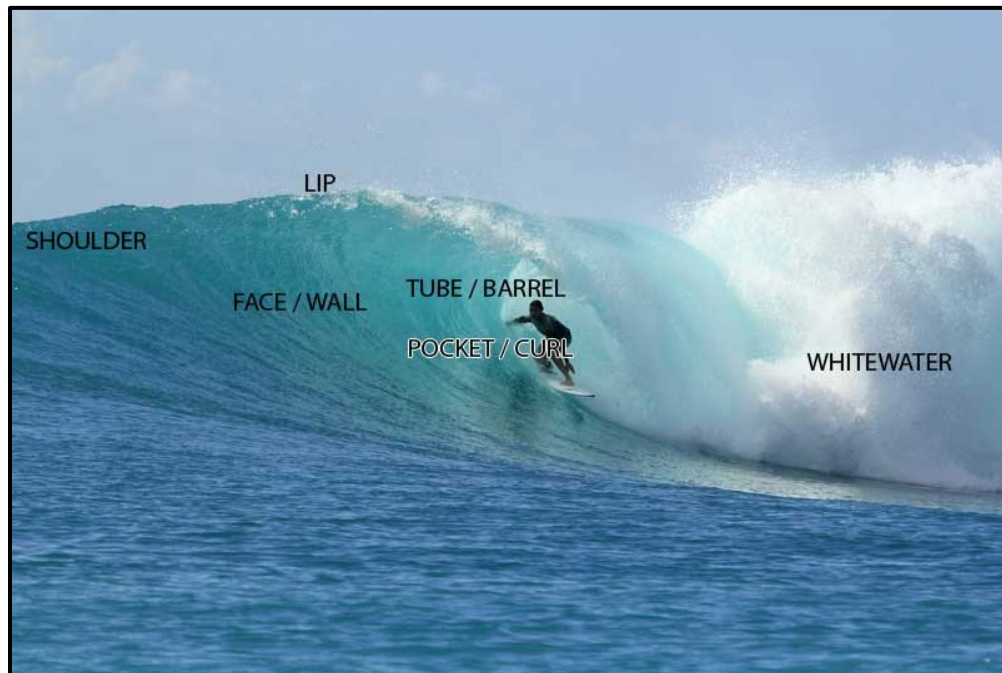
**Figure 3-5. Surfbreak Nomenclature for Plunging Breaker**

Figure 3-5 shows a surfer riding a plunging breaker along with the nomenclature associated with different sections of the wave. If the wave were of the spilling type but still surfable (discussed below), there would be no clearly defined *Lip* or *Tube/Barrel/Pocket/Curl*. Also, the *Face/Wall* would not be as steep as in the case shown.

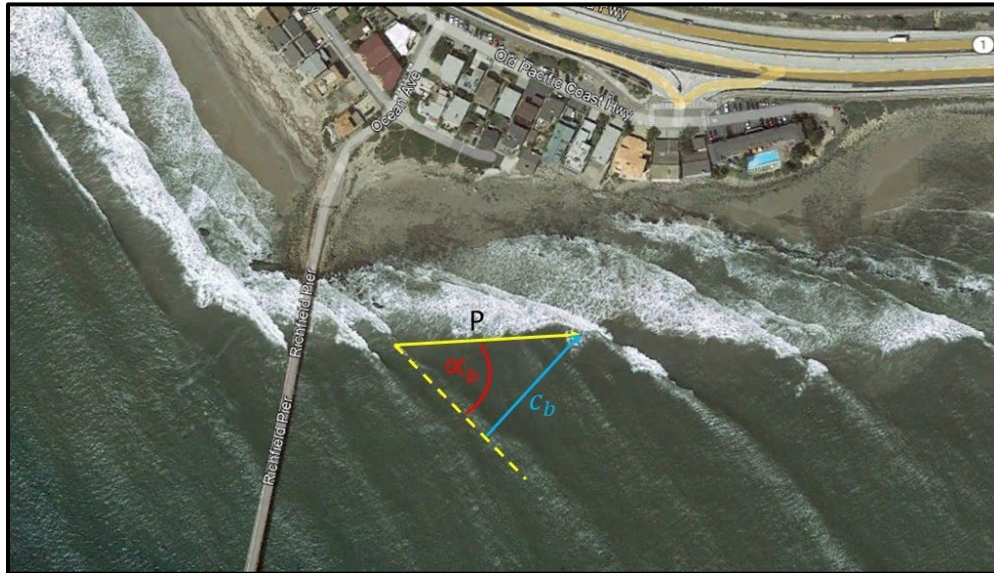
Figure 3-6. Definition Sketch of Peel Angle, Wave Celerity, and Peel Rate

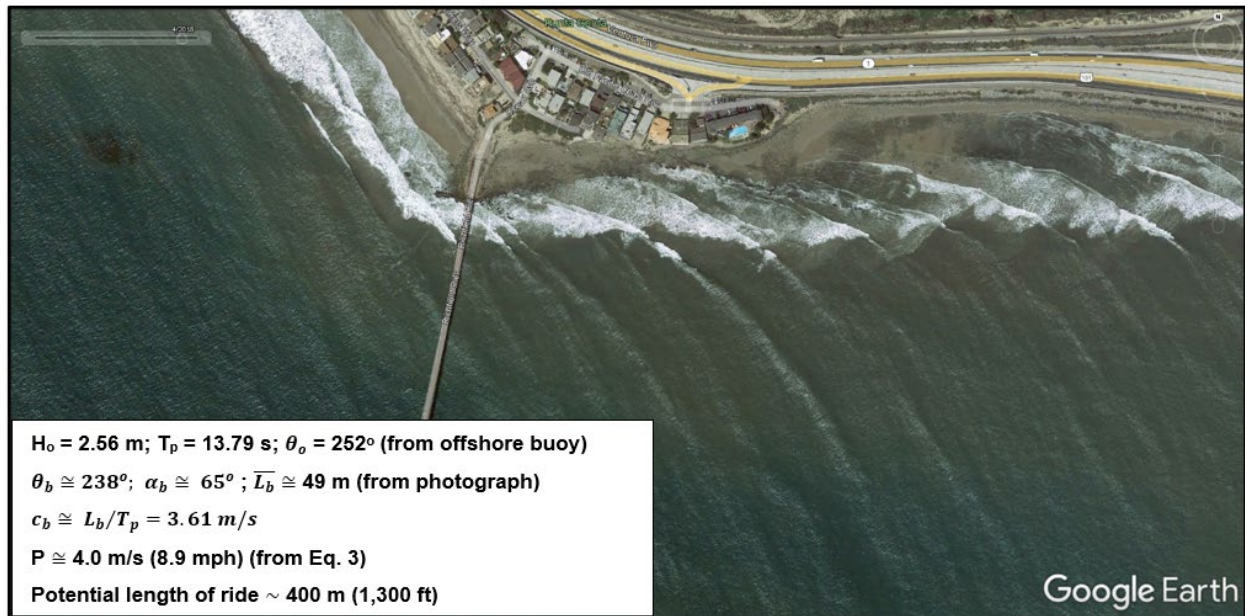
Figure 3-8. Little Rincon Surf Conditions on April 12, 2018

The favored wave conditions for surfing at Little Rincon occur when large, long-period swell approach from the west-southwest through west, resulting in a “right-handed” point break. Of the 27 aerial photographs available of the Little Rincon site on Google Earth® from 2009 to 2021, only three captured conditions that were favorable for surfing, with large peel angles and potentially long rides due to large wave heights. Figure 3-8, Figure 3-9, and Figure 3-10 present these photographs. Because the exact time each photo was taken is not available, the characteristic wave conditions during daylight hours on these dates, extracted from the record measured at NDBC 46053 as described in Section 2.1, are provided along with the wave lengths and peel angles estimated from each photograph. Figure 3-8 and Figure 3-10 appear to have been taken under “near-epic” conditions, with wave breaking starting under the pier off the tip of the abutment and continuing uninterrupted far into the embayment to the east. In Figure 3-9, it appears that breaking does not start until the wave has passed the abutment, providing only a short ride at this outer break. However, approximately 1,200 ft to the east an inner break appears that offers rides up to 1,000 ft long under smaller wave conditions.

associated with westerly waves. Under such conditions, wave refraction cannot turn the waves quickly enough to significantly affect their surfability, and consequently they do not close out. It is not until approximately 2,600-3,000 ft farther to the east, where the shoreline orientation rotates clockwise to the extent that the waves again become roughly shore-normal, that surfing conditions deteriorate. Consequently, the rides during epic conditions can be quite long.

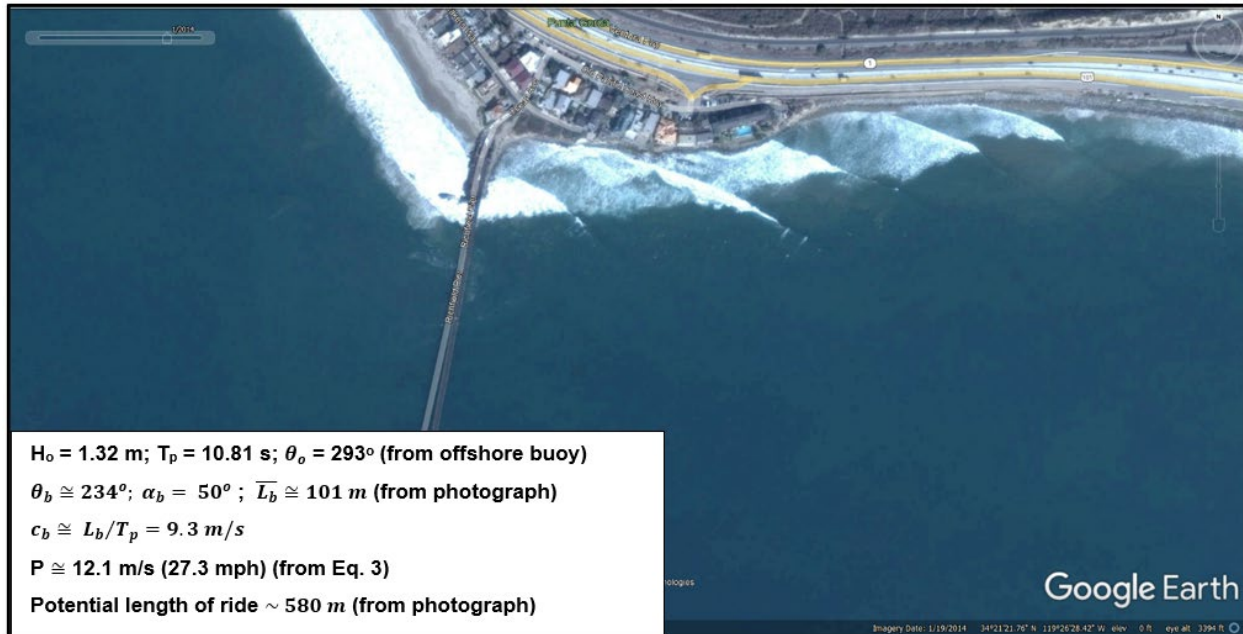
Figure 3-10. Little Rincon Surf Conditions on January 9, 2014

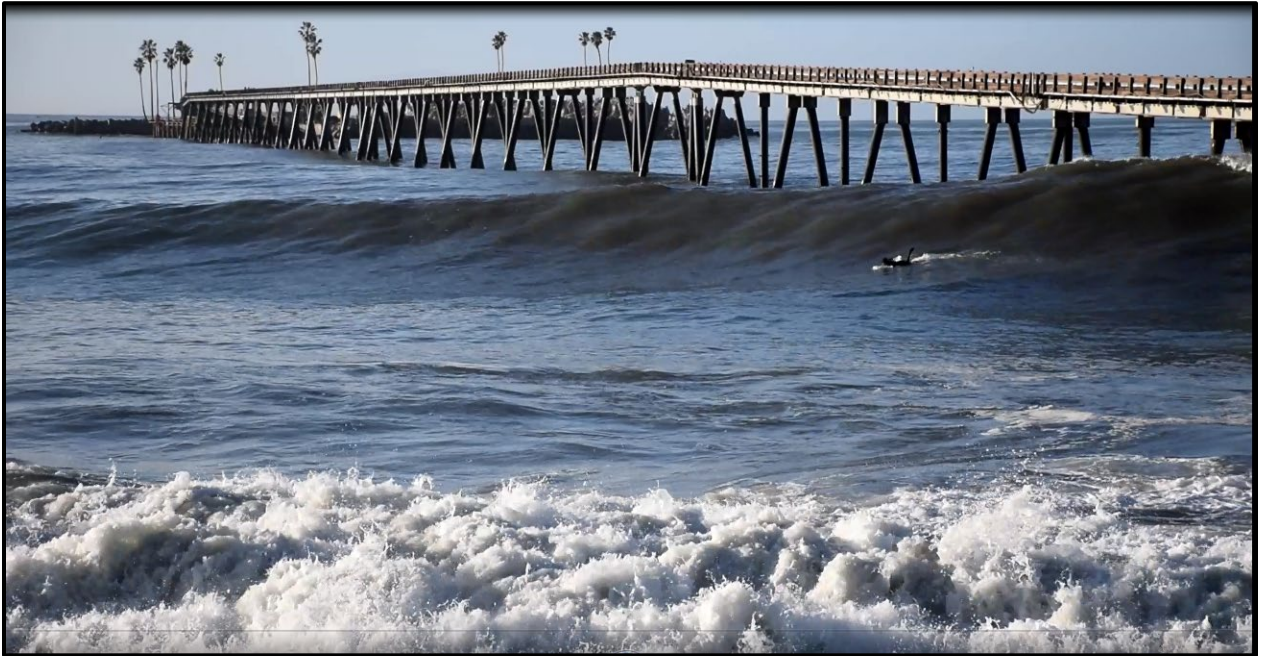
**Figure 3-12. View from Ground Camera #1 Showing Surfer Paddling to Catch a Wave**

To document the breaker type and estimate the breaker height as a surfer caught a particular wave, one land-based camera was positioned near the pier abutment, with its operator concentrating on the surfers' favored take-off location (Figure 3-12). The second camera was positioned on the shore approximately 500 ft (150 m) to the south for the purpose of tracking the surfer during his or her ride, with the intent of capturing footage that would allow estimation of the local wave height as the ride progressed (Figure 3-13).

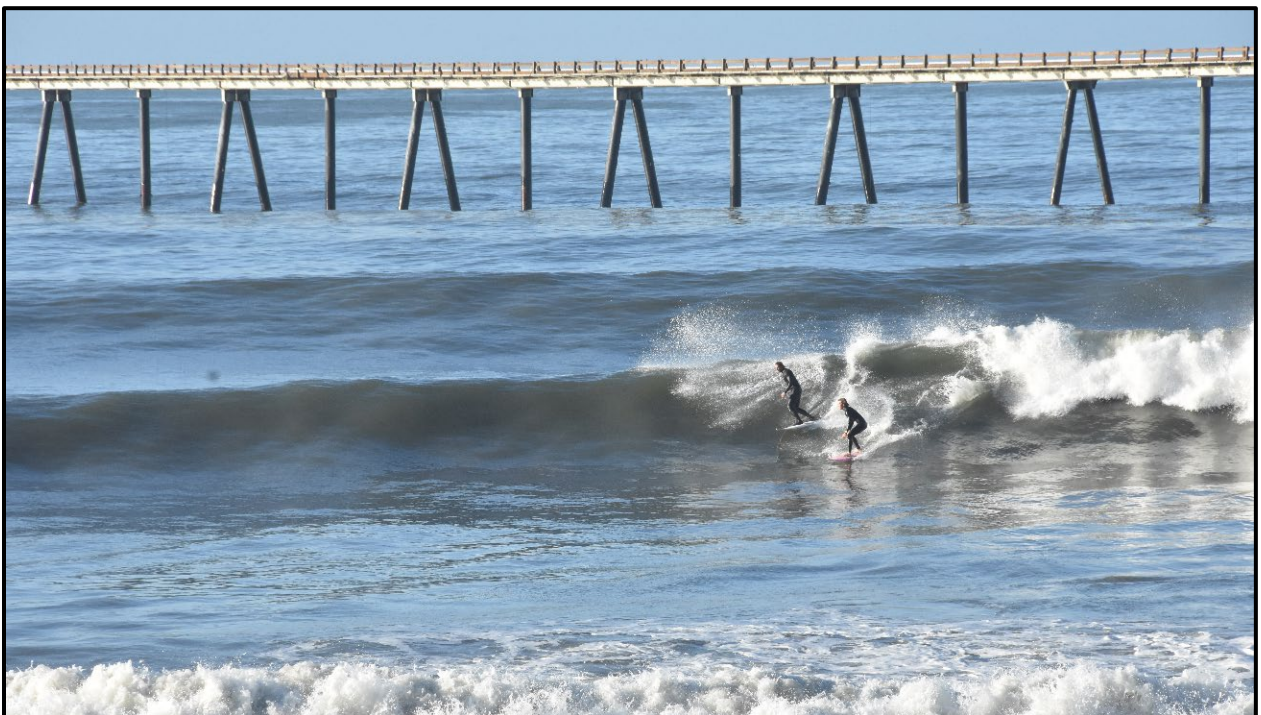
**Figure 3-13. View from Ground Camera #2 Showing Two Surfers Riding the Same Wave**

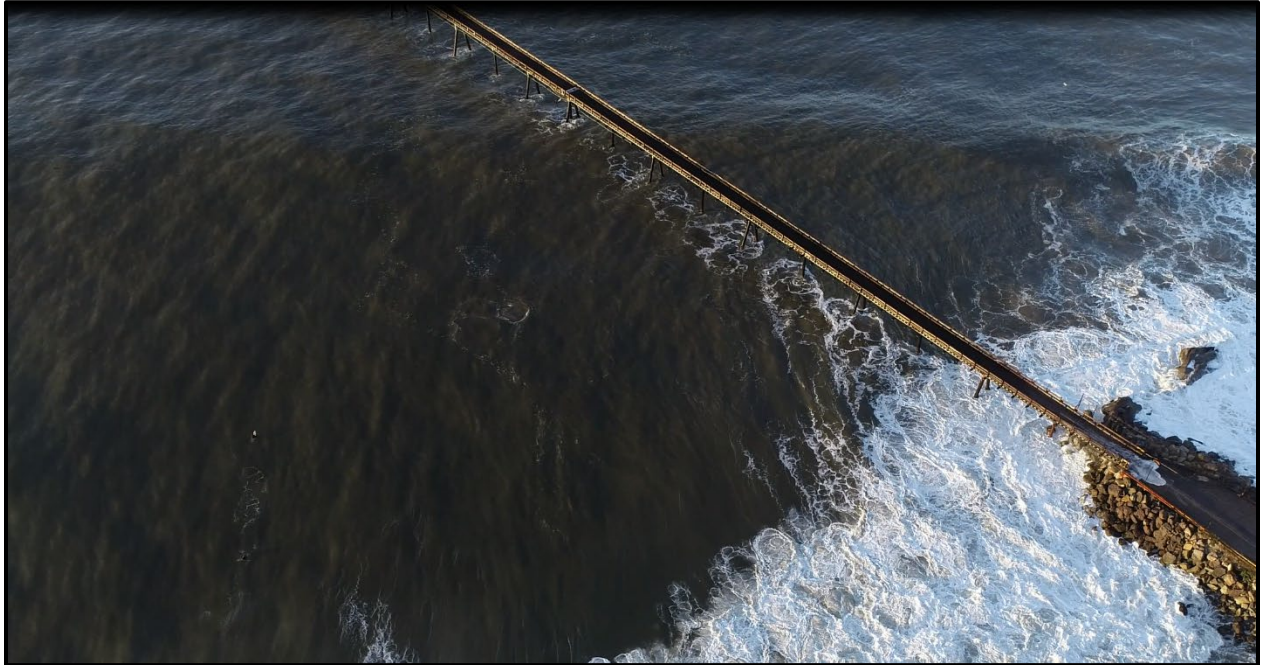
**Figure 3-14. Frame from UAV Video Showing Waves Passing through Pier**

The video footage obtained by the UAV also was analyzed to determine if the characteristics of the waves changed when they passed through the causeway access pier. As illustrated in Figure 3-14, no changes were evident.

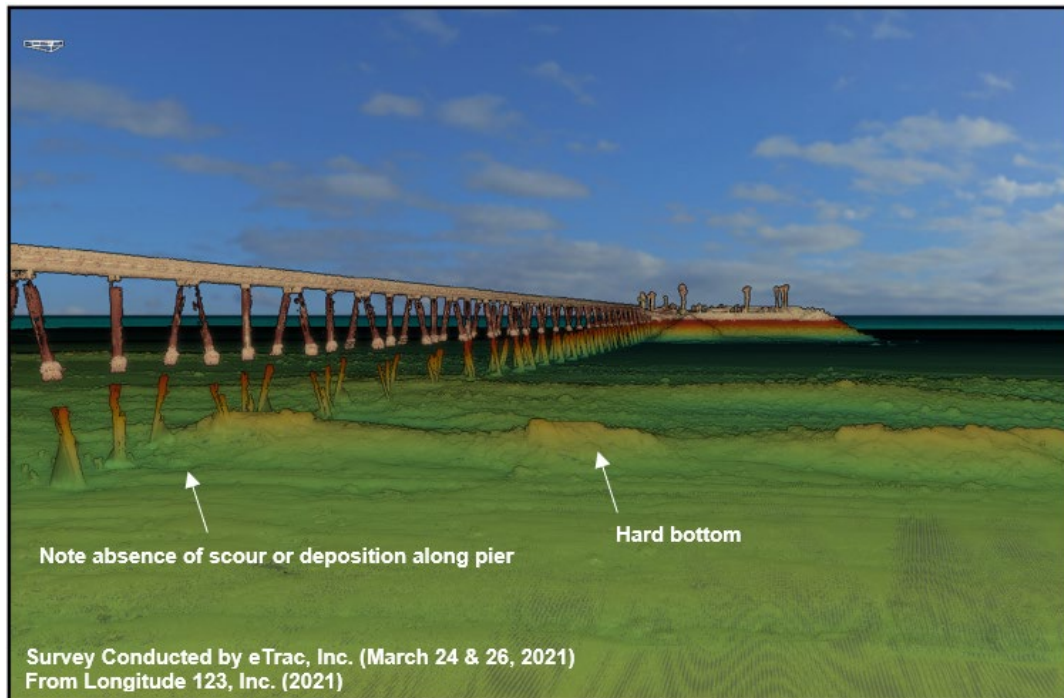
**Figure 4-4. Sea Bottom at Rincon Pier**
