**RINCON PHASE 2 DECOMMISSIONING PROJECT -  
POTENTIAL CAUSEWAY ALTERNATIVE DECOMMISSIONING IMPACTS**

**GARY GRIGGS**

**NOVEMBER 2022**

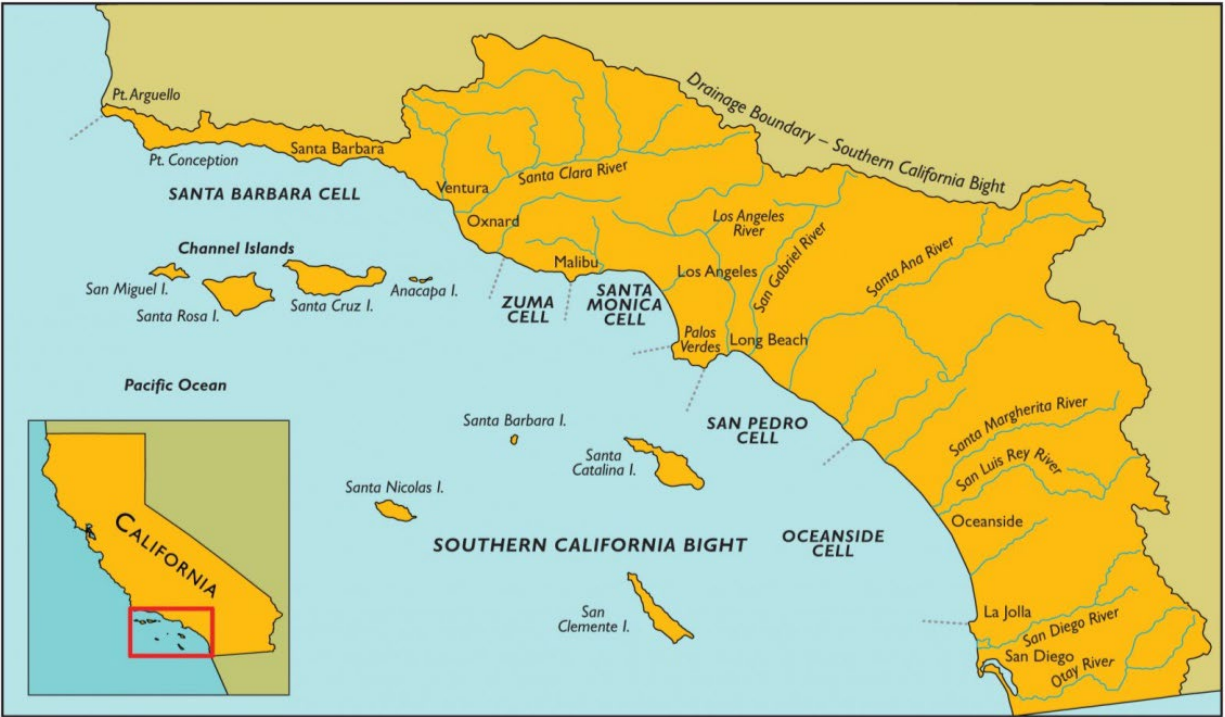
Figure 3. Major littoral cells or beach compartments along the southern California coast. The Santa Barbara Channel is the offshore area from Pt. Conception to Oxnard and from the shoreline to the Channel Islands.

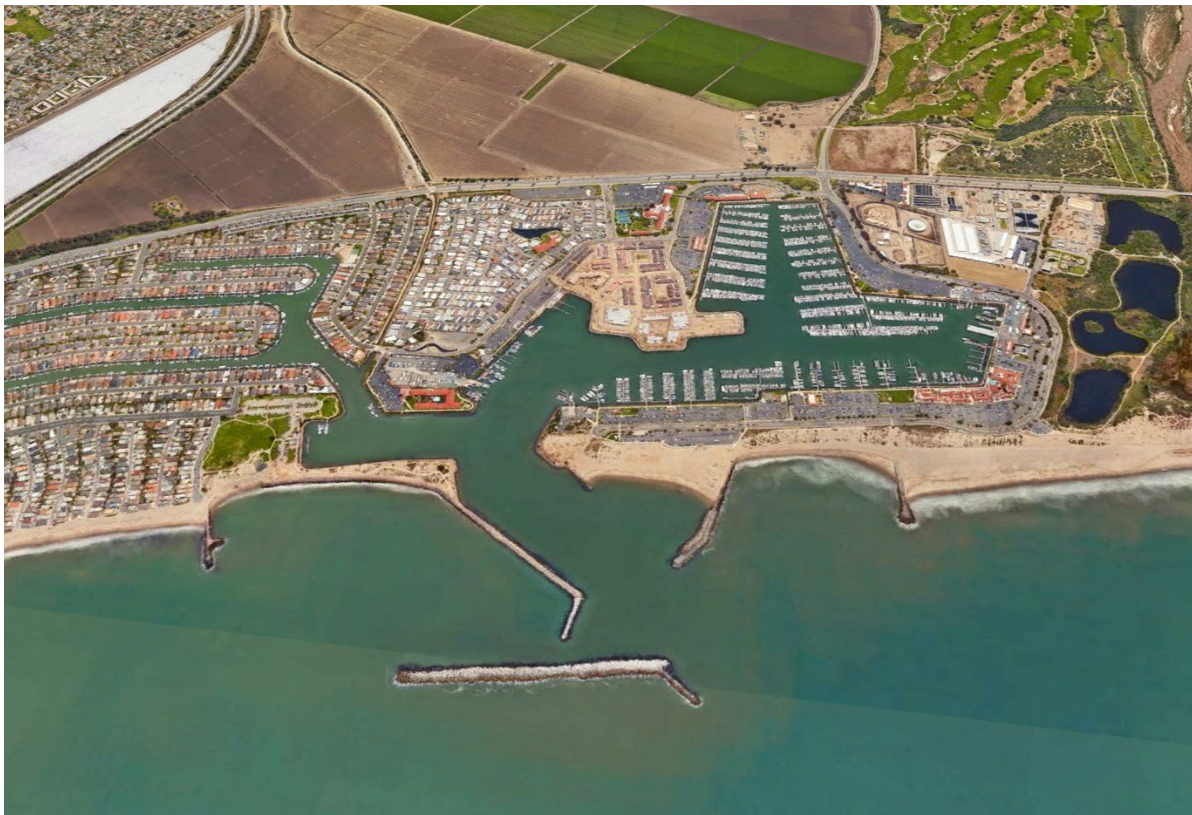
Figure 6. Ventura Marina, 10 miles east of Punta Gorda, where an average of about  $600,000 \text{ yds}^3$  is dredged annually. Littoral drift of sand moves from left to right.

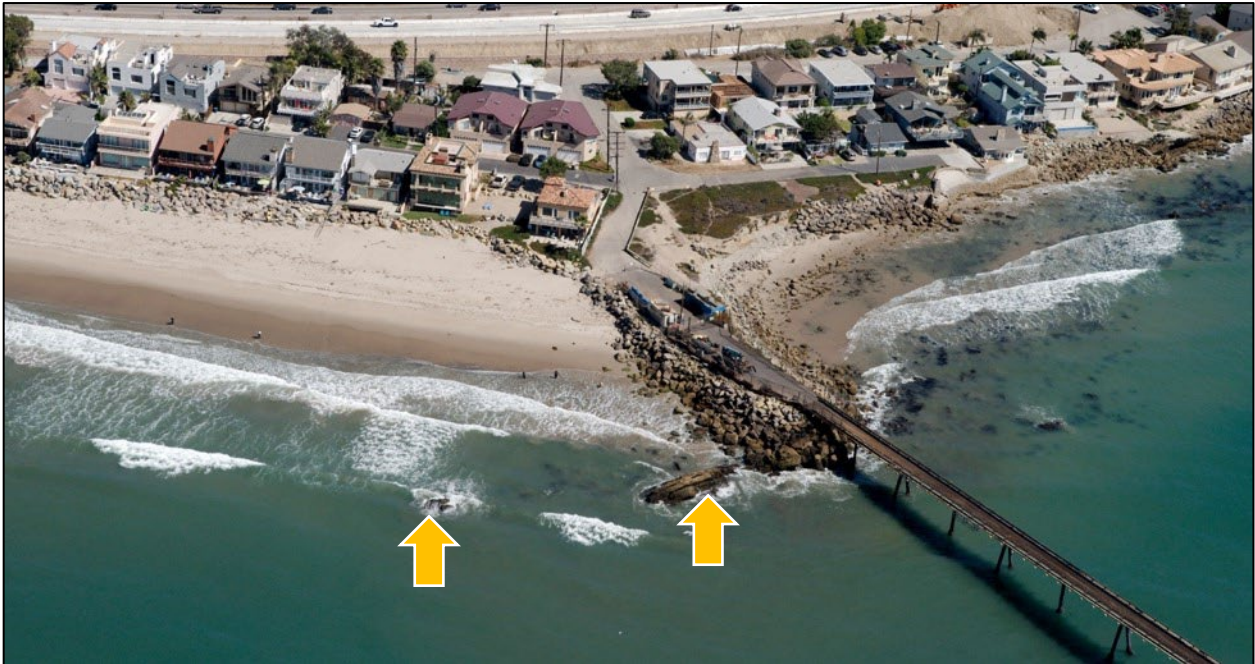
Figure 8. Nearshore bedrock outcrops forming Punta Gorda adjacent to left side of abutment (2013 photo from California Coastal Records Project, Kenneth and Gabrielle Adelman).

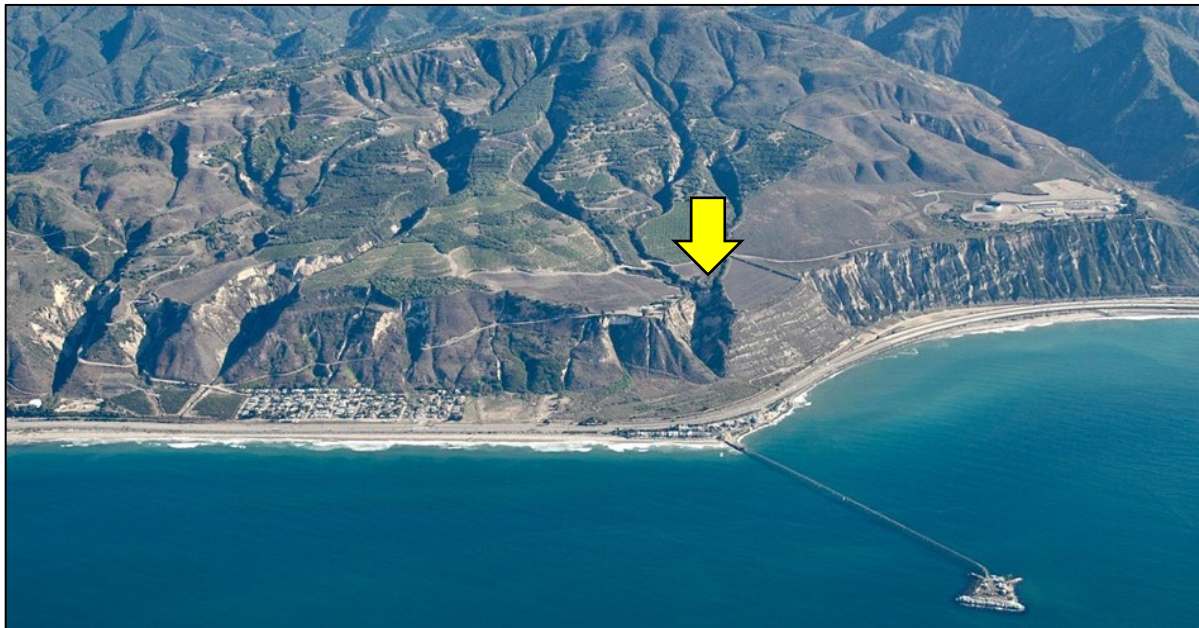
Figure 11. Terraced hills of Rincon Mountain showing deep arroyo and large drainage area (arrow) directly onshore from Punta Gorda where the arroyo would have discharged its sediment load (Photo: Bruce Perry-CSULB).

A regional aerial view provides a good perspective of the extent of arroyo erosion in the erodible materials making up the terraced hillsides onshore along Rincon Mountain (see Figure 11). Rincon Point, 2.3 miles upcoast of Punta Gorda, has also been formed by the armoring of the shoreline by the coarse material brought to the shoreline by another drainage system, Rincon Creek (Figure 14). Downcoast, the bulges in the shoreline, which has led to home construction at Dulah and Faria, were also due to deltas forming at the mouths of the onshore arroyos/streams.

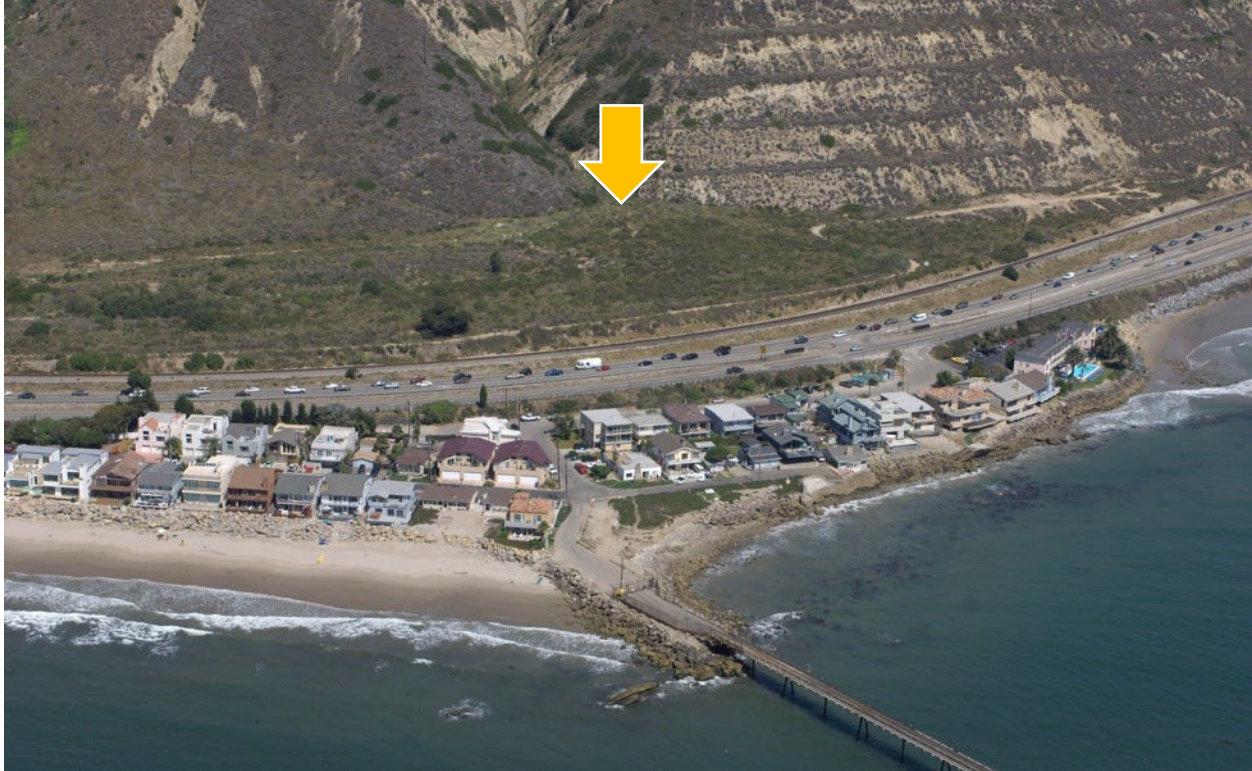
Figure 12. Alluvial fan (at arrow) formed at mouth of arroyo immediately inland from Punta Gorda. (Photo: California Coastal Records Project – Kenneth & Gabrielle Adelman).

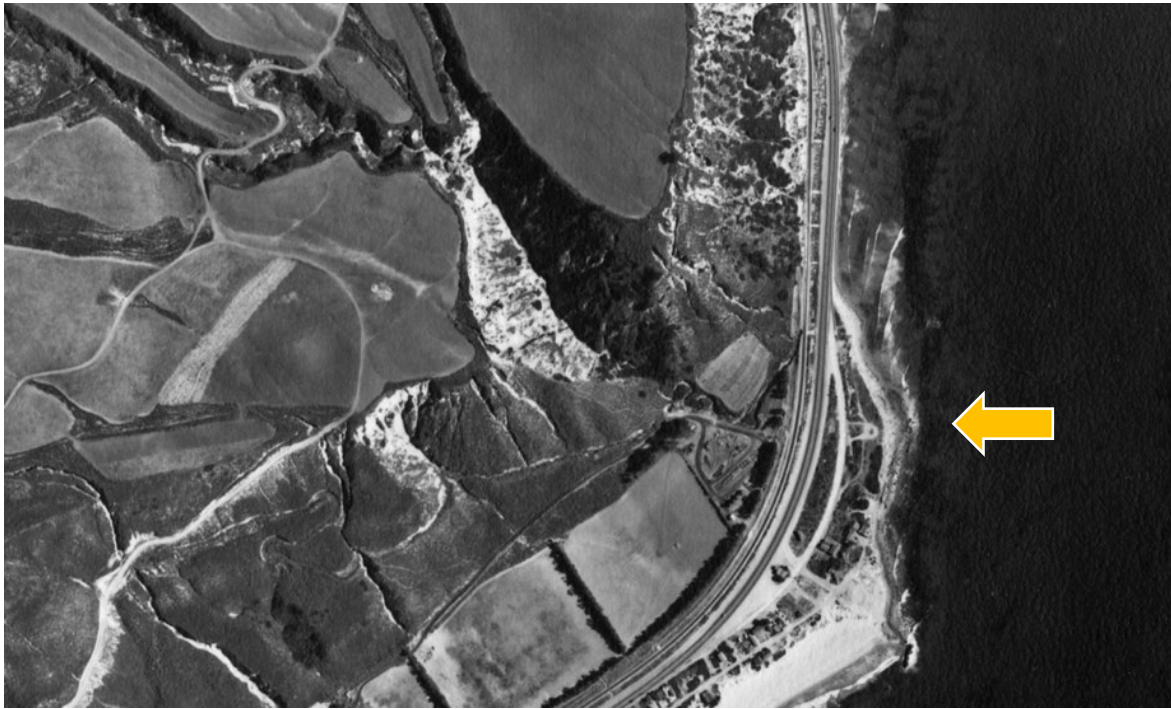
Figure 13. 1945 aerial photograph showing a smaller delta (bulge in shoreline) at the mouth of the arroyo just downcoast from Punta Gorda at the mouth of the large arroyo.

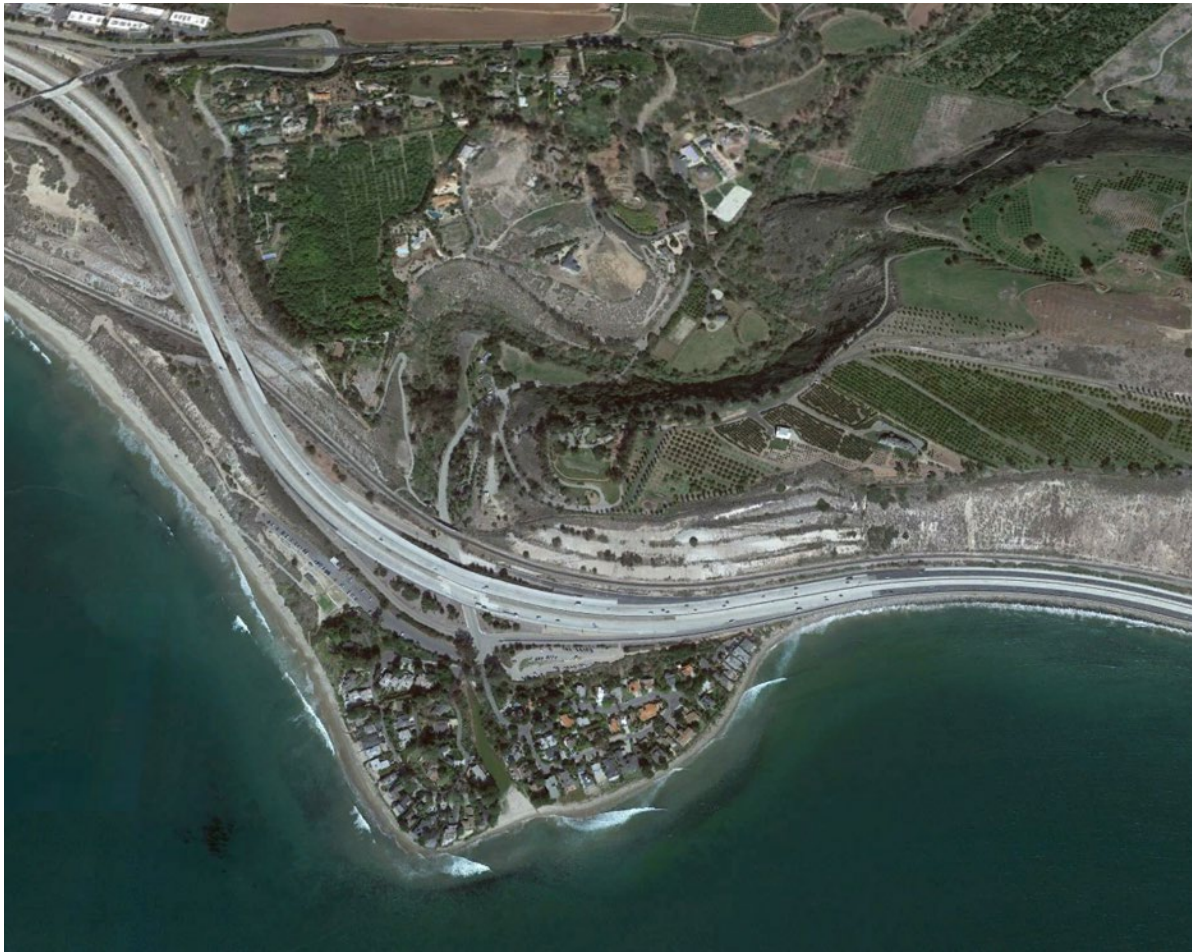
Figure 14. Rincon Point is the delta formed by the coarse sediment discharge of Rincon Creek.

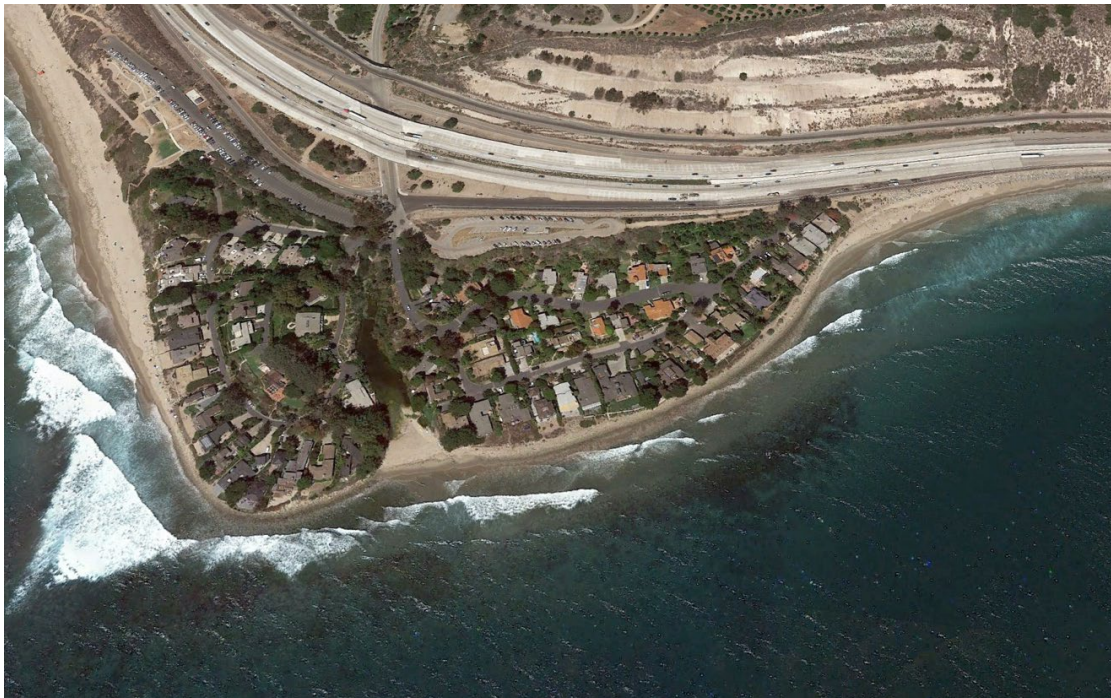
Figure 16. Rincon Point in August 2014 showing wave refraction around point and narrow beach immediately downcoast.

The outcrop pattern of the sedimentary rock of the Pico Formation in the surf zone at Mussel Shoals is evident in many of the pre-1959 causeway and island construction aerial photographs and this has created a natural groin that has retained the littoral drift of sand from upcoast or the west (Figure 15). The result is a sandy beach that extends approximately 1.6 miles upcoast to where the coastline and Highway 101 changes orientation and heads more westerly towards Rincon Point (Figure 7). Wave refraction or bending around Rincon Point produces a world-famous surf break but also a strong longshore current along this northeast-southwest oriented shoreline (Figure 16). Where the shoreline turns almost 90 degrees to the southeast, wave

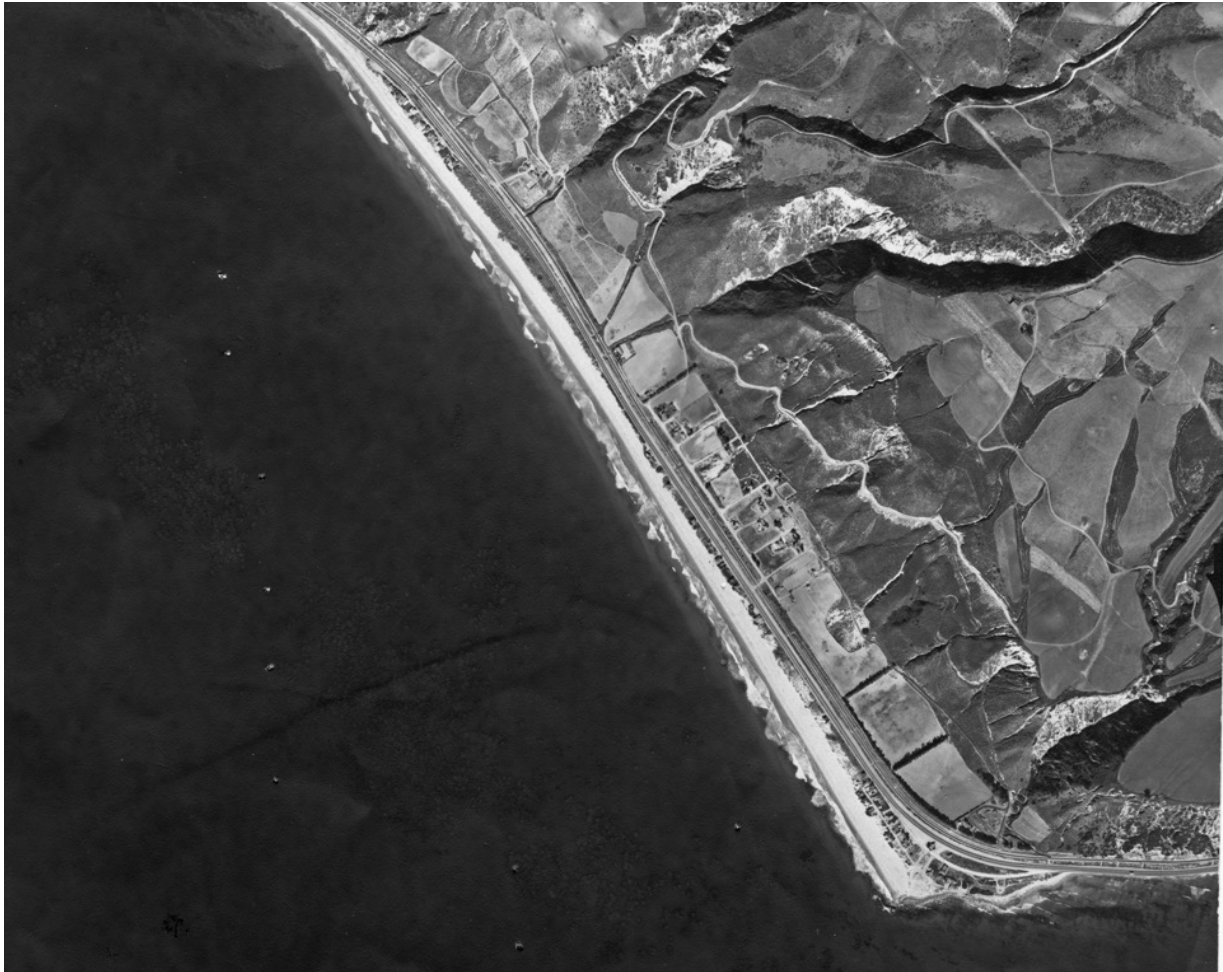
Figure 17. Wide sandy beach upcoast from Punta Gorda (October 1945).

The beach upcoast of Punta Gorda is present on all historic aerial photographs of this stretch of coast going back nearly a century, as far as 1927. The beach varies in width seasonally, as do all of California's beaches, but generally ranges from about 50 to 150 feet wide (Figure 17). This beach was wide and stable enough that dunes have formed, covered with vegetation in places.

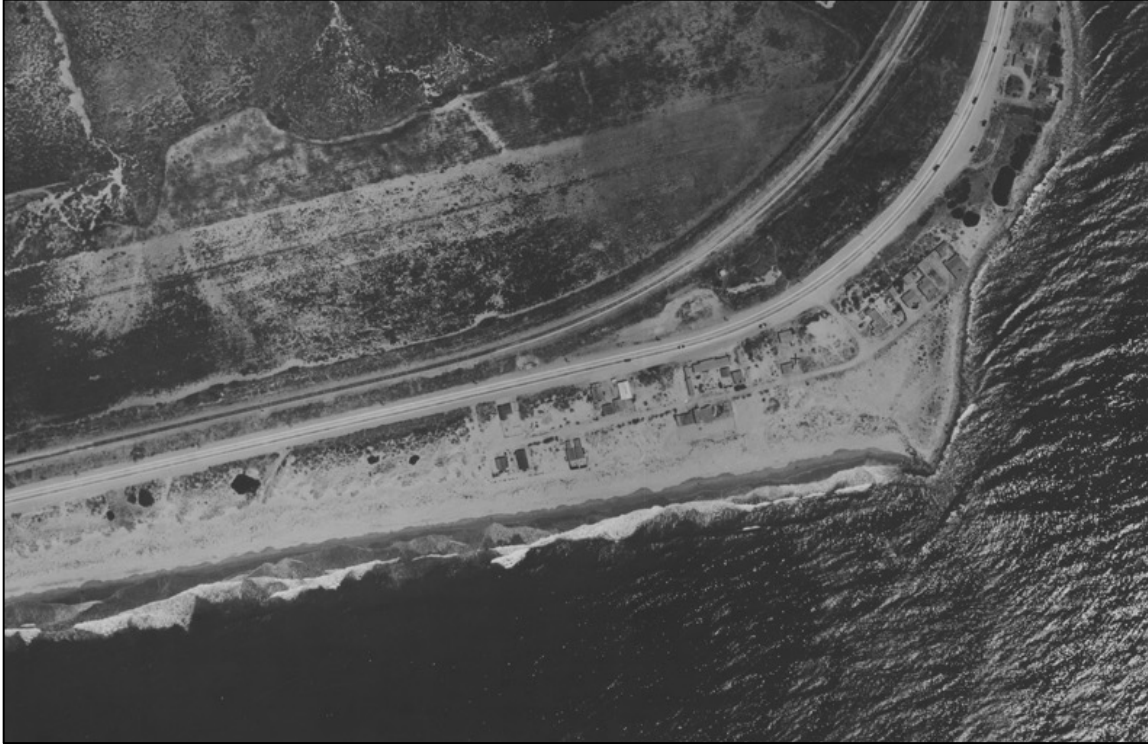
Figure 18. Punta Gorda (January 1927) with some houses built on the back beach and dunes.

Approaching Punta Gorda, the beach widens as sand has accumulated against the natural bedrock groin. Based on the vertical aerial photographs from 1927, 1936, 1939 and 1945, the beach next to Punta Gorda has varied in width from about 230 to 400 feet. It was this wide, relatively stable beach resulting from the bedrock groin at Punta Gorda that led to the construction of the first beach houses here. By as early as 1927, there were already about fifteen homes that had been constructed on this wide back beach/dune area (Figure 18).

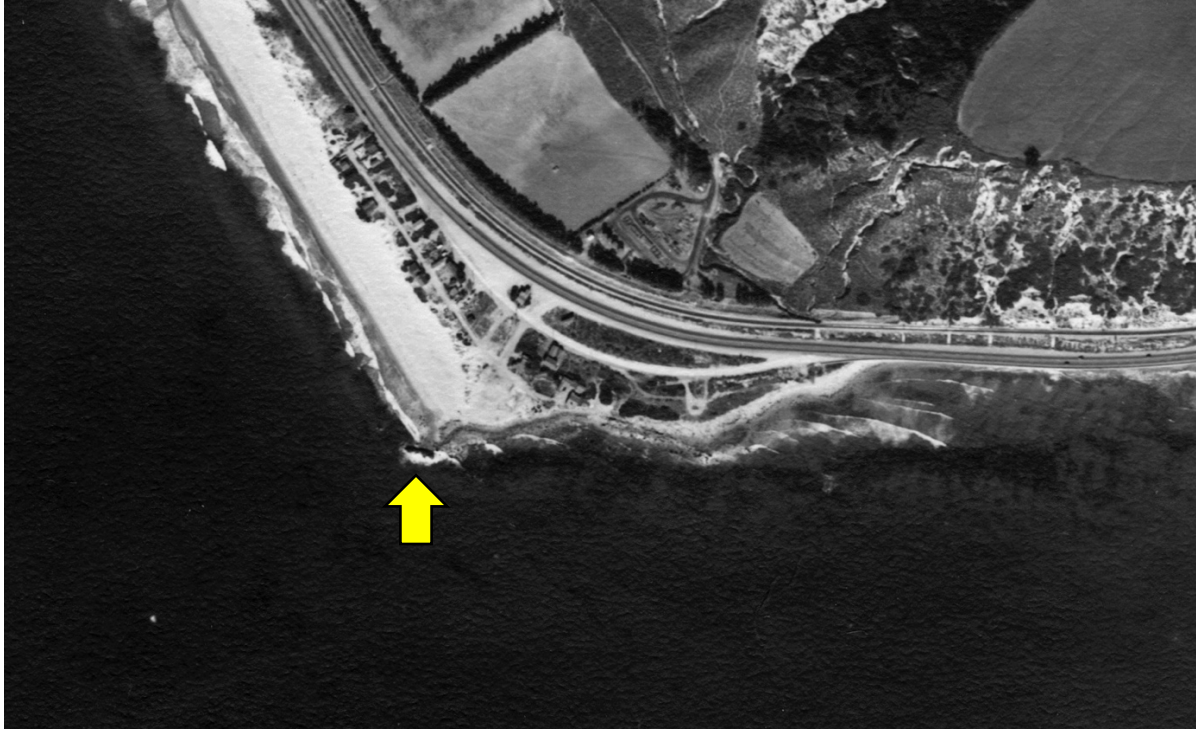
Figure 19. Punta Gorda in November 1945 showing Pico Formation bedrock trapping sand and forming the point.

Although a concrete abutment was built extending out from the shoreline and armored on both sides and at the tip by riprap in 1959, this only extended seaward as far as the existing bedrock outcrop in the surf zone (Figure 8). The shoreline construction didn't significantly lengthen or extend the original natural bedrock groin forming Punta Gorda. The bedrock outcrop of Pico Formation is clearly visible on all pre-installation aerial photographs from 1927 to 1945 (Figure 19).

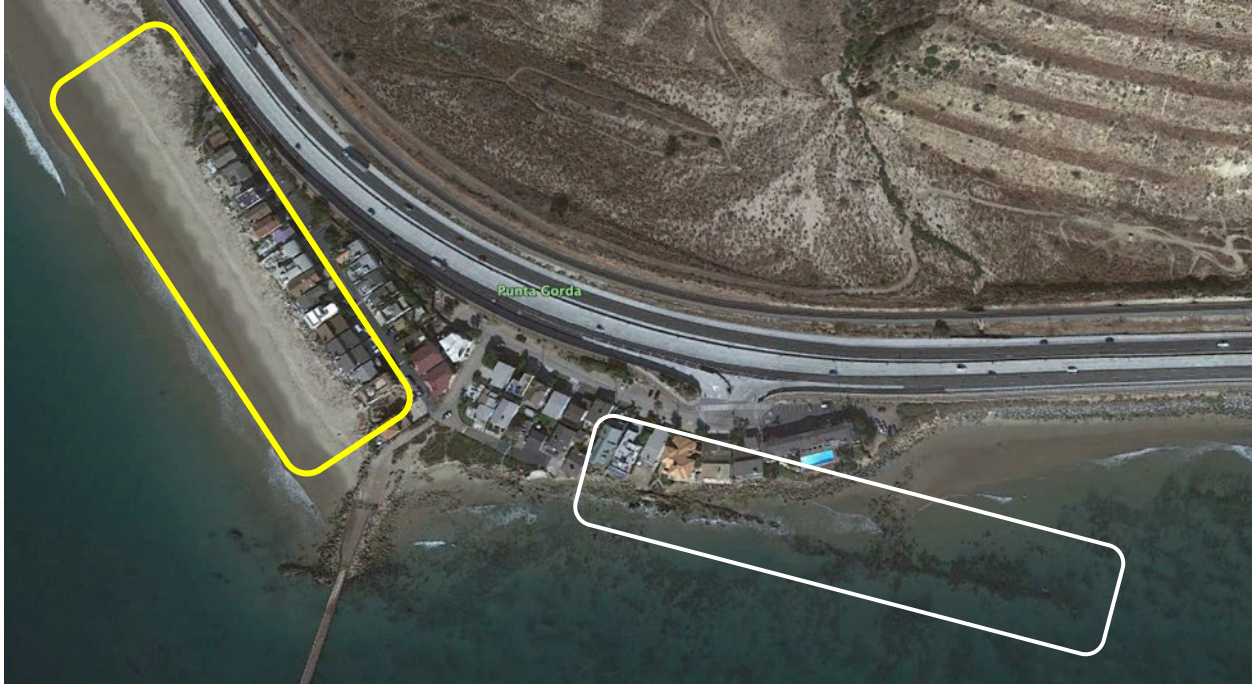
Figure 20. Beach upcoast of Punta Gorda showing encroachment of homes on the shoreline that reduced beach width (outlined in yellow), and downcoast rocky shoreline. Note Pico Formation bedrock outcropping along the back beach extending into the subtidal (outlined in white)(Google Earth August 2019).

It was this natural bedrock groin that trapped the southeastward movement of littoral sand and determined the width of the adjacent upcoast beach. While this beach does change in width seasonally and from year to year due to differences in wave climate, there has not been any consistent increase or decrease apparent in the adjacent beach width in the 63 years since abutment and riprap construction. The first 850 feet of beach immediately upcoast of the abutment has been significantly reduced in width, however, due to the construction of homes on the back beach and dunes and the emplacement of riprap along the shoreline to protect those 19 homes (Figure 20).

- 1] Outcrops of Pico Formation bedrock are exposed on the beach, in the nearshore zone and also in the subtidal (Figures 20 & 21). Rocks of the Pico Formation are also shown clearly on the multibeam bathymetry recently collected just offshore and were almost certainly the reason behind the Mussel Shoals name for this feature.
- 2] The riprap that has been added completely around the concrete abutment and also in front of the homes downcoast of the abutment. Rip rap was also placed beginning about 130 feet downcoast of the abutment that extends approximately 900 feet fronting and protecting the 12 homes and motel that were built on the low bluff. Rip rap then continues downcoast protecting Highway 101.

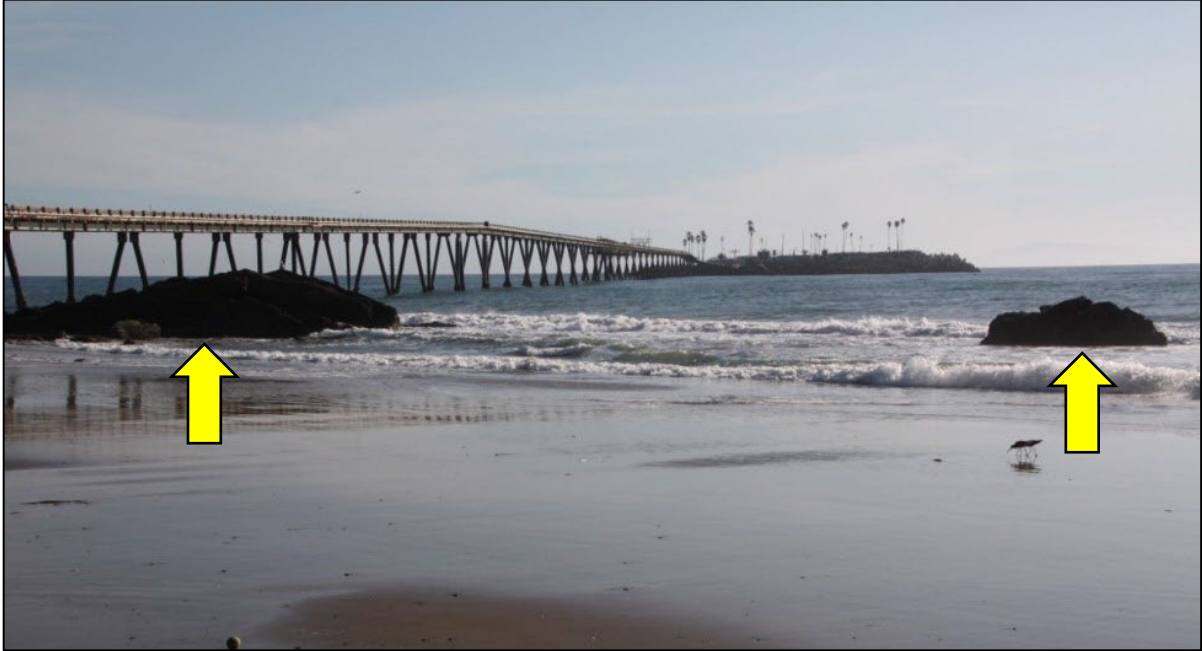
Figure 21. Outcrops of the Pico Formation adjacent to the causeway.

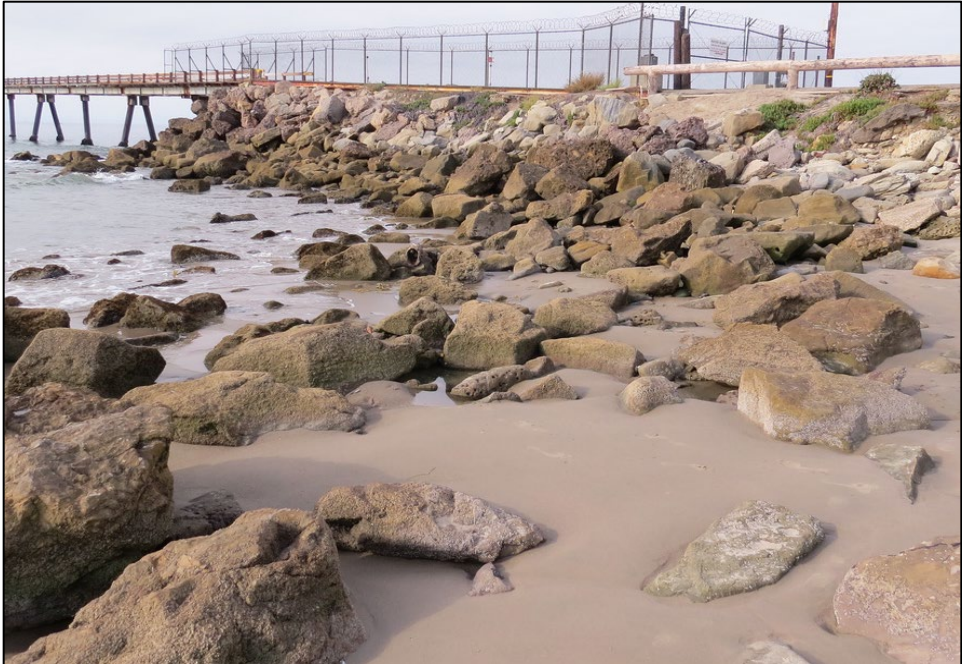
Figure 22. Boulders along the present shoreline downcoast from the abutment.

An October 2022 site visit reveals that the larger rocks on the beach at present are the same type of rock that was used to armor the abutment and also to protect the homes east of the abutment, which appears to be a very hard volcanic clastic rock. Some of the rock scattered across the downcoast beach and into the surf zone and beyond appears to be “fugitive” boulders that were loosened and then removed from the original riprap placement in 1959 by storm waves in the subsequent years (Figure 22).

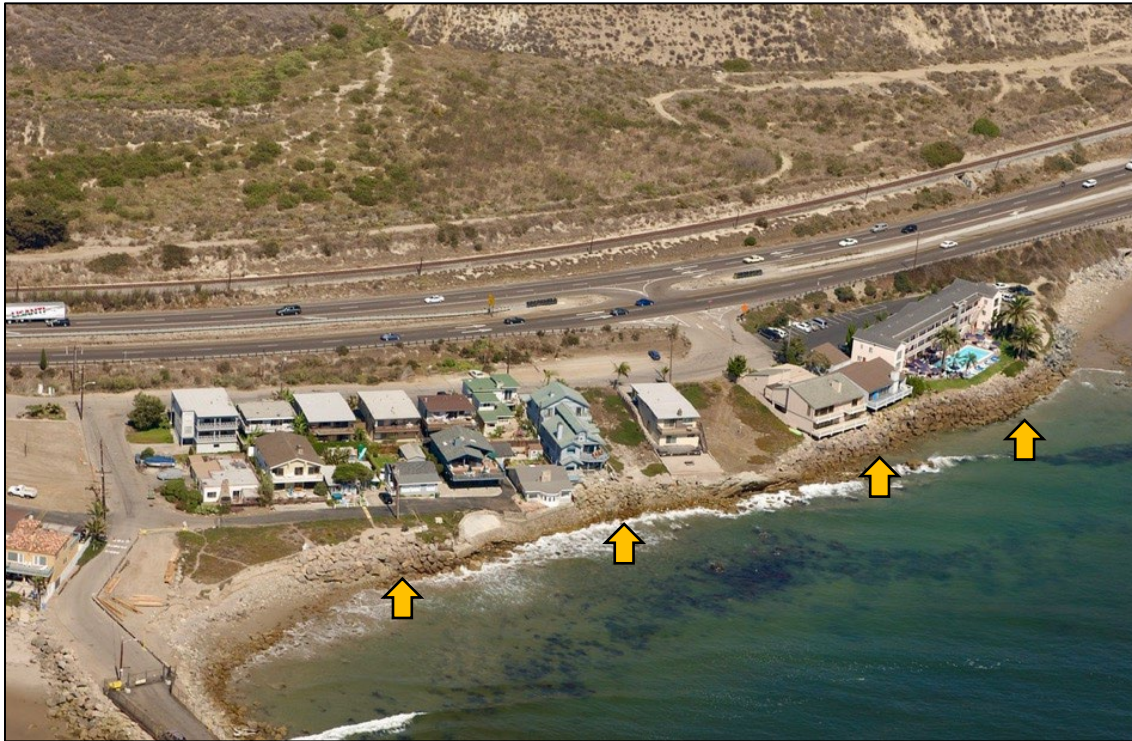
Figure 23. 2002 photo showing where riprap has been placed downcoast from the abutment.

By 1987, the upcoast homes all have been armored, and the downcoast shoreline also appears to have had some riprap emplaced. A higher resolution photo from 2002 show where riprap was placed downcoast (Figure 23).

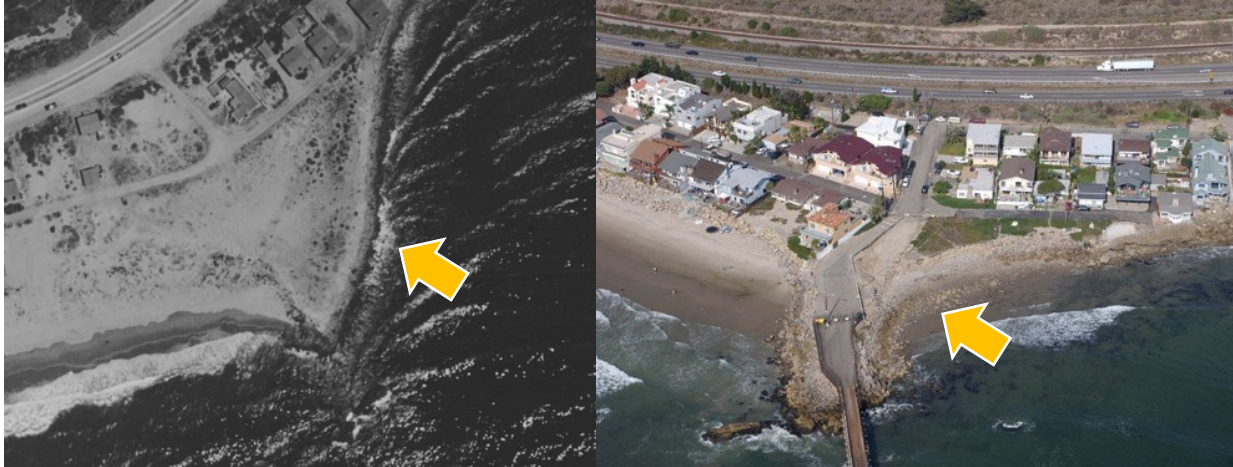
Figure 24. Comparison of 1927 image and 2004 image showing difference in shoreline area immediately downcoast of the abutment.

The shoreline immediately downcoast of Punta Gorda has changed in configuration from a generally convex seaward shape prior to causeway construction to a concave configuration following construction of the causeway abutment (Figure 24). The pre-installation photographs show a sandy back beach area fronted by a rocky shoreline. This may be due to wave reflection off of the abutment focusing energy in this area, leading to scour of the beach, which is a common effect where groins have been spaced too far apart along a shoreline. It also may be due to continued erosion of the former active delta as the sediment supply was cut off, or a combination of the two.

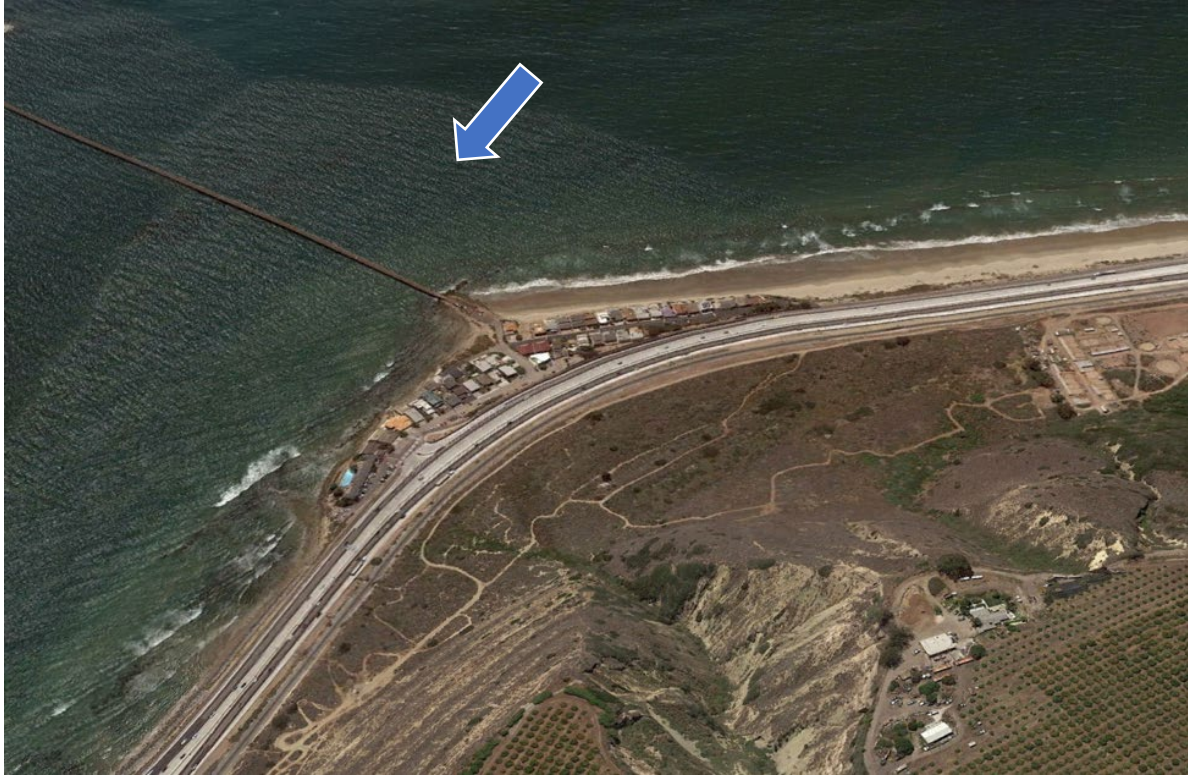
Figure 25. May 2015 Google Earth image showing wave fronts approaching from the WNW (from approximately 280°) and striking the upcoast sandy beach before reaching the causeway.

Because the dominant waves along the Rincon coast approach from the west (NV5, 2021) and move eastward down the Santa Barbara Channel (Figures 25 & 26), and the causeway is downcoast from where the waves break on the sandy beach, the causeway has no impact on wave action at this location. As discussed earlier on pages two and three, waves are the major driver of nearshore beach processes, whether seasonal differences in wave climate (height, period and steepness) that produce changes in the beach profile, or longshore transport of sand driven by the angle that waves approach and break on the shoreline (see Figure 2). Essentially all of the waves breaking on the sandy shoreline upcoast or west of Punta Gorda are completely unaffected by the causeway, which is downcoast. Removal of the causeway would therefore have no effect on the shoreline and the sandy upcoast beach.

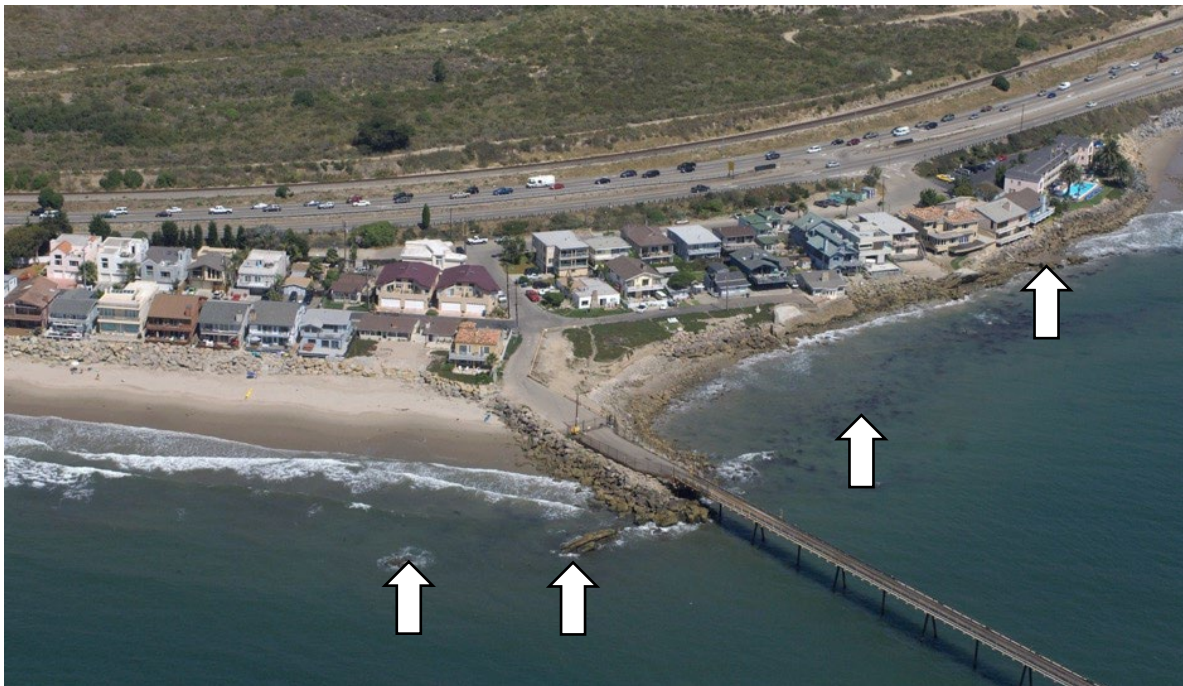
Figure 27. Comparison of shoreline up and downcoast from Punta Gorda with resistant rock outcrops marked with arrows (2006 California Coastal Records Project – Kenneth and Gabrielle Adelman).

The coast immediately downcoast from Punta Gorda differs from the upcoast shoreline in having a rocky beach backed by a low eroded bluff with rocks of the Pico Formation exposed in the bluff, along the beach and on the nearshore seafloor (Figure 27). The evaluation of the changes along the coastline downcoast from Punta Gorda from the construction of the abutment, causeway and island were discussed earlier. There were no significant shoreline changes evident in the post-1959 photographs in contrast to the pre-1959 photographs other than in the area adjacent to the abutment and riprap (see Figure 22). The convex seaward sandy shoreline backed by dunes in the 1927 aerial photo ) had already begun to erode by the time of the 1945 photo (see Figure 13). This erosion continued in the subsequent years with the dunes and most of the sandy beach gradually being removed, leaving a rocky shoreline with a concave seaward shape (Figure 28).

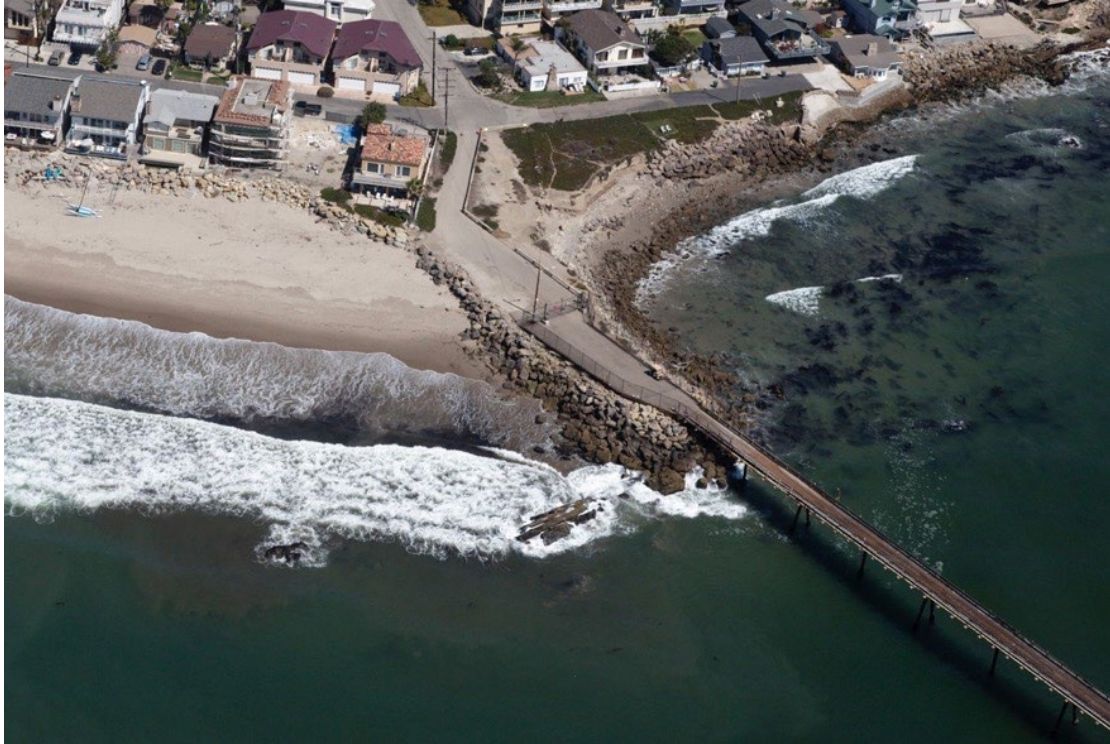
Figure 28. Close-up of the shoreward end of the causeway showing concave shape (2010 – California Coastal Records Project – Kenneth and Gabrielle Adelman).

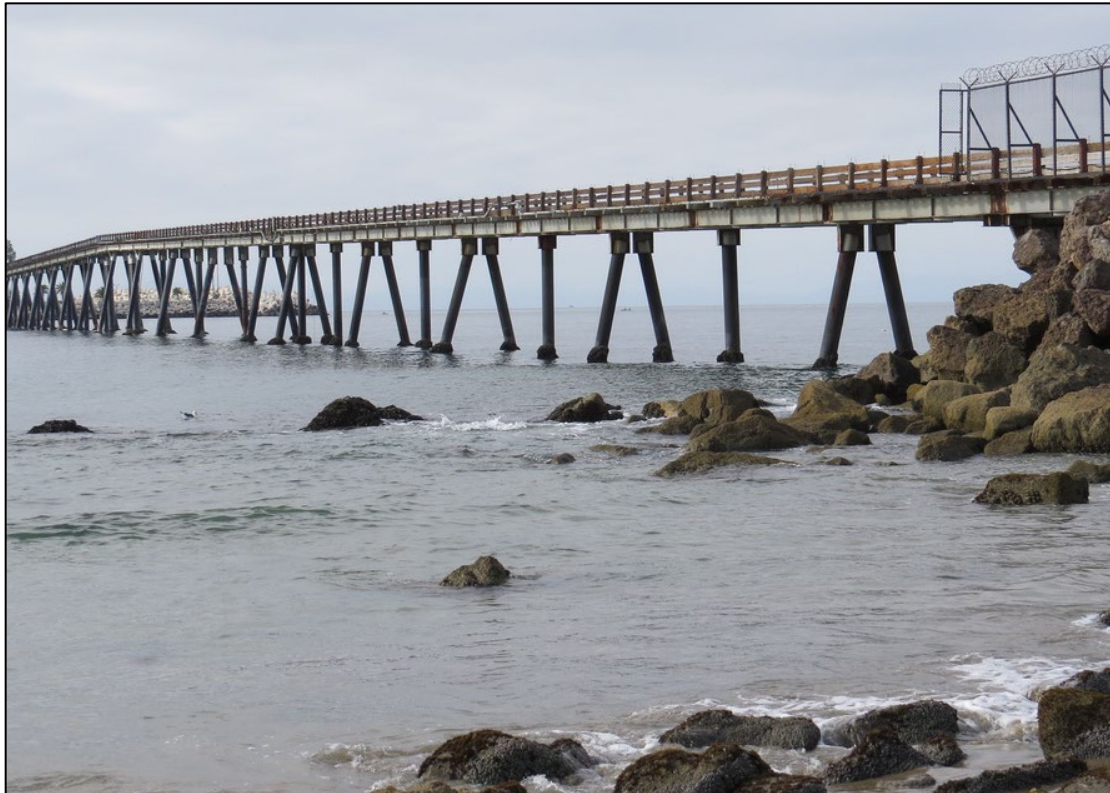
Figure 29. View of the causeway from downcoast showing wide spacing and small diameter of pilings.

Waves approaching this stretch of shoreline typically pass through the causeway. The pilings for the causeway are of a very small diameter and also widely spaced (see Figure 29), however, such that they have no significant effect on the waves passing through the causeway. An earlier coastal engineering study on the Decommissioning Project (NV5, 2021: p.15) also concluded that “the impact of the causeway removal on the nearshore processes is negligible because the size of the causeway piles is negligible compared to the wavelength(of the waves) and scale of the nearshore area”. Additionally, aerial photos that capture waves approaching the shoreline do not indicate any obvious effect of the causeway on the waves passing through the pilings (Figures 30 and 31).

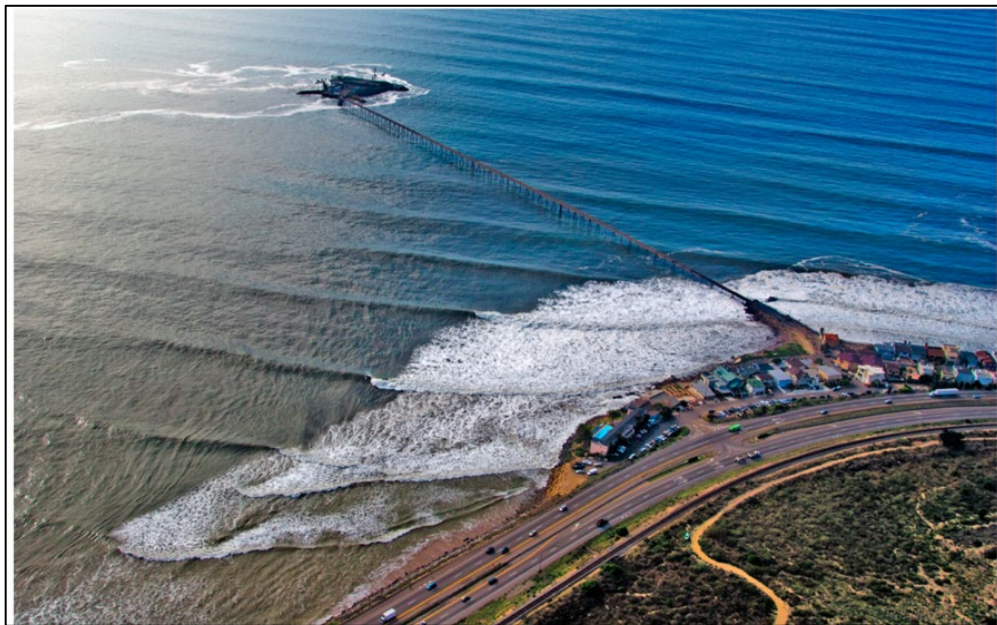
Figure 32. December 21, 2006, aerial photograph of swell approaching Mussel Shoals and passing unchanged through the causeway during what has been called the largest swell in a decade (© Anthony Ghiglia).

The best aerial photographs of waves passing through the causeway and approaching the shoreline were taken by commercial surf photographer Anthony Ghiglia on December 21, 2006 (during what was labeled as the biggest swell in a decade), and Jason Wolcott (Figures 32 and 33). In both of these photographs, wave crests are completely unchanged as they pass through the causeway and show that complete removal of the causeway would have no significant effect on the waves and therefore the shoreline up or downcoast from Punta Gorda.

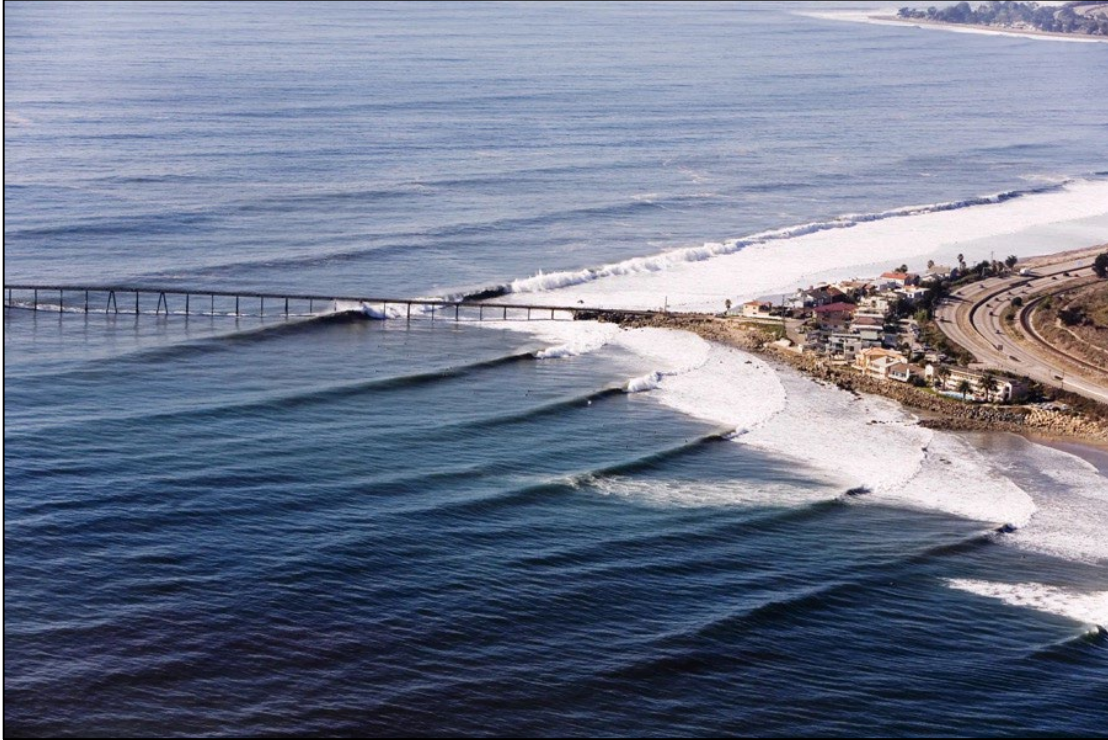
*Figure 33. Aerial view of a large swell breaking at Punta Gorda showing no change in waves as they pass through the causeway (© Josh Wolcott).*

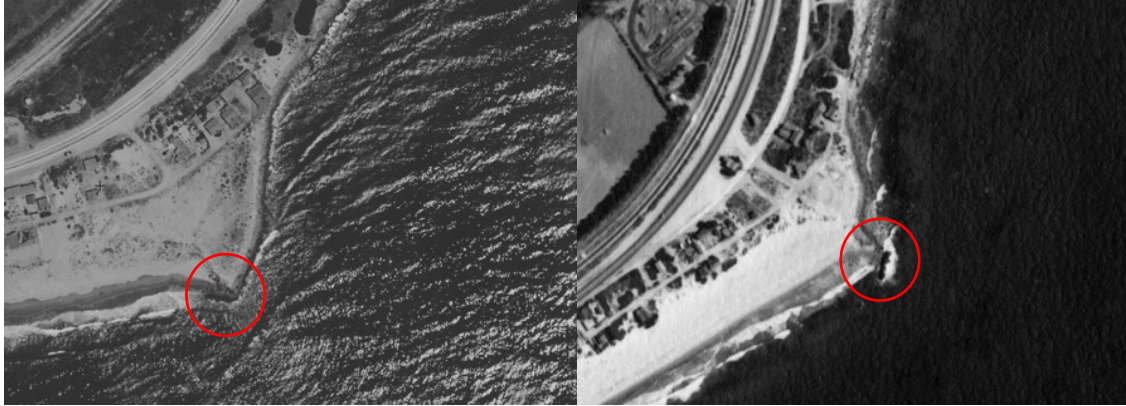
Figure 34. Changing configuration of the rock outcrop at Punta Gorda in 1927 (left) and 1945 (right).

The pre-1959 aerial photographs (1927, 1936, 1939, 1944 and 1945) all show a prominent rock outcrop that forms the promontory or point at Punta Gorda. The size and shape of the rock has changed from the earliest 1927 image to the more recent 1945 photograph, however (Figure 34). The rock appears to have been reduced in size over this 18-year period by wave attack and erosion.
