**RINCON PHASE 2 DECOMMISSIONING PROJECT -  
POTENTIAL CAUSEWAY ALTERNATIVE DECOMMISSIONING IMPACTS**

**GARY GRIGGS**

**NOVEMBER 2022**

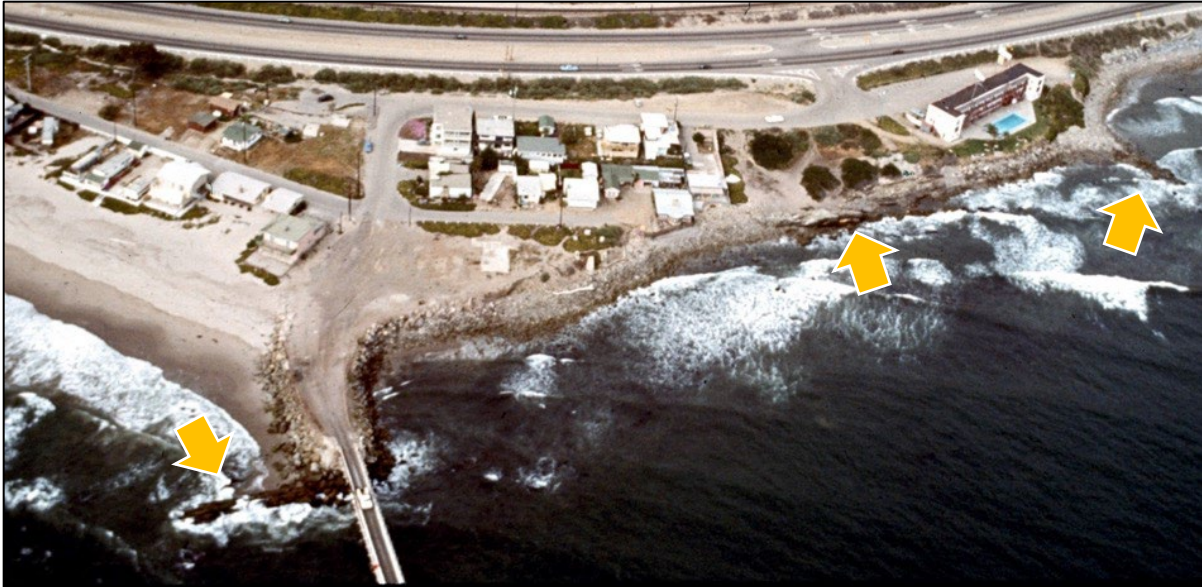
Figure 35. Concrete abutment and riprap was built seaward only as far as the bedrock outcrop in 1959 (arrow). There are additional rock outcrops downcoast (arrows) (Photo 1972 California Coastal Records Project – Kenneth and Gabrielle Adelman).

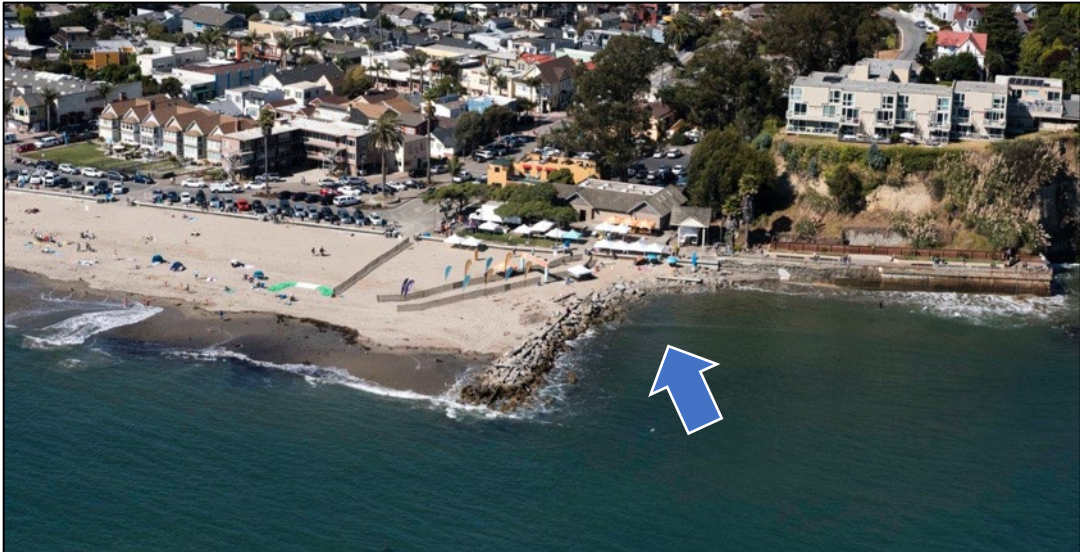
Figure 36a. The Groin Effect. Groin constructed in city of Capitola in northern Monterey Bay which has retained beach to the left but erosion is occurring downcoast to the right.

Where natural or built groins either exist or have been built, there is often a “groin effect”, where the shoreline adjacent to the downdrift side of the groin erodes and no beach forms or is retained (Figures 36a & b). While this groin effect doesn’t show up in the oldest aerial photographs of Punta Gorda, the recession of the shoreline immediately downcoast shows up in subsequent photographs (see Figure 42 – 1945 and Figure 35 - 1972). It seems likely that the rock outcrops along the shoreline here – and the name Mussel Shoals - may have originally protected this section of coast, but in recent years erosion has eroded portions of the bedrock and allowed erosion to take place.

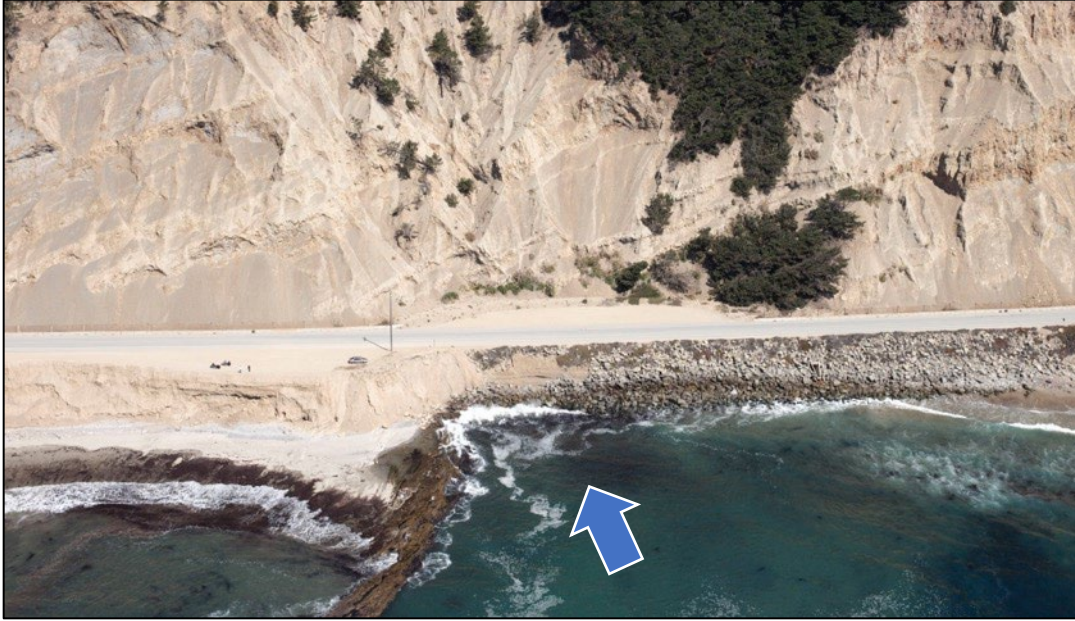
Figure 36b. Natural bedrock groin that has trapped sand upcoast (to the left) but produced erosion downcoast requiring the installation of riprap to protect State Highway 1 in northern Santa Cruz County (both photos: California Coastal Records Project- Kenneth and Gabrielle Adelman).

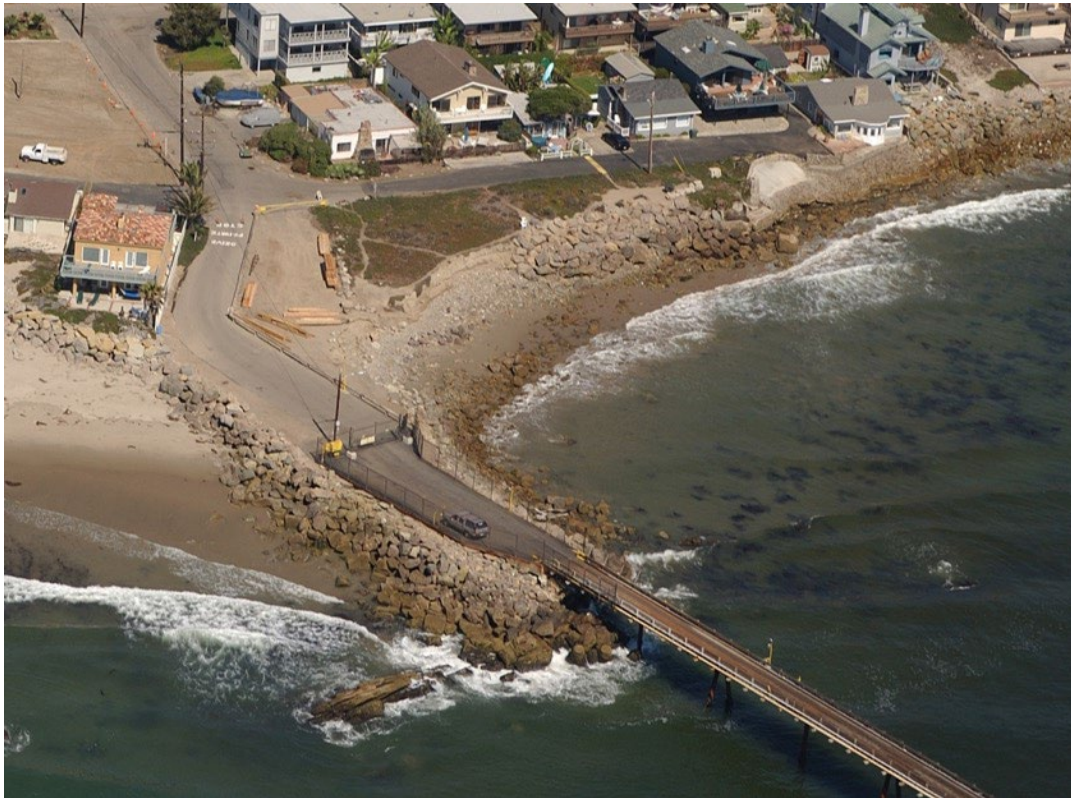
Figure 40. Downcoast shoreline in 2002 (California Coastal Records Project, Kenneth and Gabrielle Adelman).

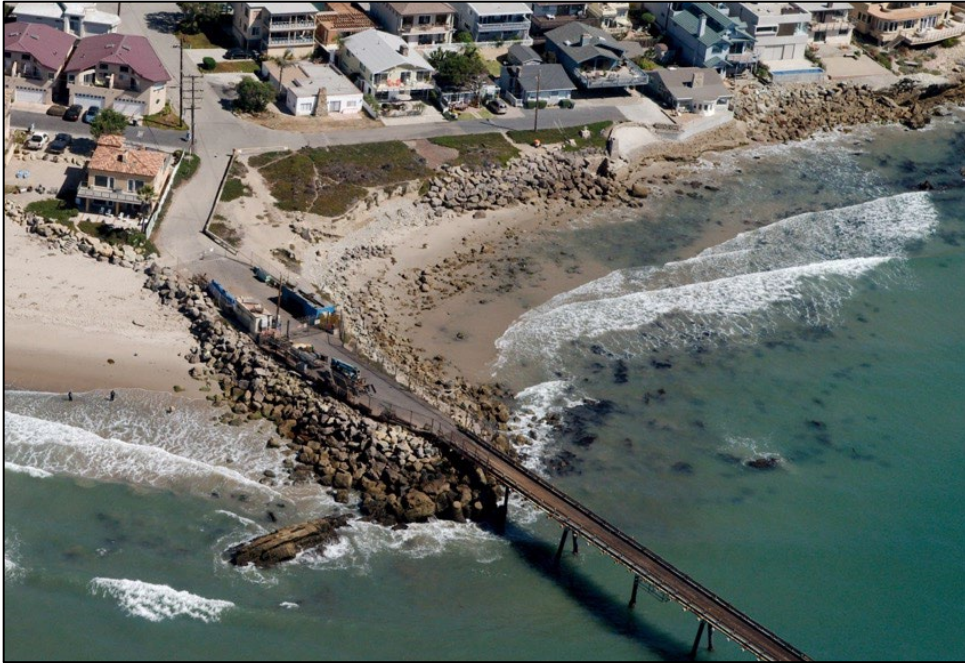
Figure 41. Downcoast shoreline in 2013 (California Coastal Records Project, Kenneth and Gabrielle Adelman).

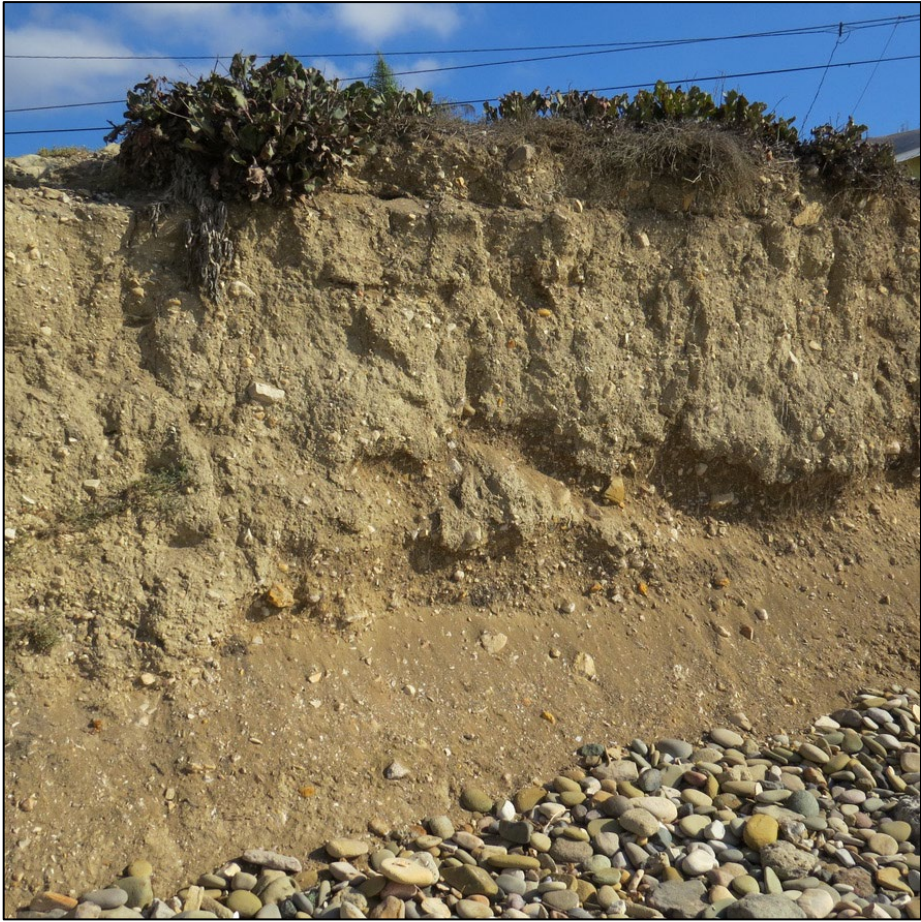
Figure 42. Eroding coastal bluff immediately east of the abutment.

There is an approximately 115-foot gap of coastal bluff which has not been armored, however, extending from the abutment to the first area downcoast riprap, although the shoreline here is mantled with cobbles and boulders that does provide some degree of protection (Figure 41). Large waves at times of high tide, however, have continued to erode the eight-foot high nearly vertical coastal bluff (Figure 42). The removal of the abutment and replacement of the existing riprap on the same footprint, even at a slightly lower elevation, will have no significant effect on the downcoast shoreline as the general footprint and seaward extent of Punta Gorda will not be significantly changed. Neither the upcoast beach nor the downcoast beach will be affected by the removal of the underlying concrete abutment and the replacement of the protecting riprap.
