# Appendix CR-1

Historical and Architectural Evaluation of 4434 Mapel Lane,  
Carmichael, County of Sacramento, CA

**Kathleen A. Crawford, M.A.**  
Crawford Historic Services  
P.O. Box 634,  
La Mesa, CA 91944

August 2018 | NSP-01

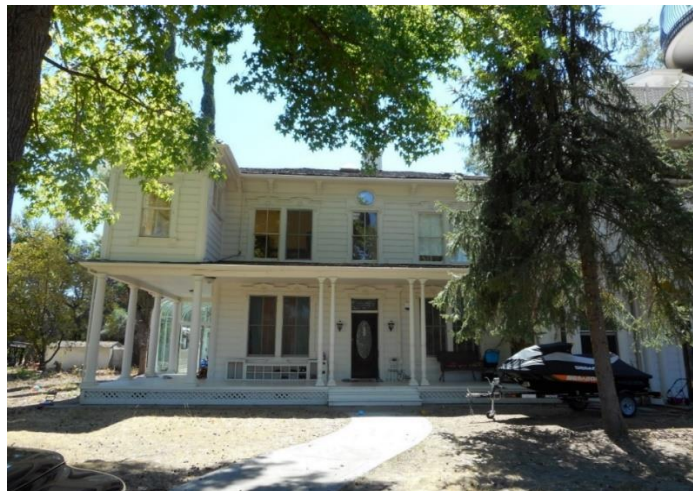
Photograph No. 1: West Elevation of c. 1875 Residence.

The building is basically rectangular shaped and has a symmetrical primary elevation, painted wood horizontal siding exterior, a large wrap around porch on the four elevations, and a hipped roof with wood shake shingles, exposed rafters, and skylights. A chimney projects from the center of the roof area. The foundation of the building is wood piers. The front face of the area below the porch is faced with trellis siding. Simple wood steps lead to each of the elevations.

The west, or primary, elevation contains a large porch with a flat roof that is supported by pairs of wood, round, carved, columns with simple capitals and bases. The floor and ceiling of the porch are wood with dovetailed joining at the corners. Simple wood steps lead up to the front porch. Wood trellis type facing is present around the lower edge of the porch to hide the foundation elements. Non-historic ceiling lights have been added to the roof of the porch.

The primary elevation includes a centered entrance flanked by two pairs of large, wood framed, four-pane, double hung sash style windows. The main entrance includes a carved wood door with an oval stained-glass window in the center of the door. Brass hardware is present on the door and includes a small handle that turns and functions as the doorbell. A rectangular shaped, wood framed transom window is present above the front door. The transom contains a stained-glass window. Raised paneling is located on the side walls of the recessed entrance area. A decorative carved section with a tulip motif is present over the transom window and the other windows. This detail is repeated at various points around both the old and new sections of the residence. Small, metal lights are present on each side of the entrance door.

The north facing/south wall of the primary elevation forms an L-shape with the main portion of the façade and contains an additional entrance with a non-historic, carved wood door with stained glass inserts and sidelights. A small wood box structure with multiple compartments is present on the front porch, presumably to store shoes. This appears to be a non-historic addition.

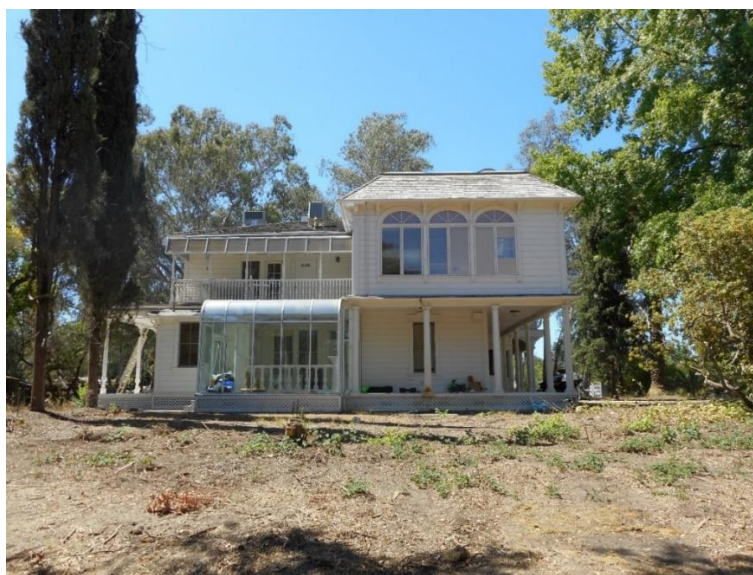
Photograph No. 2: North Elevation of c. 1875 Residence.

The north, or side, elevation includes the same detailing as seen on the primary elevation – open porch with flat roof, pairs of round columns, horizontal siding, and wood framed, multi-lite, double hung sash style windows. The west portion of the residence, both first and second floors, forms a block and includes the open porch that wraps around from the west elevation. The east half of the elevation steps back from this front section.

The second floor of the north elevation includes multiple windows and a balcony. The west portion of the second floor over the wrap around porch area includes three, large, rectangular shaped, casement style windows. These non-historic windows have semi-circular arched window sections directly over each window. They are placed in a contiguous row. The east half of the second floor, the area directly over the solarium, includes a balcony with a turned wood railing, a slanted shed roof, and a wood framed, multi-lite French door which leads onto the balcony area. Air conditioning units and skylights are noted on the roof.

The second floor of the residence steps back, leaving a wide, flat porch roof expanse. The second floor contains multiple wood framed windows. Two of the windows are rectangular in shape with arched, fan light window sections above the main, multi-light window. The other window is the same as seen on the other portions of the house – wood framed, rectangular shaped, double hung sash style with four panes of glass and the carved decorative section over the window.

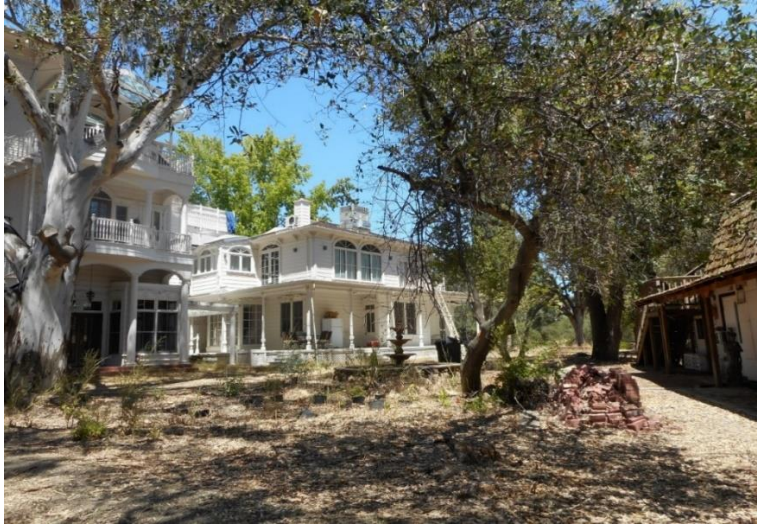
The south, or side, elevation is the location of the large addition constructed in 1985. Only a portion of the original south elevation remains as approximately half of the west end of the south elevation was removed to facilitate the construction of the addition. The remaining east half of the south elevation contains the same exterior siding and open porch details. An additional single wood and glass door entrance is present at the juncture of the old and new portions. Wood stairs with a wood railing lead to the porch area and door entrance area. A large, three-sided, wood framed, full height, fixed pane, multi-lite window section is present on the side wall of the house. Three large window sections comprise this window element, creating a quasi-bay window effect. This area provides a wide viewing area from the dining area on the interior of the house. Double hung sash style windows with the same four-pane configuration, and the carved wood detailing, are present on the south wall.

The second floor is L-shaped. Each section contains a rectangular shaped, multi-lite window with an arched, fan light detail window over the lower portion. This L-shaped area attaches to the new addition on the upper floors.

Photograph No. 4: South and East Elevations of c. 1875 Residence.

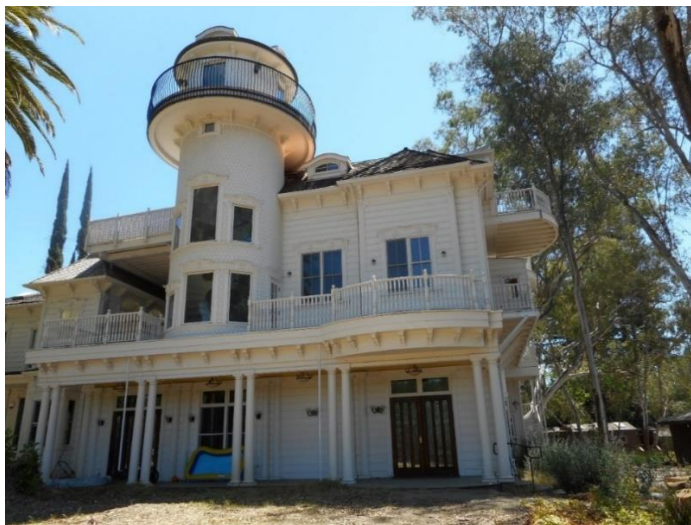
Photograph No. 5: West Elevation of Turtletaub Addition.

The west, or primary, elevation contains numerous components on the various levels of the residence. The main entrance is centered on the west elevation and contains a carved wood door with stained glass inserts and rectangular transoms. The entrance is recessed under an open porch area. The roof of the porch is supported by pairs of round, wood columns with simple capitals. The underside of the porch roof contains exposed rafters. A secondary entrance with glass panels is located north of the main entrance. Metal lights are present at various points along the ground floor elevation.

The ground floor of this elevation contains two large, rectangular shaped windows, flanking a smaller, vertically oriented window with multiple lights. The window on the west end of the façade contains multiple panels and arched detailing at the top of the window. The window located on the east section of the façade is a curved, bay window with multiple windows with multiple lights.

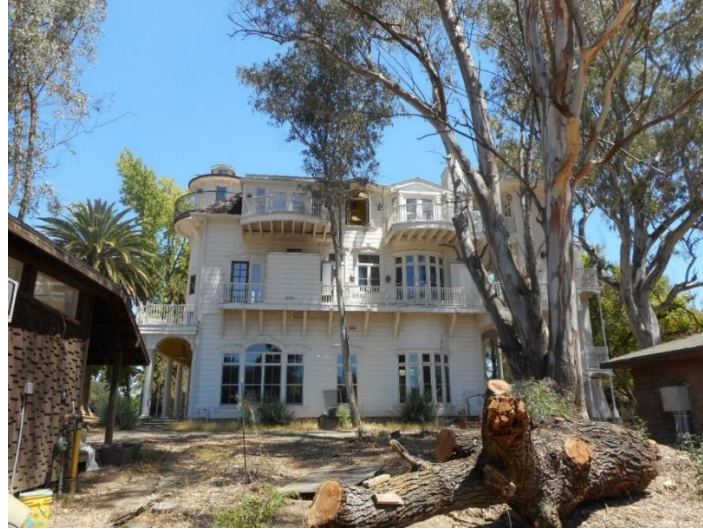
Photograph No. 6: South Elevation of Turtleaub Addition.

The second floor contains a wood balcony with a turned wood railing. The balcony extends along the width of the façade and is supported by wood braces. Access to the balcony is from a bathroom with a hot tub on the second floor. A large bay window with multiple lights is present on the east end of the façade; a rectangular shaped, multi-lite window with carved detailing is present in the middle of the façade; a large section houses a sauna and steam room; and a dark wood framed, multi-lite door is present on the west end of the elevation.

The third floor contains two large, curved balconies with turned wood railings and wood supports. Rectangular shaped, multi-light windows are present along the elevation. Two front gable roof sections project above the main roof line above the rectangular window sections.

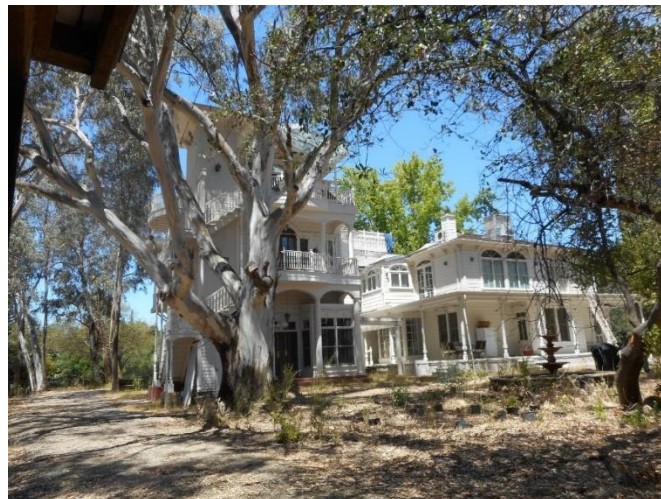
Photograph No. 7: East Elevation of Turtleaub Addition.

The east, or rear elevation contains an open porch on the ground floor with a flat roof supported by round columns with simple capitals. Arches fill the spaces between the columns. Large, wood framed, French doors lead onto the porch from the interior. A large, wood framed window with multiple lights is present on the ground floor of the rear elevation.

A three-story elevator with a fish scale shingle pattern is present at the southeast corner of the elevation. The elevator is housed in a square shaped structure and extends up the side of the rear elevation. A wood staircase with turned wood railing wraps around the various elevations of the elevator. Each level has a landing to access the interior of the house.

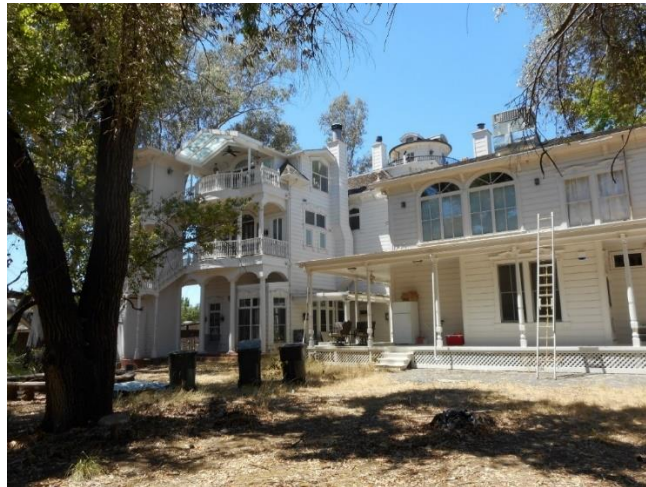
Photograph No. 8: North Elevation of Turtletaub Addition.

The second and third floors have large balconies with turned wood railings. Multi-lite French doors lead onto the balconies from the interior. The second-floor balcony has round wood columns to support the third-floor balcony. Arches separate the columns and match the ground floor column detail. The second-floor balcony is rectangular shaped; the third-floor balcony is curved.

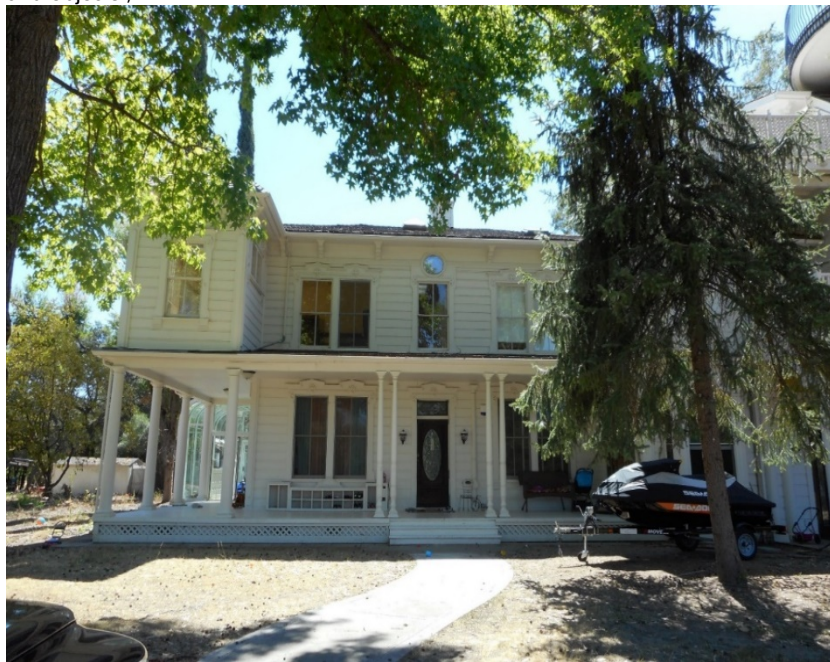
P5a. Photograph or Drawing (Photograph required for buildings, structures, and objects.)

Photograph No. 1: West Elevation of c. 1875 Residence

The building is basically rectangular shaped and has a symmetrical primary elevation, painted wood horizontal siding exterior, a large wrap around porch on the four elevations, and a hipped roof with wood shake shingles, exposed rafters, and skylights. A chimney projects from the center of the roof area. The foundation of the building is wood piers. The front face of the area below the porch is faced with trellis siding. Simple wood steps lead to each of the elevations.

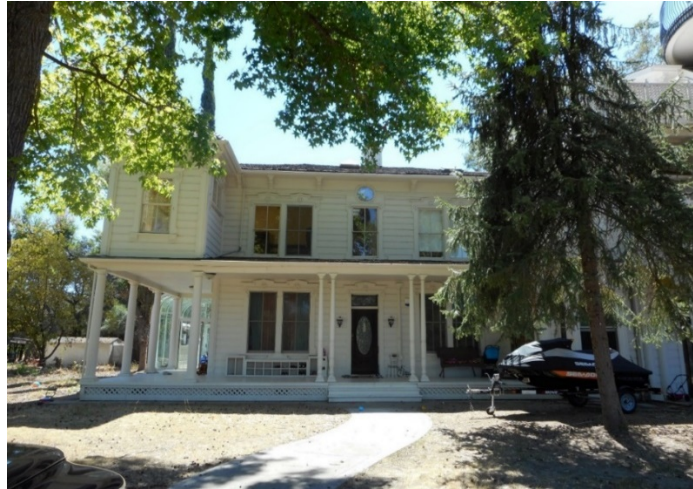
inserts and sidelights. A small wood box structure with multiple compartments is present on the front porch, presumably to store shoes. This appears to be a non-historic addition.

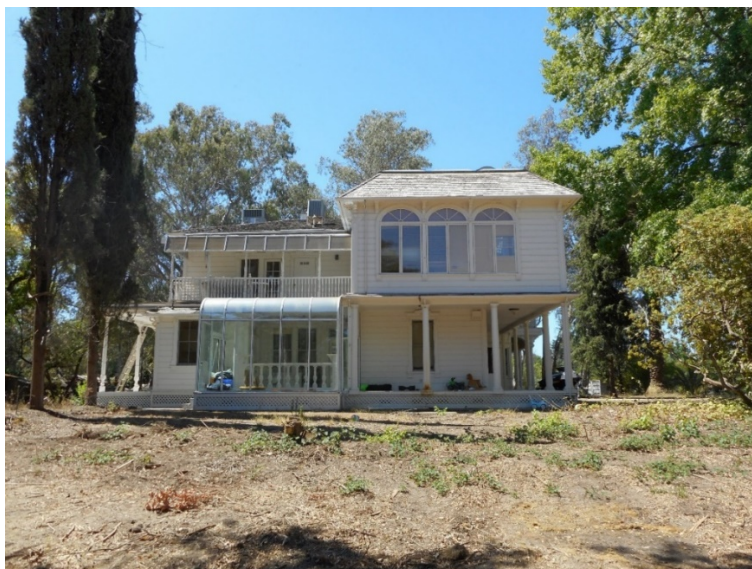
Photograph No. 2: North Elevation of c. 1875 Residence

The north, or side, elevation includes the same detailing as seen on the primary elevation – open porch with flat roof, pairs of round columns, horizontal siding, and wood framed, multi-lite, double hung sash style windows. The west portion of the residence, both first and second floors, forms a block and includes the open porch that wraps around from the west elevation. The east half of the elevation steps back from this front section.

Air conditioning units and skylights can be seen on the roof.

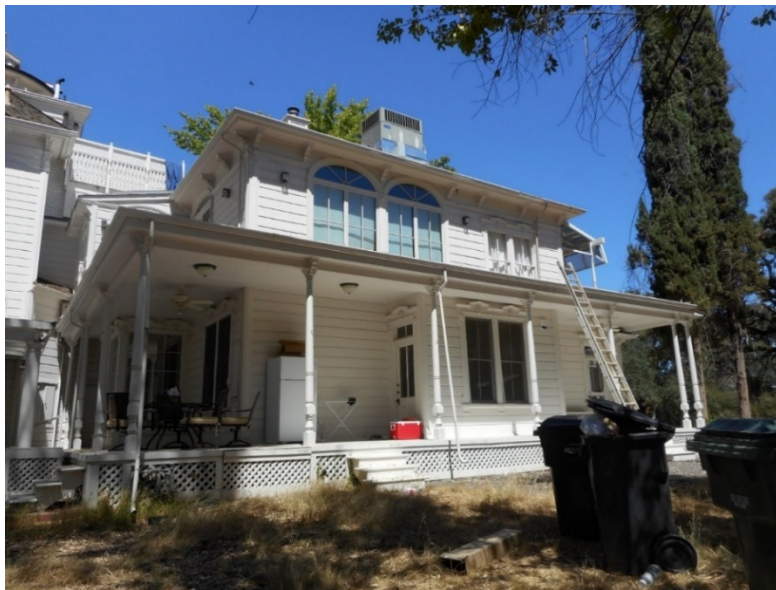
Photograph No. 3: East Elevation of c. 1875 Residence

The east, or rear, elevation, contains the same open porch details with wood columns supporting the flat roof, wood horizontal siding, and multiple single wood and glass door entrances. Some of the entrance doors have decorative carved wood screen doors at each entrance. Simple wood steps lead to the porch area. The same rectangular shaped, four-pane, double hung sash style windows are present. The windows have the same carved wood detailing over the windows as seen on the other elevations. The ceiling of the porch contains non-historic ceiling lights.

light window sections above the main, multi-light window. The other window is the same as seen on the other portions of the house – wood framed, rectangular shaped, double hung sash style with four panes of glass and the carved decorative section over the window.

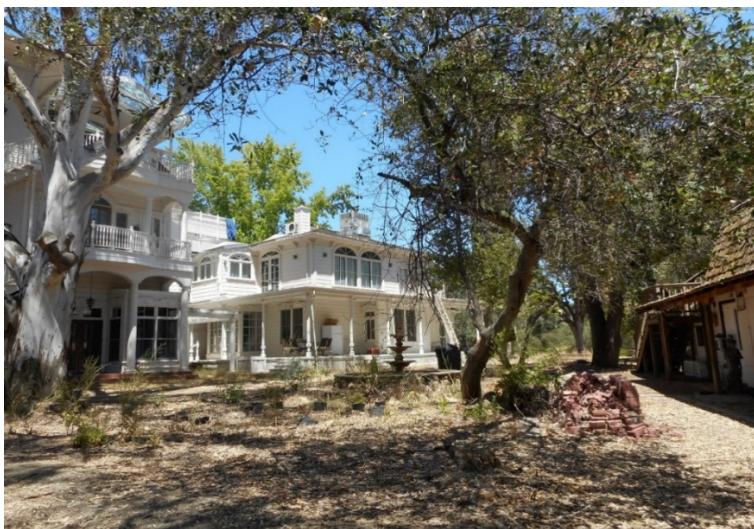
Photograph No. 4: South and East Elevations of c. 1875 Residence

The south, or side, elevation is the location of the large addition constructed in 1985. Only a portion of the original south elevation remains as approximately half of the west end of the south elevation was removed to facilitate the construction of the addition. The remaining east half of the south elevation contains the same exterior siding and open porch details. An additional single wood and glass door entrance is present at the juncture of the old and new portions. Wood stairs with a wood railing lead to the porch area and door entrance area. A large, three-sided, wood framed, full height, fixed pane, multi-lite window section is present on the side wall of the house. Three large window sections comprise this window element, creating a quasi-bay window effect. This area provides a wide viewing area from the dining area on the interior of the house. Double hung sash style windows with the same four-pane configuration, and the carved wood detailing, are present on the south wall.

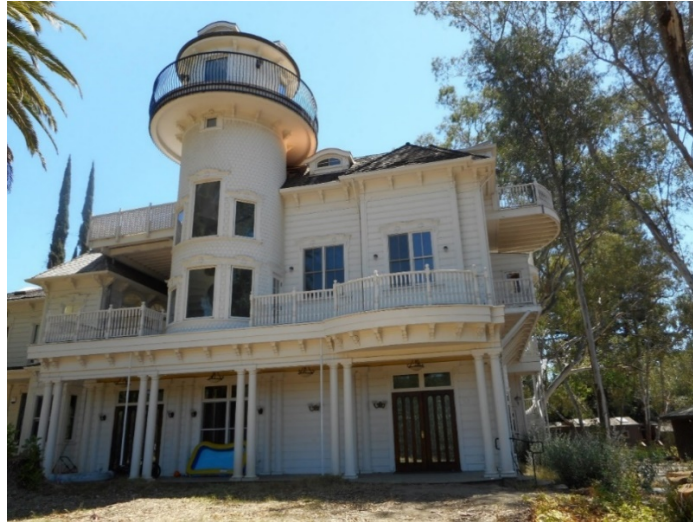
Photograph No. 5: West Elevation of Turtletaub Addition

The west, or primary, elevation contains numerous components on the various levels of the residence. The main entrance is centered on the west elevation and contains a carved wood door with stained glass inserts and rectangular transoms. The entrance is recessed under an open porch area. The roof of the porch is supported by pairs of round, wood columns with simple capitals. The underside of the porch roof contains exposed rafters. A secondary entrance with glass panels is located north of the main entrance. Metal lights are present at various points along the ground floor elevation. The dominant feature of the west elevation is a four-story, round tower with fish scale shingles. The upper portion of the tower includes a round, metal railing and small balcony area. Windows are present on each level of the tower and the windows contain the same carved detailing as seen on the original residence windows.

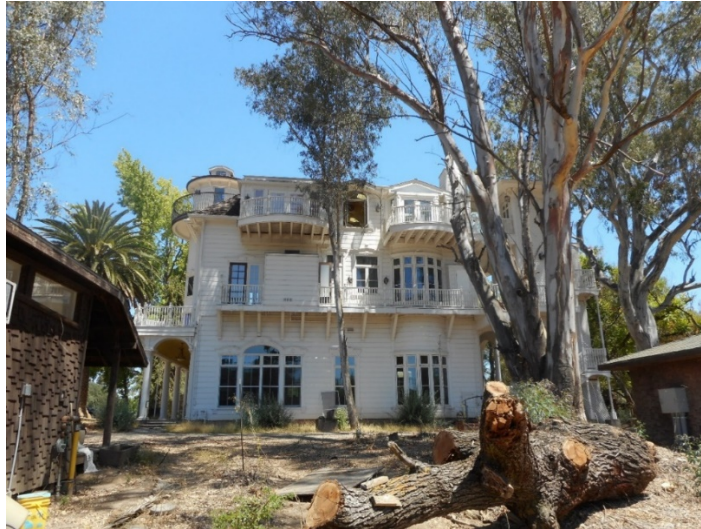
Photograph No. 6: South Elevation of Turtletaub Addition

The south, or side, elevation includes two short sets of stairs, one at the west end to access the front porch area, and the other at the east end of the elevation to provide access to the rear elevation. The south side of the porch section has a curved roofline.

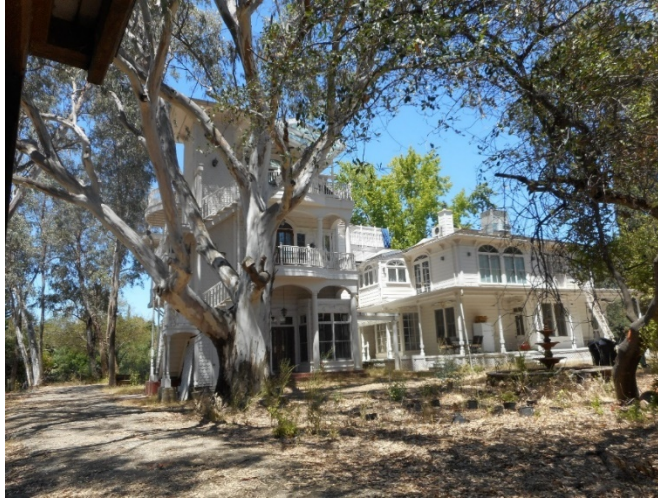
Photograph No. 7: East Elevation of Turtletaub Addition

The east, or rear elevation contains an open porch on the ground floor with a flat roof supported by round columns with simple capitals. Arches fill the spaces between the columns. Large, wood framed, French doors lead onto the porch from the interior. A large, wood framed window with multiple lights is present on the ground floor of the rear elevation.

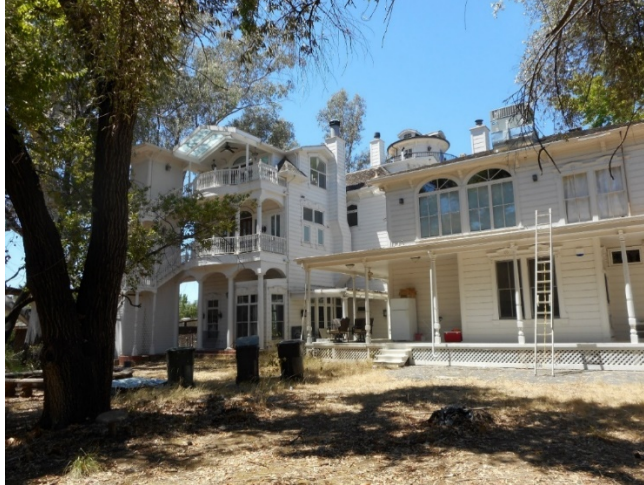
Photograph No. 8: North Elevation of Turtleaub Addition

The second and third floors have large balconies with turned wood railings. Multi-lite French doors lead onto the balconies from the interior. The second-floor balcony has round wood columns to support the third-floor balcony. Arches separate the columns and match the ground floor column detail. The second-floor balcony is rectangular shaped; the third-floor balcony is curved.
