PLANNING PUBLIC HEARING - APPLICATION

Town of Woodside

Tree Inventory, Assessment and Protection

988 Godetia Drive Woodside, CA 94062

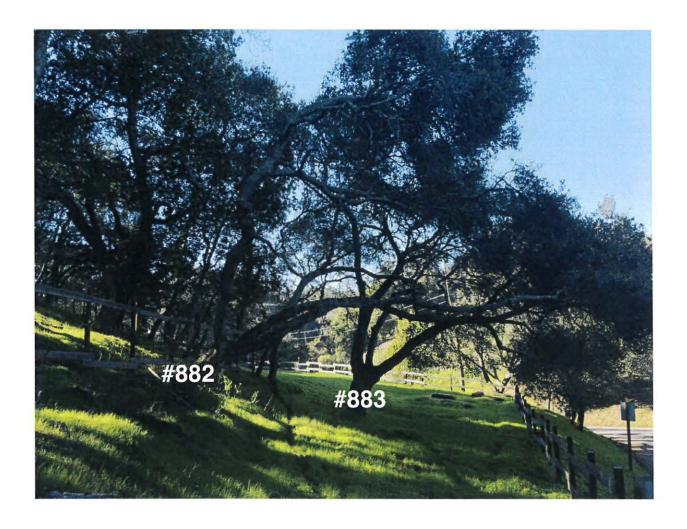
C3: Trees #882 and #883
