Preliminary
Habitat Restoration Plan

501 Sand Point Road

Santa Barbara County

November 2020

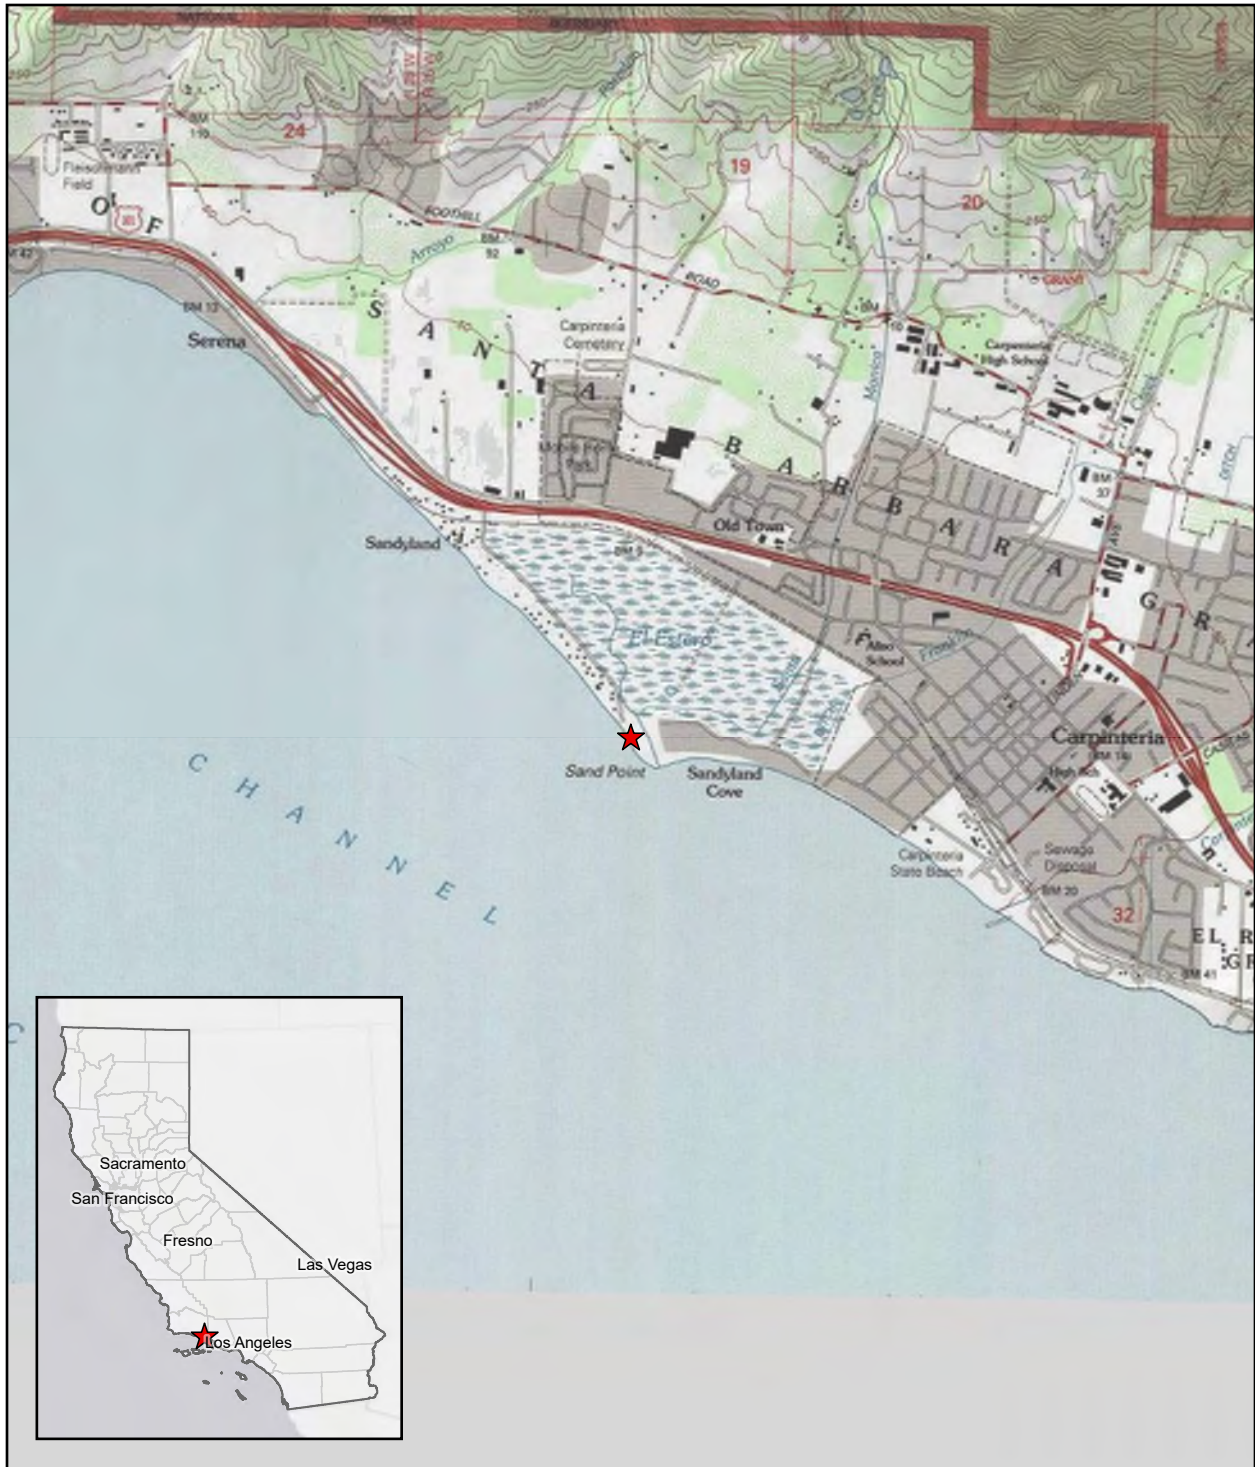
Figure 1. United States Geological Survey Topographic Map

Approximate coordinates for the center of the Property are 34.3975° N / -119.5380° W (WGS84) in the United States Geological Survey (USGS) 7.5-minute topographic quadrangle (Figure 1). Elevation ranges from approximately 0 to 16 feet above mean sea level. The Property is located in an unincorporated portion of Santa Barbara County within the Coastal Zone.

The proposed Restoration Project is located west of the mouth of the Carpinteria Salt Marsh (CSM) depicted in Figures 1 and 2. The Property is located at the end of Sand Point Road about 1.25-miles from the intersection with Santa Claus Lane near southbound U.S. Highway 101 on ramp within a much larger 8.95-acre parcel (APN 004-098-011), the balance of which will be either restored or both restored and permanently protected as a result of the Project.

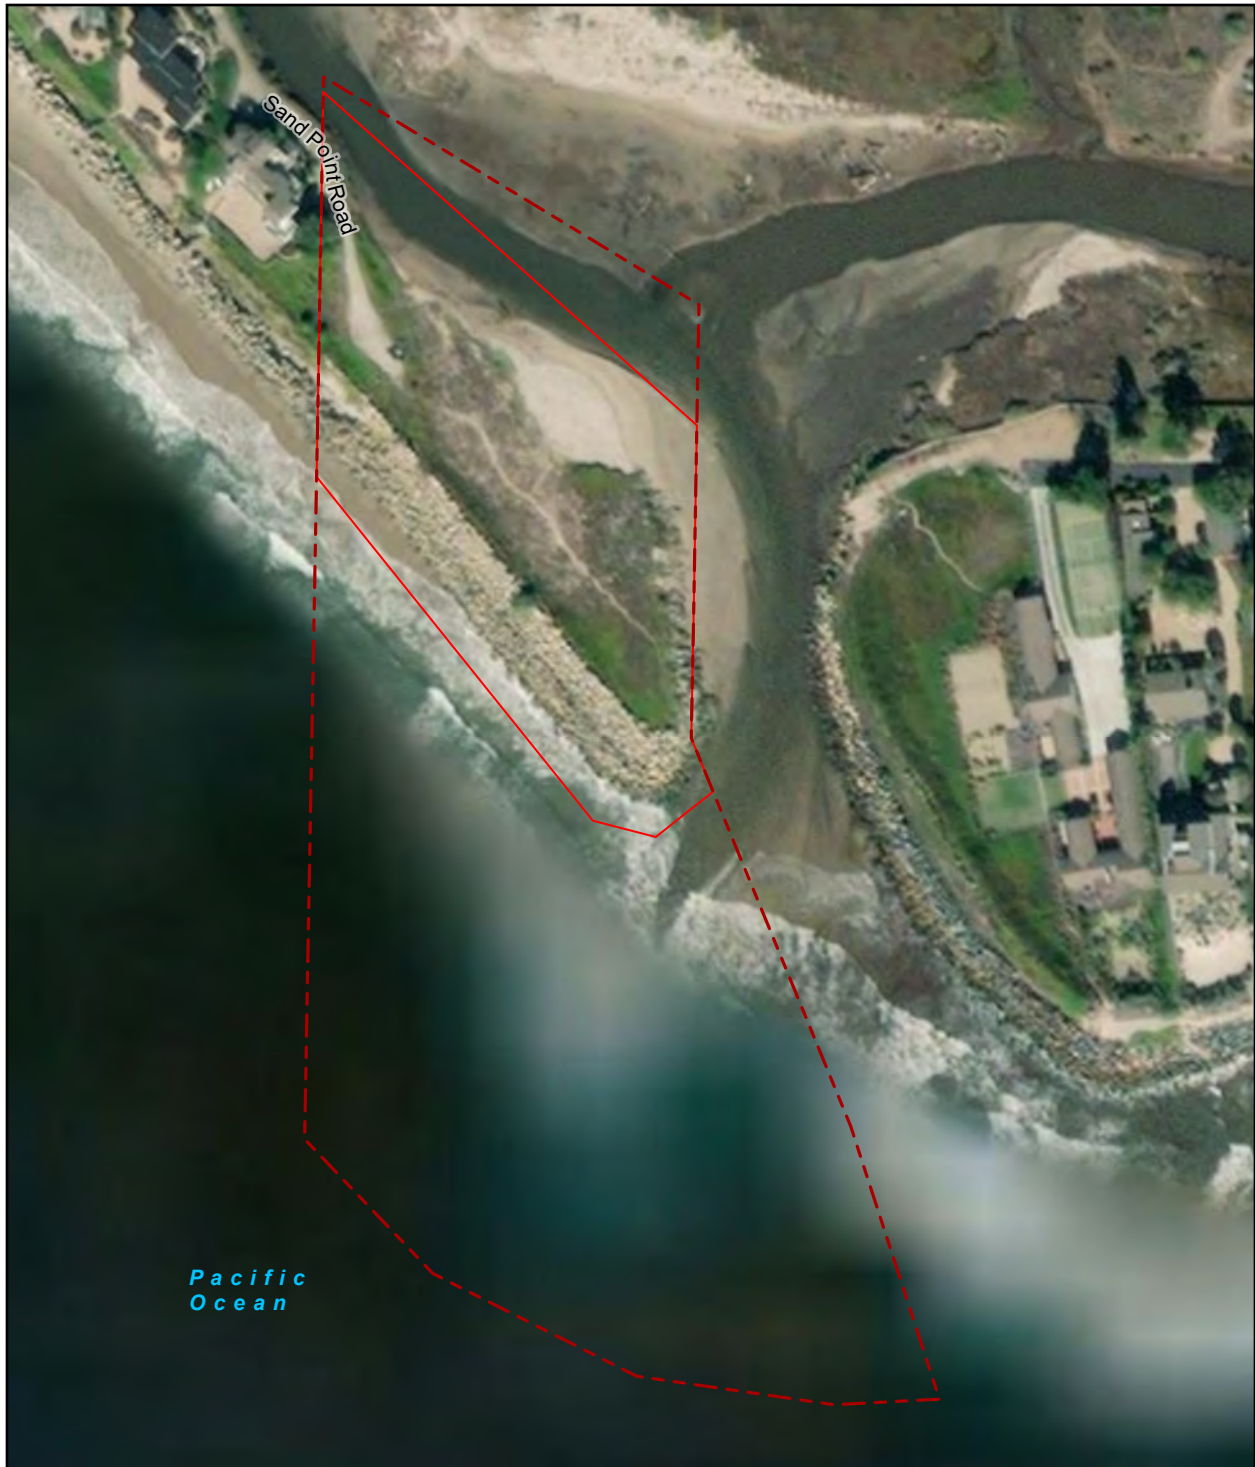
Figure 2. Aerial Photograph

The parcel extends north into CSM, and south into the Pacific Ocean (Figure 2). North of the parcel is CSM, a 230-acre estuary that lies within the jurisdictional boundaries of Santa Barbara County. Portions of CSM are privately owned, and 120 acres known as the Carpinteria Salt Marsh Reserve (CSMR) are owned and managed by the University of California. CSM is managed by the University as a single reserve within an integrated ecosystem (Ferren et al. 1997).

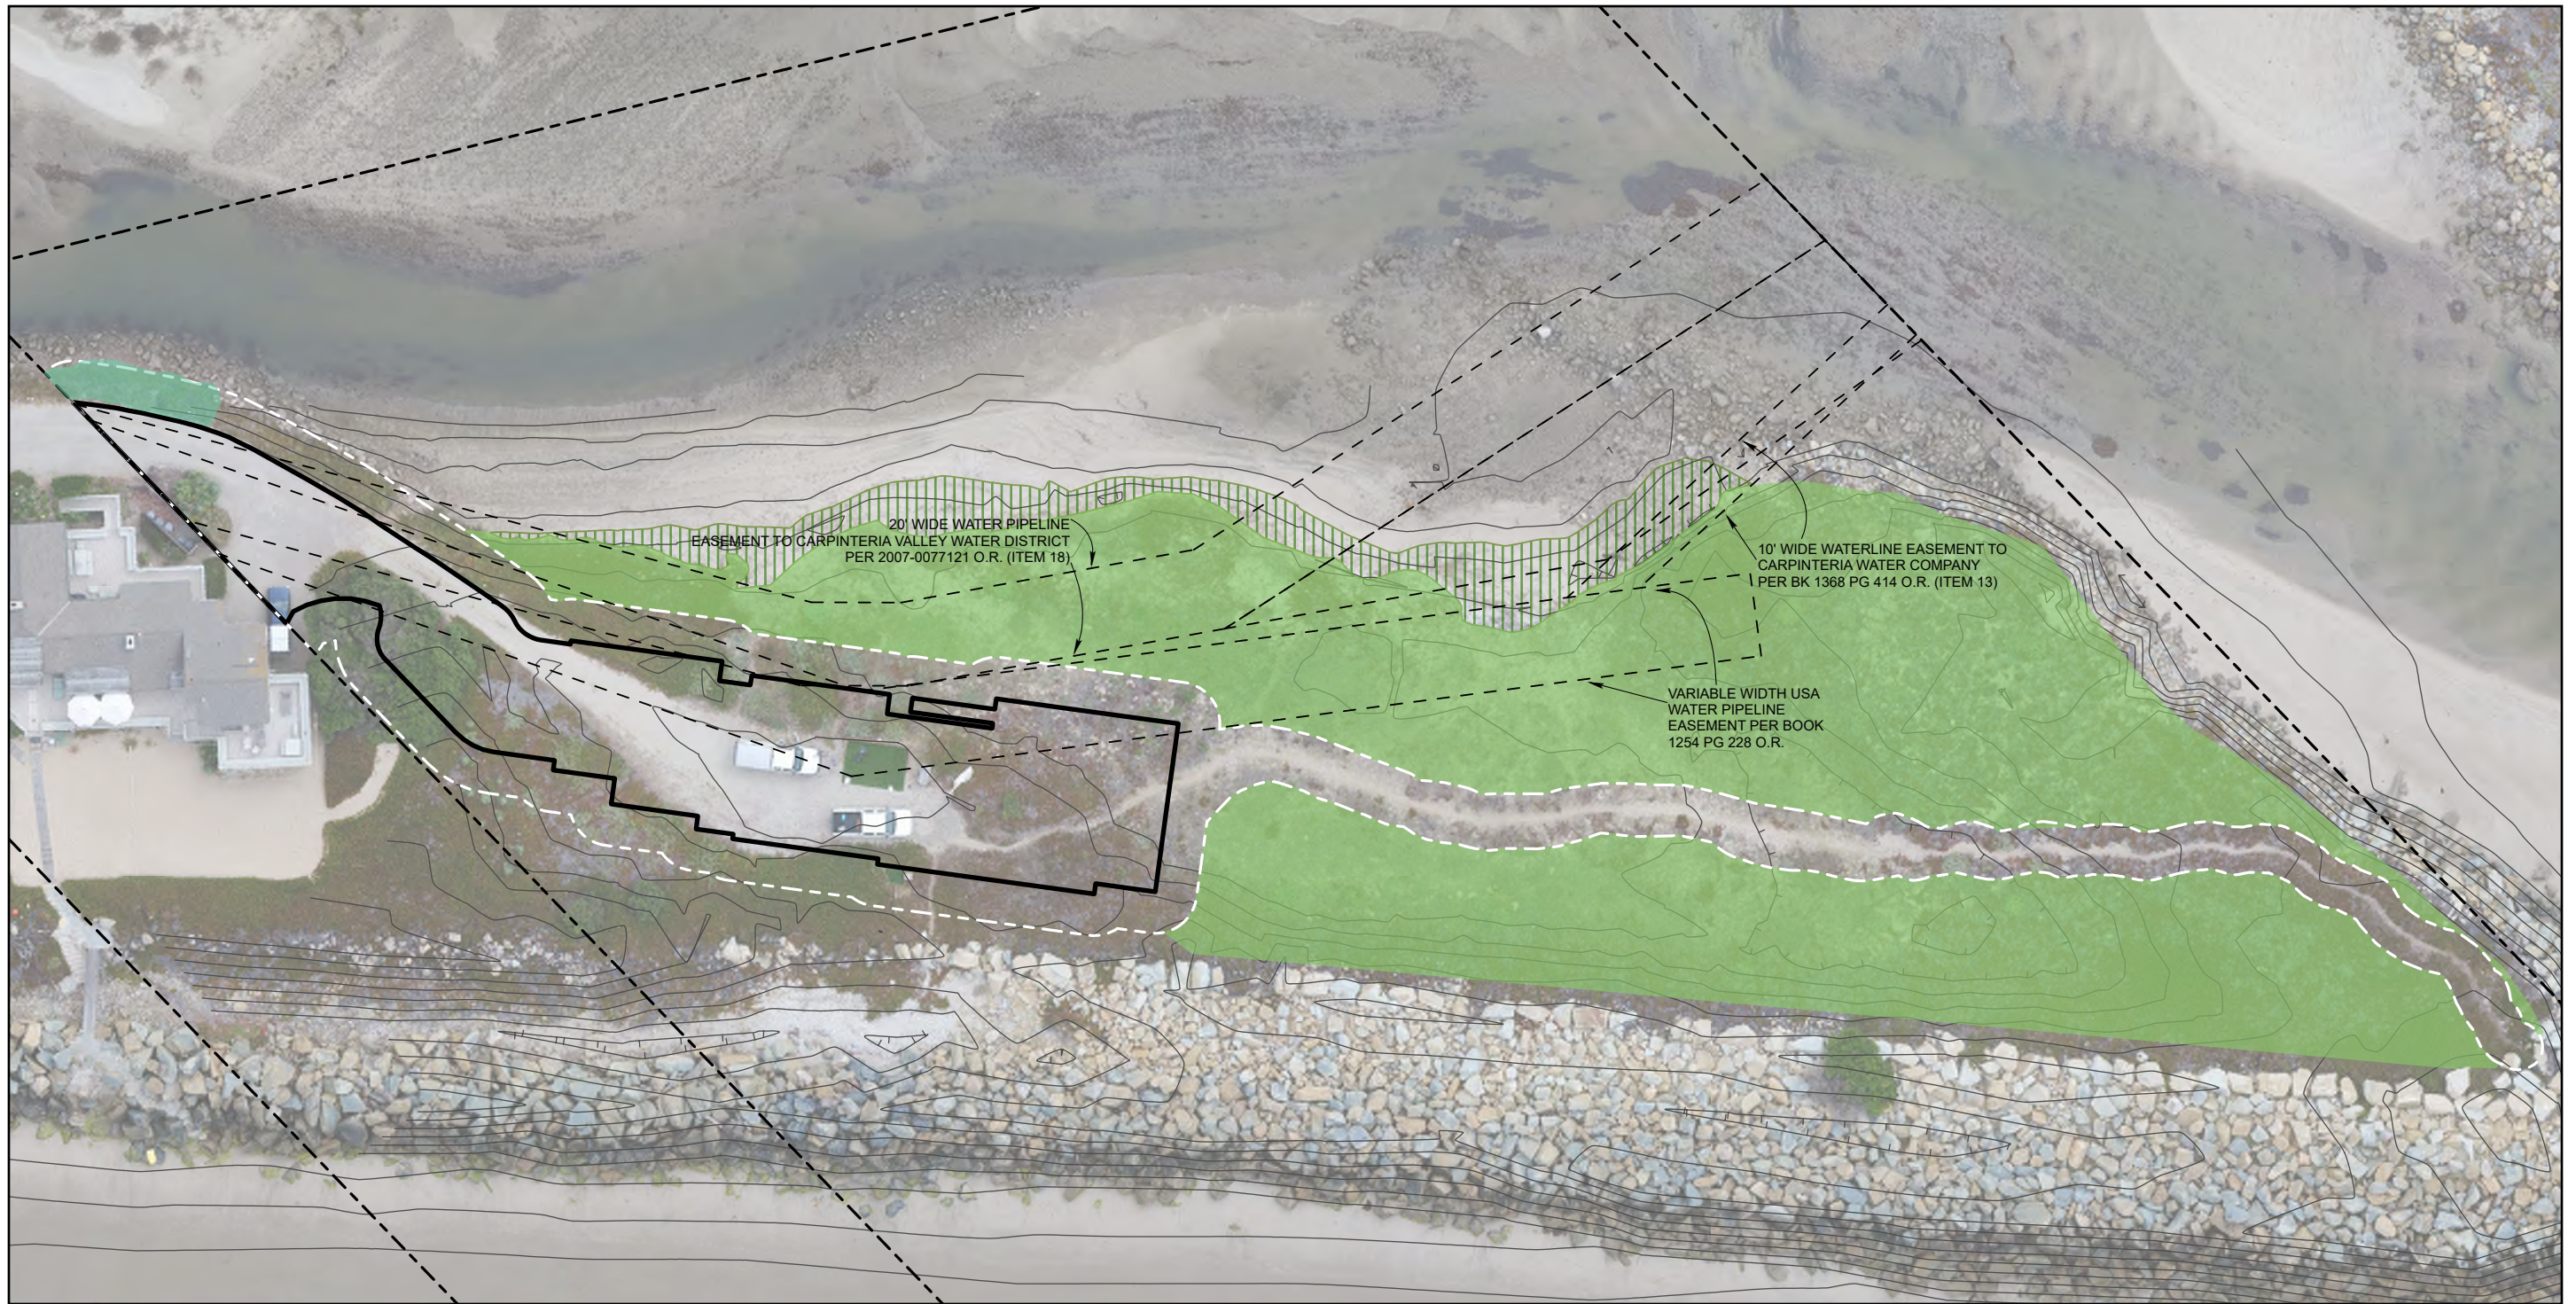
Figure 4. Vegetation Restoration Plan

- Restoration Area (0.67 acre)
- Building Footprint and Driveway
- Alkali Heath Marsh to Preserve (0.01 acre)
- Sandy Beach/Salt Grass to Preserve (0.07 acre)
- Native 10-Foot Access Buffer

*Remainder to be revegetated with native species

A 2:1 mitigation ratio was applied for temporary impacts and a 4:1 ratio for permanent impacts (Table 3, Figure 4). A 4:1 ratio for permanent impacts would require 0.32 acre of dune mat habitat, and the 2:1 mitigation ratio for temporary impacts would require 0.22 acre, for a total of 0.54 acre (23,522 square feet) of restored dune mat habitat.

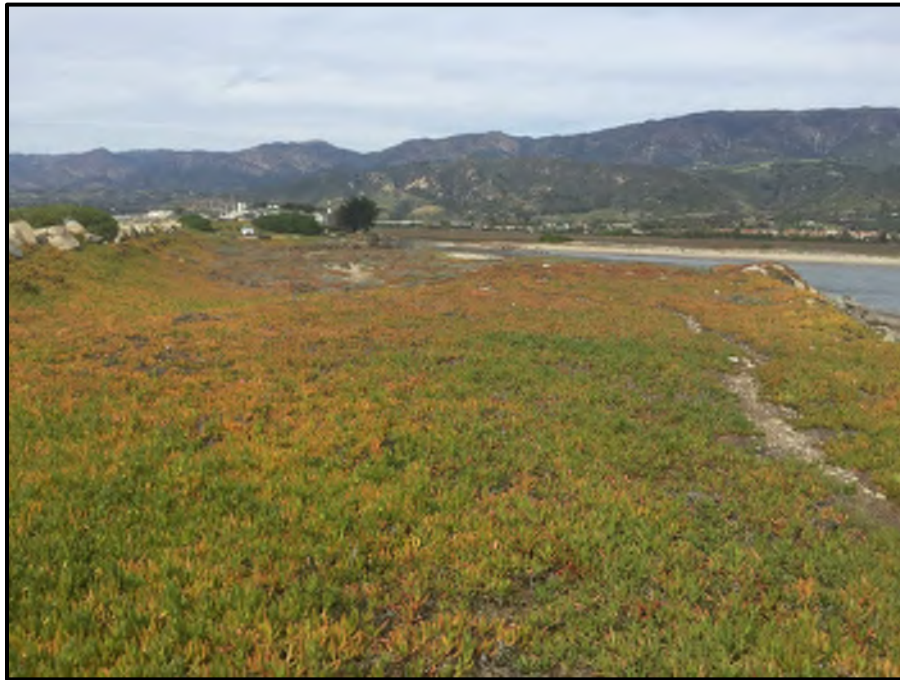
Photo 1. Dense ice plant mats habitat within Restoration Site. View northwest, February 28, 2020.

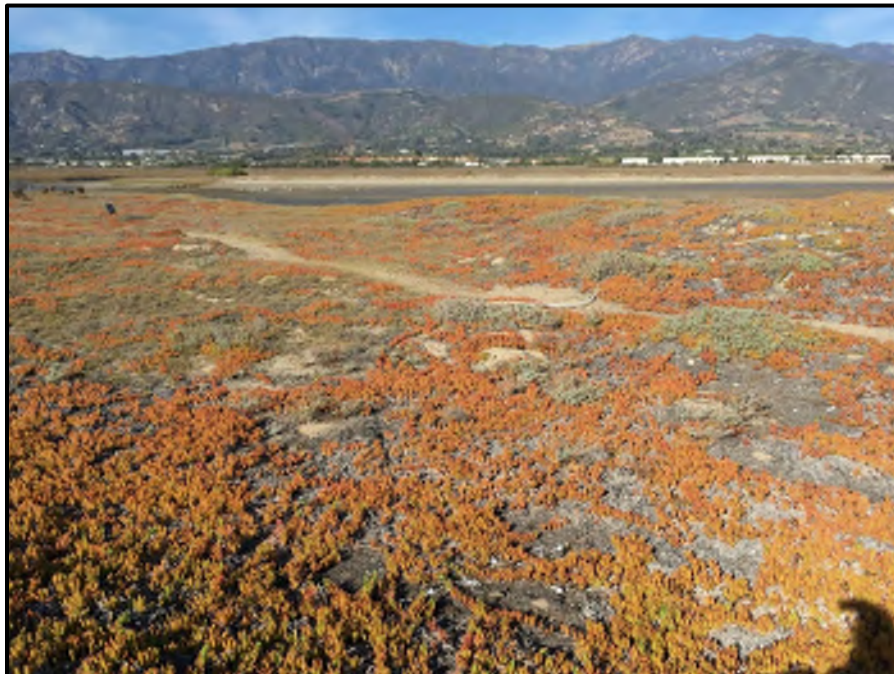
Photo 2. Degraded Dune mat habitat with scattered ice plant as dominant species within Restoration Site. View north, November 8, 2017.

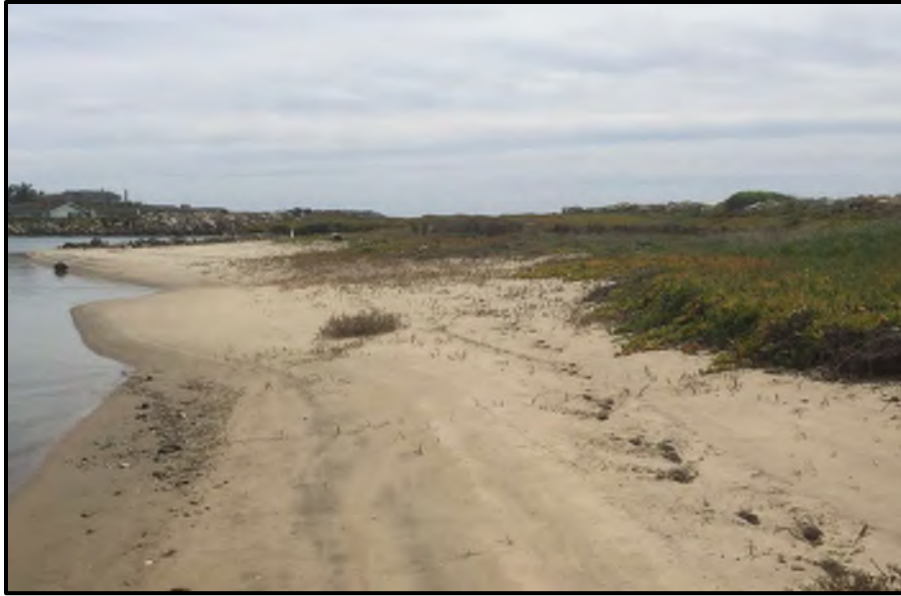
Photo 3. Sandy beach with degraded dune mat in background. View southeast, February 28, 2020.

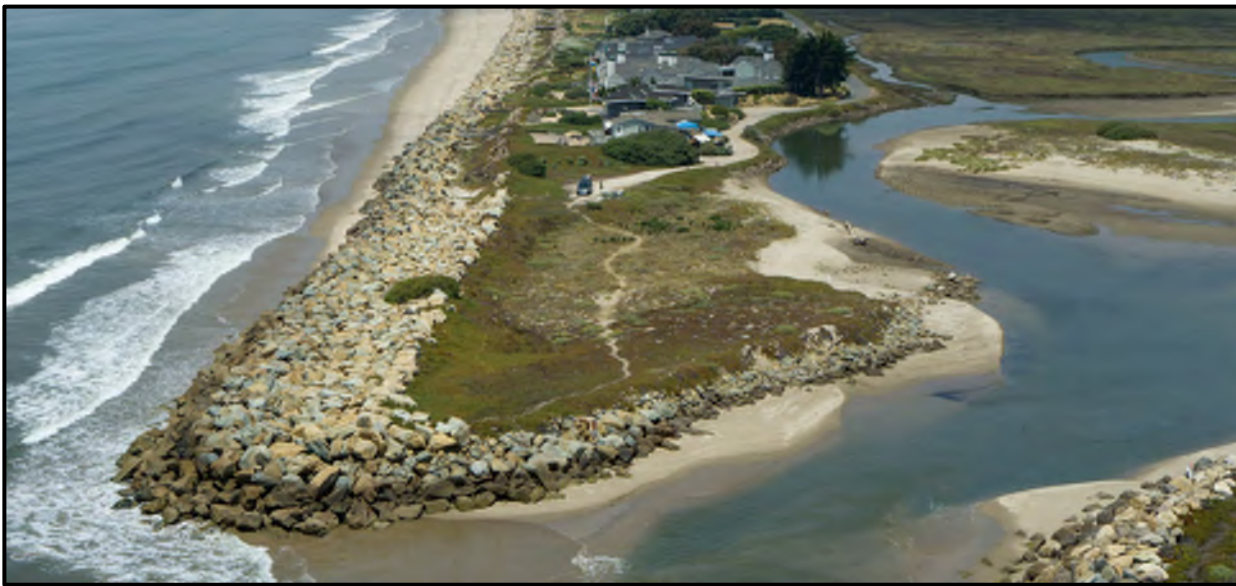
Photo 4. Myoporum, pampas grass, and ice plant need to be removed from the property. Drone imagery by Kyle Nessen. View west, July 22, 2019.

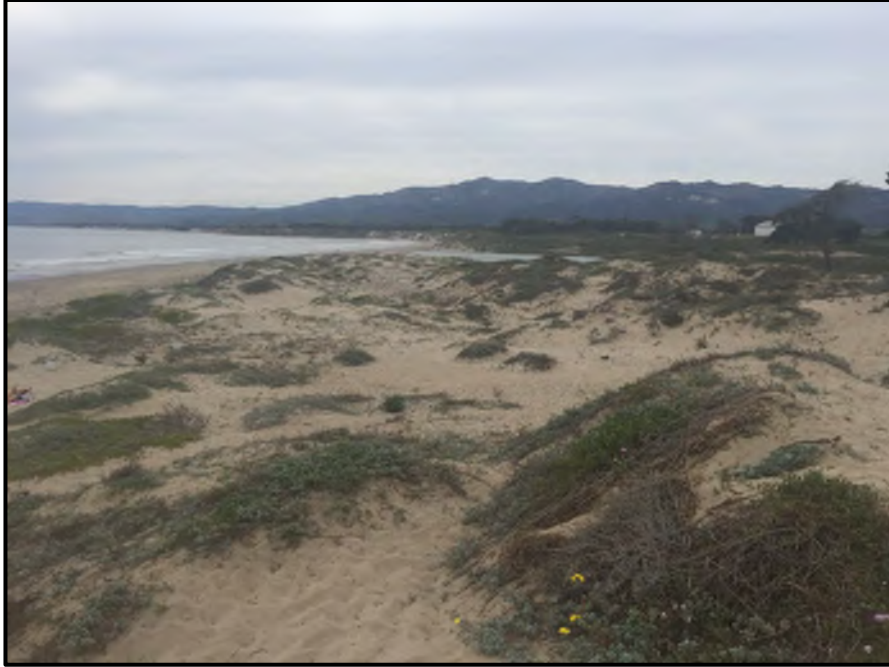
Photo 5. Coal Oil Point Reference Site showing intact dune mat habitat. View northwest, February 27, 2020.

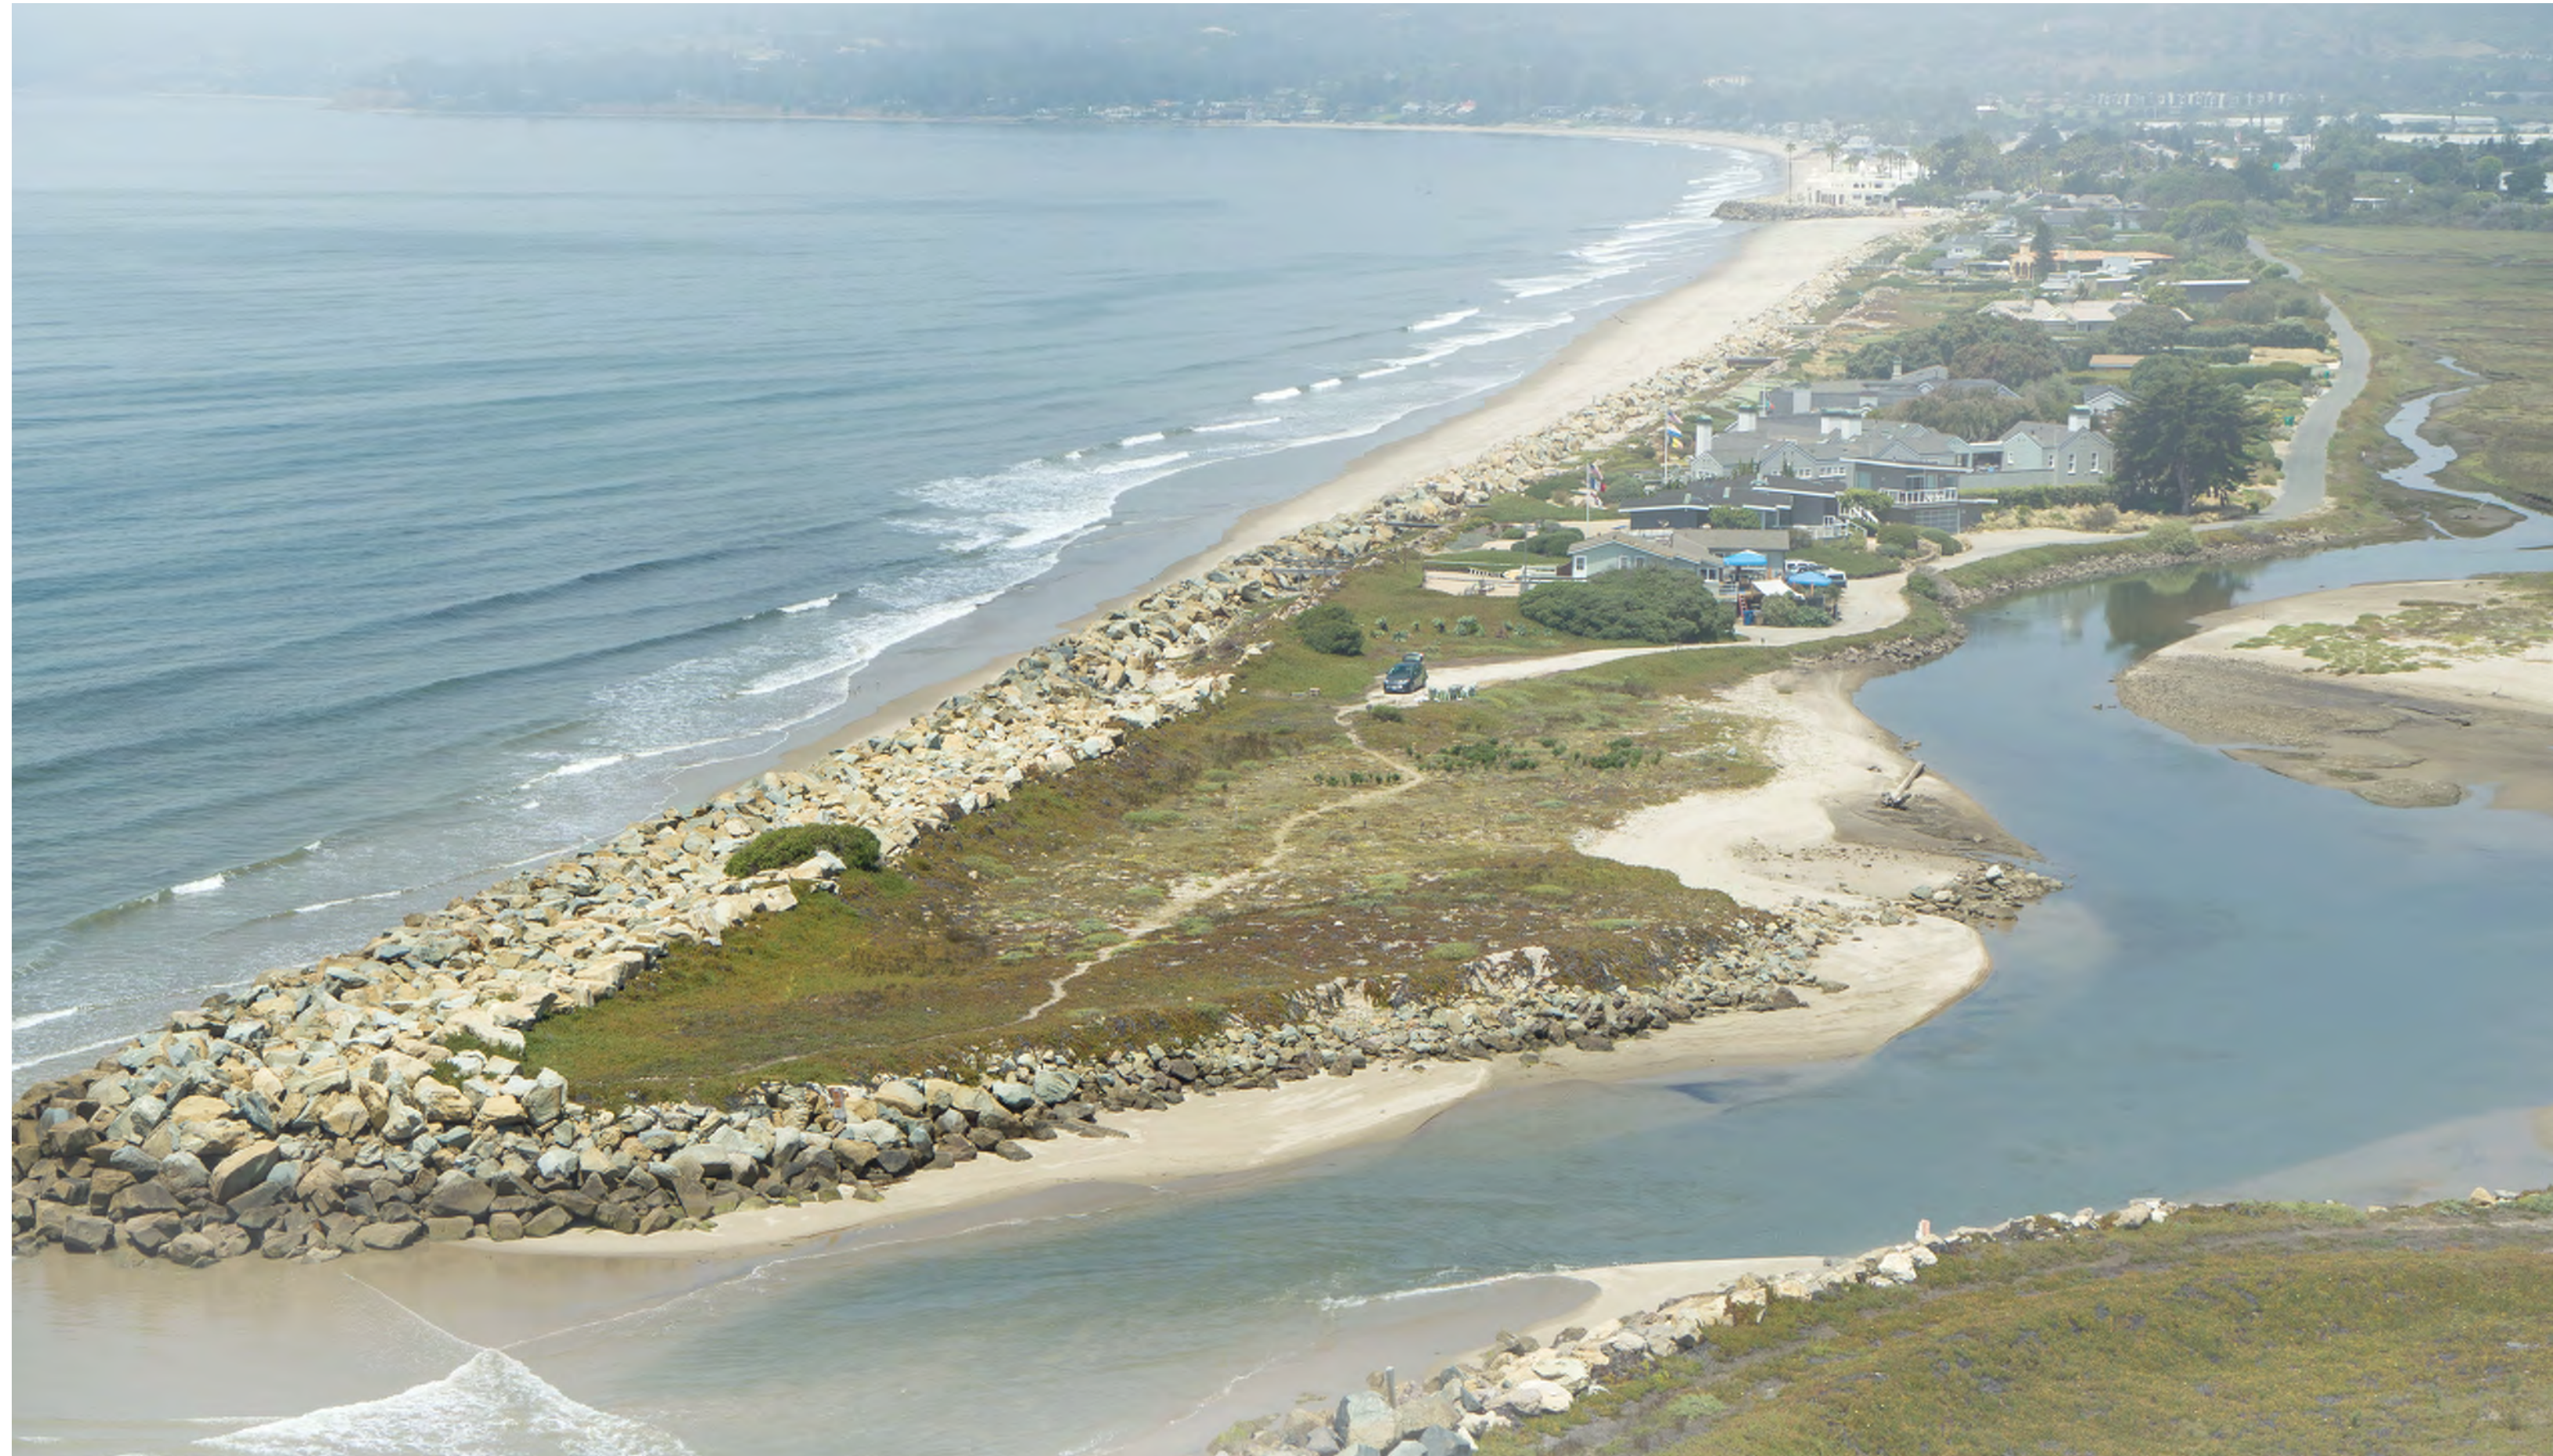
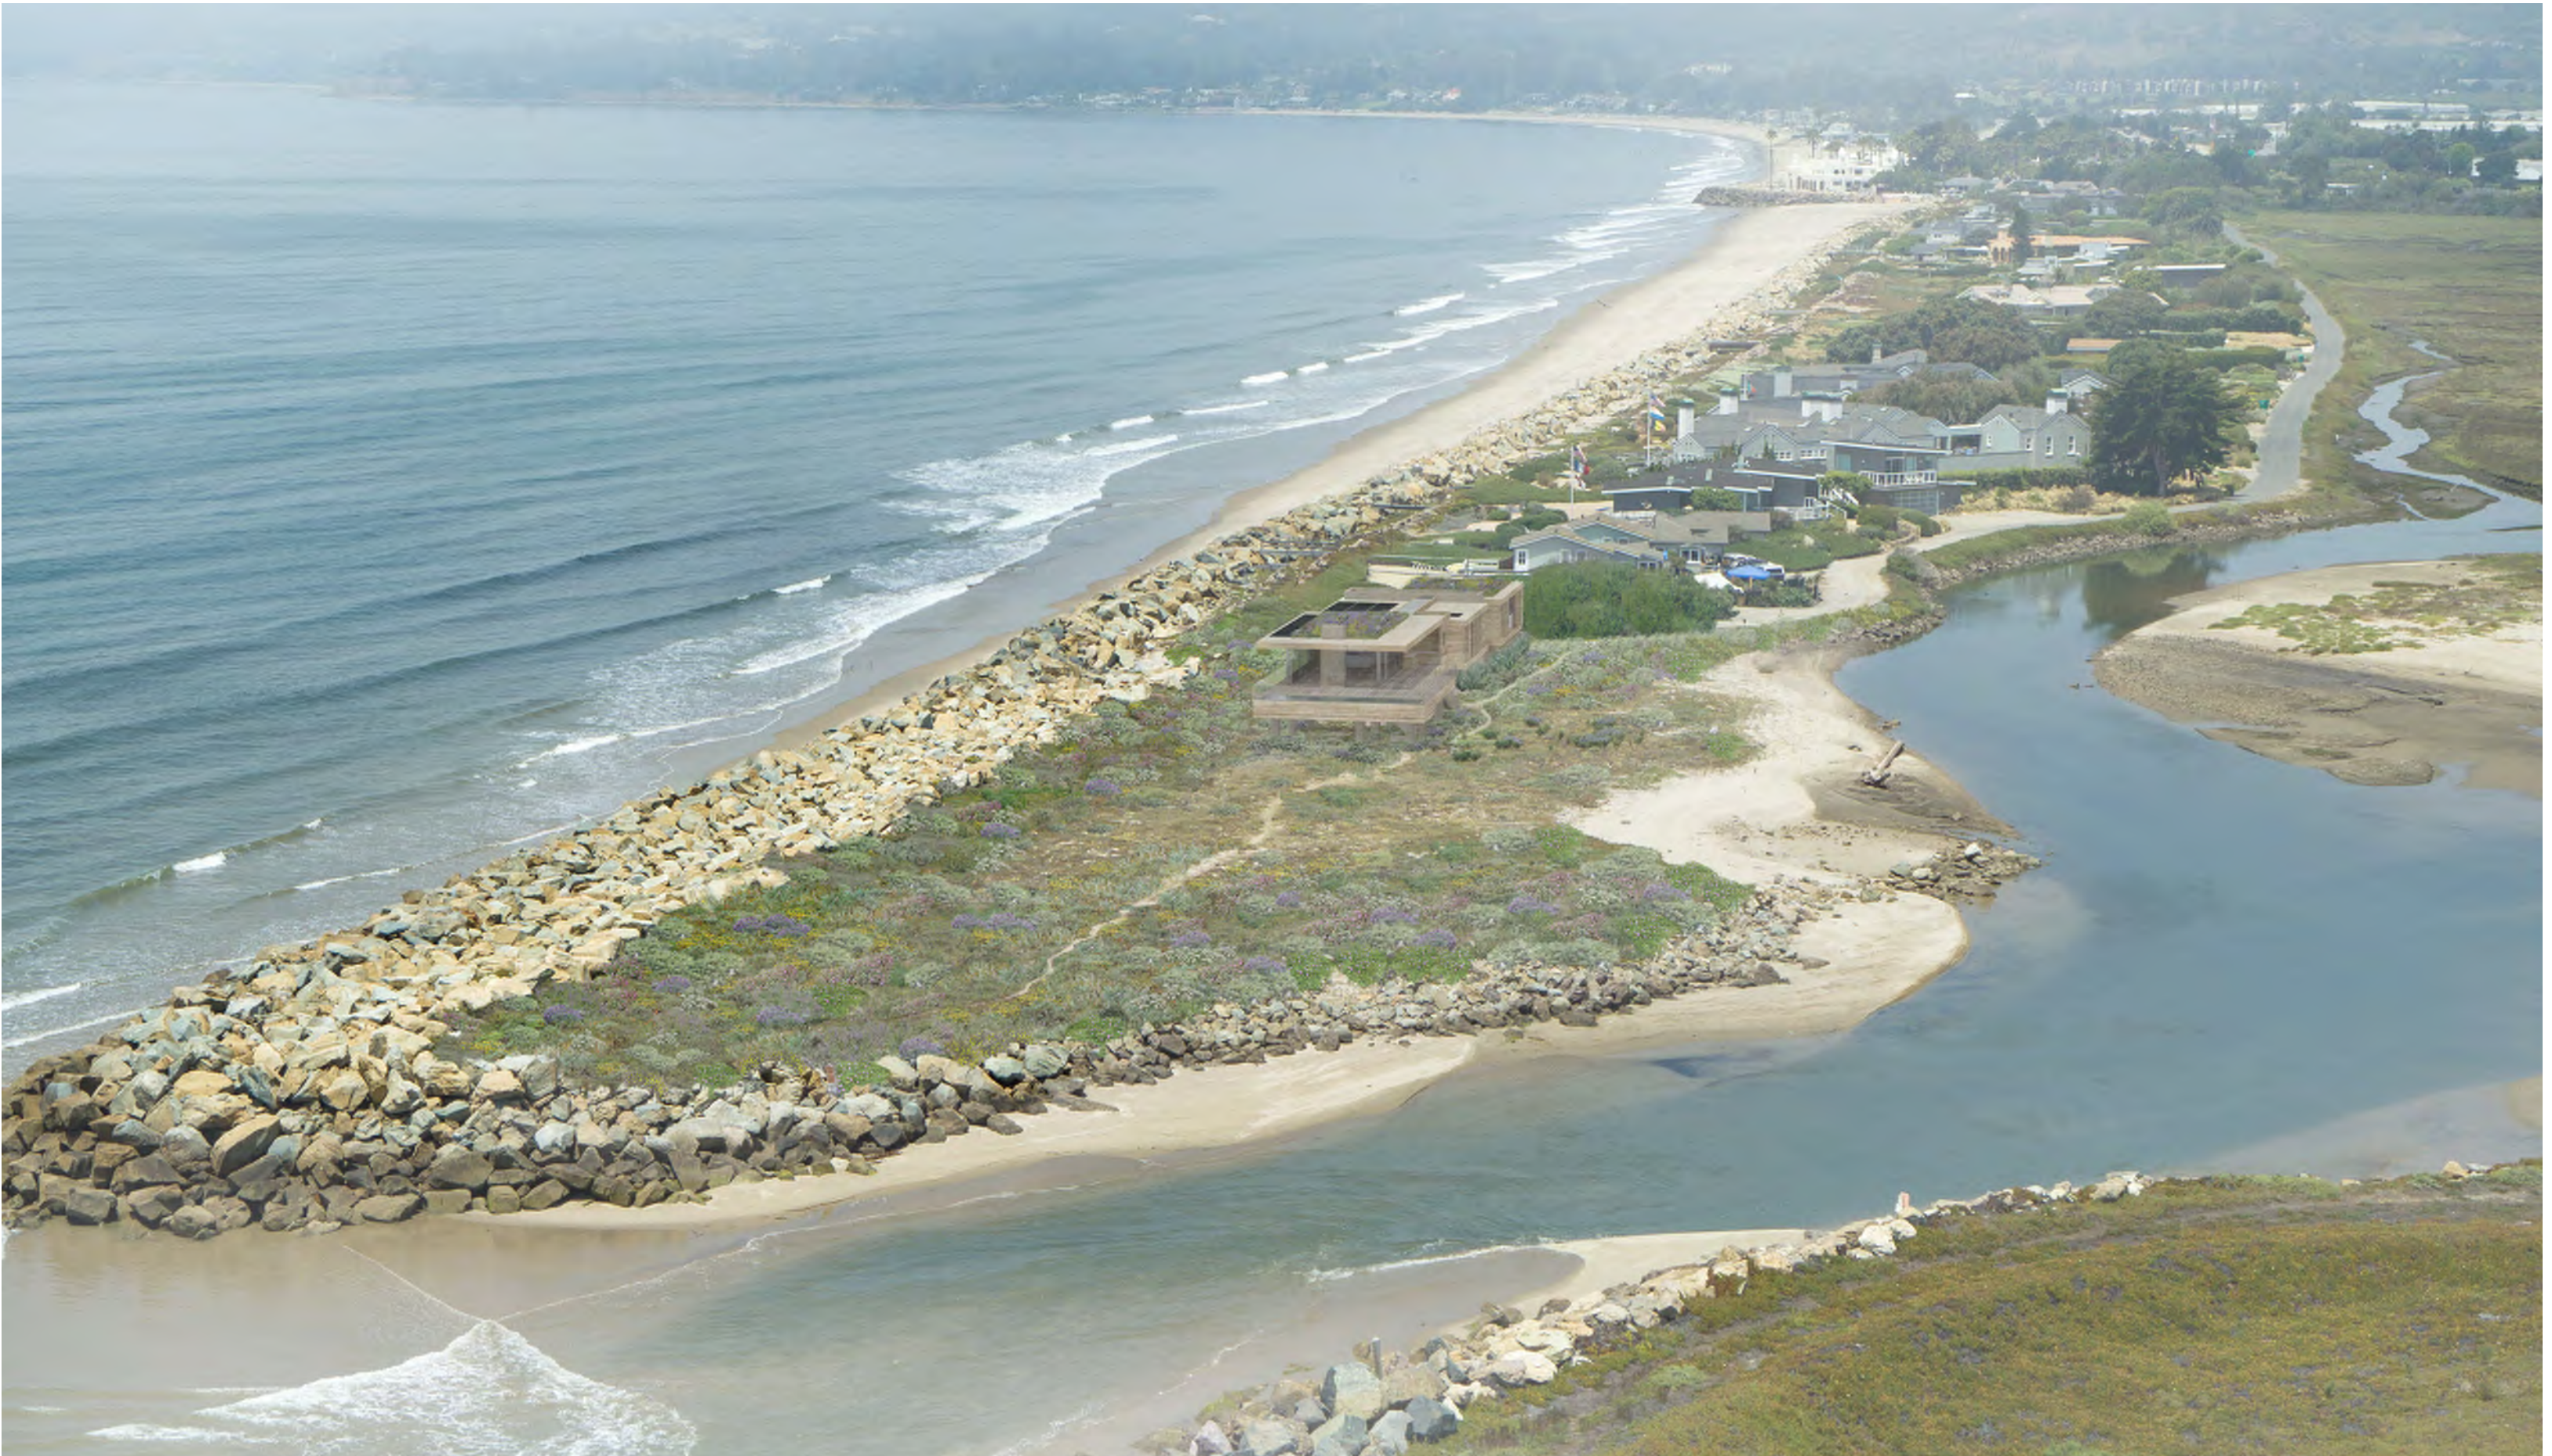
Before

After
