City of Beaumont – 2nd Street Improvement

**WESTERN RIVERSIDE COUNTY MULTIPLE SPECIES
HABITAT CONSERVATION PLAN CONSISTENCY
ANALYSIS**

**2nd STREET IMPROVEMENT
RIVERSIDE COUNTY, BEAUMONT, CALIFORNIA**

September 26, 2022

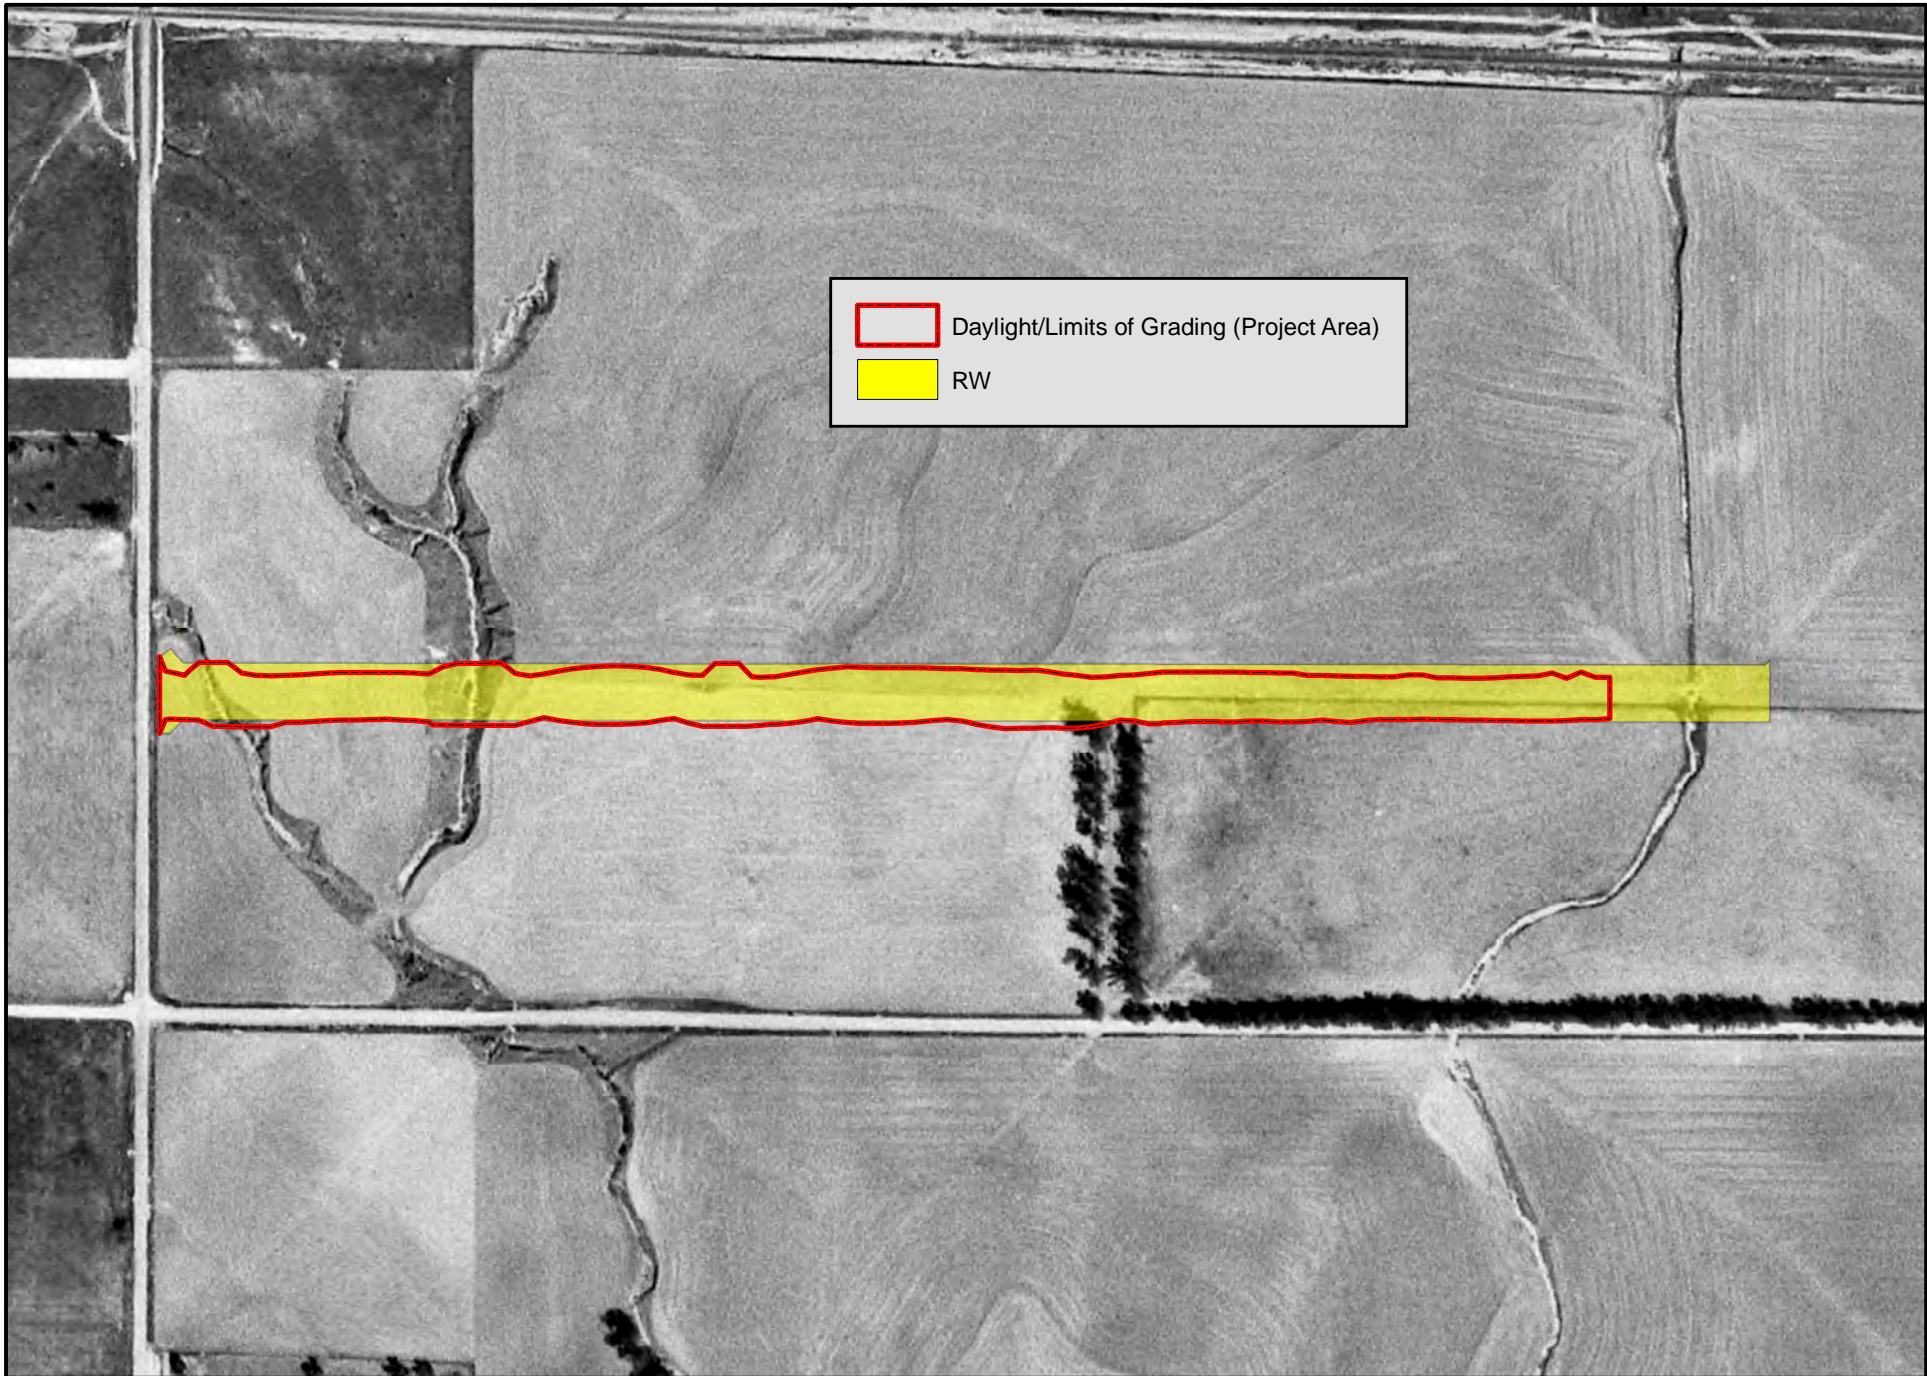
FIGURE 9
1966 Aerial
Photograph

In 1966 the Project and its immediate vicinity was similar to the current conditions though the primary difference was no development was present. The three ephemeral washes were present; however, Potrero Creek in the eastern end followed a more north/south alignment and was located a bit further east from the Project. The upland areas in the vicinity were likely utilized for dryland agriculture. Pennsylvania Avenue and 1st Street to the south were unimproved, dirt roads at the time. *Figure 9 – 1966 Aerial Photograph* (Page 18) depicts the Project and the immediate surrounding area.

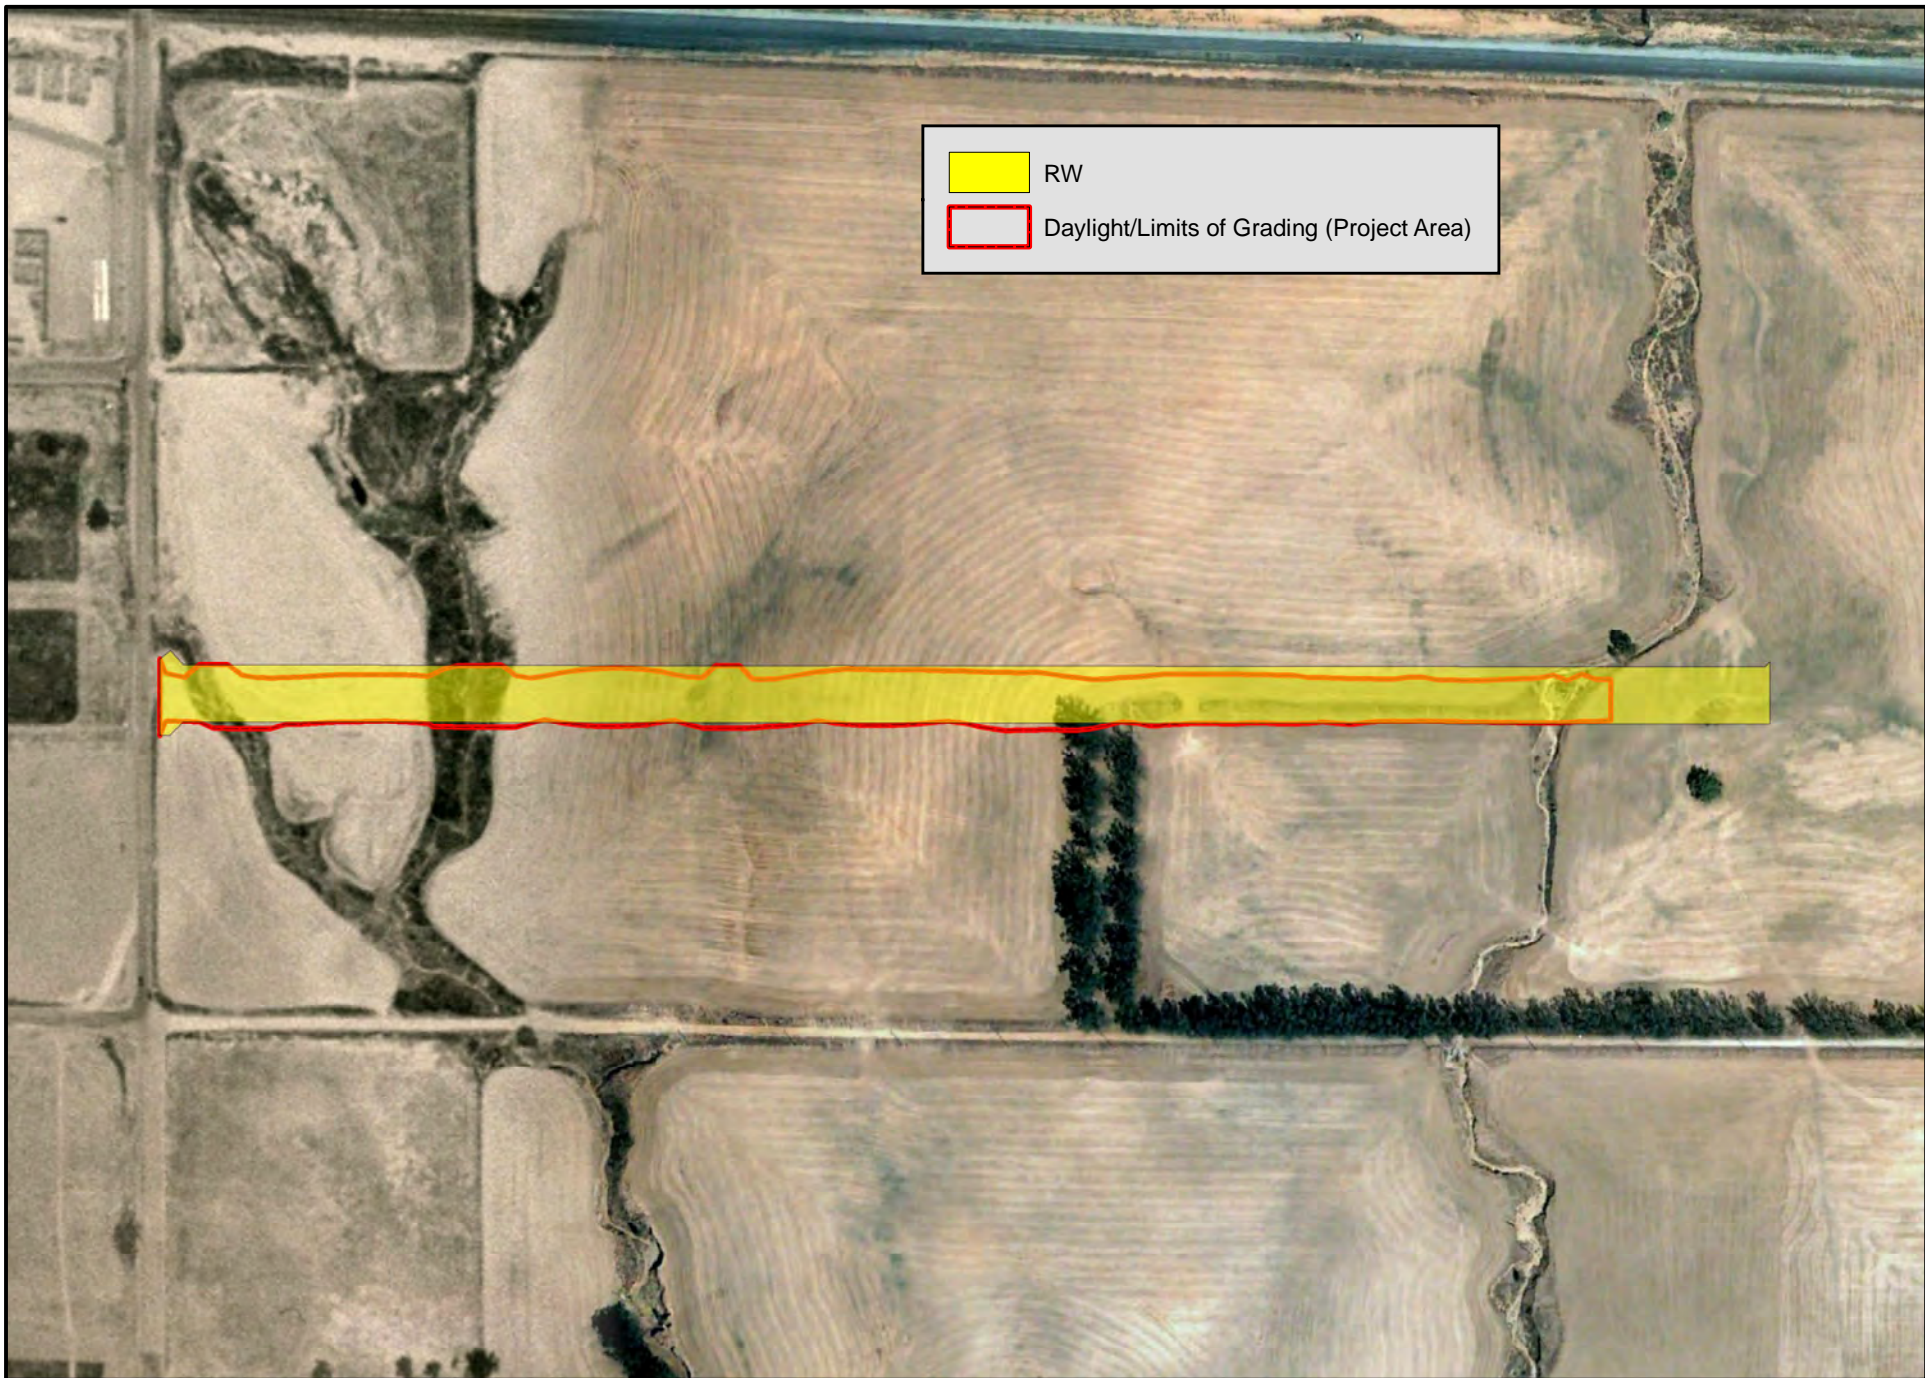
FIGURE 10
2003 Aerial
Photograph

The conditions in 2003 were similar to those in 1966. Potrero Creek appeared wider and veered southwest near the Project. Pennsylvania Avenue and 1st Street were still dirt roads and the planted trees along 1st and perpendicular to the Project were also still present. Dryland agriculture was likely still the primary land use in the vicinity. *Figure 10 – 2003 Aerial Photograph* (Page 19) depicts the Project and the immediate surrounding area.

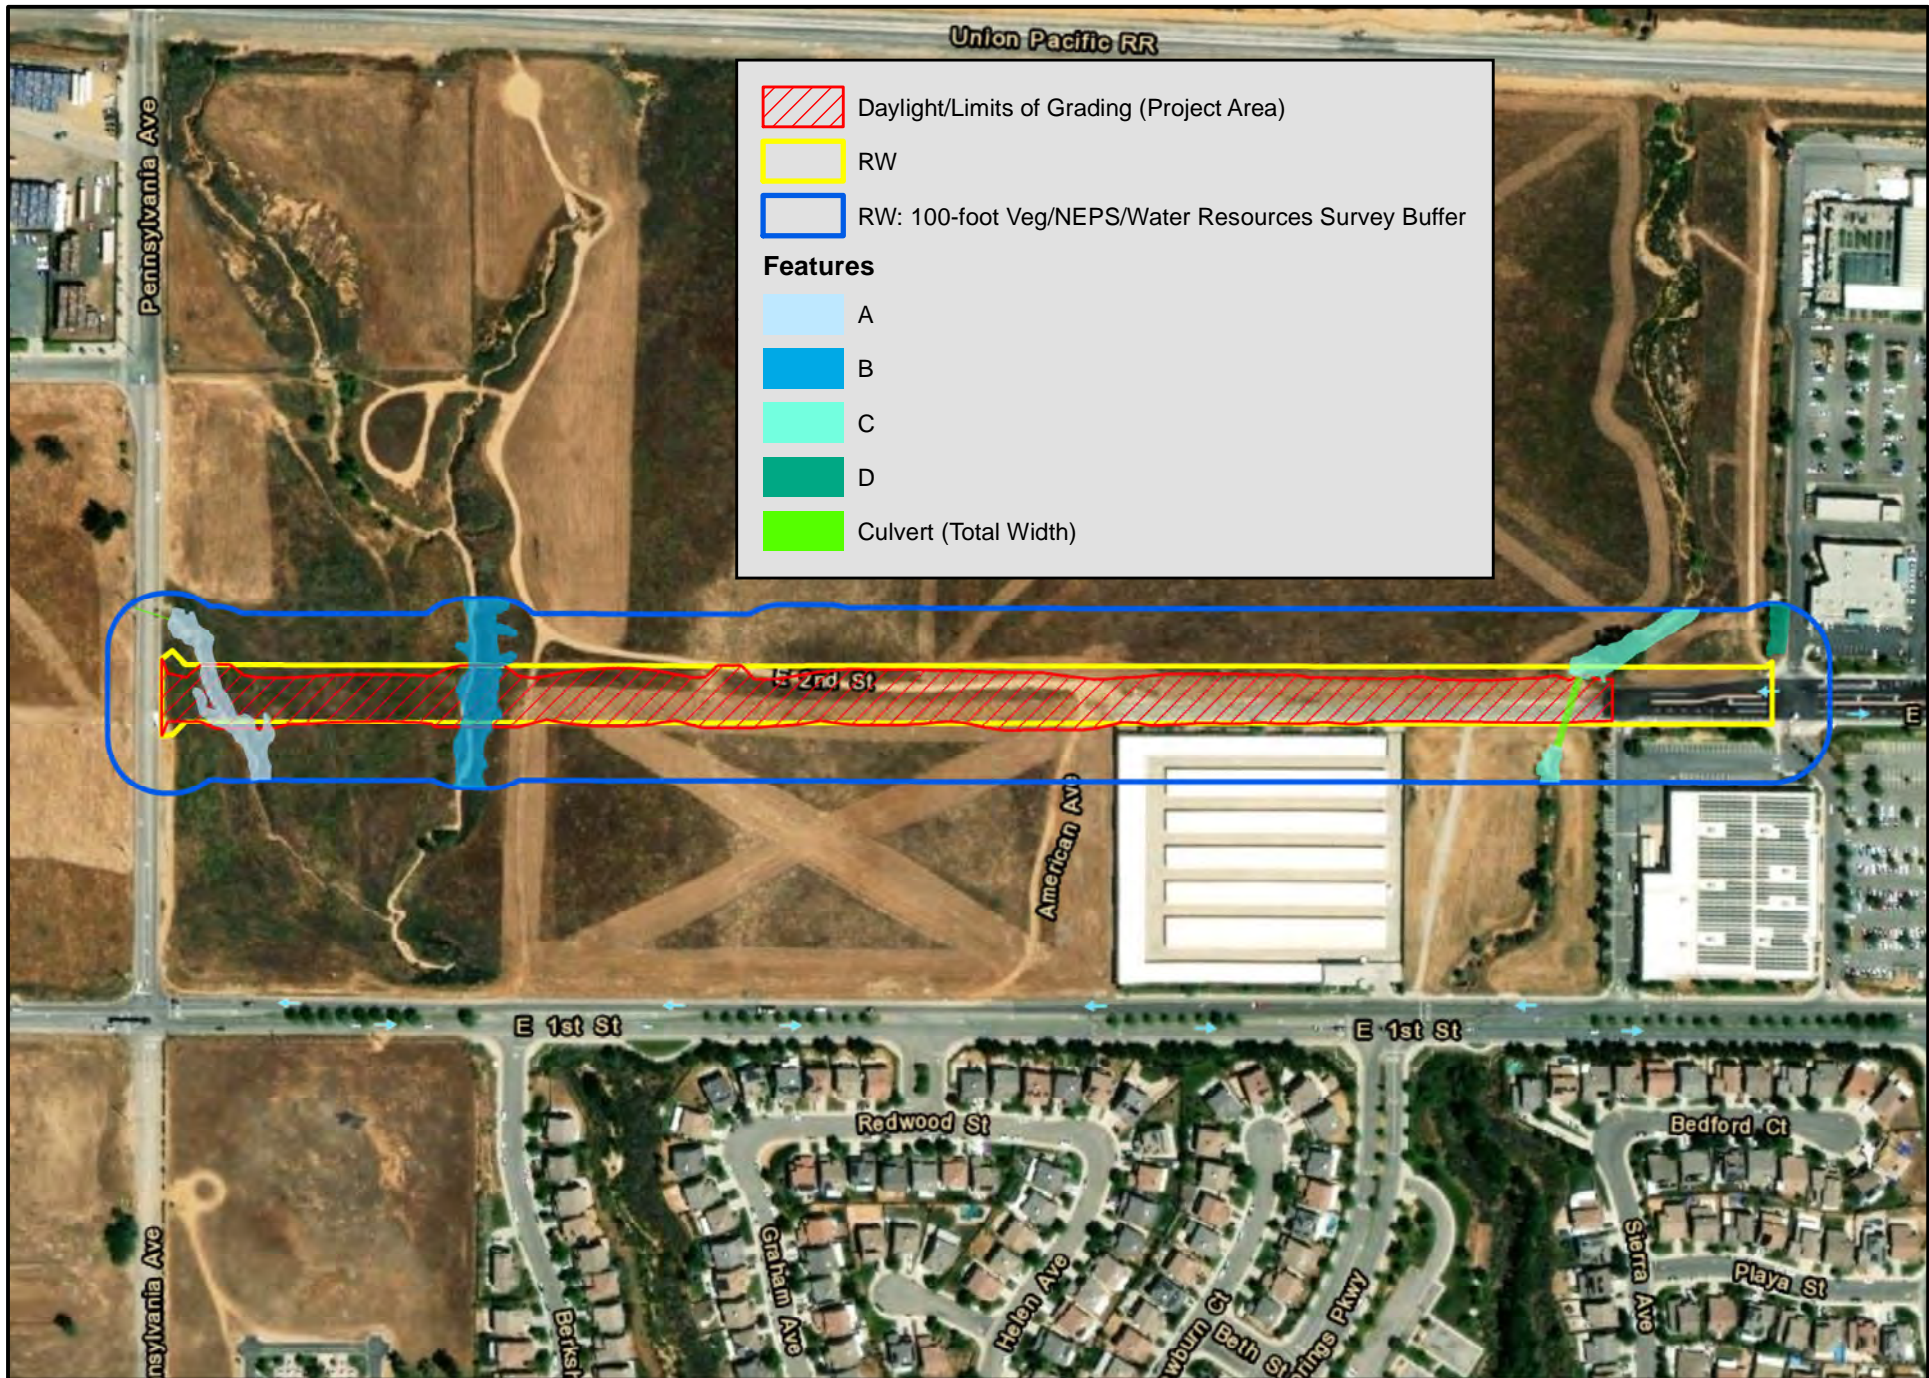
Daylight/Limits of Grading (Project Area)
	RW
	RW: 100-foot Veg/NEPS/Water Resources Survey Buffer
Features	
	A
	B
	C
	D
	Culvert (Total Width)

⁷ The areas for Features A and C include the existing culverts depicted on Figure 16. Feature A culvert width was 5-foot with an area of 188.20-SqFt (0.004-acre) and Feature C culverts (box culvert with 3 cement culverts beneath 2nd Street) totaled a width of 13-feet with an area of 1,640.98-SqFt (0.04-acre).

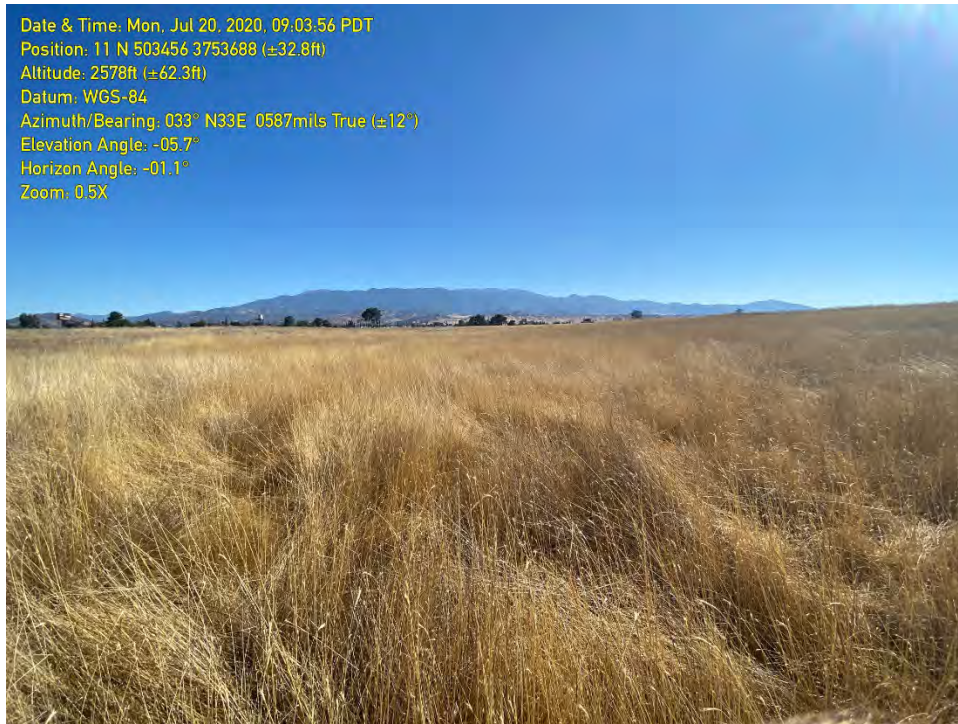
PHOTOGRAPH 1: A northerly view of the Ruderal habitat with non-native grasses dominant.

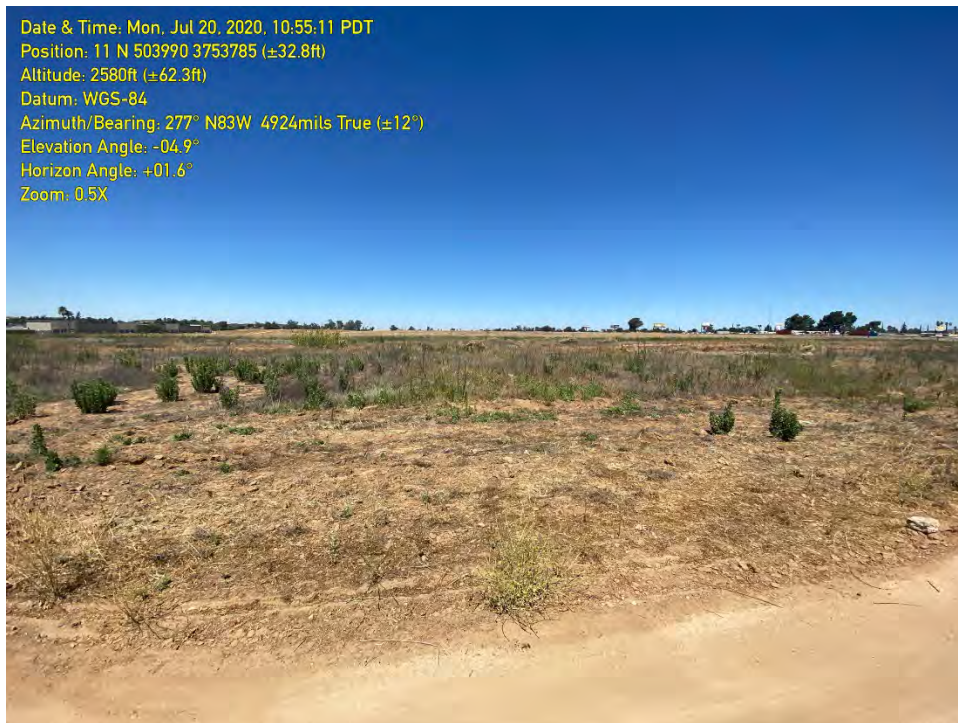
PHOTOGRAPH 2: A westerly view from the northeast portion of the 500-foot survey area.

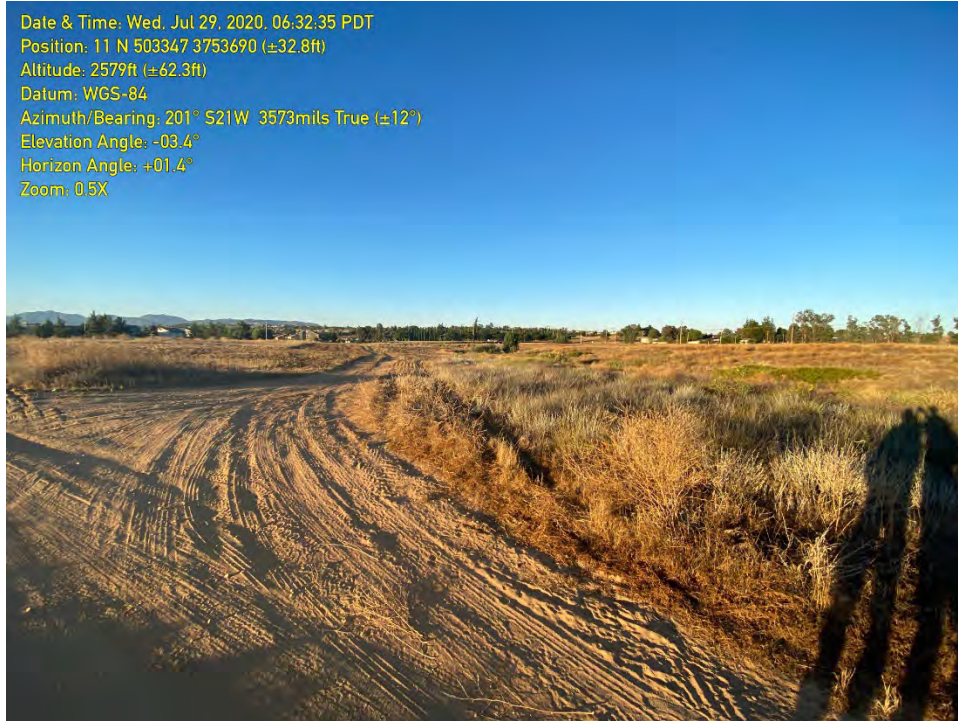
PHOTOGRAPH 3: A southerly view from near the 100-foot buffer boundary in the western portion.

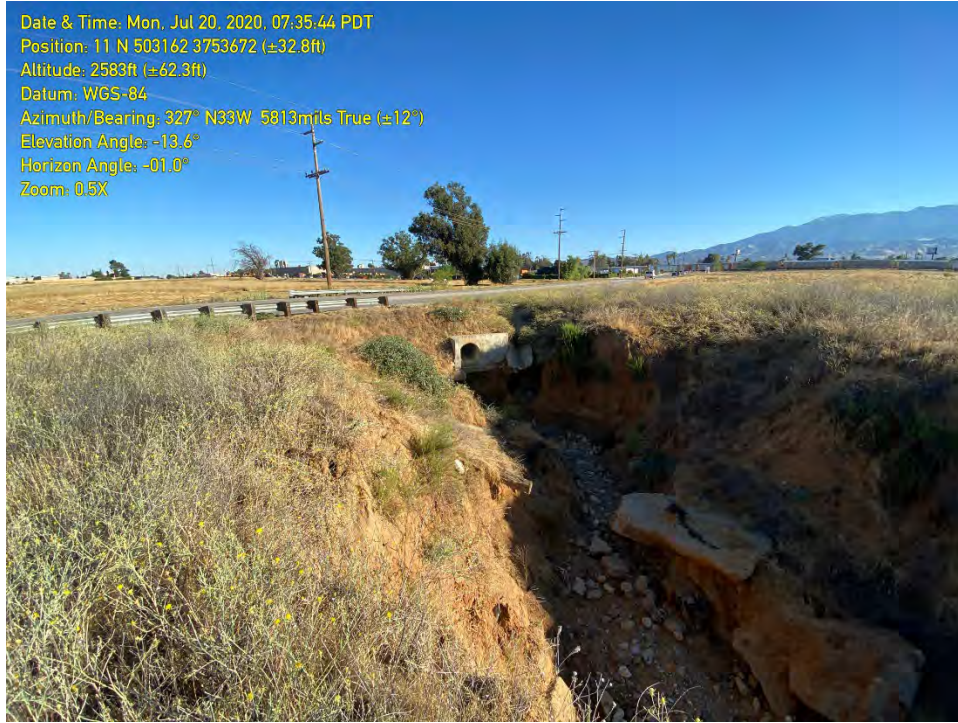
PHOTOGRAPH 1: The upstream portion of Feature A where the culvert begins the feature beneath Pennsylvania Avenue.

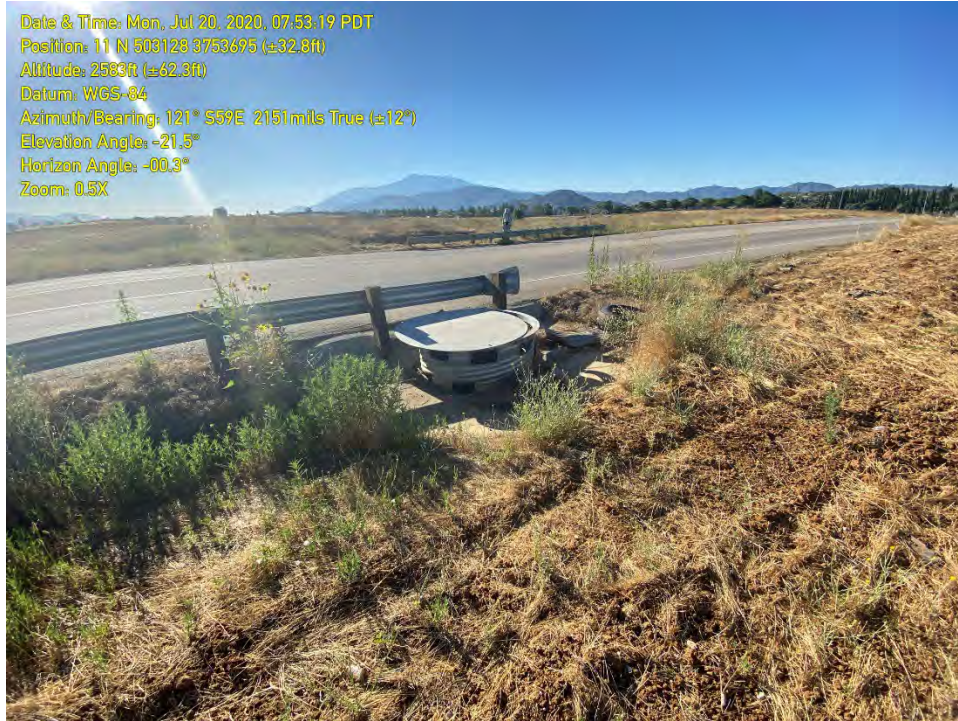
PHOTOGRAPH 3: The westside of Pennsylvania Avenue where storm runoff entered a standpipe connected to the culvert where Feature A began.

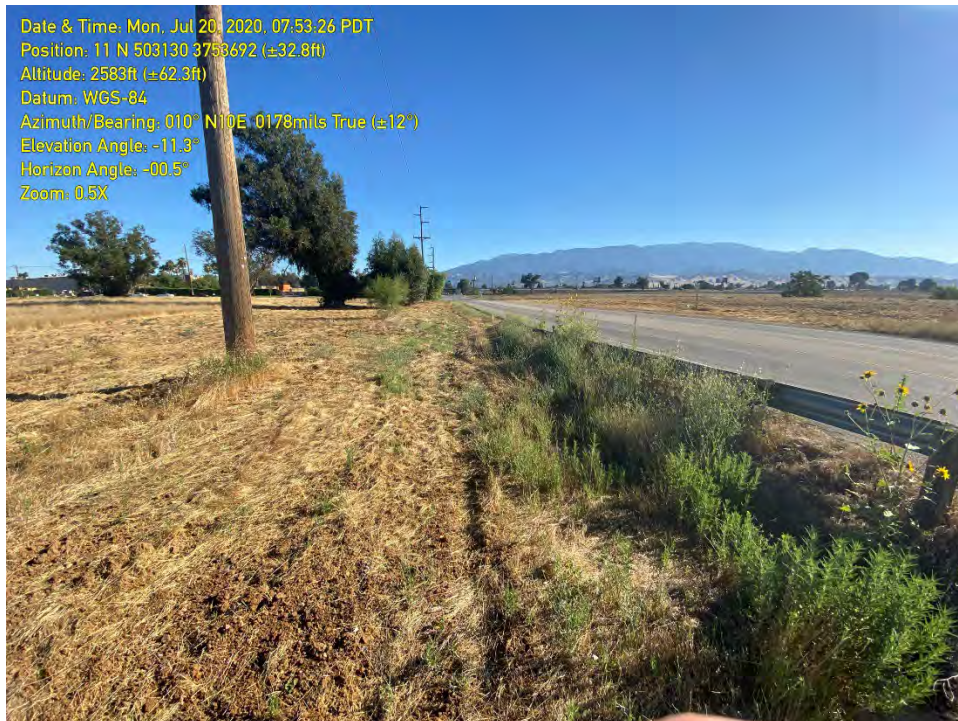
PHOTOGRAPH 4: No roadside drainage was present, or evidence thereof, indicating all flow for Feature A originated from road runoff.

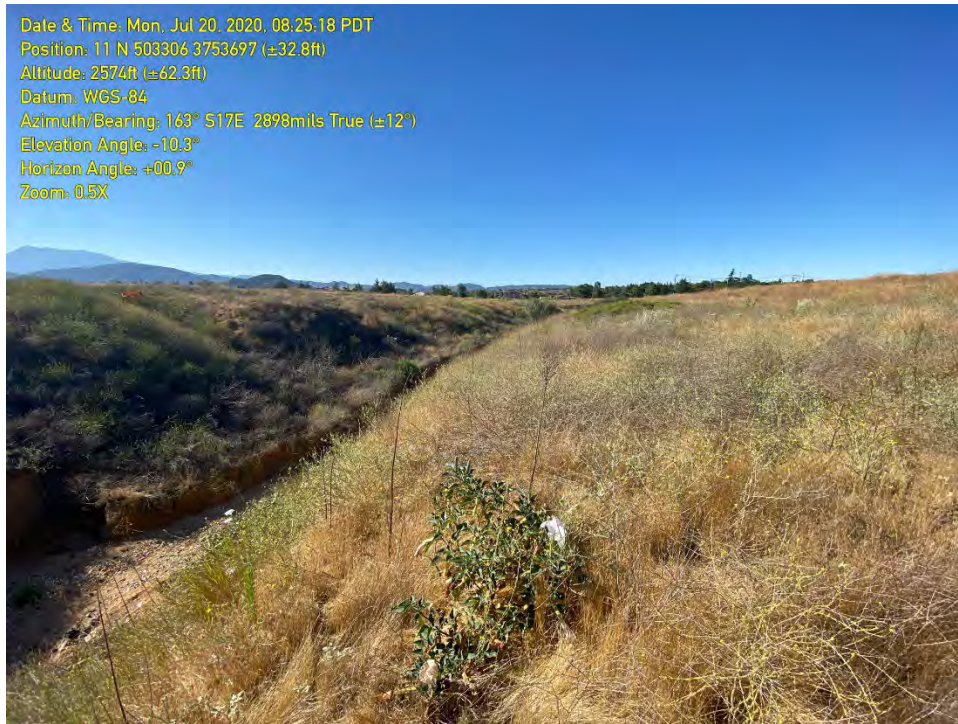
PHOTOGRAPH 5: A view looking down Feature B.

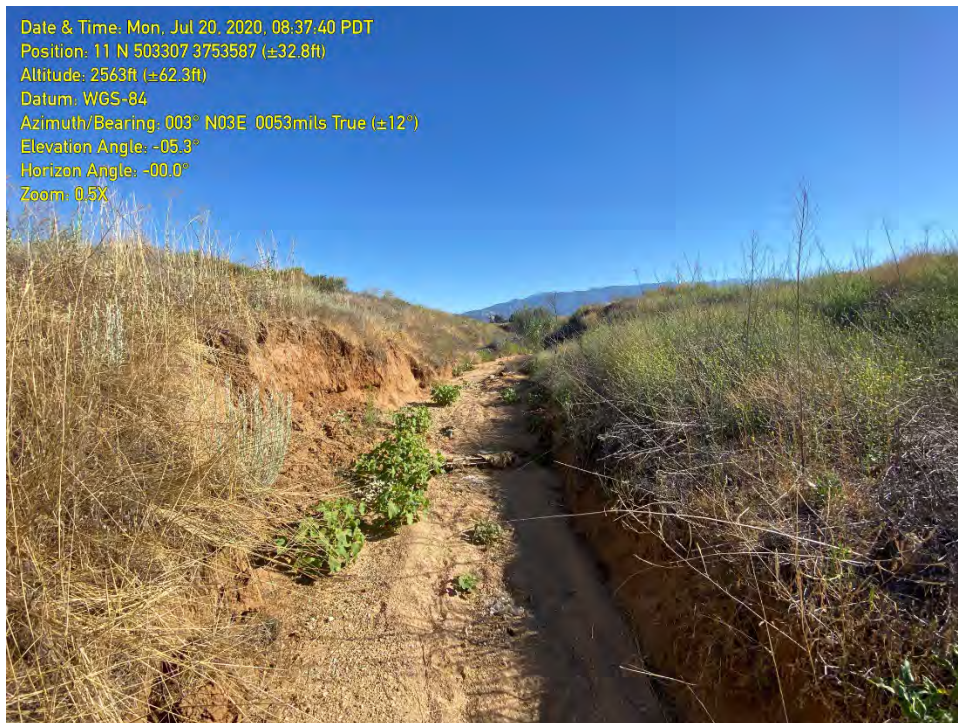
PHOTOGRAPH 6: The depth of Feature B varied and decreased from the upstream end to the downstream portion.

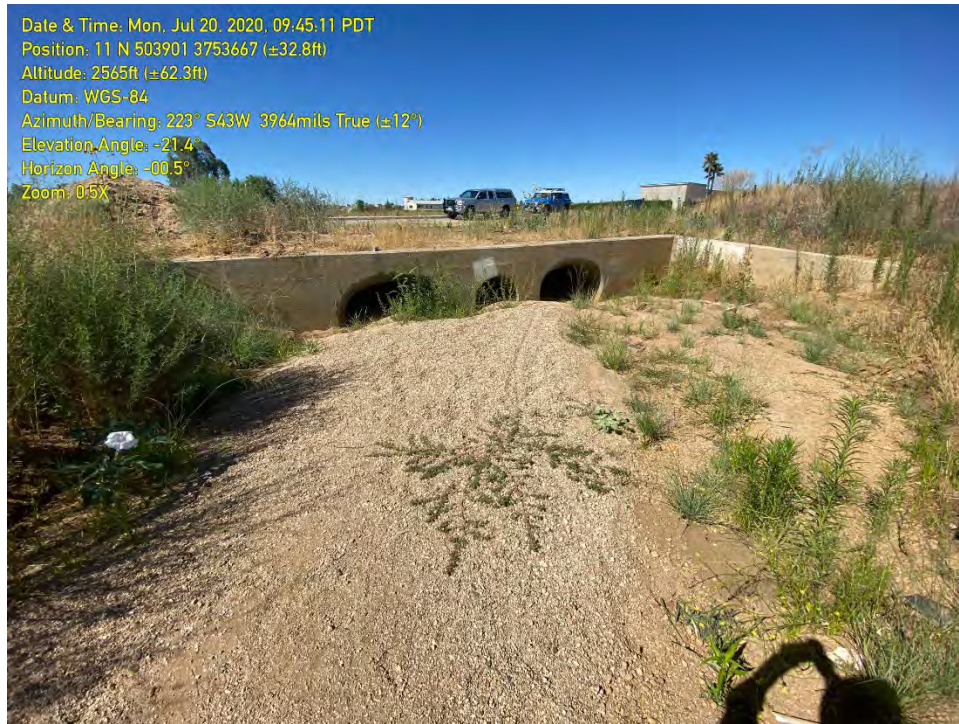
PHOTOGRAPH 7: The culvert at 2nd Street from the upstream end of Feature C (Potrero Creek).

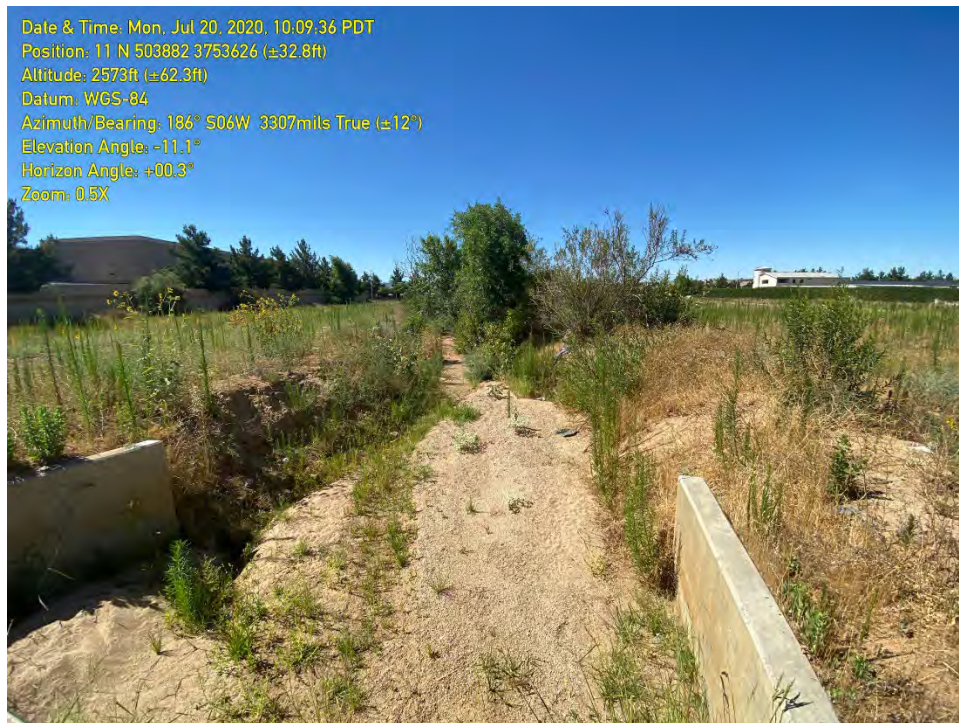
PHOTOGRAPH 8: The low-quality willow scrub in Feature C downstream of 2nd Street.

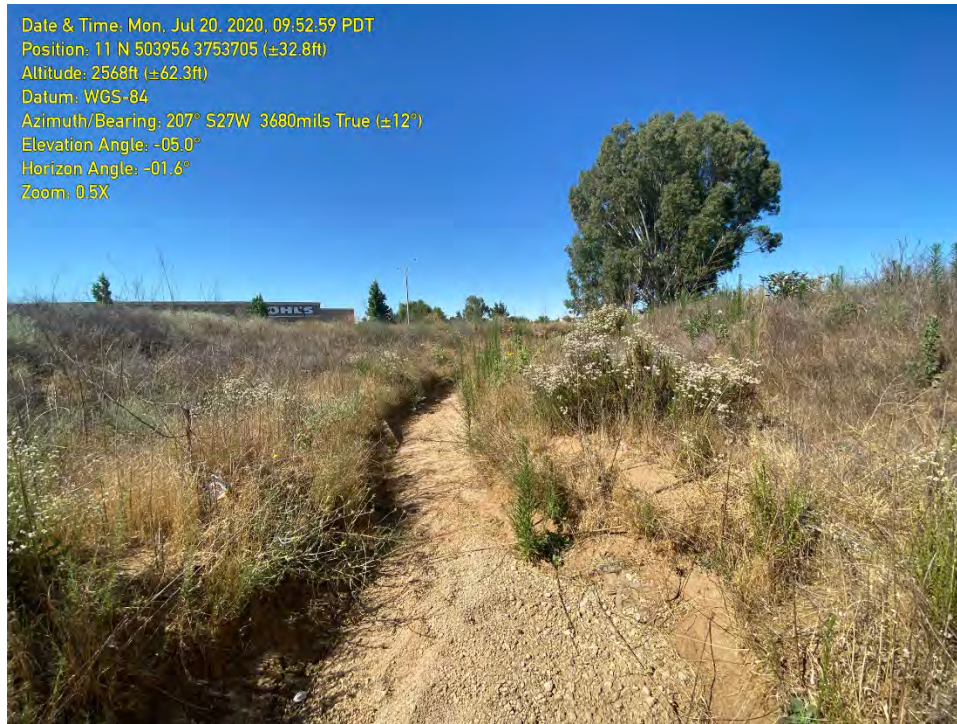
PHOTOGRAPH 9: Feature C upstream of 2nd Street looking downstream. No riparian habitat present. The large blue gum tree depicted in the background.

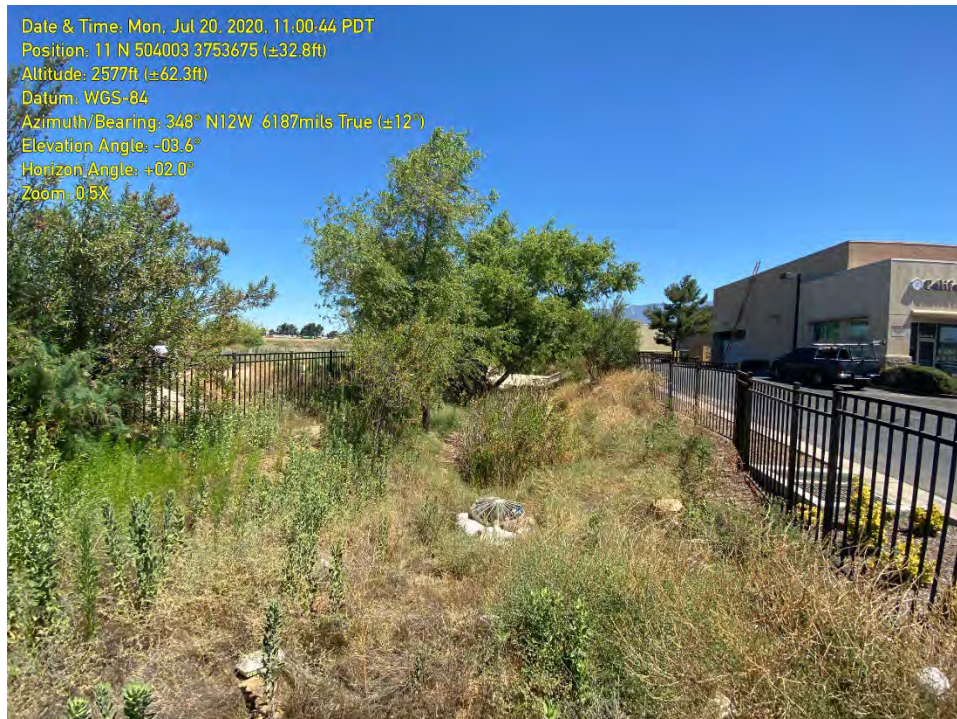
PHOTOGRAPH 10: The human-created ditch Feature D with low-quality riparian habitat. The drainpipe entered the underground drainage system.

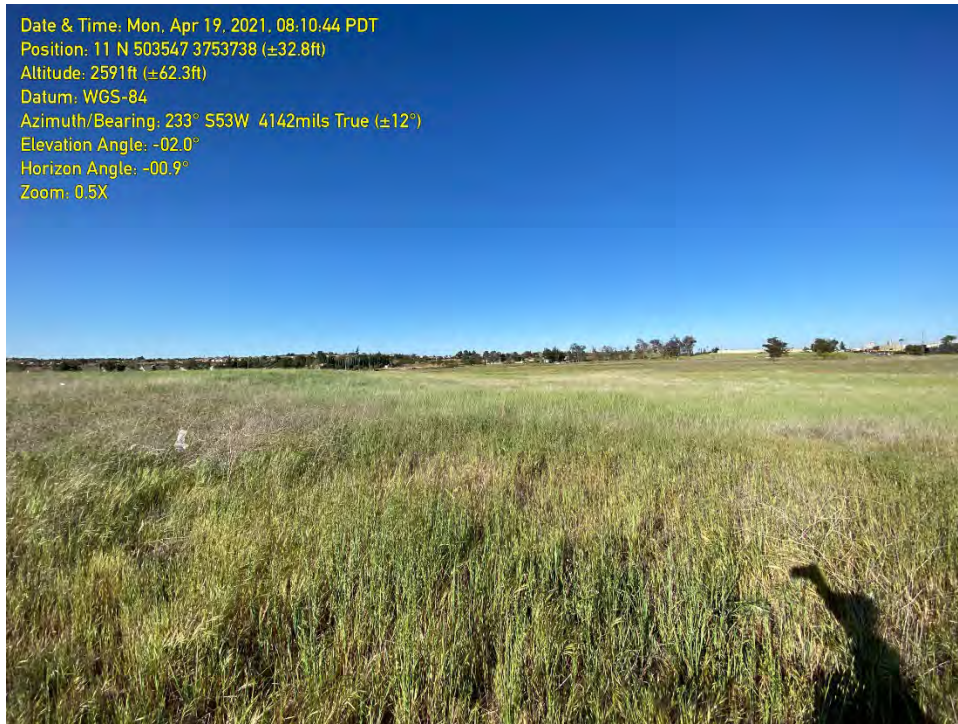
PHOTOGRAPH 1: A view of the habitat during the first focused survey.

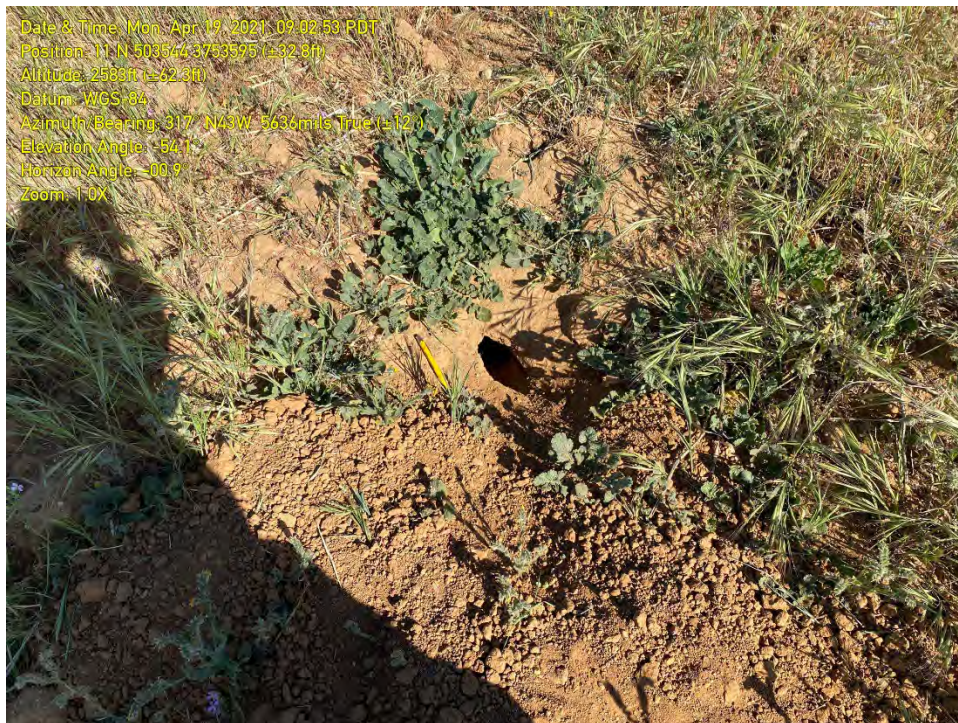
PHOTOGRAPH 2: A single CGS burrow. No BUOW sign was observed at any of the burrow entrances.

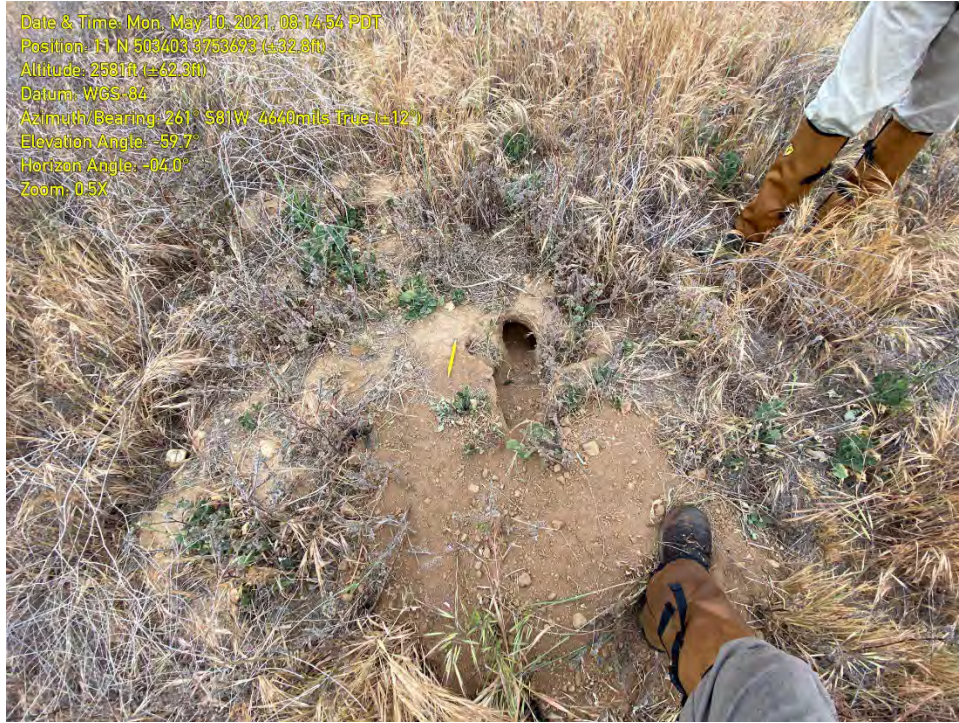
PHOTOGRAPH 3: Another CGS burrow that was part of a burrow complex.

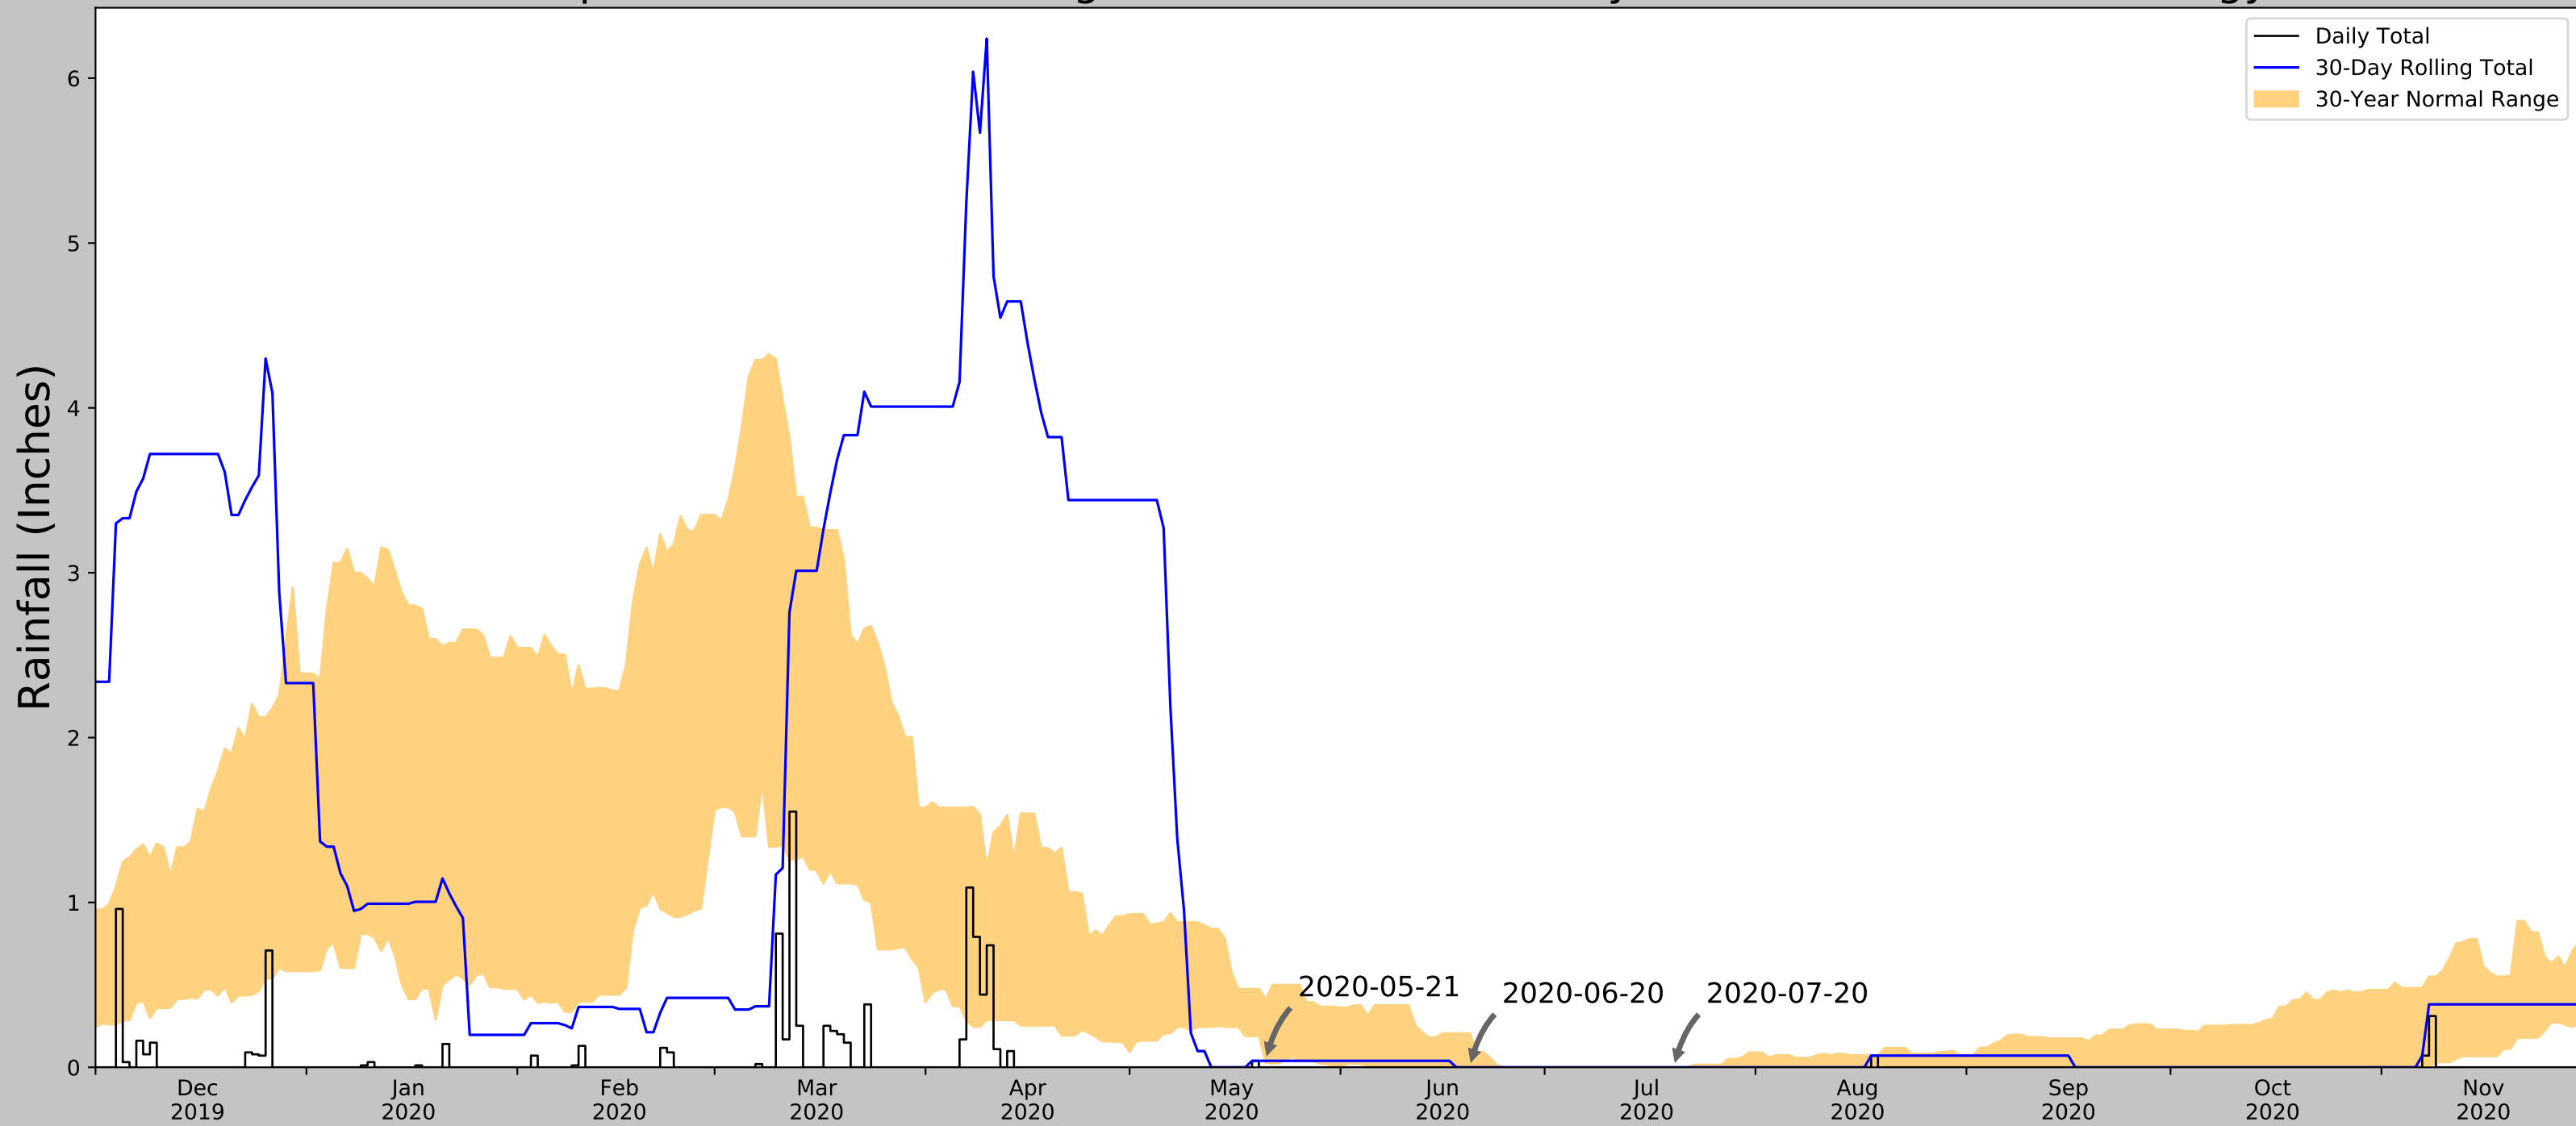
Coordinates	33.923289, -116.961809
Observation Date	2020-07-20
Elevation (ft)	2586.24
Drought Index (PDSI)	Normal
WebWIMP H ₂ O Balance	Dry Season

An analysis of the WETs, with the results provided in Appendix E, indicated that the Project’s location was not experiencing drought conditions during the July field assessment, and the field work was conducted during normal conditions.
