City of Beaumont – 2nd Street Improvement

**WESTERN RIVERSIDE COUNTY MULTIPLE SPECIES
HABITAT CONSERVATION PLAN CONSISTENCY
ANALYSIS**

**2nd STREET IMPROVEMENT
RIVERSIDE COUNTY, BEAUMONT, CALIFORNIA**

September 26, 2022

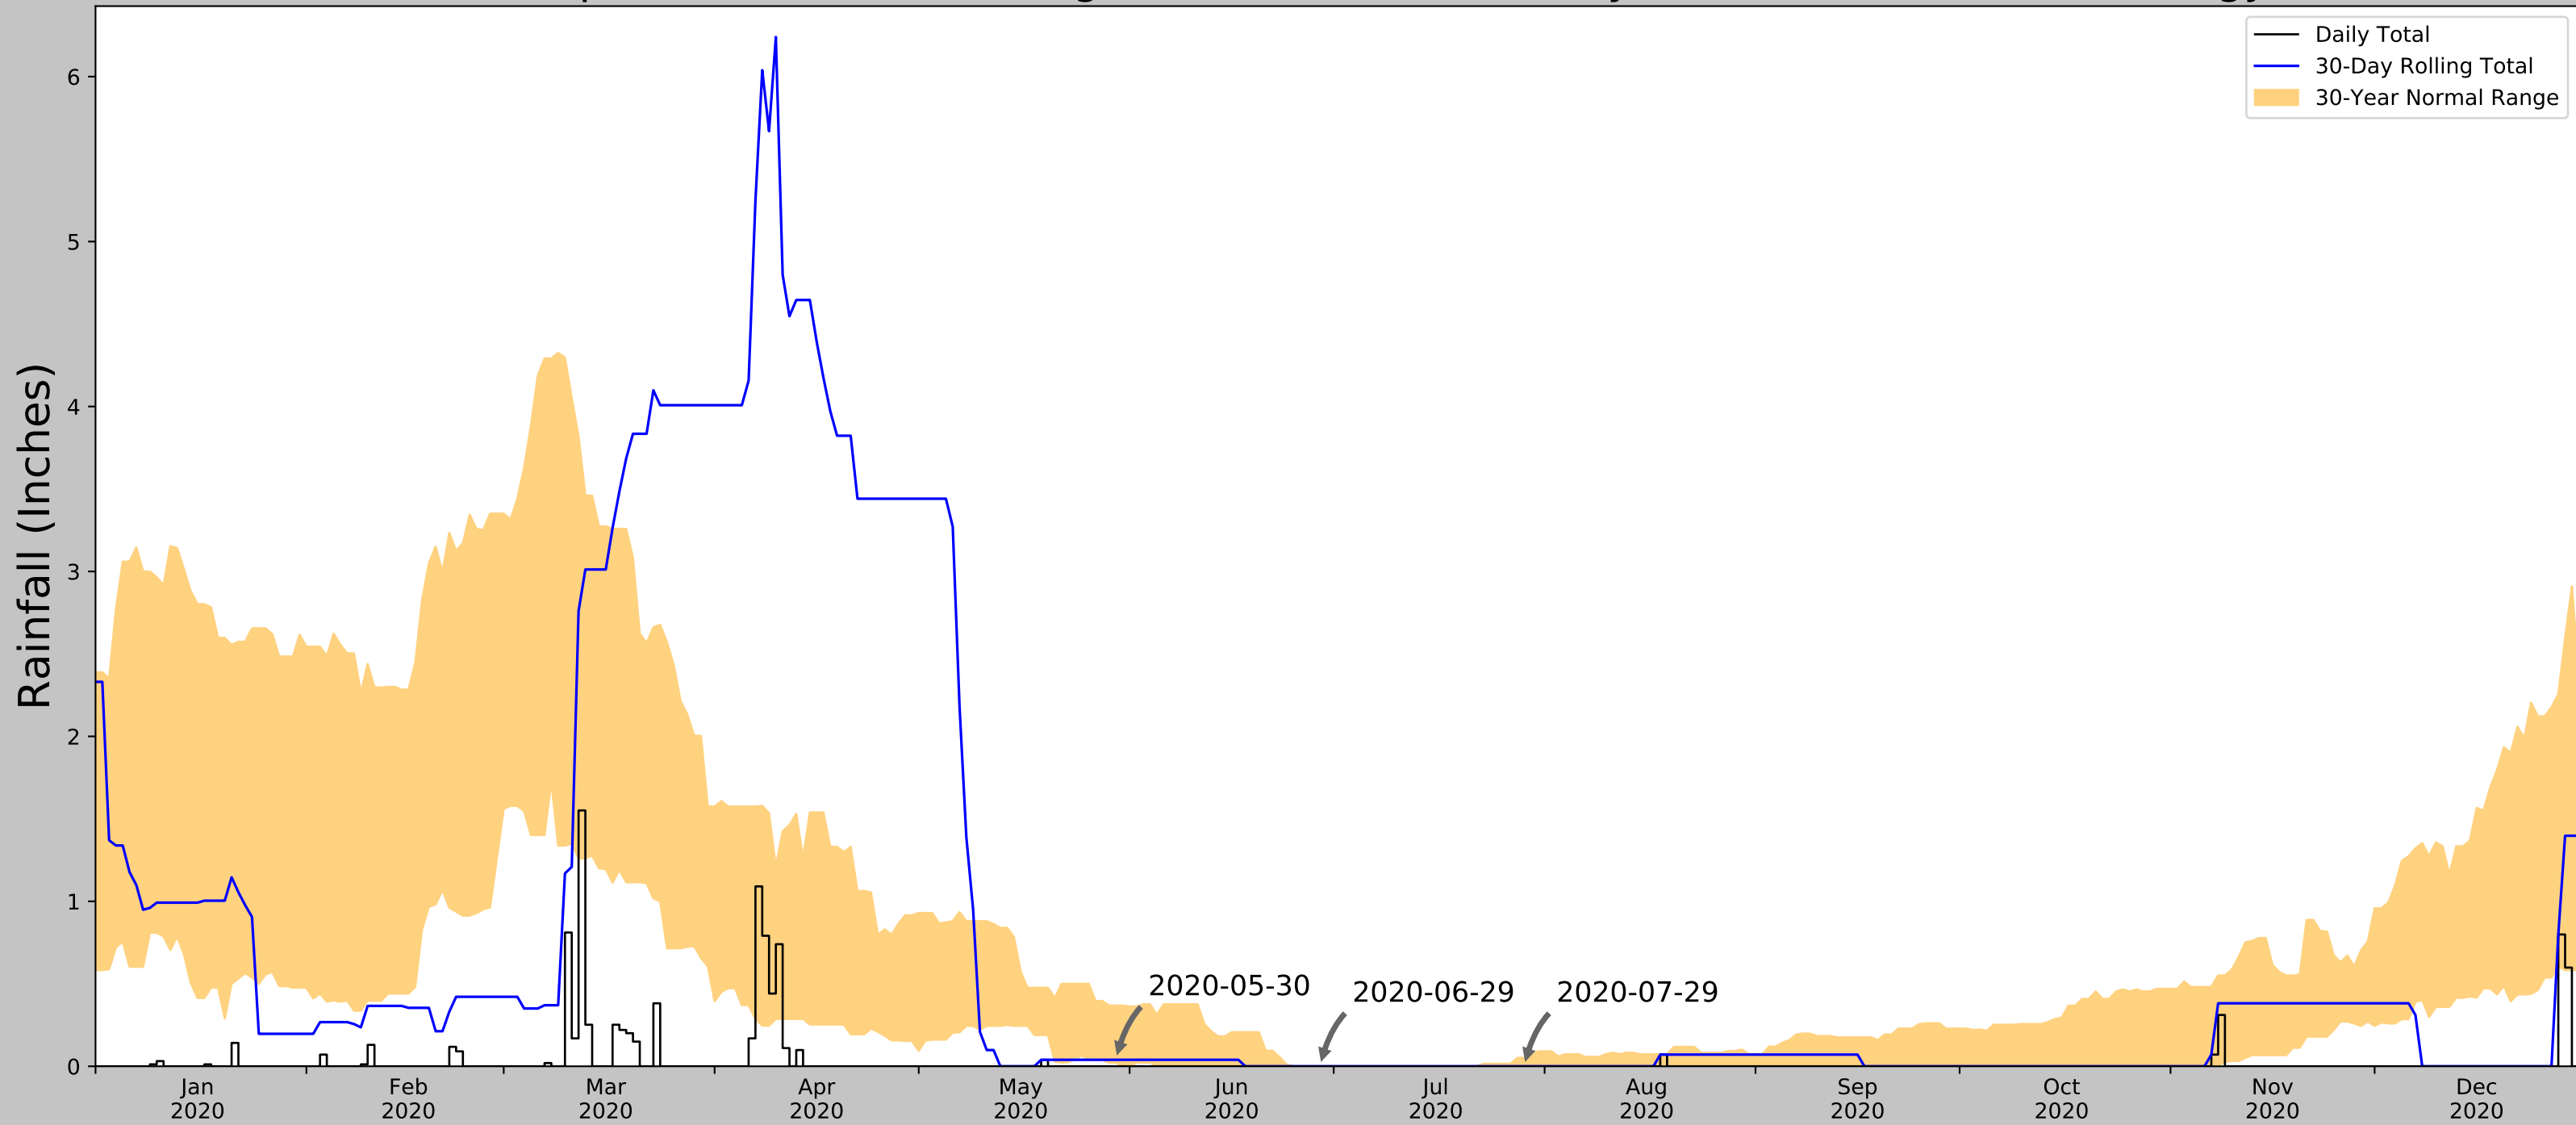
Coordinates	33.923289, -116.961809
Observation Date	2020-07-29
Elevation (ft)	2586.24
Drought Index (PDSI)	Normal
WebWIMP H ₂ O Balance	Dry Season

An analysis of the WETs, with the results provided in Appendix E, indicated that the Project’s location was not experiencing drought conditions during the July field assessment, and the field work was conducted during normal conditions.

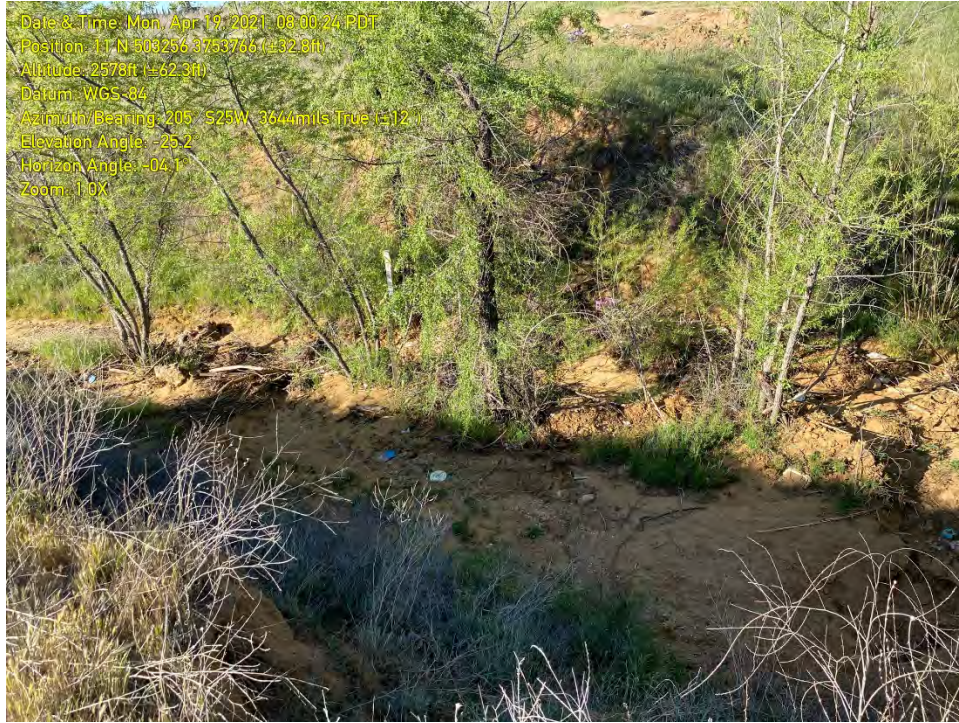
PHOTOGRAPH 1: The black willow thicket in the upstream portion of the unnamed ephemeral drainage. An understory was lacking, and the area was utilized often by trespassers.

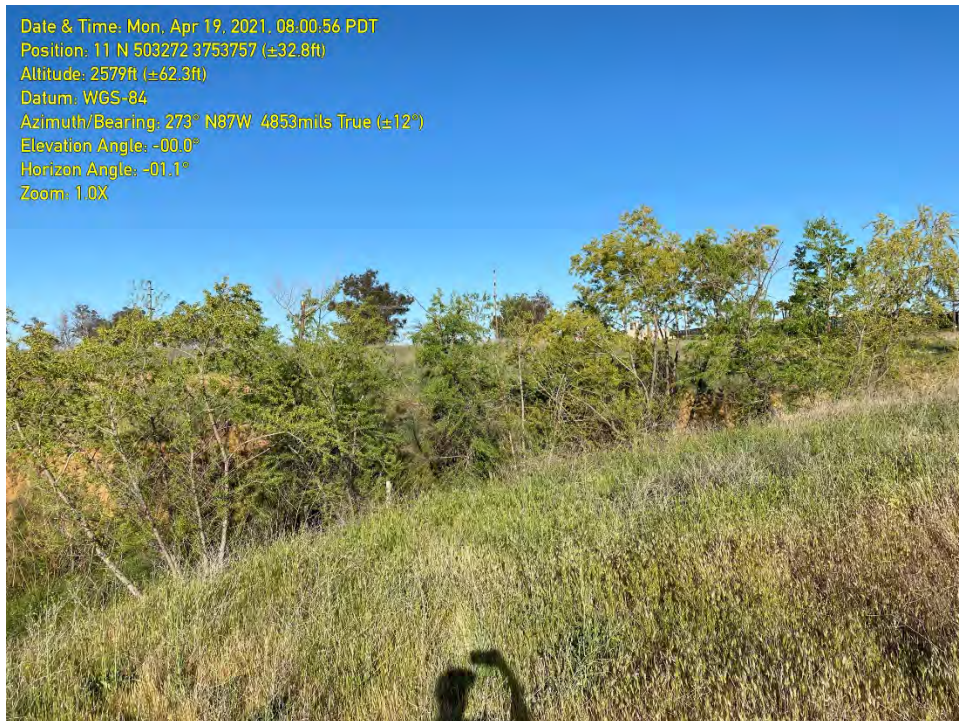
PHOTOGRAPH 2: The ephemeral drainage was a deep gully, approximately 30-feet in some locations. The canopy of the black willow thicket is pictured.

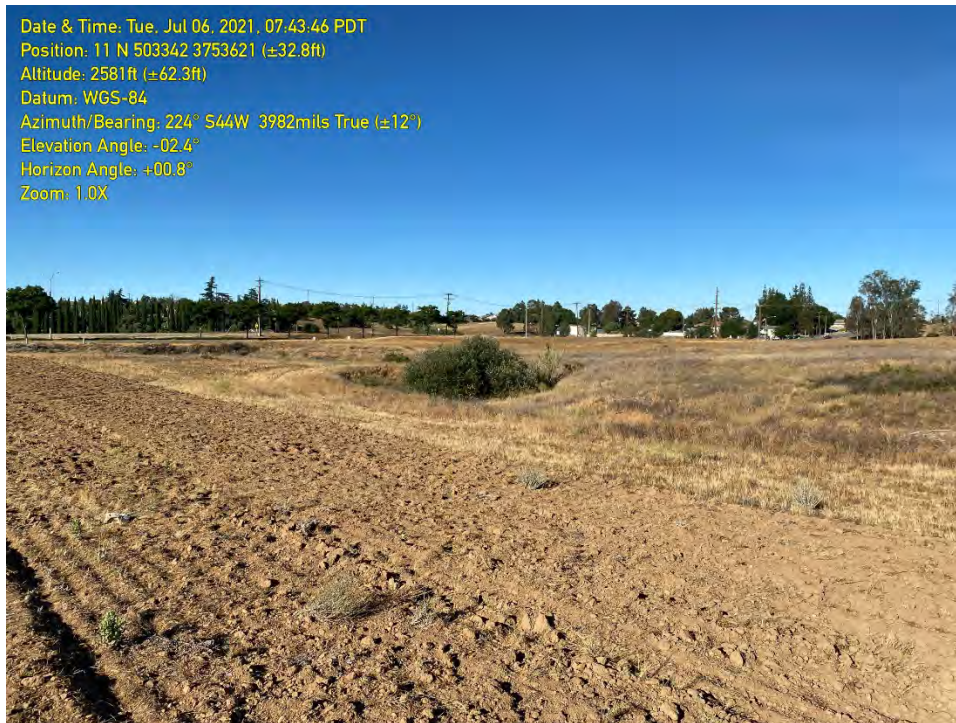
PHOTOGRAPH 3: A small patch of arroyo willow in the ephemeral drainage.

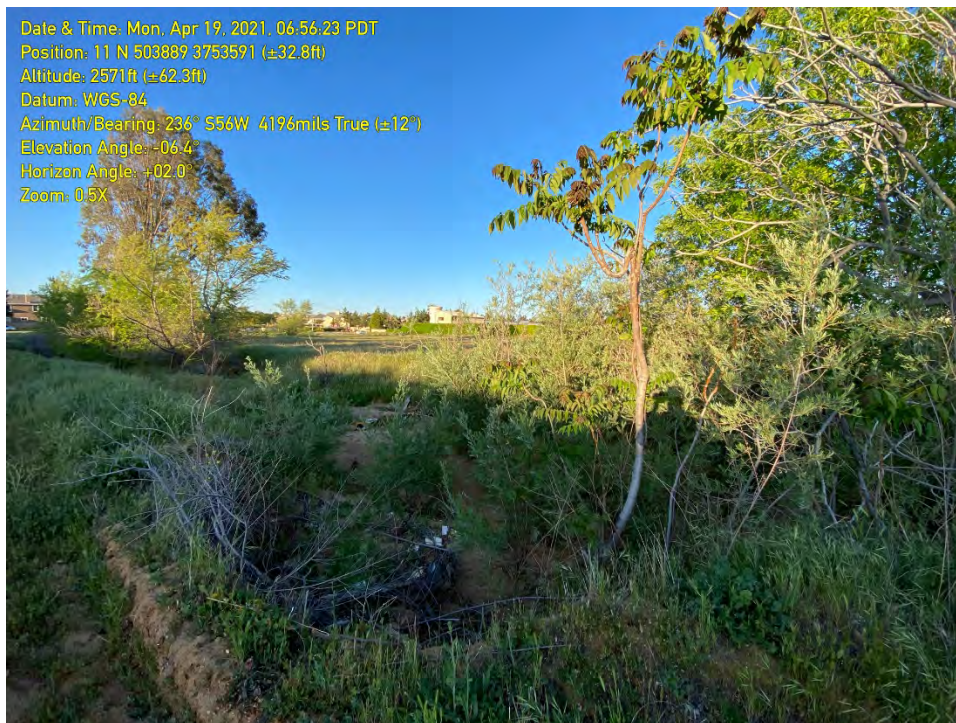
PHOTOGRAPH 4: Potrero Creek downstream of a culvert at 2nd Street. The habitat had a mix of willow species, including narrow-leaved, but occurred sparingly throughout and was mixed with non-natives, such as Chinese elm, Shamel ash, and tree-of-heaven.

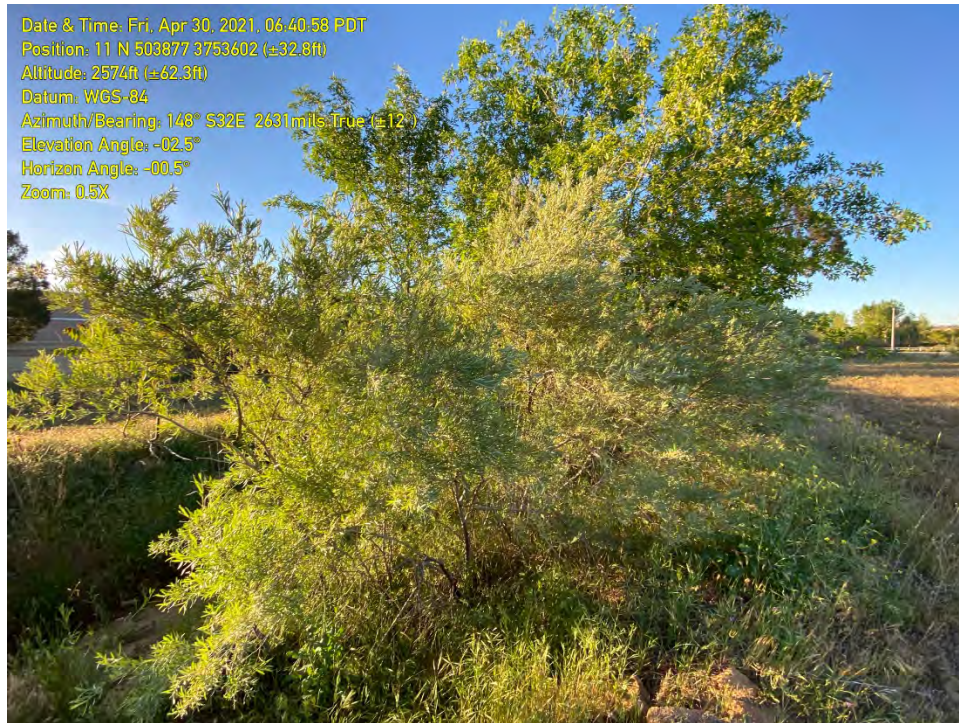
PHOTOGRAPH 5: A patch of mixed willow downstream of 2nd Street.

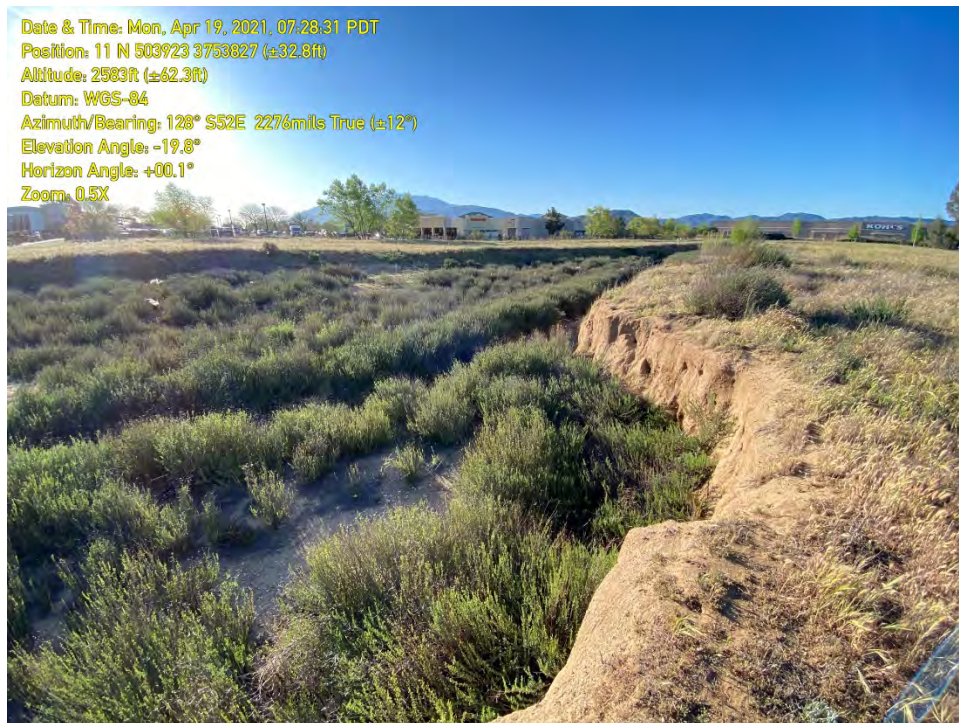
PHOTOGRAPH 6: The entirety of Potrero Creek upstream of 2nd Street consisted of upland habitat with a homogenous stand of California buckwheat in the upstream end then transitioned to more non-native vegetation near 2nd Street.

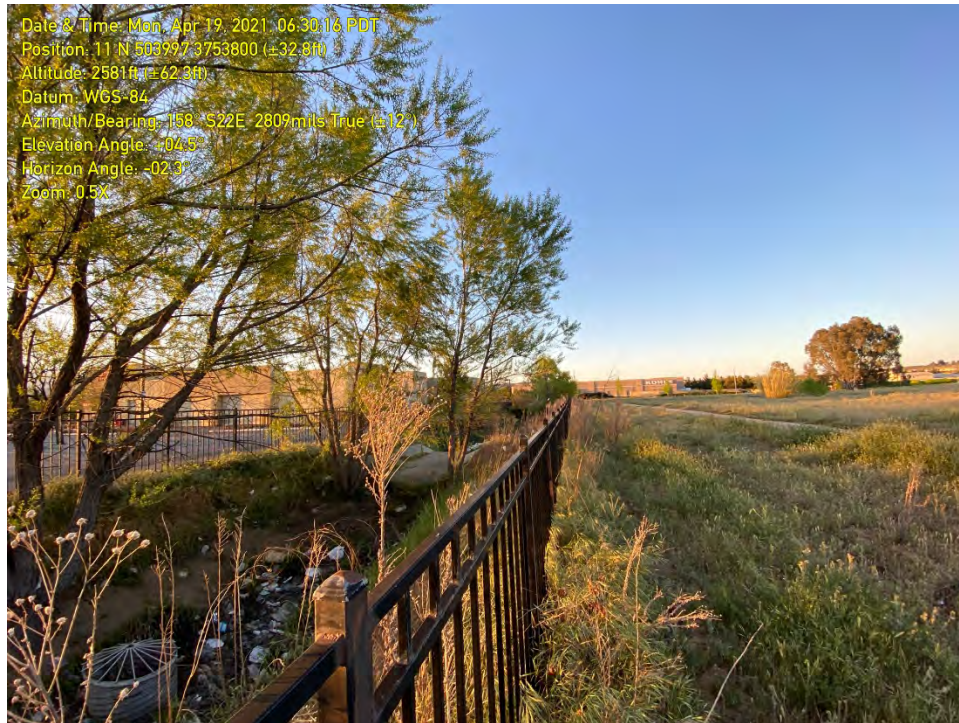
PHOTOGRAPH 7: The human-created ditch supported only a few, scattered black willow and generally lacked an understory. Trash was prevalent throughout the ditch and was likely the result of being located adjacent to a commercial parking lot.

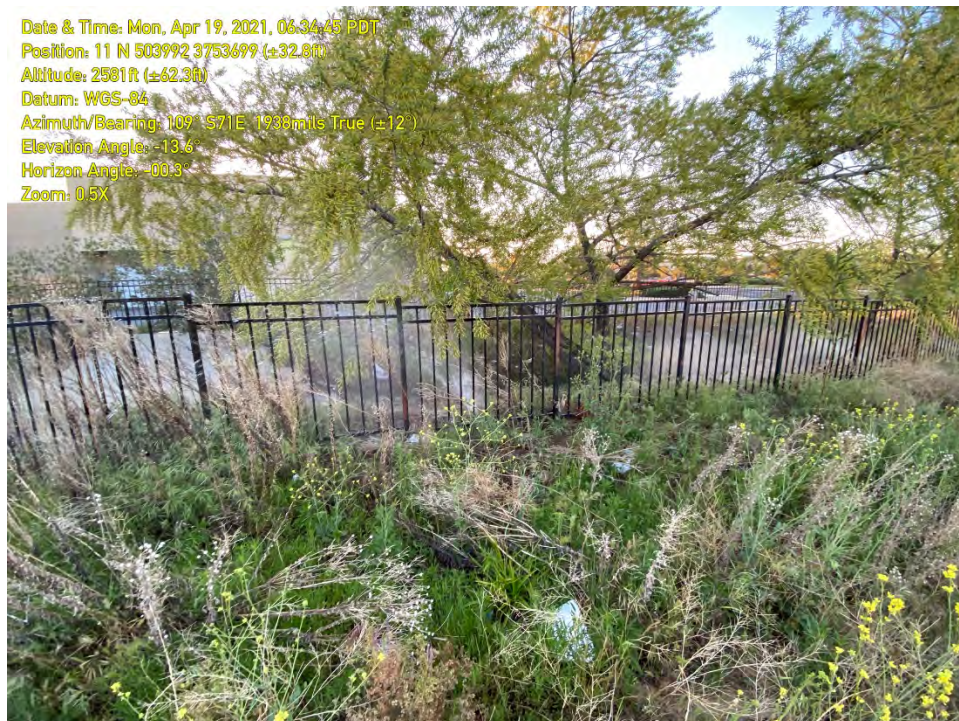
PHOTOGRAPH 8: The ditch was irrigated but ruderal, weedy vegetation was dominant.
