**PHASE I ENVIRONMENTAL SITE ASSESSMENT AND
LIMITED PHASE II SUBSURFACE INVESTIGATION
1020 TERRA BELLA AVENUE
MOUNTAIN VIEW, CALIFORNIA 94043**

Terraphase Engineering Inc.
1404 Franklin Street, Suite 600
Oakland, California 94612

June 16, 2017

Project Number 0229.001.001

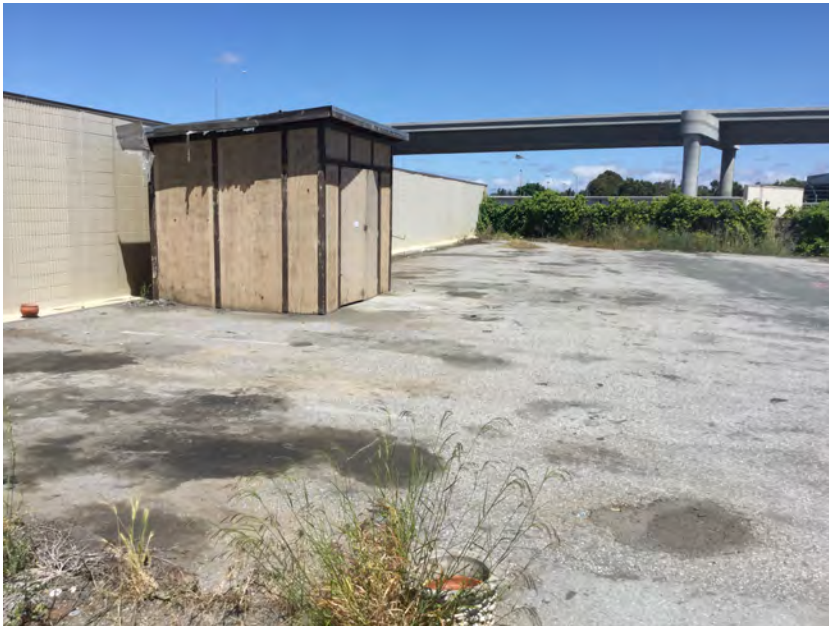
Photograph 6: View of wooden storage shed along western property boundary. Stained asphalt in foreground of photo is common in paved areas of Subject Property.

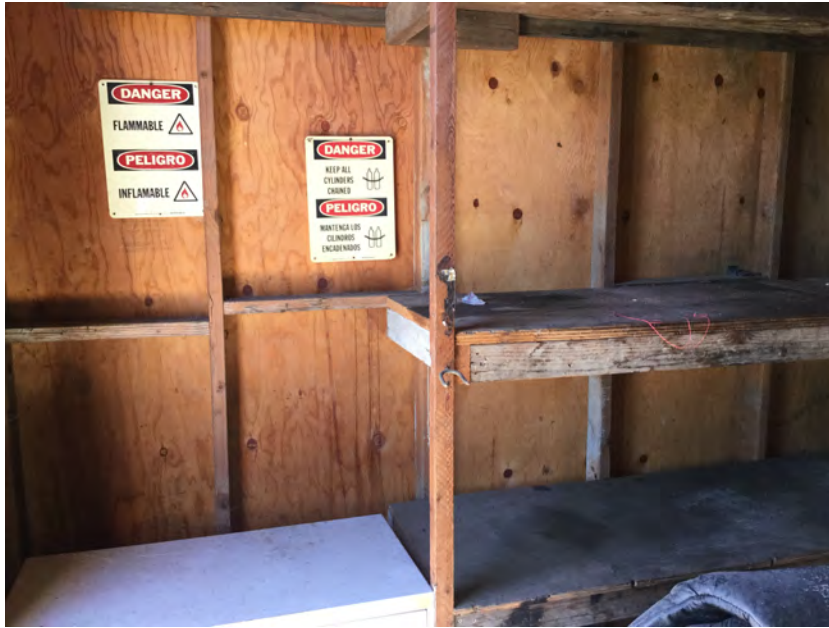
Photograph 7: Shelves inside of wooden storage shed with signs indicating past storage of cylinders and flammables.

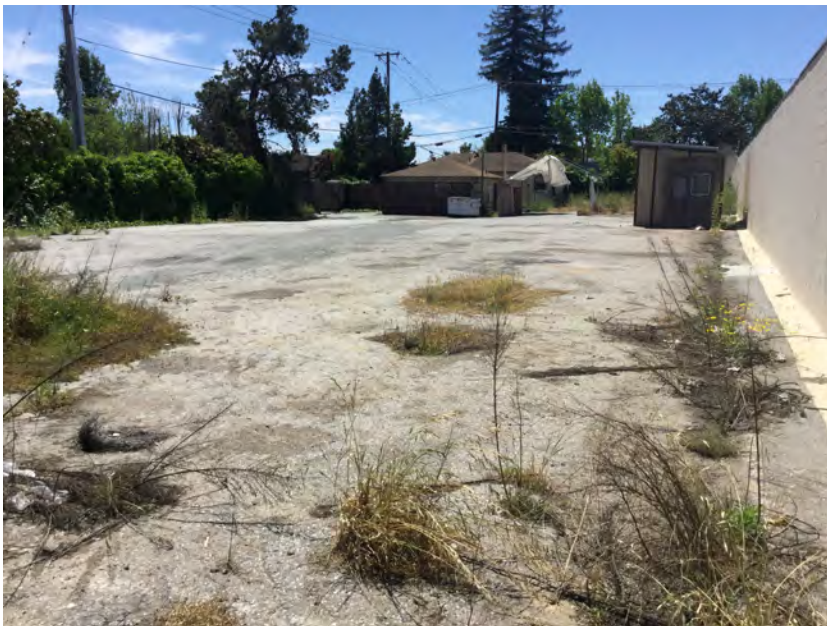
Photograph 8: Overview of paved asphalt yard area in northern and central portions of Subject Property. View looks south, across the Subject Property, from the northwestern corner of the Subject Property.

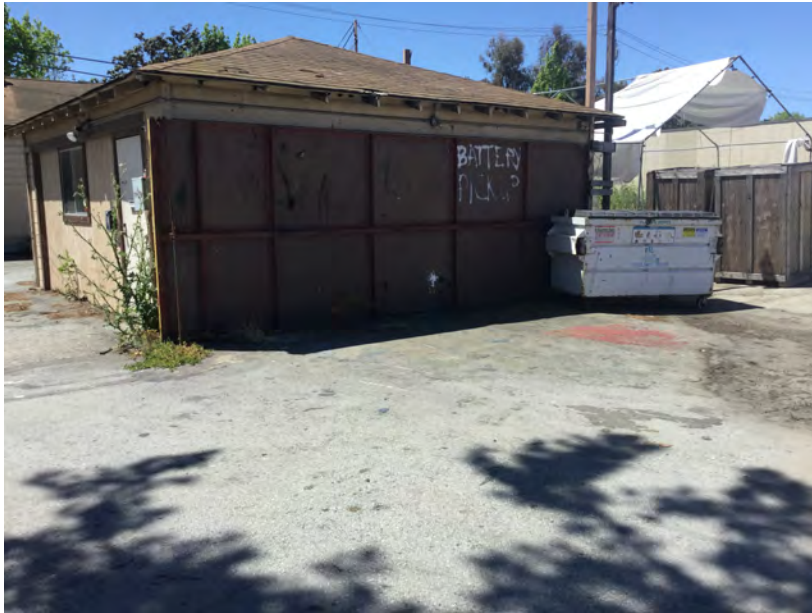
Photograph 9: View of northern side of industrial office building, "Battery Pickup" area, and solid waste dumpster; located in the south-central portion of the Subject Property. View looks towards the southwest.

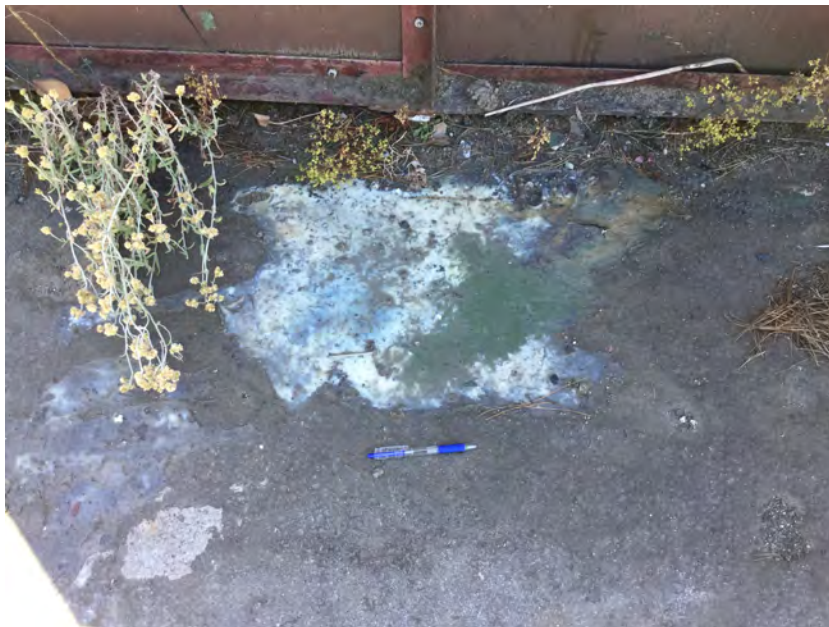
Photograph 10: White staining on asphalt in "Battery Pickup" area with pen for scale.
