# HISTORIC STRUCTURE ASSESSMENT FOR THE EAST STATE STREET PROJECT

745 AND 825 EAST STATE STREET, 810 EAST MAIN  
STREET, AND 235 SOUTH CAMPUS AVENUE

CITY OF ONTARIO,  
SAN BERNARDINO COUNTY, CALIFORNIA

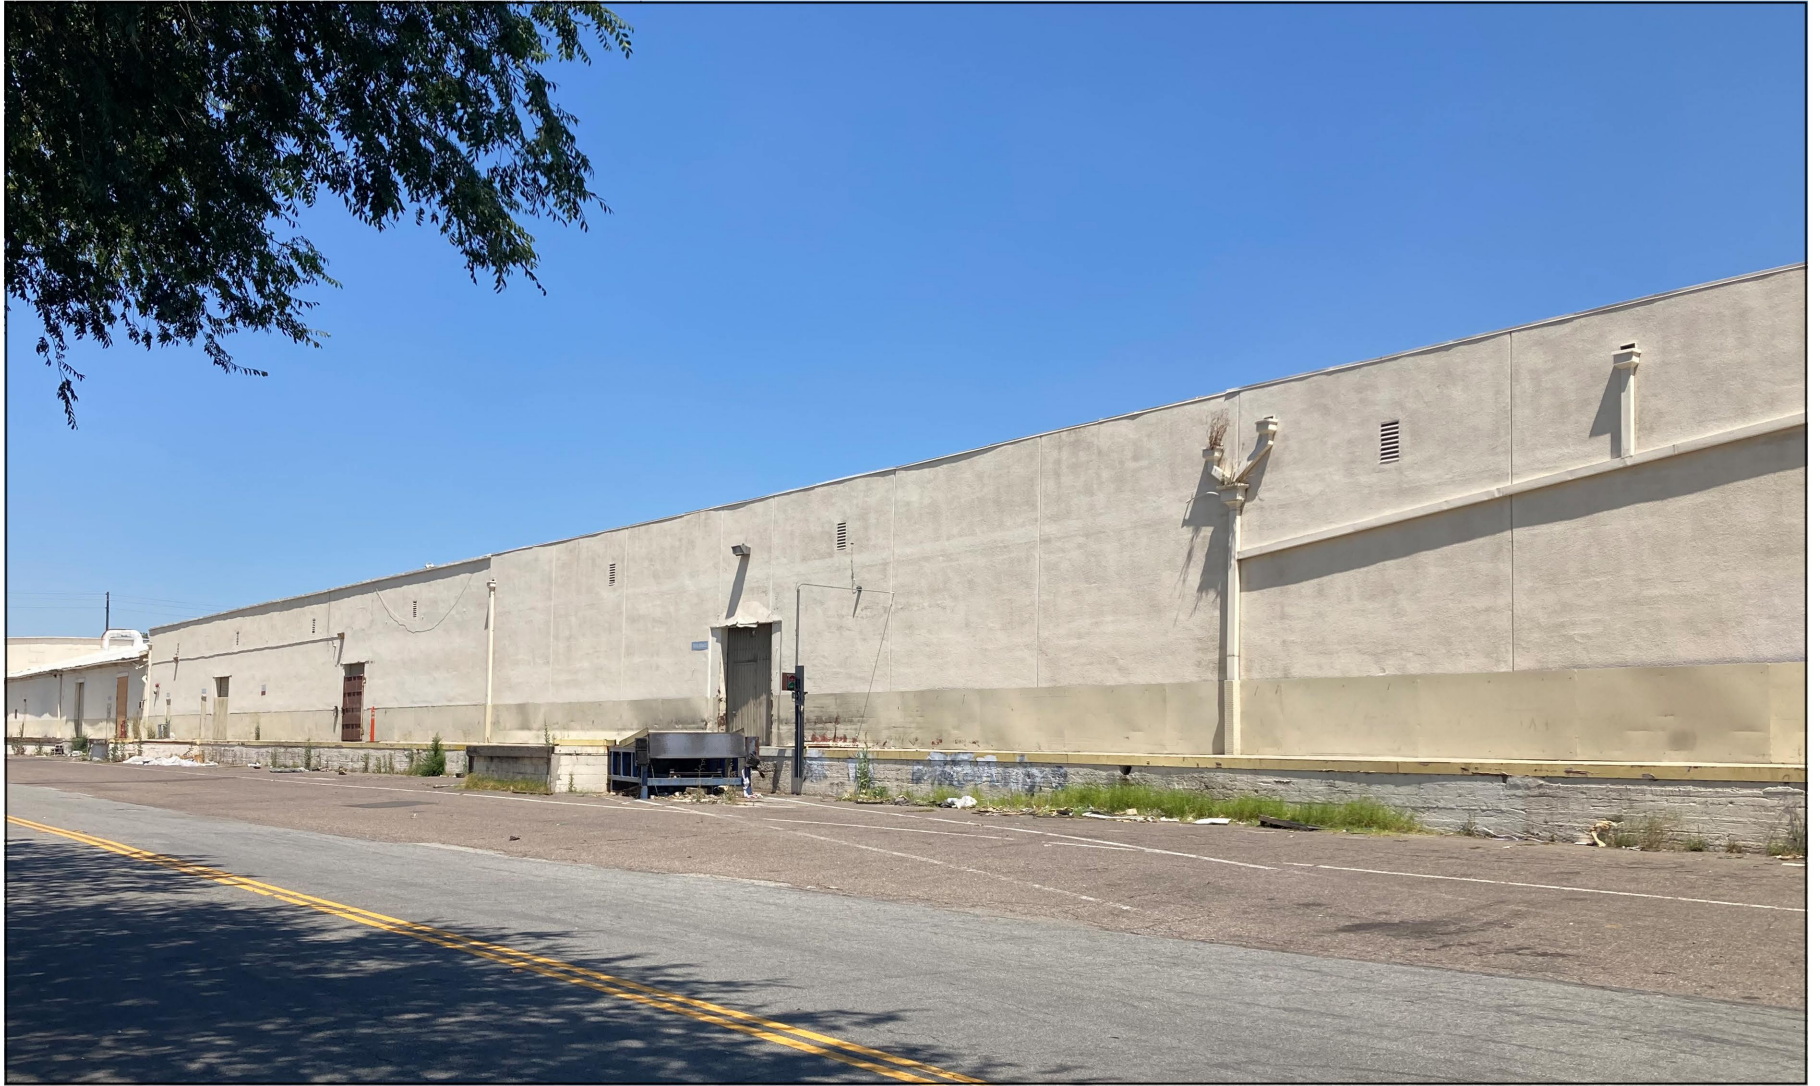
**Plate 13**

Structure C covers the east end of the large manufacturing plant. The south façade of the structure features four loading doors, two pedestrian doors, and a loading dock (Plates 13 and 14). The structure has a flat roof covered with sheet metal. A platform runs along the south façade of Structures A, B and C and is level with the loading docks in front of buildings B and C (see Plates 13 and 14). This platform envelops the building on its east façade and ends where Structure C and Structure D meet. The east façade of Structure C features two roll-top loading doors (Plate 15).

**View of the South Façade of Structure C  
at the 745 East State Street Building, Facing Northeast**

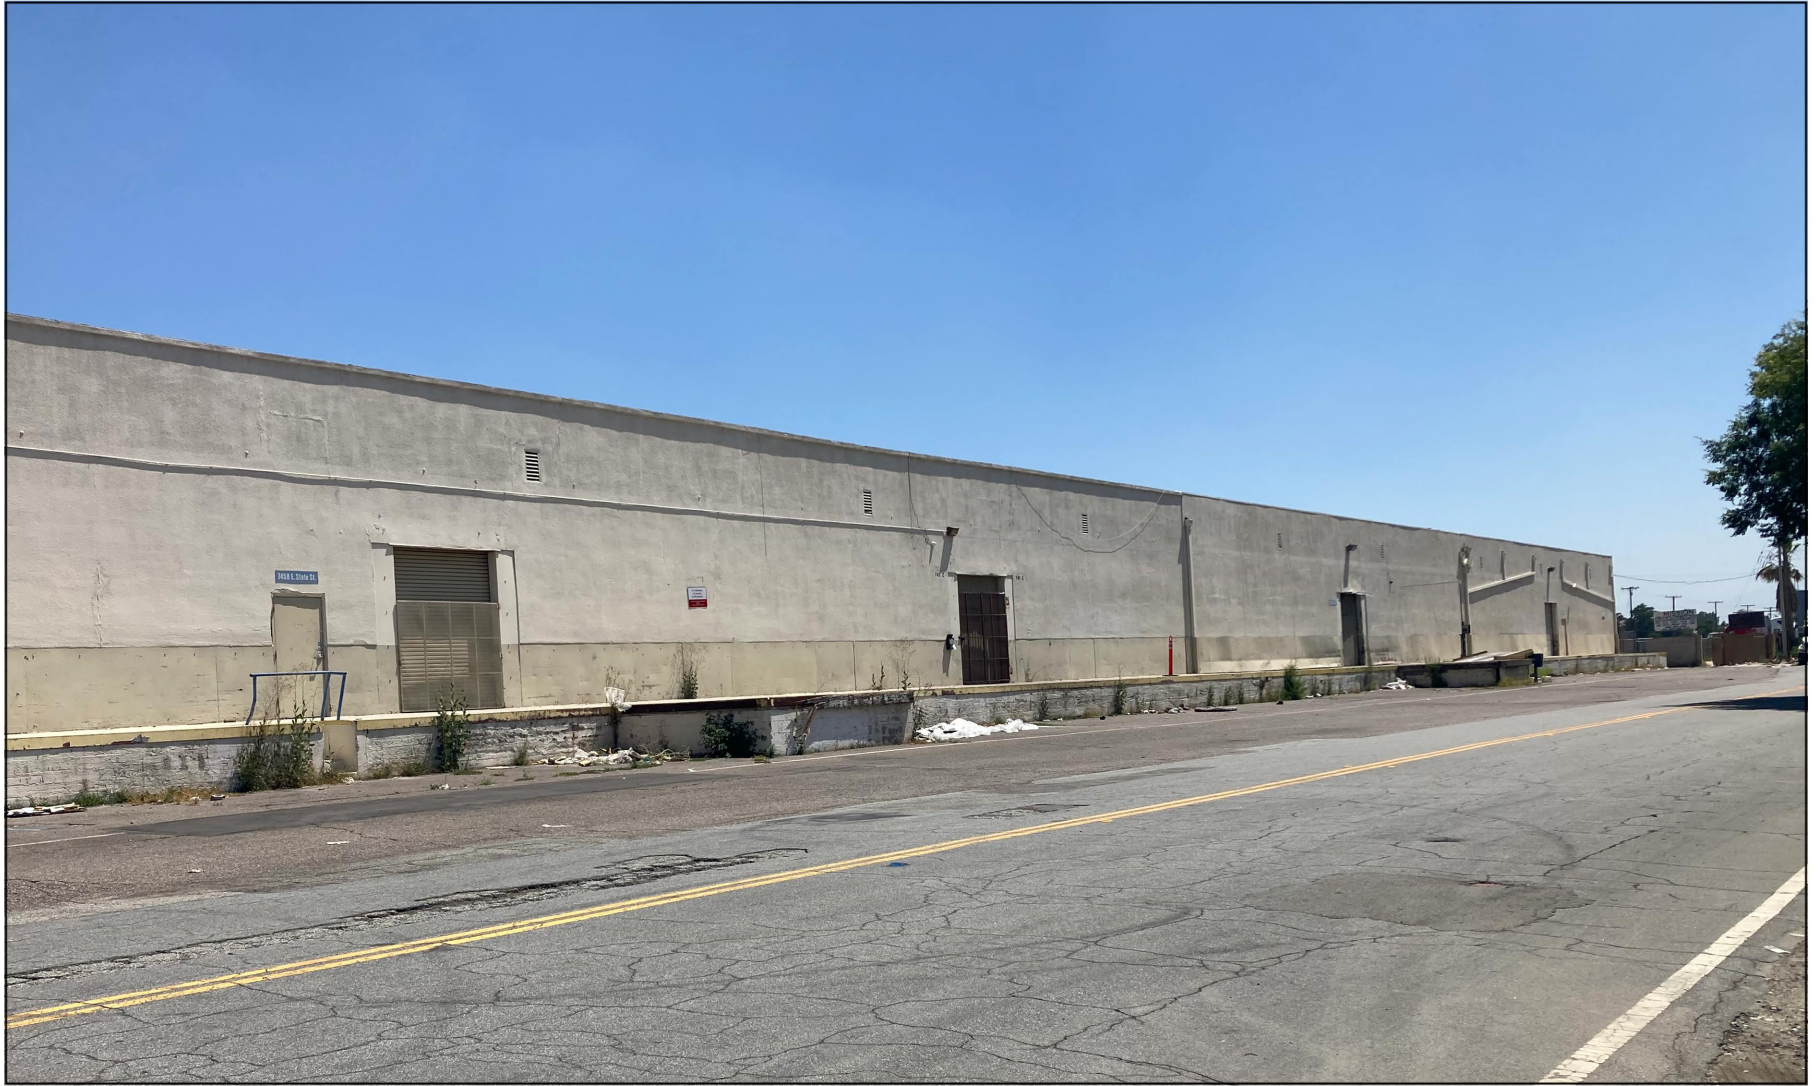
**Plate 14**

**View of the South Façade of Structure C  
at the 745 East State Street Building, Facing Southwest**

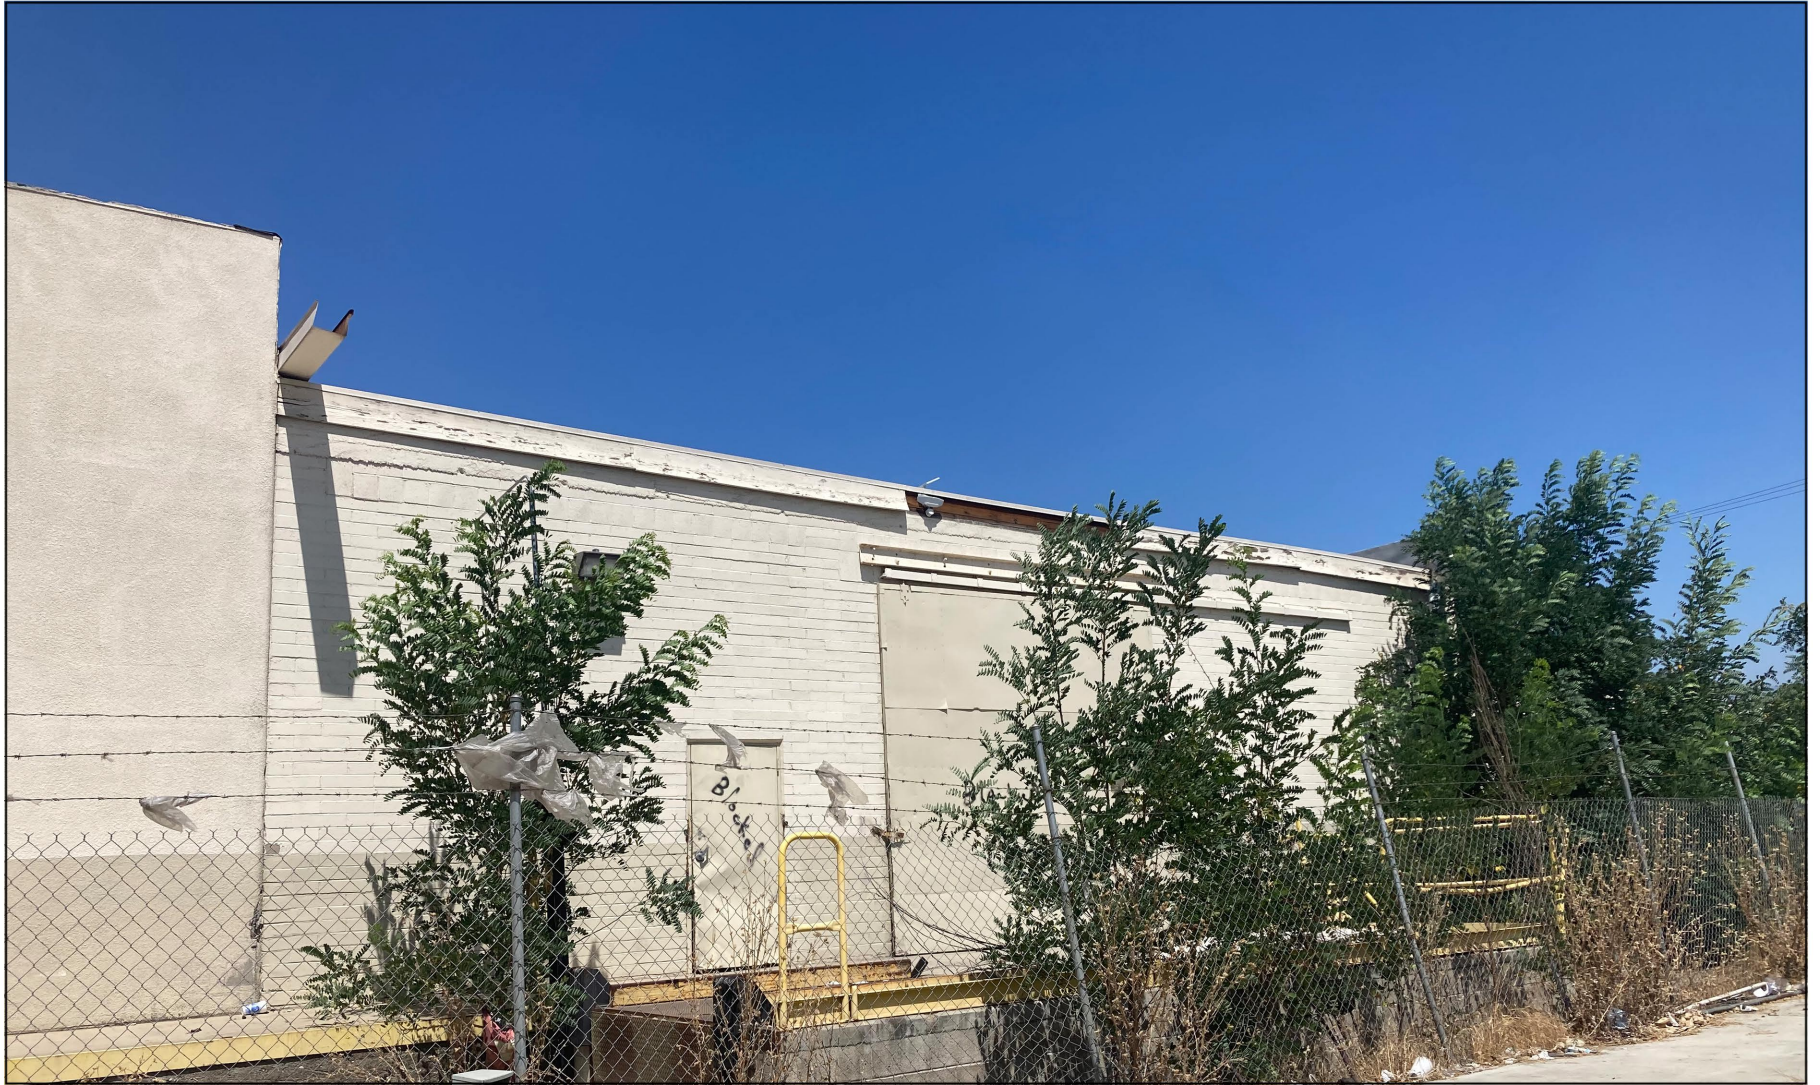
**Plate 16**  
**View of the East Façade of Structure D**  
**at the 745 East State Street Building, Facing Southeast**  
The East State Street Project

Structure D is a later addition to the manufacturing plant constructed between 1949 and 1953. Although Structure D shows an address of “810 E. Main Bldg. 11,” it is attached to the north side of the 745 East State Street building, north of Structures A, B, and C. The structure exhibits a flat roof covered with metal sheets and brick walls. Its east façade features a pedestrian door and a large sliding loading door (Plate 16). The north façade includes three loading doors and three pedestrian doors (Plate 17). Other than these elements, this façade is plain (Plates 18 and 19). The west façade features a loading door and a pedestrian door. Some infrastructure elements are attached to this façade (Plate 20).

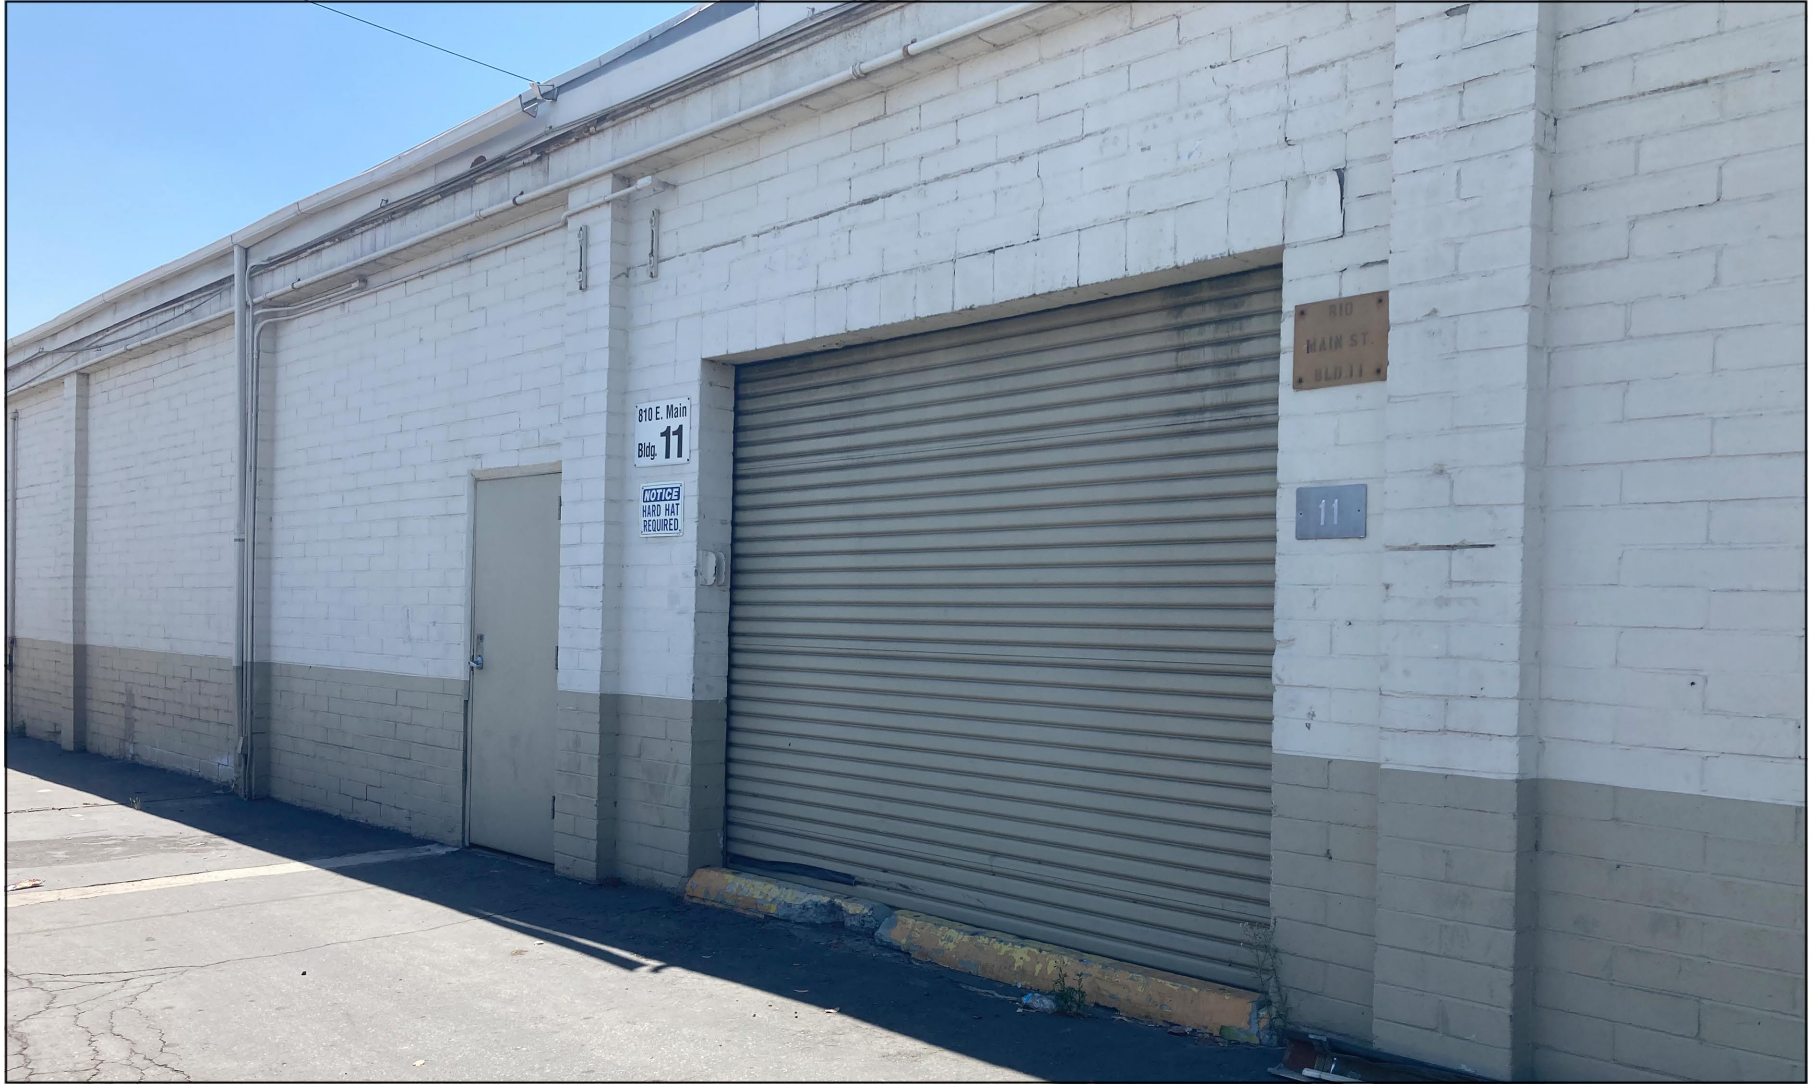
**Plate 17**

**View of the North Façade of Structure D  
at the 745 East State Street Building, Facing Southeast**

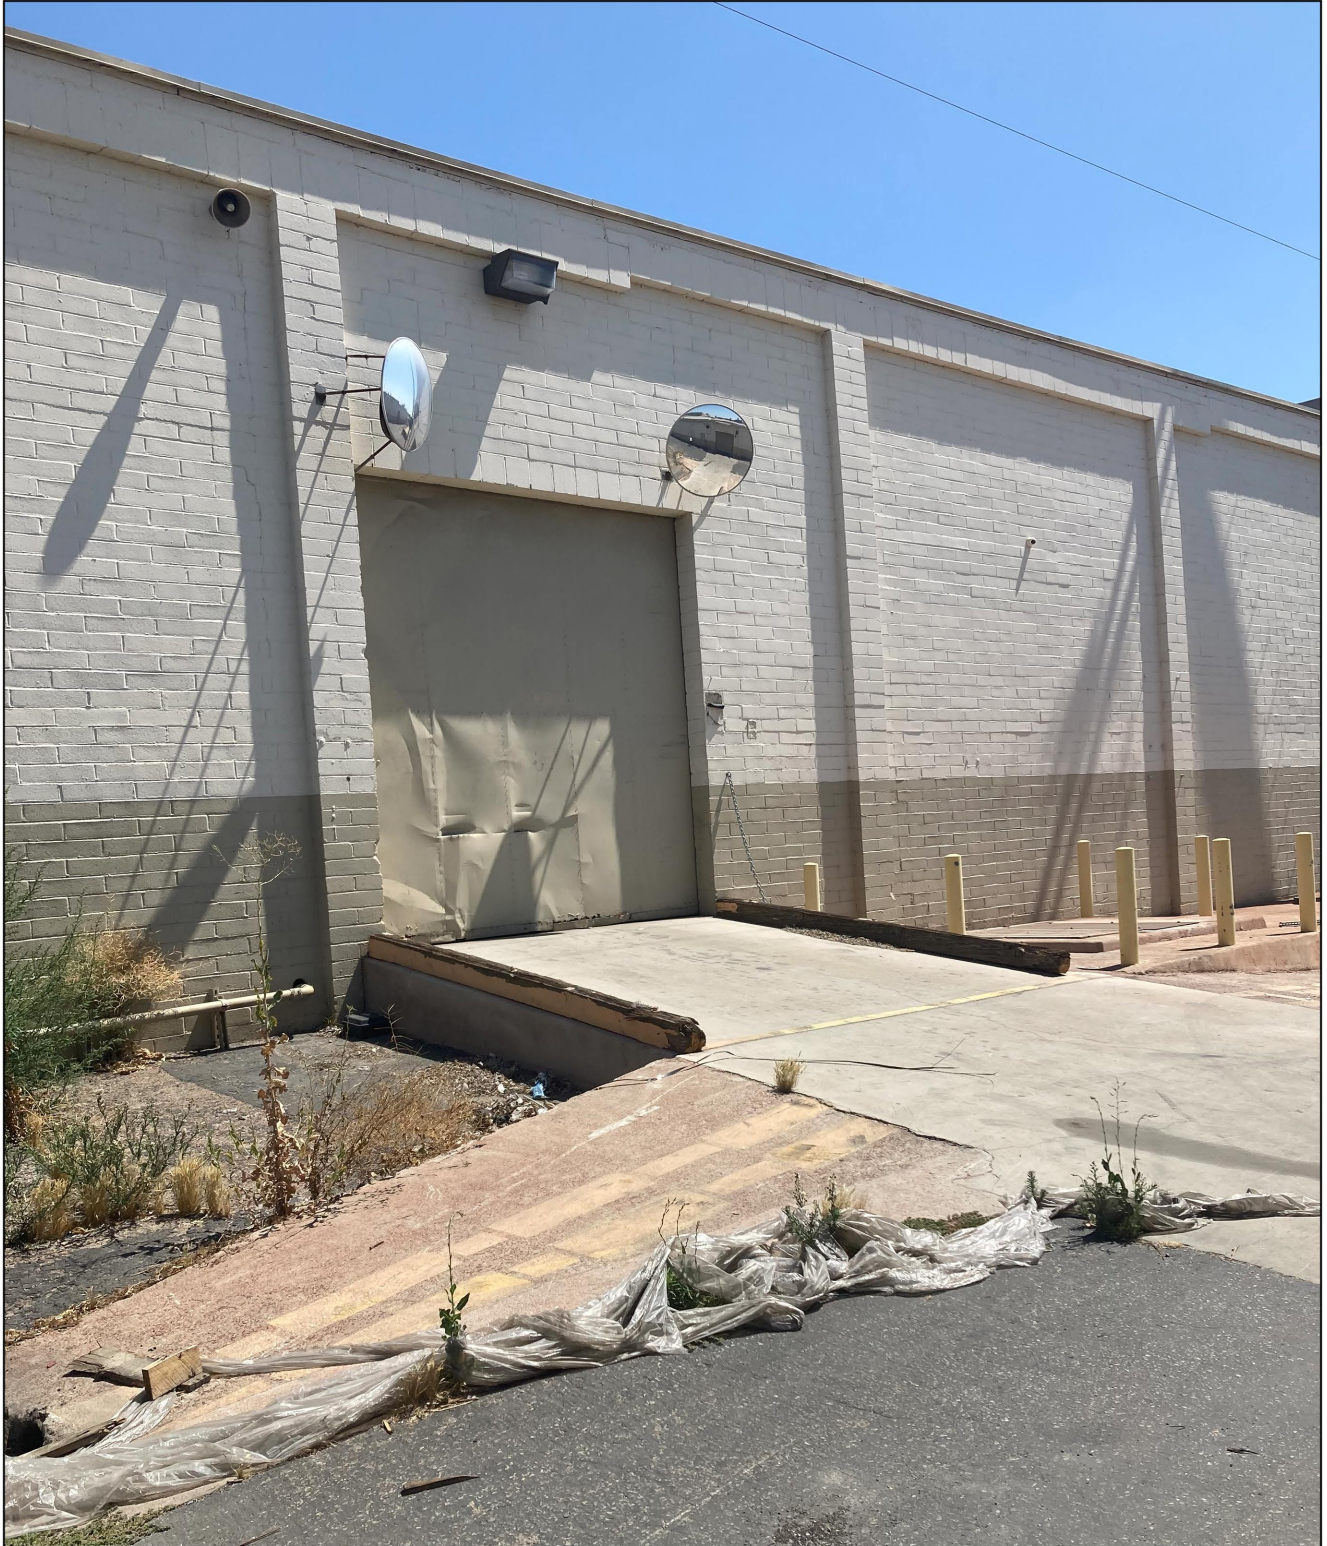
**Plate 25**

**View of the West Door on the South Façade of the  
810 East Main Street Building, Facing Northeast**

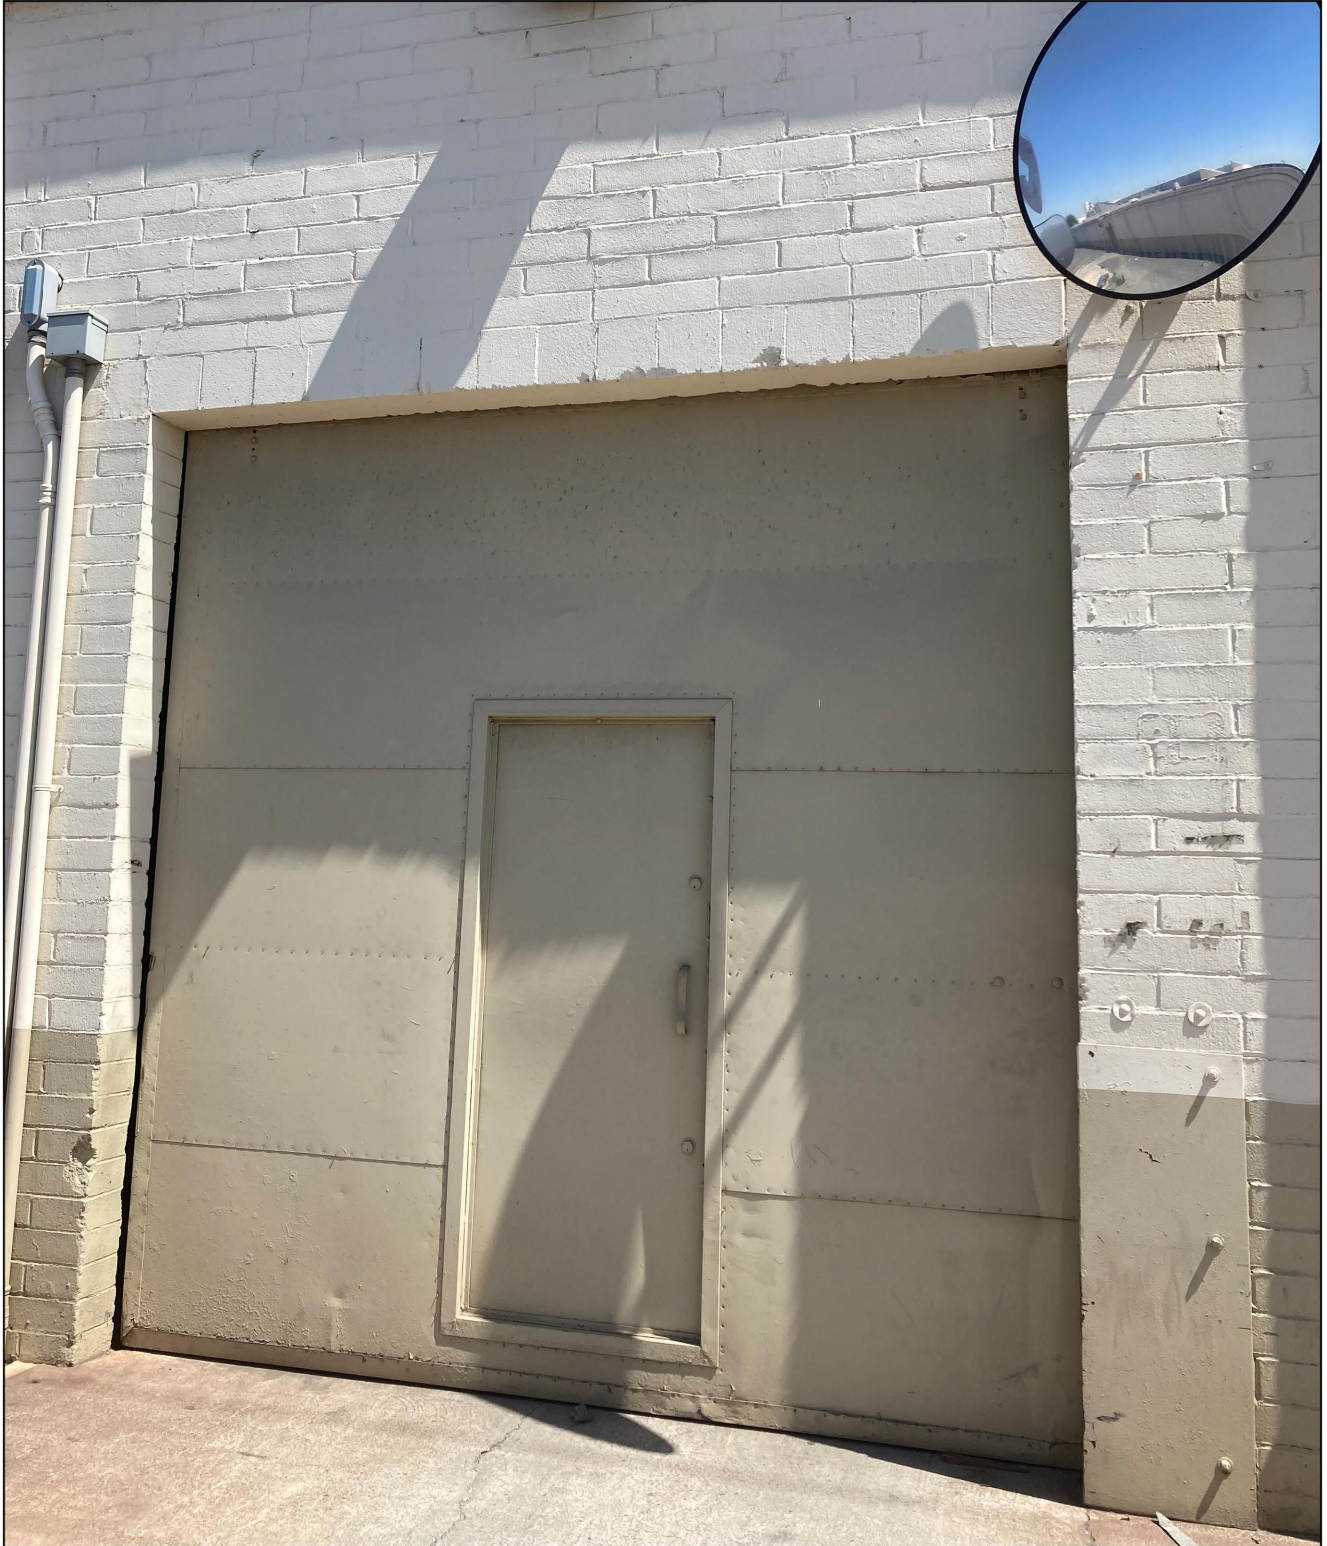
**Plate 26**

**View of the East Door on the South Façade of the  
810 East Main Street Building, Facing North**

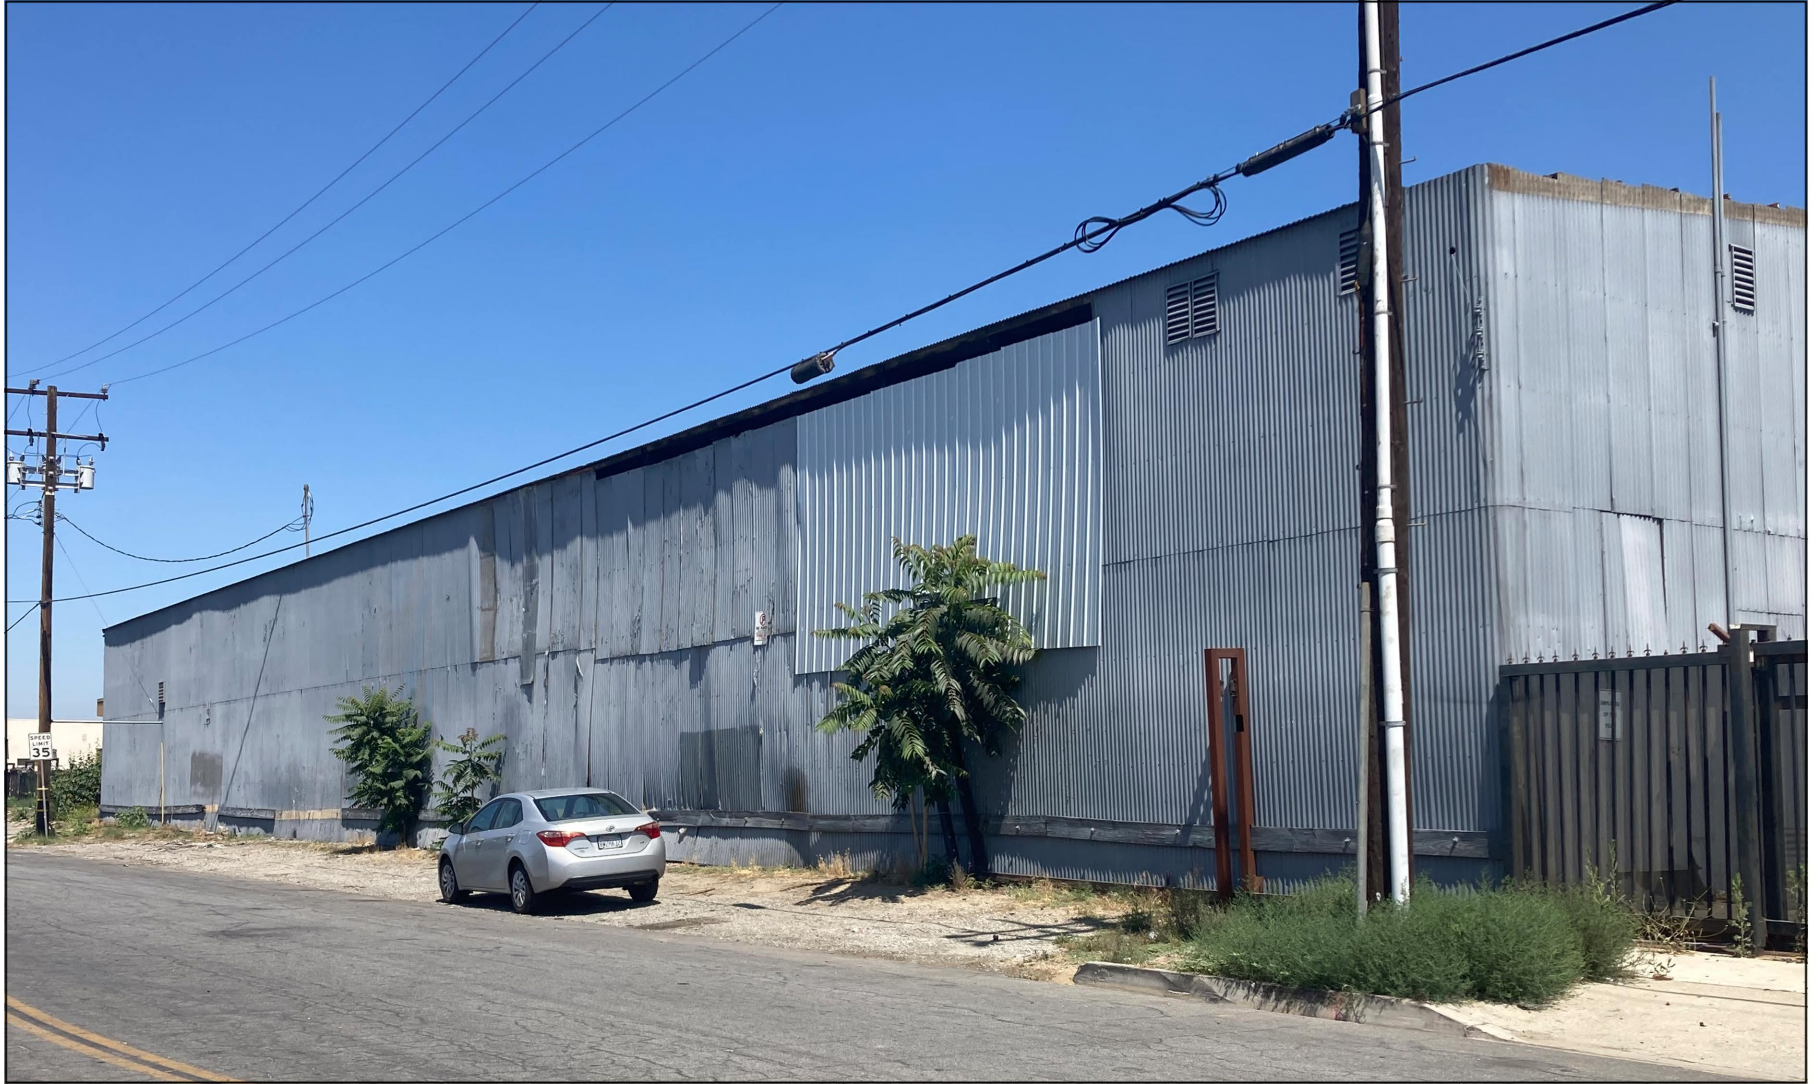
**Plate 31**  
**View of the South Façade of the 825 East State**  
**Street Building, Facing Northwest**  
The East State Street Project

The 825 East State Street building is located east of the other historic buildings at the East State Street property. This building is constructed between 1960 and 1966. The back of the building faces East State Street and the front of the building faces north. The building features a shed roof covered with metal sheets and the building is clad in corrugated metal (Plate 31). The north façade features several openings of various sizes and some of these openings are covered with plastic wrap (Plate 32). A shed structure is attached to the west end of this façade (see Plate 32). The other façades of the building do not feature any elements (Plate 33).

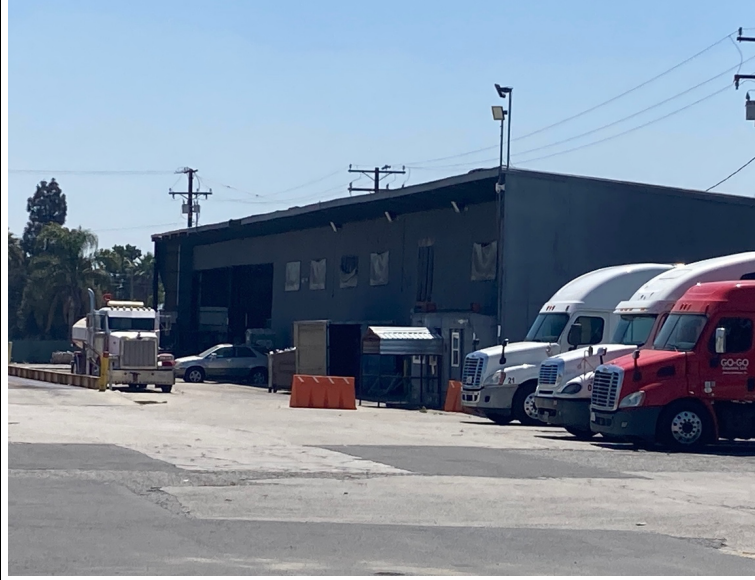
\*P5b. Description of Photo: (View, date, accession #)  
View of the north (left) and west (right) façades of the 825 East State Street building, facing southeast, 2022

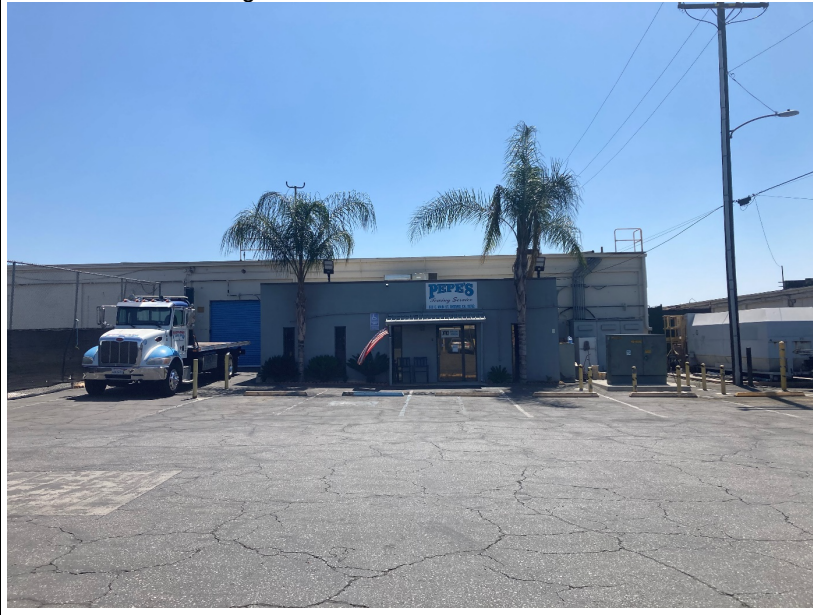
\*P3a. Description: (Describe resource and its major elements. Include design, materials, condition, alterations, size, setting, and boundaries)  
The 810 East Main Street building follows the curve of the former spur track, providing railroad access into the property. The south portion of the building was constructed between 1949 and 1953 and the curved north portion was added between 1953 and 1959. The building has a quarter circle footprint with a curved edge facing northeast. The 810 East Main Street building has been evaluated as not historically or architecturally significant under any CEQA criteria due to a lack of association with any significant persons or events and a lack of distinctive characteristics representative of a specific type, style, or method of construction. Because the building is not eligible for listing on the CRHR, no mitigation measures are required for any future alterations or planned demolition of the building.

**P5b. Description of Photo:** (View, date, accession #)  
View of the south portion of the west façade of the 810 East Main Street building, facing east.

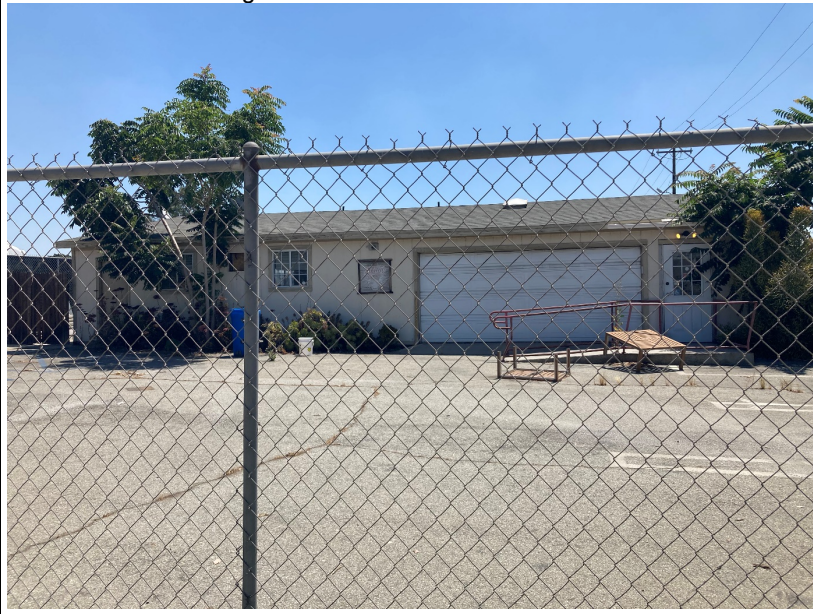
\*P3a. **Description:** (Describe resource and its major elements. Include design, materials, condition, alterations, size, setting, and boundaries)  
The 235 South Campus Avenue building was originally constructed as a cafeteria in 1926 in the Utilitarian style. The building has been converted into a Minimal Traditional-style residence at an unknown date. The 235 South Campus Avenue building has been evaluated as not historically or architecturally significant under any CEQA criteria due to a lack of association with any significant persons or events and a lack of distinctive characteristics representative of a specific type, style, or method of construction. Because the building is not eligible for listing on the CRHR, no mitigation measures are required for any future alterations or planned demolition of the building.

**P5b. Description of Photo:** (View, date, accession #)  
View of the east façade of the 235 South Campus Avenue cafeteria building, facing west.
