**County Road R over Glenn-
Colusa Canal Bridge
Replacement Project**

Delineation of Waters of the
United States

March 13, 2018

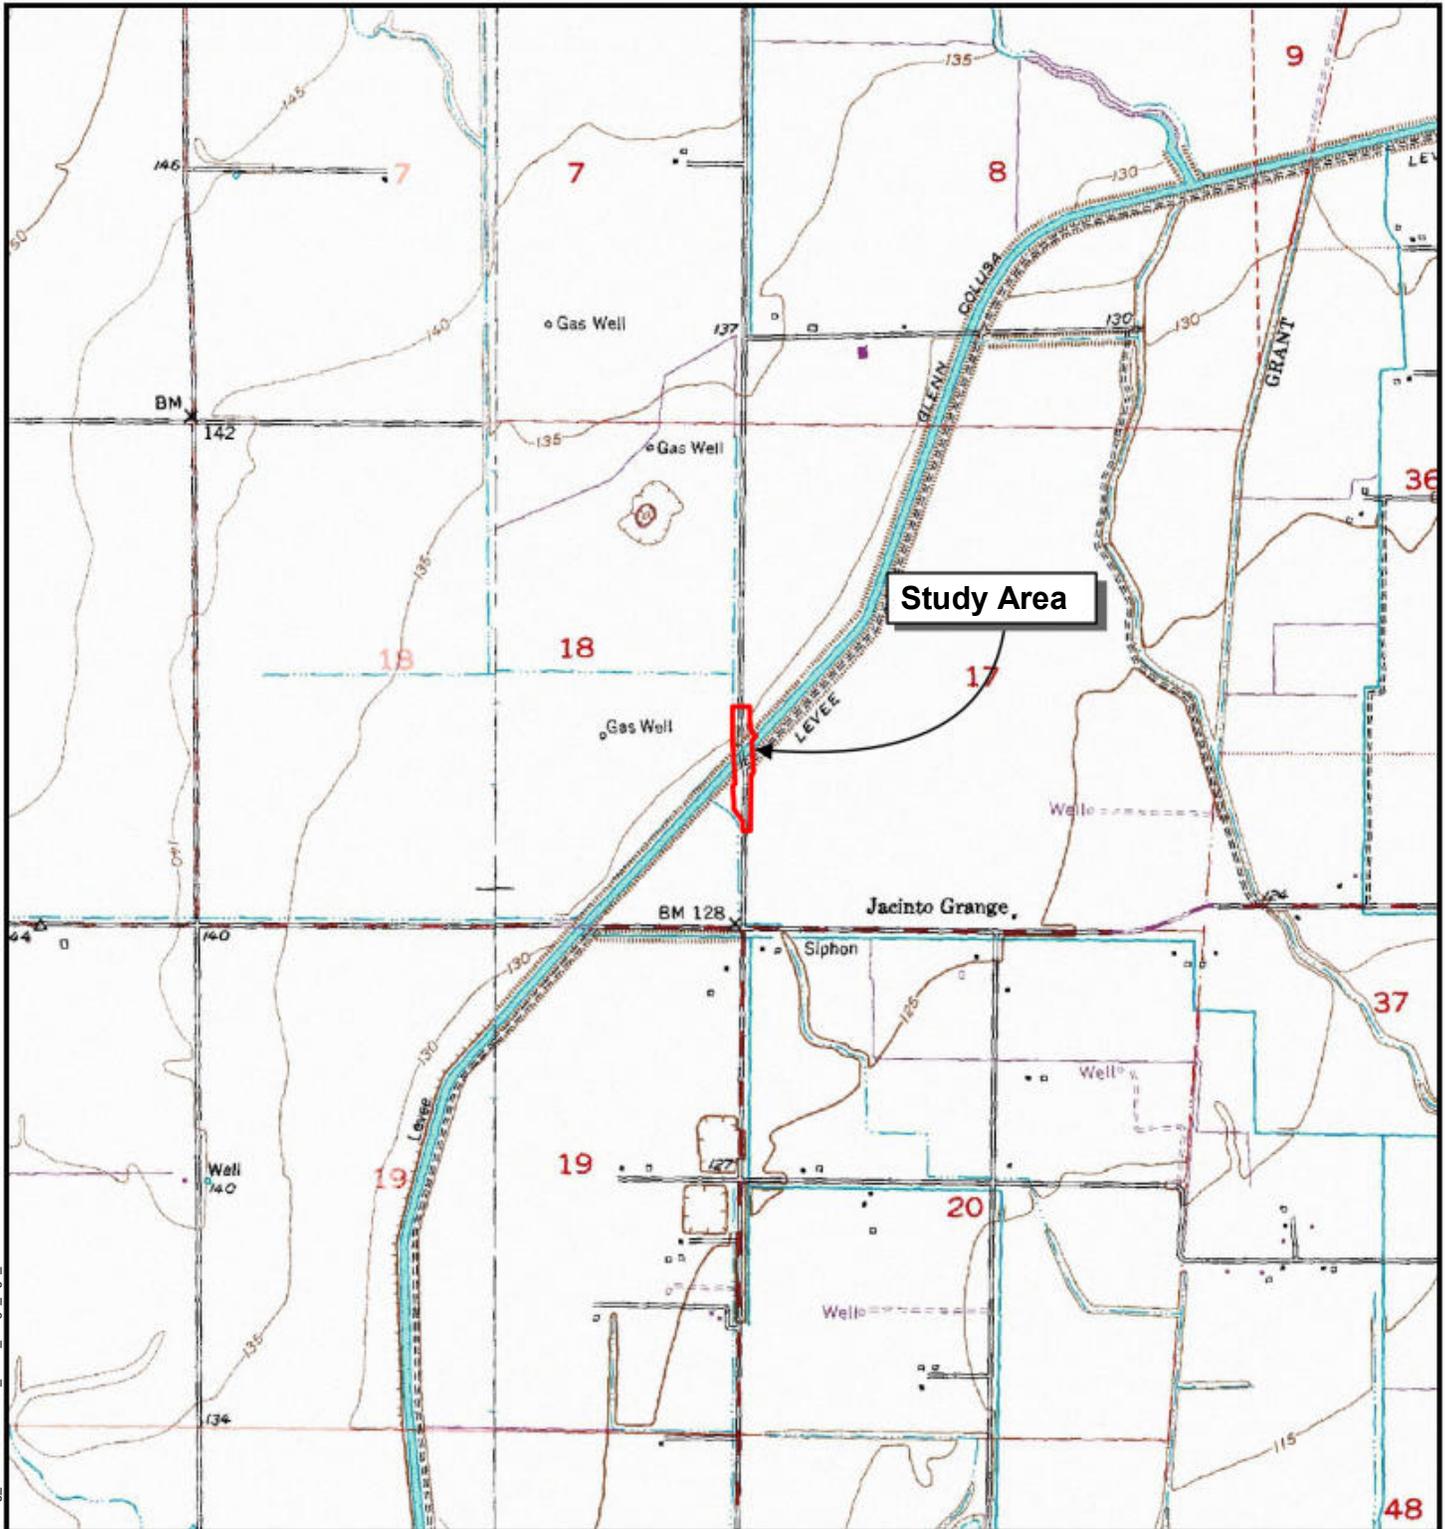
Figure 1
Study Area Location

The study area is located in a rural area near the unincorporated community of Artois in Glenn County, California and it consists of a 1,200-foot alignment along County Road R. This location can be found on the *Glenn, California* 7.5-minute U.S. Geological Survey (USGS) quadrangle in Township 20N, Range 2W, Sections 17 and 18. The approximate center of the study area is located at latitude 39.586947°, longitude -122.116908° (North American Datum 83). The study area location is shown in Figure 1.

To access the study area from Interstate 5, travel 5 miles east on County Road 39 (Bayliss Blue Gum Road) to County Road R. Turn left and travel 0.2 mile to the study area where the County Road R Bridge crosses over the Glenn-Colusa Canal (Figure 1).

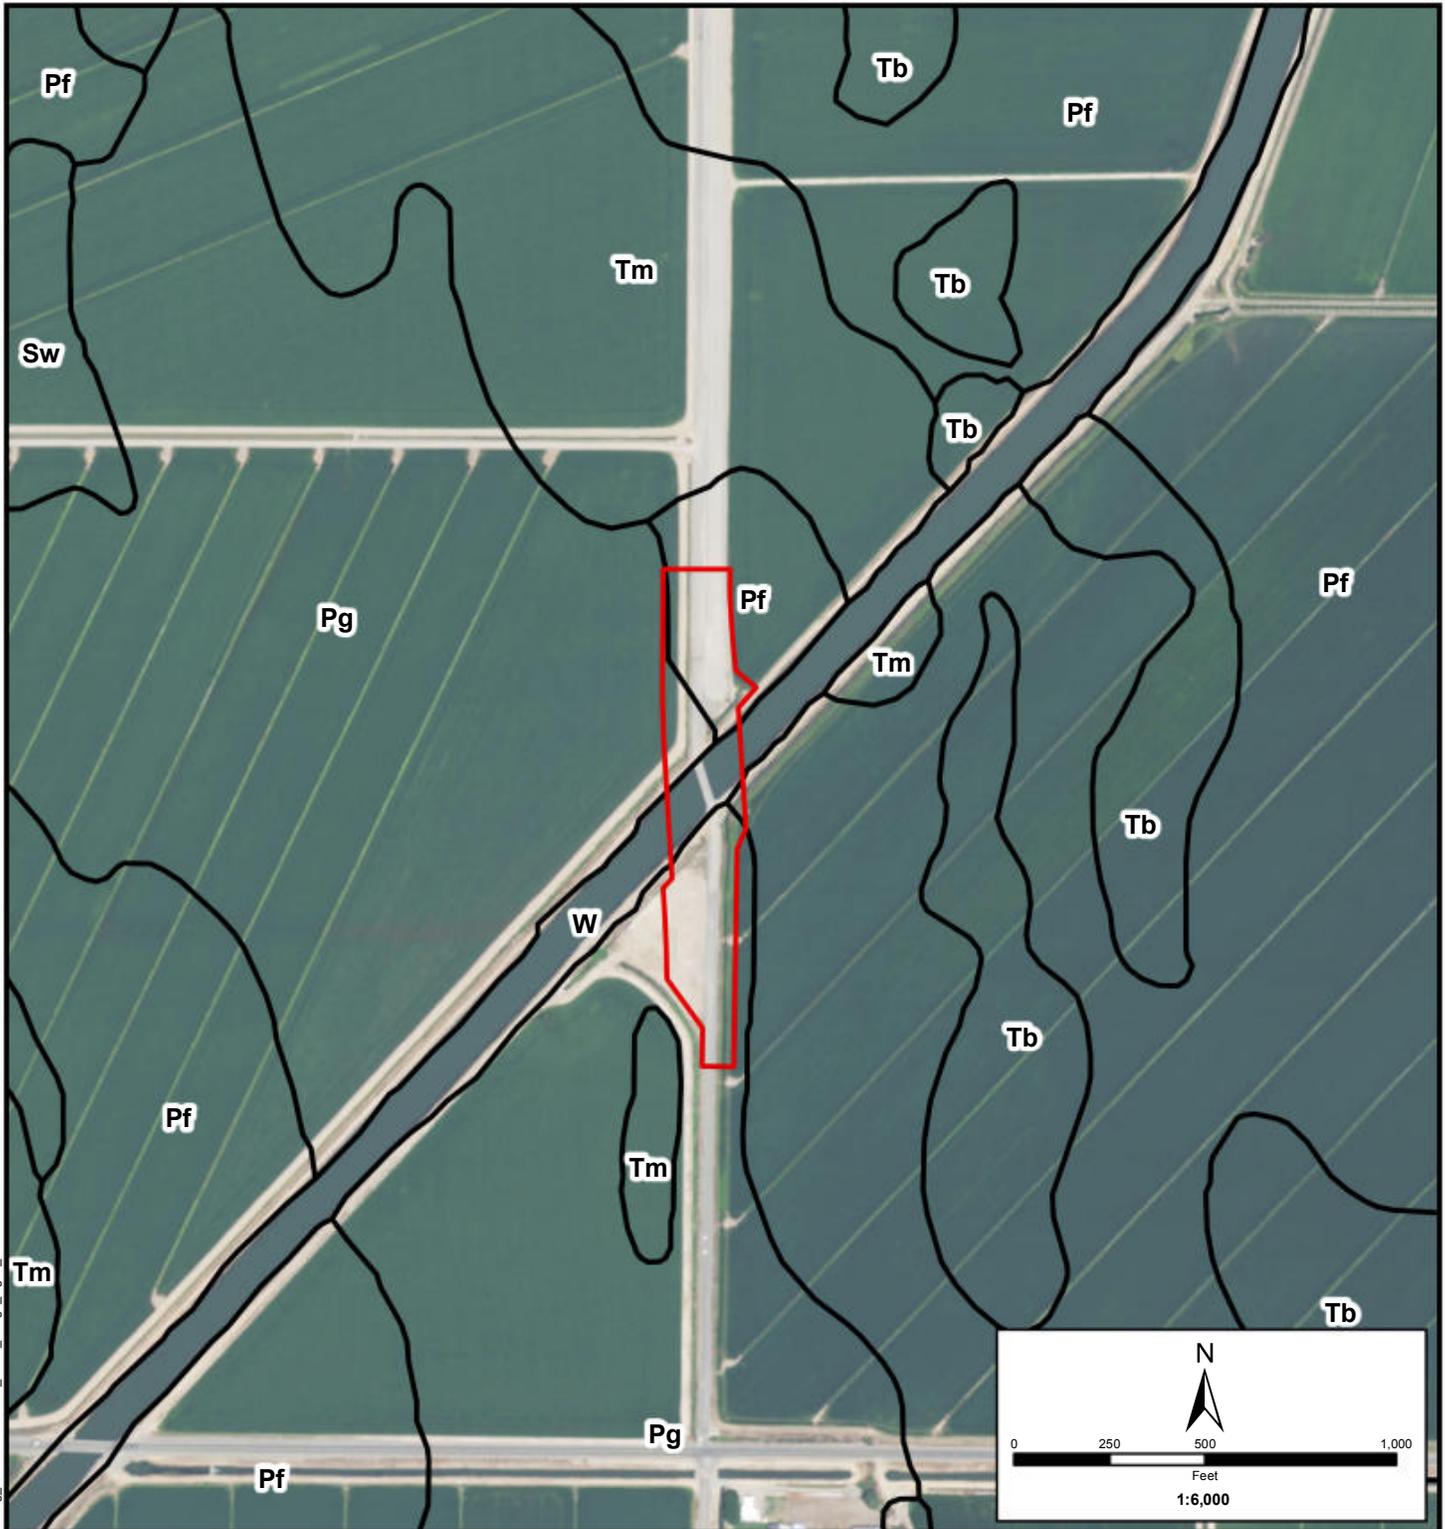
Soil Map Units

Two soil map units occur in the study area. They are described in the *Soil Survey of Glenn County, California* (Natural Resources Conservation Service 1999). Soil map units in and around the study area are shown in Figure 2. The soil map units that occur within the study area are described below:

- **Plaza silt loam (Pf).** This is a non-hydric, moderately well to imperfectly drained soil formed in alluvium. These soils occur in rice producing areas and consequently water tables persist for longer periods than would be expected under natural conditions. The depth to a restrictive layer is 60 inches.
- **Plaza silty clay loam (Pg).** This is a non-hydric, moderately well to imperfectly drained soil formed in alluvium. These soils occur in rice producing areas and consequently water tables persist for longer periods than would be expected under natural conditions. The depth to a restrictive layer is 60 inches.

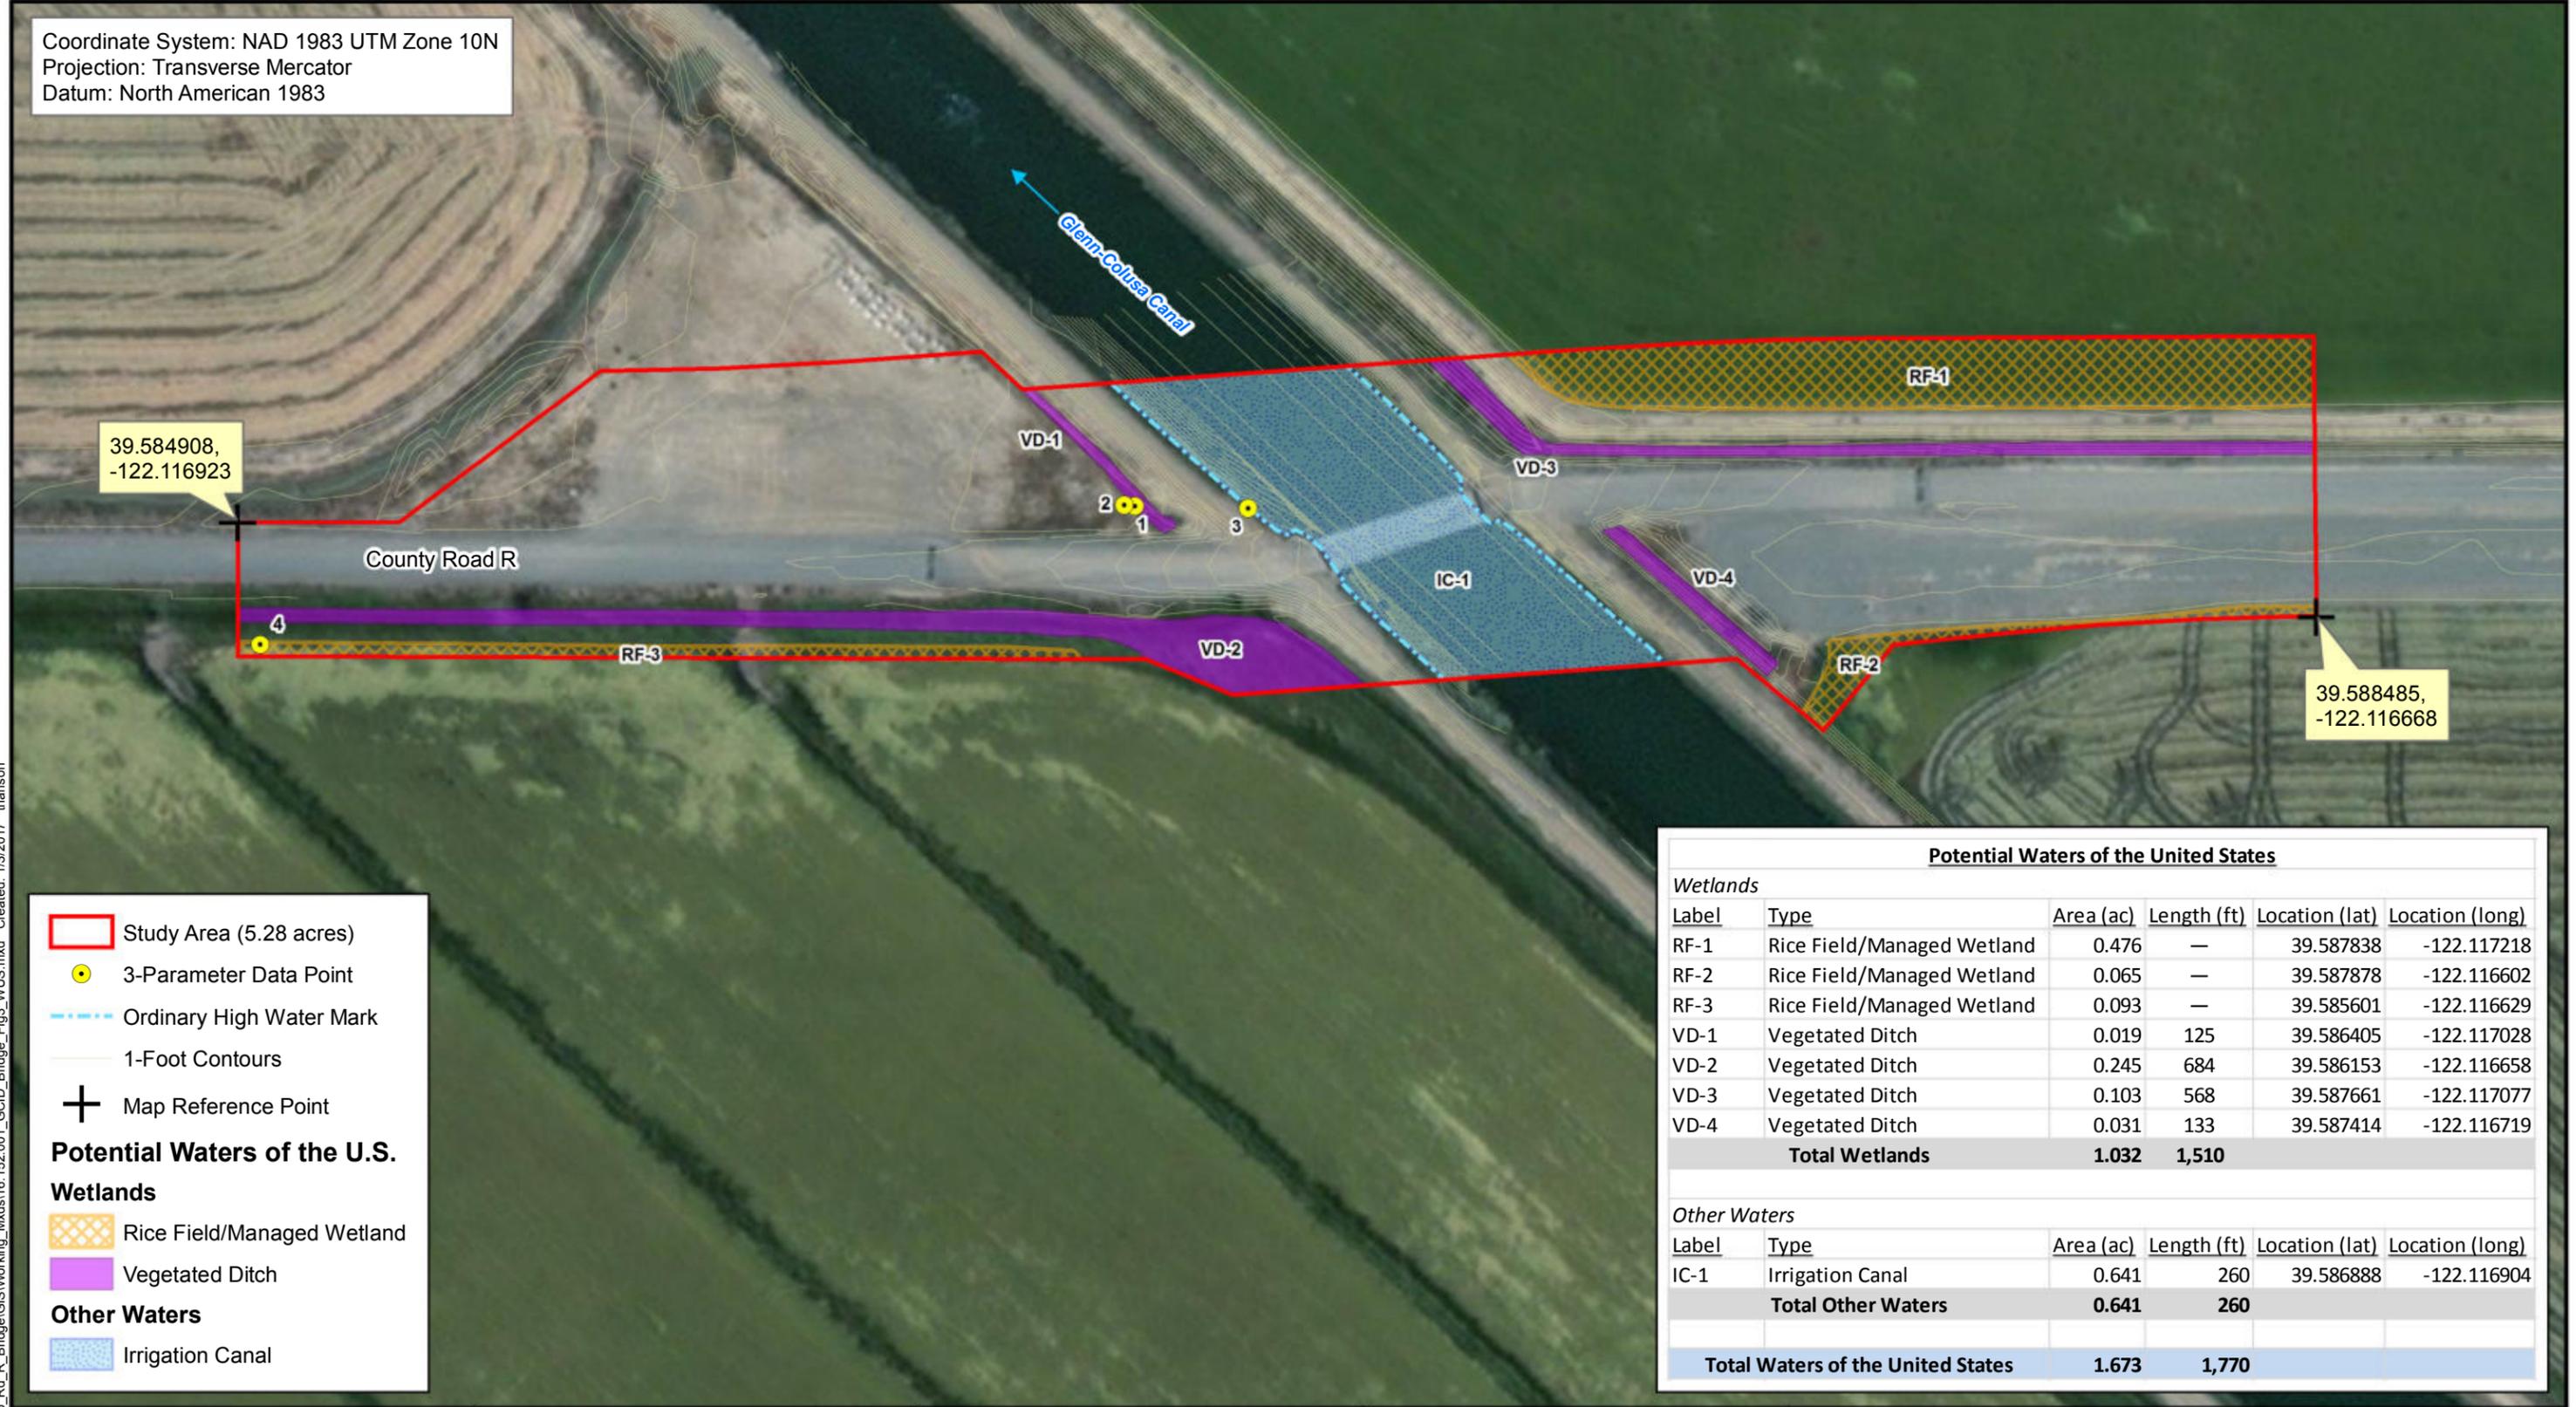
Figure 3
Potential Waters of the United States

The boundaries and area of potential waters of the United States occurring in the study area are illustrated in Figure 3. A total of 1.673 acres of waters of the United States were delineated. A summary of the delineated features is presented in Table 1. Routine wetland determination data forms are presented in Appendix A. Representative photographs of the delineated features and data point locations are presented in Appendix B.

Potential Waters of the United States					
Wetlands					
Label	Type	Area (ac)	Length (ft)	Location (lat)	Location (long)
RF-1	Rice Field/Managed Wetland	0.476	—	39.587838	-122.117218
RF-2	Rice Field/Managed Wetland	0.065	—	39.587878	-122.116602
RF-3	Rice Field/Managed Wetland	0.093	—	39.585601	-122.116629
VD-1	Vegetated Ditch	0.019	125	39.586405	-122.117028
VD-2	Vegetated Ditch	0.245	684	39.586153	-122.116658
VD-3	Vegetated Ditch	0.103	568	39.587661	-122.117077
VD-4	Vegetated Ditch	0.031	133	39.587414	-122.116719
Total Wetlands		1.032	1,510		
Other Waters					
Label	Type	Area (ac)	Length (ft)	Location (lat)	Location (long)
IC-1	Irrigation Canal	0.641	260	39.586888	-122.116904
Total Other Waters		0.641	260		
Total Waters of the United States		1.673	1,770

Table 1. Waters of the United States Summary

Waters of the United States	Total Acreage	Total Linear Feet	Cowardin Type ¹
Wetlands			
Rice Field/Managed Wetland	0.634	N/A	PUBMKf
Vegetated Ditch	0.398	1,510	PEM1Kx
Other Waters			
Irrigation Canal	0.641	260	R2UBHx
Total Waters of the United States	1.673	1,770

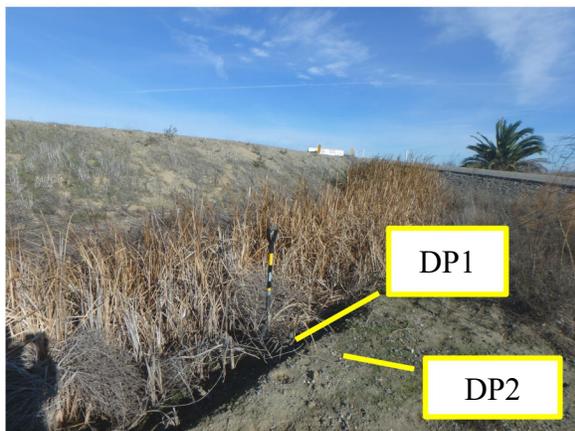
Photograph 1. Vegetated Ditch (VD-1). Data points (DP) 1 and 2 document the feature and the uplands, respectively. Orientation: northeast.

Vegetated ditches are located throughout the study area. They are excavated ditches that convey water from the irrigation canal to the adjacent rice fields. VD-1 is located to the west of County Road R, south of the Irrigation Canal. VD-1 is dominated by broad leaved cattail (*Typha latifolia*) which is an obligate wetland plant species. VD-2 is located to the south of the irrigation canal and runs parallel to the east side of County Road R. VD-2 is also dominated by cattails and water primrose (*Ludwigia* sp.) which are both obligate wetland species. During the November 30, 2017 survey, there was evidence that the vegetation in VD-3 and VD-4 had recently been excavated. Remnants of hydrophytic vegetation such as cattails and flat sedge (*Cyperus difformis*) seedlings were present in VD-3 and VD-4. Hydrology indicators include surface water and saturation. All vegetated ditches in the study area meet wetland criteria and also qualify as other waters of the United States due to the presence of an OHWM.

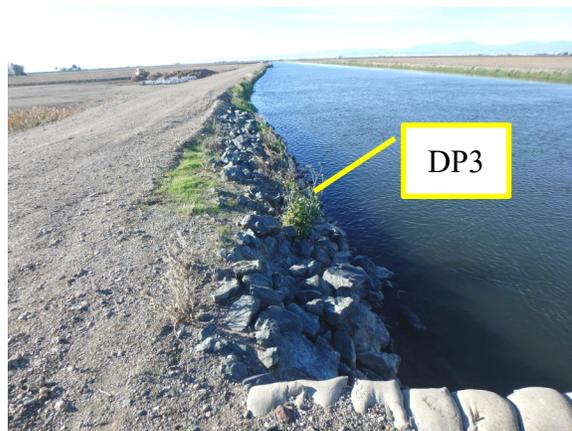
Photograph 2. Irrigation Canal (IC-1). DP3 documents the OHWM of the feature. Orientation: southwest.

The Glenn-Colusa Canal is an irrigation canal (IC-1) that flows westerly through the study area. This feature is typically flooded year round to convey water to agricultural crops. IC-1 is characterized as a bed and bank feature that exhibits indicators of scour, deposition, and watermarks. Hydrology indicators include surface water and inundation visible on aerial imagery. IC-1 qualifies as other waters of the United States.

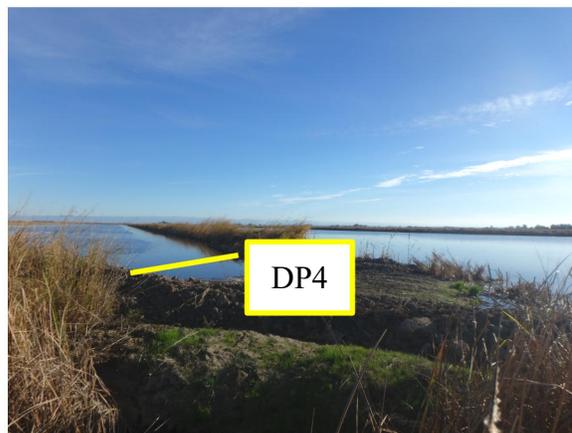
Photograph 3. Rice Field (RF-3). DP4 documents the feature. Orientation: northeast.

The study area is bounded by rice fields/managed wetlands. Rice fields are generally flooded for the duration of the growing season, which may exceed five months. RF-1 and RF-2 are located in the northern portion of the study area and were both dry during the November 30, 2017 survey. However, inundation is visible on aerial imagery. RF-3 lies in the southeastern portion of the study area and was flooded during the November 30, 2017 survey. If irrigation ceased, RF-1, RF-2, and RF-3 might revert to uplands. Determining whether these wetlands would revert to upland in absence of irrigation would require additional investigation after cessation of irrigation for rice cultivation. For the purposes of this delineation (i.e., to support a Preliminary Jurisdictional Determination), RF-1, RF-2, and RF-3 are considered potential wetlands.
