## **Initial Study/Mitigated Negative Declaration**

# **Buckman Road Bridge Replacement Project**

**February 2023**

**Prepared for:**  
San Joaquin County  
Department of Public Works  
1810 E. Hazelton Avenue  
Stockton, CA 95205

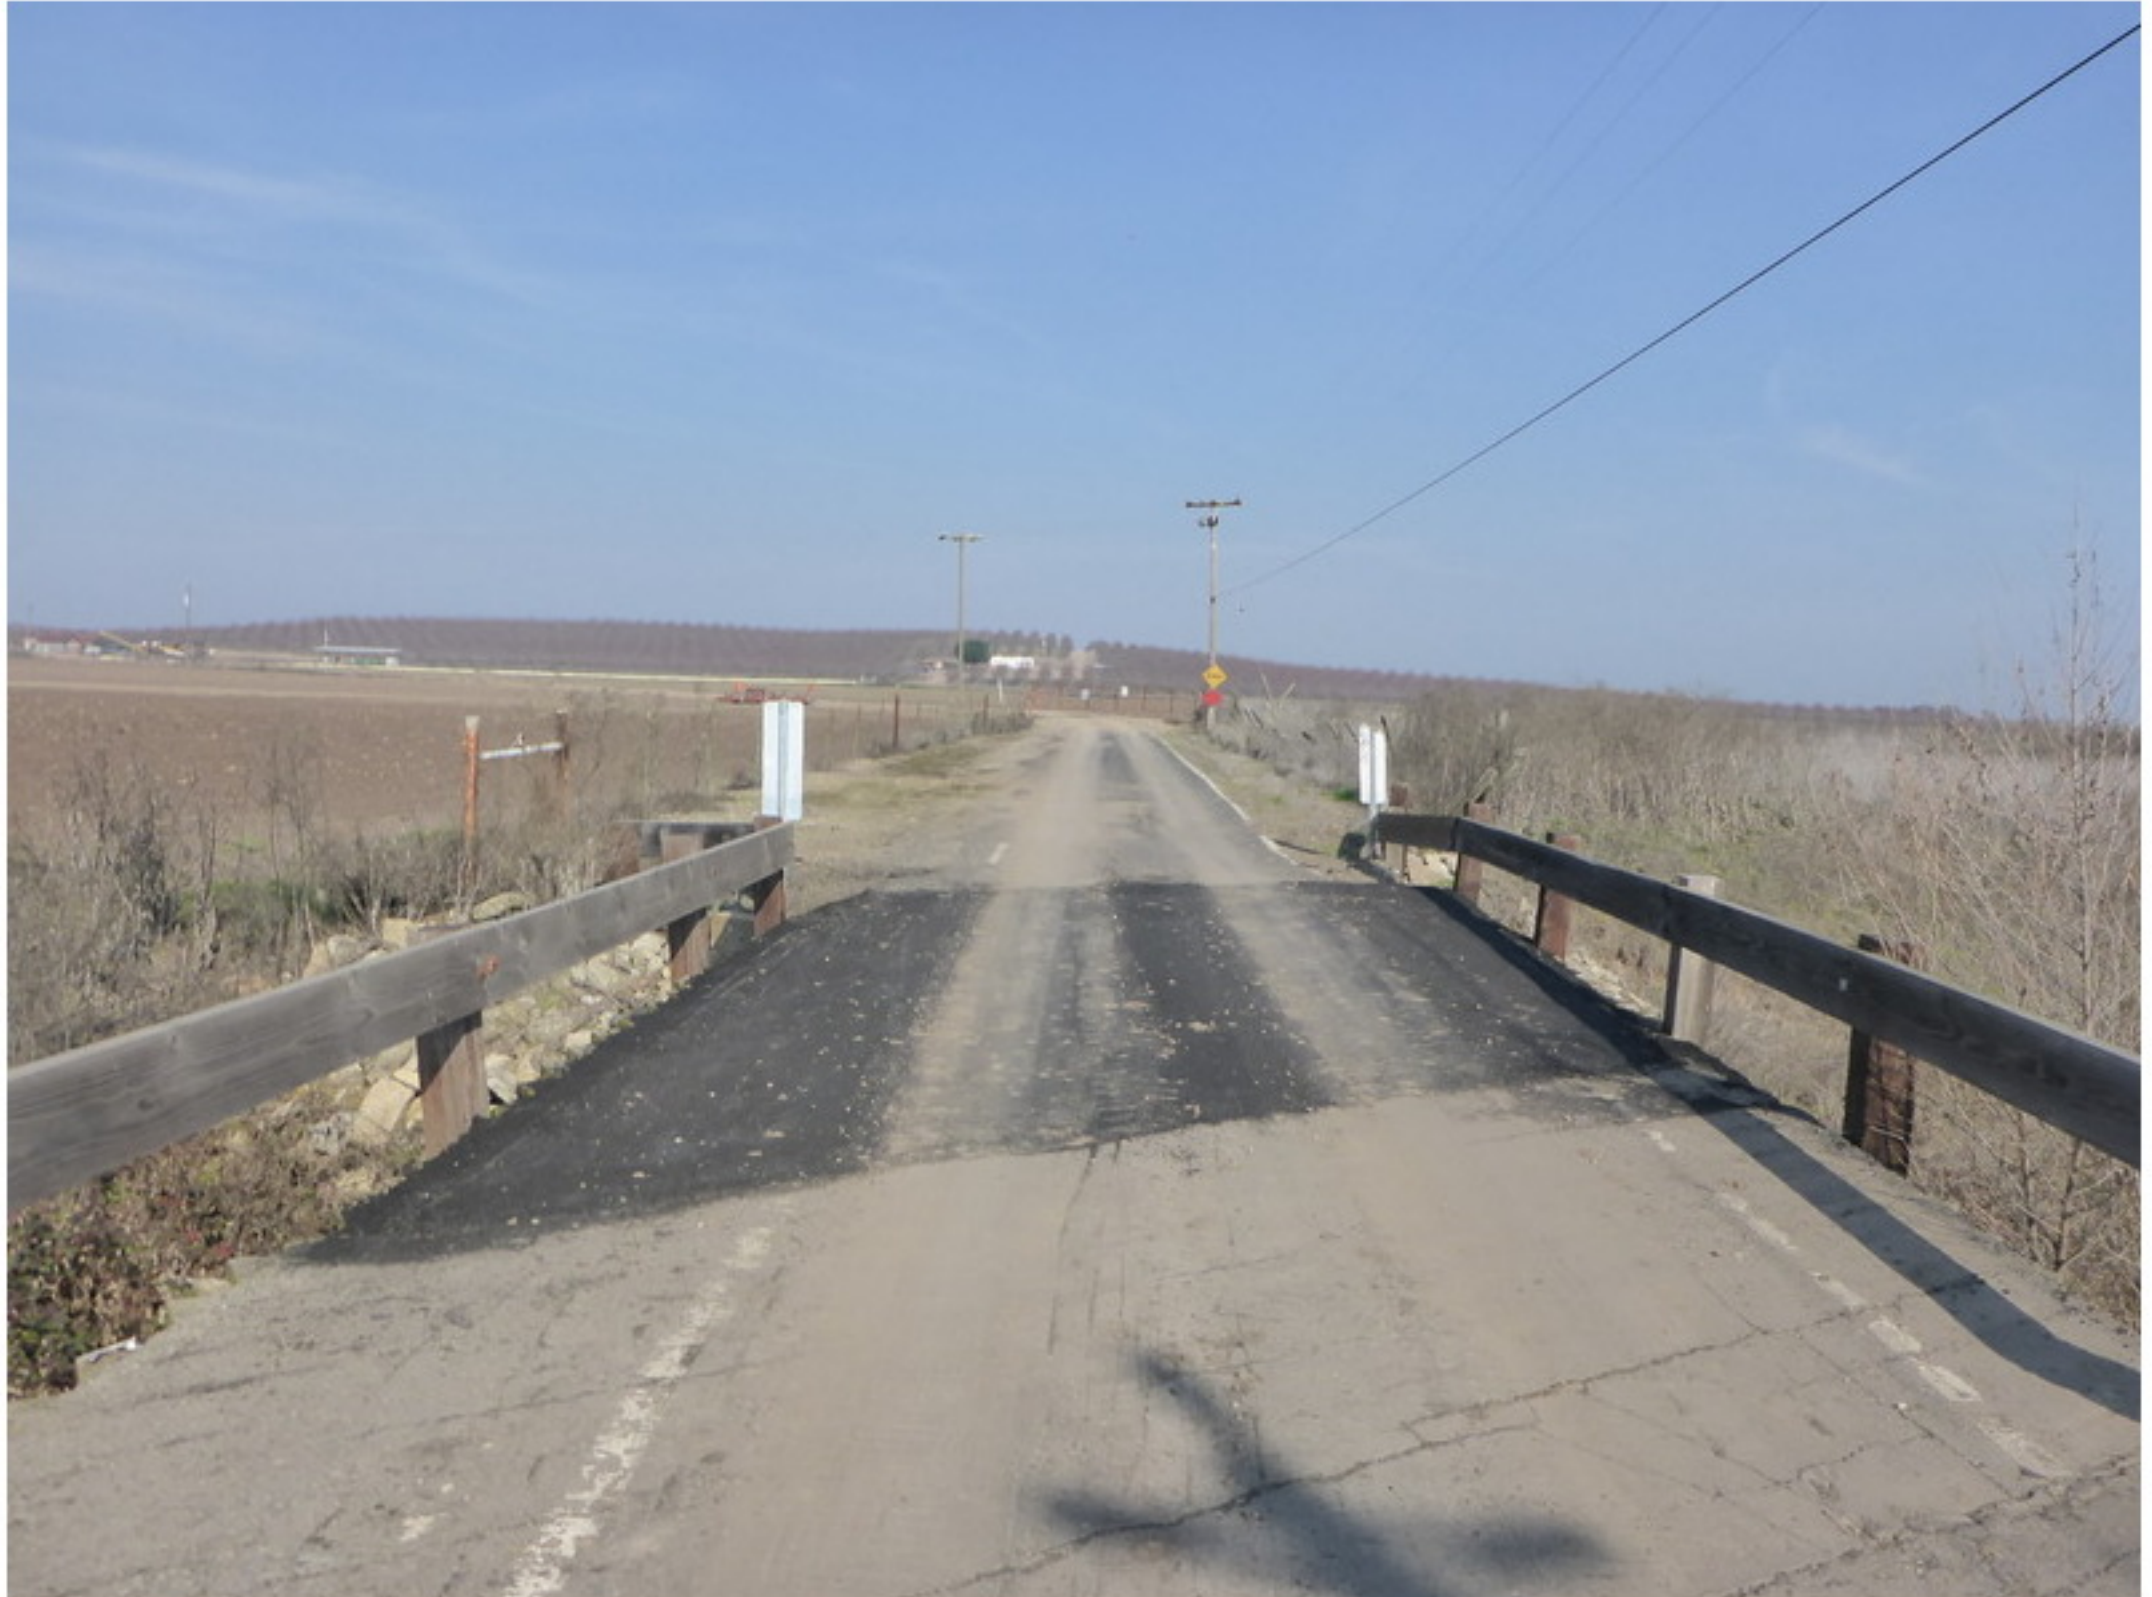
Photo No. 7  
New AC overlay after repairs at Abutment 4. Looking north.

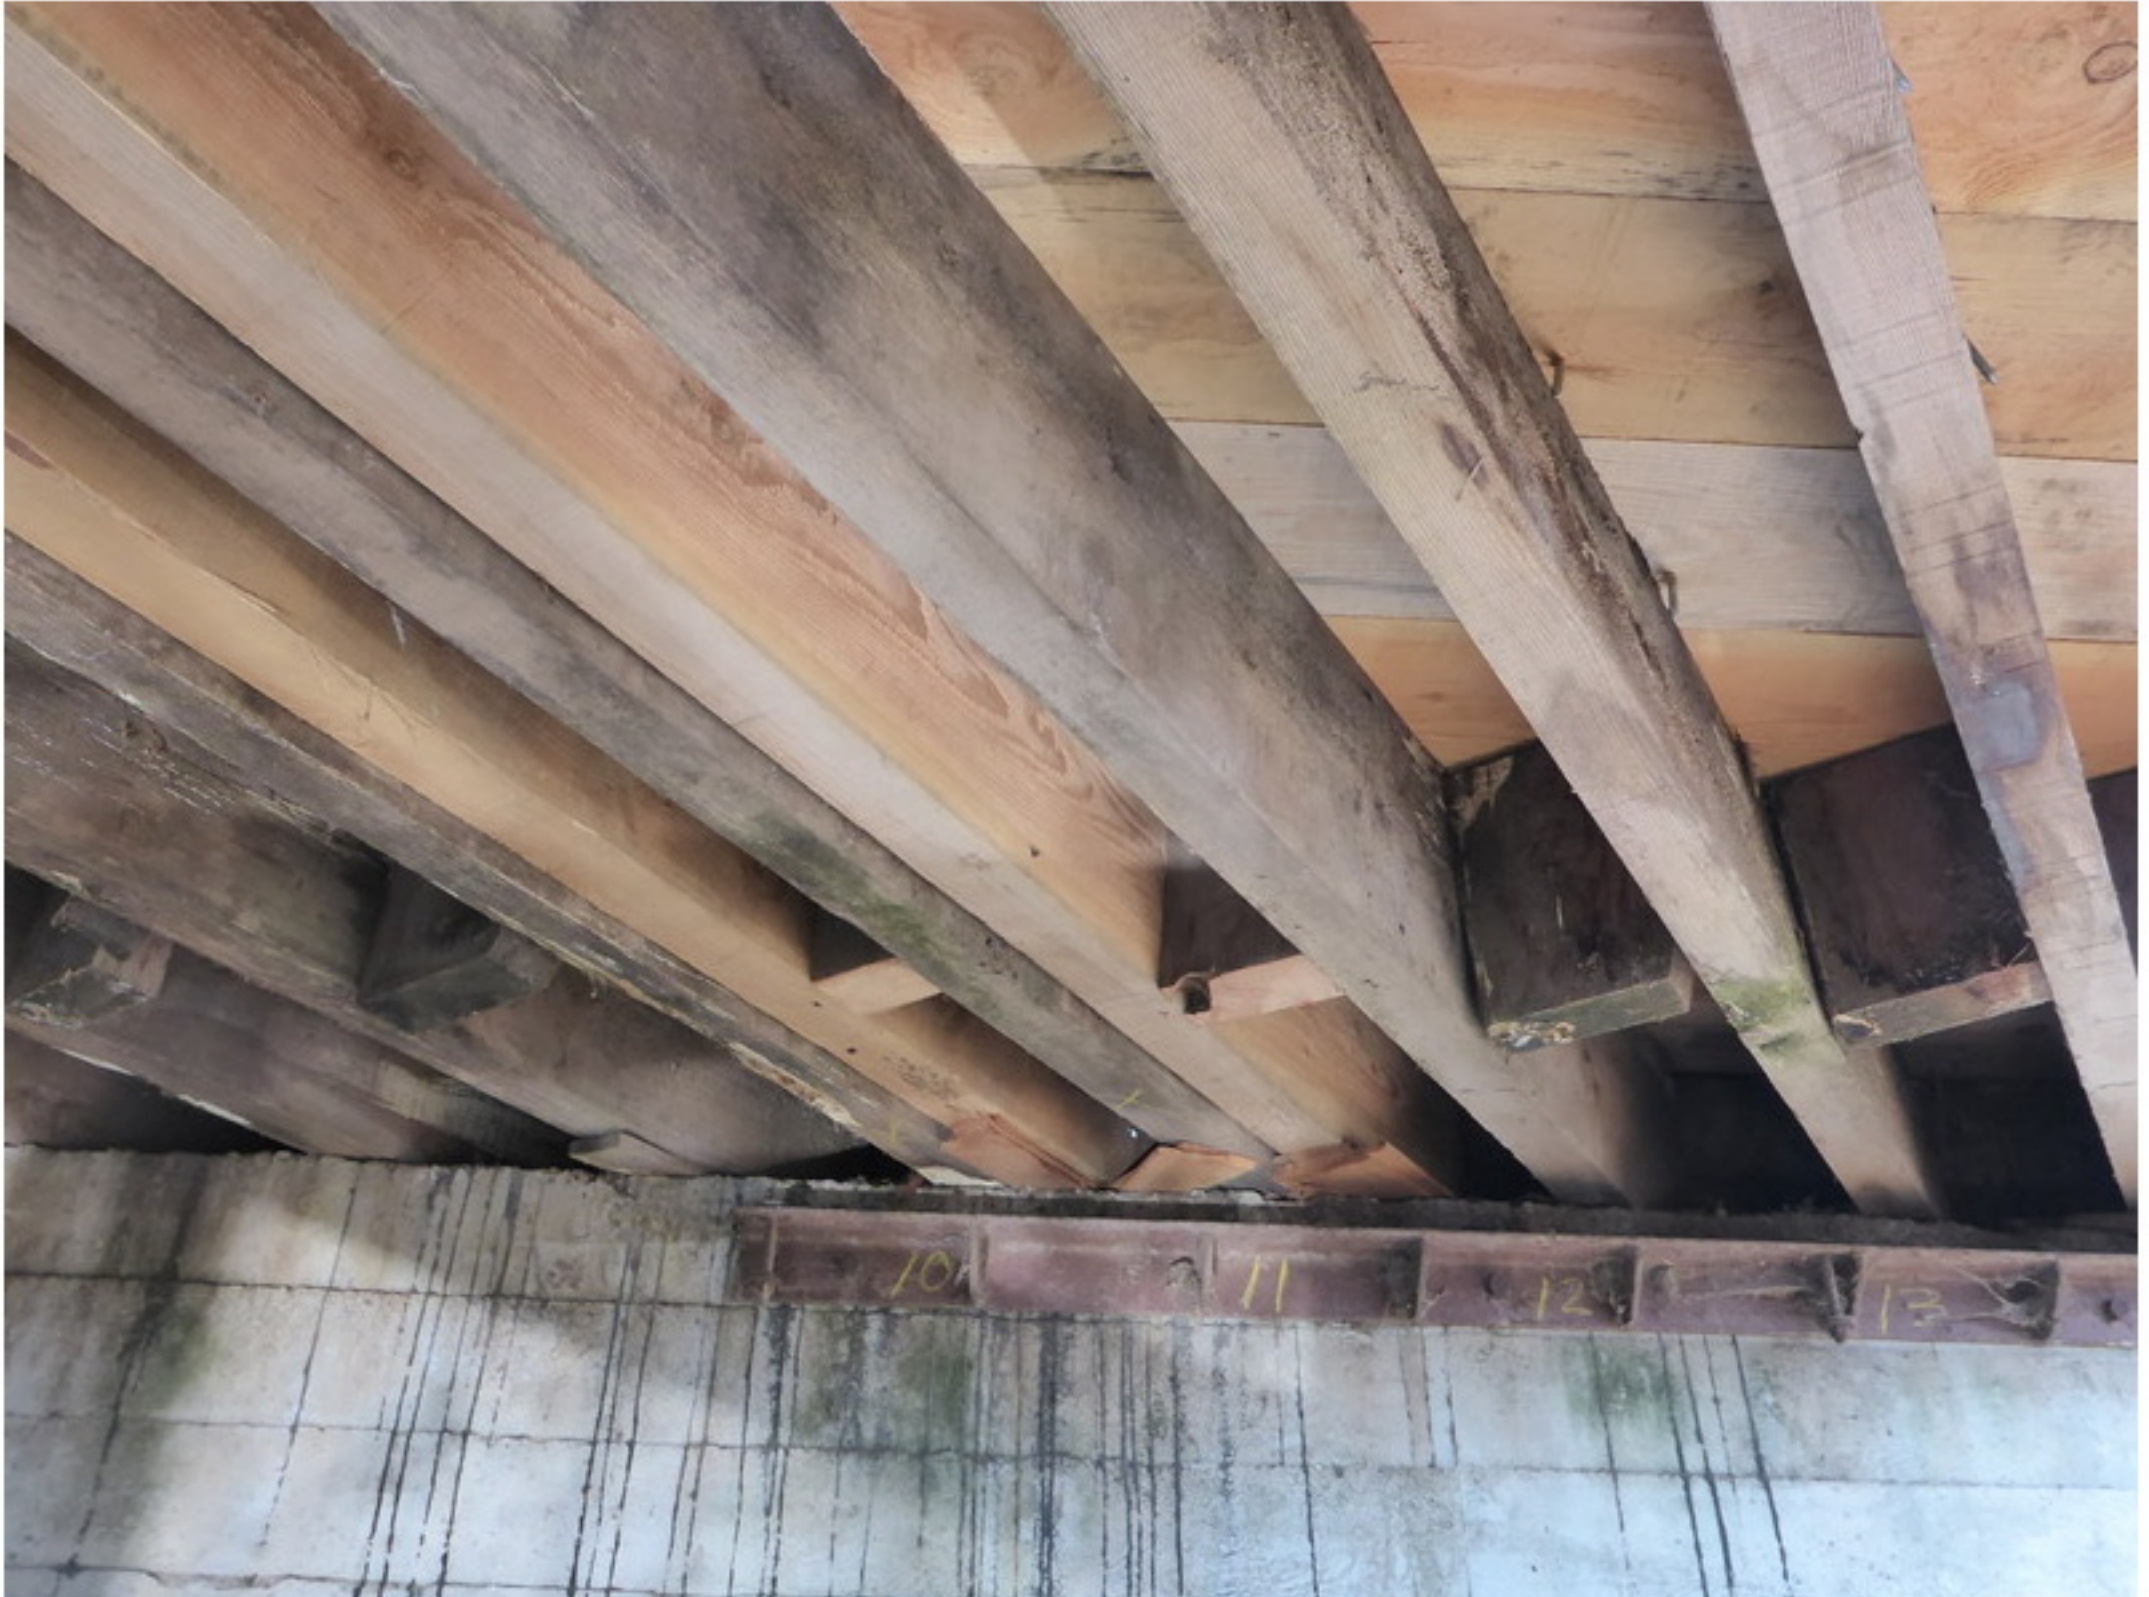
Photo No. 8  
Supplemental girders (7 and 8) and new decking as seen from Span 3 right.

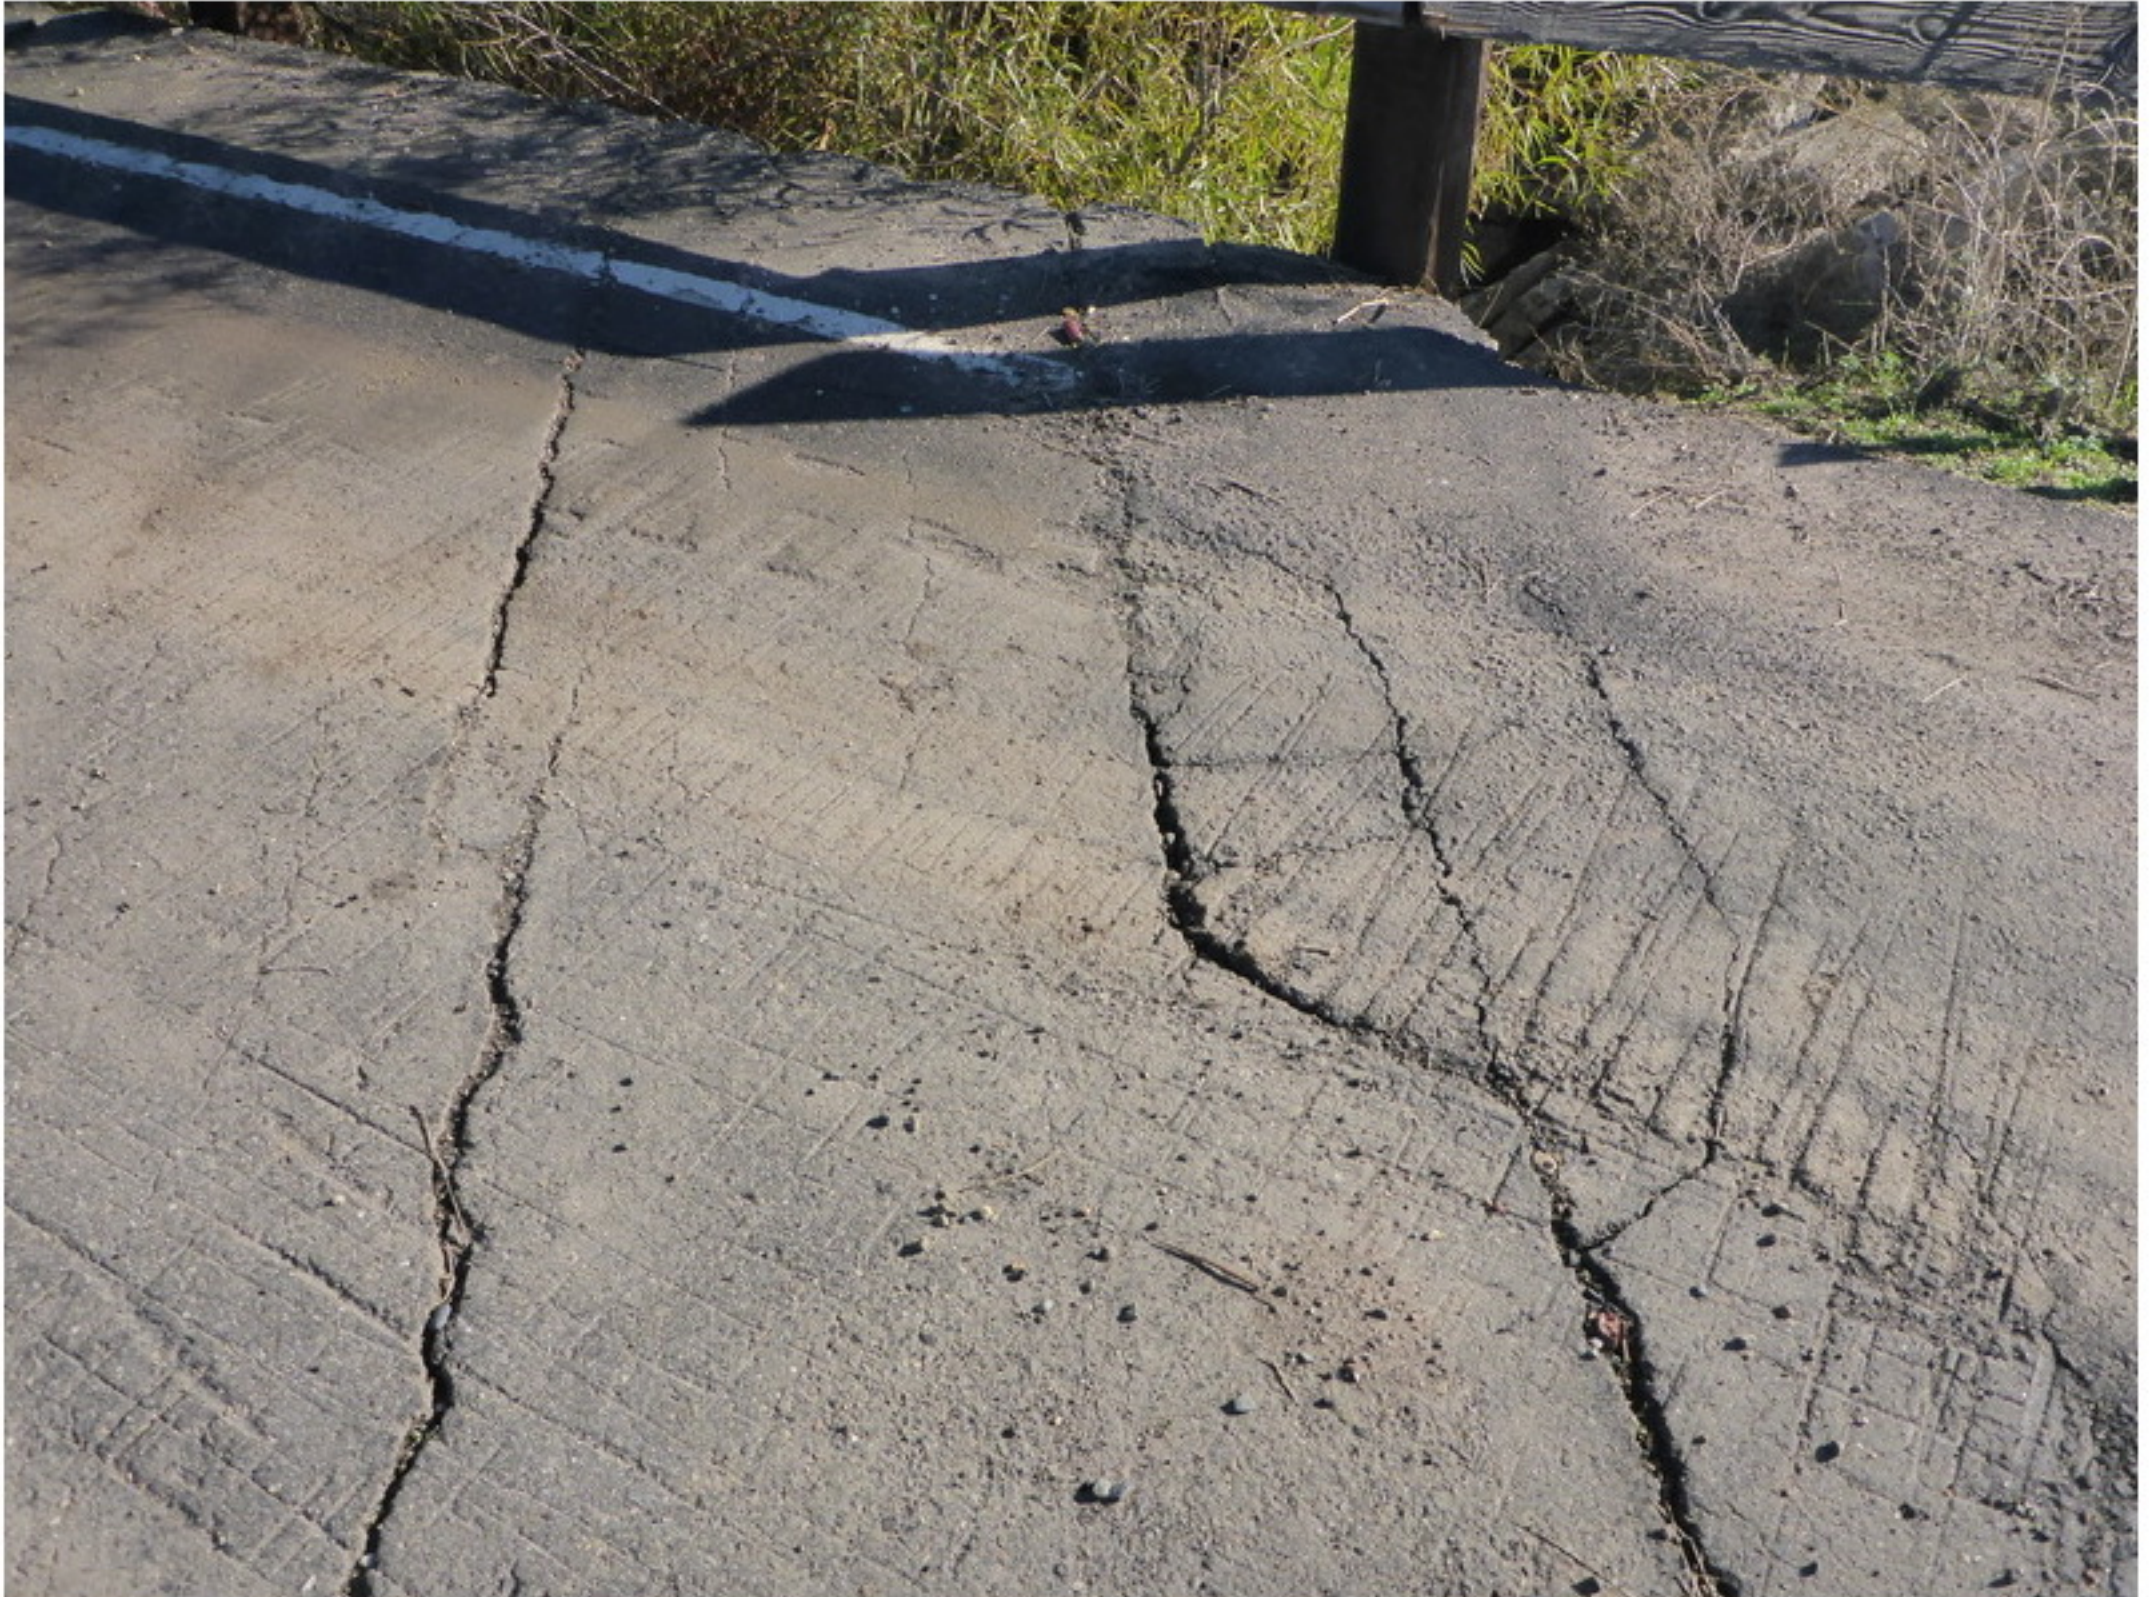
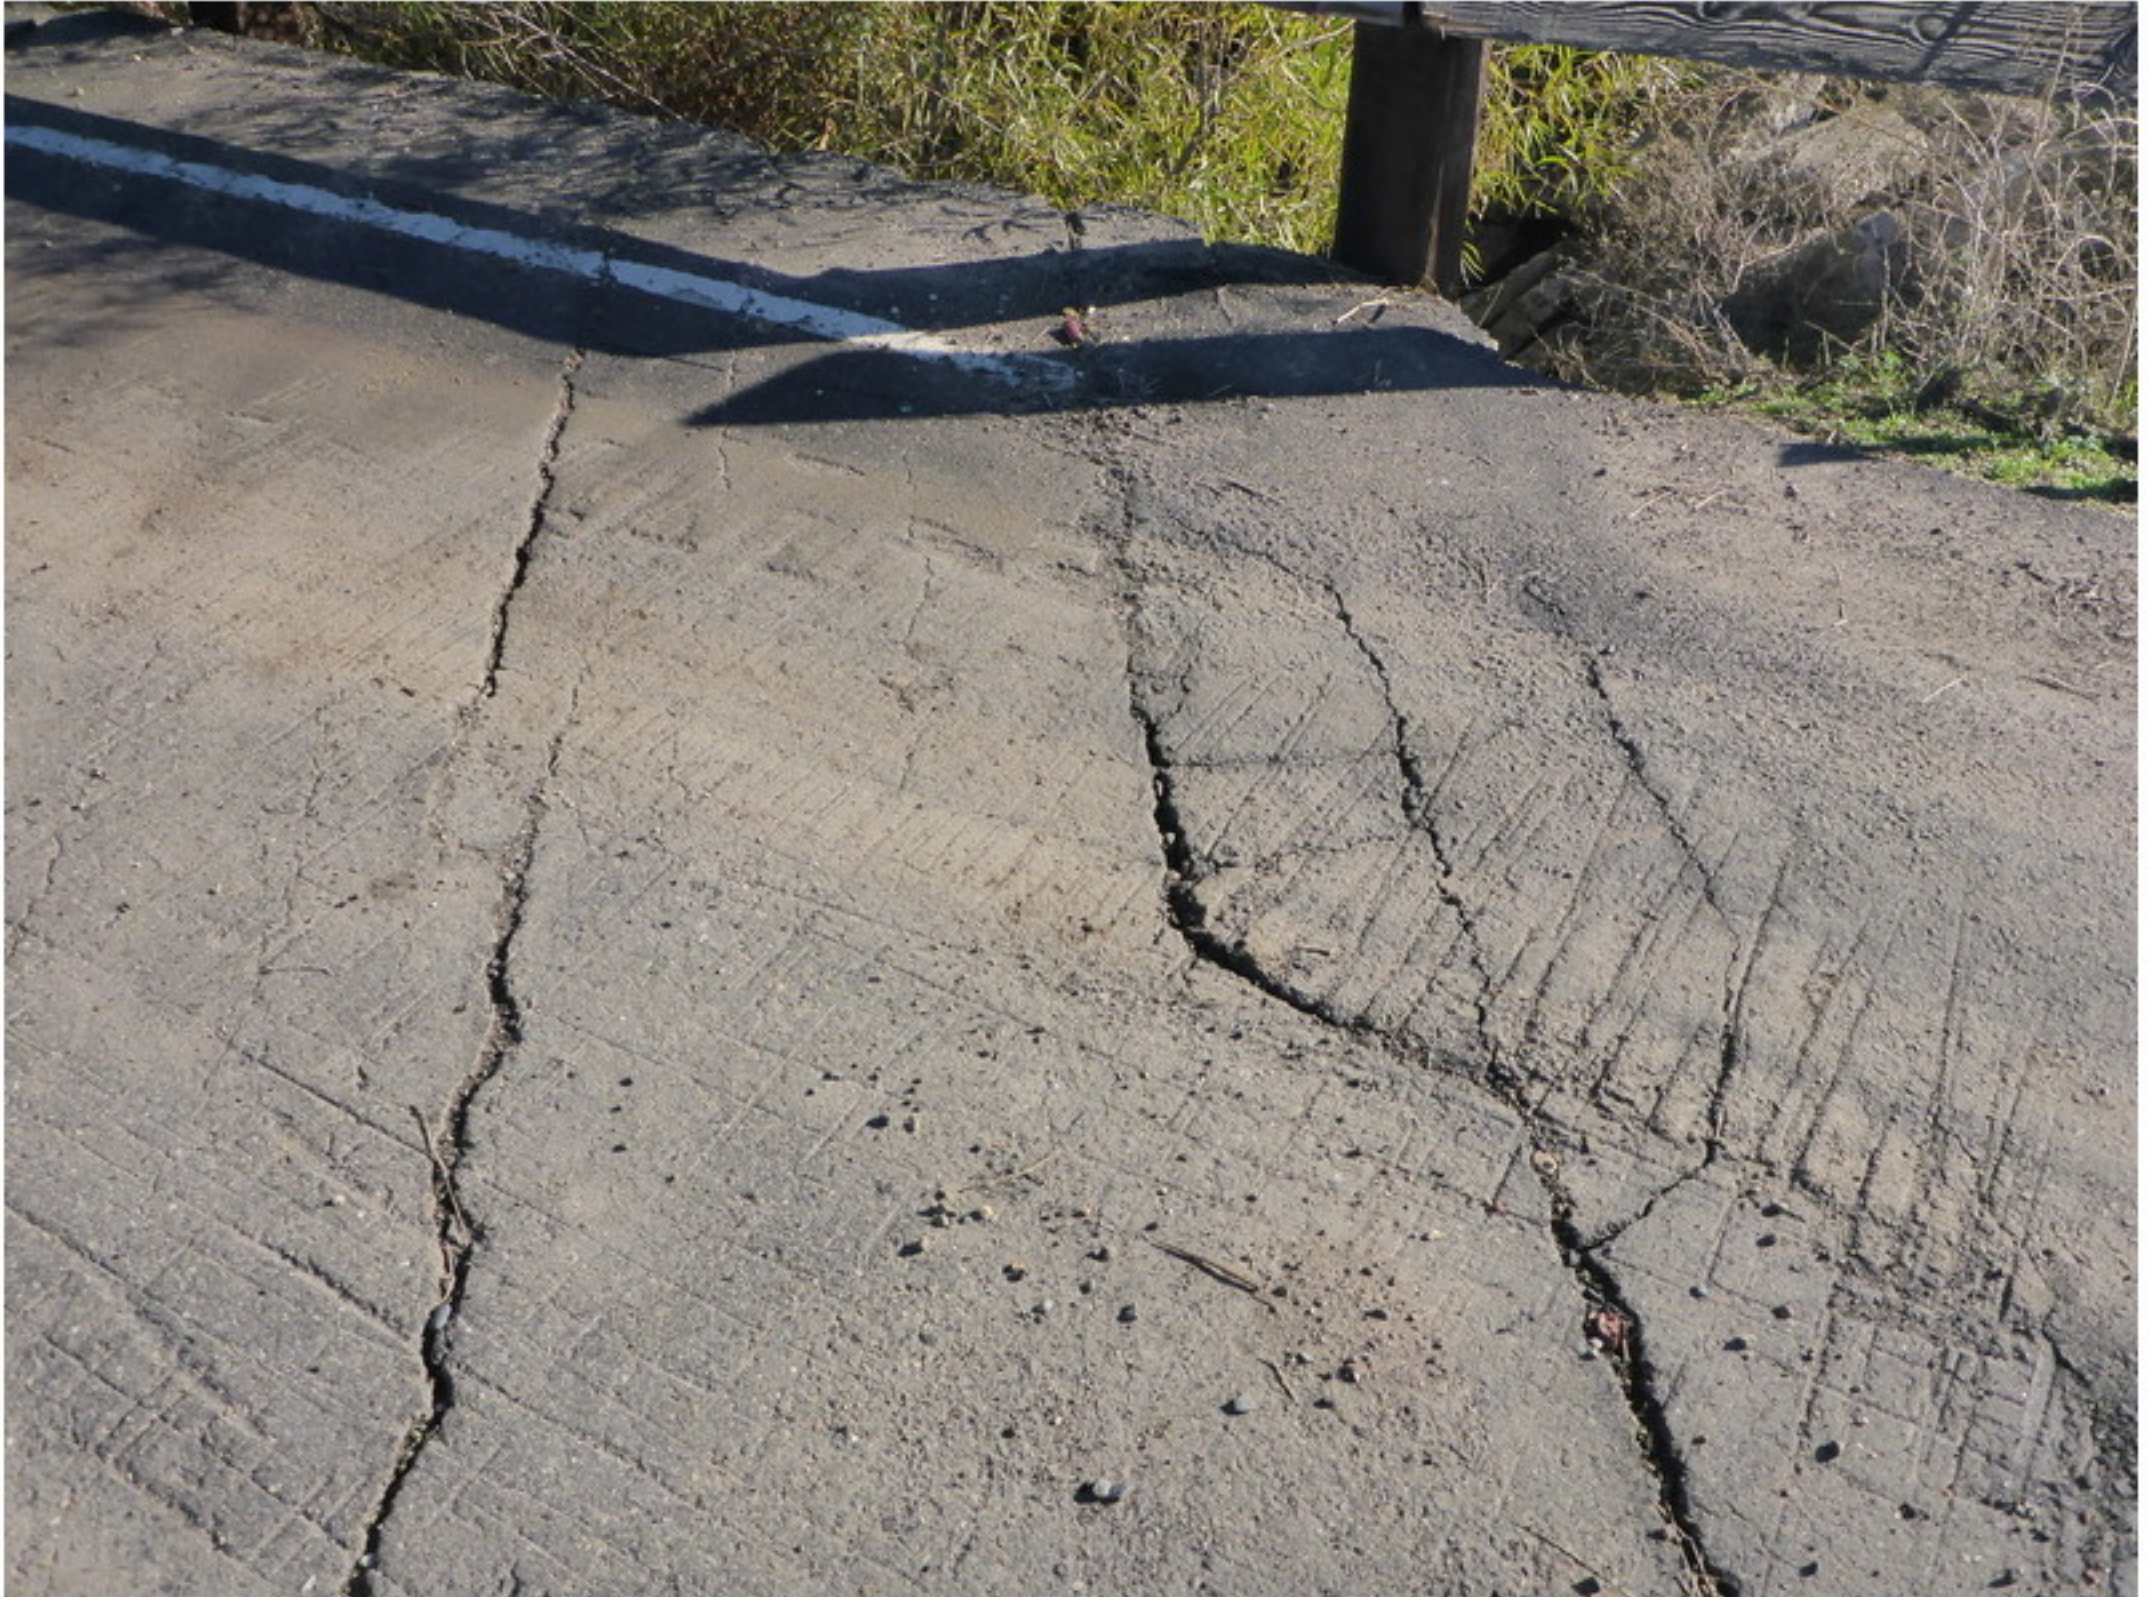
Photo No. 1  
Cracking AC at the right side of Abutment 1.

Repair the areas of the deck where the AC is breaking up, primarily at midspan of Span 2 and near Abutment 4. This may require replacing the transverse deck planks below the AC,

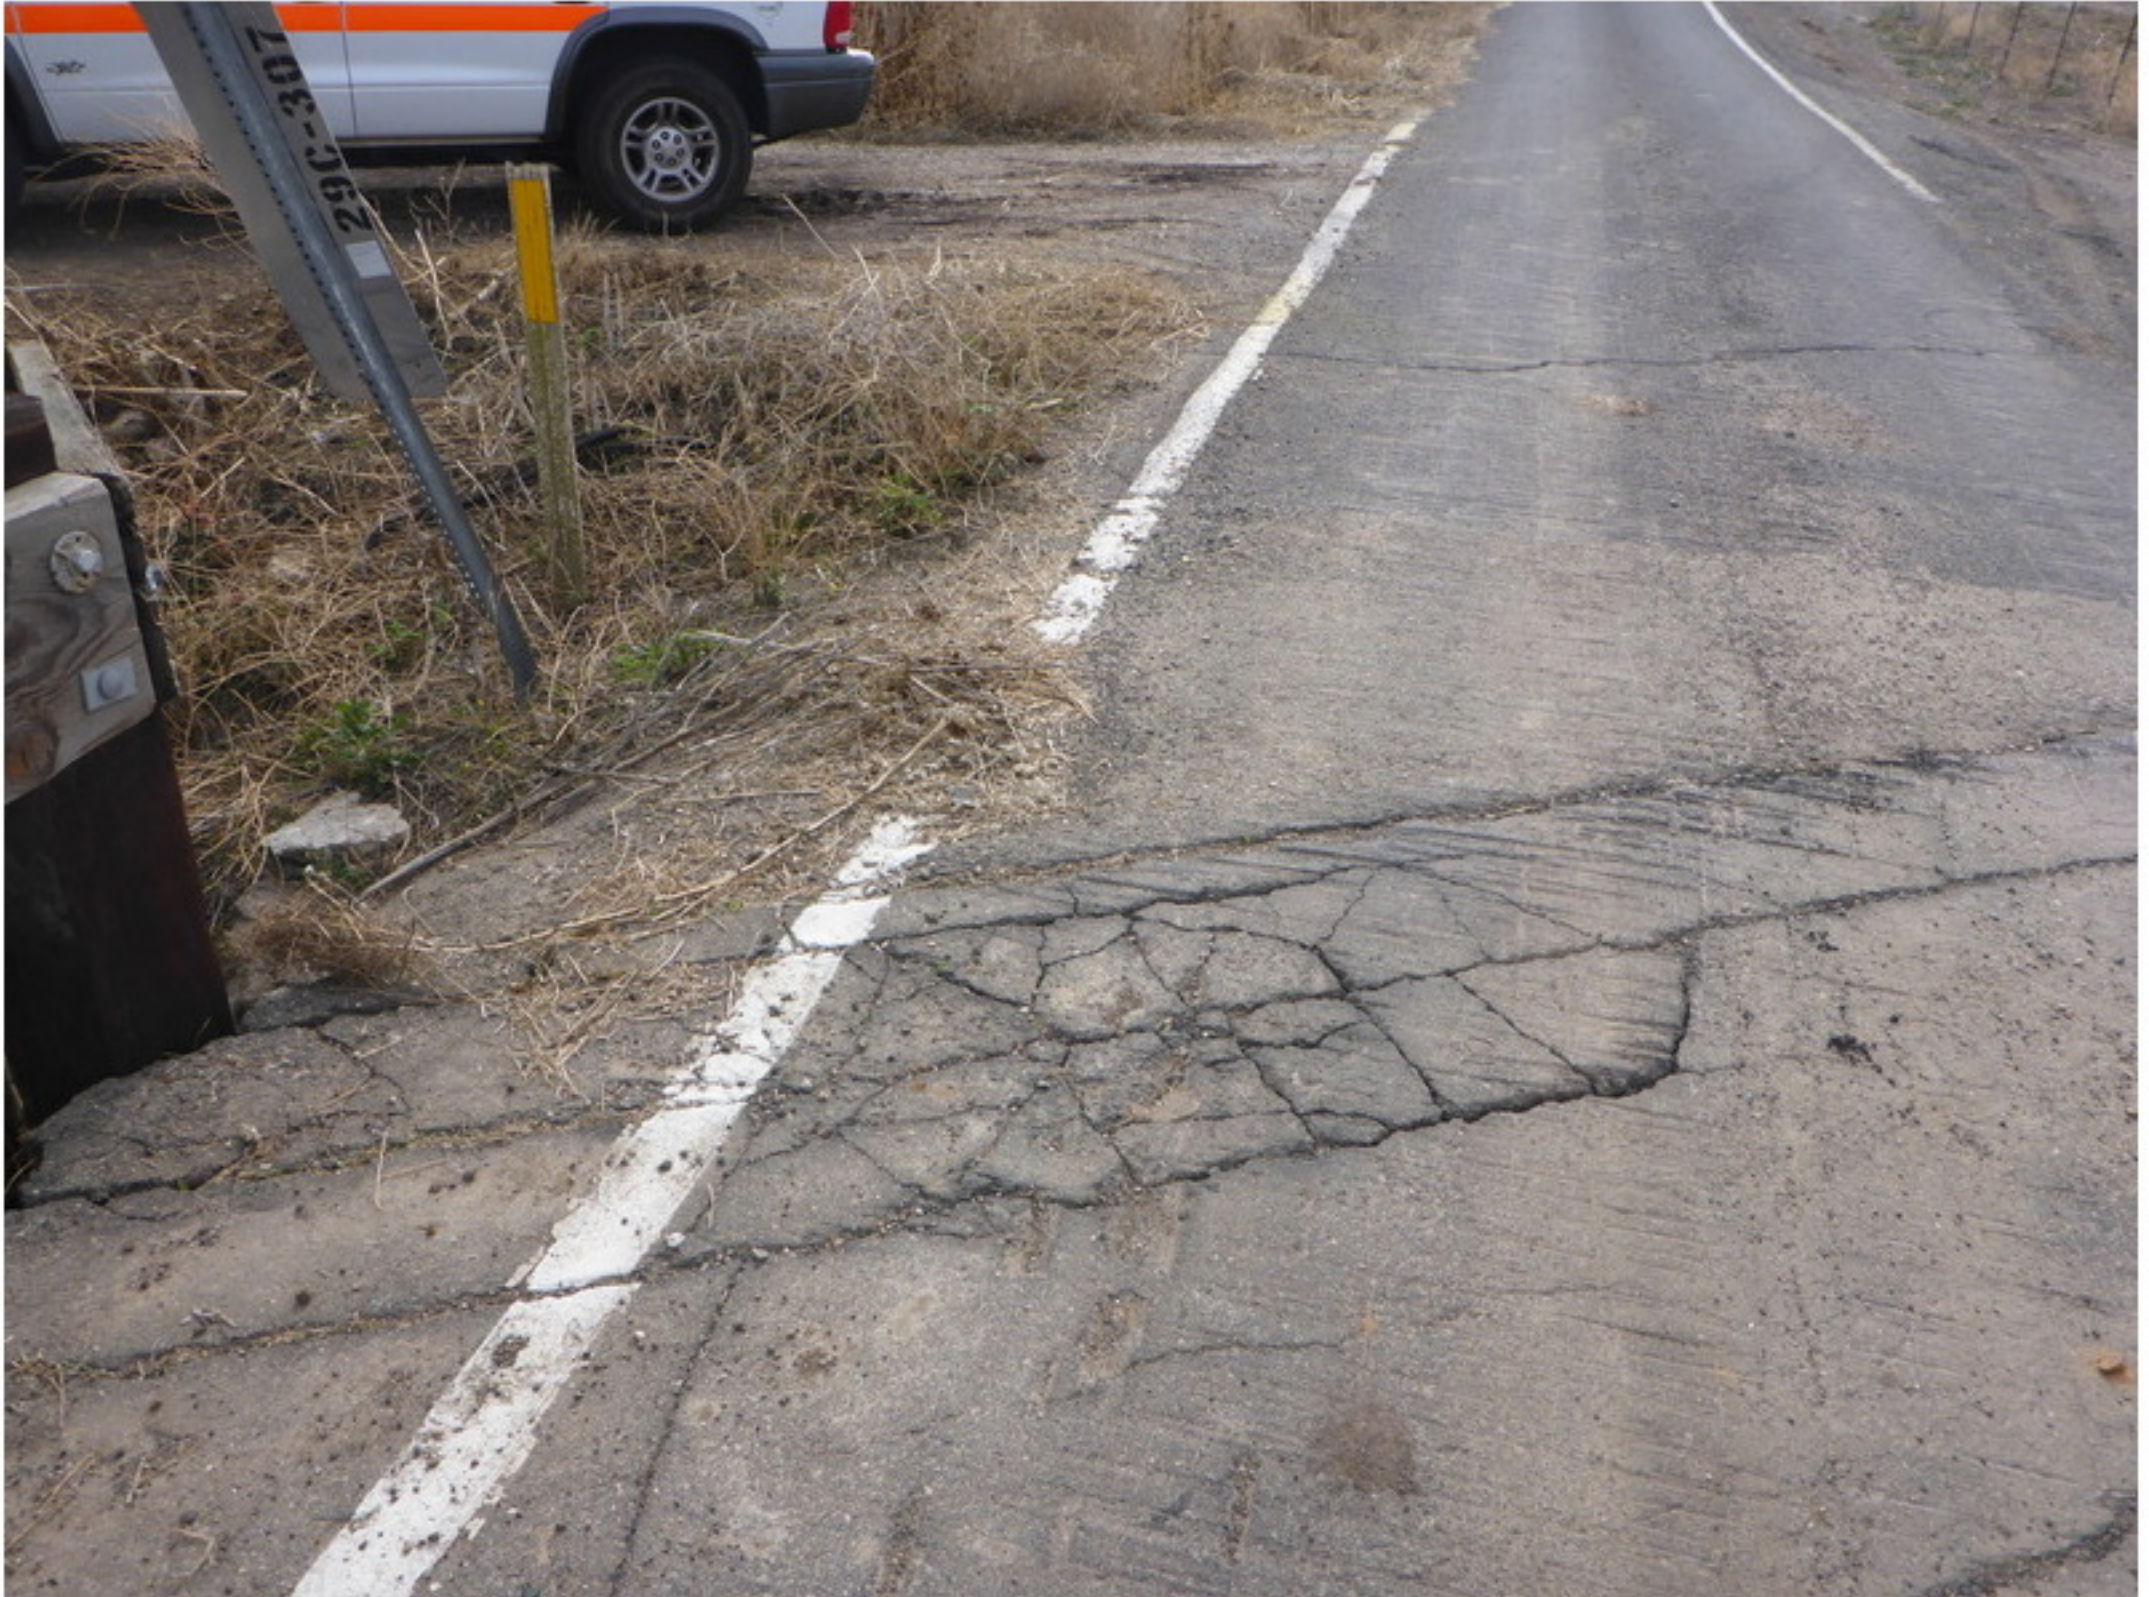
Photo No. 1  
Broken up AC at Abutment 1 right.

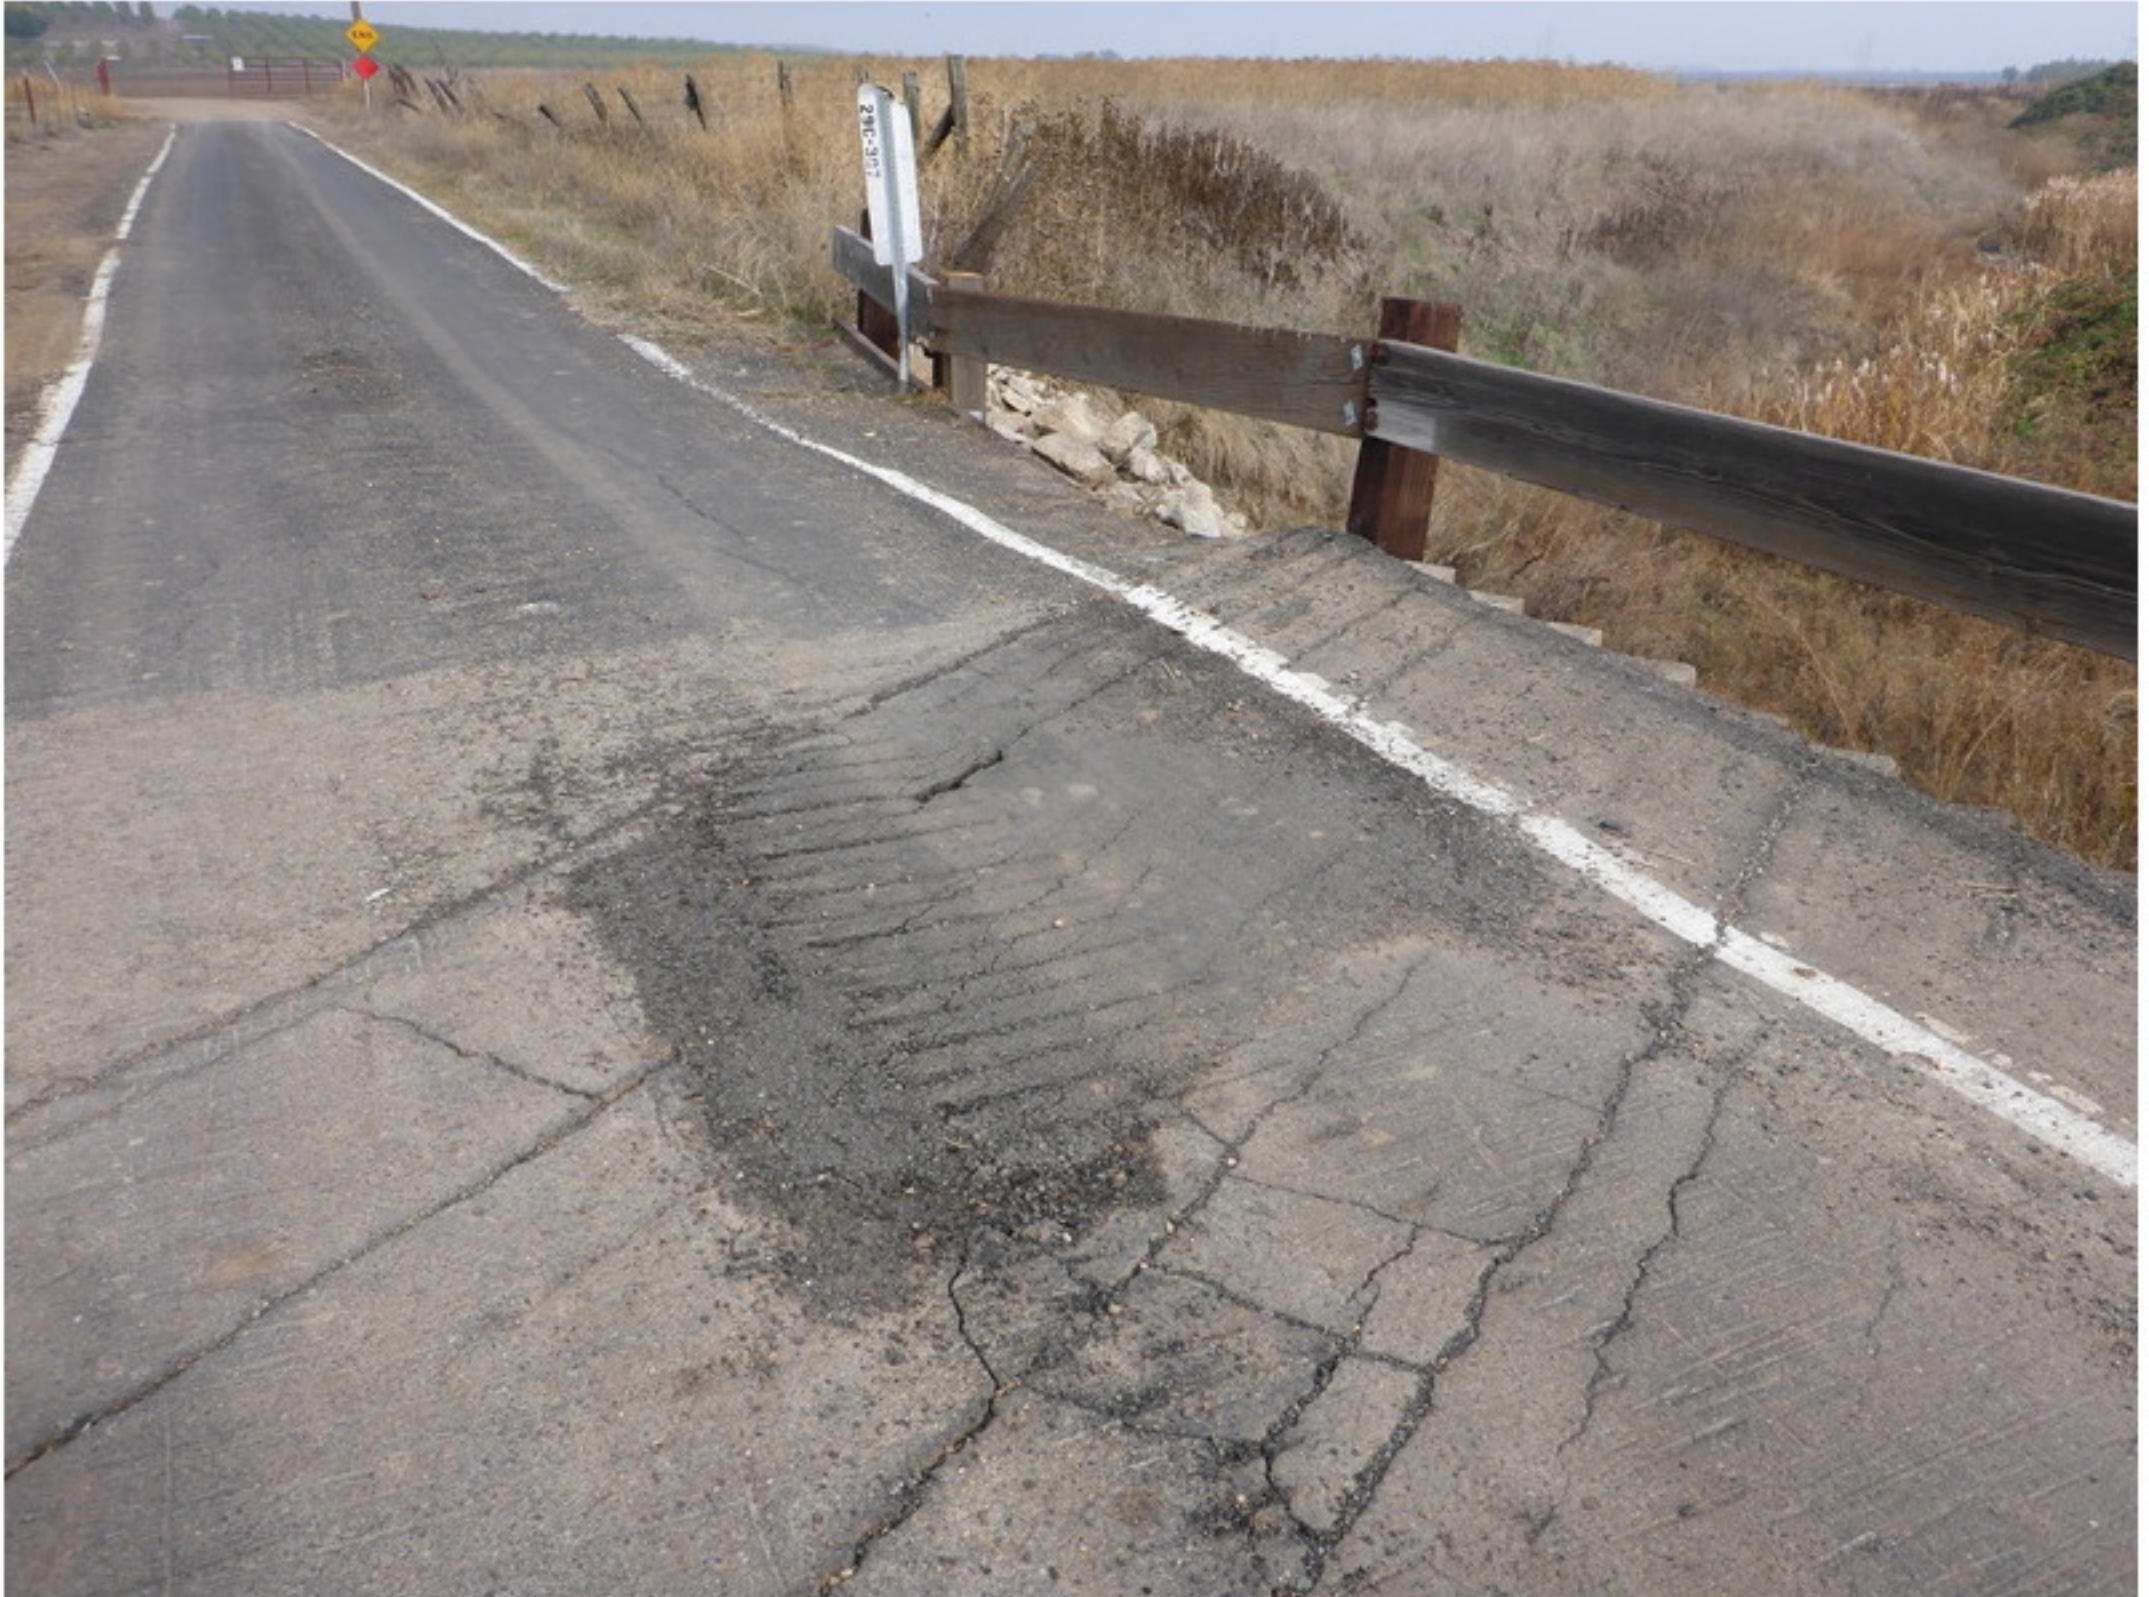
Photo No. 2  
AC patch at Abutment 4 right.
