## **Initial Study/Mitigated Negative Declaration**

# **Buckman Road Bridge Replacement Project**

**February 2023**

**Prepared for:**  
San Joaquin County  
Department of Public Works  
1810 E. Hazelton Avenue  
Stockton, CA 95205

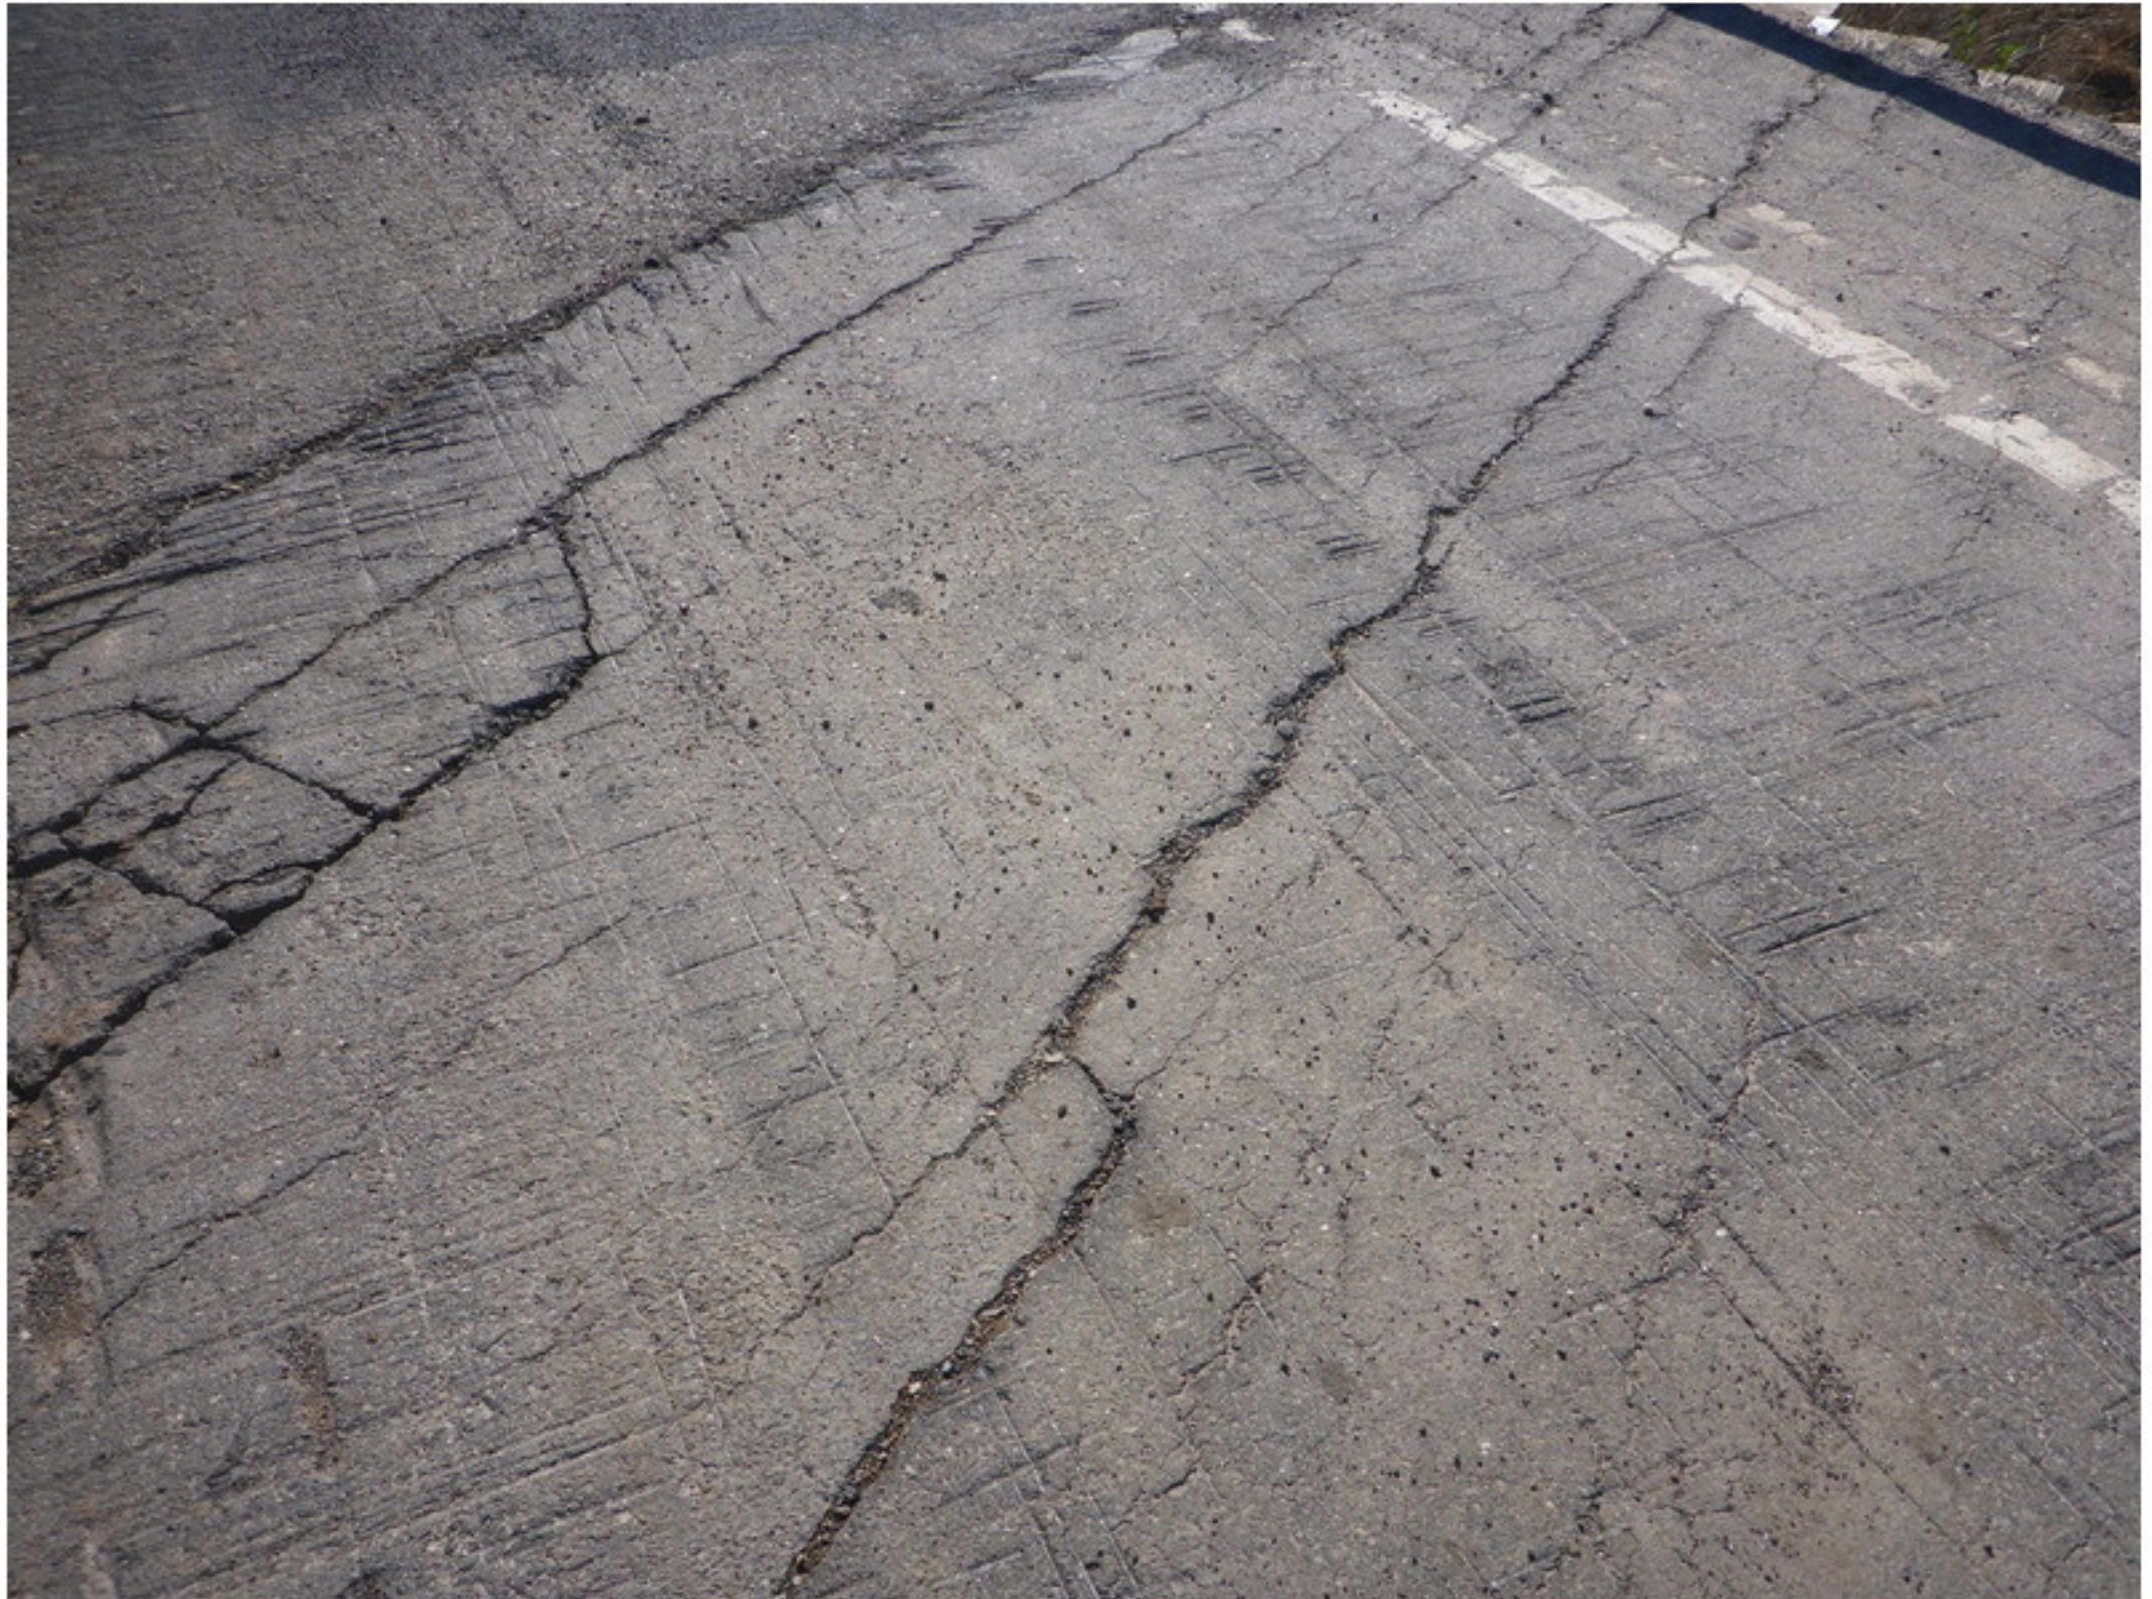
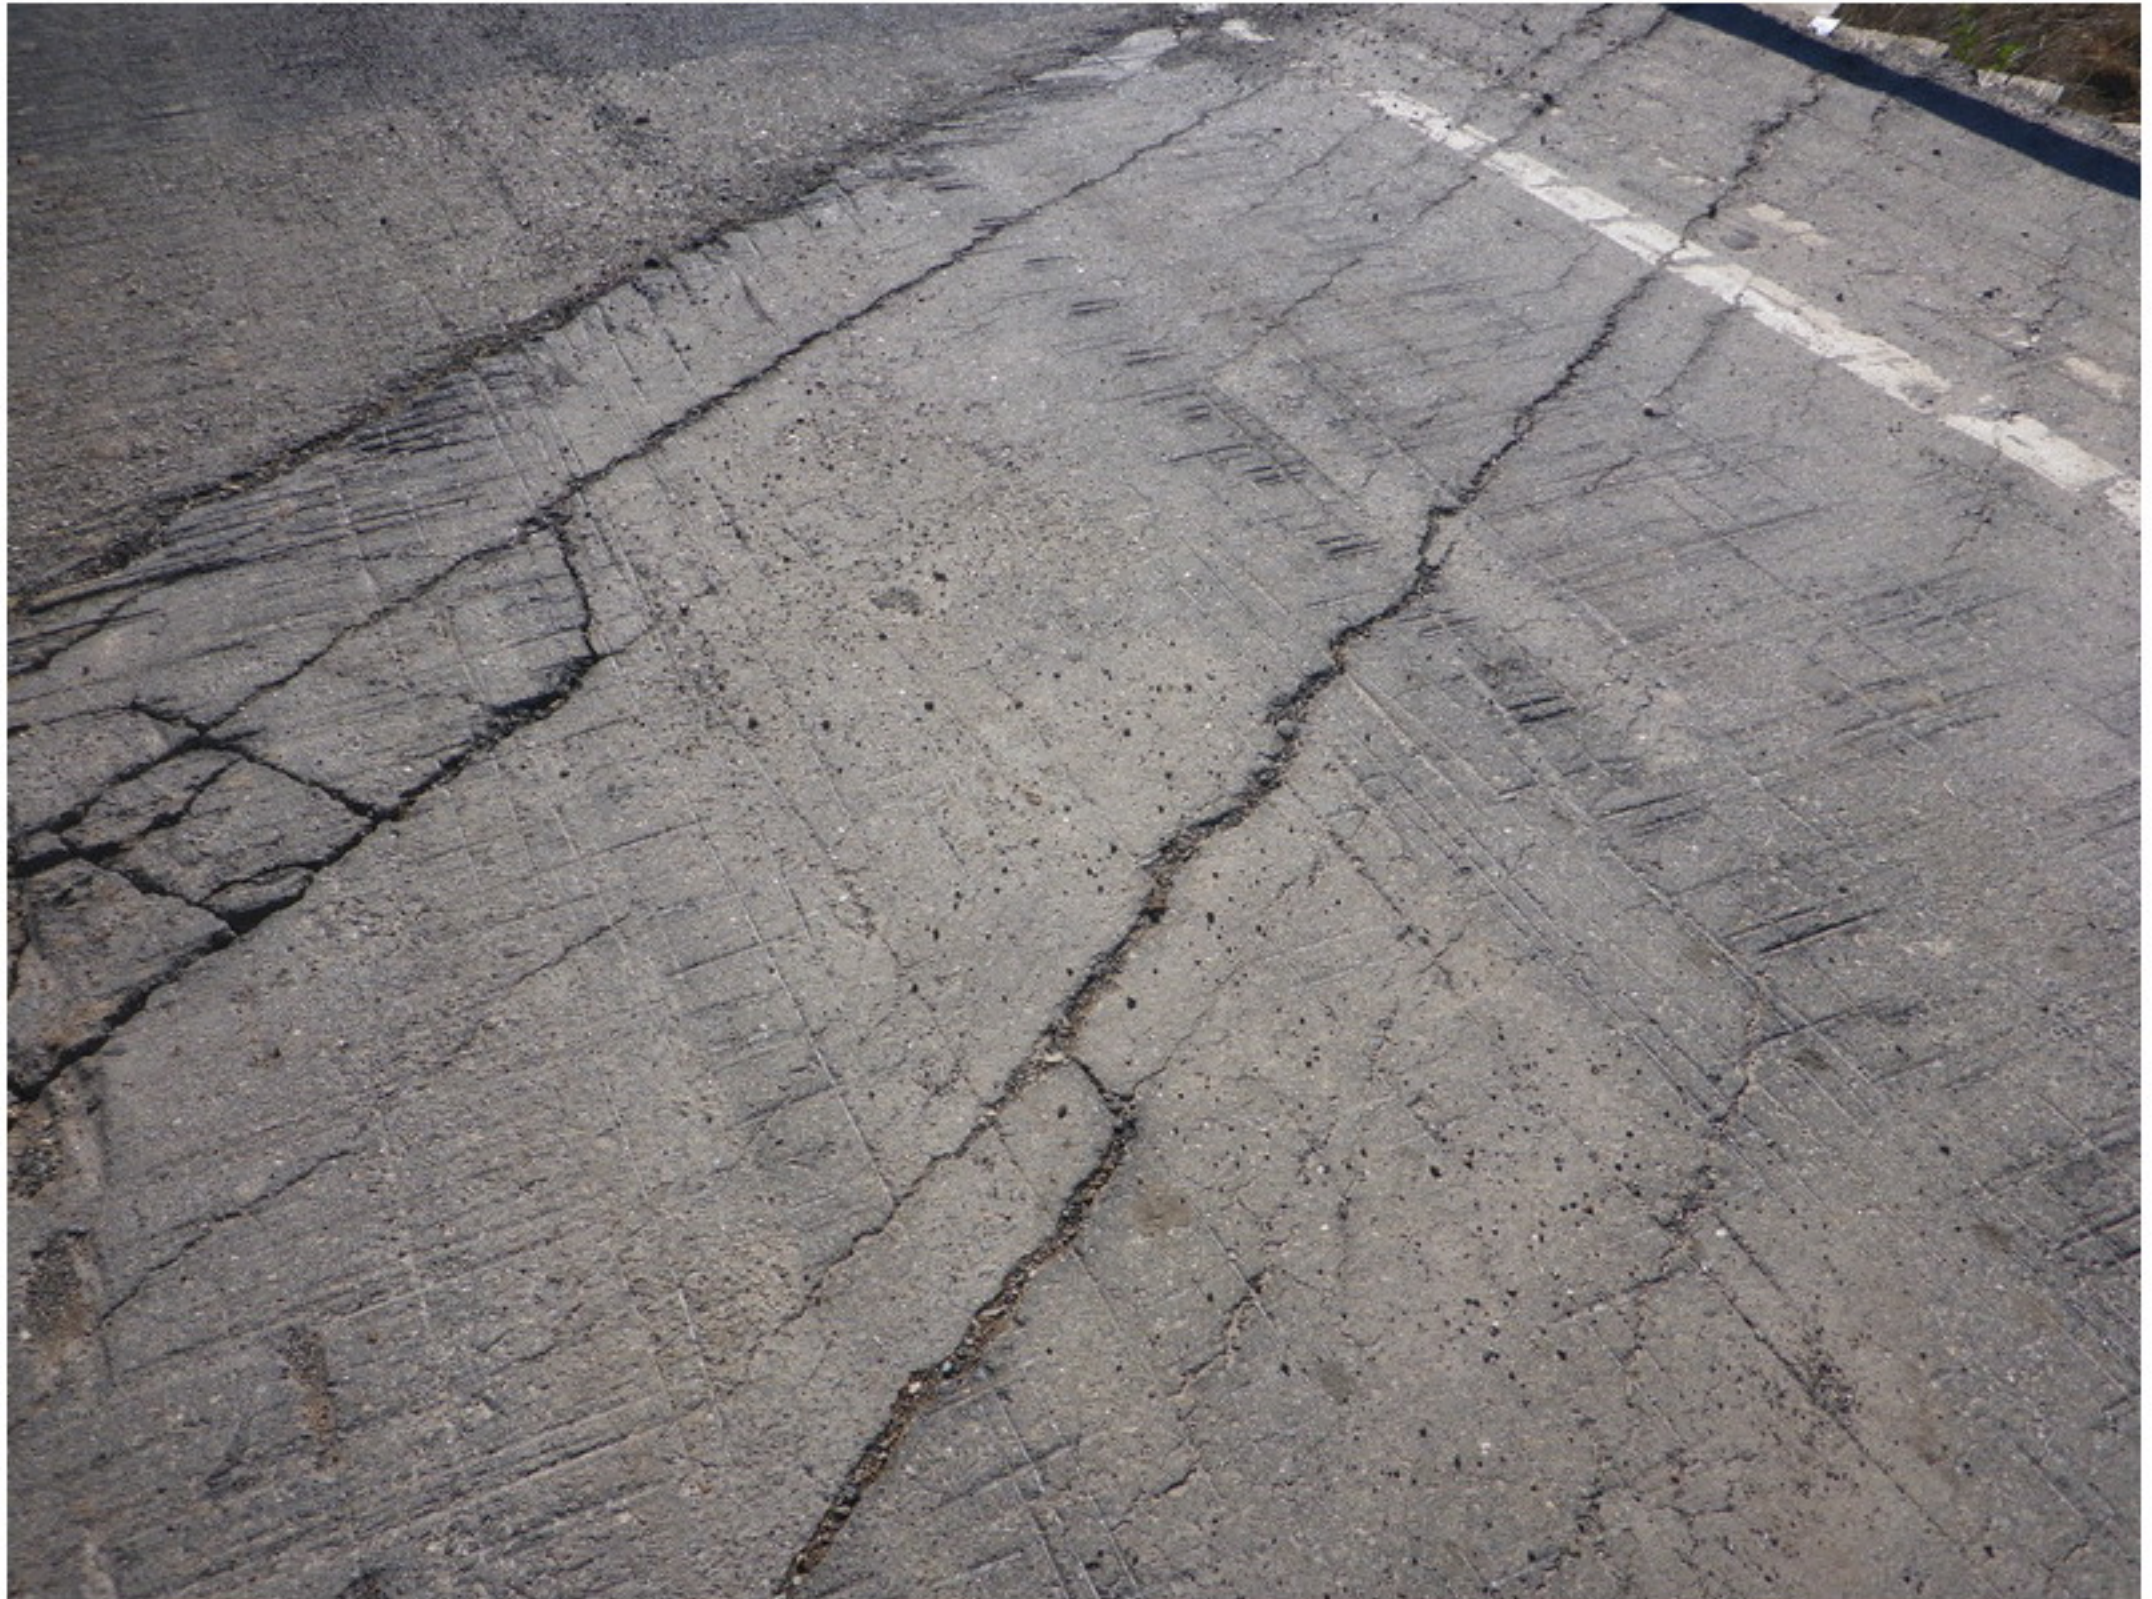
Photo No. 1  
Transverse cracks in the deck AC

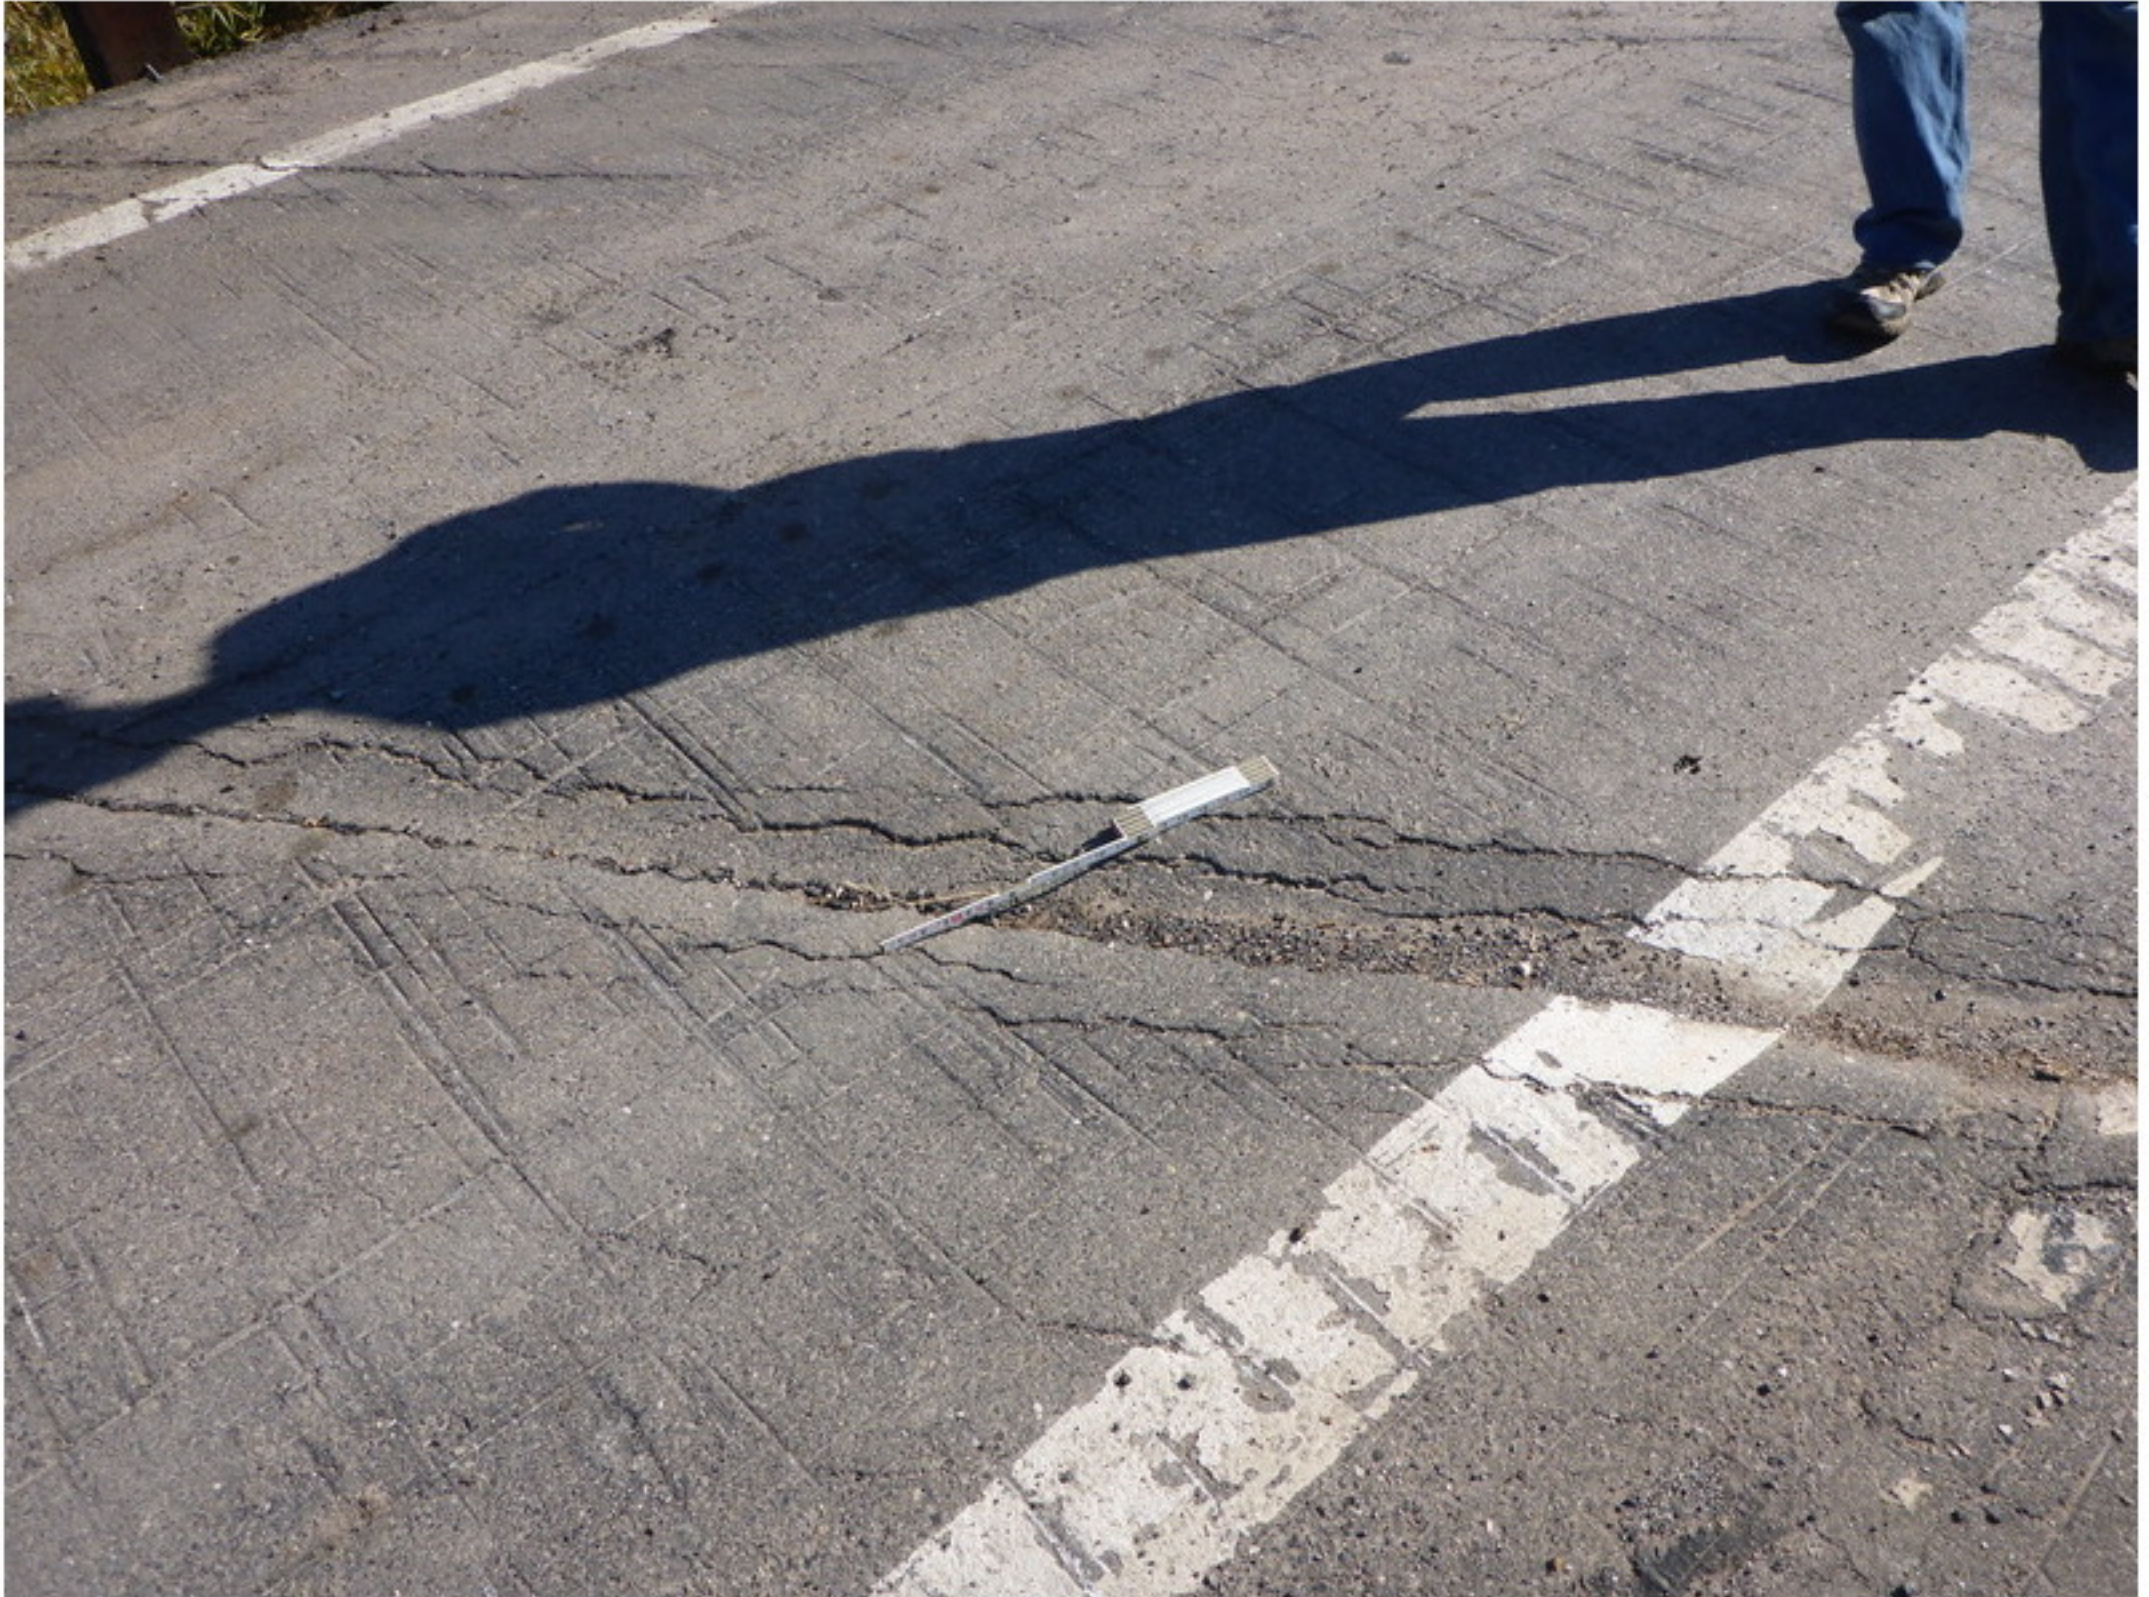
Photo No. 2  
Transverse dip in the deck AC at midspan of Span 2

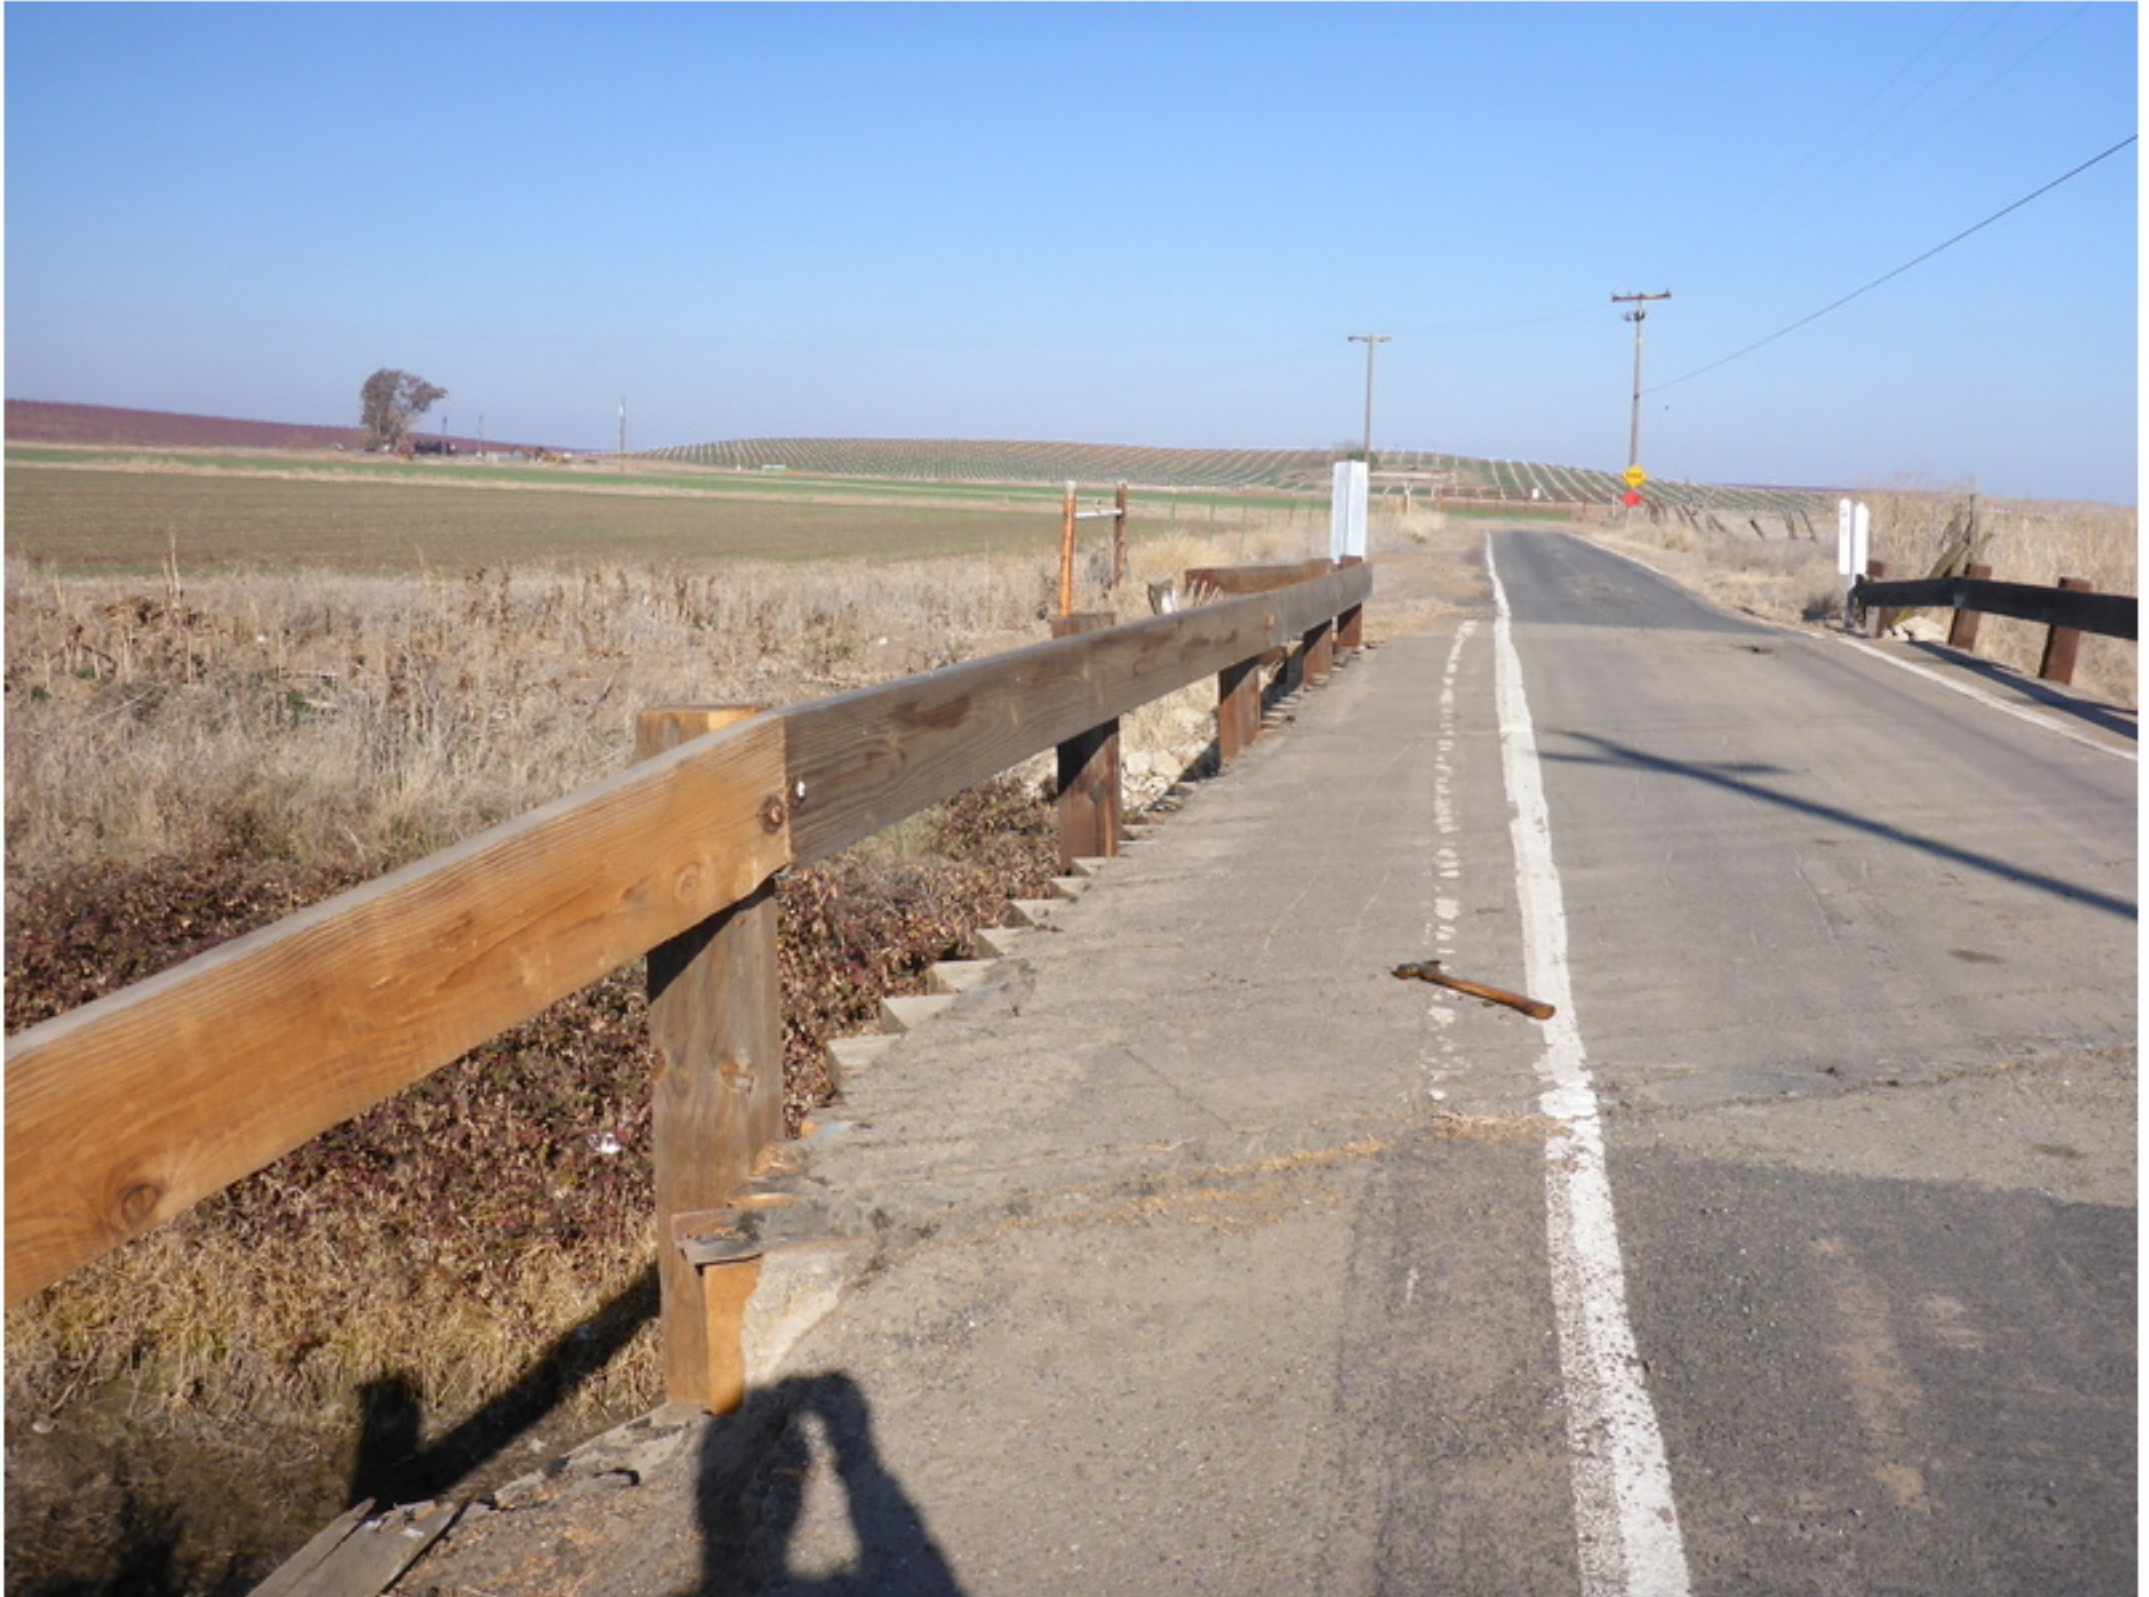
Photo No. 1  
New left timber rail

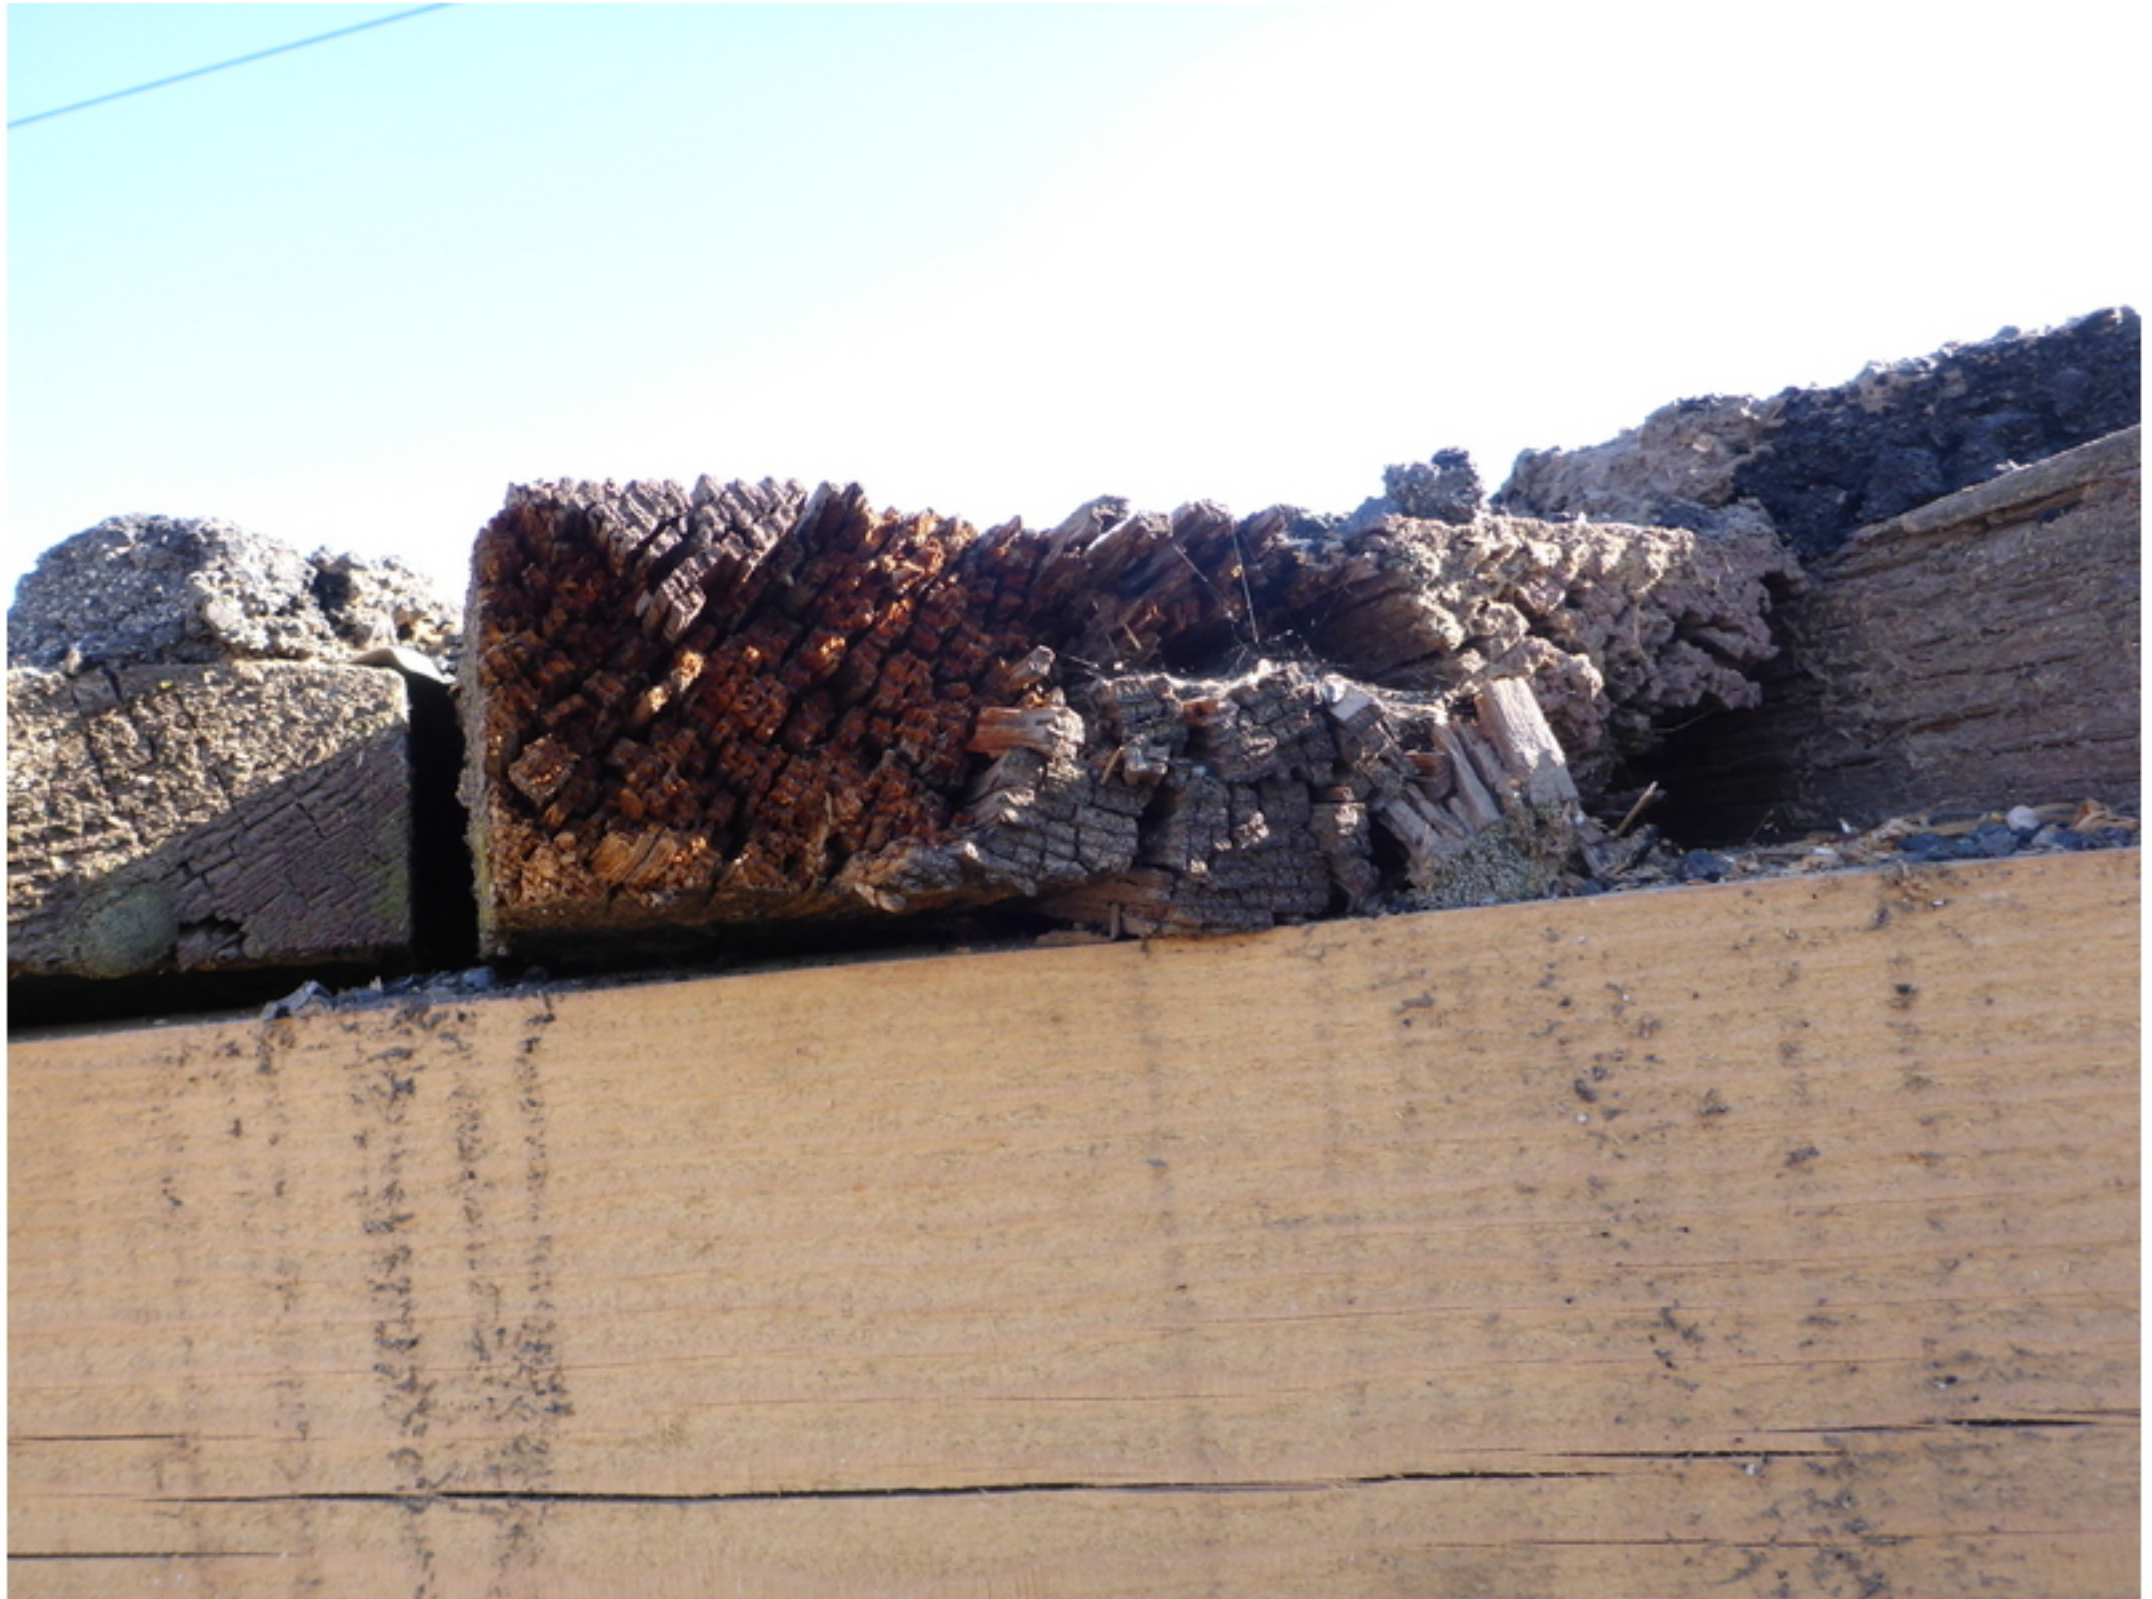
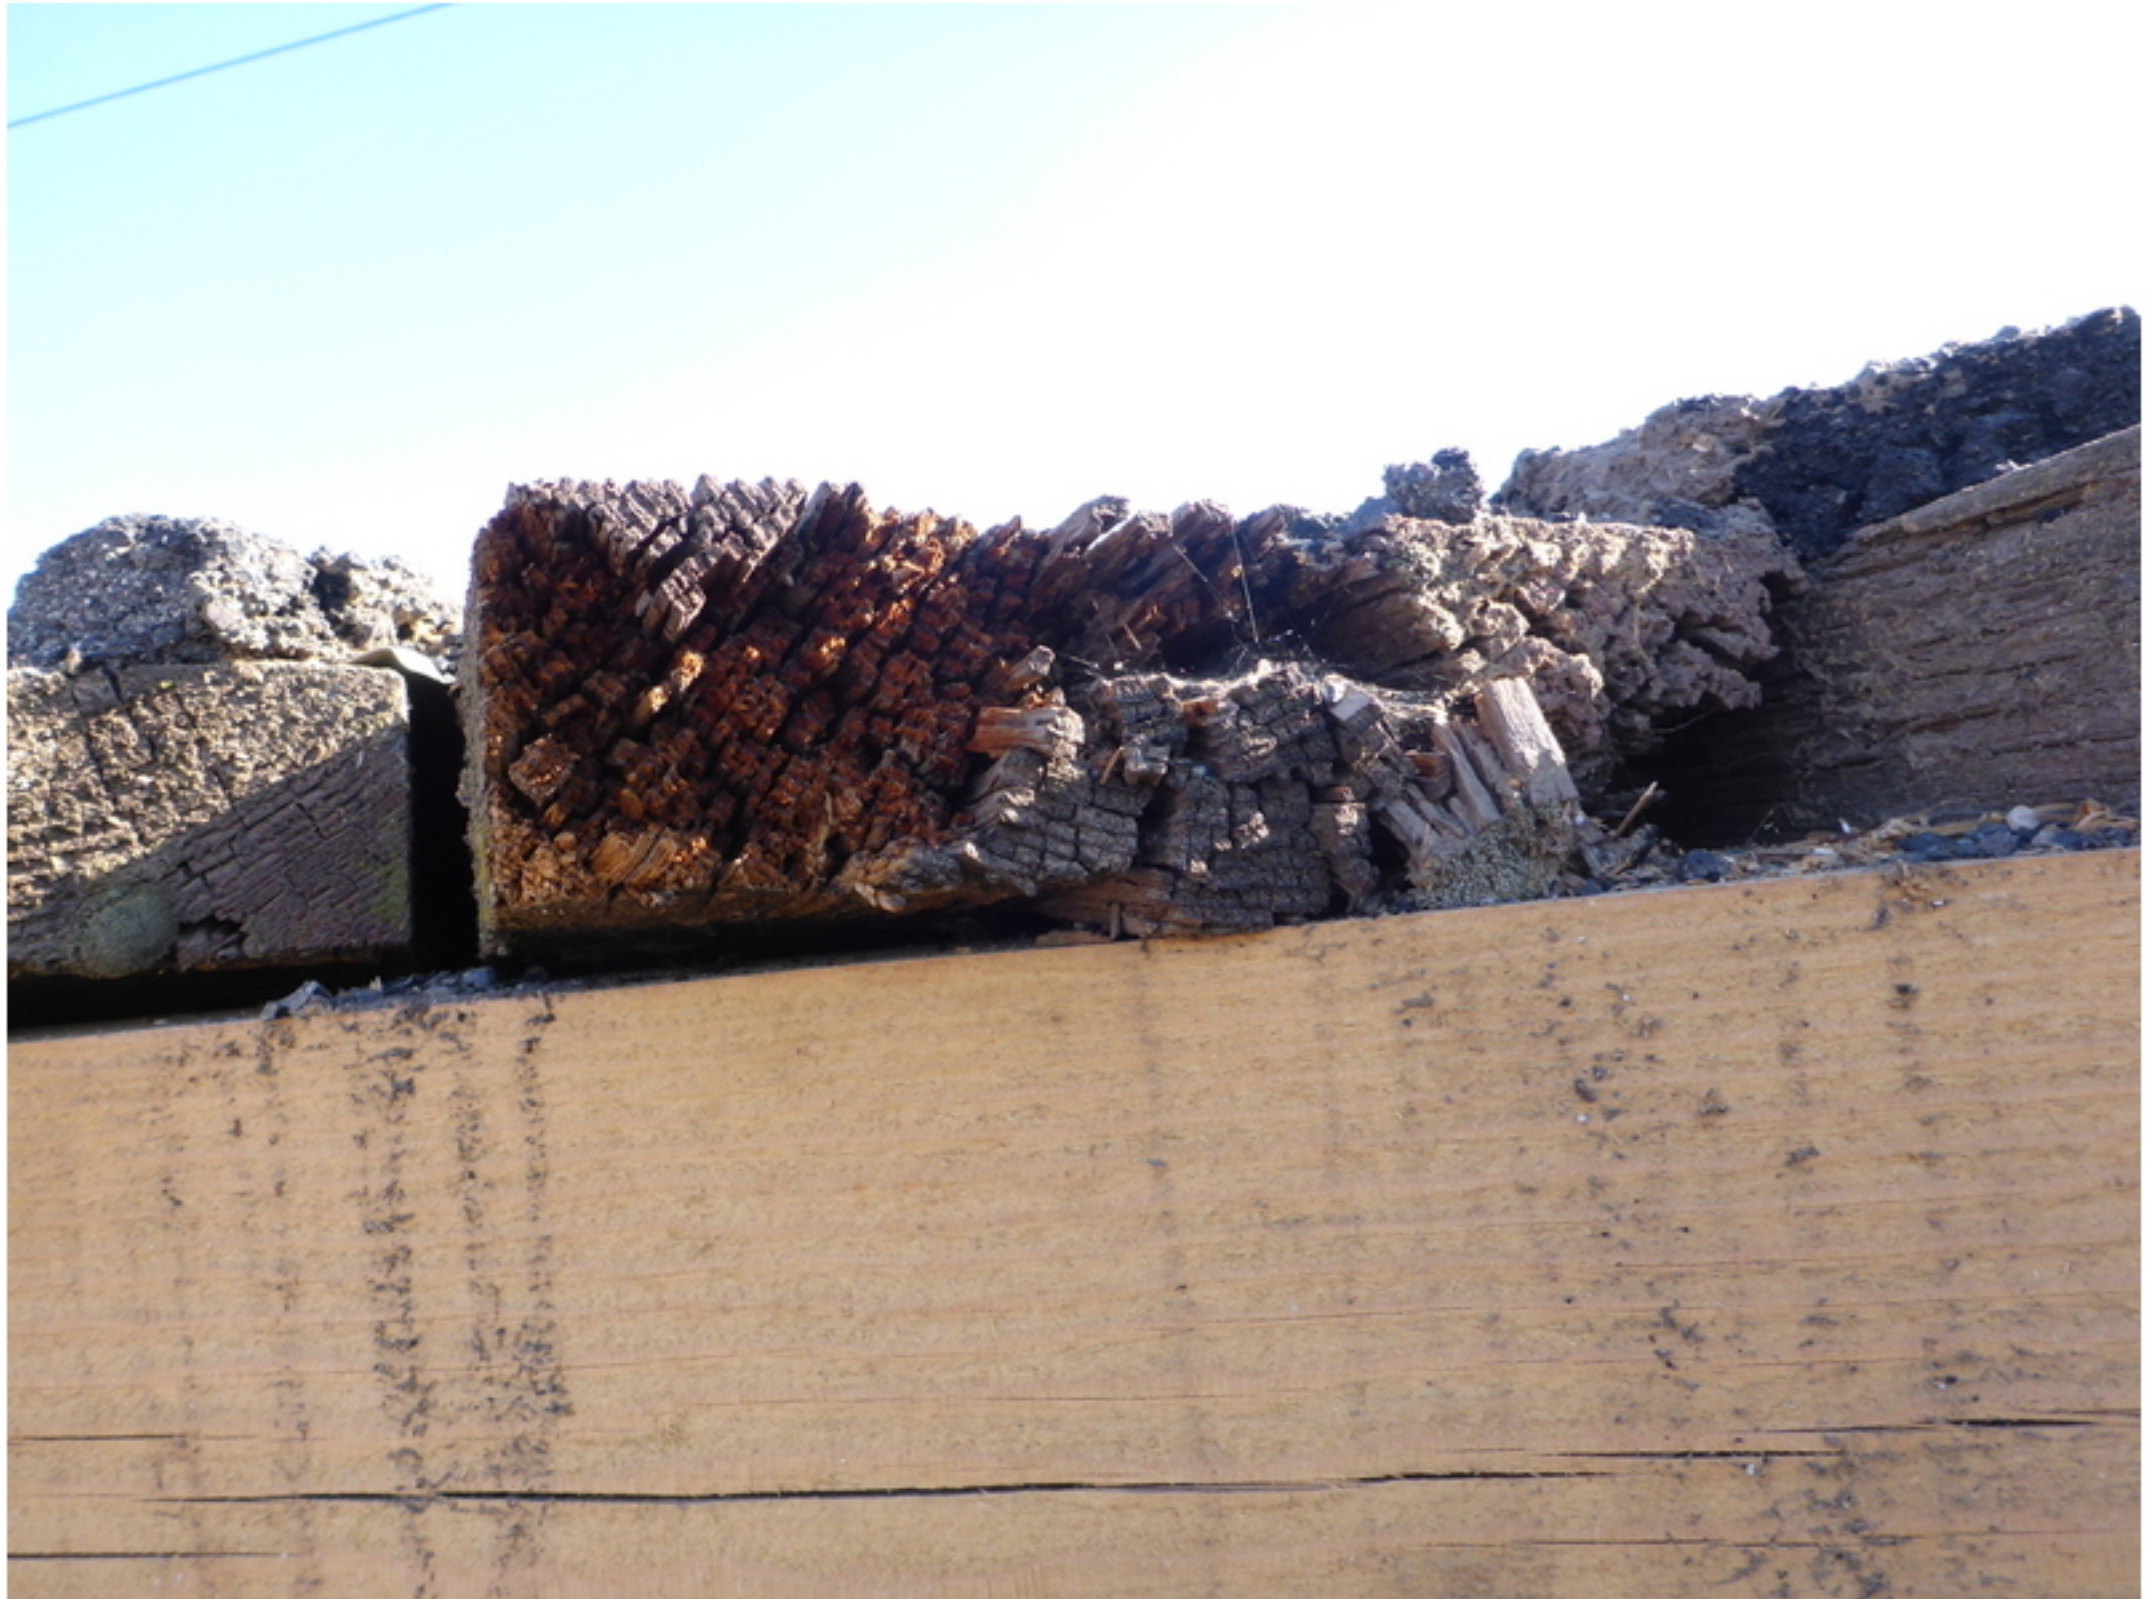
Photo No. 6  
Typical condition of the deck board edges
