## **Initial Study/Mitigated Negative Declaration**

# **Buckman Road Bridge Replacement Project**

**February 2023**

**Prepared for:**  
San Joaquin County  
Department of Public Works  
1810 E. Hazelton Avenue  
Stockton, CA 95205

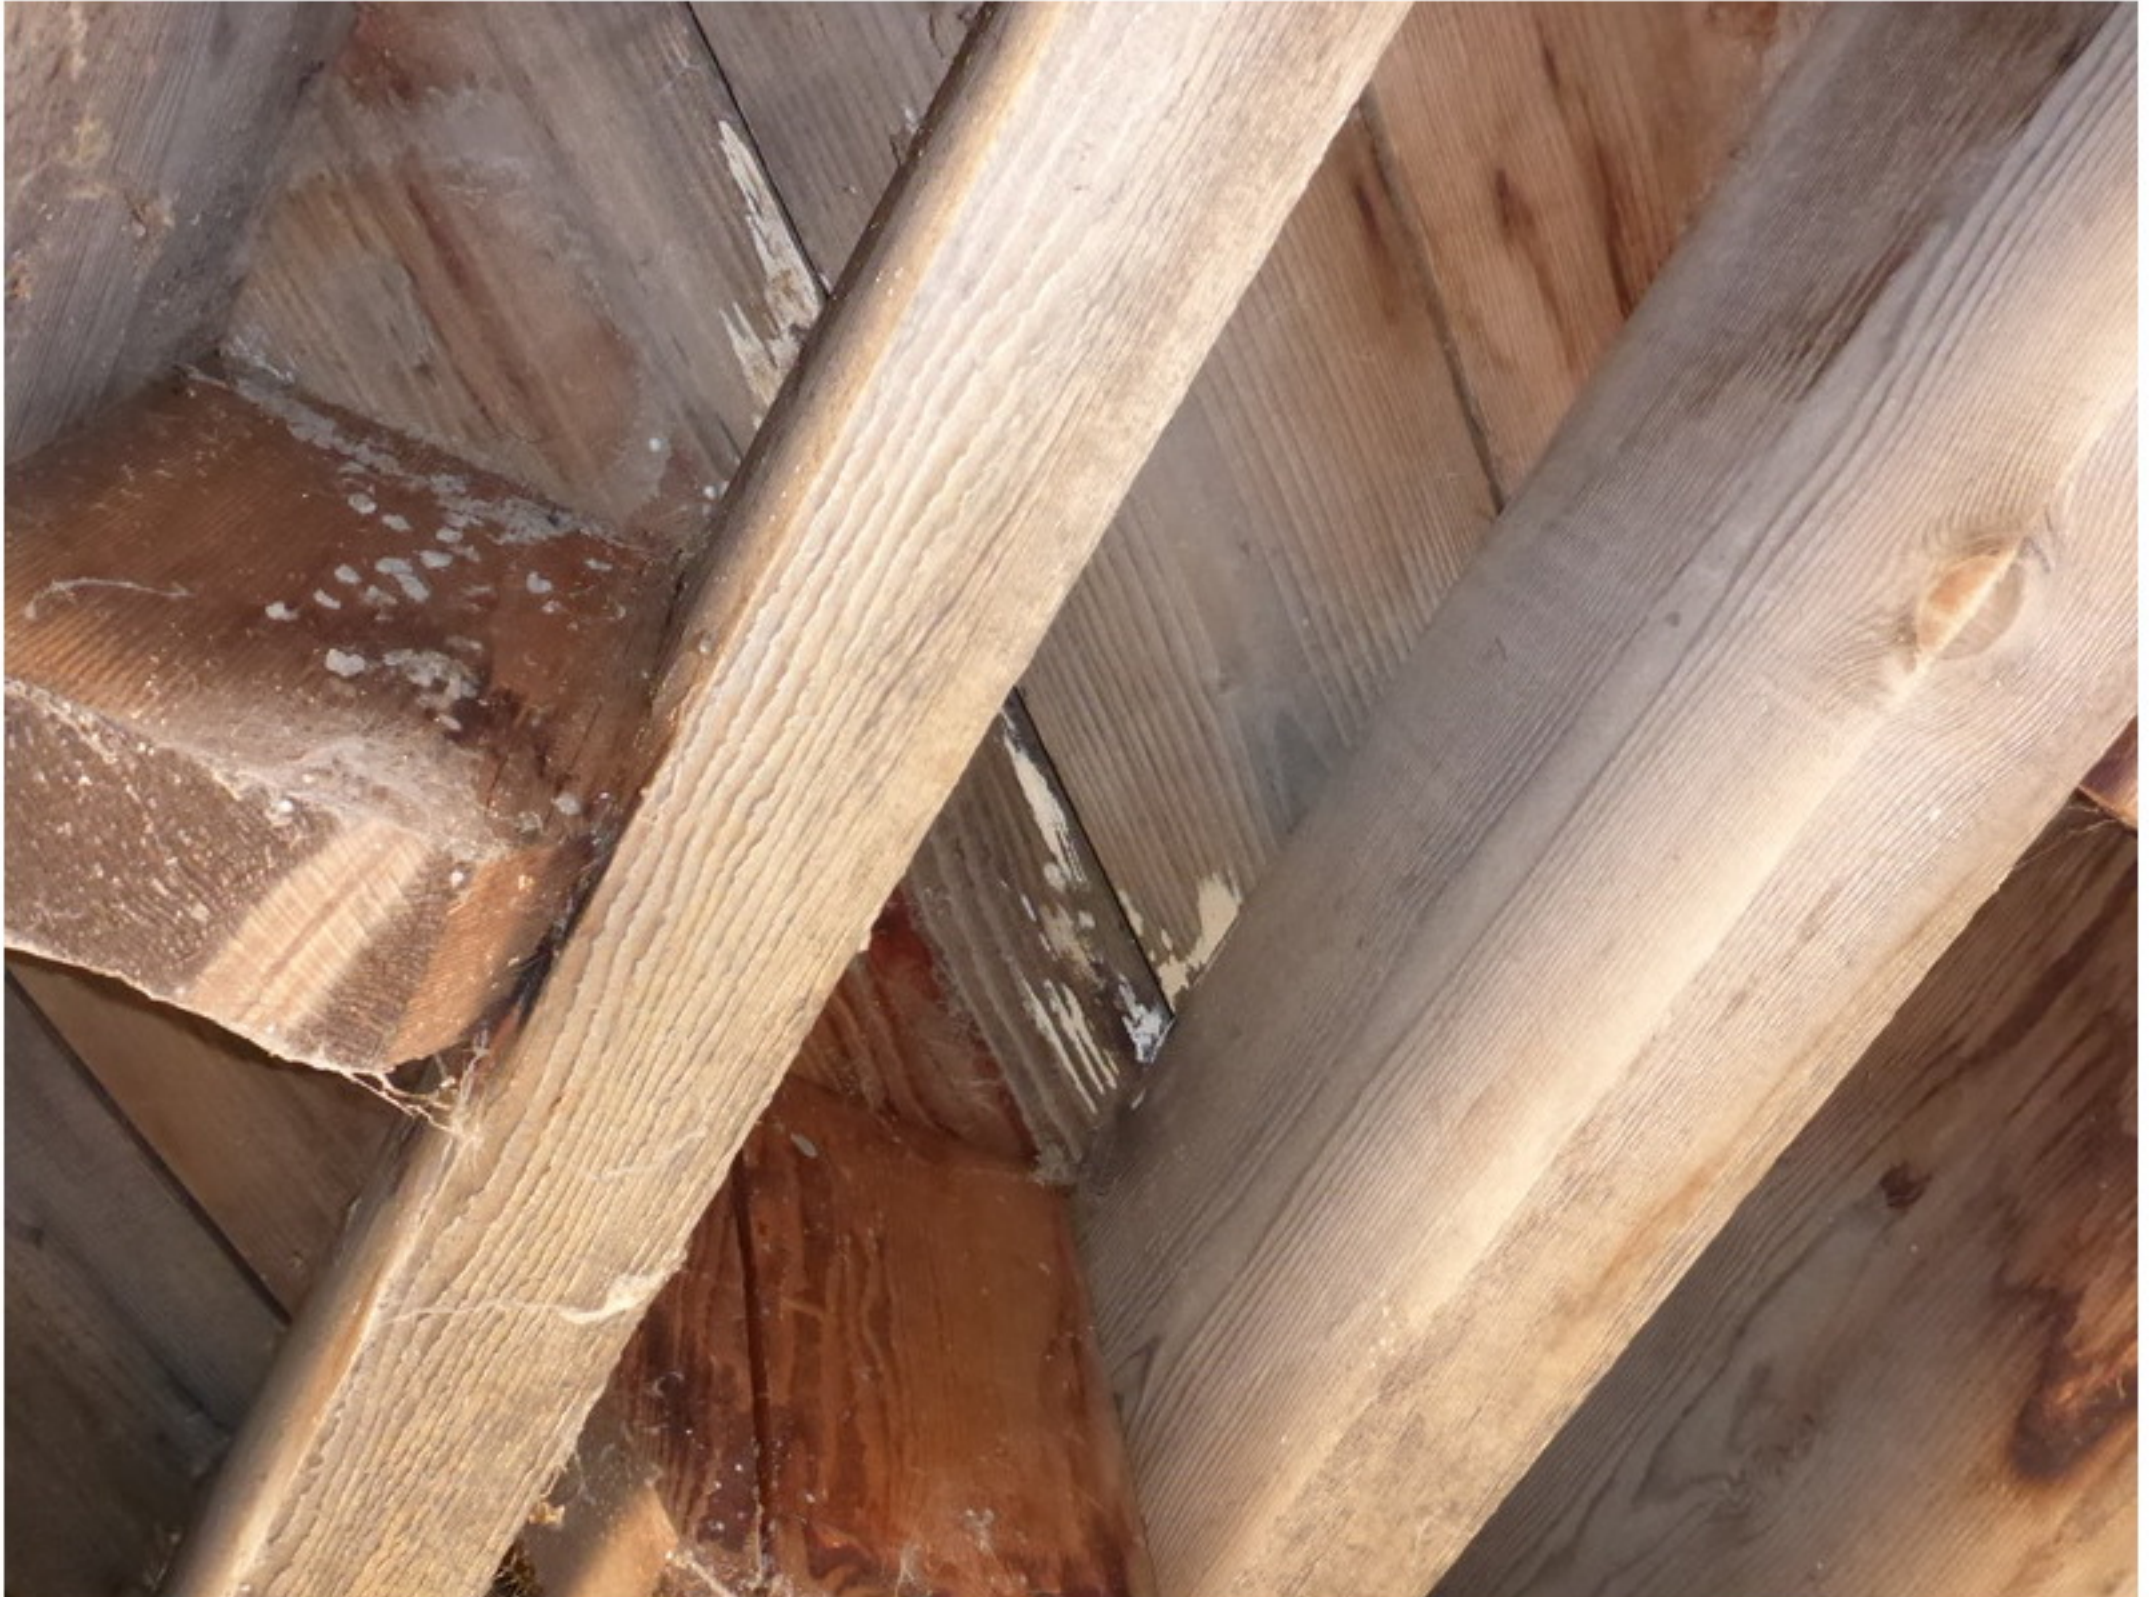
Photo No. 7  
White fungus on the left side of Span 3

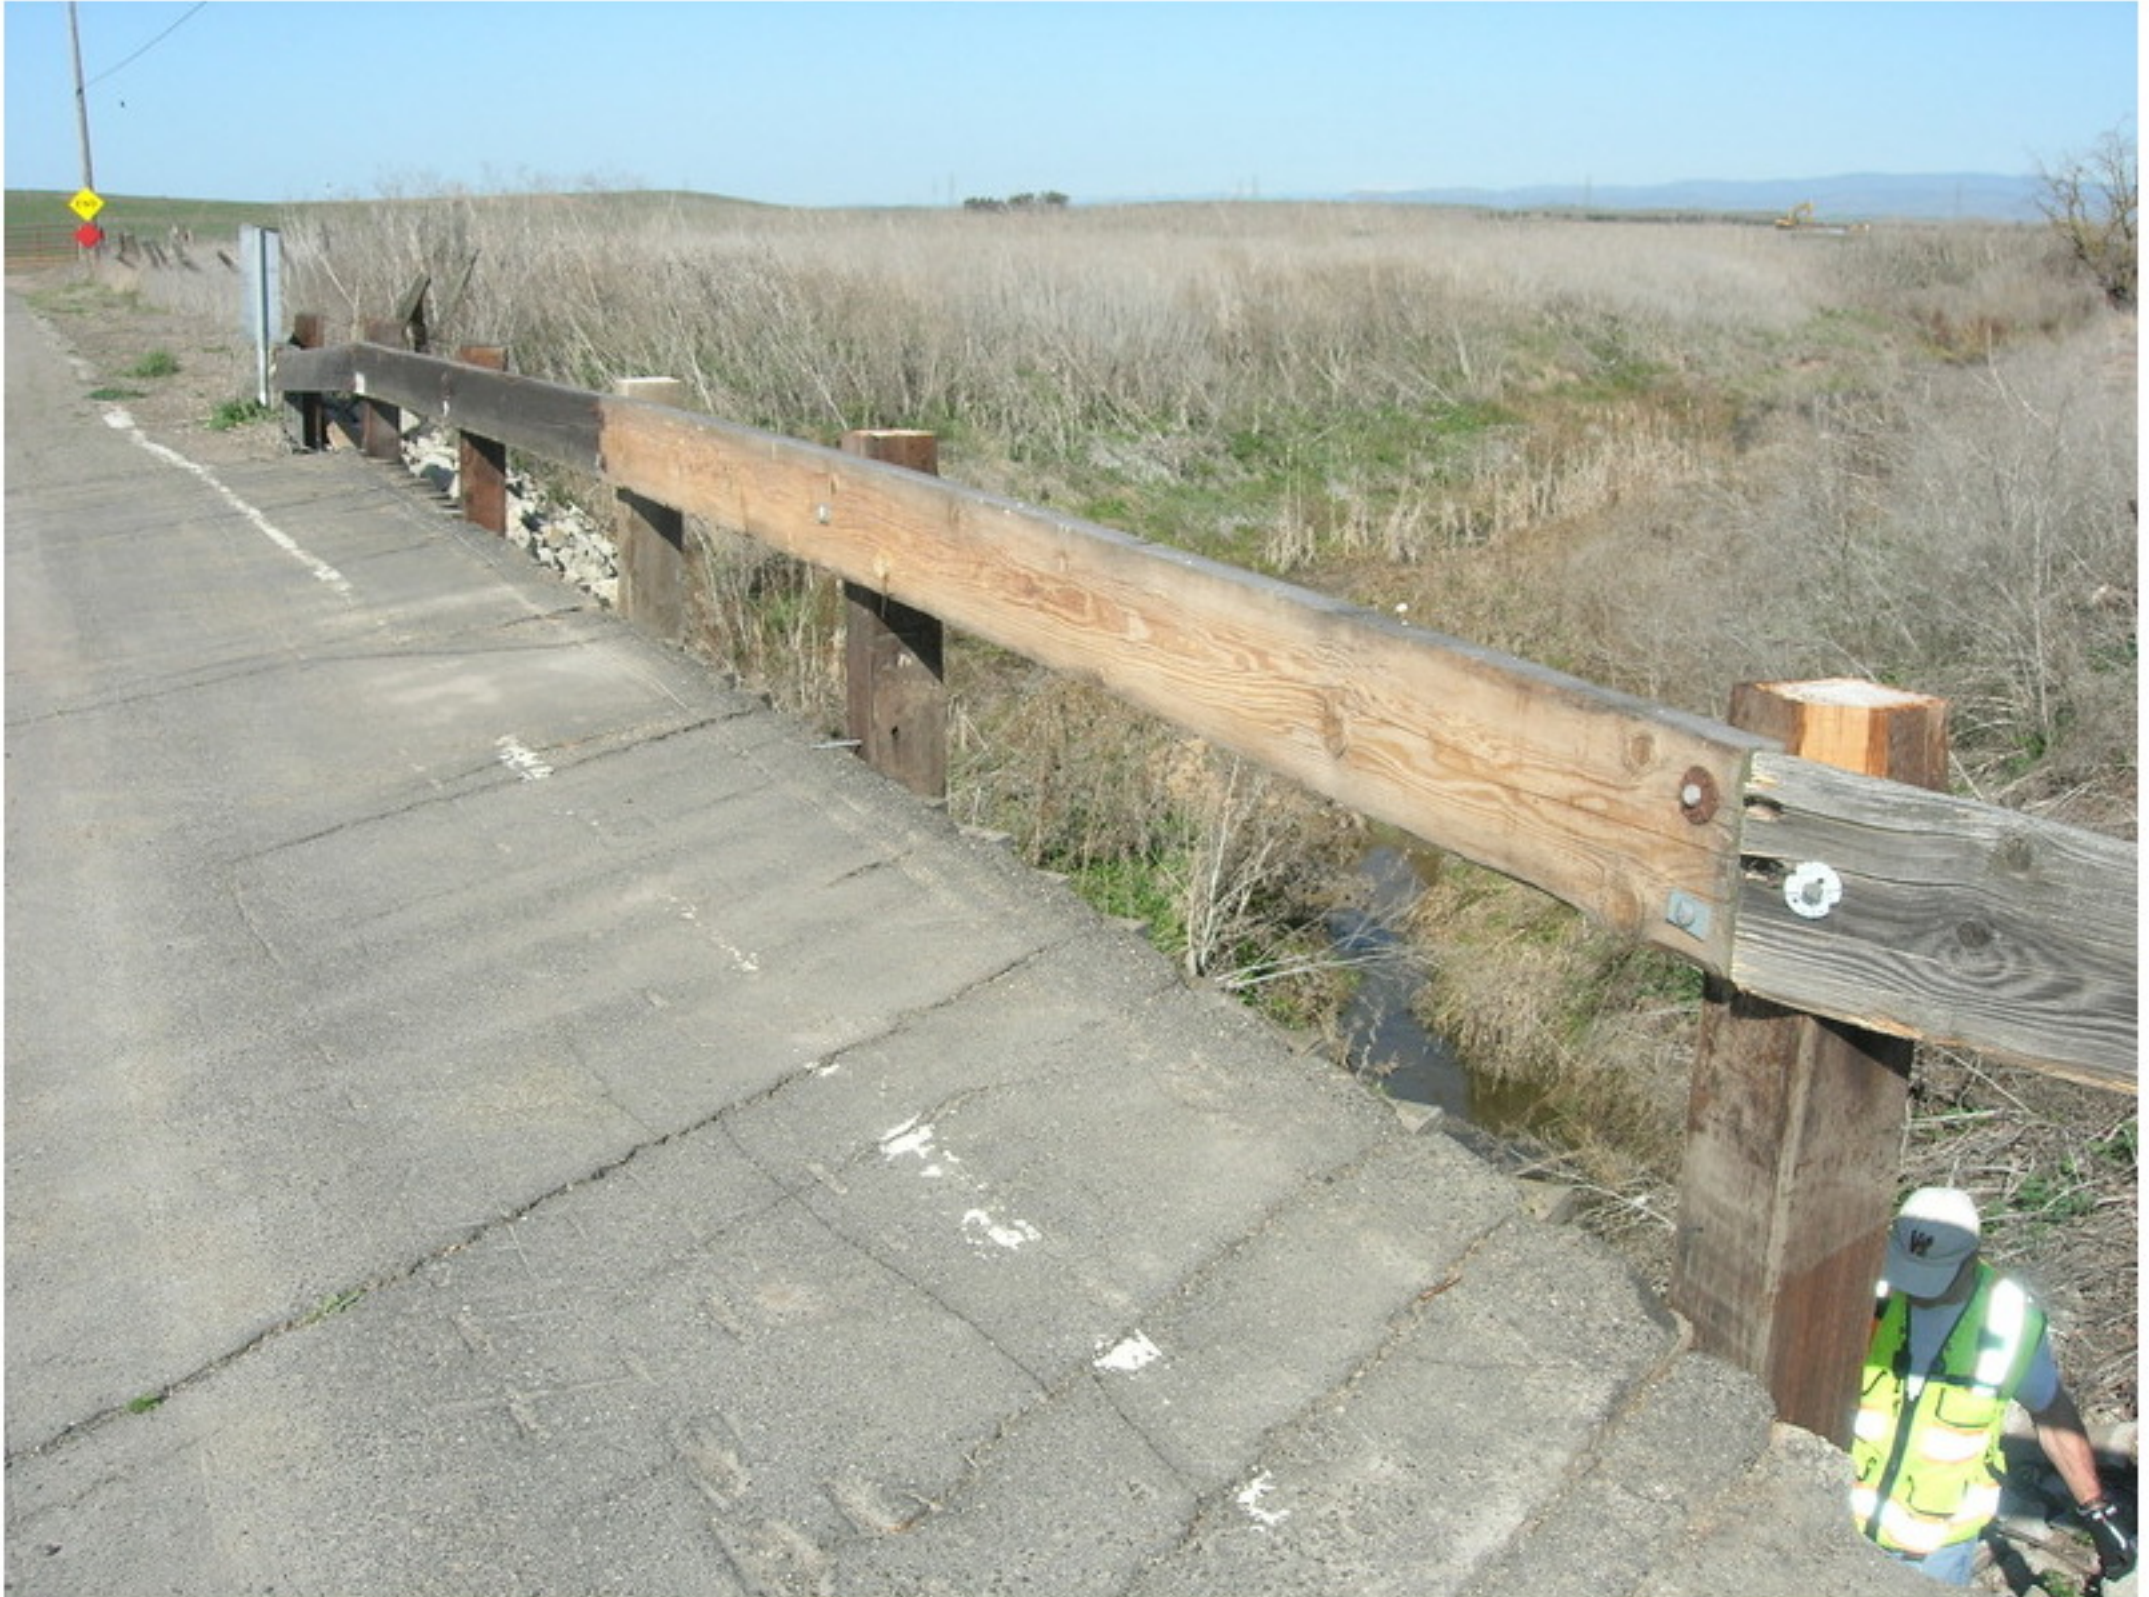
Photo No. 1  
New timber rail on the right side.

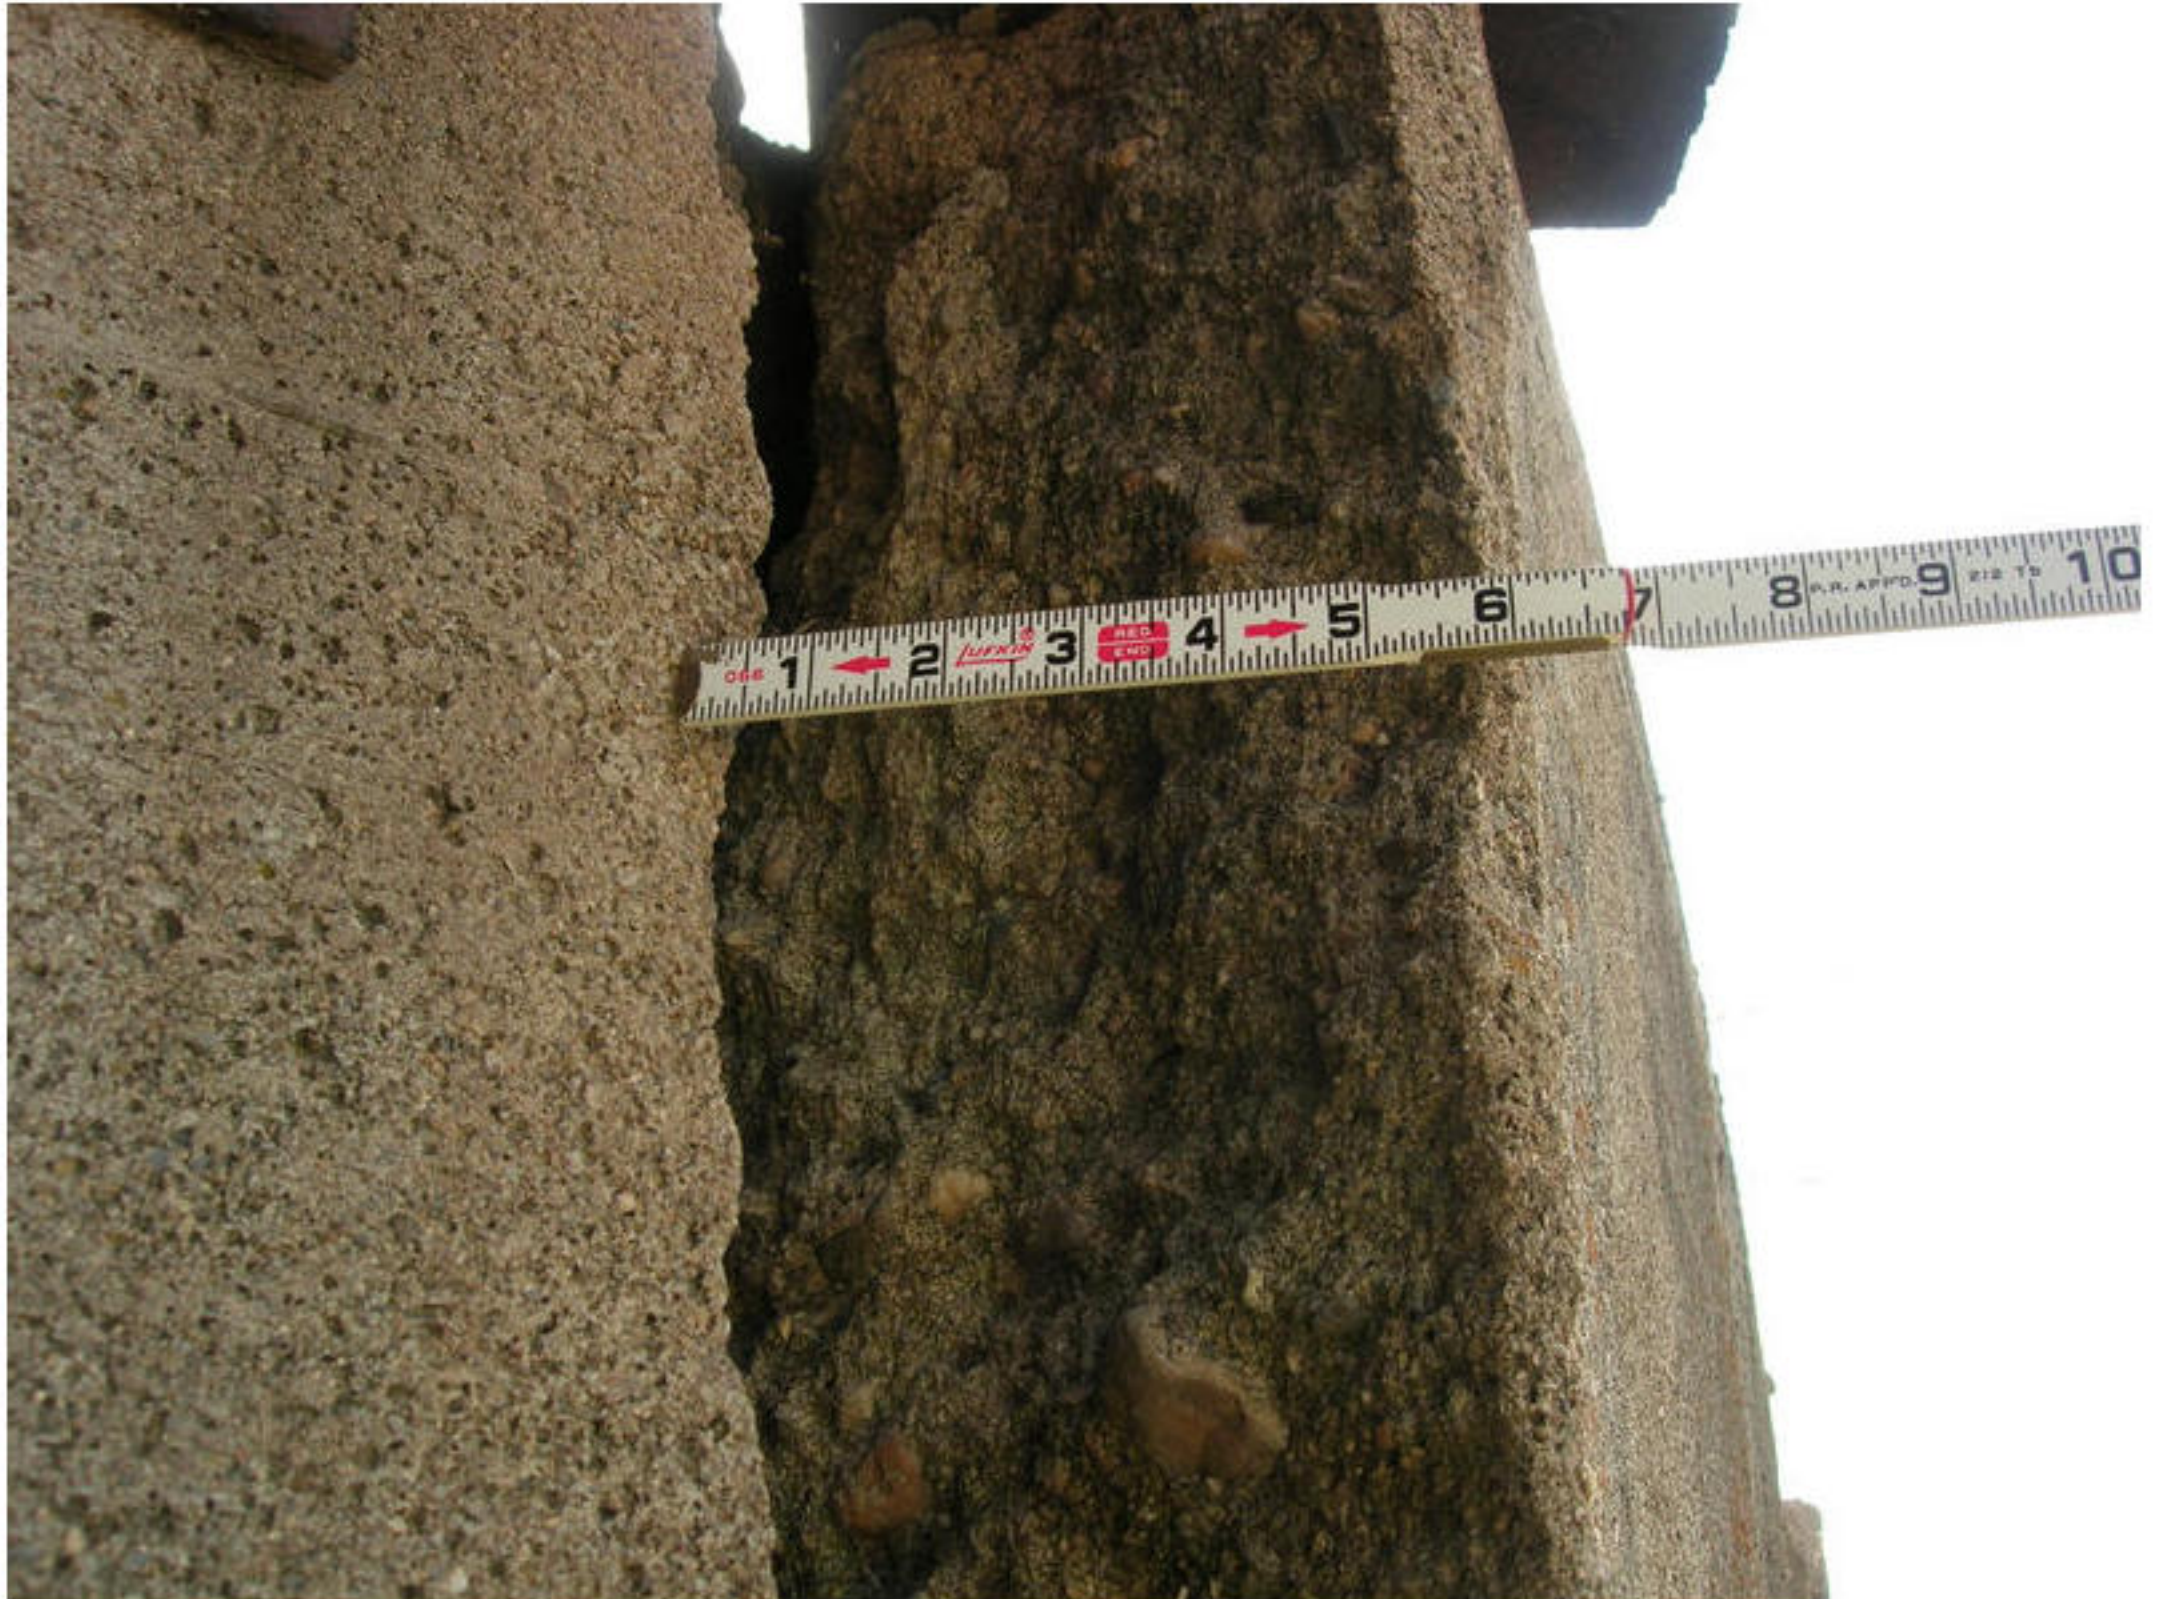
Photo No. 1  
Movement of the left wing wall at Abutment 1.

The left wingwall at Abutment 1 has moved laterally. The wingwall had been moving laterally as shown by measurements reported in the October 10, 2006 BIR and in the November 4, 2008 BIR; the left and right wingwalls were tied together with steel cables to impede further movement. The BIR of 2011 reports that the vertical gap between wingwalls appears to remain stable since the 2008 inspection.

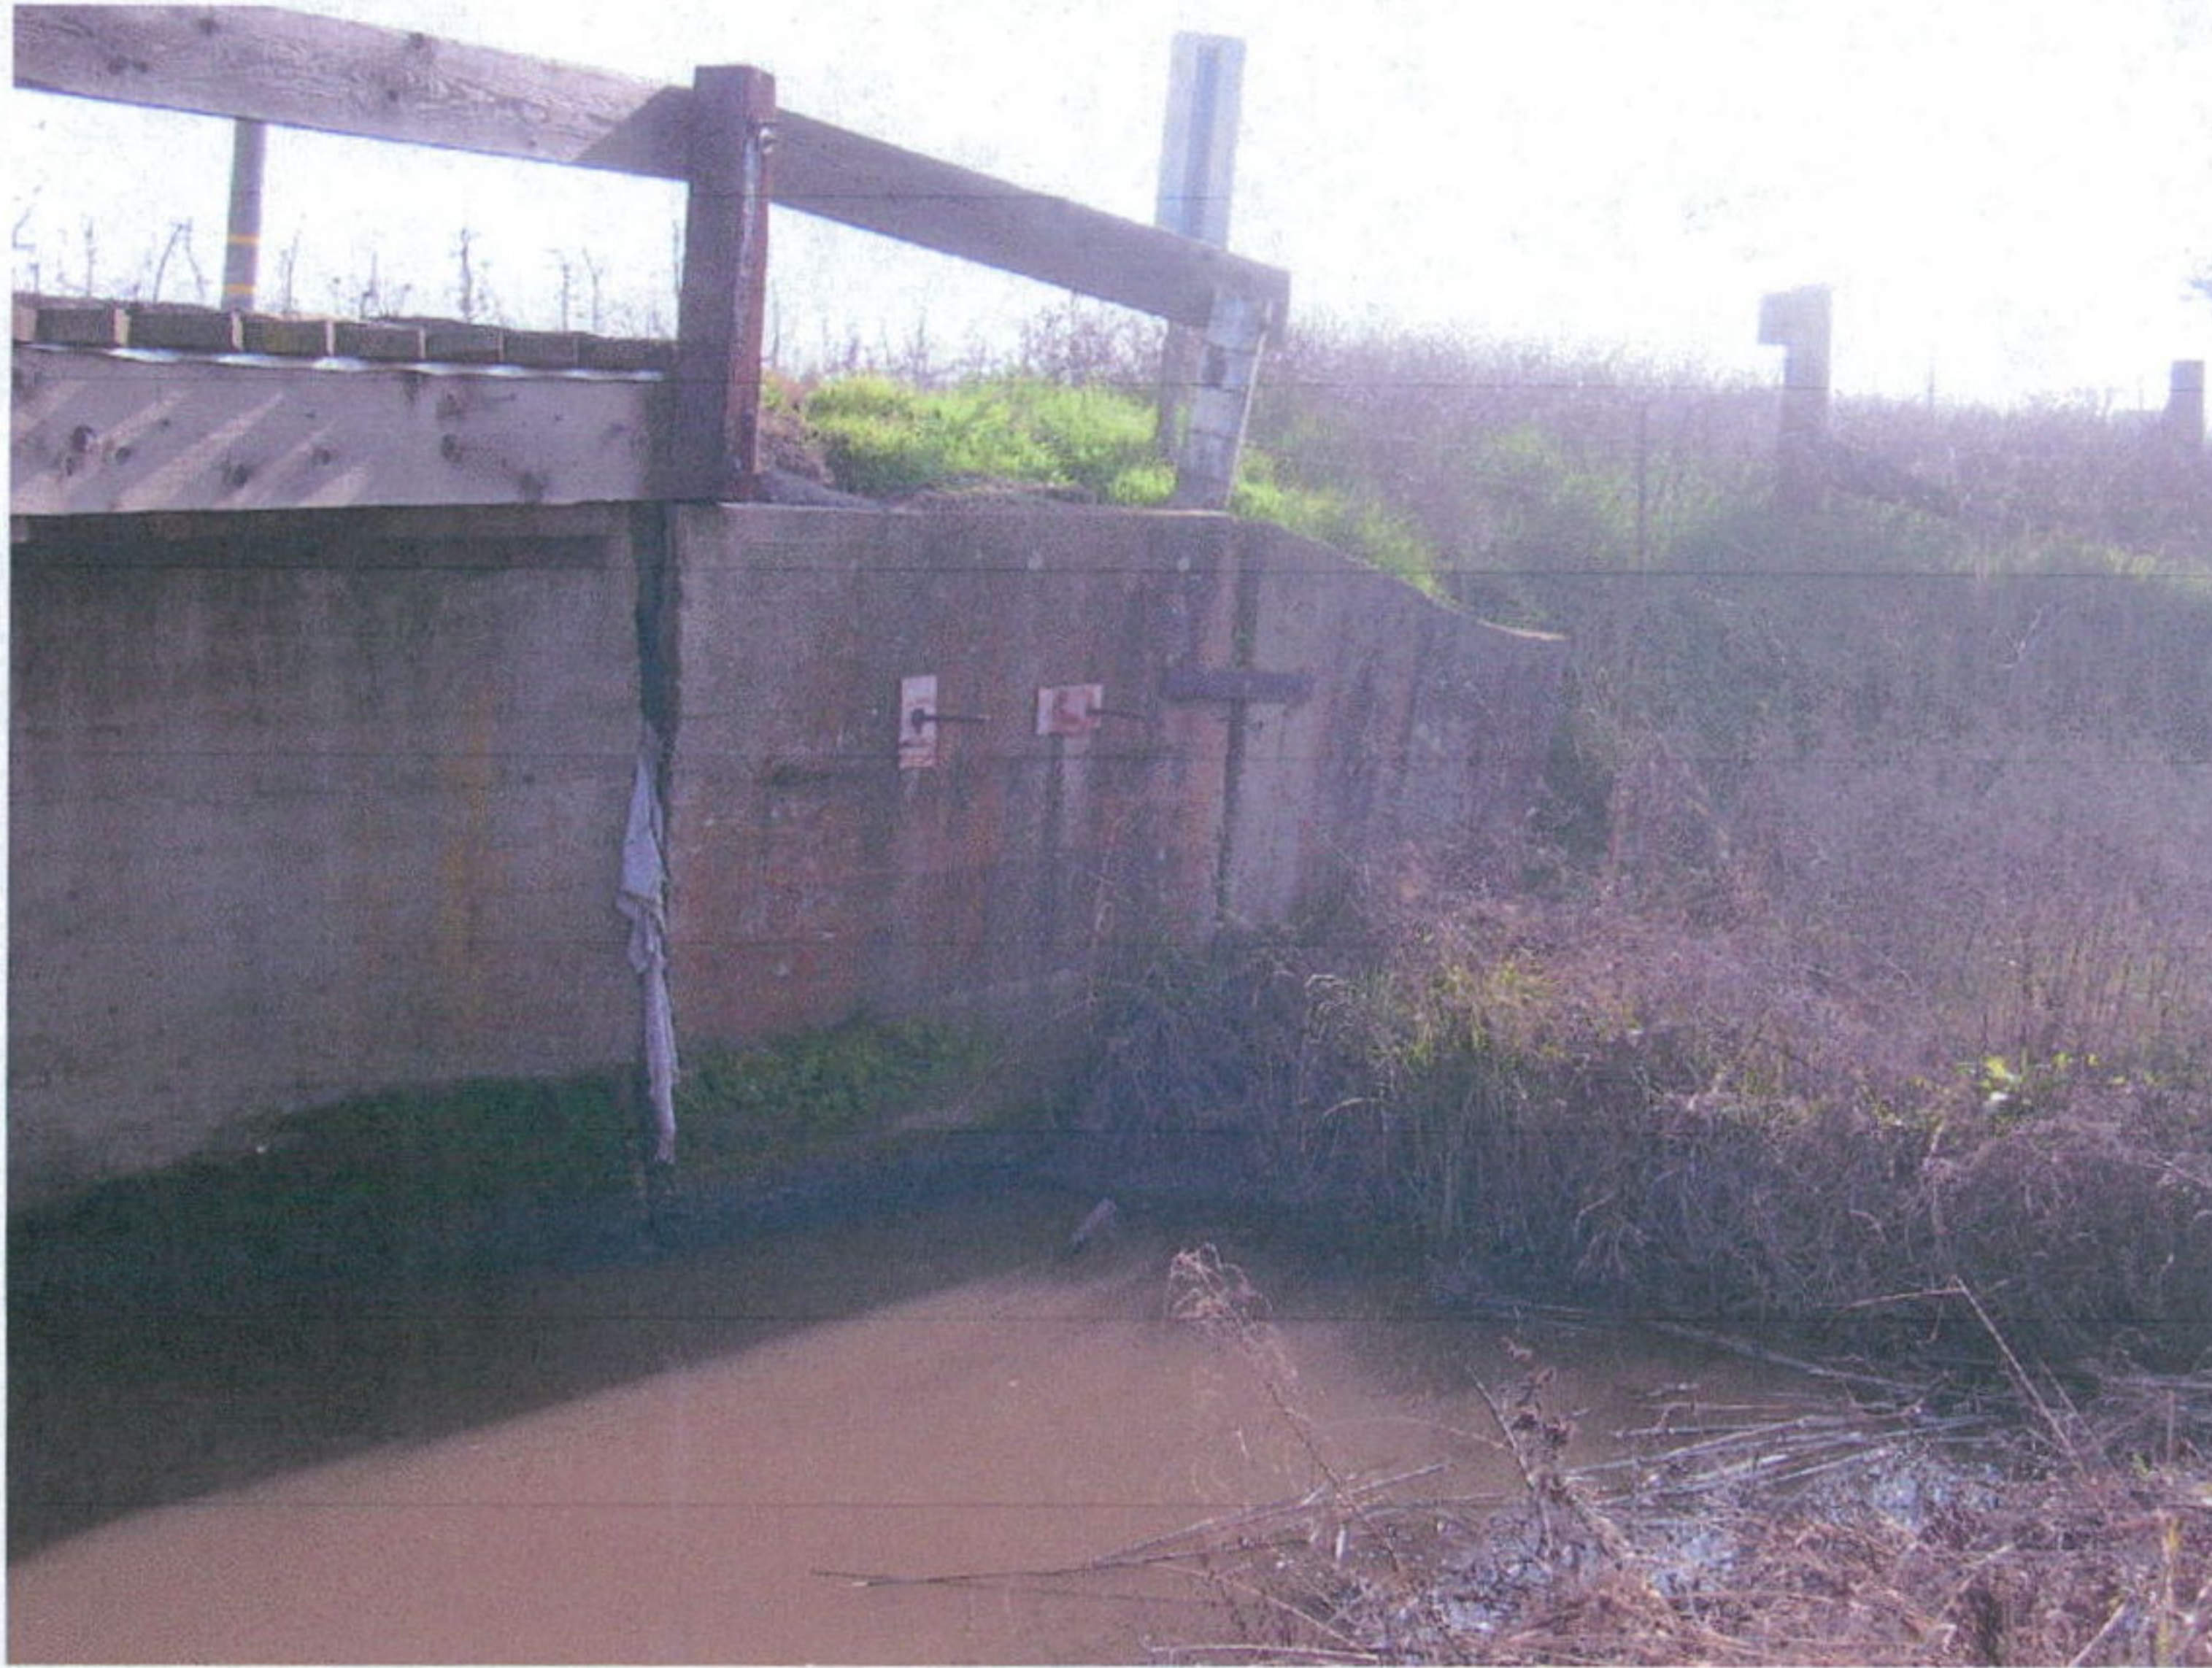
04C-SAS-25-2004-13

DETERIORATION: Left wingwall at Abutment 1

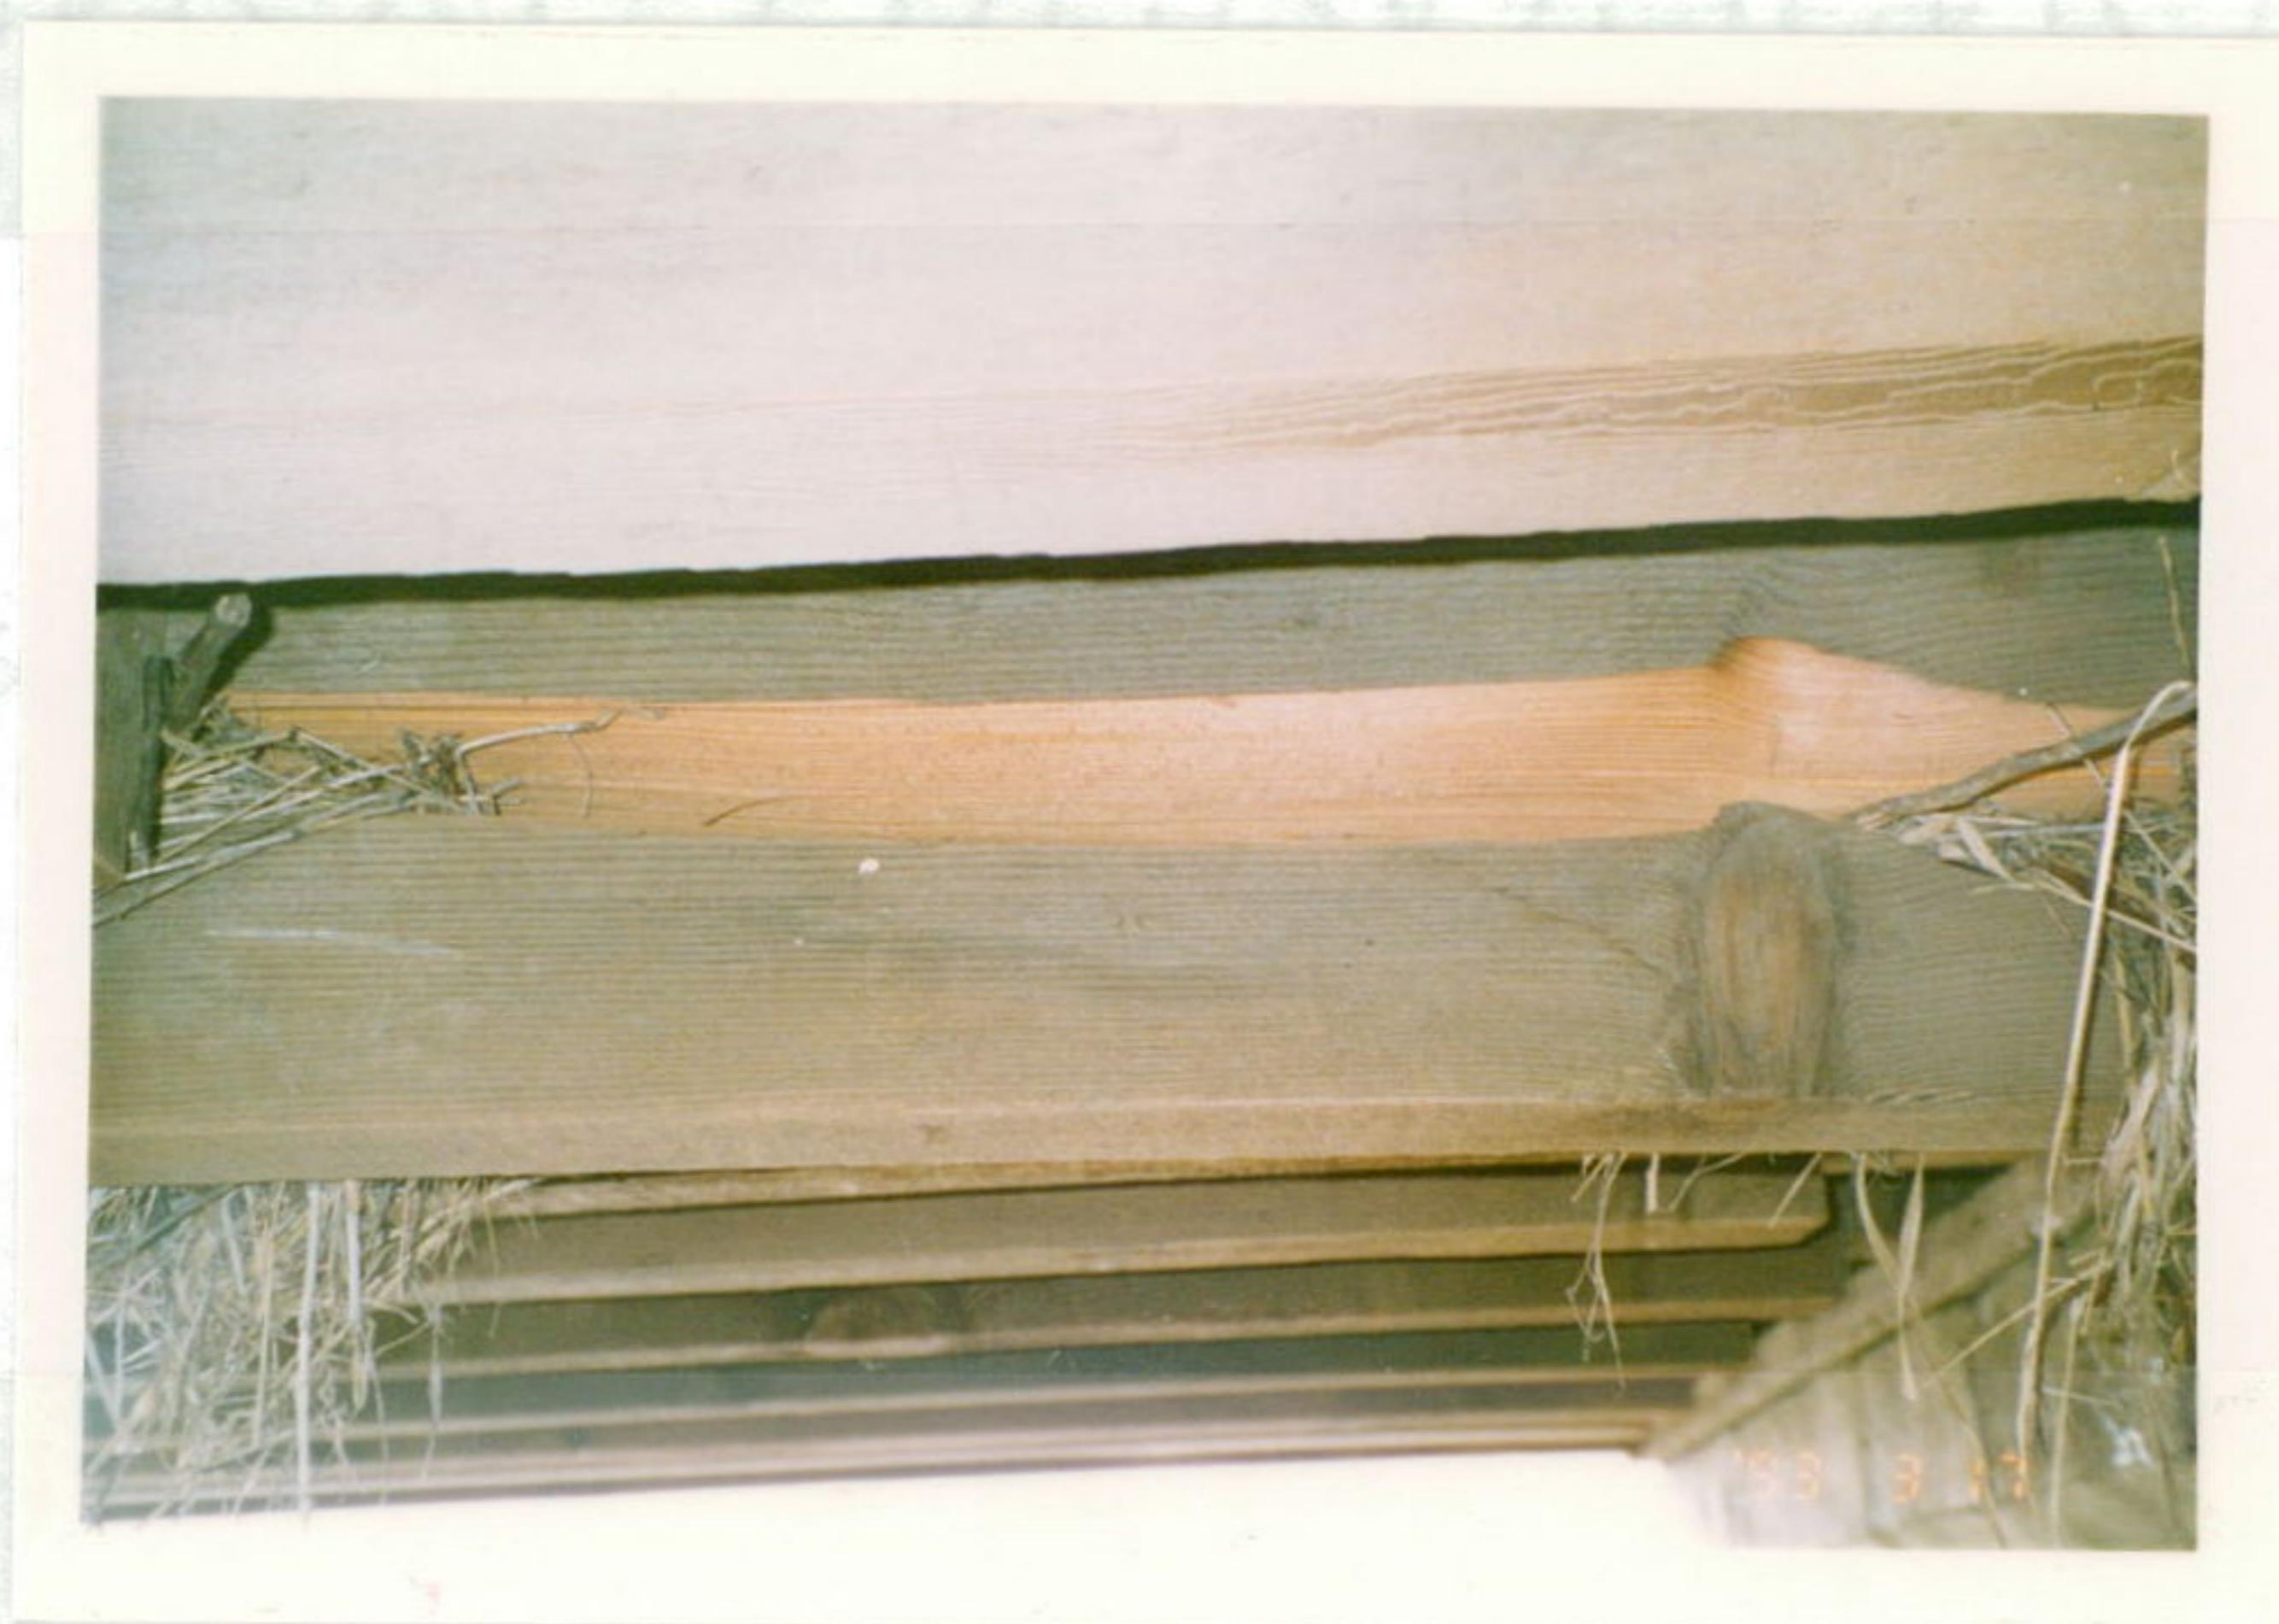
SPLIT ON STRINGER #8 OF SPAN 3  
3-16-93.17  
TH-4

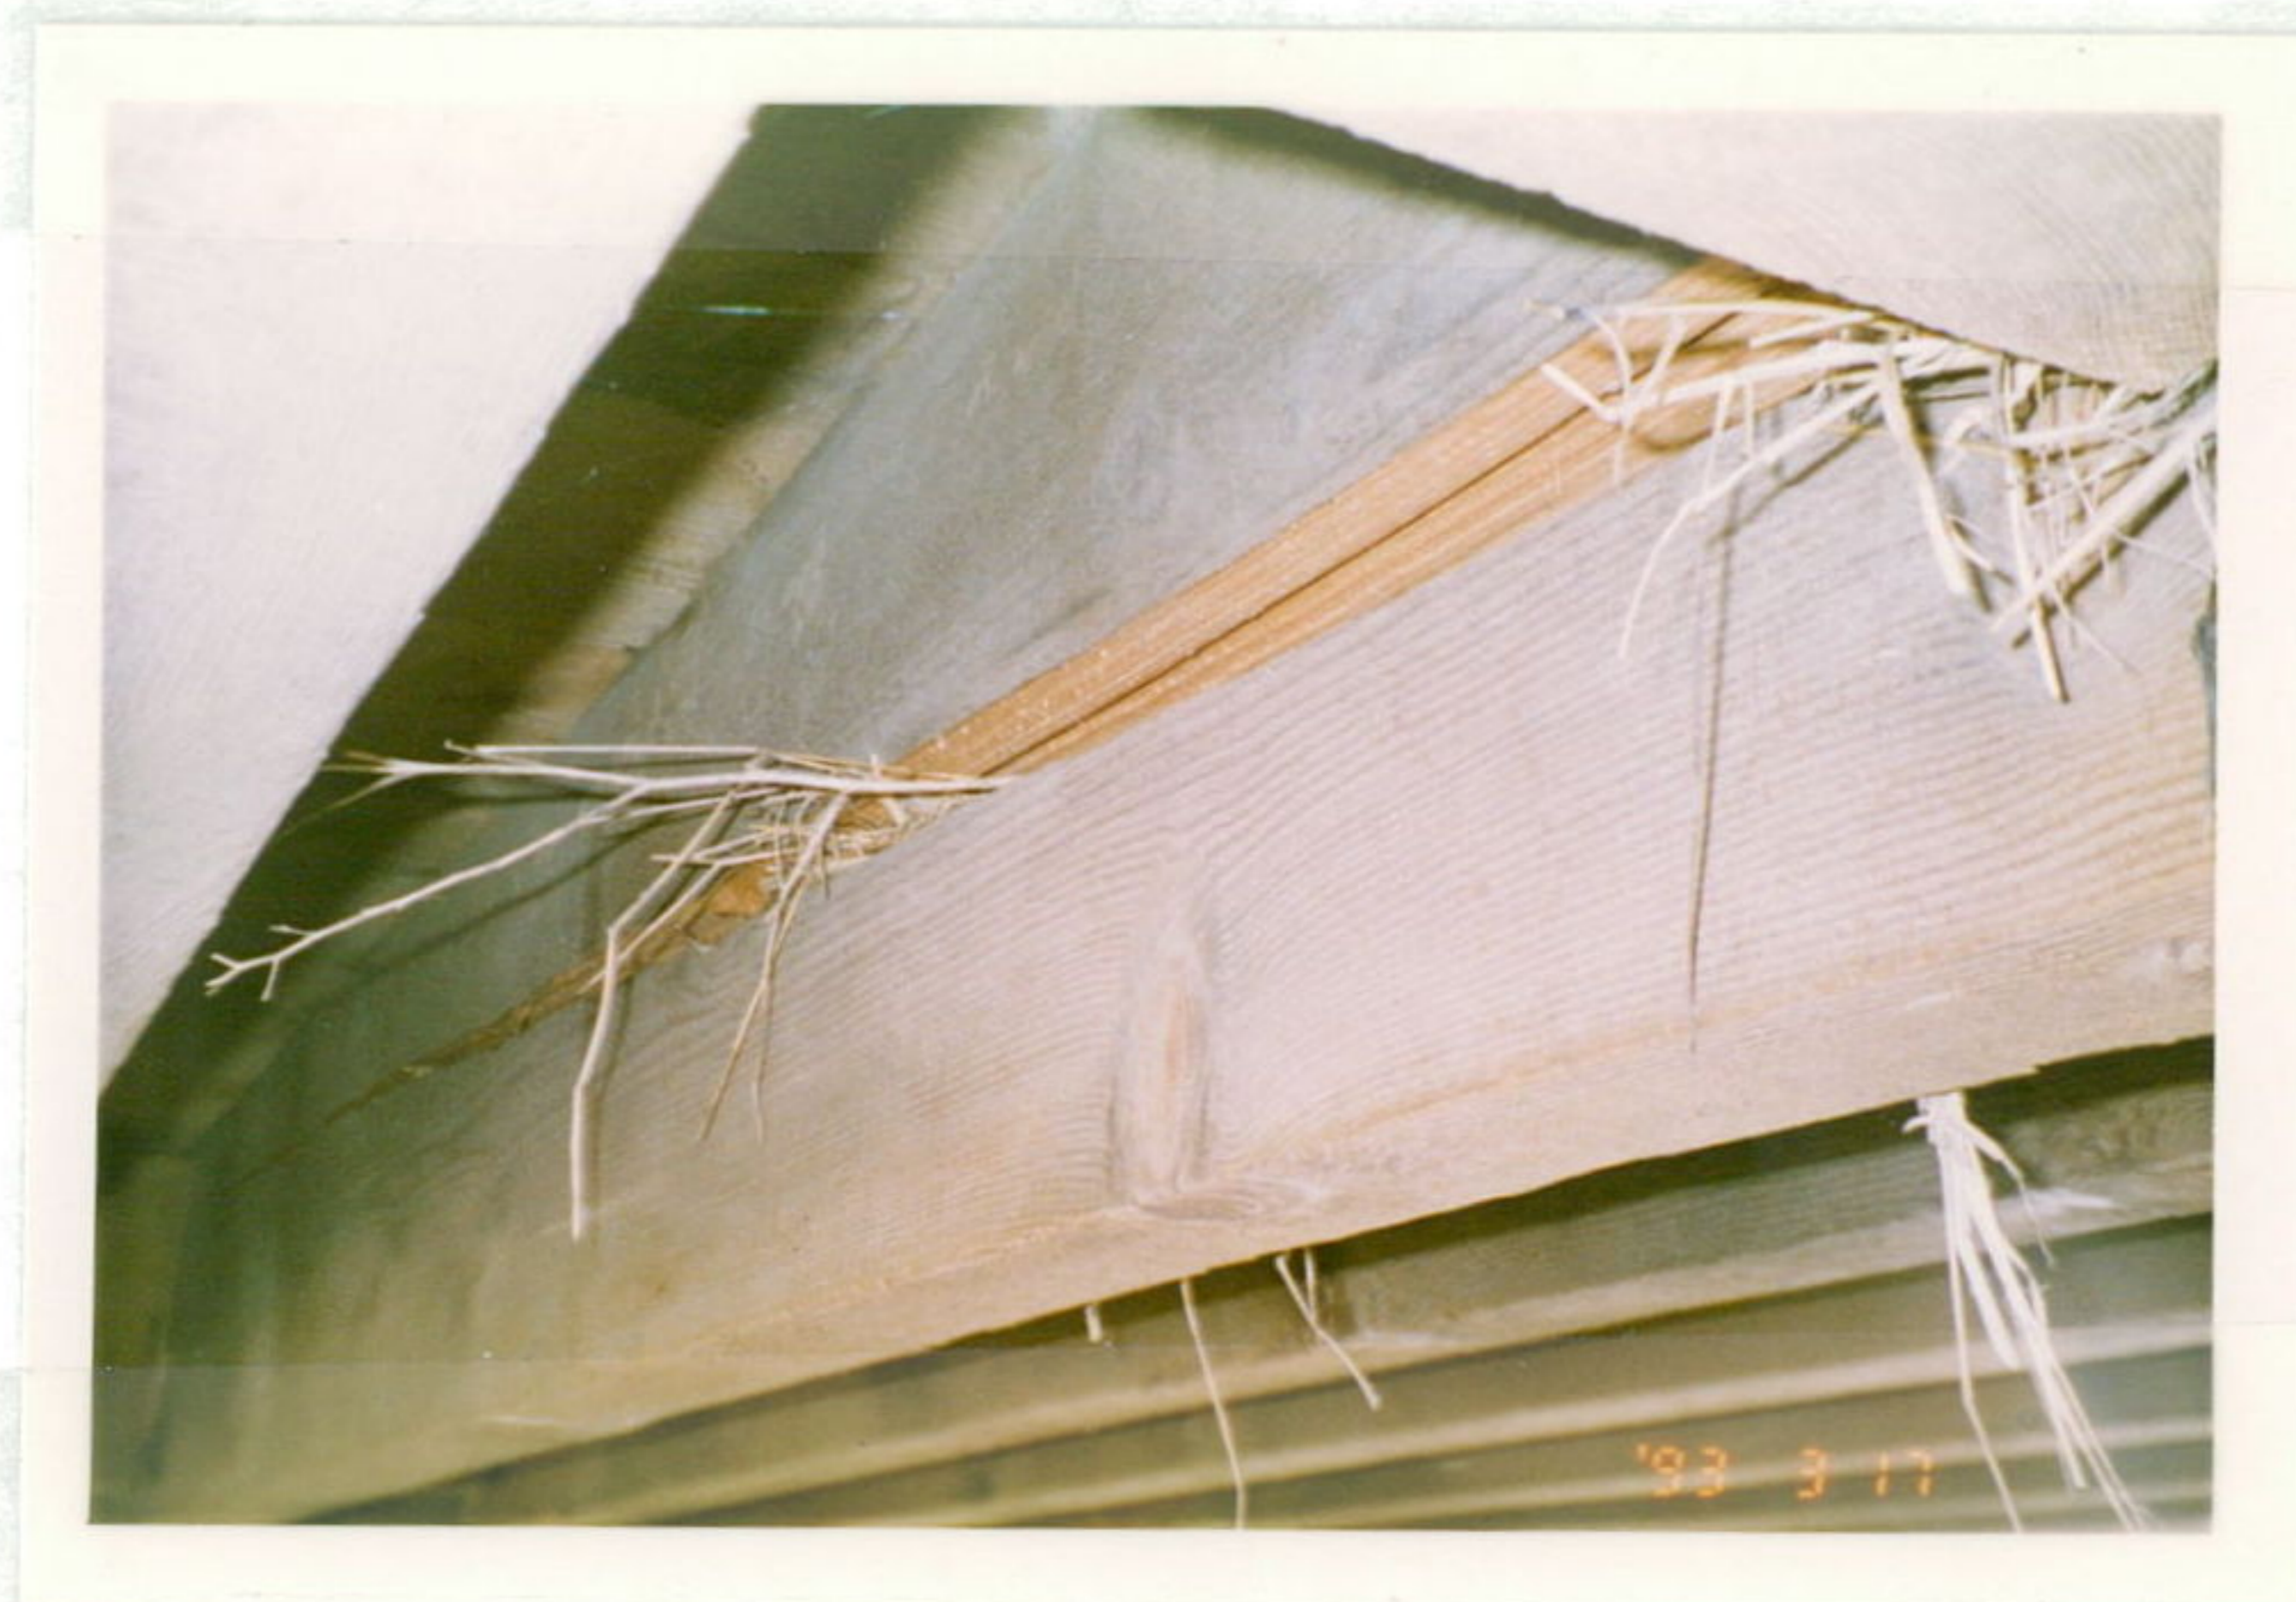
SPLIT ON STRINGER #8 OF SPAN 3  
3-16-93.18  
TH-4

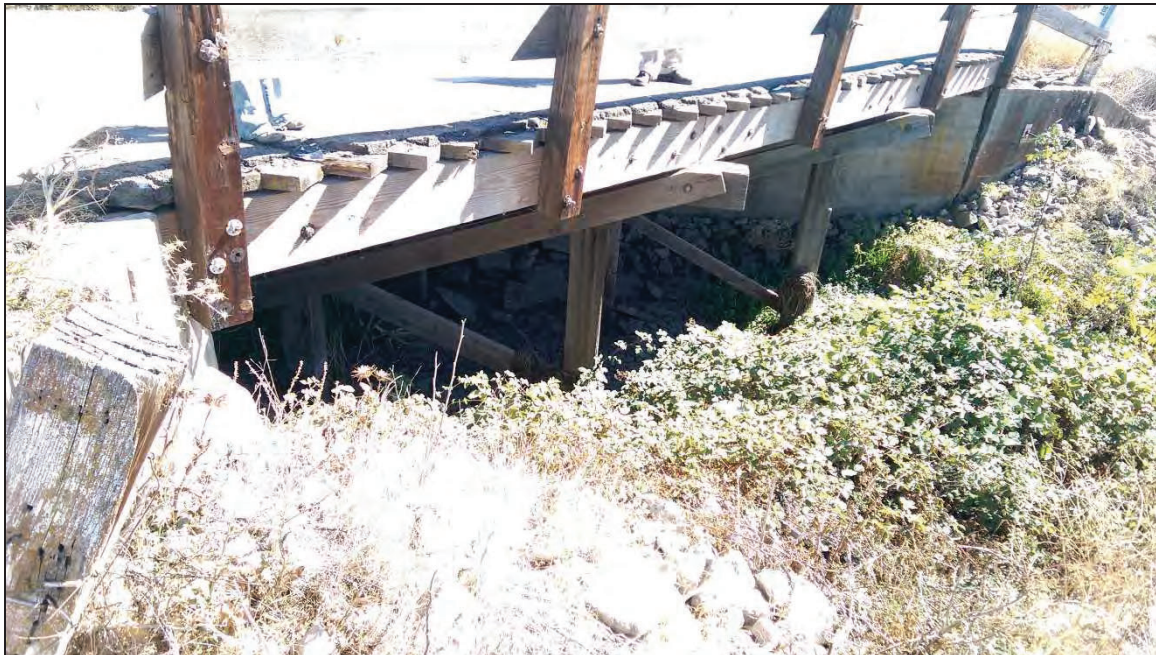
**Photo 1. Existing Buckman Road Bridge, Upstream Face**
