## **Initial Study/Mitigated Negative Declaration**

# **Buckman Road Bridge Replacement Project**

**February 2023**

**Prepared for:**  
San Joaquin County  
Department of Public Works  
1810 E. Hazelton Avenue  
Stockton, CA 95205

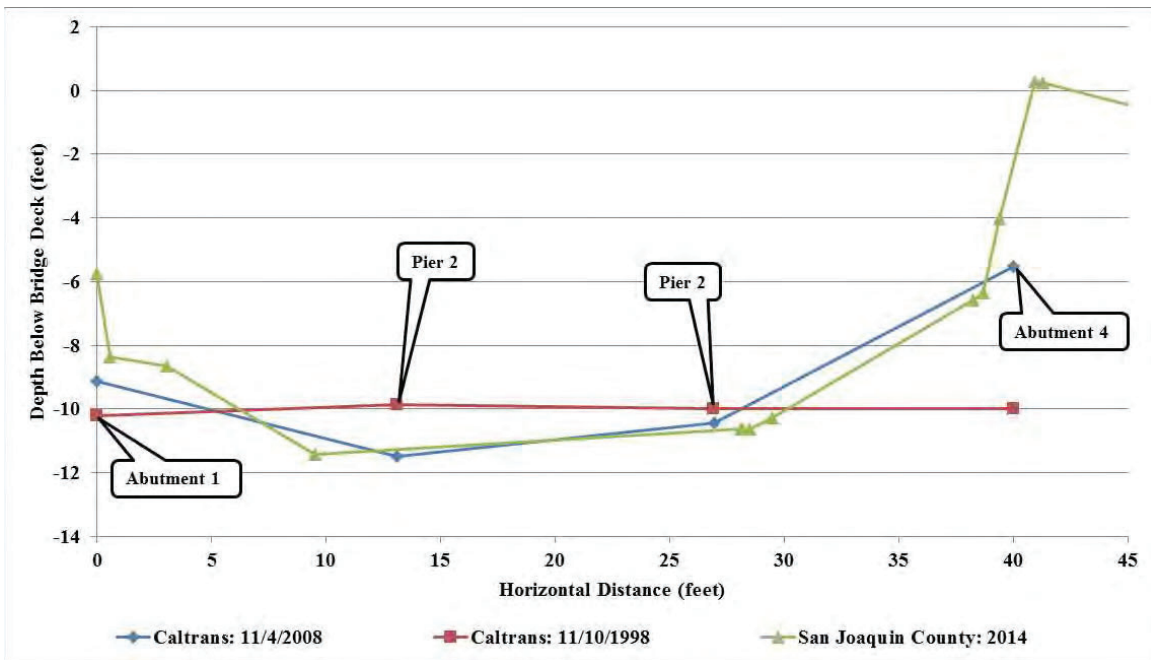
**Figure 12. Historical Channel Cross Sections, Upstream Face of Existing Buckman Road Bridge**

inspection on November 23, 2015 only listed note indicating no significant changes in channel cross sections were observed in comparison to the channel cross section from November 4, 2008. The cross sectional view of the two surveys and channel cross section from the hydraulic analysis are shown in Figure 12. The changes in channel cross section from 1998 to 2008 at abutment 4 is from the placement of riprap as noted in the BIR dated October 25, 2006. Similar to the inspection notes in the 2015 BIR, there were no significant changes to the channel between Caltrans 2008 survey and San Joaquin County's 2014 survey. Based on the channel information from the 2008 and 2015 BIR and San Joaquin County's 2014 survey, it was assumed that proposed bridge would not encounter long-term degradation over the lifespan of the proposed bridge.
