Mattole Road P.M. 5.25 Storm Damage Repair Project

**Public Circulation Draft Initial Study &
Proposed Mitigated Negative Declaration**

Humboldt County

January 17, 2023

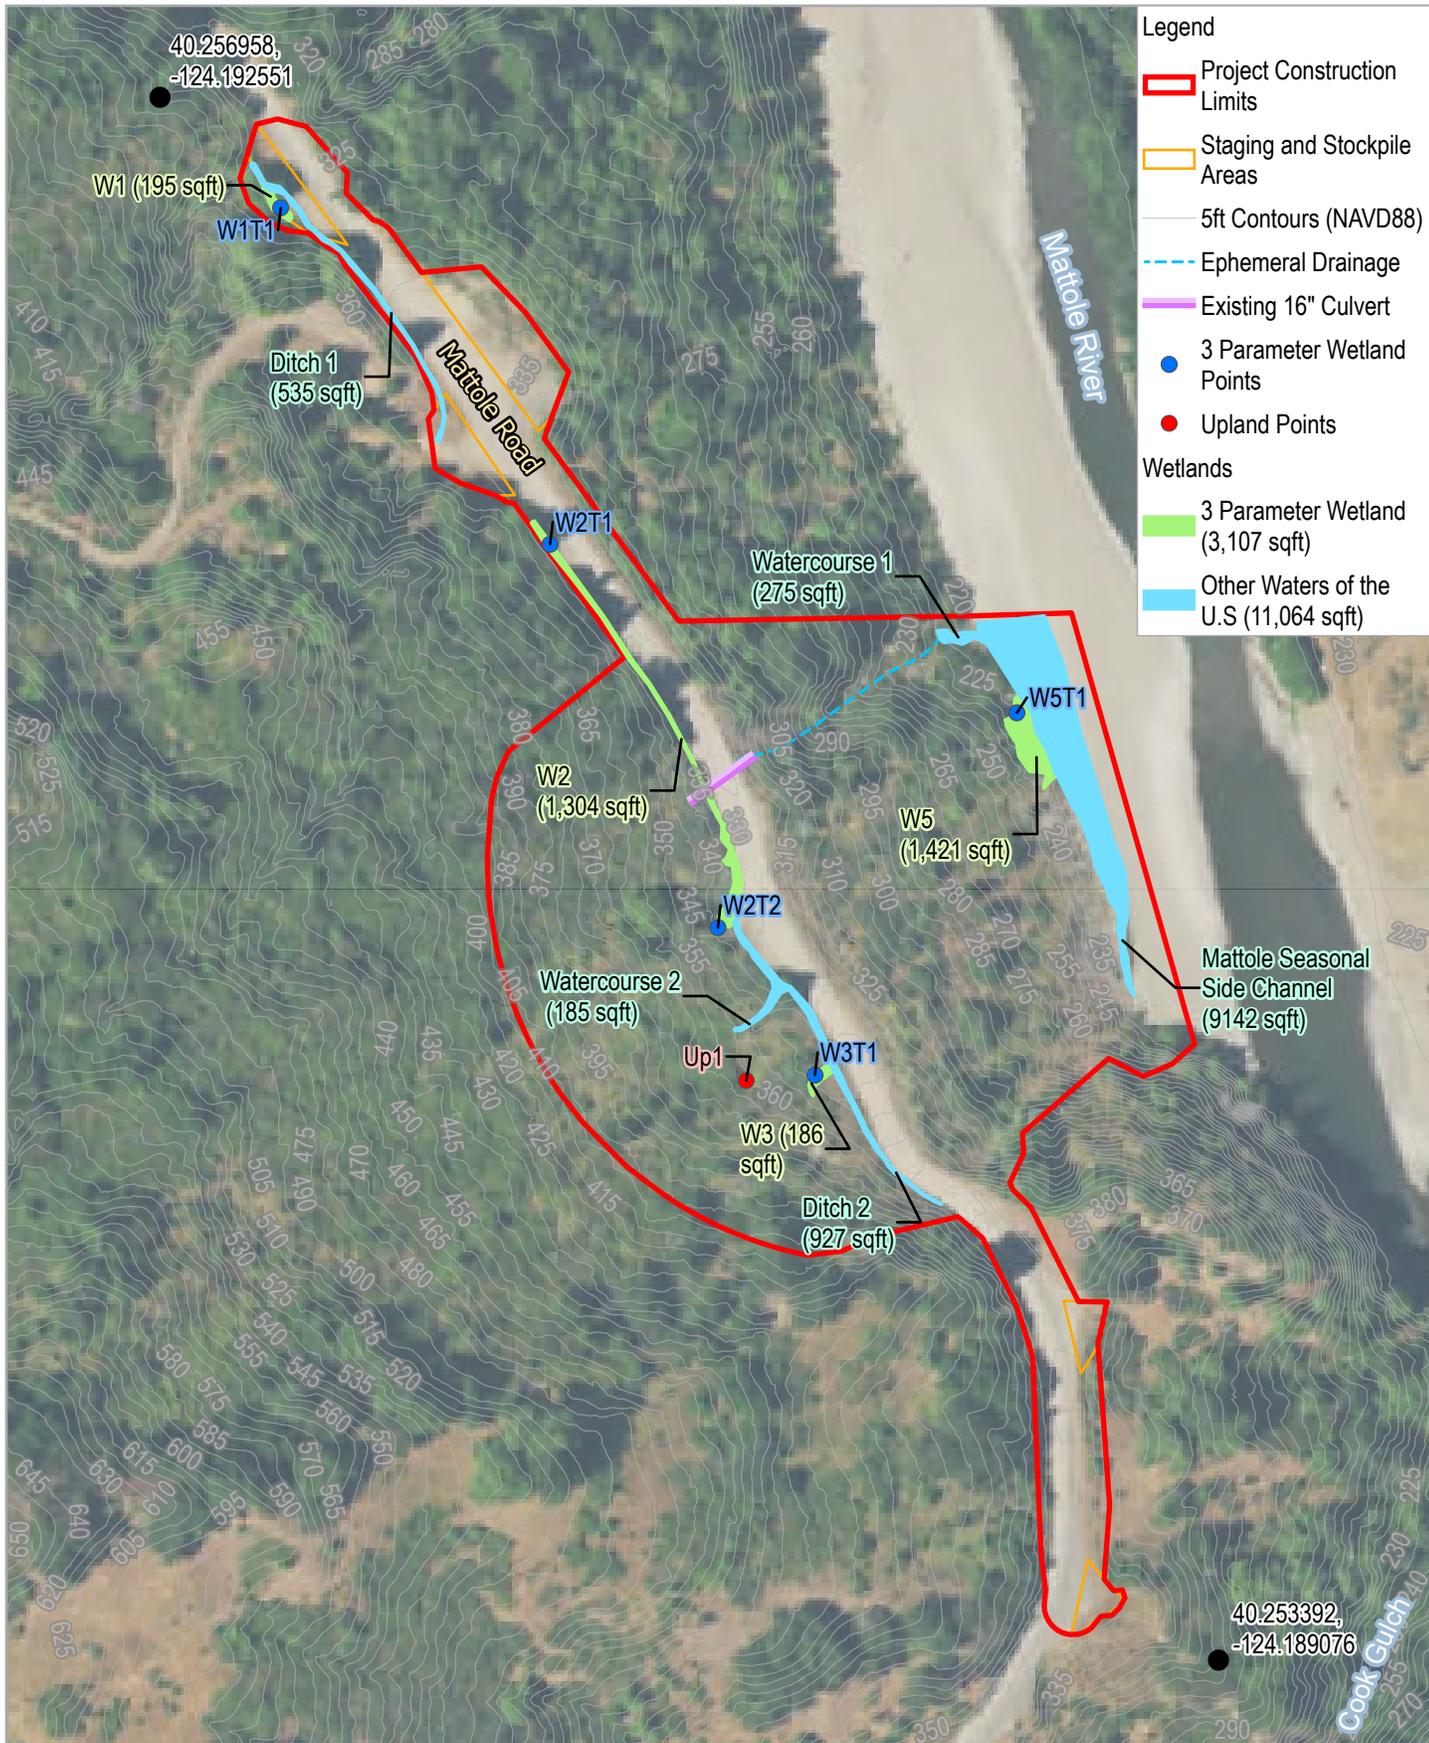
FIGURE 3

Project Overview

Project elements include longitudinal and transverse slope sub-drainage, a reinforced road embankment (supplemented by lightweight fill if feasible), replacement of the existing culvert and RSP armoring at the slope toe along the Mattole River. Project elements are shown in **Appendix A, Figure 3 – Project Overview**. The primary Project elements are described below.

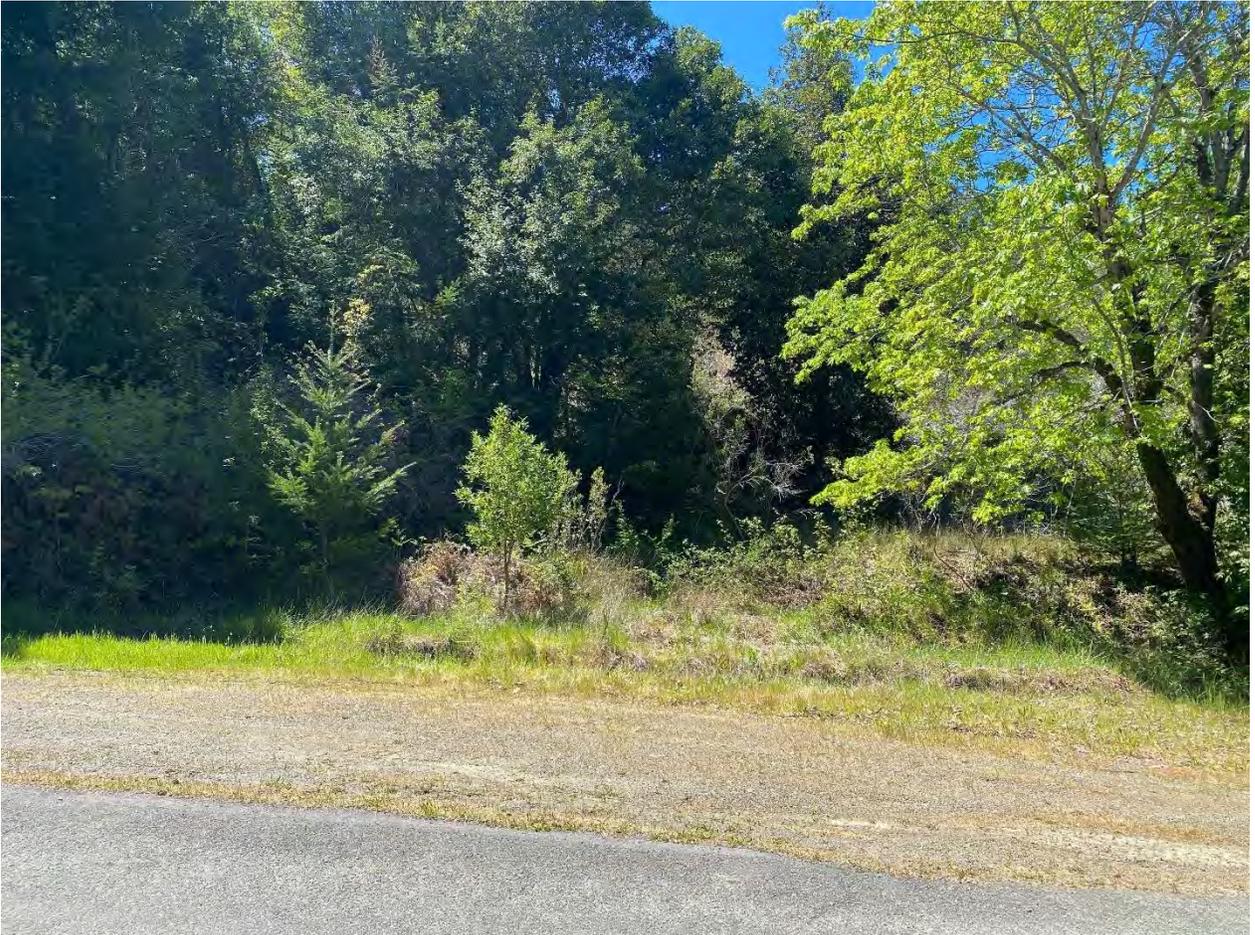
Photo 1. Wetland 1, observed west of Mattole Road in the northwest corner of the Project Area, in a natural ephemeral channel.

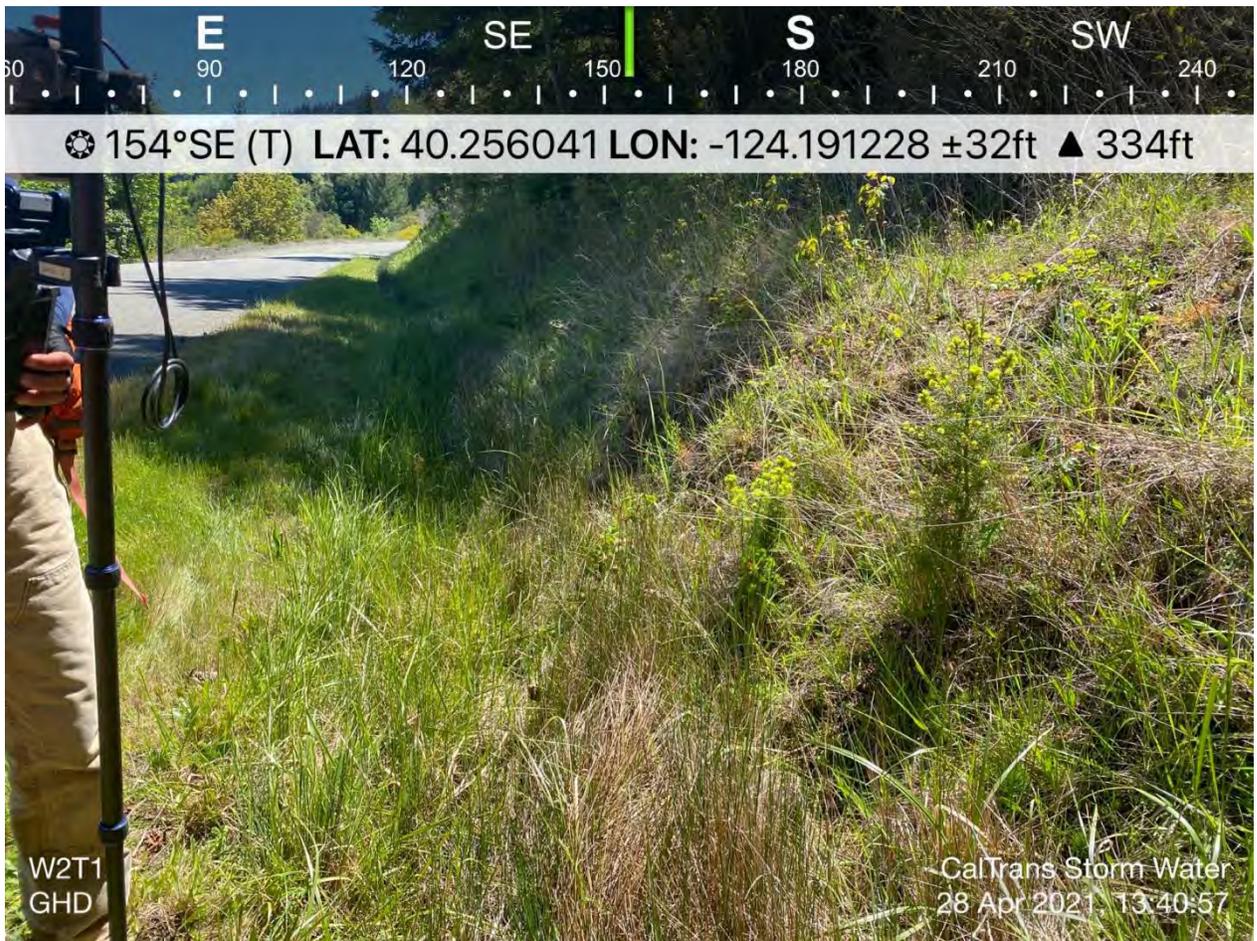
Photo 2. Wetland 2, a vegetated wetland ditch, observed along the western side of Mattole Road.

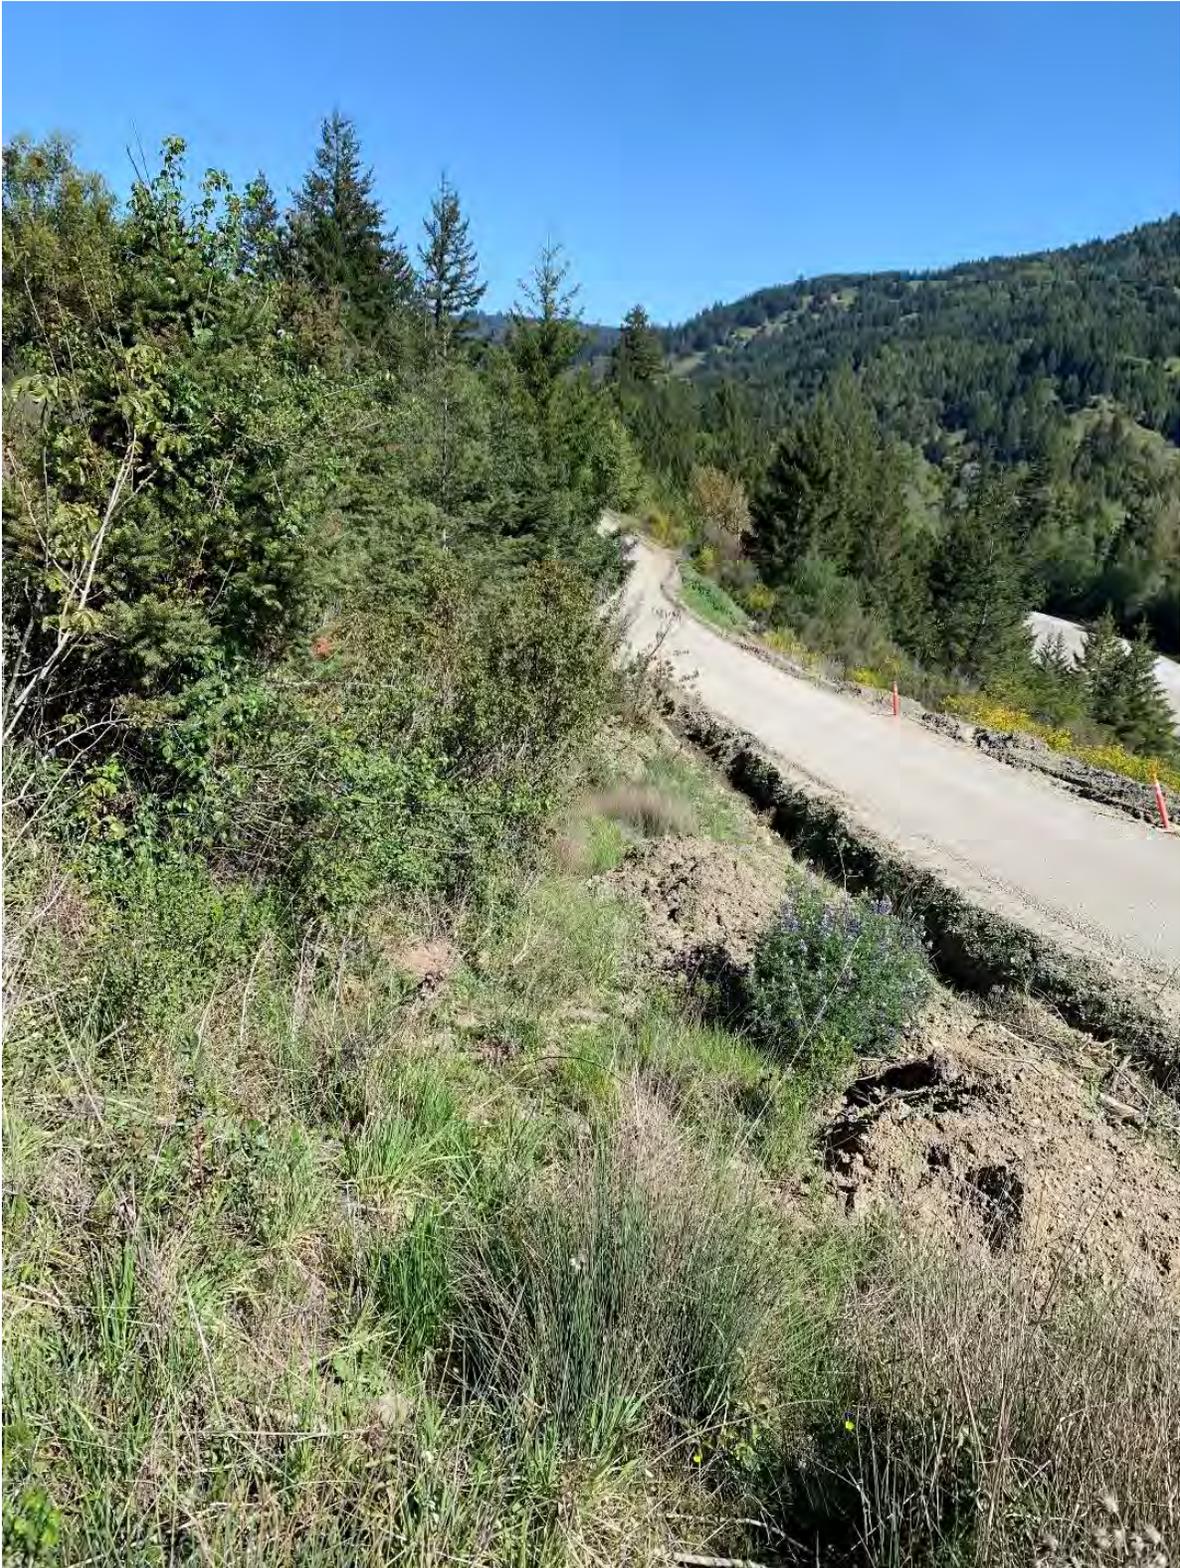
Photo 4. Wetland 3. Wetland 3 was observed west side of Mattole Road, at the slope toe of the existing hillslope failure located above the road.

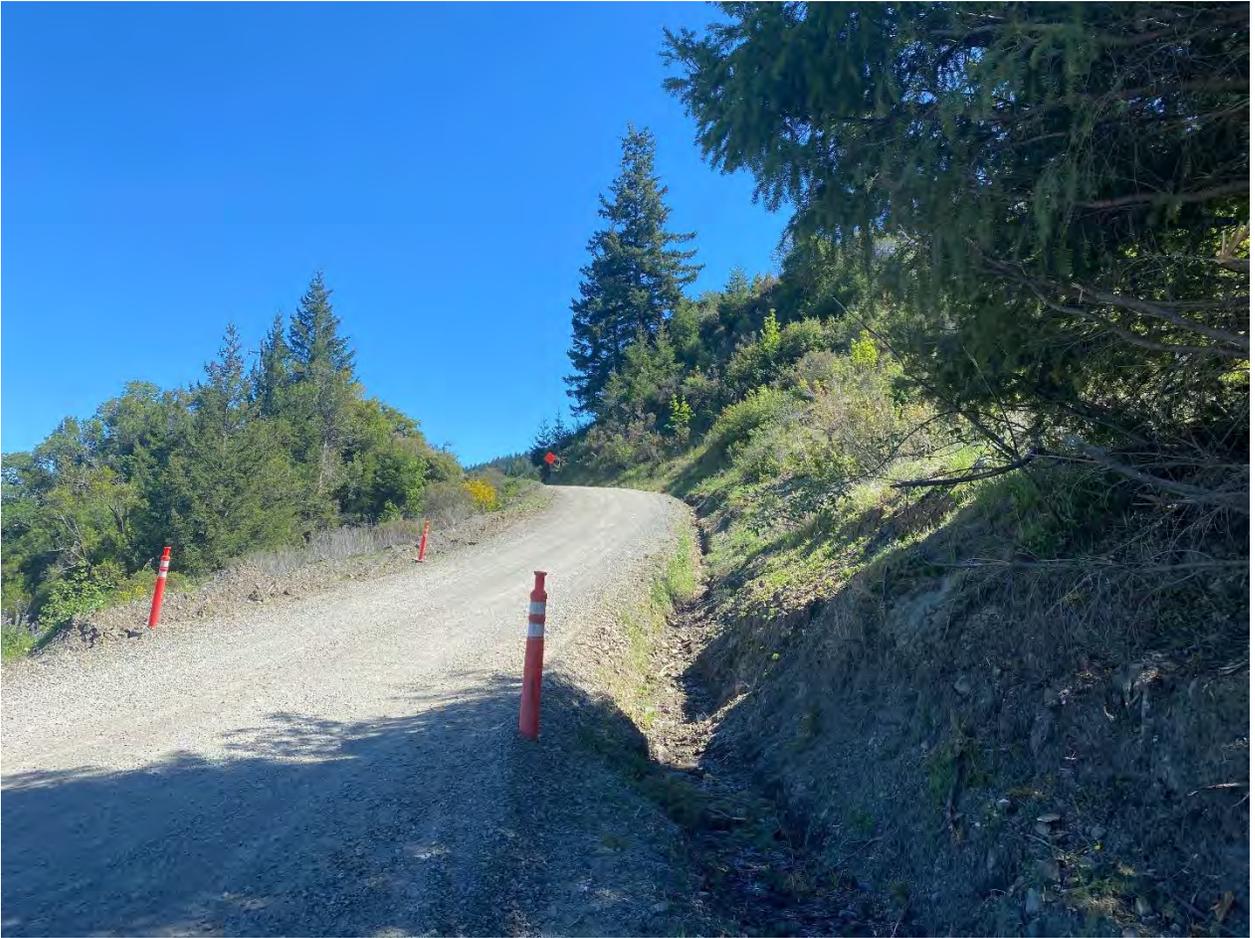
Photo 7. Ditch 2, observed along the western side of Mattole Road, directly below the hillside failure at the slope toe.

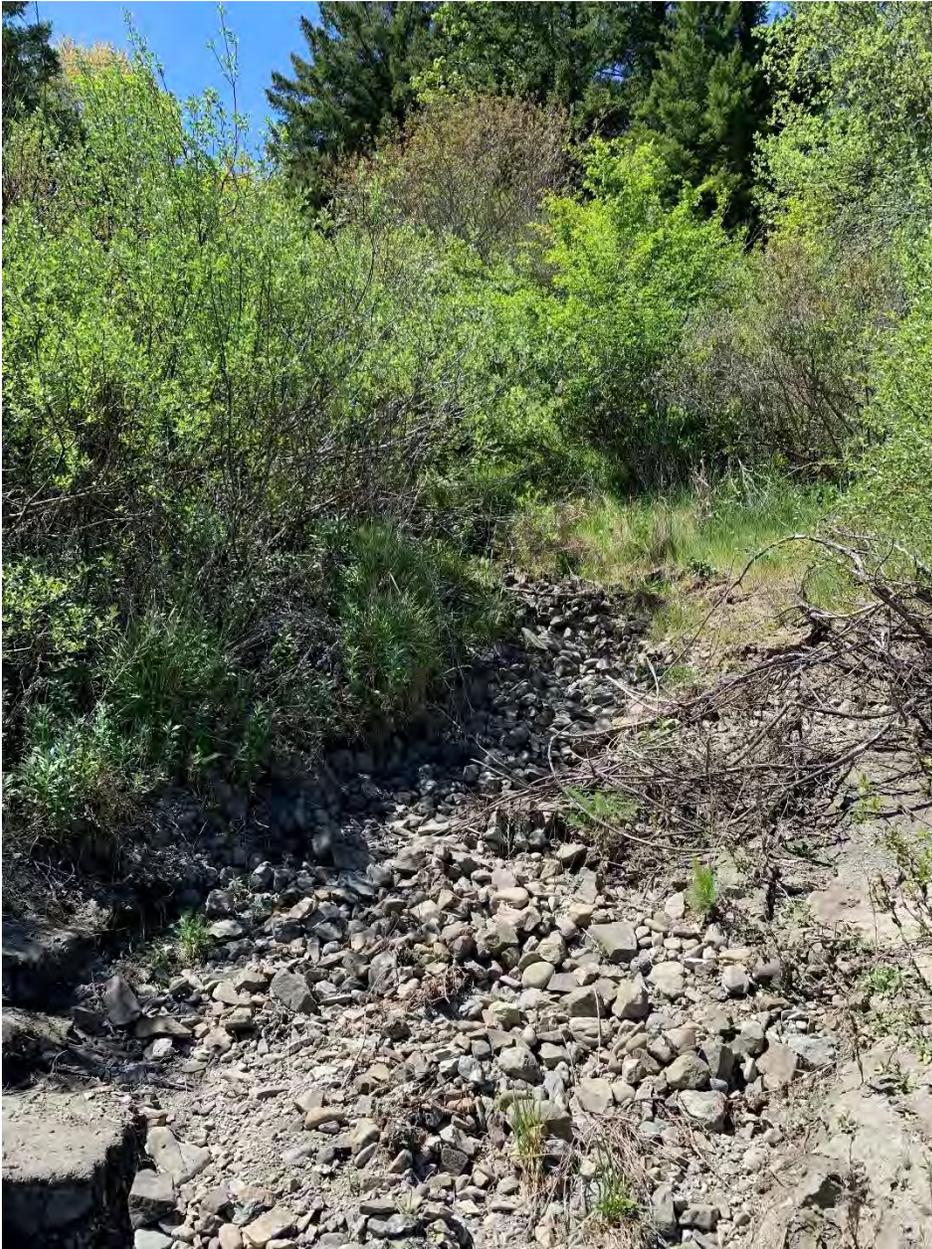
Photo 8. Watercourse 1, observed below the existing Mattole Road culvert outlet.

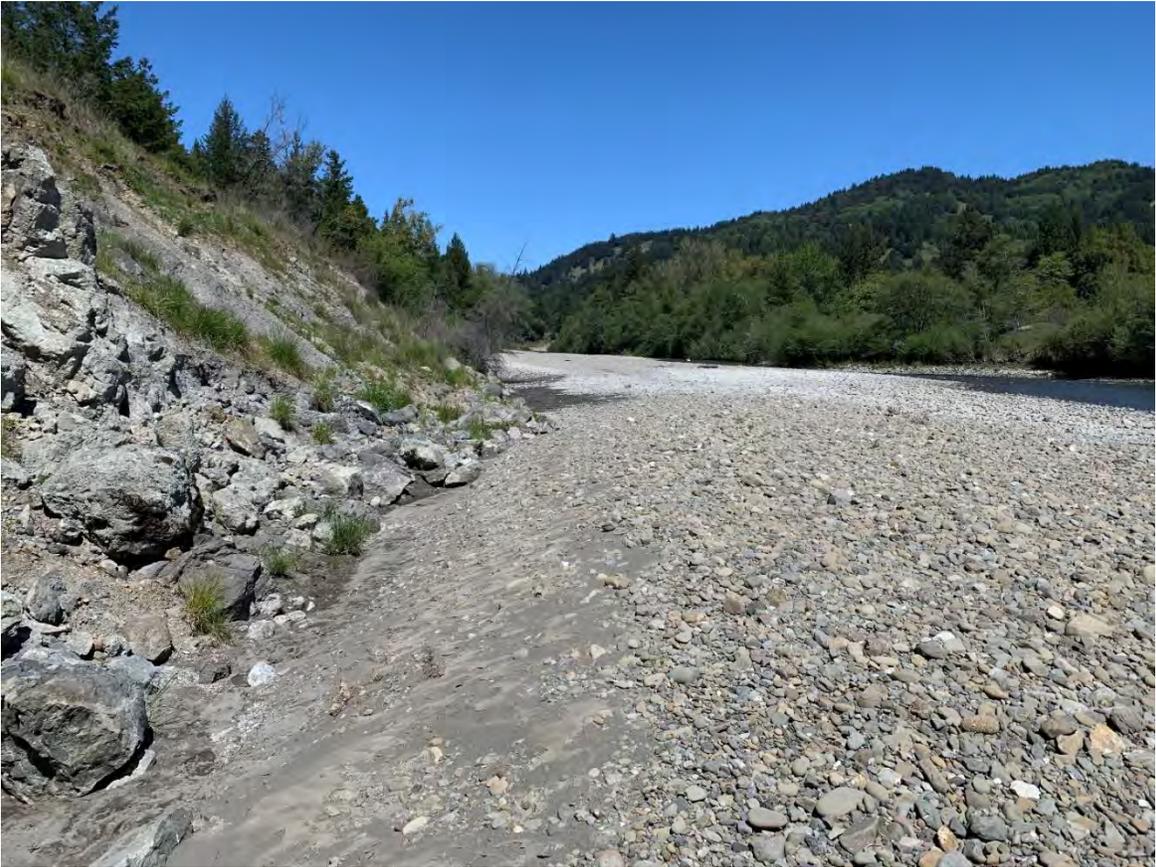
Photo 9. The Mattole Seasonal Side Channel is a seasonally connected component of the Mattole River observed at the base of the hillside failure. The gravel bar (above OHWM) separates the Seasonal Side Channel from the Mattole River.

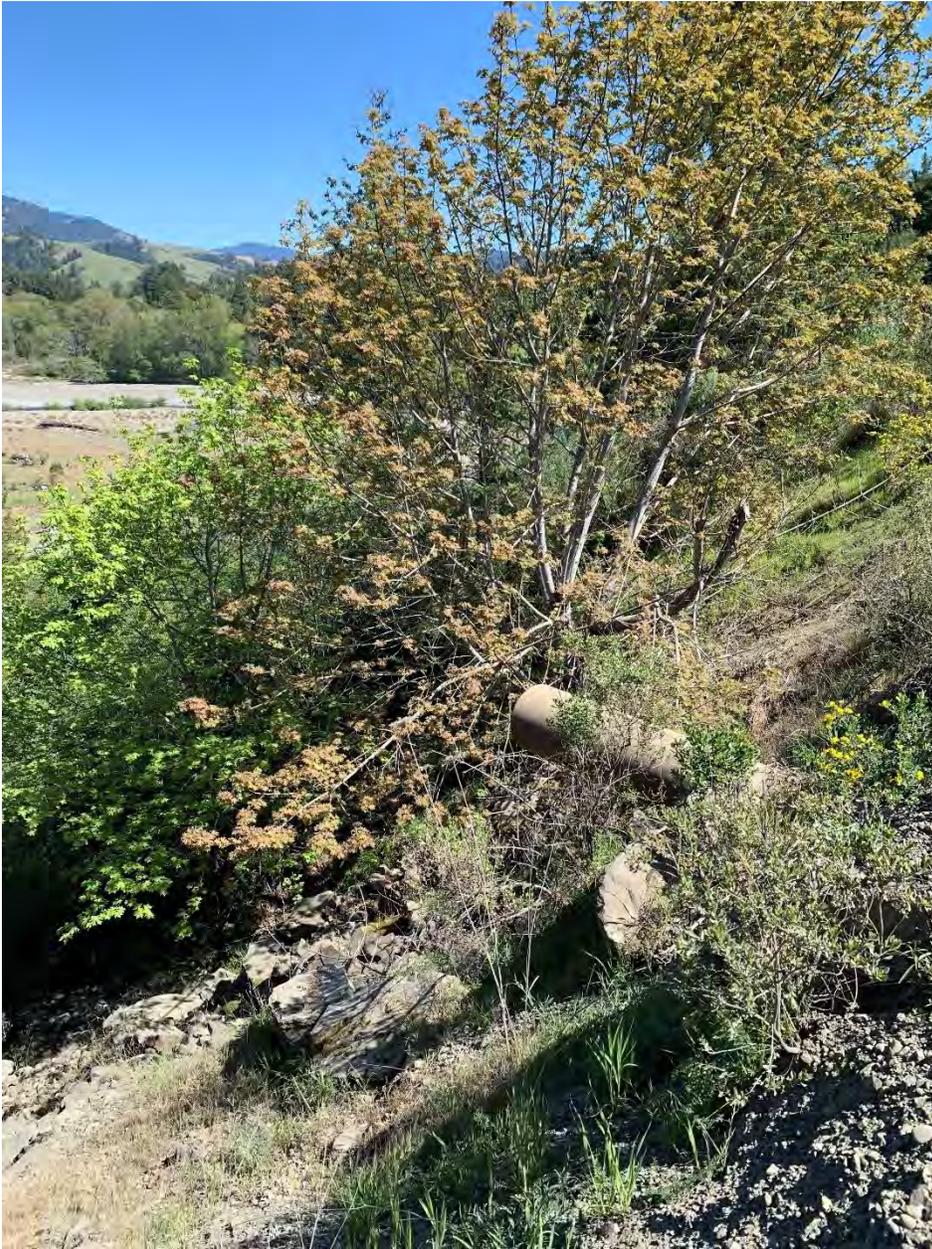
Photo 10. Culvert outlet above ephemeral drainage.
