Phase I Environmental Site Assessment

Nu-Way Live Oak Landfill
13620 Live Oak Lane
Irwindale, Los Angeles County, CA
September 16, 2021
Terracon Project No. CB217088

Re: Phase I Environmental Site Assessment
Nu-Way Live Oak Landfill
13620 Live Oak Lane
Irwindale, Los Angeles County, California 91706
Terracon Project No. CB217088

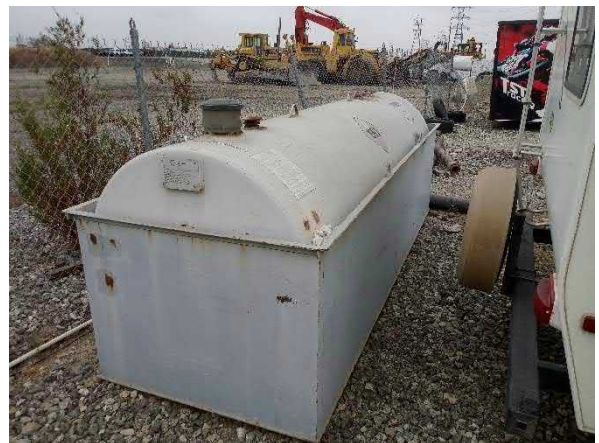
Photo #6 Empty and non-operation 1,000-gallon diesel fuel AST located on Lot 35.

Mike Bubalo construction storage area (Photo #30)	100	Unknown	Operational
Lot 35	Maintenance Area (Photo #13)	250	Used oil	Partially full
	Hazardous material storage shed (Photo #12)	100	New oil	Operational
	South of Steel Shed (Photo #6)	1,000	Empty*	Non-operational

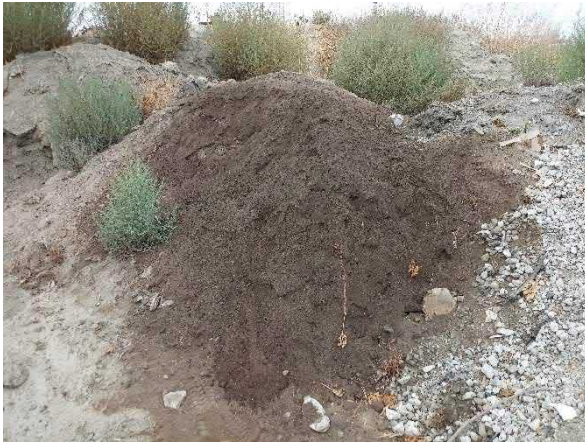
- Based on visual observations, estimated volume (approximately 100 cubic-feet) and unknown origin, the stained and stockpiled soil located on the southern portion of Lot 35 represents a REC in connection with the site.

Photo #7 Stained stockpiled soil located on the southern portion of Lot 35.

- Terracon recommends conducting a limited site investigation to evaluate subsurface conditions associated with the identified RECs.
- Terracon recommends that if soils or groundwater located on the site are to be disturbed during future excavations or construction activities, proper procedures should be followed with respect to worker health and safety, and any affected soil or groundwater encountered should be properly characterized, treated, and/or disposed in accordance with applicable local, state or federal regulations. Terracon recommends the preparation of a soil and groundwater management plan to assist with management of these media.

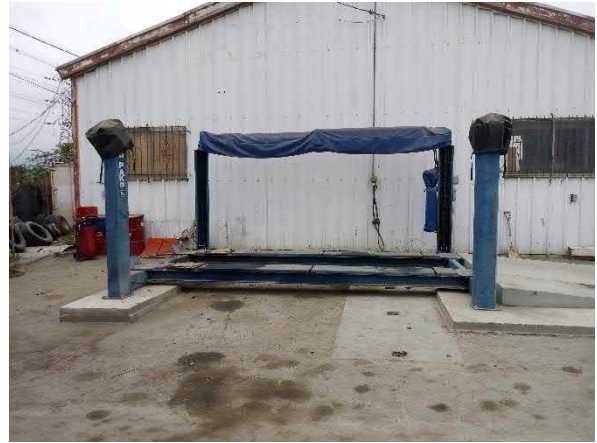
Photo #10 View of the aboveground hydraulic lift located adjacent to the maintenance garage on Lot 35.

On Lot 35, Terracon observed *de minimis* staining on the concrete pad under the 250-gallon tote containing used motor oil (Photo #13) and adjacent to the hydraulic lift (located in the maintenance area / Photo #10). The staining on the concrete was approximately 2 square-feet. Additionally, *de minimis* was observed on the concrete ground located inside the maintenance garage (Photo #18). The concrete appeared to be in good condition with no evidence of cracks or potential

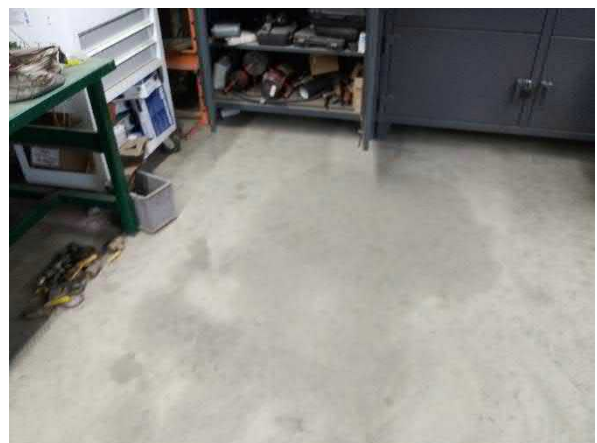
Photo #18 *De minimis* concrete staining located inside the maintenance garage on Lot 35.

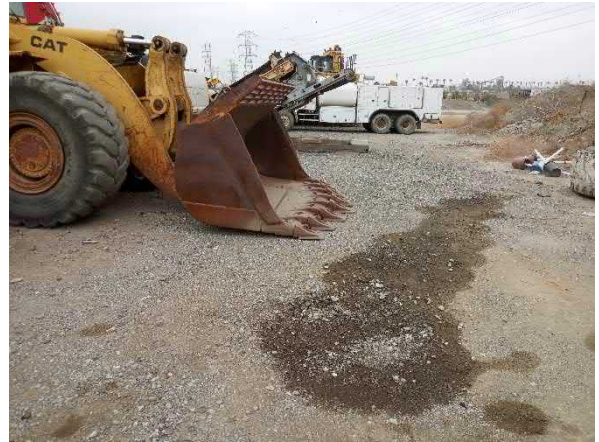
Terracon identified areas of stained soils located adjacent to the heavy machinery on Lot 35, beneath the metal storage containers located in the Mike Bubalo construction storage area, on the landfill site associated with drum storage area located behind the office near the landfill

- Based on visual observations of the drums and containers labeled used oil and hydraulic fluid and associated staining located behind the office near the landfill site entrance, the stained soil located in the Mike Bubalo construction storage yard, and the staining adjacent to the heavy machinery located on Lot 35, represent a REC in connection with the site.

Photo #21 Soil staining located on Lot 35.

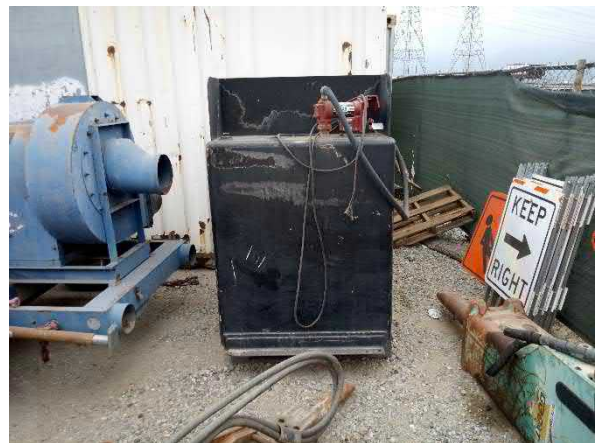
Photo #28 Approximately 250-gallon AST with unknown contents located inside the Mike Bubalo staging area.

Lot	Location	Approximate Size (gallons)	Contents	Status
Landfill	Near landfill entrance (Photo #37)	1,000	Diesel	Operational
	Mike Bubalo construction storage area (Photo #28)	250	Unknown	Non-operational
	Mike Bubalo construction storage area (Photo #29)	100	Unknown	Non-operational
	Mike Bubalo construction storage area (Photo #30)	100	Unknown	Operational

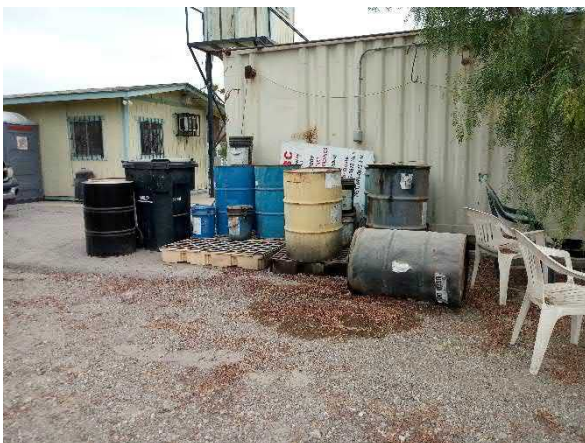
Photo #35 Hazardous materials storage area located near the landfill entrance.

Staining and/or releases were observed on the drums, the secondary containment (full), on the asphalt pavement and soil in the vicinity of the drums and containers, located behind the office near the landfill entrance. The area of stained asphalt pavement and soil was estimated to be approximately 50 square-feet and appears to be releasing onto the surrounding soil (Photo #36). Based on visual observations and the hazardous nature of the contents, the drums and containers labeled as used oil and hydraulic fluid represent a REC in connection with the site.

Staining and/or releases were observed on the drums, the secondary containment (full) and on the asphalt pavement in the vicinity of the drums and containers, located behind the office near the landfill entrance (Photos #35 and #36). The area of stained asphalt pavement was estimated to be approximately 50 square-feet and appears to be releasing onto the surrounding soil. Based on visual observations and the hazardous nature of the of their contents, the drums and containers of used oil and hydraulic fluid represent a REC in connection with the site.

- Staining was observed on the drums, secondary containment and on the asphalt pavement in the vicinity of the drums and containers, located behind the office near the landfill entrance (Photo #35). The area of stained pavement and soil was estimated to be approximately 50 square-feet and appears to be releasing onto the surrounding soil.

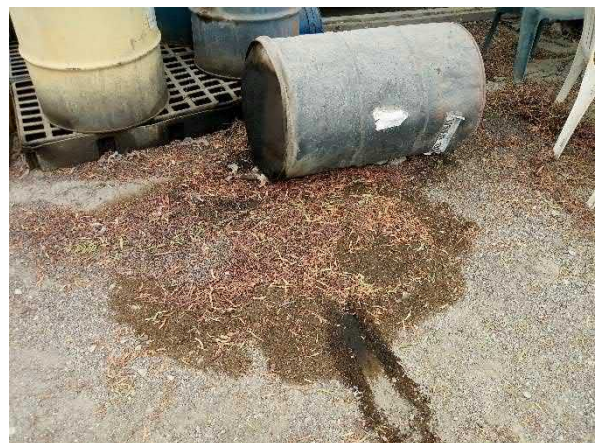
Photo #36 Soil staining emanating from a 55-gallon drum containing used oil, located near the landfill entrance.

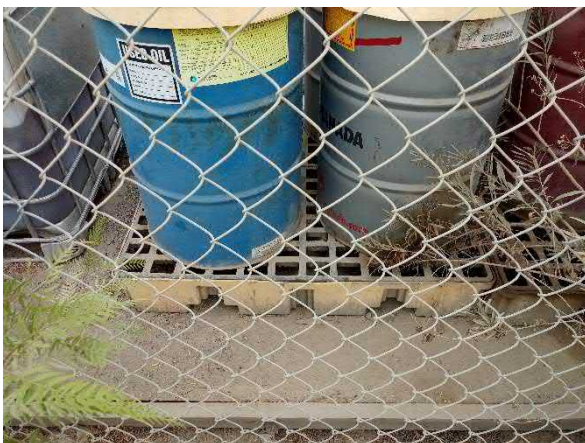
Photo #47 55-gallon drums on secondary containment located on the American Asphalt facility, and adjacent to the site boundary.

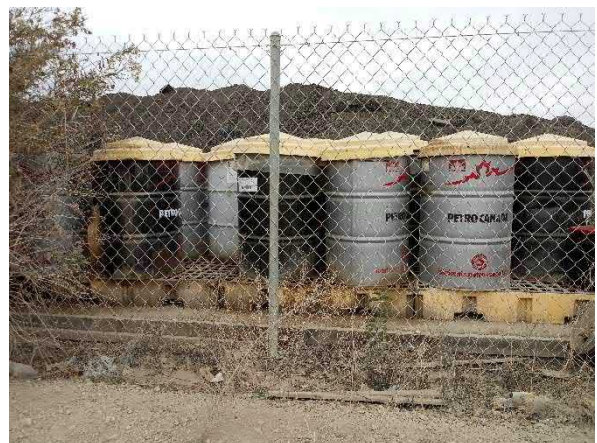
Photo #48 55-gallon drums on secondary containment located on the American Asphalt facility, and adjacent to the site boundary.
