**AN HISTORIC RESOURCE EVALUATION AND  
SECRETARY OF INTERIOR'S STANDARDS  
FOR THE TREATMENT OF HISTORIC  
PROPERTIES REVIEW OF THE PROPERTY  
LOCATED AT 3 NORTH STREET,  
HEALDSBURG, SONOMA COUNTY**

**February 12, 2018  
(Updated December 8, 2021)**

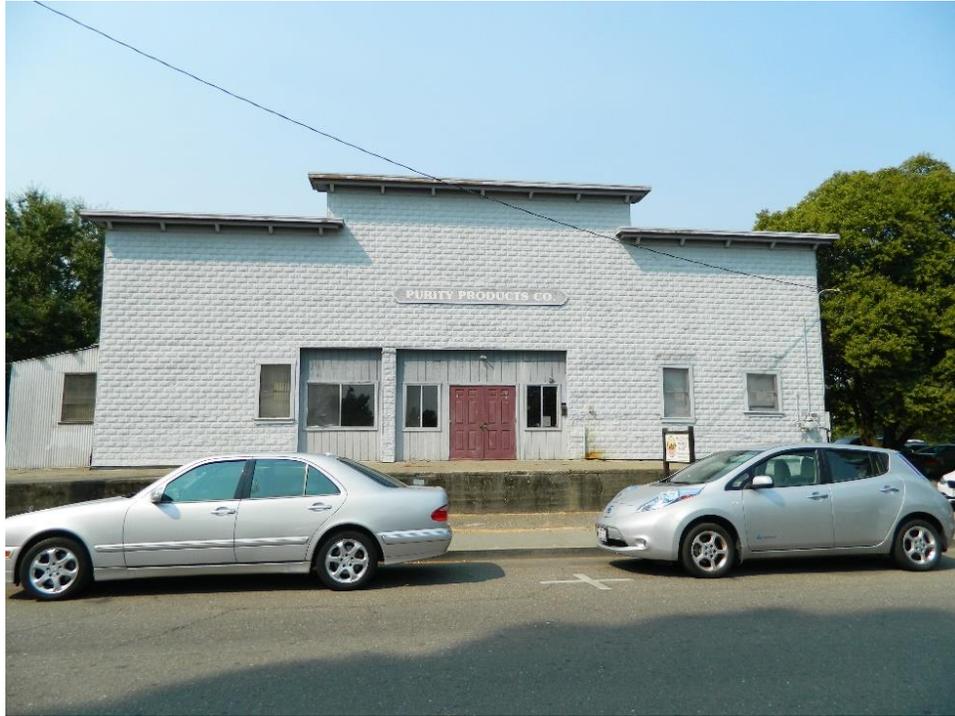
**Figure 13. Photograph showing the primary façade, facing north.**

The primary façade (south elevation) consists of a stepped parapet and is clad in decorative stamped metal sheets that were popular in the 1920s for its resistance to corrosion. The primary façade consists of a raised concrete loading dock and a ramp that faces east. The ramp was initially utilized for loading and unloading through wide barn-style doors (Figure 13). However, the original doorway was modified in the 1950s or 1960s that was enclosed with vertical wood paneling, and standard-sized double-entry doors, as well as three metal slider windows. There are three window openings along this façade and four original double-hung wood windows and wood trim along the primary façade that appear to be in fair condition (Figure 14). The stepped parapet is constructed of wood and consists of an overhanging eave and a decorative wood cornice and a wide wood fascia board (Figure 15). There is also a metal sign, which is not original to the building, along the center of the primary façade that states "Purity Products Co." Although the stamped metal is original, the original painted signage that once showed Cerri Brothers, Rosenberg Brothers, and Del Monte had been painted over. Changes to the primary façade, which occurred in the 1960s (and possibly in the 1970s), including several window openings, changes to the front entry, and the infill of the front entry opening, are incompatible with the original design.

The proposed Project consists of the rehabilitation and reconstruction of the false front façade, including the restoration of the stepped parapet, or based on a condition assessment, may include the reconstruction of the stepped parapet, including the wood cornice and wood frieze based; the removal of the incompatible 1950s/1960s alterations, including the vertical wood paneling, standard sized double-entry doors, and three metal slider windows; and the rehabilitation of the primary façade utilizing the Rehabilitation guidelines to reconstruct the centered front entrance opening, which will be flanked by new side openings that will replace several incompatible windows (Figure 24). Any features that are reconstructed due to their inability or feasibility to be restored will be based on historic photographs and physical evidence. The majority of these changes to the false front façade is considered rehabilitation, but the need to reconstruct instead of restoring the parapet *must* be based on physical evidence that the removal of historic materials is necessary, either due to their inability to be restored or feasibility related to costs. As such, the architectural designs completed by TLCDC Architecture (dated 11/23/2021) include the reconstruction of the parapet with like materials and design.

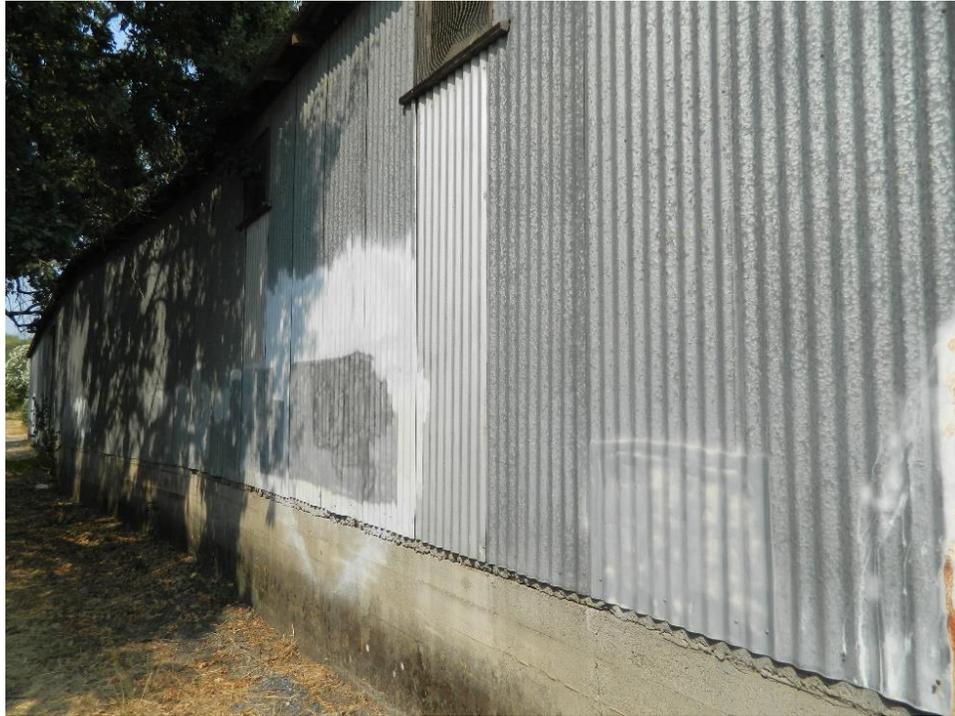
**Figure 16. Photograph showing the west elevation, facing north.**

The west elevation consists of a shed addition, which may have consisted of some open bays at one time for loading when the building was a fruit packing warehouse. The west elevation is clad in panels of sheet metal (Figure 16 and Figure 17). There are also several double-hung wood windows along the upper portion of the walls near the roof overhang of the shed addition. The windows are wood and appear to be original to the building, or at least over 50 years in age. The shed roof consists of exposed rafters and a corrugated sheet metal roof. The concrete loading dock also extends around a portion of the west façade, and there are several doors that appear to be original entryways to the building. However, it is unclear if the doors are original.

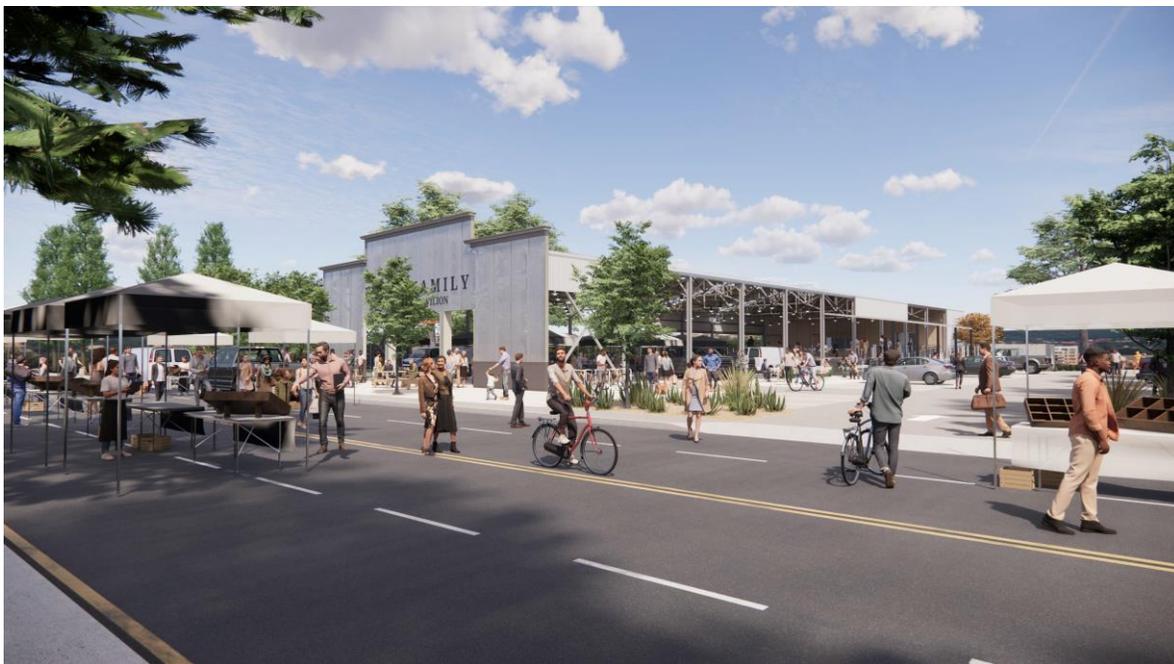
Figure 26. 3D rendering shows the ca. 1922 Cerri Brothers commercial warehouse building (TCLD Architecture, 11/23/2021).

No conjectural features or architectural elements from other buildings are included in the Project (Figure 26).

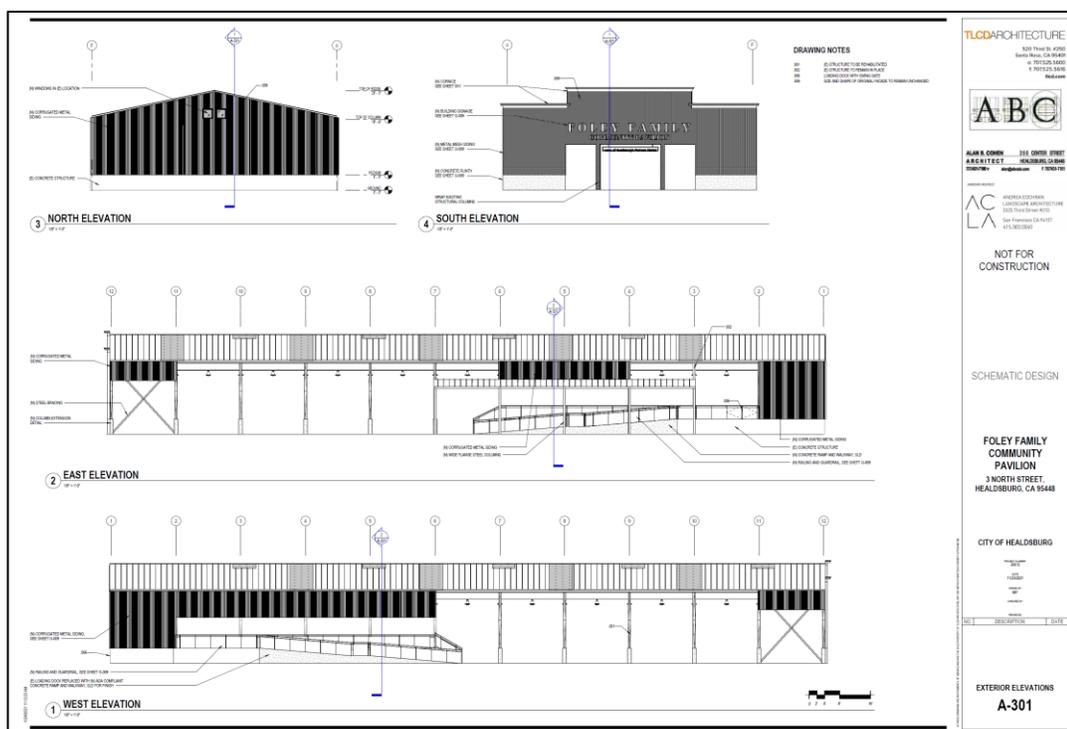
Figure 27. Drawing showing the proposed exterior elevations of the 1922 building (TCLD Architecture, 11/23/2021).

The exterior alterations as part of the proposed Project are compatible with the massing, size, scale, and architectural features of the 1922 building and protect the historic integrity of the property and its environment to convey its significance under Criterion 1 for its association with early twentieth-century fruit and nut packing industry within the City of Healdsburg.

A new standing seam metal roof with skylights will replace the original corrugated metal roof, which is in keeping with the Standards for Rehabilitation.

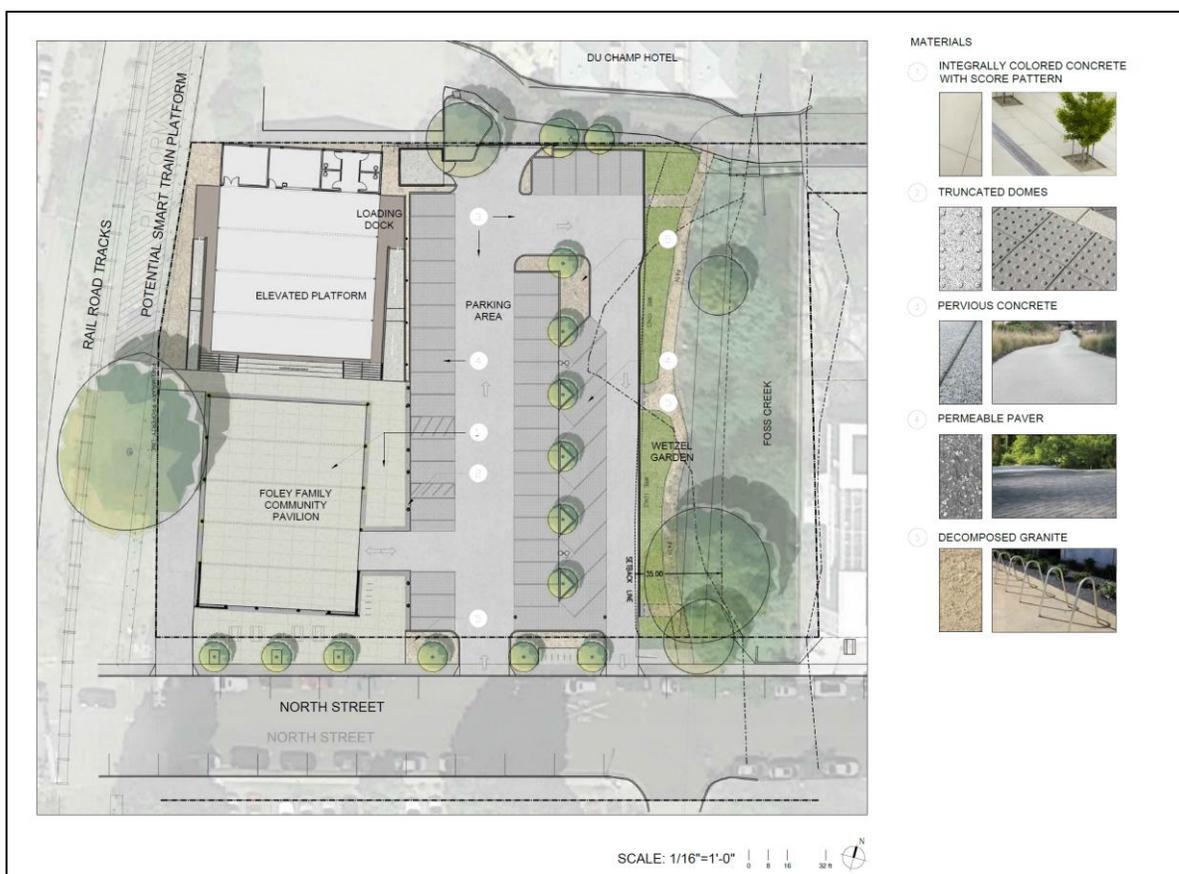
Figure 28. Landscape materials plan (TCLD Architecture, 11/23/2021).

The current changes to the associated landscape include the installation of scored, pervious, and permeable concrete and decomposed granite for walkways and the parking area, as well as the planting of approximately 12 trees and 213 shrubs (Figure 28). These changes are minimal and will not affect the integrity of the 1922 building.
