**V. SATTUI WINERY INC.
HIBBARD RANCH**

**EROSION CONTROL PLAN
REVISED APRIL 2020**

**REVISED APRIL 2020
ORIGINAL SUBMITTAL FEBRUARY 2019**

**PPI ENGINEERING
2800 JEFFERSON STREET
NAPA, CALIFORNIA 94558
(707) 253-1806**

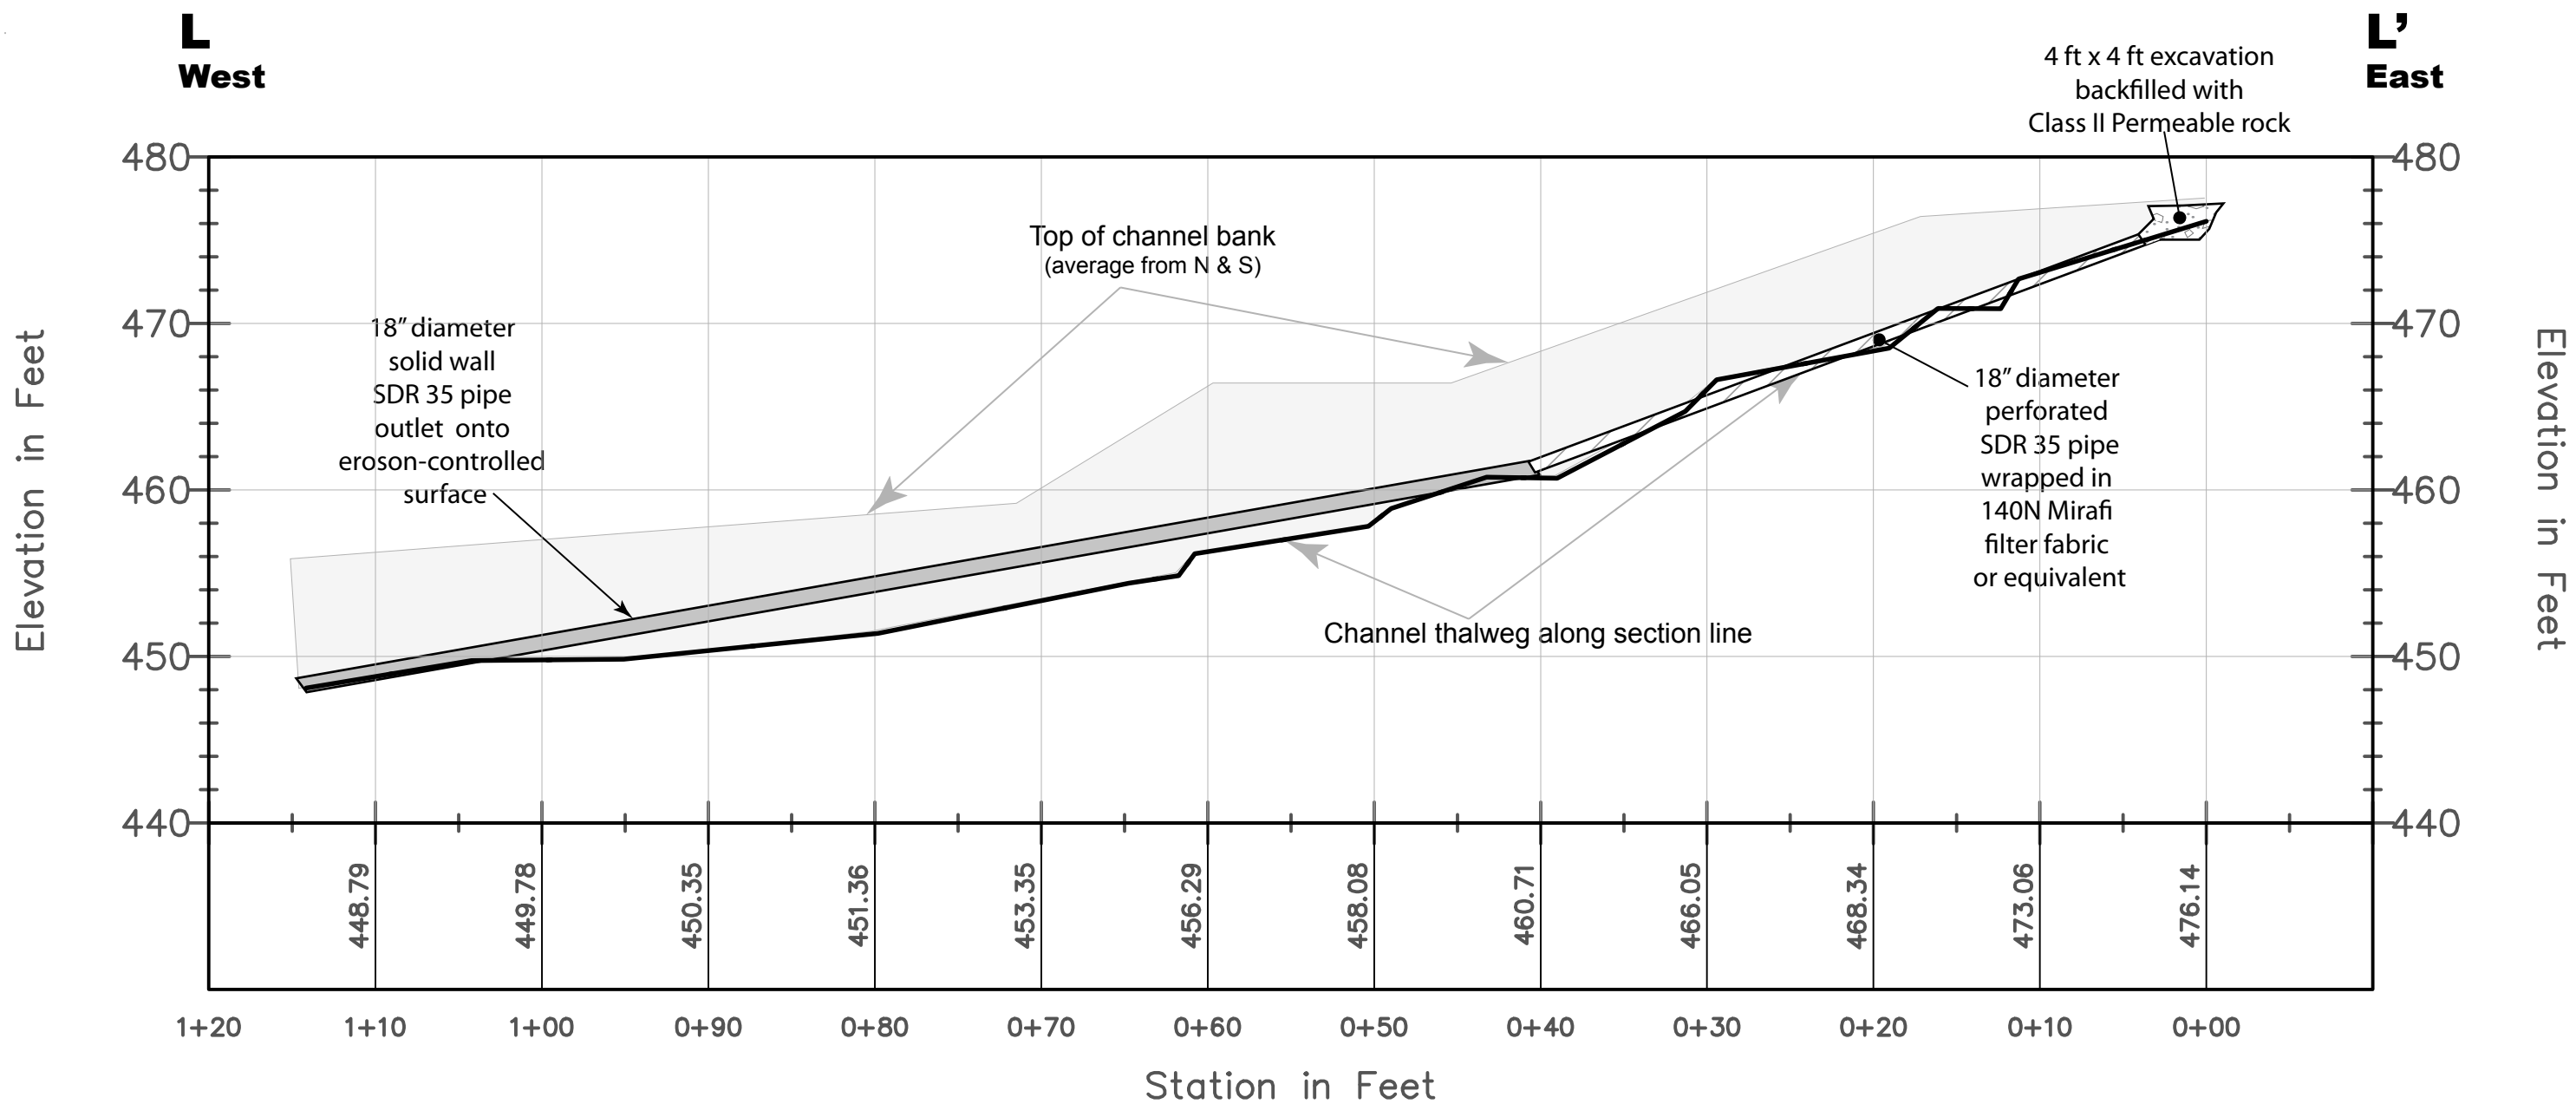
CROSS SECTION L - L' Block 7A		
Hibbard Ranch Henry Road Napa, California		
Date 1/24/20	Project No. 91650.01	Figure 5B

- Constuction Sequence:**
1. rough grade channel to fit pipe
 2. place 18"-diameter pipe
 3. excavate and place Class II permeable material at top of pipe
 4. cover pipe and restore natural ground surface

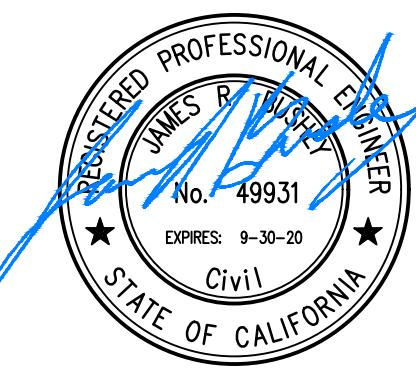
V. SATTUI WINERY INC.
HIBBARD RANCH
EROSION CONTROL PLAN
BLOCK 1

TOPOGRAPHIC MAPPING PROVIDED BY AMERICAN AERIAL MAPPING, INC. MAY 2017. 2' CONTOUR INTERVAL

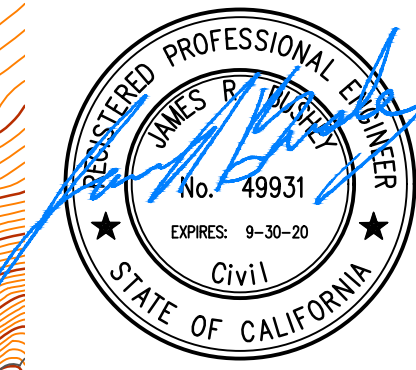
V. SATTUI WINERY INC.
HIBBARD RANCH
EROSION CONTROL PLAN
BLOCKS 7 & 9

TOPOGRAPHIC MAPPING PROVIDED BY AMERICAN AERIAL MAPPING, INC. MAY 2017. 2' CONTOUR INTERVAL

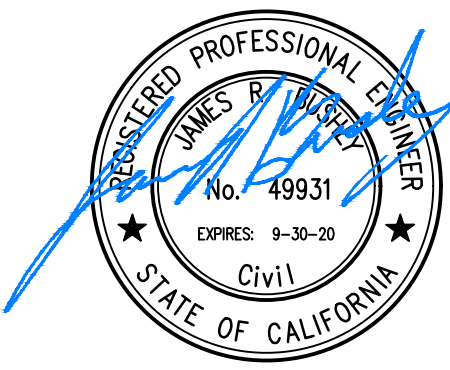
V. SATTUI WINERY INC.
HIBBARD RANCH
EROSION CONTROL PLAN
BLOCK 6

USDA SOIL CLASSIFICATIONS:

- 132 FAGAN CLAY LOAM, 15-30% SLOPE
- 133 FAGAN CLAY LOAM, 30-50% SLOPE
- 136 FELTON GRAVELLY LOAM, 30-50% SLOPE

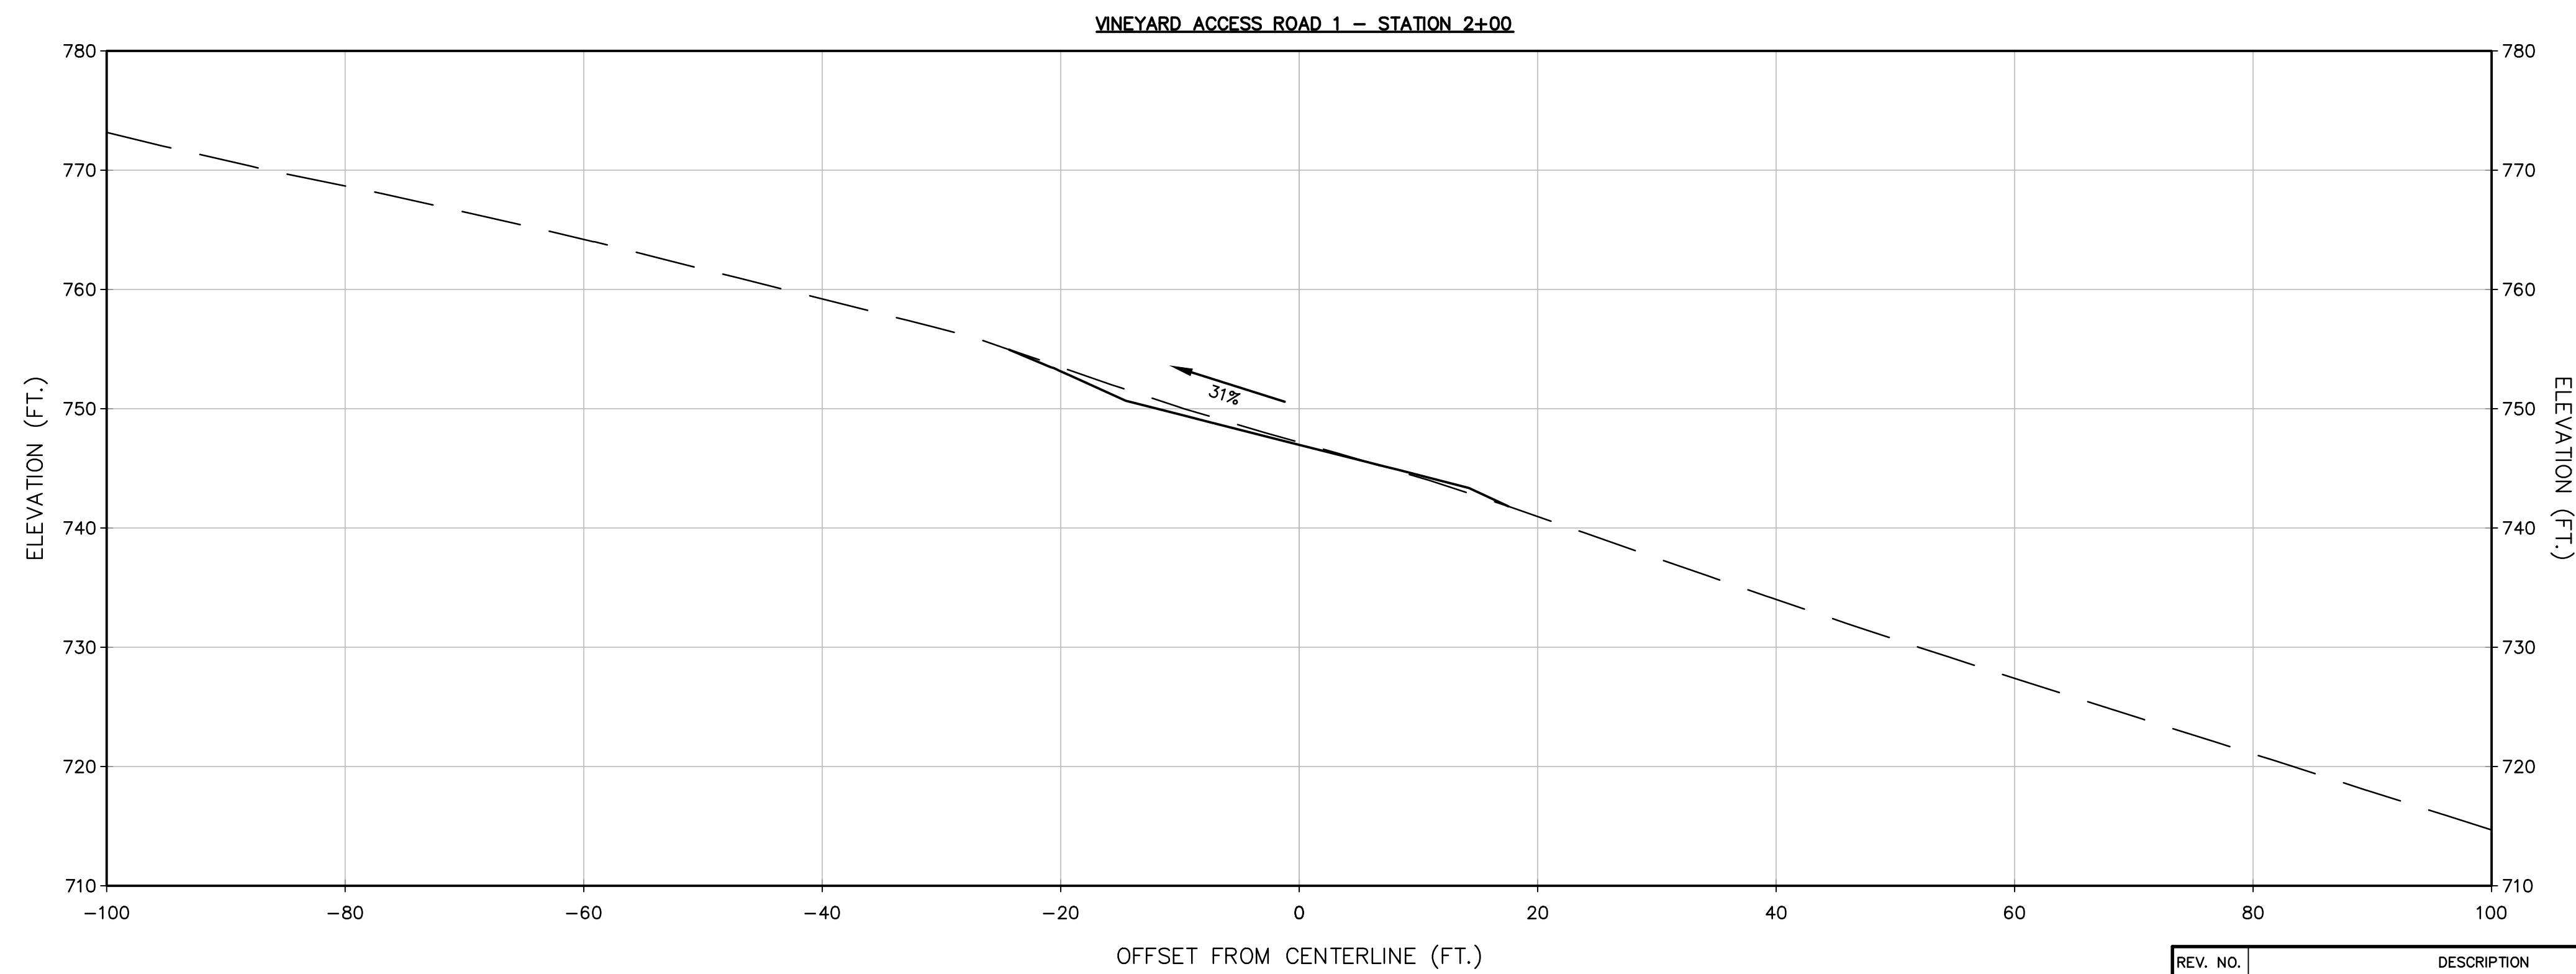
VINEYARD ACCESS ROAD 1 – CROSS SECTIONS

TOTAL LENGTH (FT.)	STA.	SLOPE (%)	AVERAGE SLOPE (%)
200	0+00	25%	28%
	1+00	29%	
	2+00	31%

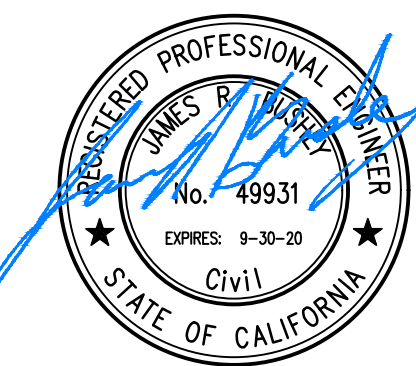
EROSION CONTROL PLAN
DETAILS – ACCESS ROAD 1

VINEYARD ACCESS ROAD 1 – SLOPE TABLE
