## Aquatic Resources Delineation Report Mojave 68 Project San Bernardino County, California

### **Industrial Property Group, Inc.**

## Huffman-Broadway Group, Inc. ENVIRONMENTAL REGULATORY CONSULTANTS

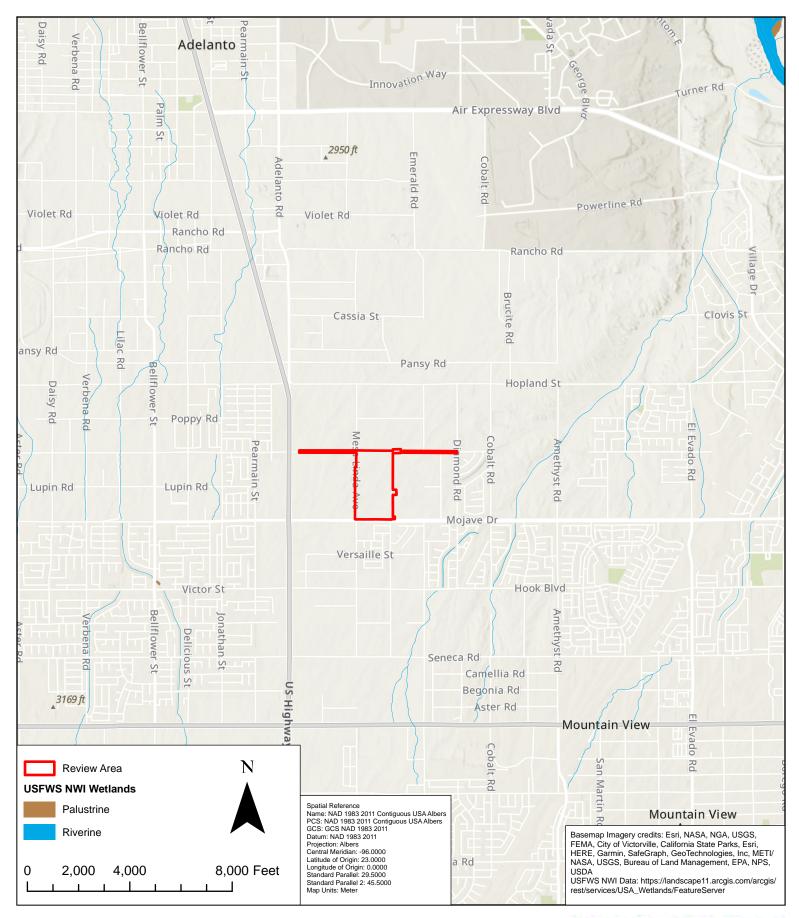
# Figure 4a. USFWS National Wetlands Inventory Mapping

A review of national Wetland Inventopry Mapping associated with the Review Area found no wetlands or deepwater habitats present (Appendix A, Figure 4a).

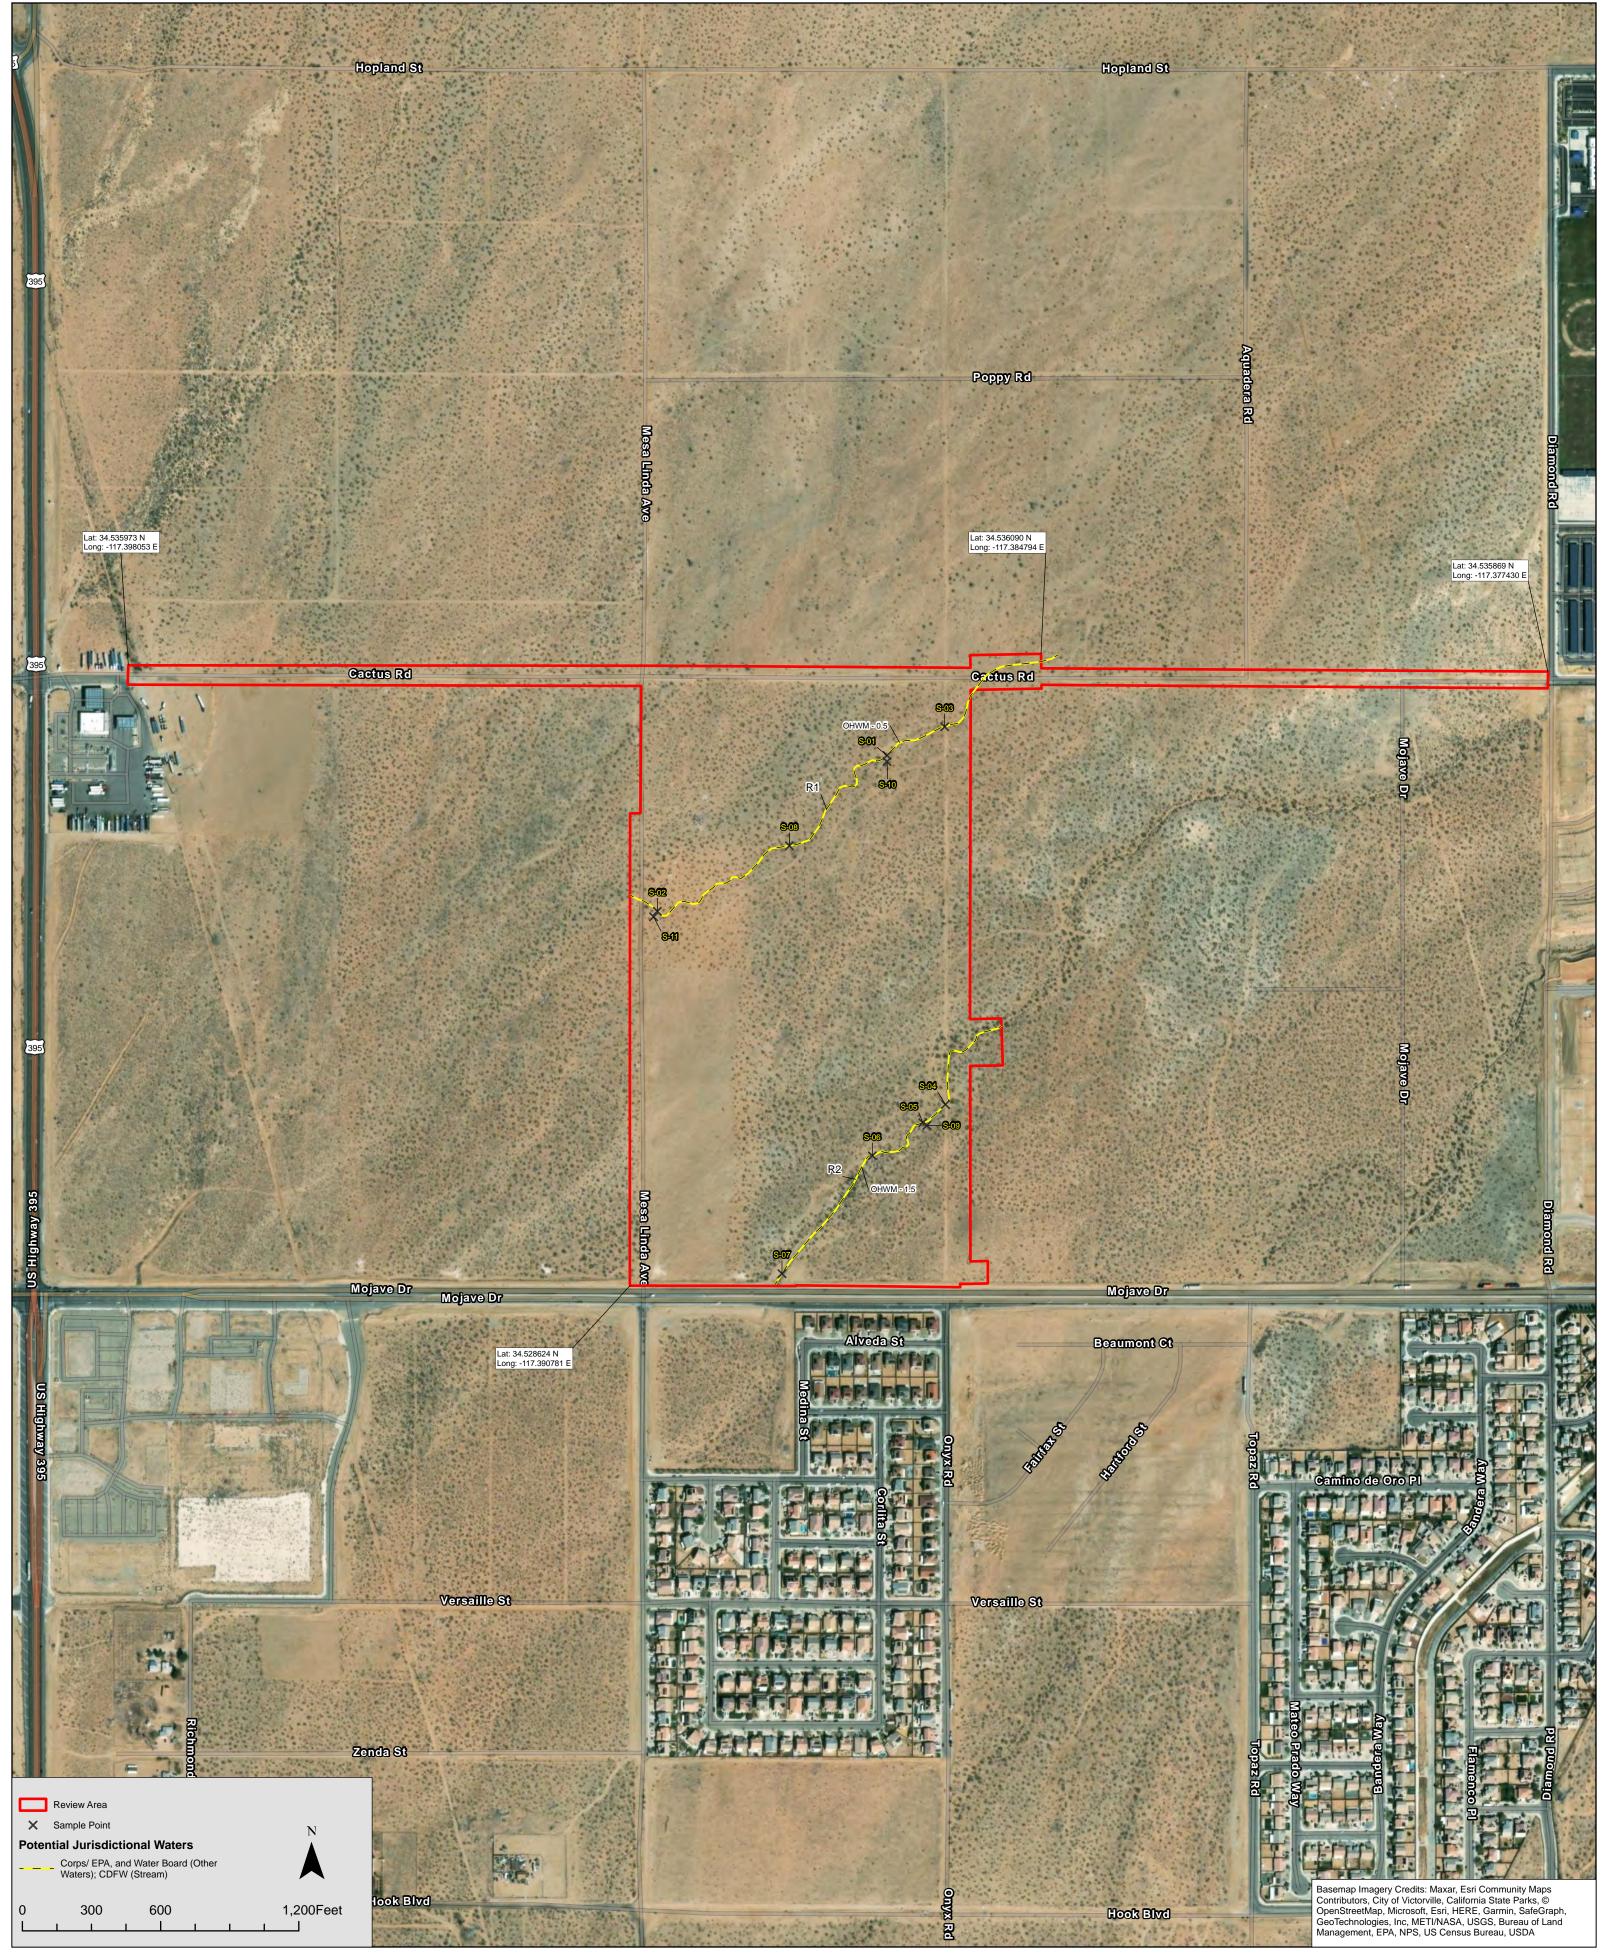
**Figure 6. Aquatic Resource Delineation**

Streams With Observable Physical Features. OHWMs were observed within streams at eight sample point locations within the Review Area (Appendix A, Figure 6). Physically, ephemeral streams exhibited bed and bank characteristics. Appendix A, Figure 6 shows locations where streams having an OHWM were identified and measured. Flow indicators within these streams included at least two or more of the following: sand & gravel bars; cut banks; drift: organic; headcuts; knick points; overturned rocks; rills; scour; sediment sheets; vegetation - channel alignment; water-cut benches; water level marks; and wrack: woody. Appendix F provides OHWM widths and latitude/longitude locations where OHWM determinations were made within the Review Area. Appendix E provides field data sheets (see sample points S-01 – S-08).

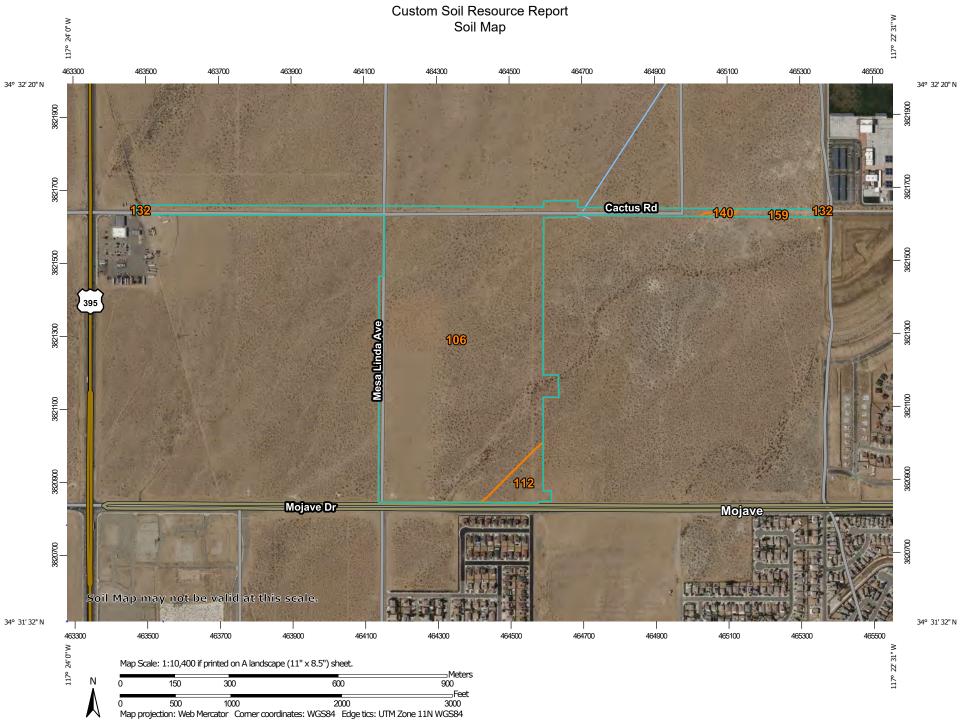
# Soil Map

The soil map section includes the soil map for the defined area of interest, a list of soil map units on the map and extent of each map unit, and cartographic symbols displayed on the map. Also presented are various metadata about data used to produce the map, and a description of each soil map unit.

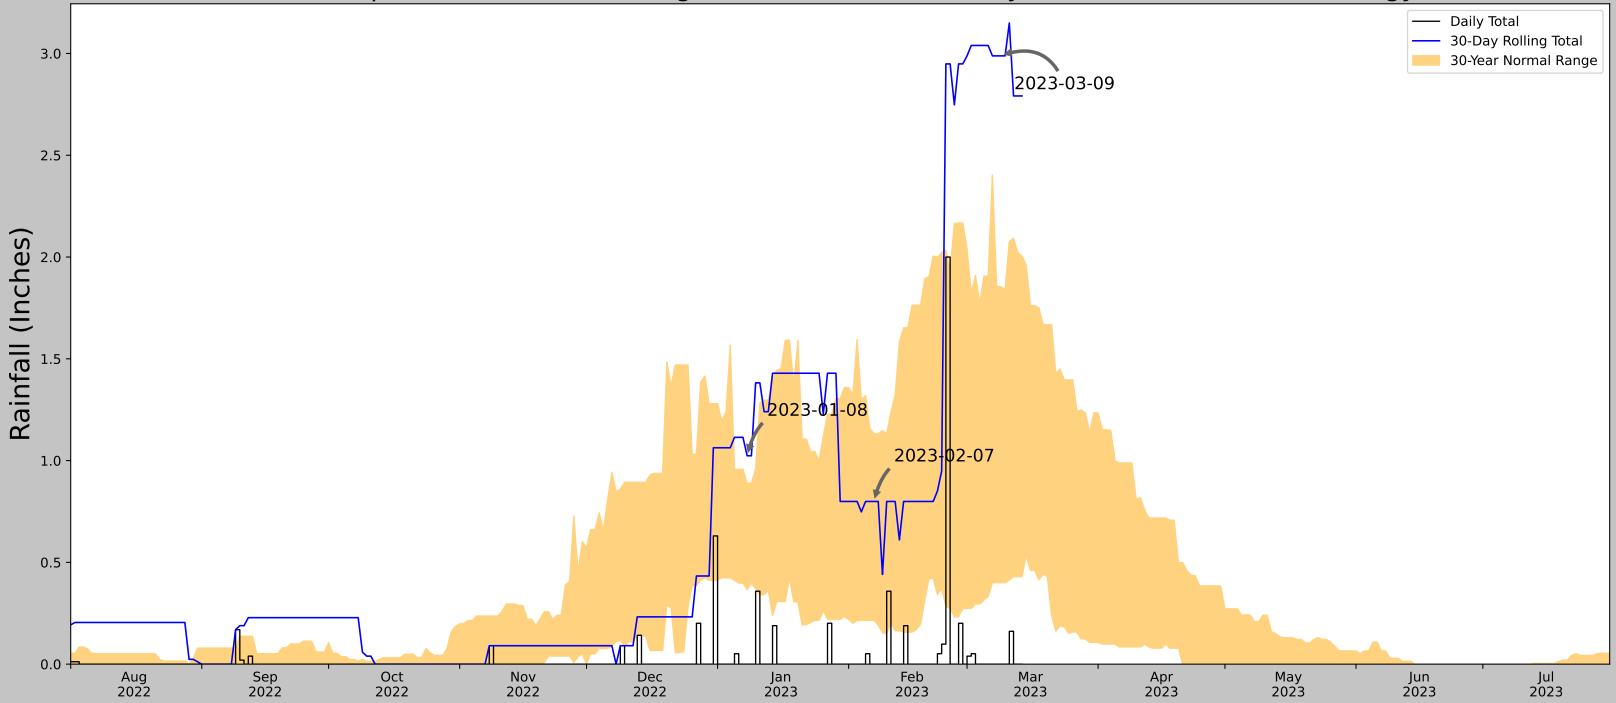
# Antecedent Precipitation vs Normal Range based on NOAA's Daily Global Historical Climatology Network

According to APT analysis results, the field survey was conducted during a mild drought following a 90-day period of precipitation ranging from wet to normal to wet conditions (Appendix D).

Coordinates	34.531834, -117.388154
Observation Date	2023-03-09
Elevation (ft)	3008.67
Drought Index (PDSI)	Mild drought (2023-02)
WebWIMP H <sub>2</sub> O Balance	Wet Season

30 Days Ending	30 <sup>th</sup> %ile (in)	70 <sup>th</sup> %ile (in)	Observed (in)	Wetness Condition	Condition Value	Month Weight	Product
2023-03-09	0.4	1.854331	2.988189	Wet	3	3	9
2023-02-07	0.214567	1.131102	0.799213	Normal	2	2	4
2023-01-08	0.366142	0.888583	1.023622	Wet	3	1	3
Result							Wetter than Normal - 16

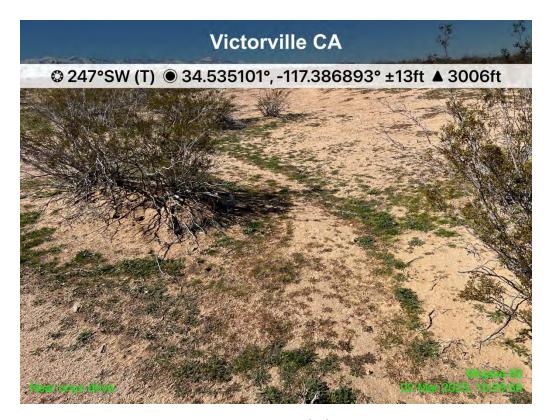
Ephemperal Drainage Channel (R1) and Vegetation

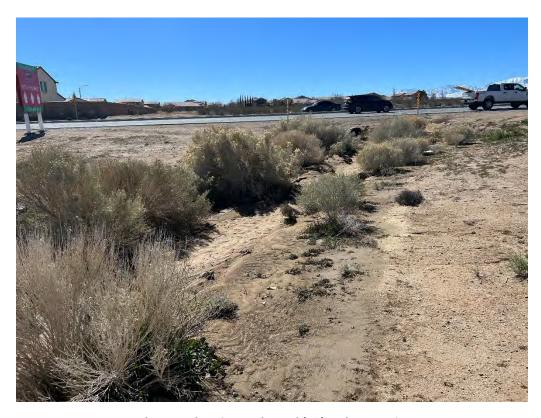
**Ephemperal Drainage Channel (R2) and Vegetation**

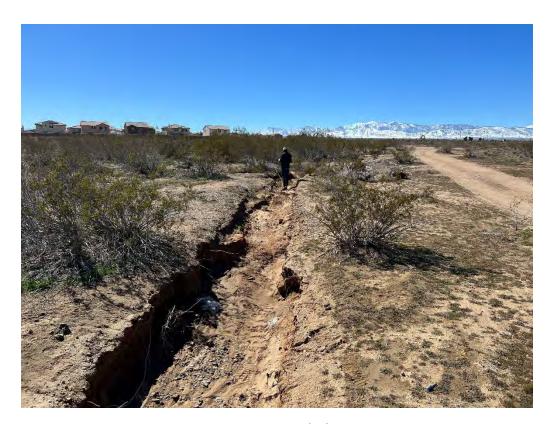
**Ephemperal Drainage Channel (R2) and Vegetation**
