**REVISED BIOLOGICAL RESOURCES ASSESSMENT  
749 SAN YSIDRO ROAD (APN 011-100-049)  
SANTA BARBARA COUNTY, CALIFORNIA**

Revised: December 10, 2021

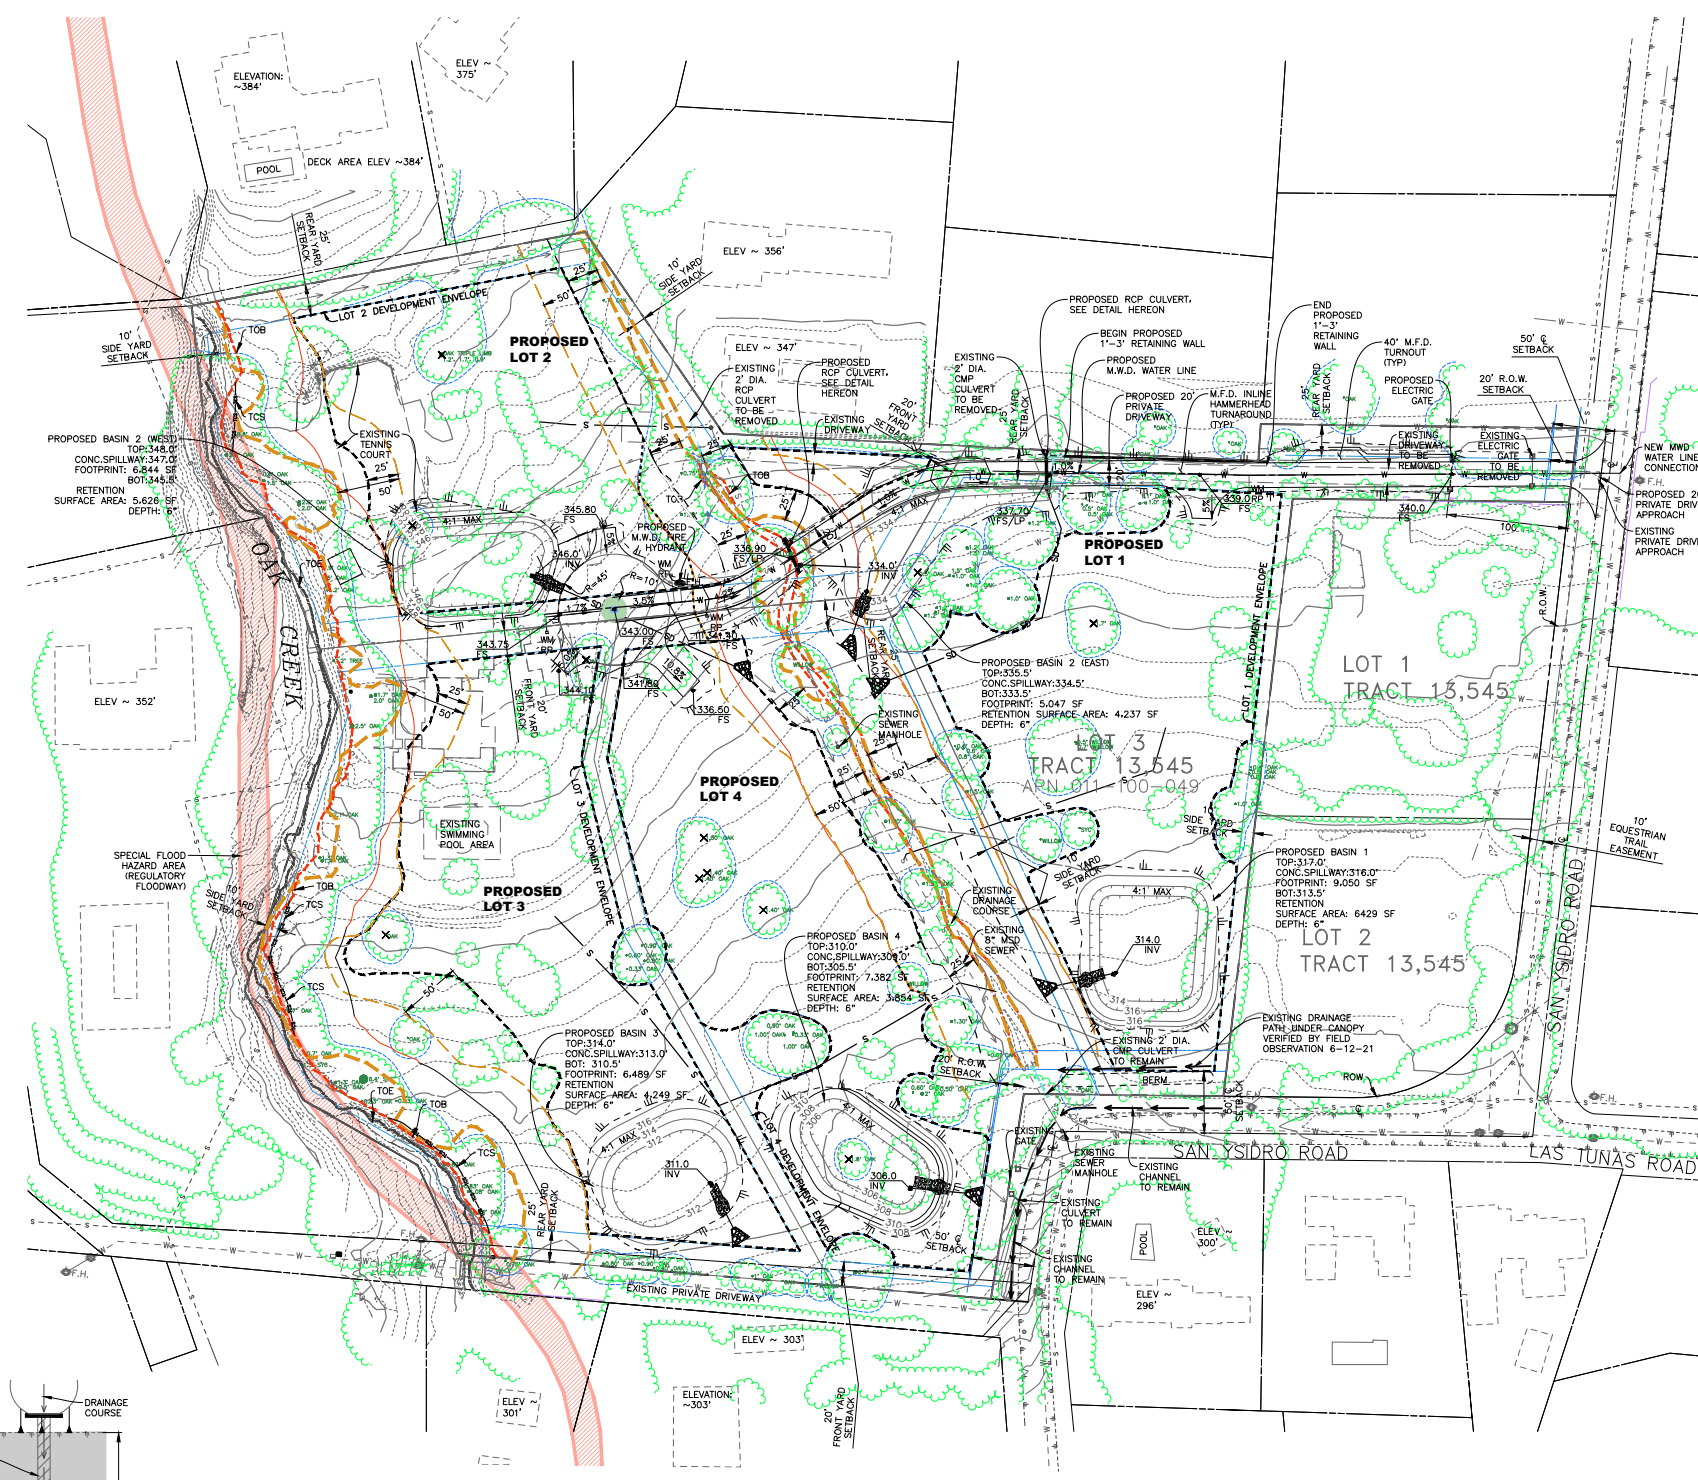
**Figure 2a**  
 December 10, 2021

**PROPOSED PRIVATE DRIVEWAY CULVERT DETAIL**

**Preliminary Grading and Drainage Plan**  
**Biological Resources Assessment**  
 749 San Ysidro Road  
 Montecito, Santa Barbara County, CA

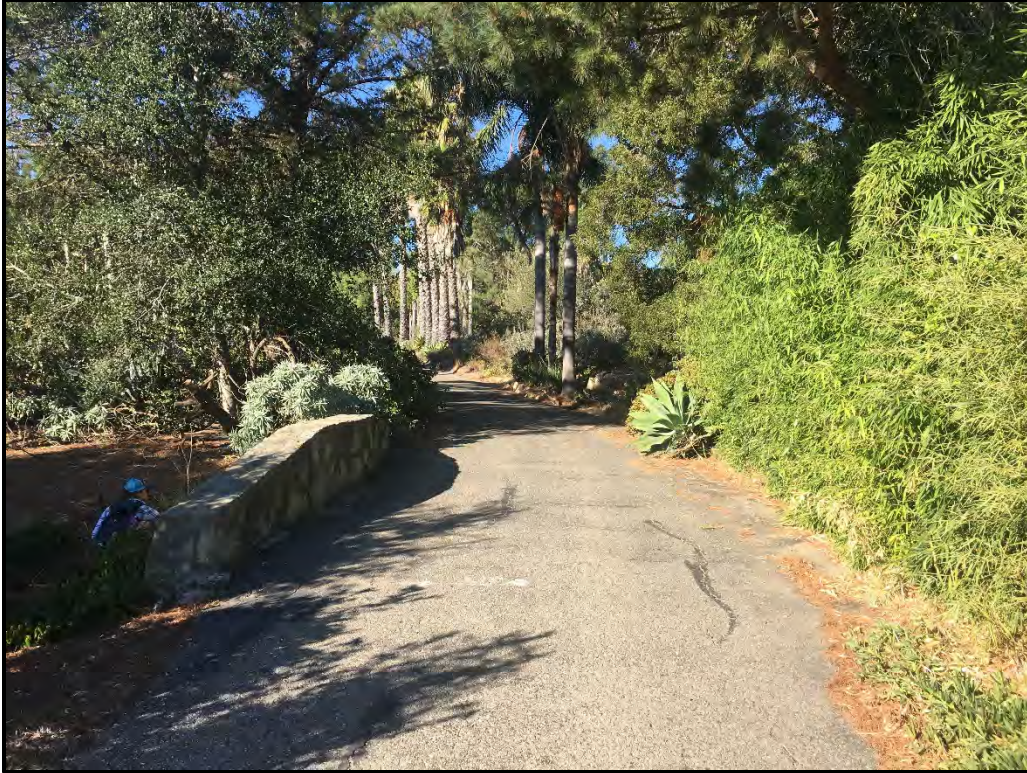
Photo 1: Main access driveway and existing bridge (Aspect: West). Photo taken 10/31/2019.

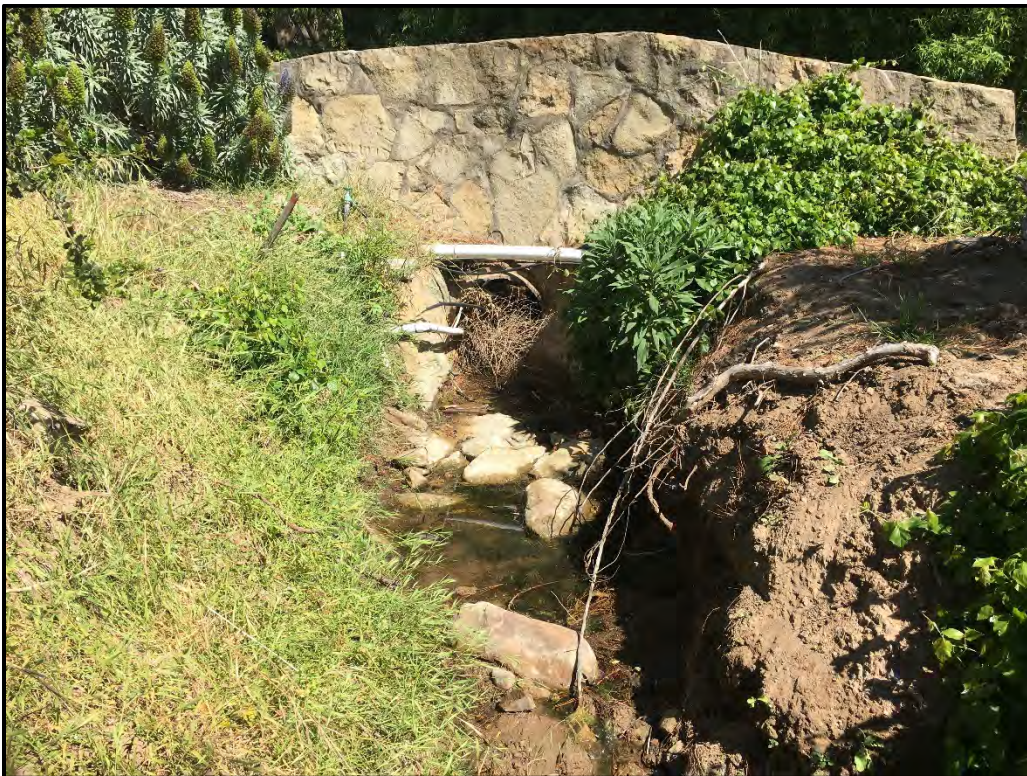
Photo 2: Existing 24 inch culvert under the bridge (Aspect: North). Photo taken 05/08/2020.

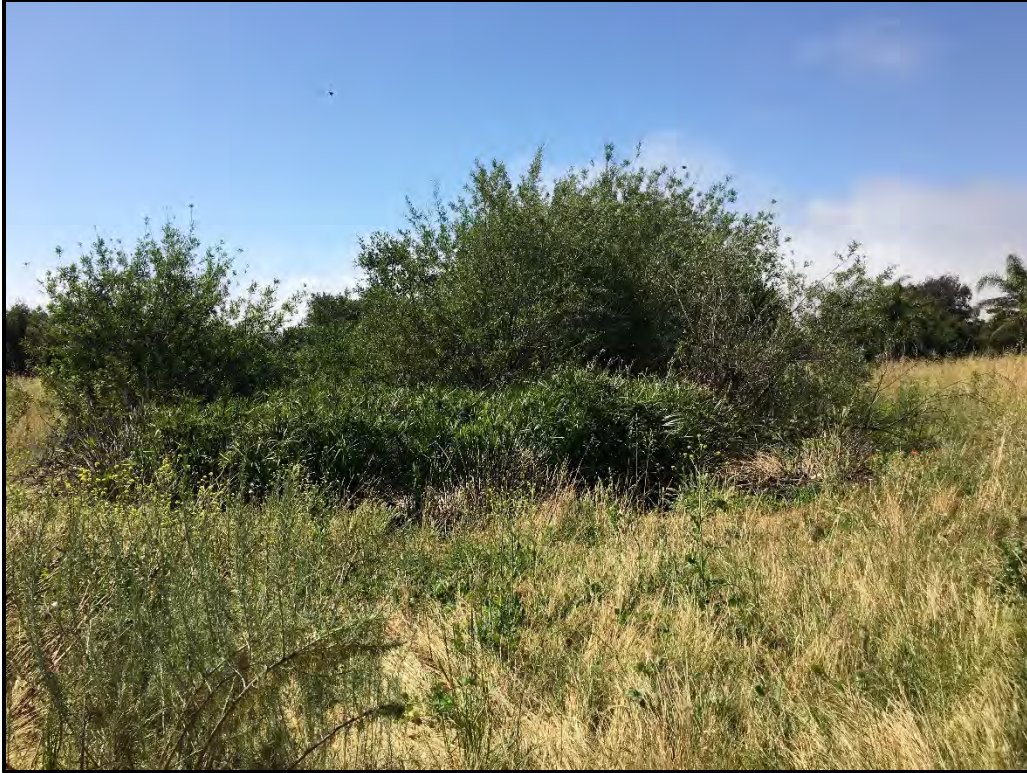
Photo 3: Arroyo willow thicket in ephemeral drainage, downstream of bridge/culvert (Aspect: Southeast). Photo taken 05/08/2020.

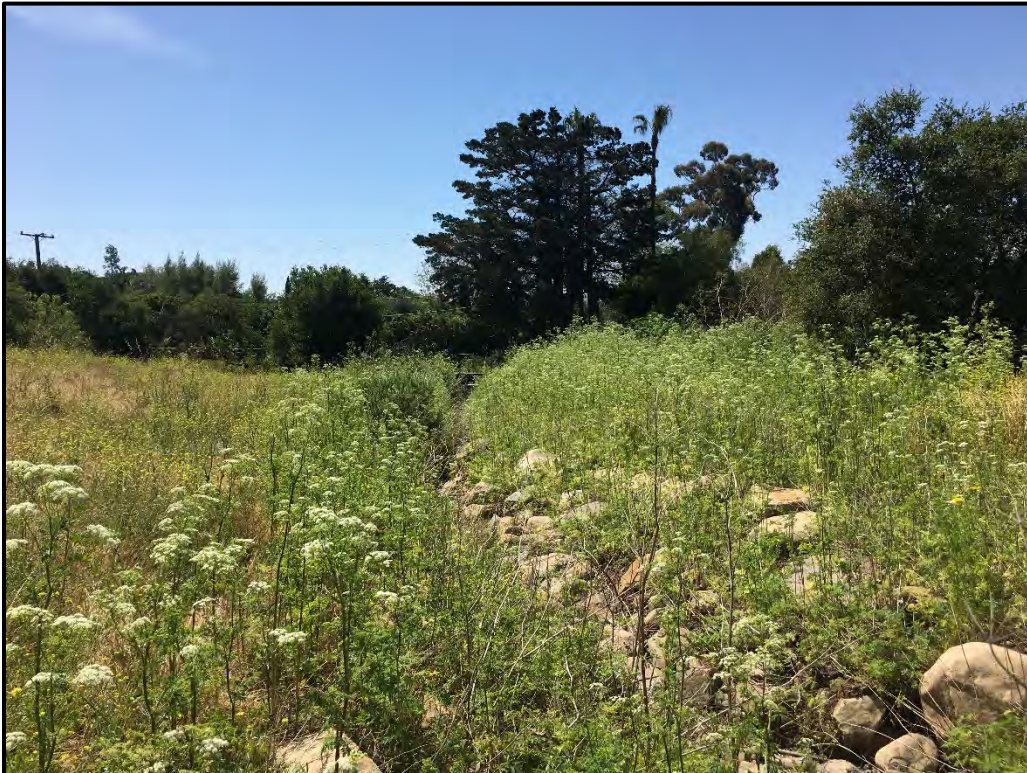
Photo 4: Southern end of ephemeral drainage with dense poison hemlock (Aspect: South). Photo taken 05/08/2020.

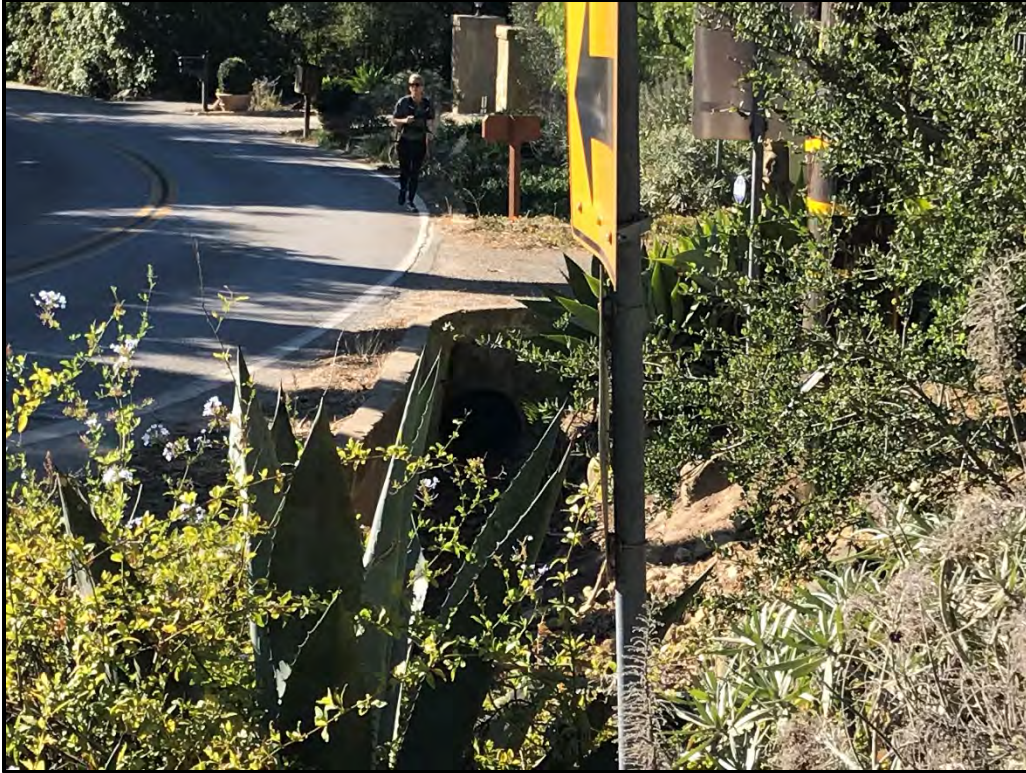
Photo 5: Downstream culvert along San Ysidro road that receives flow from the ephemeral drainage and channels it back to Oak Creek (Aspect: Southwest). Photo taken 10/31/2019.

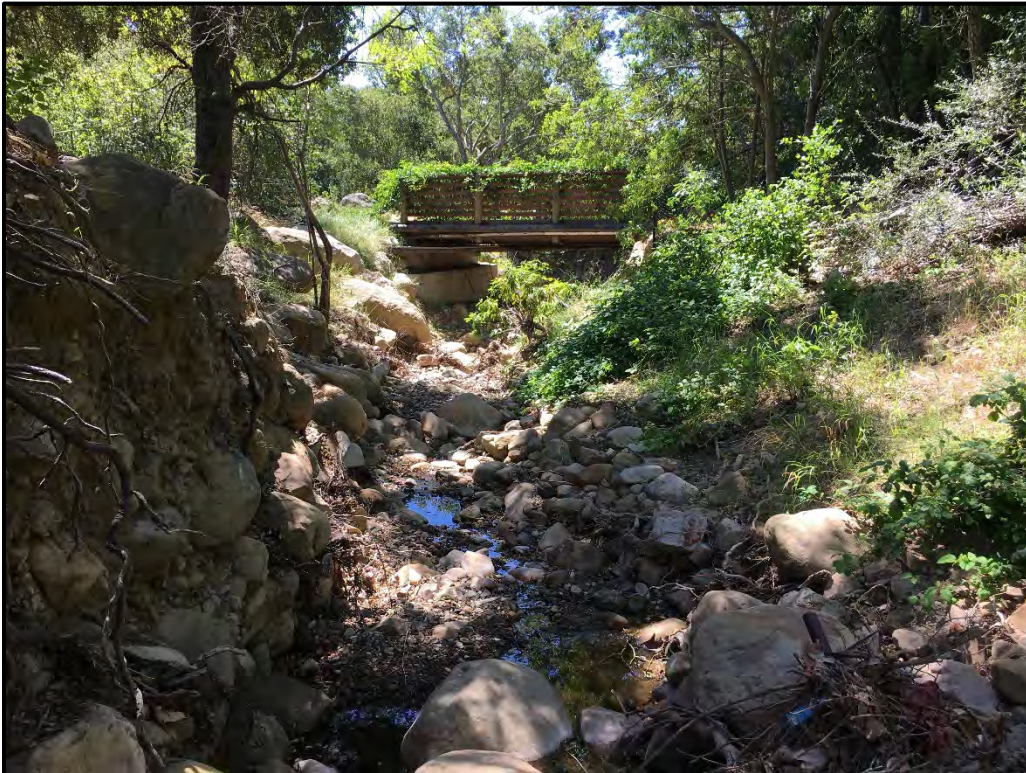
Photo 6: Lower portion of Oak Creek and the bridge along the private road southwest of the Project Area. (Aspect: South). Photo taken 05/08/2020.

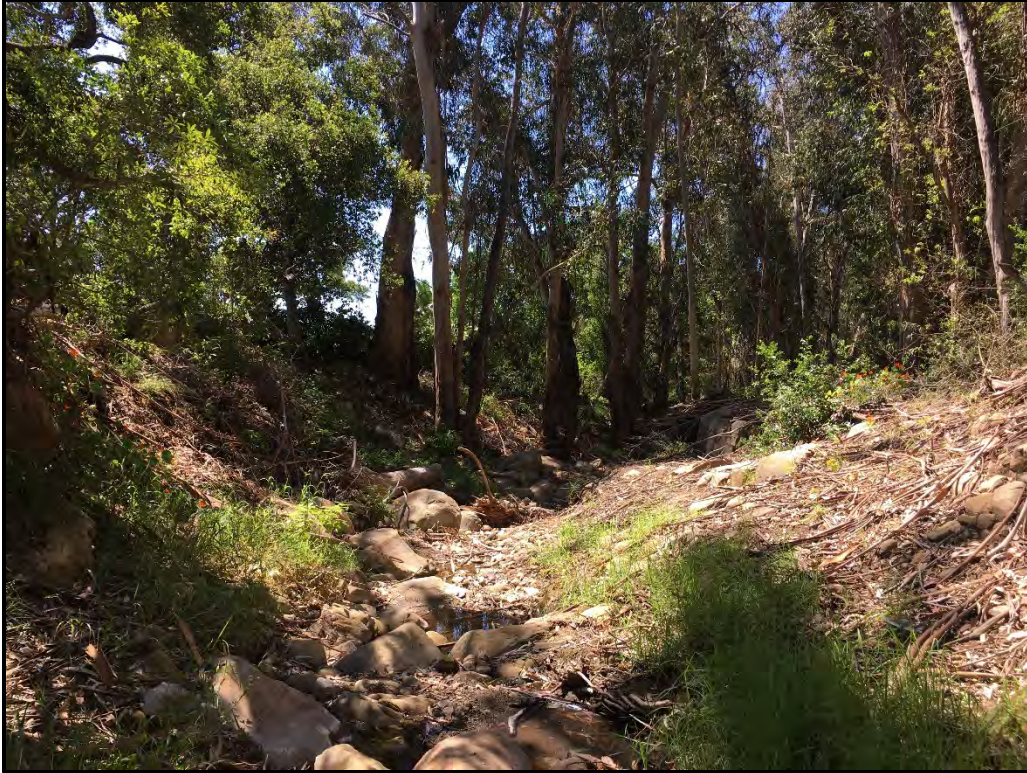
Photo 7: View of Oak Creek streambed/banks and eucalyptus grove (Aspect: South). Photo taken 05/08/2020.

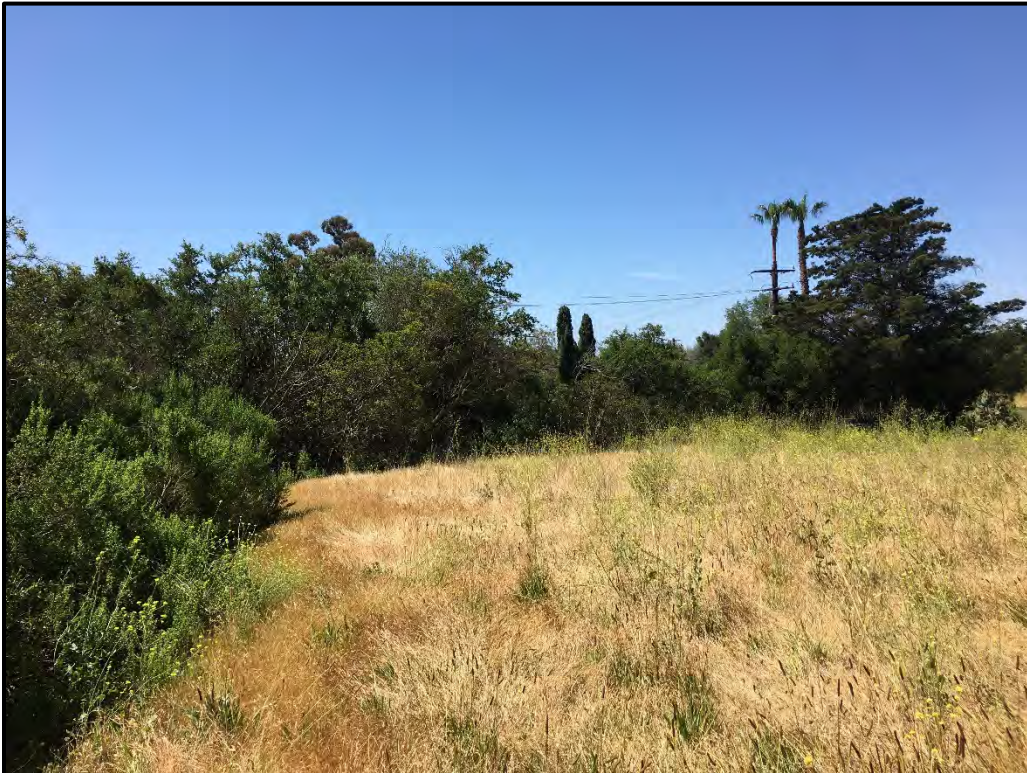
Photo 8: Native big pod ceanothus-laurel sumac scrub in the southeastern corner of Lot 1 (Aspect: South). Photo taken 05/08/2020.

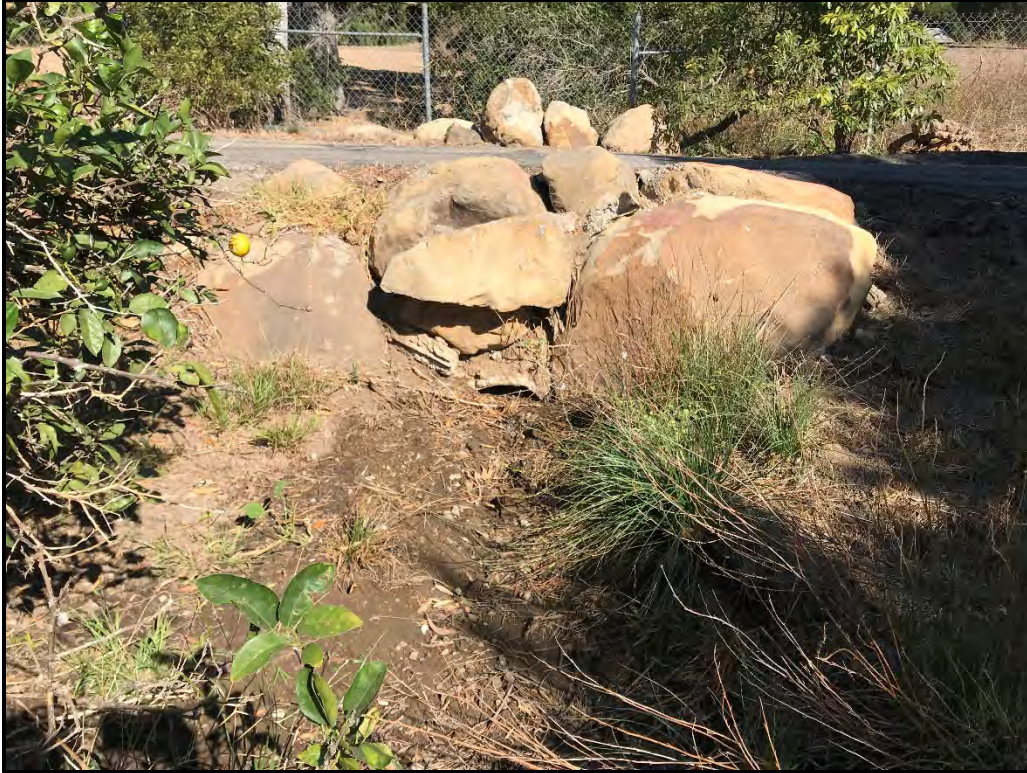
Photo 9: Clogged culvert along the main access driveway, near the middle of proposed Lot 1 (Aspect: North). Photo taken 10/31/2019.

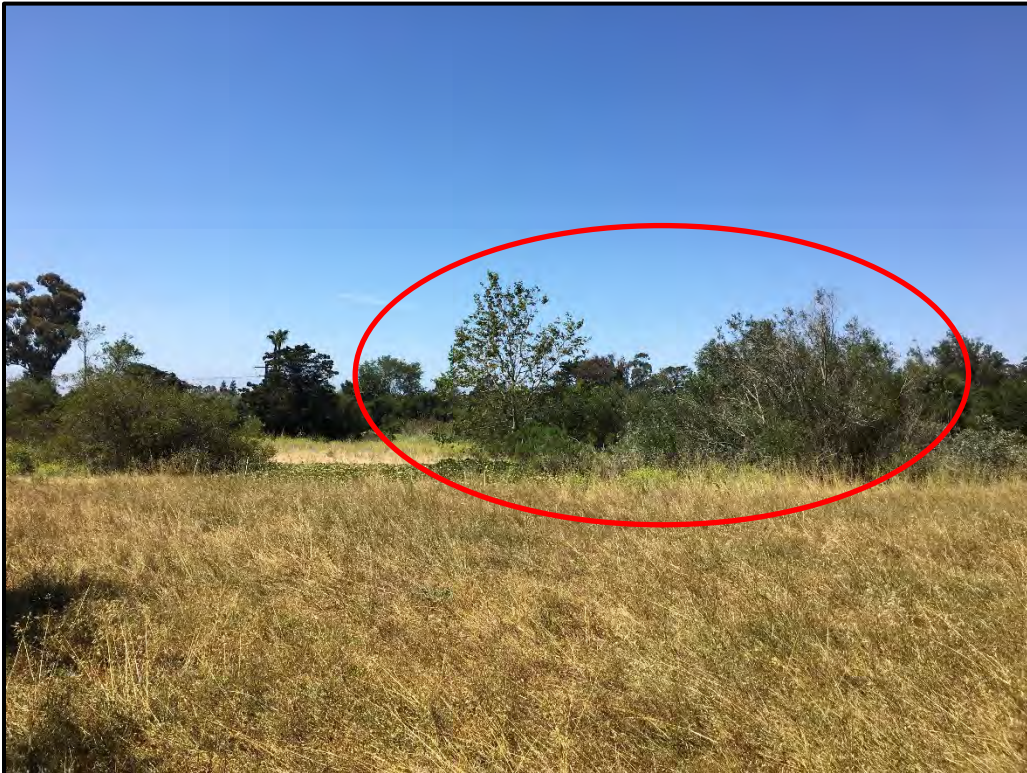
Photo 10: Arroyo willows, western sycamore, and iceplant mat in the upland habitat in the center of proposed Lot 1 (Aspect: West). Photo taken 05/08/2020.

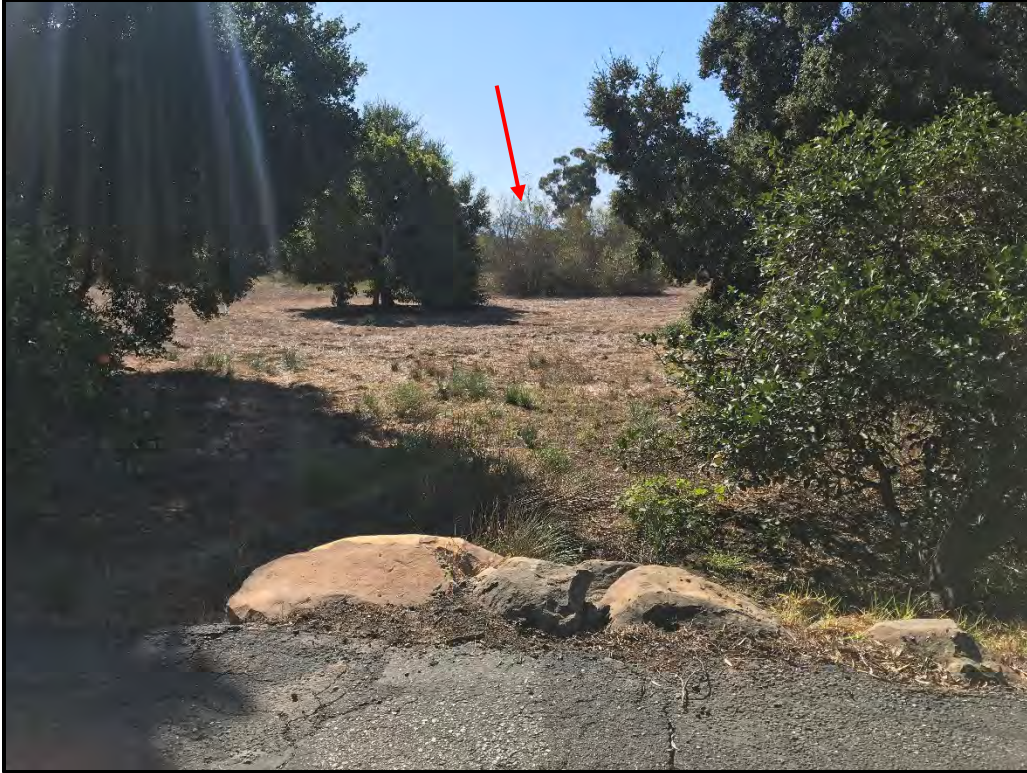
Photo 11: View from clogged culvert along the main access driveway, toward willows in the center of proposed Lot 1 (red arrow) (Aspect: South). Photo taken 10/31/2019.

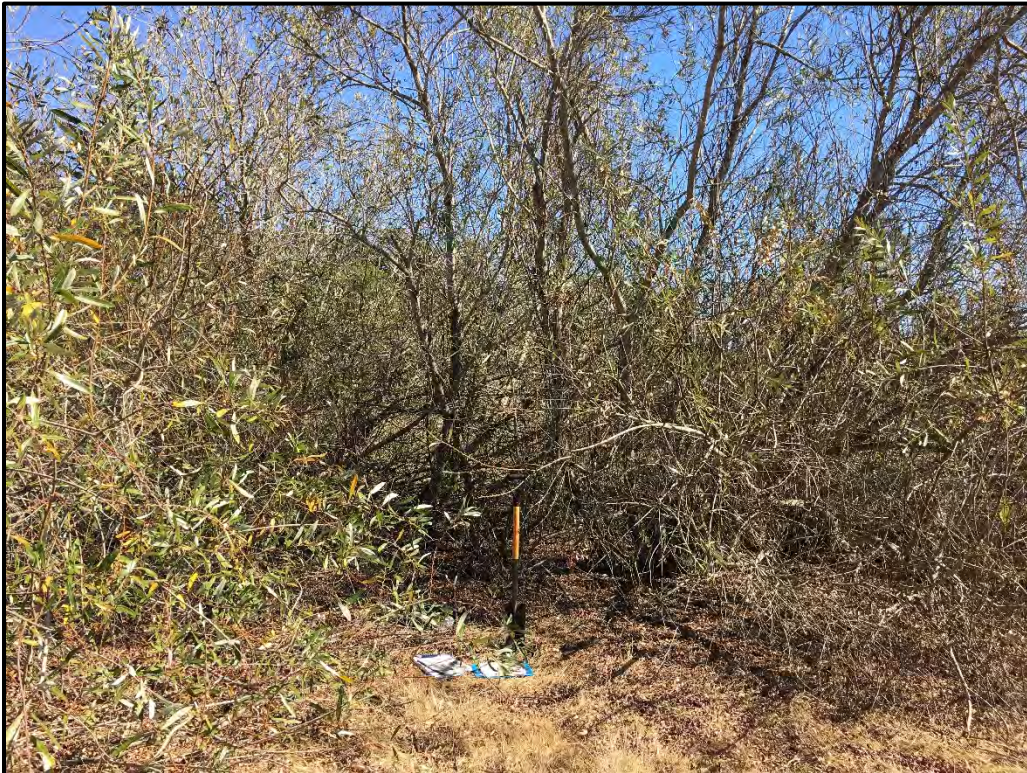
Photo 12: Soil sample location (SP-01) in the upland arroyo willow trees (Aspect: East). Photo taken 10/31/2019.

To determine whether the flat area containing the arroyo willows and western sycamore would be considered wetland habitat, a soil sample test pit was excavated (SP-01) (Figure 3 – Project Area Map) and a Wetland Form was completed (see Appendix D). No indicators of hydric soil or hydrology (i.e., drift deposits, drainage patterns, soil cracking, etc.) were observed.

Arroyo willow is considered a facultative wetland (FACW) plant, which means it usually occurs as a hydrophyte (i.e., in riparian corridors or along stream terraces), but is occasionally found in upland habitat (Lichvar et al. 2012). The soil in the Project Area has a high clay content, which results in low permeability and allows for trees that are typically riparian to survive in an upland location. There is also an arroyo willow along the street on the southern property boundary (Figure 6 – Vegetation Communities & Land Use Types). Individual native trees, such as arroyo willow and western sycamore, which are not associated with the ephemeral drainage or Oak Creek are still afforded protection by the Montecito Community Plan policies. However due to lack of a defined bed, bank, or depression, and a lack of evidence of hydrology and hydric soil indicators, individual arroyo willow and western sycamore trees do not represent a County wetland or ESH.

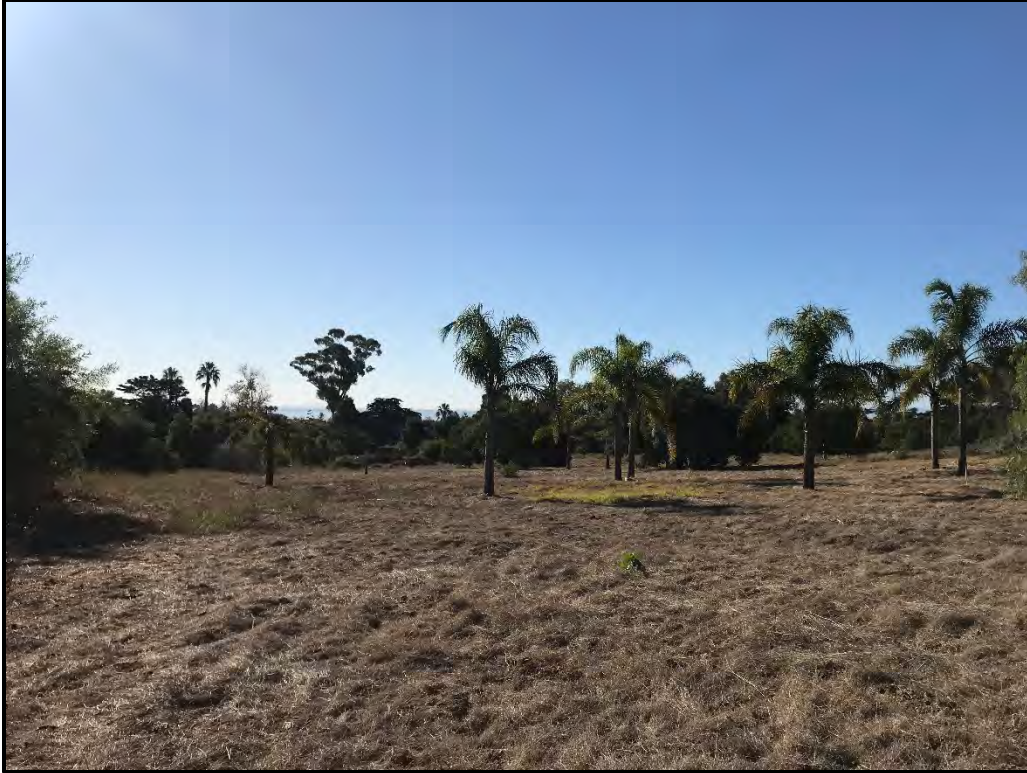
Photo 13: Annual grassland habitat and ornamental palms in proposed Lots 2 and 3 (Aspect: Southwest). Photo taken 10/31/2019.

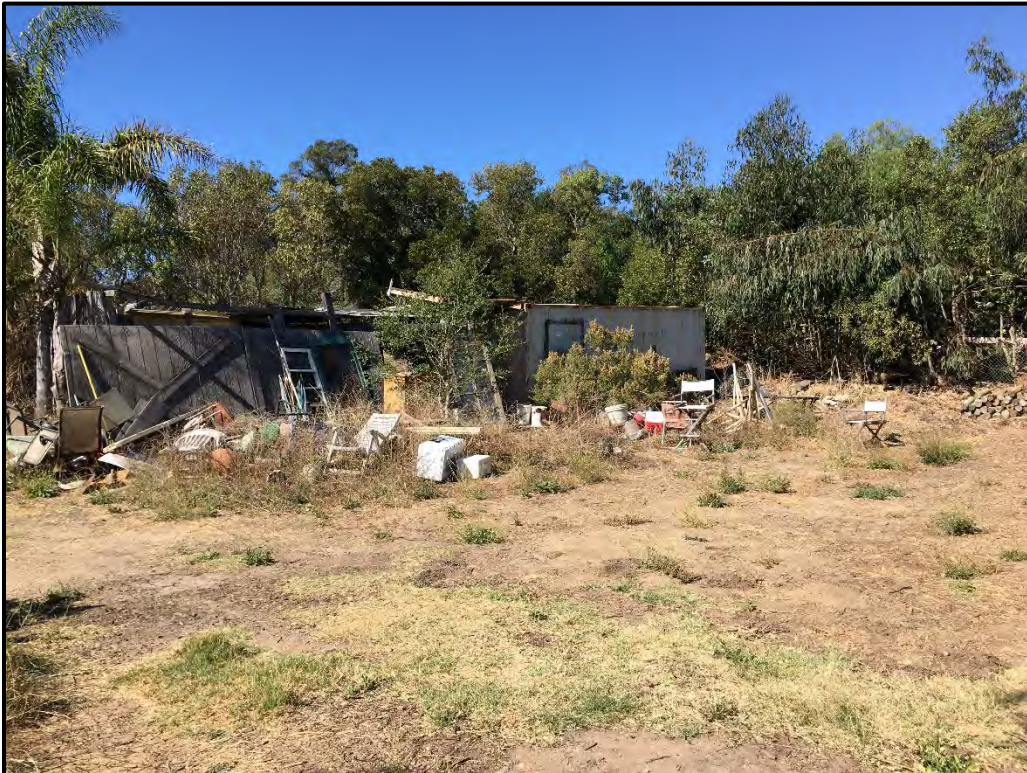
Photo 14: Disturbed/ruderal area north of the main access driveway (Aspect: Northwest).

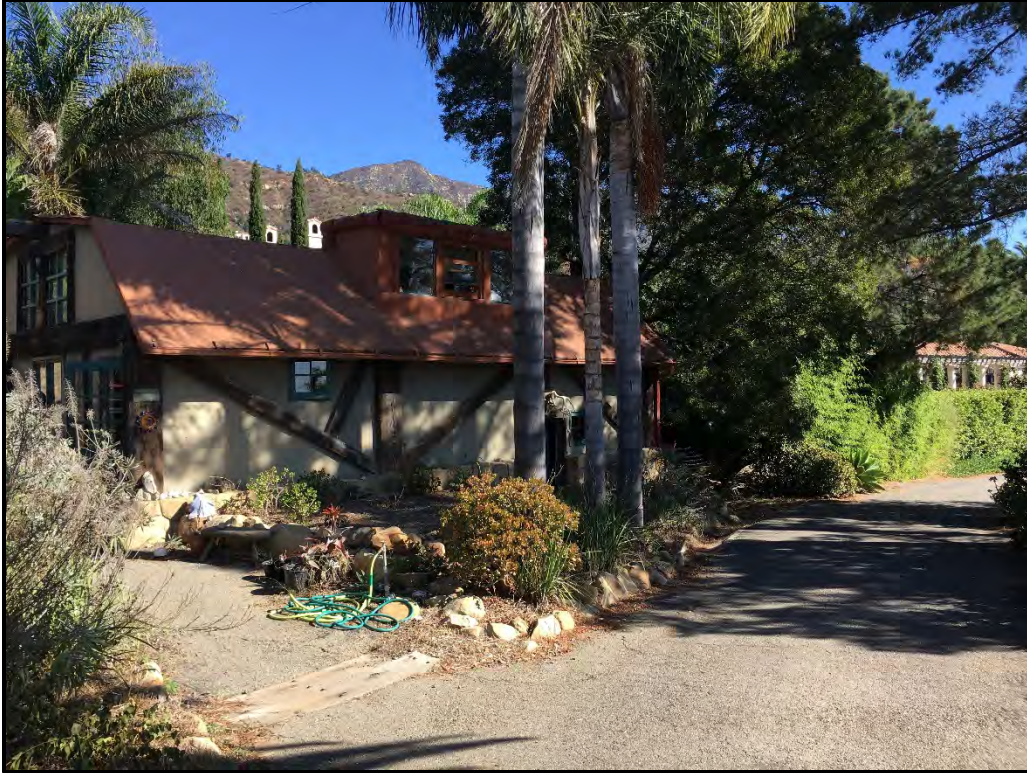
Photo 15: Existing cottage adjacent to the ephemeral drainage and bridge (Aspect: East). Photo taken 10/31/2019.

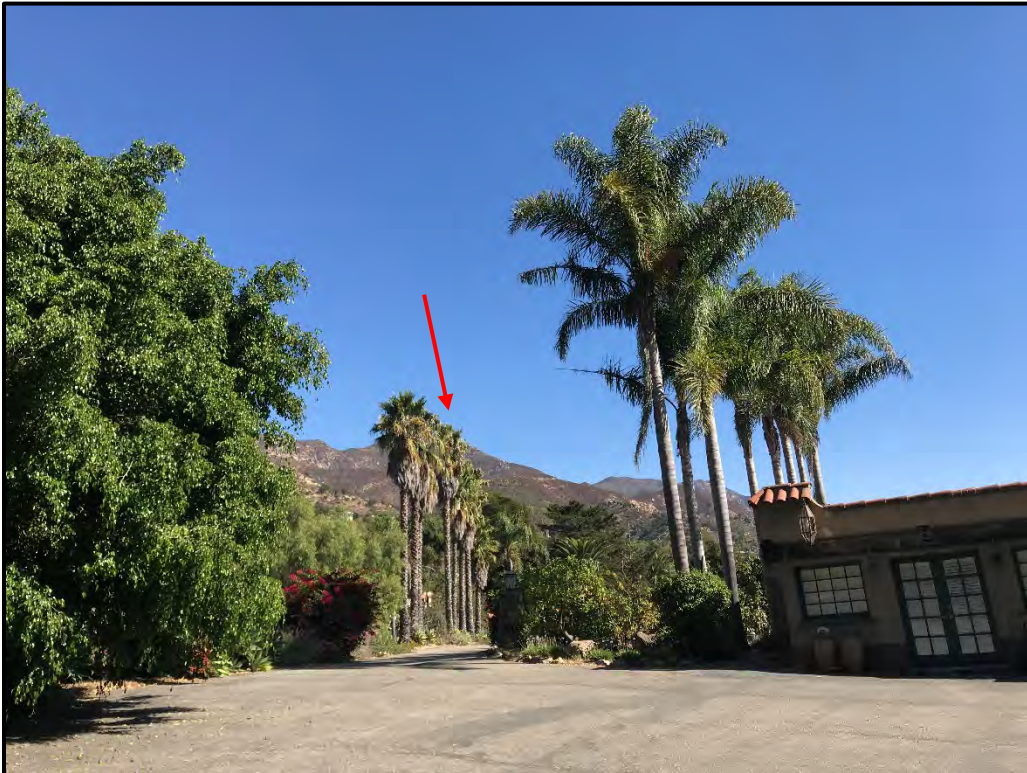
Photo 16: Part of the main residence and the west end of the driveway (Aspect: East). Hooded oriole nests are located in the palms along the driveway (red arrow). Photo taken 05/08/2020.
