**SUMMARY REPORT**  
**LIMITED SUBSURFACE INVESTIGATION**  
**20-ACRE VACANT UNDEVELOPED LAND**  
**SOUTHWEST CORNER OF**  
**TRUMBLE ROAD & MAPES ROAD**  
**PERRIS, CA 92571**

September 25, 2021

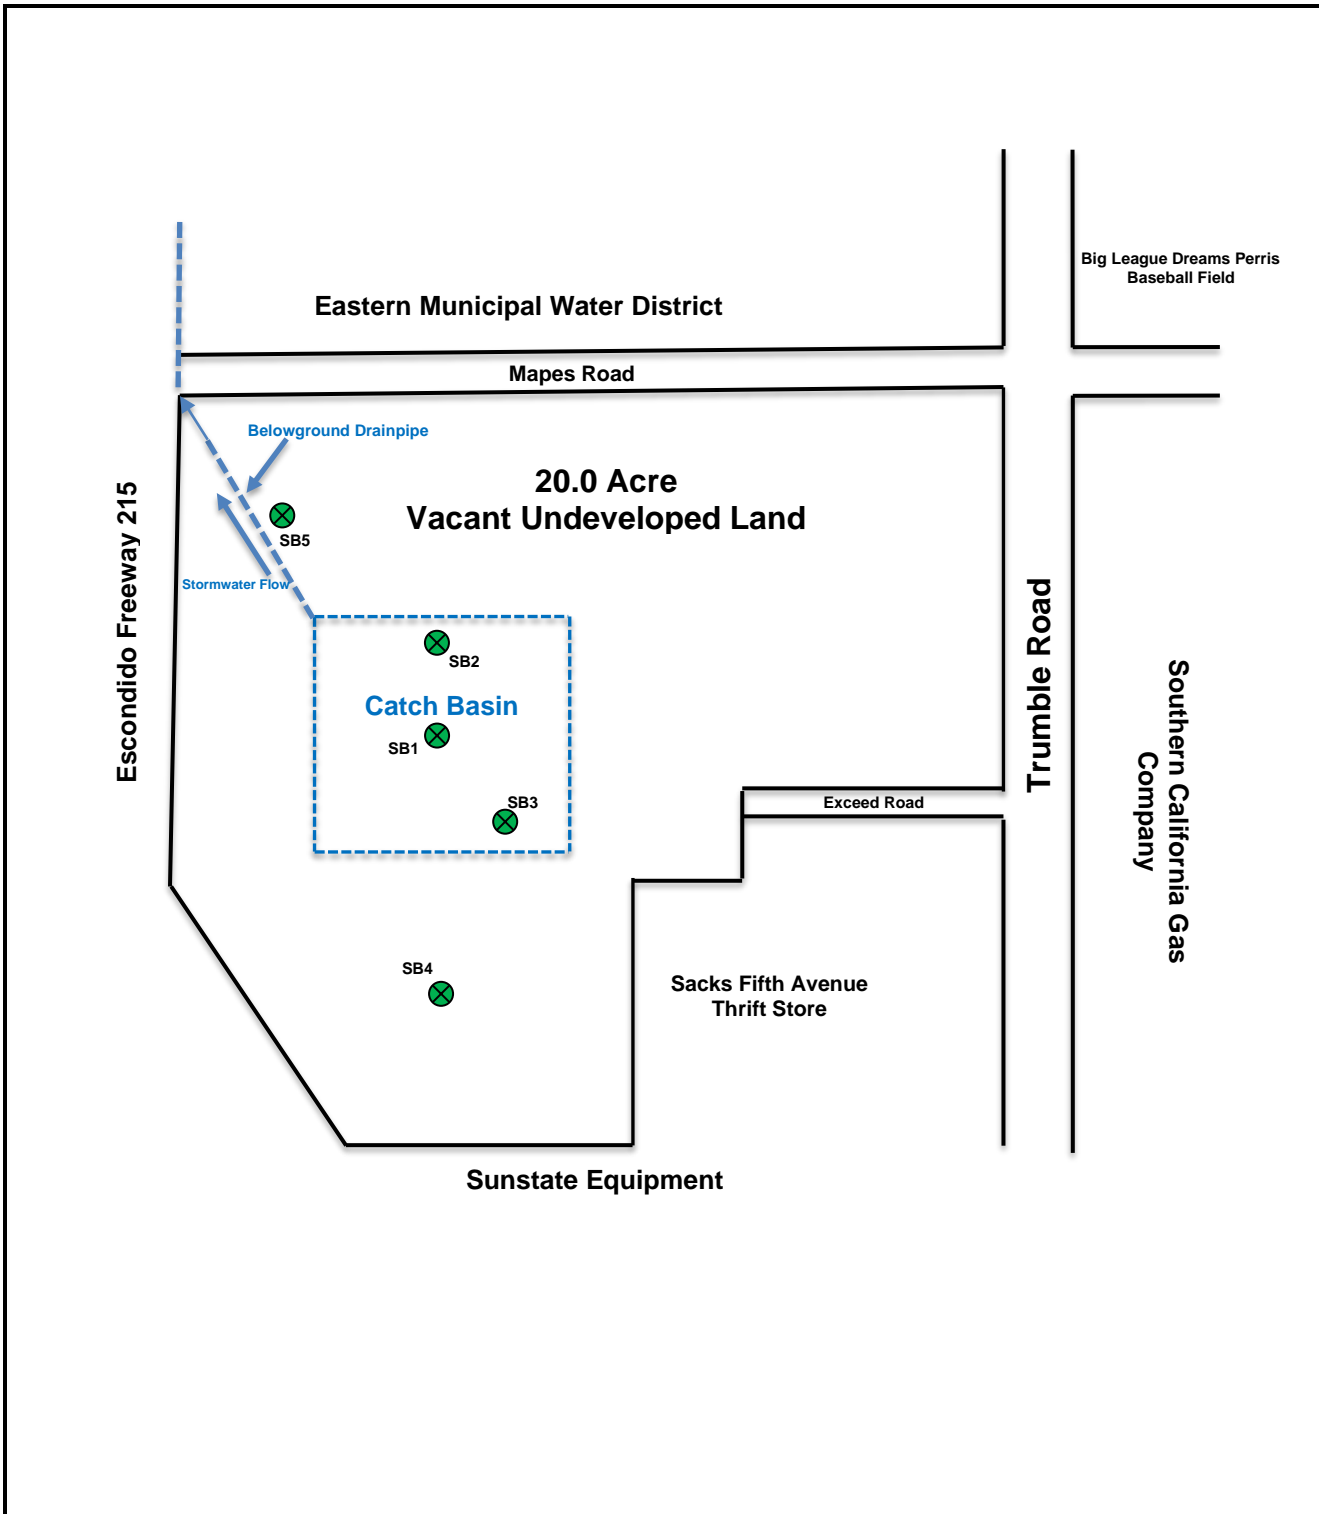
On September 6, 2021, to evaluate the potential presence of contamination beneath the Site, soil samples were collected from a total of five (5) DPT boring locations (SB1 through SB5) as follows:

- Soil borings SB1 through SB3 were drilled in the vicinity of Storm Water Catch Basin. Each boring was drilled to a maximum depth of 5 feet belowground surface (bgs) using a limited-access DPT GeoProbe® rig. In order to obtain unsaturated vadose zone samples, soil samples were collected at 5 feet bgs for lithologic description, field screening by a photoionization detector (PID) and laboratory analyses. The soil samples collected at 5-foot bgs from each soil boring were submitted for laboratory analyses.

- Soil boring SB4 was drilled in the southern portion of the property, south of Catch Basin, where significant water accumulation was noted in historical aerial photographs. The soil boring was drilled to a maximum depth of 5 feet bgs using a limited-access DPT GeoProbe® rig. In order to obtain unsaturated vadose zone samples, soil samples were collected at 5 feet bgs for lithologic description, field screening by a PID and laboratory analyses. The soil samples collected at 5-foot bgs were submitted for laboratory analyses.

- Soil boring SB5 was drilled in the vicinity of drainpipe, approximately 30 feet northwest of Catch Basin, associated with the Storm Water Catch Basin. The soil boring was drilled to a maximum depth of 5 feet bgs using a limited-access DPT GeoProbe® rig. In order to obtain unsaturated vadose zone samples, soil samples were collected at 5 feet bgs for lithologic description, field screening by a PID and laboratory analyses. The soil samples collected at 5-foot bgs were submitted for laboratory analyses.

**LEGEND:**  
 SB1 through SB5 – Soil Sampling Locations SB1 through SB5
