AQUATIC RESOURCE DELINEATION REPORT

TOLARI PROPERTY, SANTOS RANCH ROAD
HAYWARD, ALAMEDA COUNTY, CALIFORNIA
(APN: 946-3800-4-12)

SEPTEMBER 2022

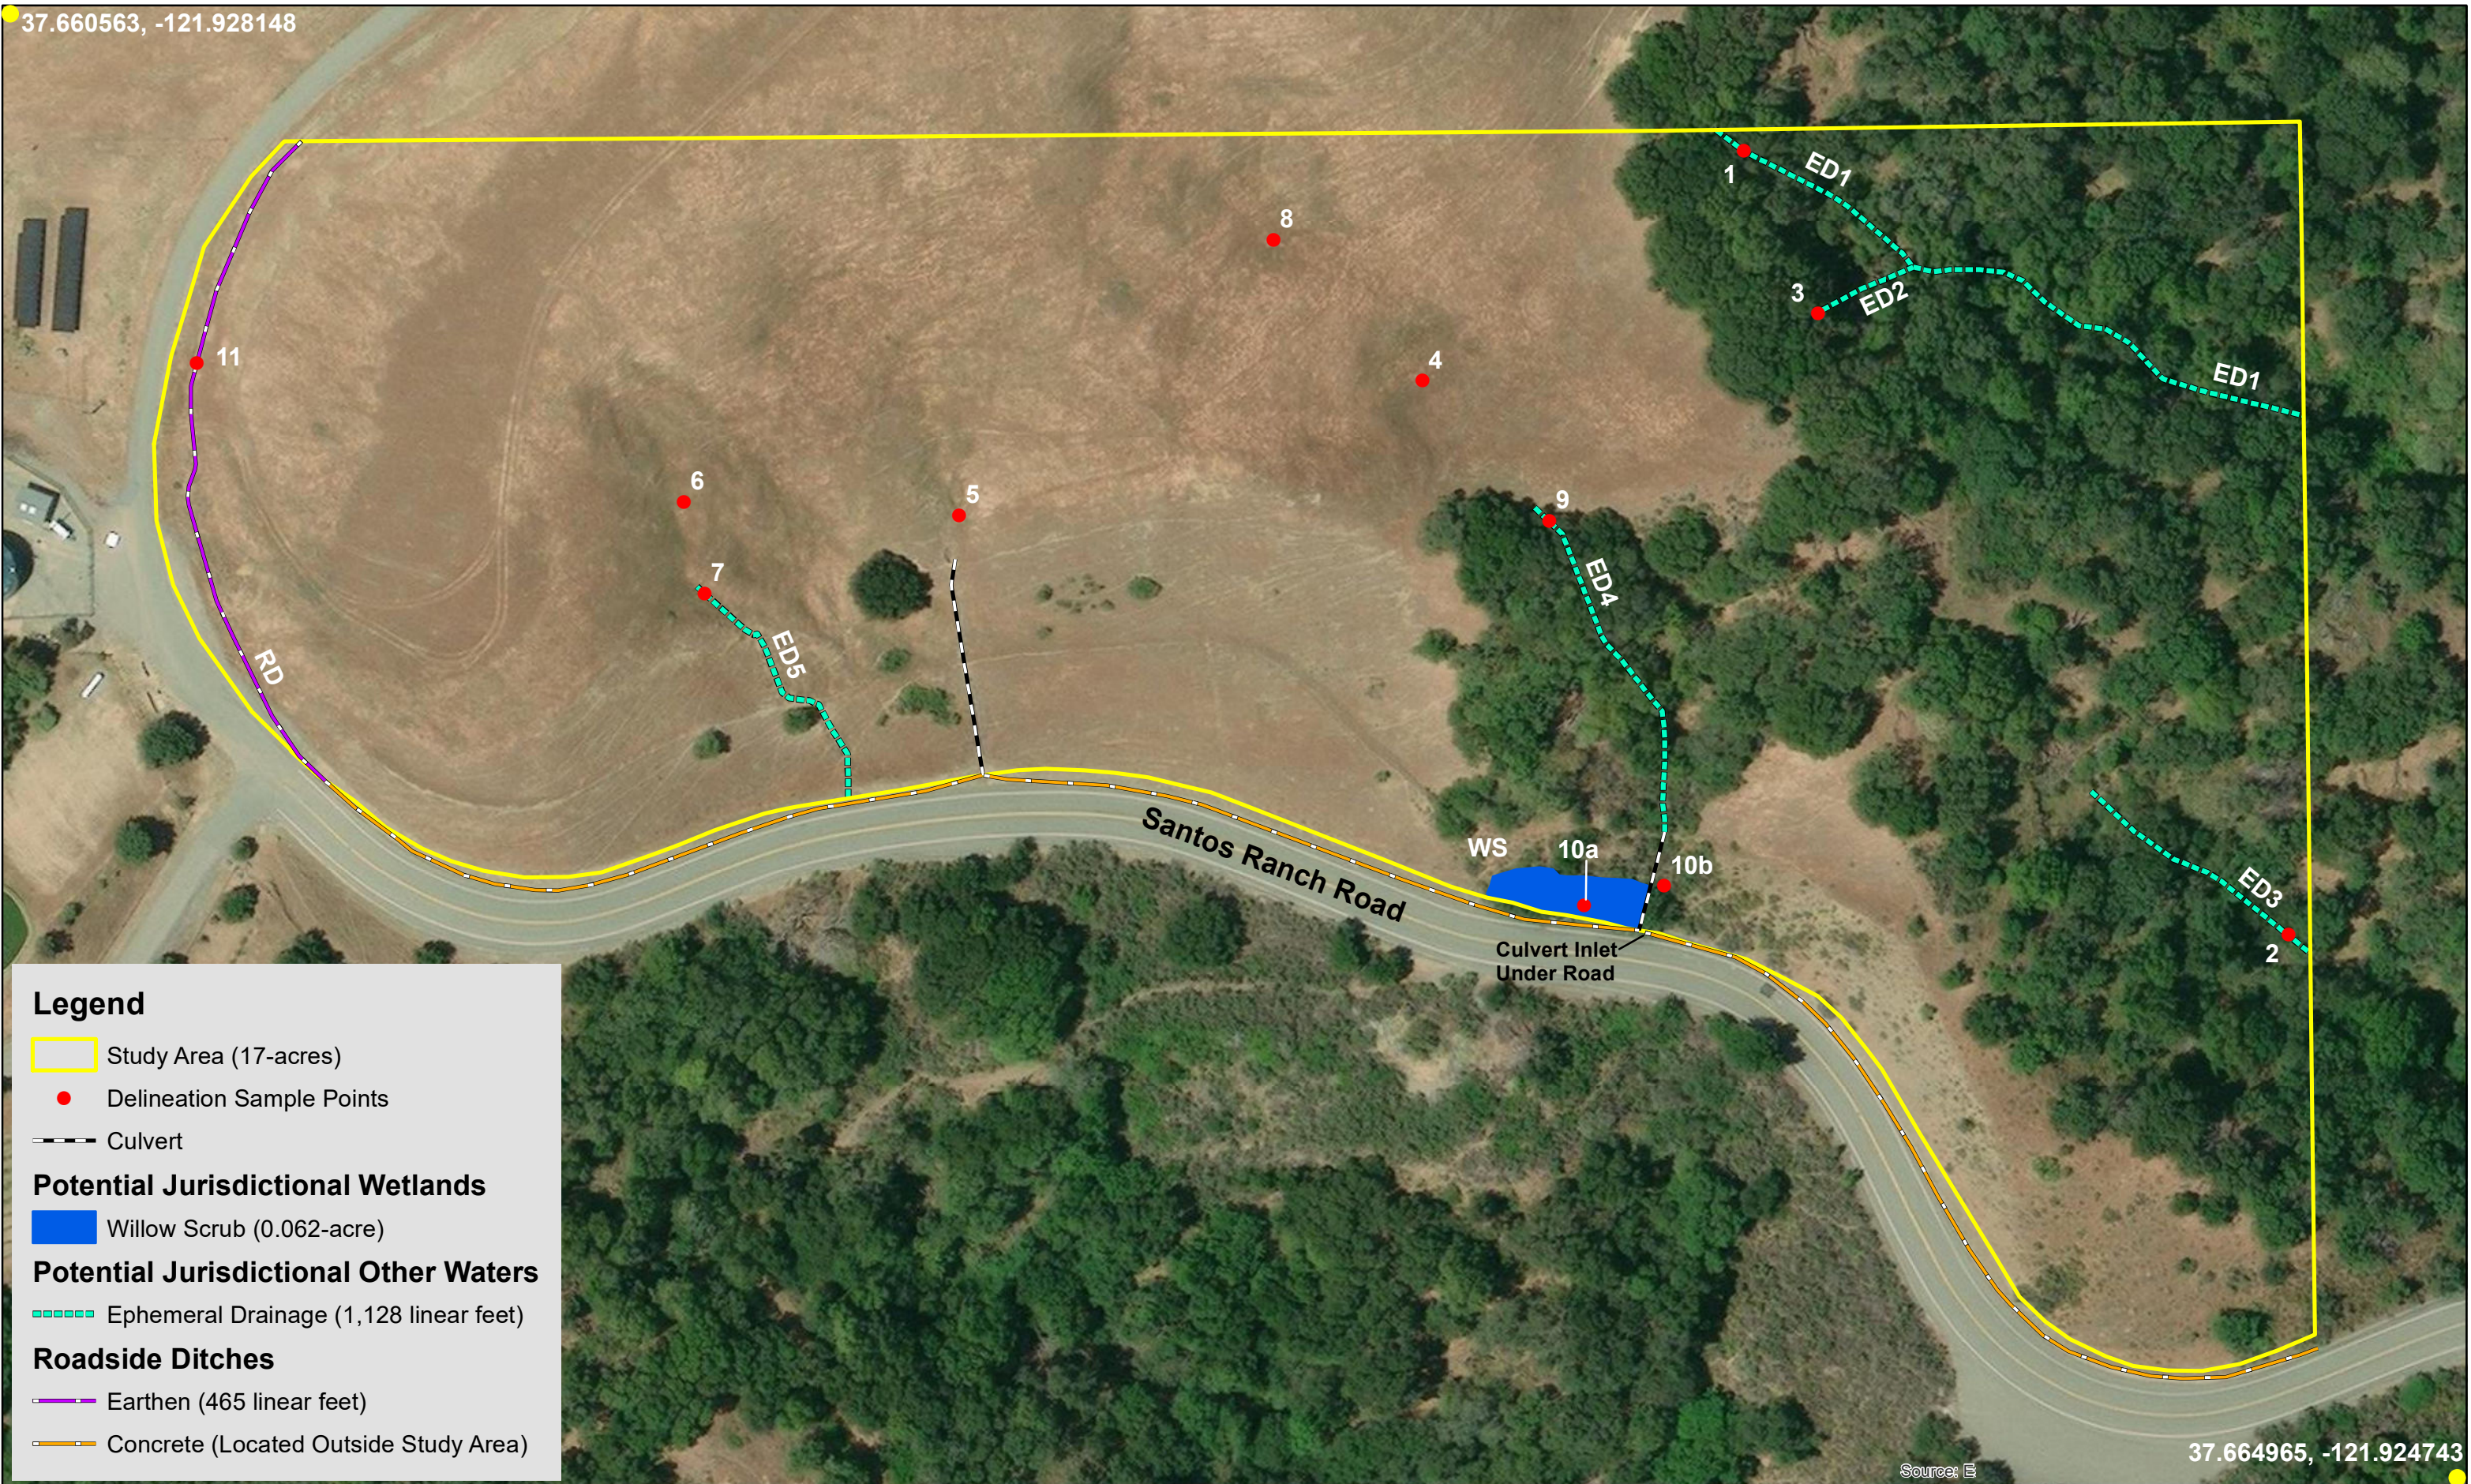
- Study Area (17-acres)
- Delineation Sample Points
- Culvert

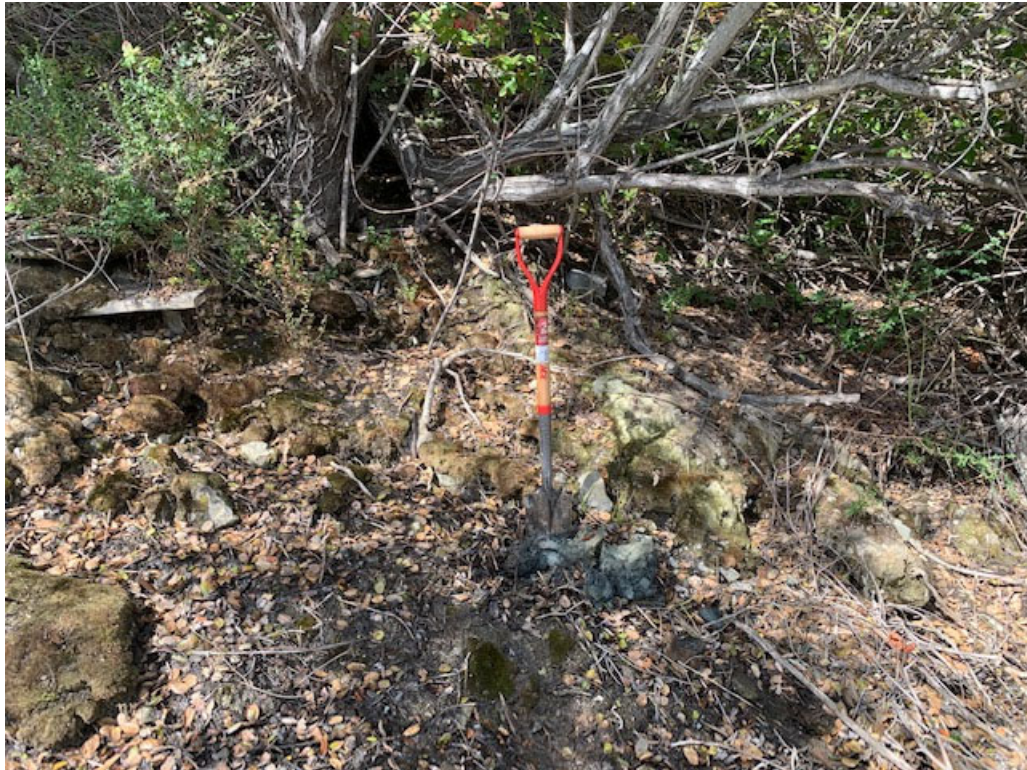
Appendix C-1. Willow Scrub wetland (WS) at Sample Point 10a.

Willow Scrub (WS) covers 2,722 ft² (0.062-acre) and is located at the toe of a graded slope west of Santos Ranch Road that receives seepage water and surfaced runoff from the adjacent slope (Table 2; Figure 4; Appendix C-1). WS is dominated by hydrophytic vegetation, including a canopy of arroyo willow and red willow, along with occasional big-leaf maple, California bay, and coast live oak. The understory consists of shrubs—including Himalayan blackberry, poison oak, coyote brush, and French broom—as well as occasional hydrophytic herbaceous species including brown-head rush (Sample Point 10a). Hydric soil indicators are present, including Loamy Gleyed Matrix (F2), as well as positive wetland hydrology indicators, including Surface Water (A1), High Water Table (A2), Saturation (A3), Drainage Patterns (B10), and FAC-Neutral Test (D5). WS discharges directly into the concrete roadside ditch that drains into a culvert under Santos Ranch Road (Appendix C-2). Adjacent uplands occur on slopes above the wetland, which are dominated by upland plant species and lack wetland hydrology and hydric soil indicators (Sample Point 10b; Appendix C-3).

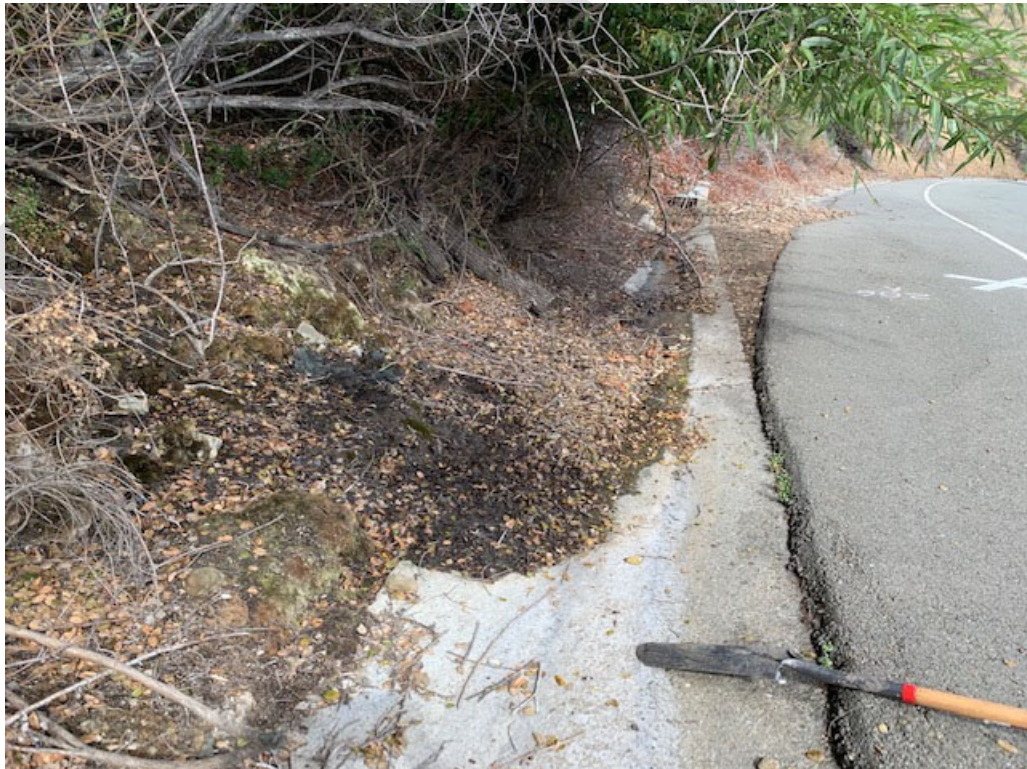
Appendix C-2. Concrete roadside ditch along Santos Ranch Road, below WS, with culvert inlet downstream in upper portion of photo, looking downstream (north).

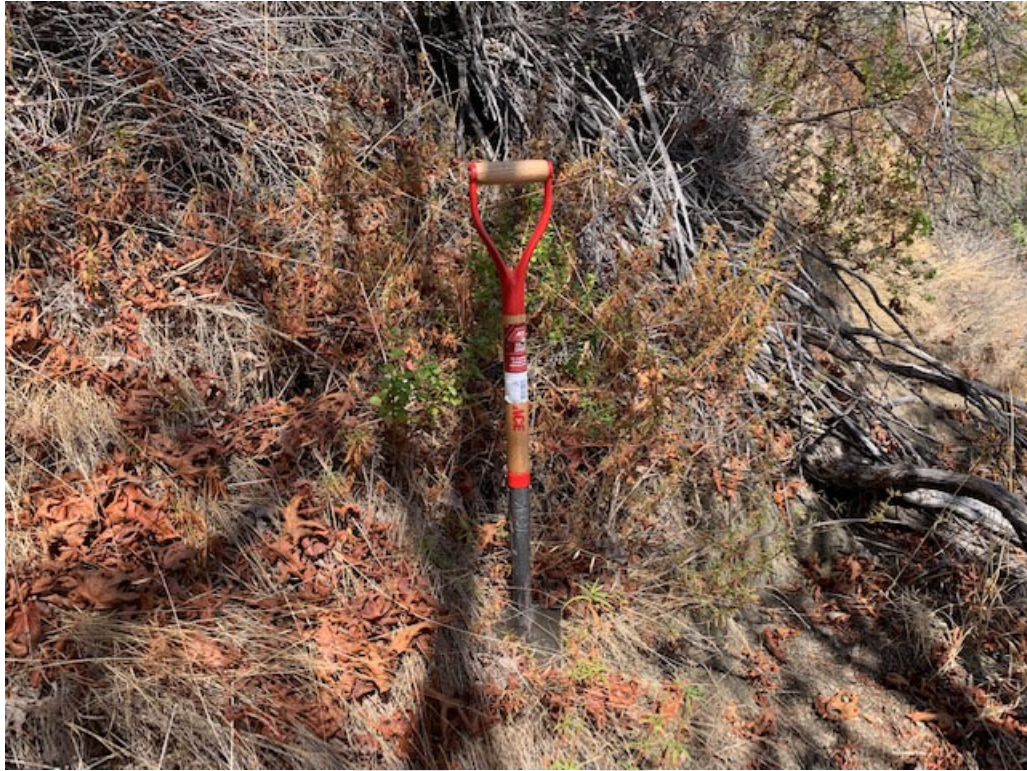
Appendix C-3. Upland slope above WS at Sample Point 10b.

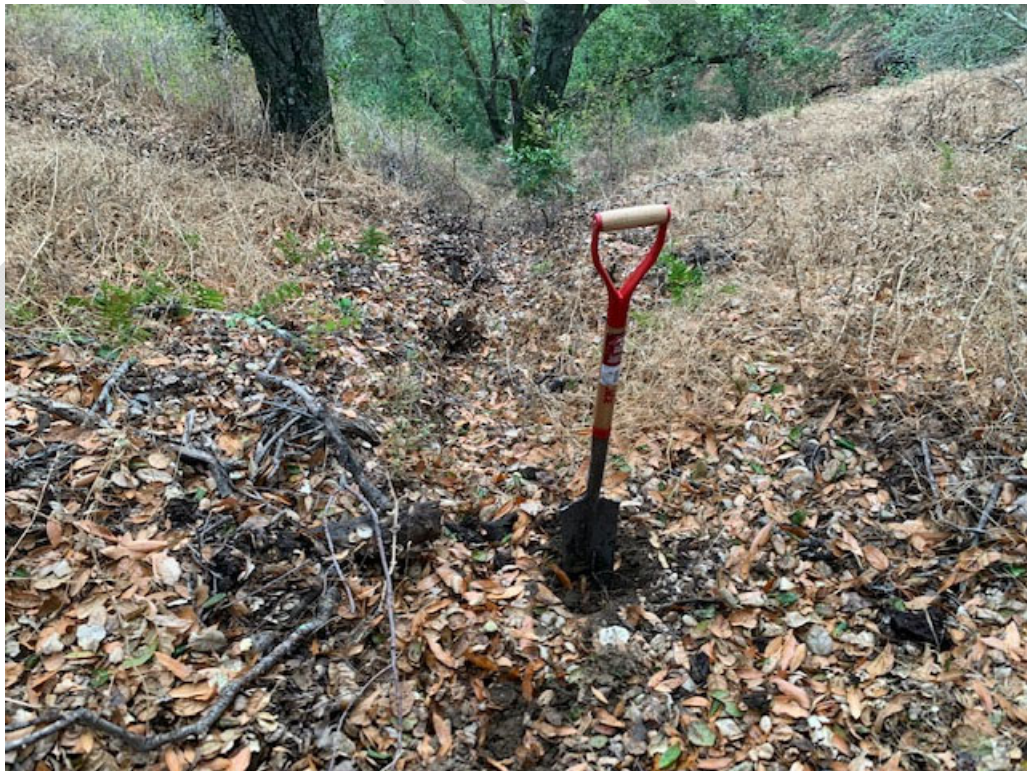
Appendix C-4. Ephemeral drainage ED1 at Sample Point 1, looking downstream.

Five drainages were observed on the study area that likely support ephemeral hydrology (flowing only after significant rain events) based on indicators observed in the field (Table 2; Figure 4). The ephemeral drainages (ED) are typically 2 to 4-feet wide, with a bed, bank, and OHWM (scour, sediment deposition, bed/banks) along with wetland hydrology indicators, including Riverine Sediment Deposits (B2) and Drainage Patterns (B10), but lack a preponderance of hydrophytic vegetation and hydric soil indicators (Sample Points 1, 2, 3, 7, 9; Appendix C-4 to C-8).

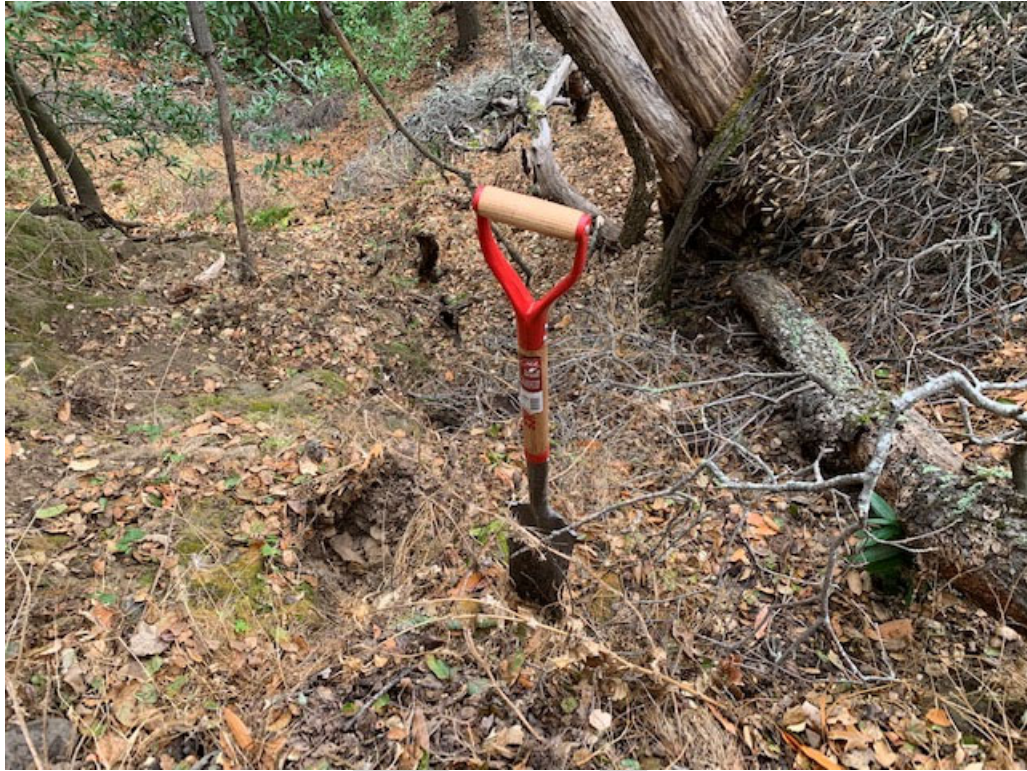
Appendix C-5. Ephemeral drainage ED2 at Sample Point 3, looking downstream.

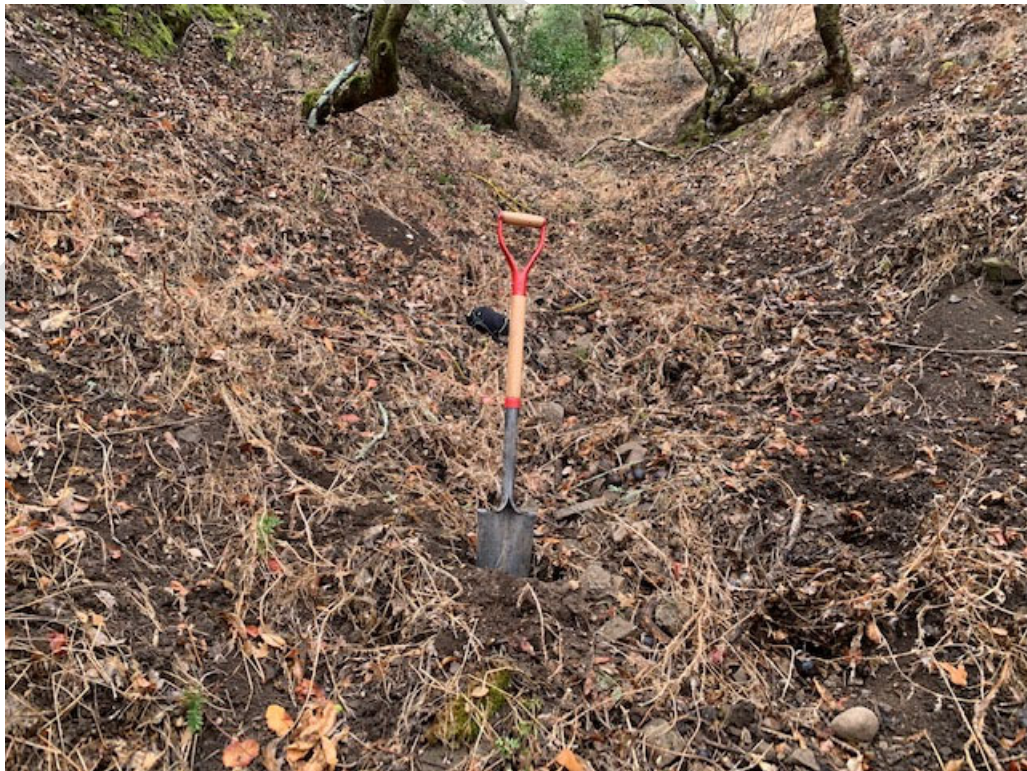
Appendix C-6. Ephemeral drainage ED3 at Sample Point 2, looking upstream.

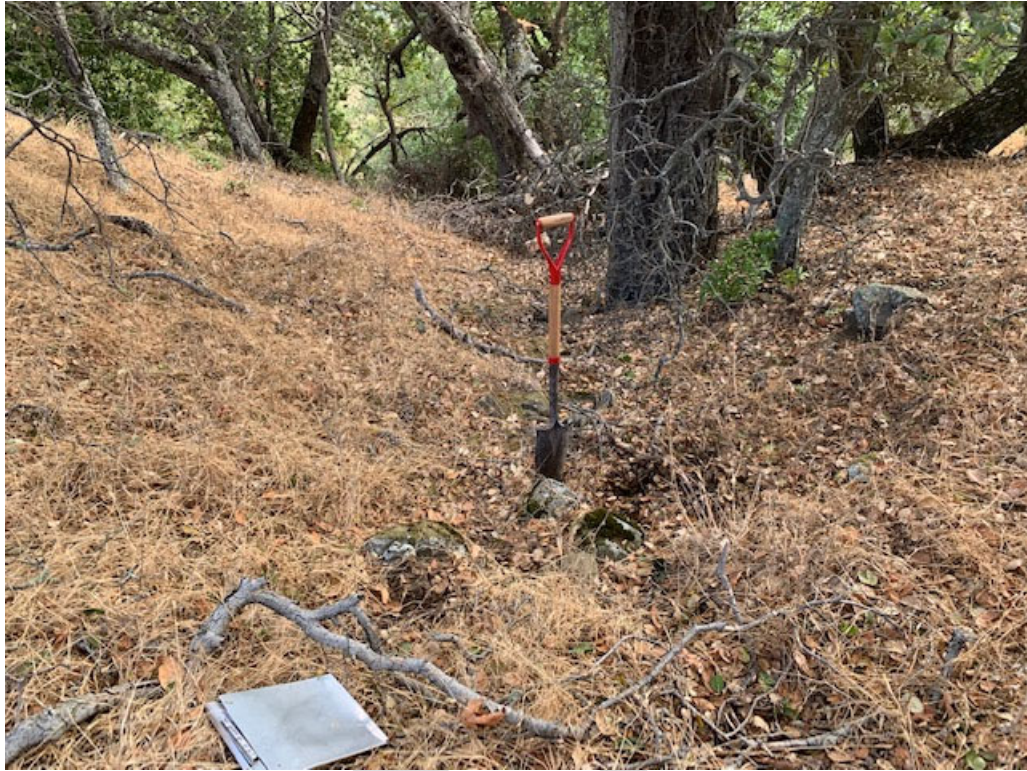
Appendix C-7. Ephemeral drainage ED4 at Sample Point 9, looking downstream.

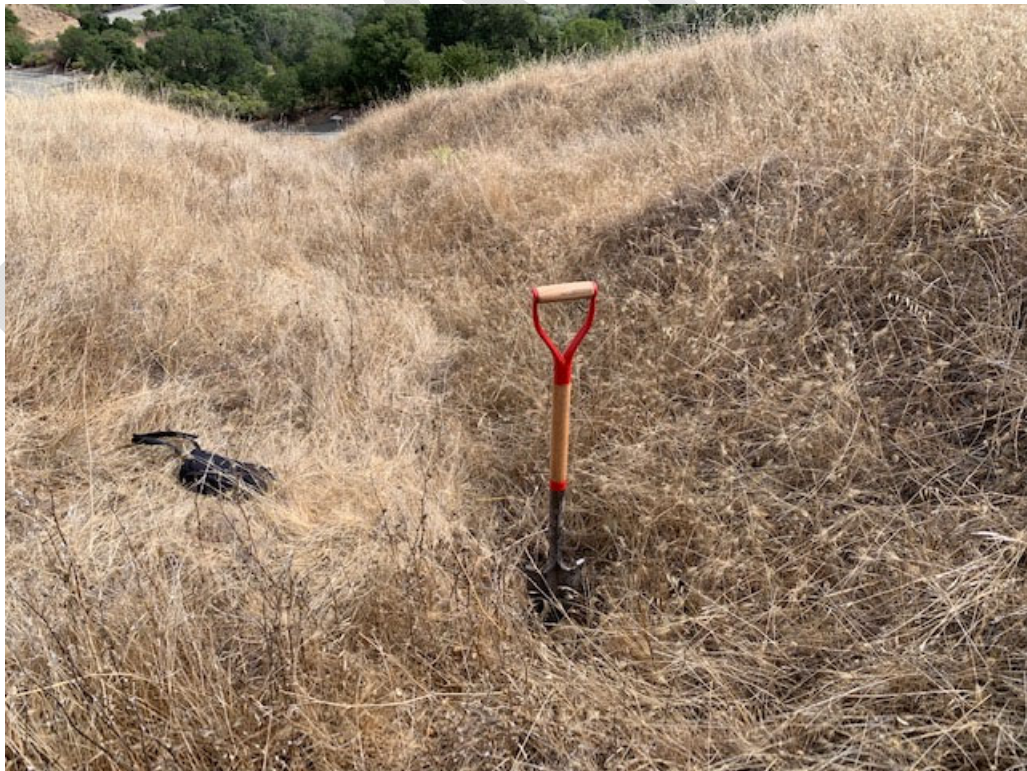
Appendix C-8. Ephemeral drainage ED5 at Sample Point 7, looking downstream.

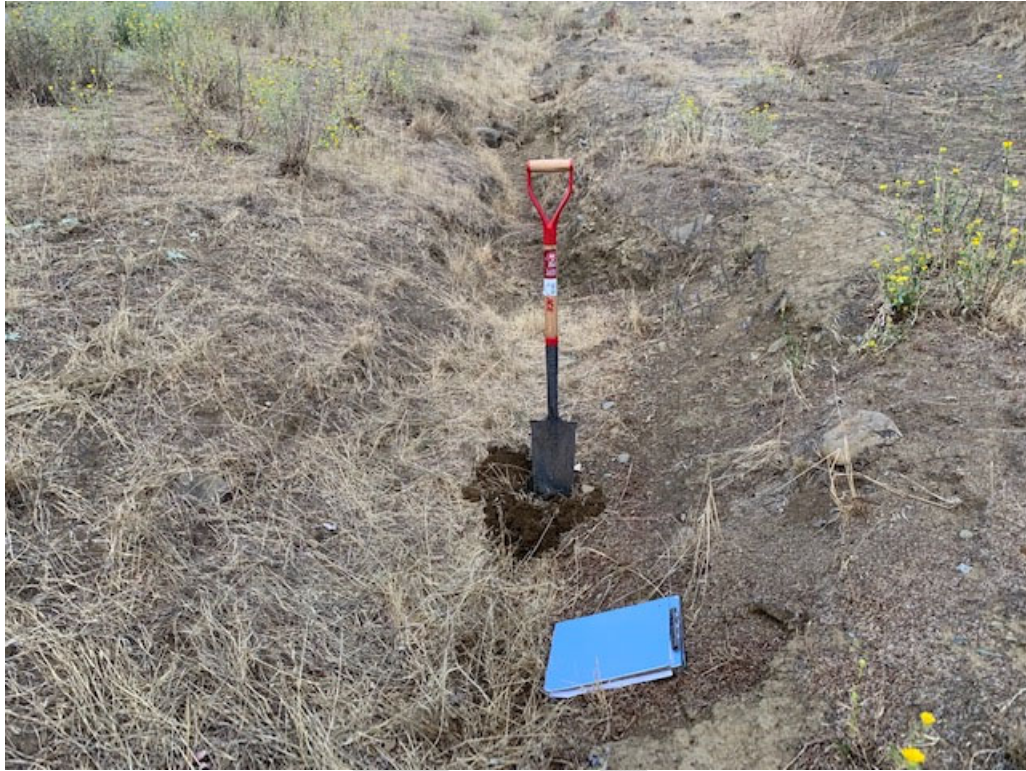
Appendix C-9. Roadside ditch (RD) at Sample Point 11, looking upstream.

RD appears to have been excavated in uplands for roadside drainage and—based on conditions observed in the field and a review of the NWI, NHD, USGS topographic maps, and other sources—is not a natural tributary to downstream TNW’s. However, Santos Ranch Road appears to have been constructed in the 1960s, with the hillside graded as part of road construction, and pre-construction drainage is difficult to determine. RD drains into the concrete roadside ditch mentioned previously (Appendix C-10). The concrete roadside ditch is not located within study area boundaries, but is included on Figure 4 for reference.

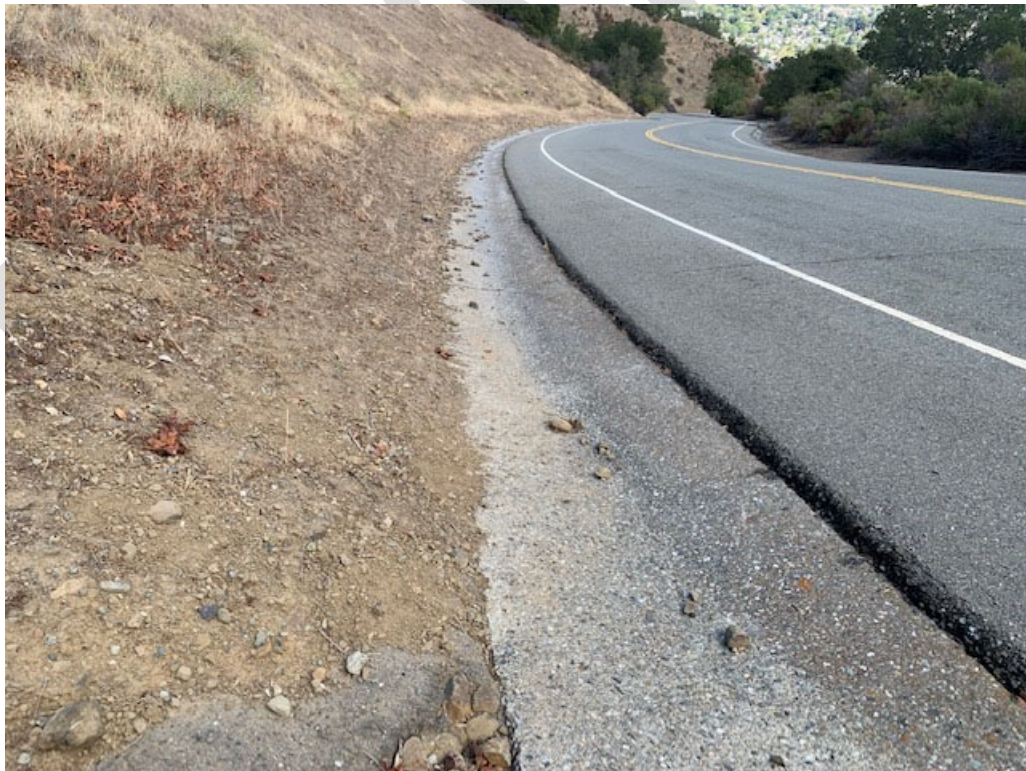
Appendix C-10. Concrete roadside ditch along Santos Ranch Road, located off the study area, looking downstream (north).

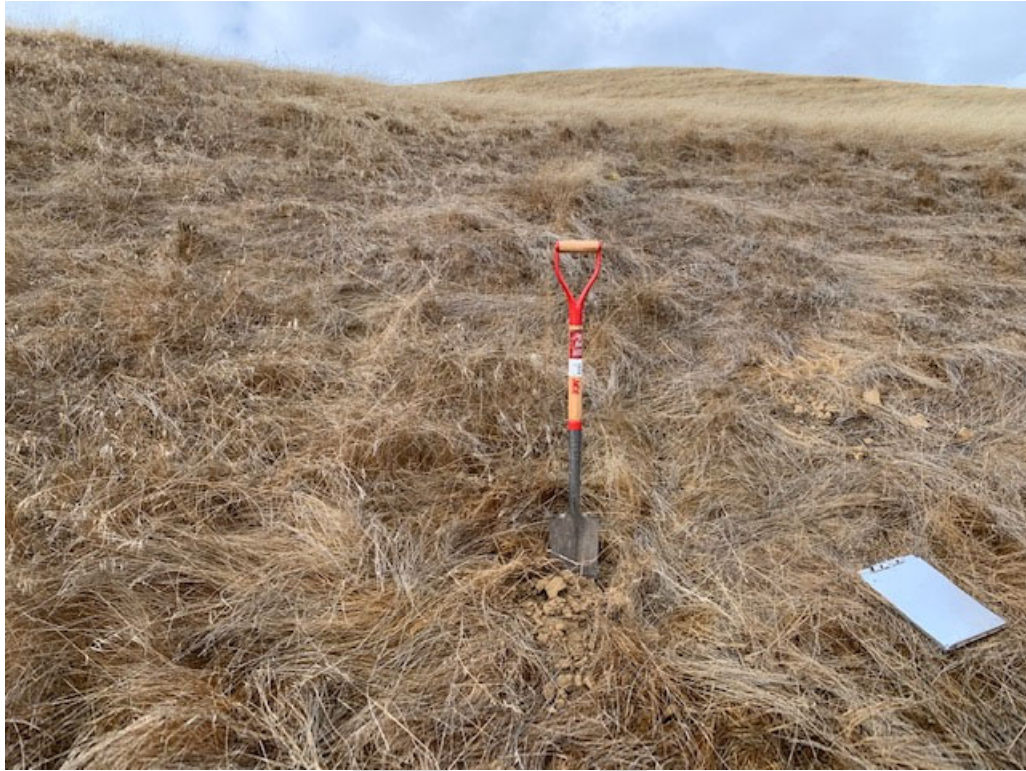
Appendix C-11. Sample Point 4 in slump/draw above ED4, looking upslope (west).

Remarks:
Located in concave slump/draw that appears to receive more hydrologic input compared to surrounding slopes and drains toward ephemeral drainage downslope. However, no surface or sub-surface wetland hydrology indicators observed.

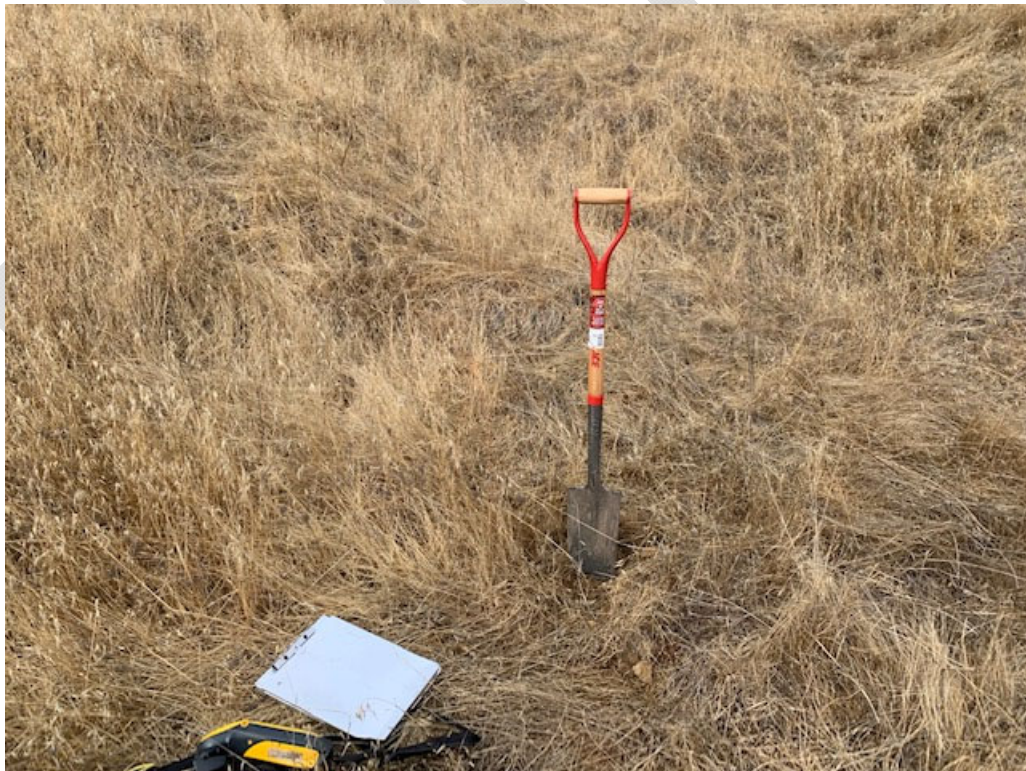
Appendix C-12. Sample Point 5 in slump/draw lacking bed, bank, and OHWM and positive indicators of all the three wetland parameters, looking upslope (west).

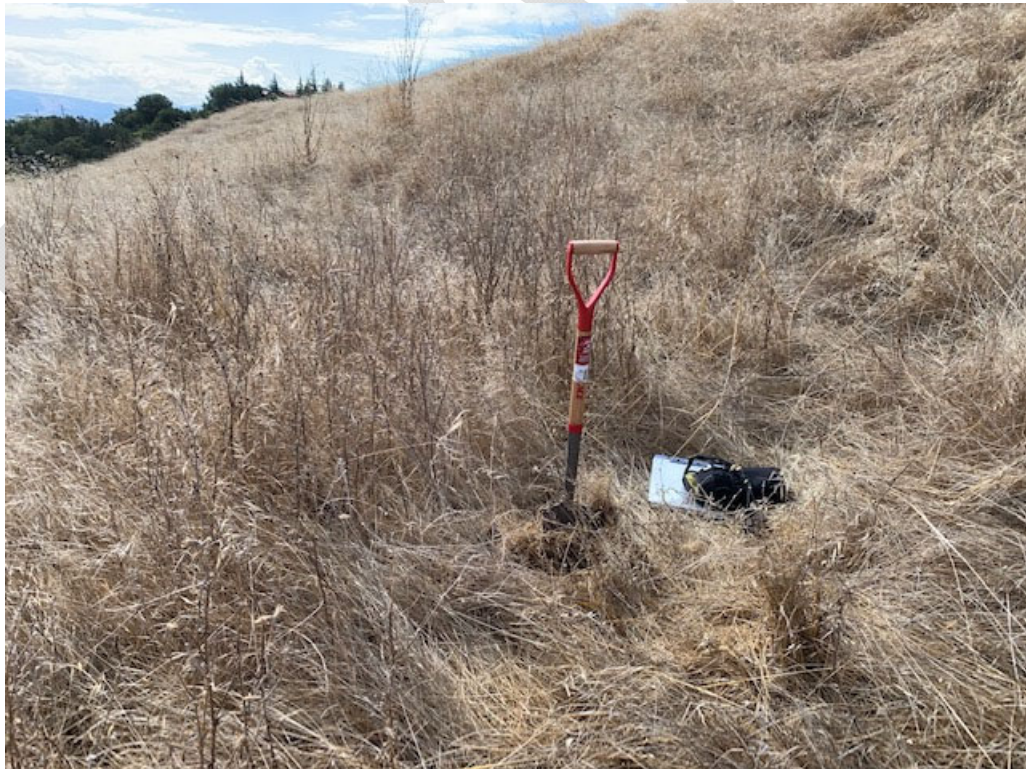
Appendix C-14. Sample Point 8 in shallow basin, lacking positive indicators of all three wetland parameters, looking south.
