COUNTY OF SAN MATEO, PLANNING AND BUILDING DEPARTMENT

**NOTICE OF INTENT TO ADOPT  
MITIGATED NEGATIVE DECLARATION**

FILE NO.: PLN2017-00135 (AT&T) and PLN2006-00075 (Sprint PCS)

1. **Project Title:** Renew existing Sprint PCS cell facility, legalize existing AT&T cell facility, 2,065 cubic yards of grading to repair existing eroded hiking trail/access road and relocate existing above-ground above poles to underground within hiking trail/access road.

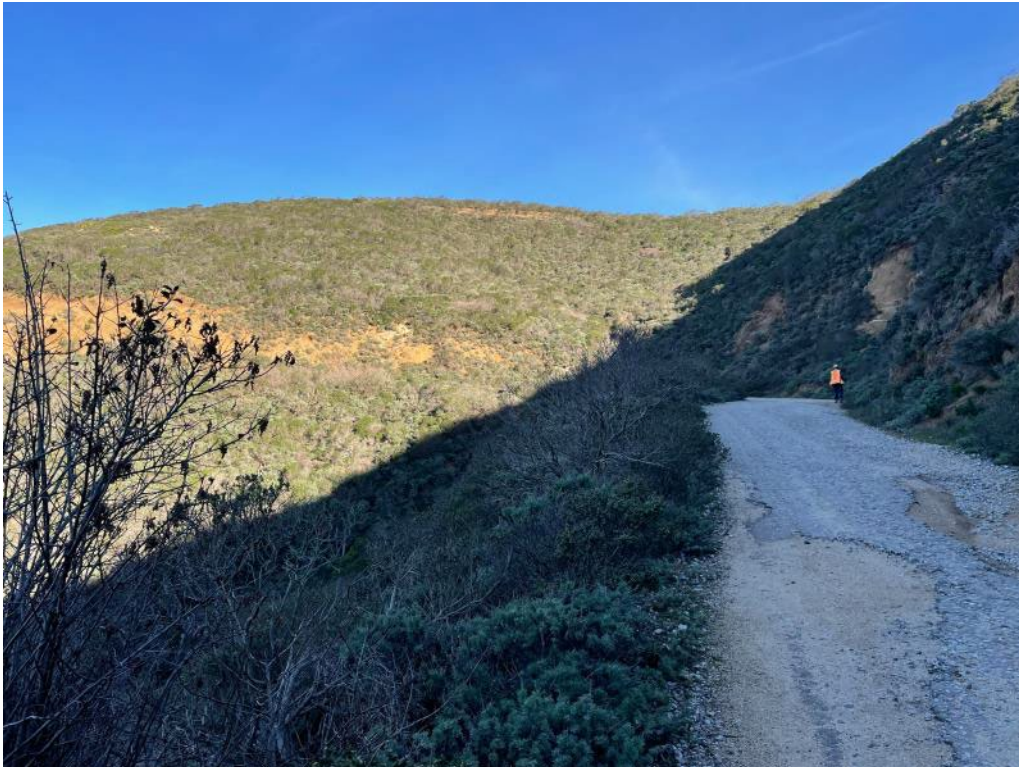
**Photo B-1.** Example of coyote brush scrub, the dominant vegetation community along North Peak Access Road (2/8/2022)

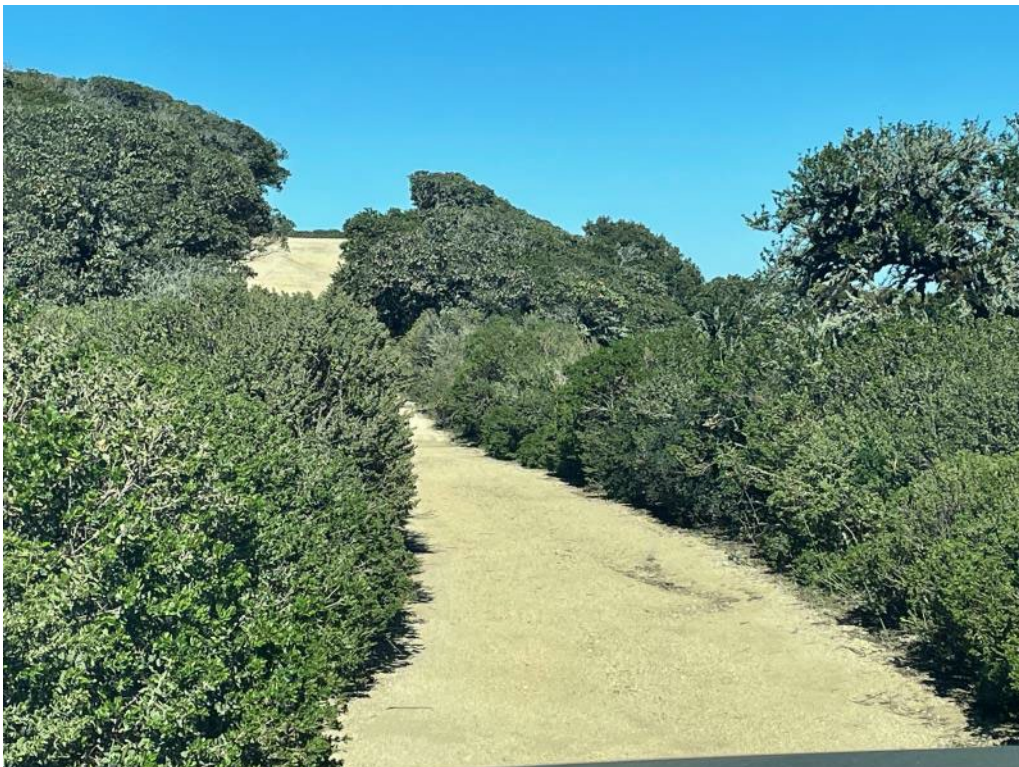
**Photo B-2.** Coyote brush scrub encroaching into the roadway (2/8/2022)
