BIOLOGICAL RESOURCES ASSESSMENT

Battenburg Residence

Paso Robles, San Luis Obispo County, California

June 2022

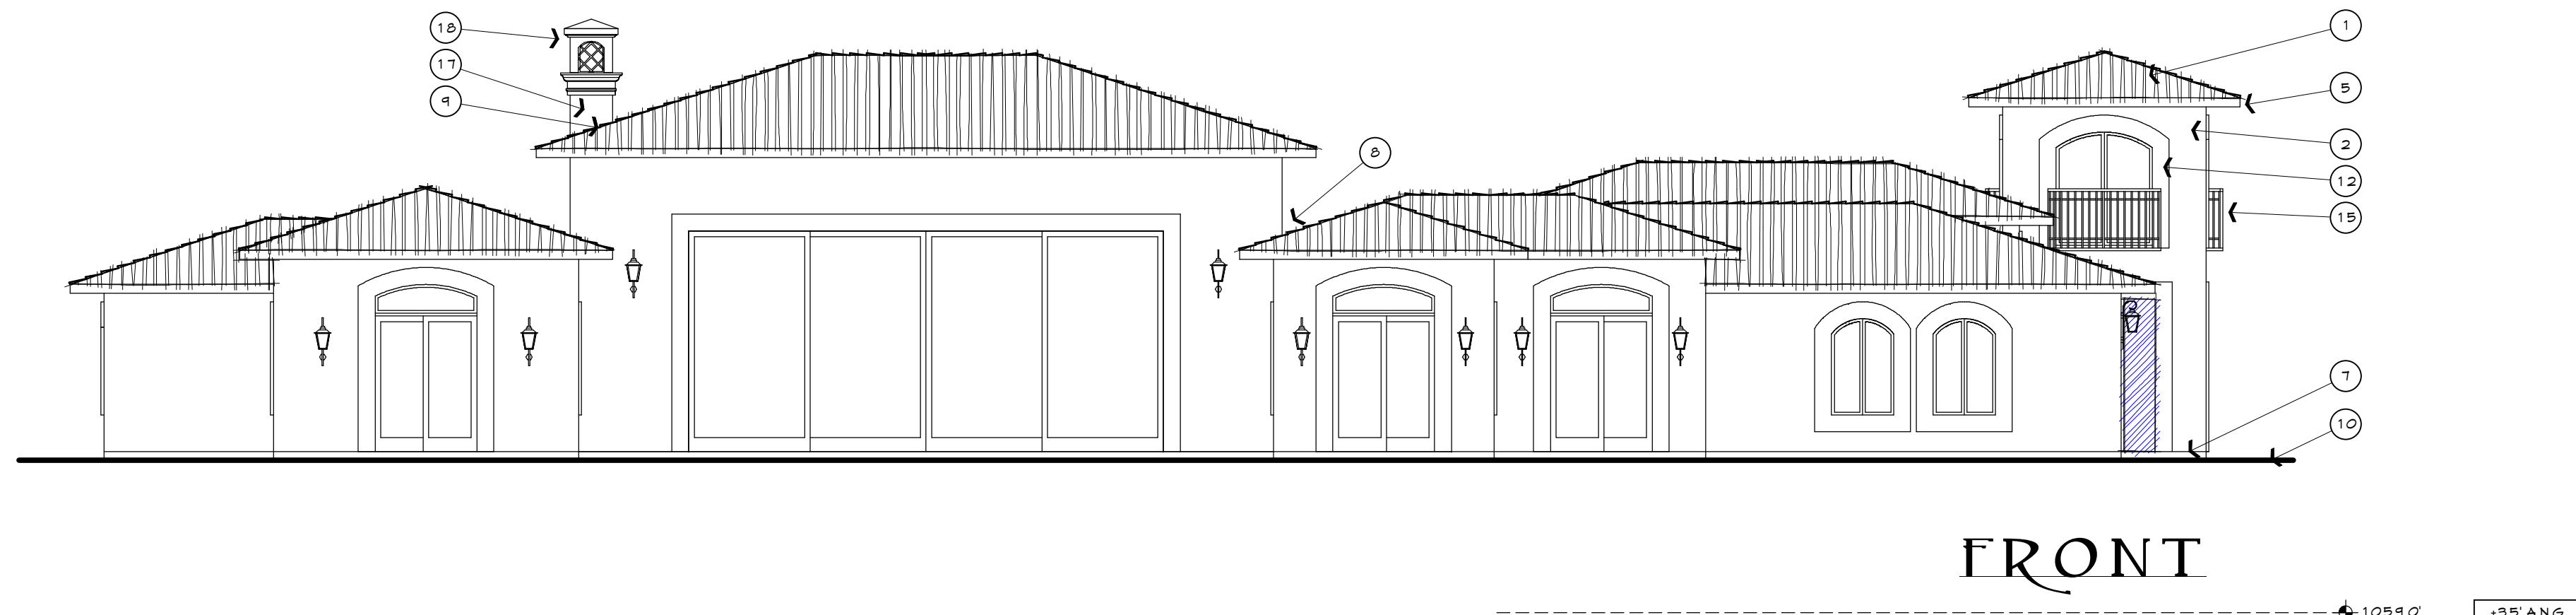
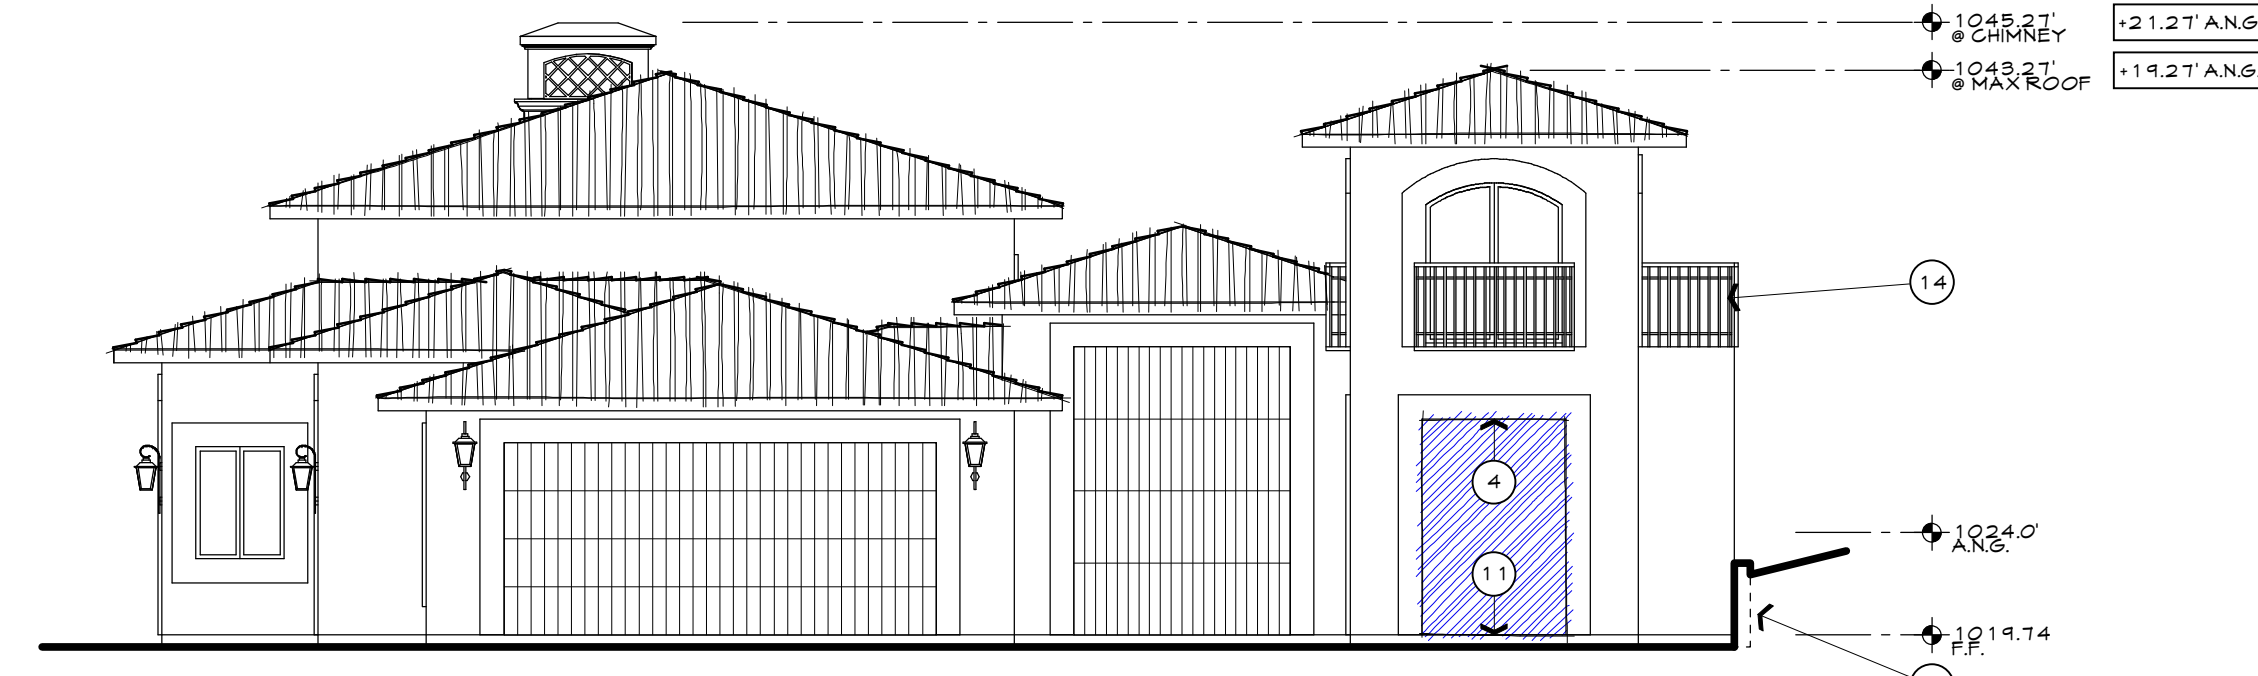
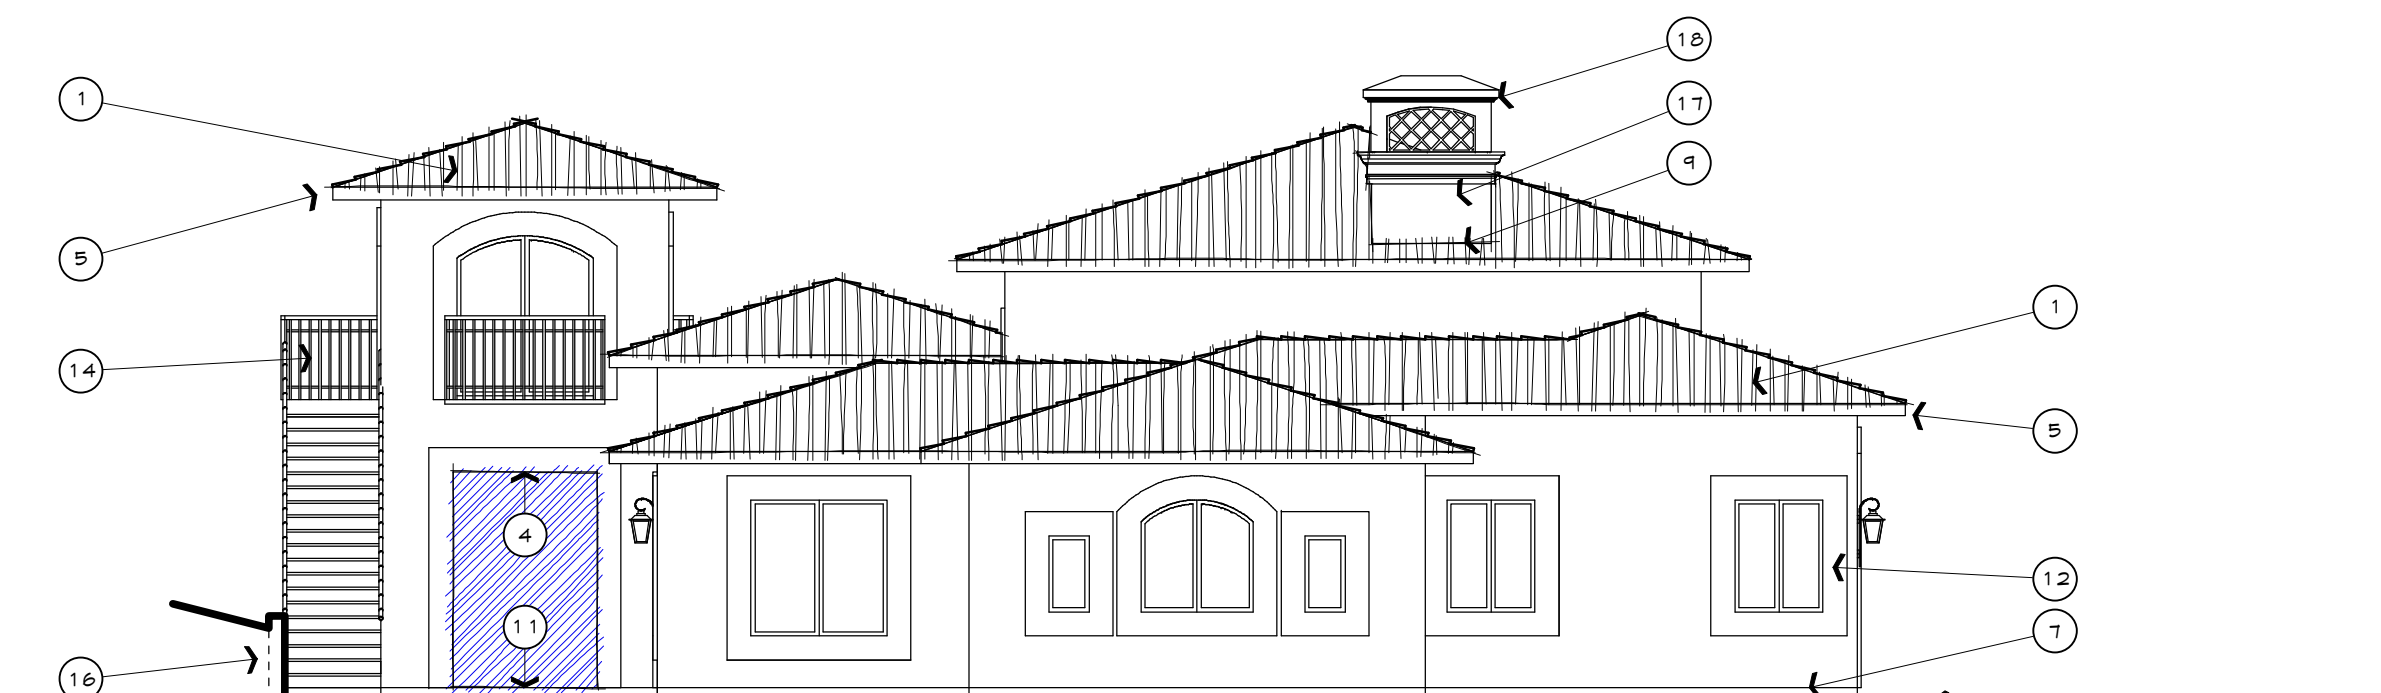
LOW	1011.0	HIGH	1031.0
ANG.	1011.0 + 1031.0		1024.0
			2
MAX. BUILDING HEIGHT ALLOWED	1024.0 + 35 = 1059.0		
PROPOSED BUILDING HEIGHT	1011.4 + 23.33 = 1045.27 = 6 CHIMNEY		
	1045.27 < 1059.0

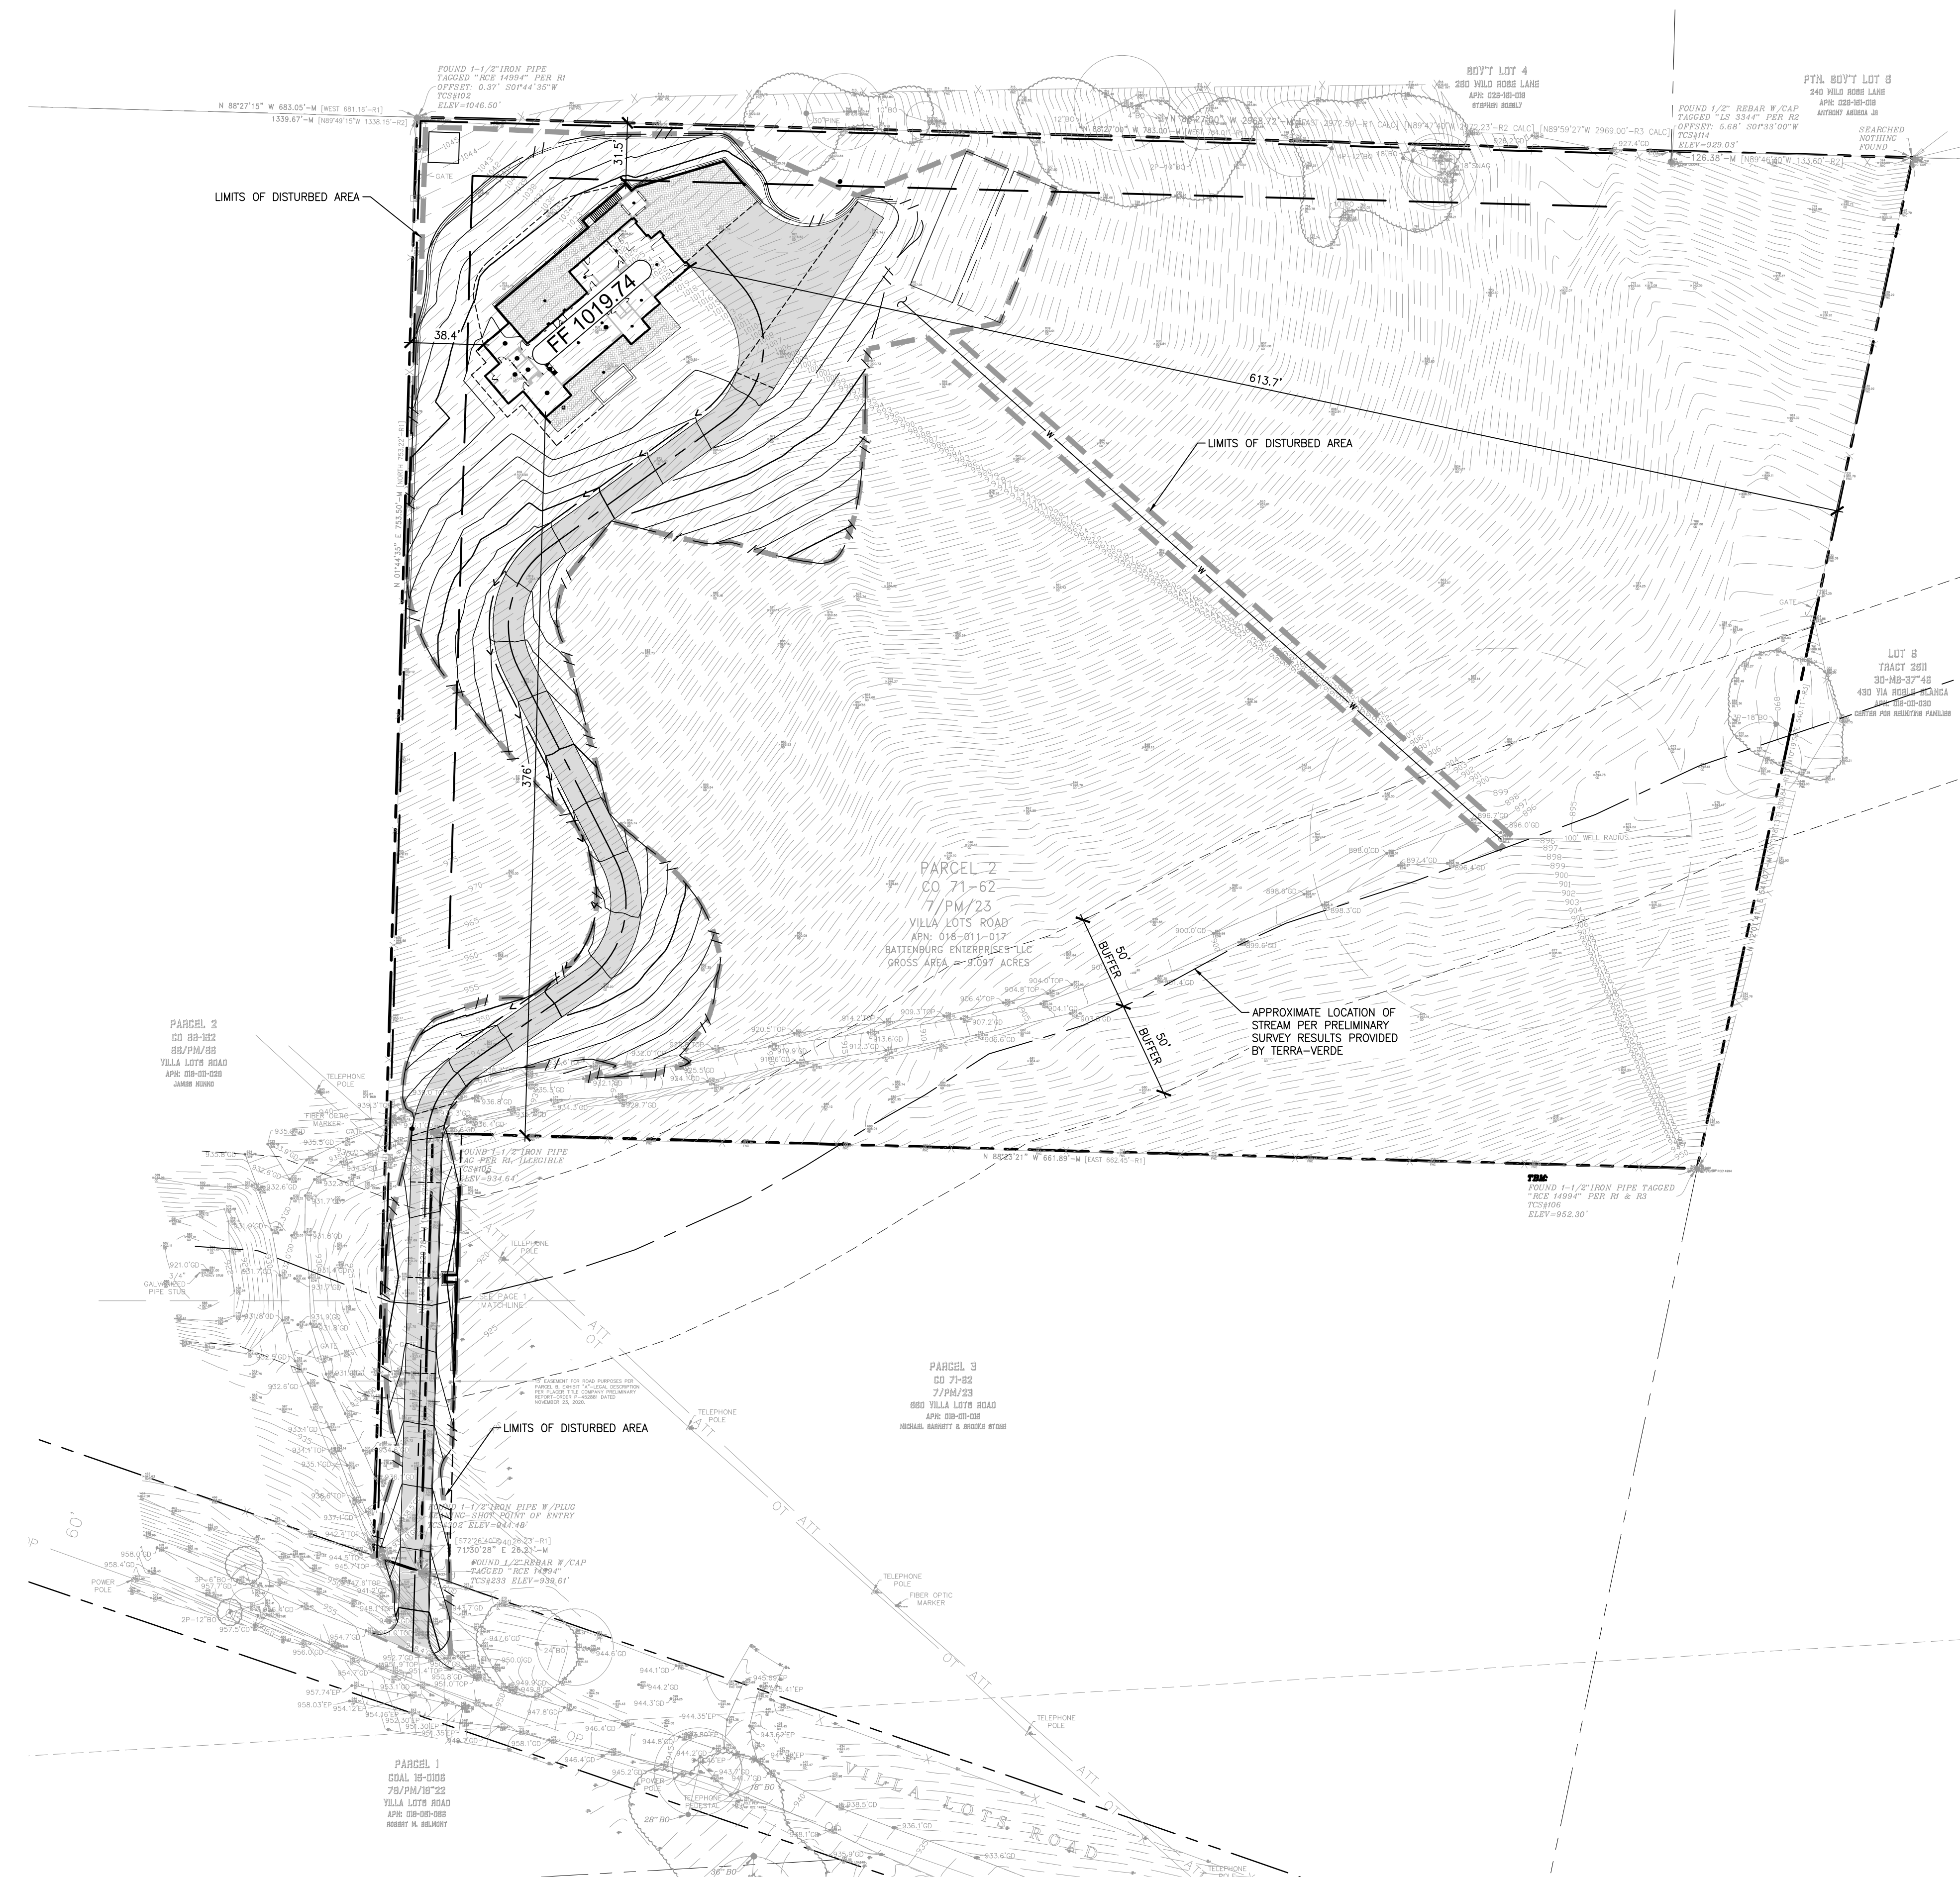
OVERALL SITE PLAN

A. PROJECT AREAS:
 RESIDENTIAL SITE AREA OF DISTURBANCE = 1.0 AC
 DRIVEWAY SITE AREA OF DISTURBANCE = 1.1 AC
 TOTAL AREA OF DISTURBANCE = 2.1 AC

TOTAL PROPOSED IMPERVIOUS AREA = 0.7 AC
 TOTAL PROPOSED PERVIOUS AREA = 1.4 AC

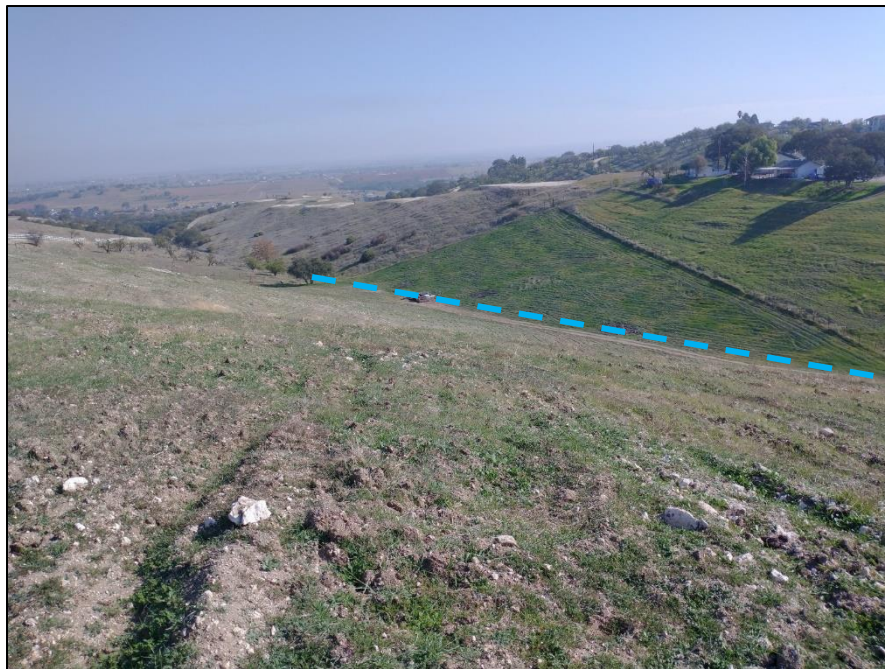
Photo 2. View southeast from proposed residence of grassland habitat and the drainage (blue line) along the topographic low point (12-08-21).

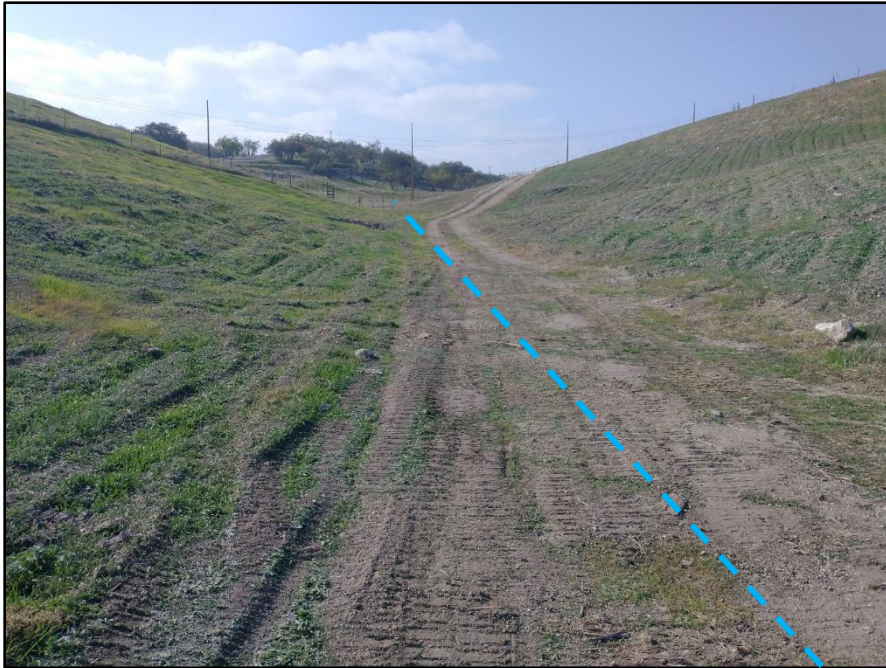
drainage does not have a clearly defined bed, bank, or evidence of an ordinary high-water mark (OHWM) likely due to historical (orchard) and current land use (site preparation for vineyard) and the upstream impoundment. No evidence of recent flows was observed during the site surveys; however, evidence may have been obscured by current activities on site related to the installation of the vineyard. As such, it is assumed this drainage would likely be considered waters of the state under jurisdiction of the CDFW and RWQCB.

Photo 3. View west of the drainage showing lack of definition due to historical and ongoing land use. Approximate path of the drainage shown in blue (12-08-21).

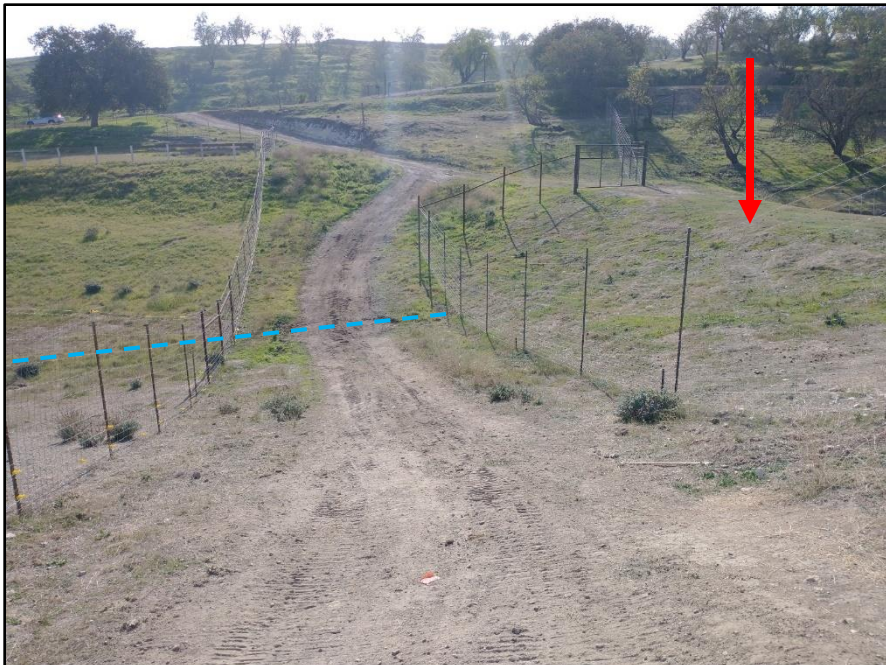
Photo 4. View south of dirt access road crossing the drainage (dashed blue line). Note the earthen berm (red arrow) just upstream of the property impounding the drainage (12-08-21).

Direct and/or indirect impacts to the drainage will occur during the implementation of the proposed project. The entrance road will cross the drainage along the western boundary of the property and the drainage will be culverted under the roadway. In addition, indirect impacts to the drainage could result from erosion, sedimentation, and/or discharges of hazardous materials, such as fuel, from construction equipment. It is expected that as proposed, project activities will require regulatory authorizations from CDFW and RWQCB. Typically, these agencies require mitigation to offset permanent impacts to jurisdictional waters, including vegetation removal, with in-kind habitat at an appropriate ratio (i.e., 1:1 to 3:1 ratio depending on quality of habitat).

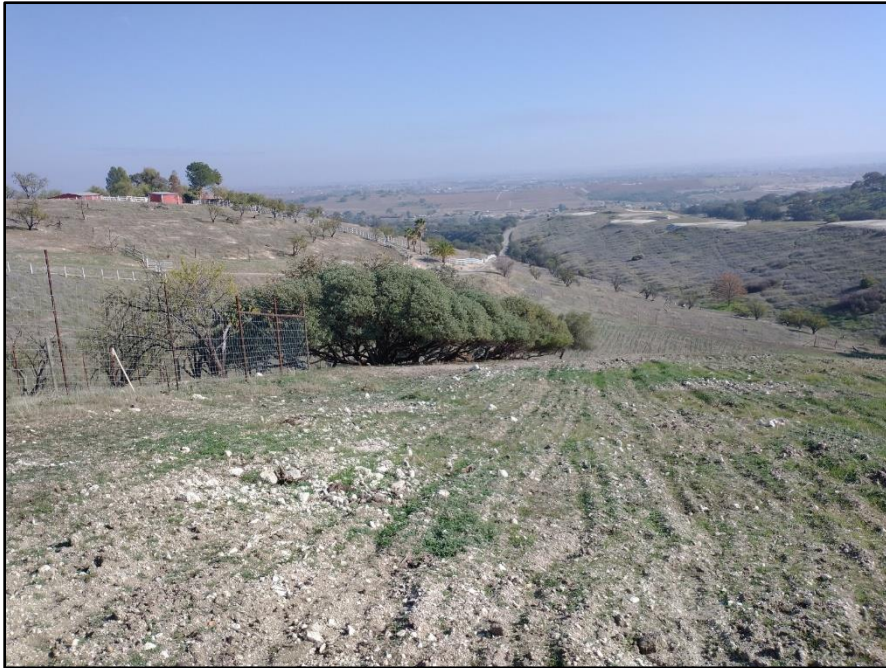
Photo 5. View east of grassland and manzanita chaparral on the northern edge of the project site (12-08-21).

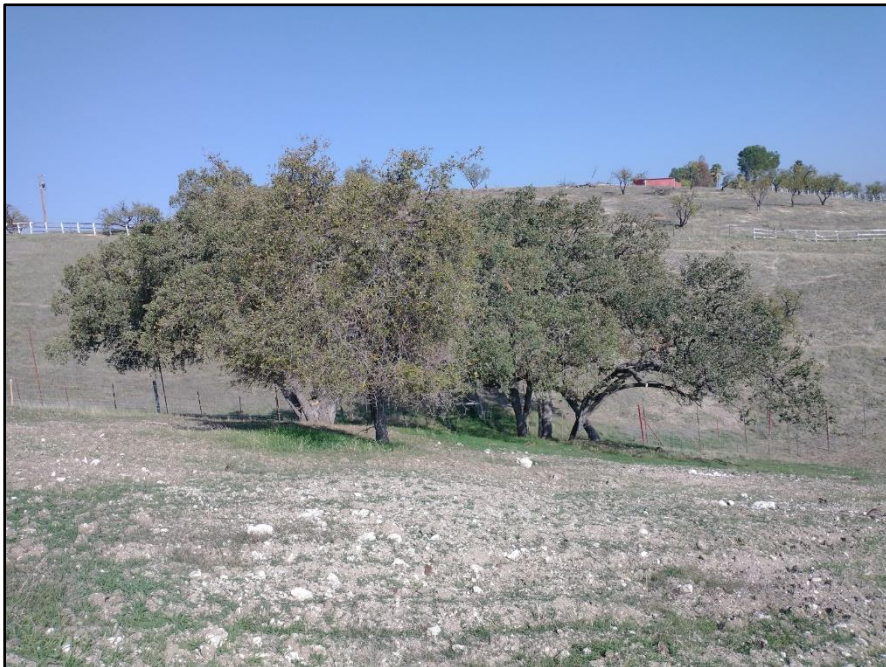
This community occurs in a remanent patch on the ridge along the northern edge of the survey area (see Appendix A – Figure 6 and Appendix E – Photo 6). It is dominated by blue oak (*Quercus douglasii*) in the overstory, with an understory of annual grasses and forbs species found in the grassland habitat.

Photo 6. View northeast of oak woodland patch on the northern edge of the project site (12-08-21).

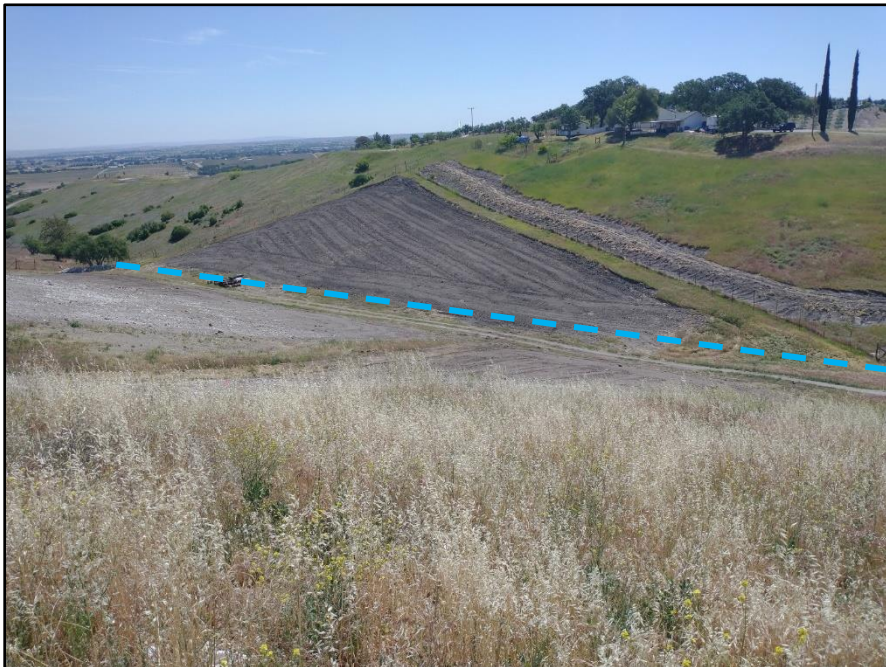
Photo 8. View southeast from proposed residence of grassland habitat (foreground), grading for vineyards, and the drainage (blue line) along the topographic low point (04-14-22).

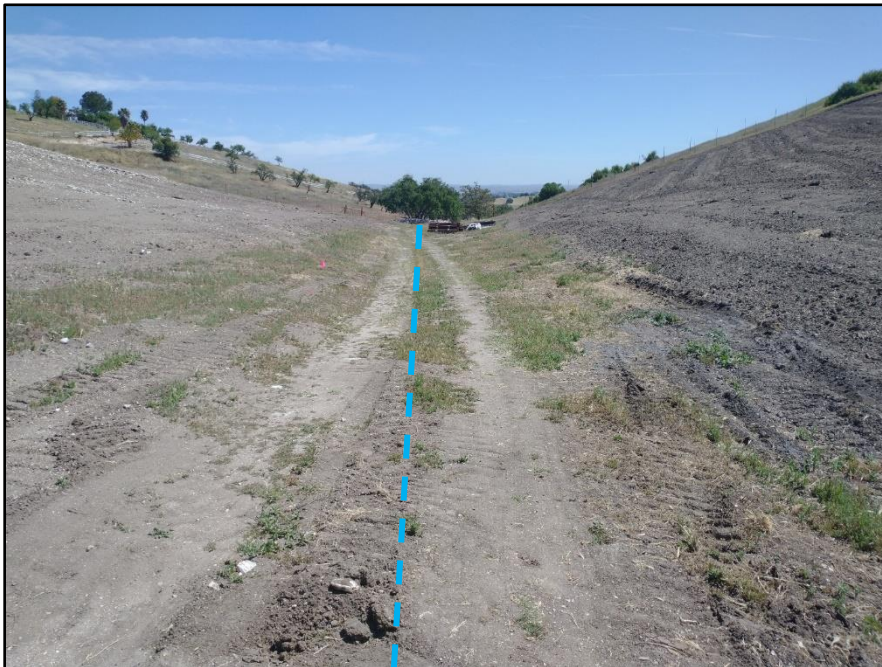
The drainage was identified as jurisdictional waters of the state under the jurisdiction of CDFW and RWQCB, though due to historical land use and the upstream impoundment it lacks a well-defined bed, bank, or channel. In addition, the drainage lacked evidence of OHWM and therefore, likely does not fall under the jurisdiction of the Corps. Impacts to the drainage will likely require appropriate regulatory agency permits and mitigation, per CDFW and RWQCB requirements. Further, recommendations are provided for the avoidance and minimization of impacts to the drainage during construction in Section 4.2 below.

Photo 10. View east along the drainage (blue line) showing lack of defined bed and bank due to historical and ongoing land use (04-14-2022).
