MERIDIAN STORM DRAIN PROJECT

BIOLOGICAL TECHNICAL REPORT

Riverside County, California

June 9, 2023

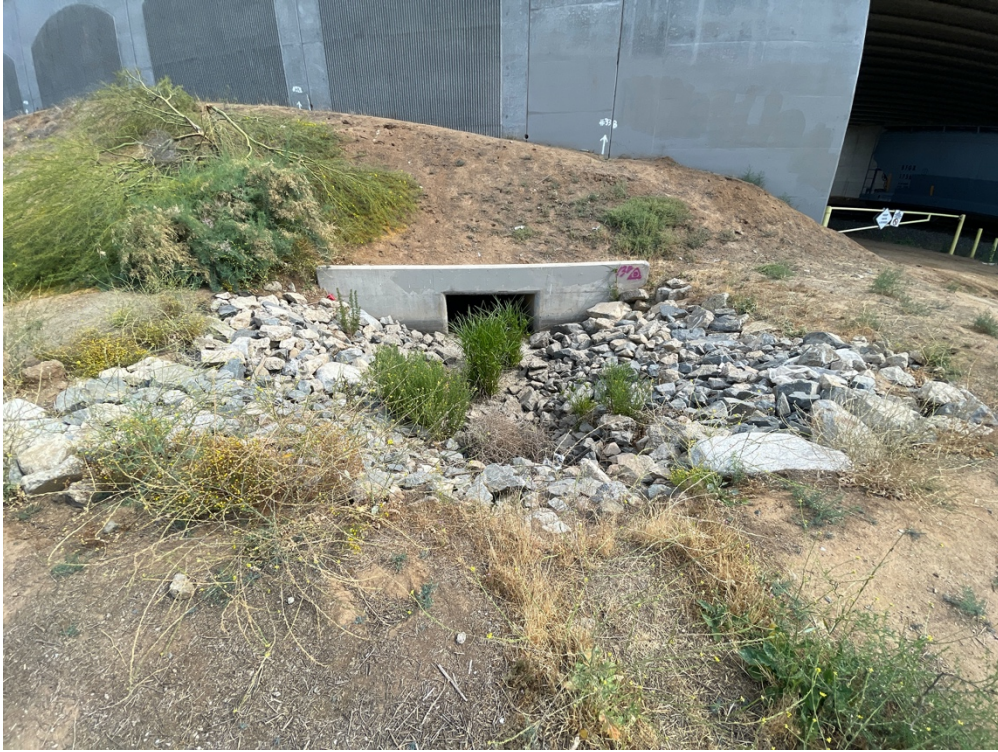
Photo 3. View of northern extent of ephemeral channel and project impacts where storm drain will connect to existing reinforced concrete box culvert, facing north.

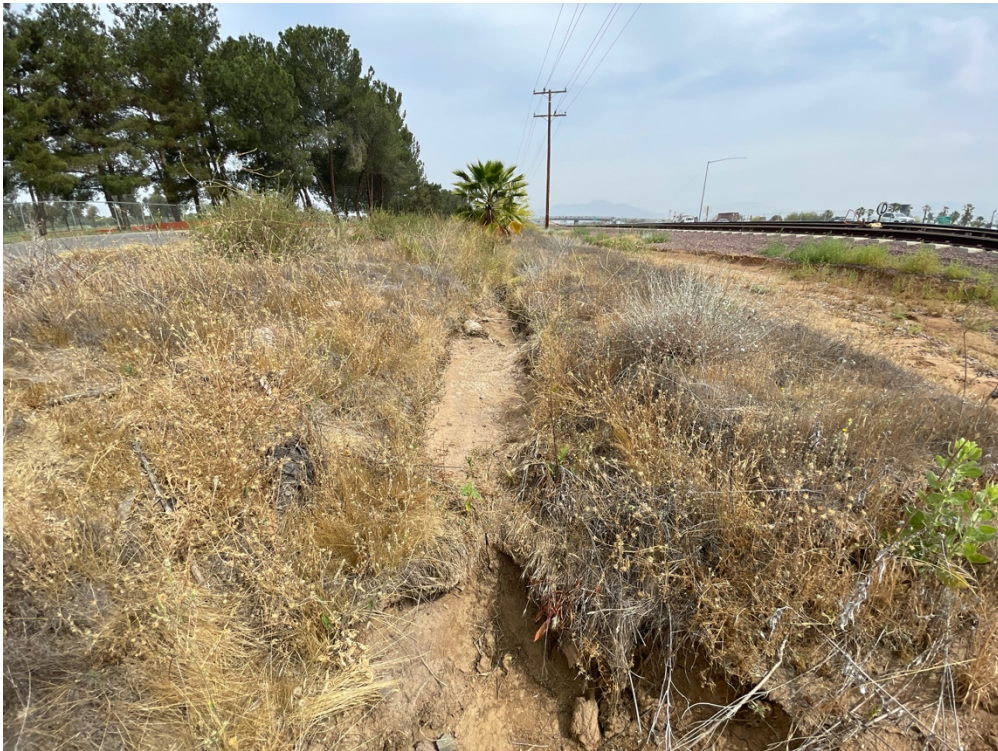
Photo 4: View of ephemeral channel near the center of the survey area, facing north.

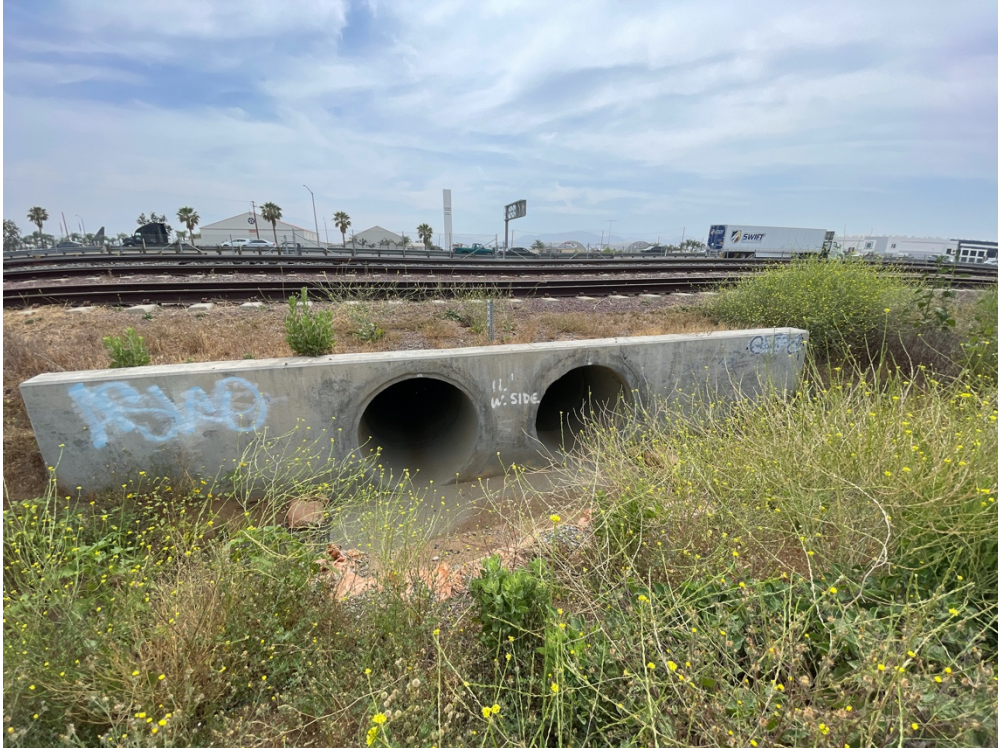
Photo 5. View of dual reinforced concrete box culverts where the storm drain will connect at the southern terminus of the project, facing east.

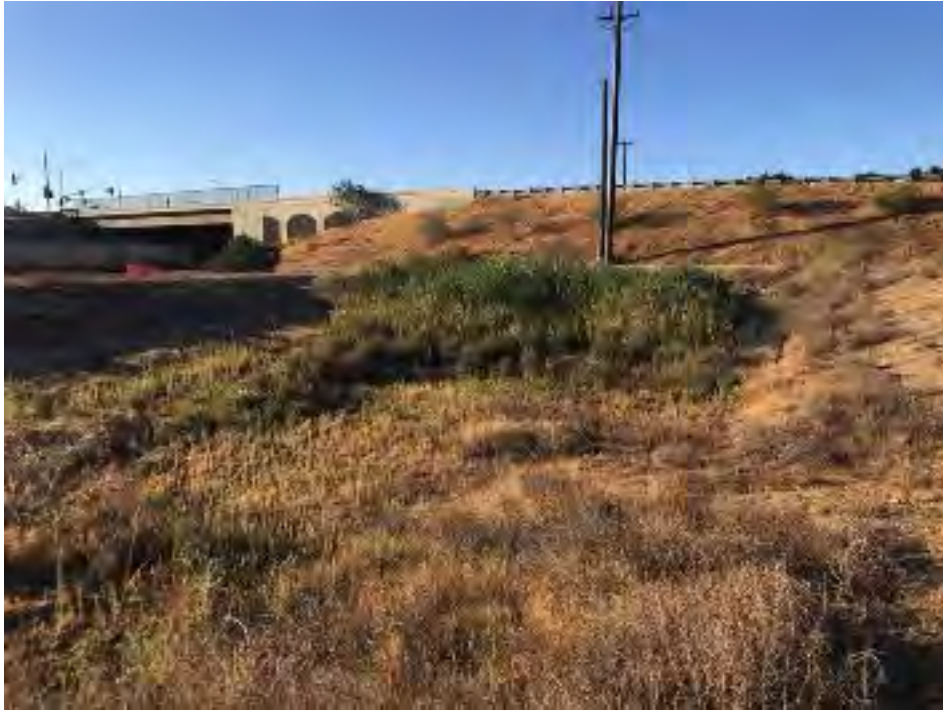
Photo 1. Overview of Feature 1 (F1). Area is between a berm adjacent to the railroad track/Interstate 215 (I-215) and commercial property. Photo taken facing south. June 27, 2018

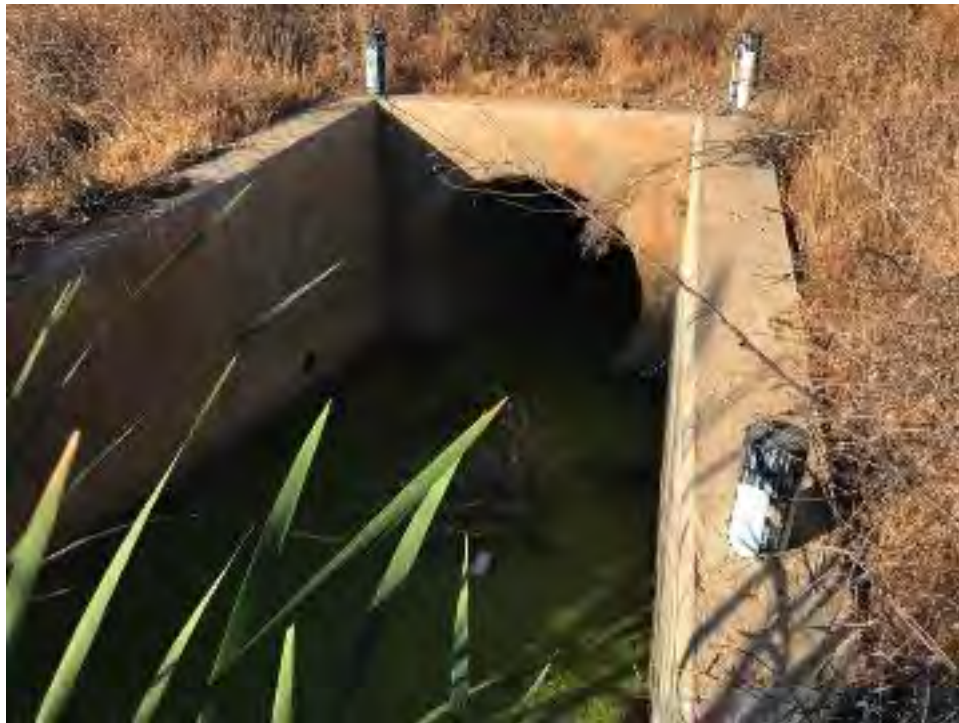
Photo 2. View of one of the culverts that feeds into F1. Culvert contains standing water and is approximately 45 feet away from the culvert that drains the entire feature. June 27, 2018

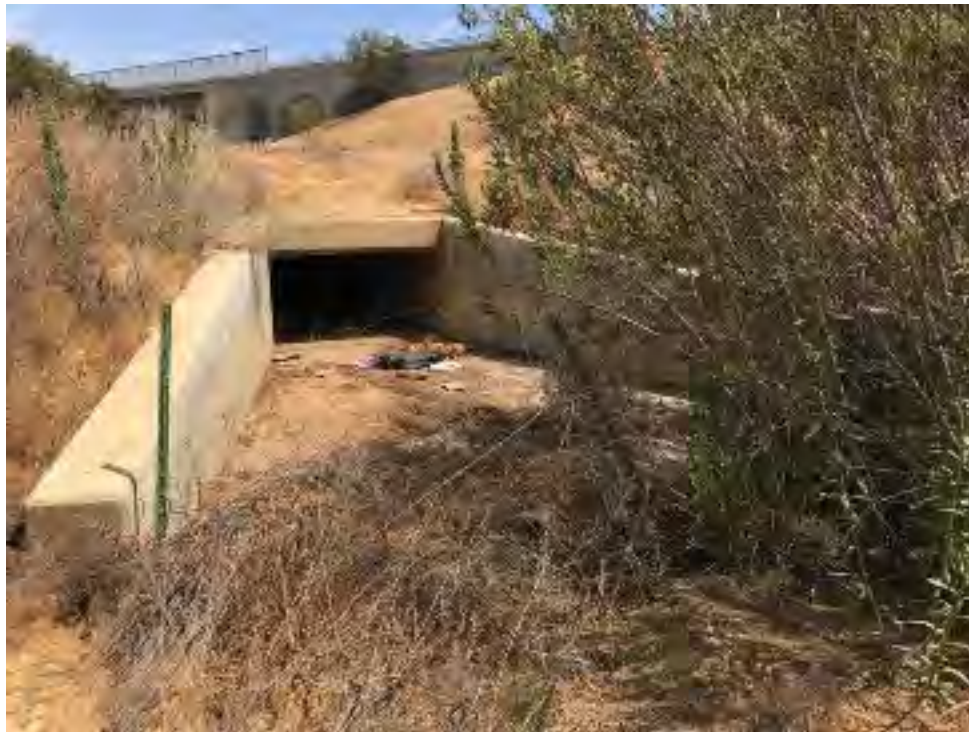
Photo 3. View of F1 downstream culvert. This culvert runs across I-215 to a large canal within March Air Force Base. Photo taken facing south. June 27, 2018

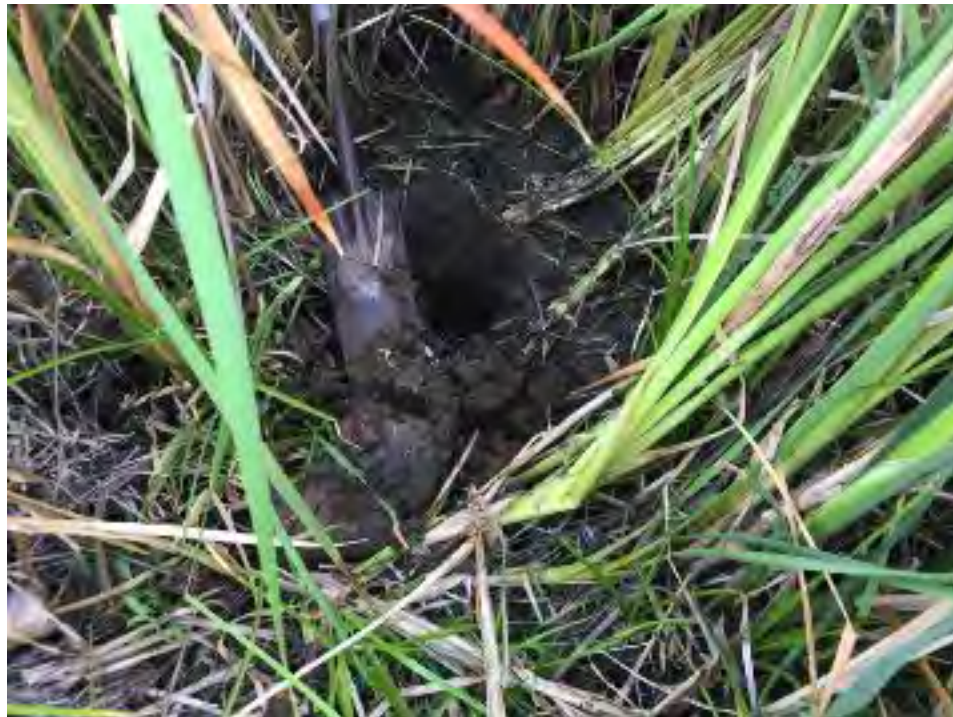
Photo 4. Wetland Sample Pit 1 (WSP 1). The sample point met the hydrophytic vegetation, wetland hydrology, and hydric soil parameters. June 27, 2018

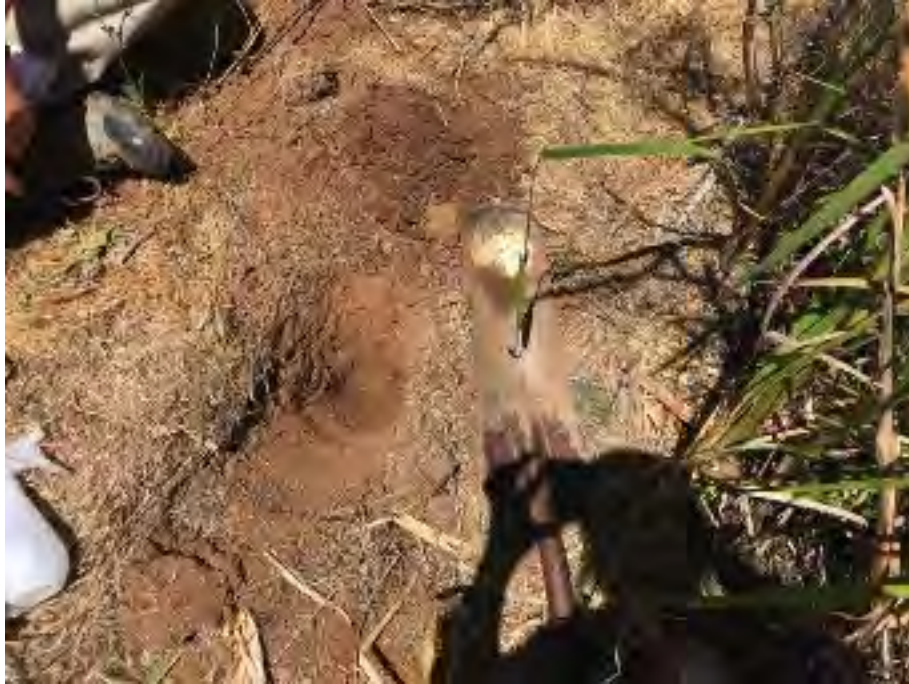
Photo 5. Wetland Sample Pit 2 (WSP 2), The sample point was taken in the uplands adjacent to an area dominated by *Typha latifolia* where WSP 1 was taken. The sample point contained hydrophytic vegetation but did not have wetland hydrology or hydric soil indicators. June 27, 2018

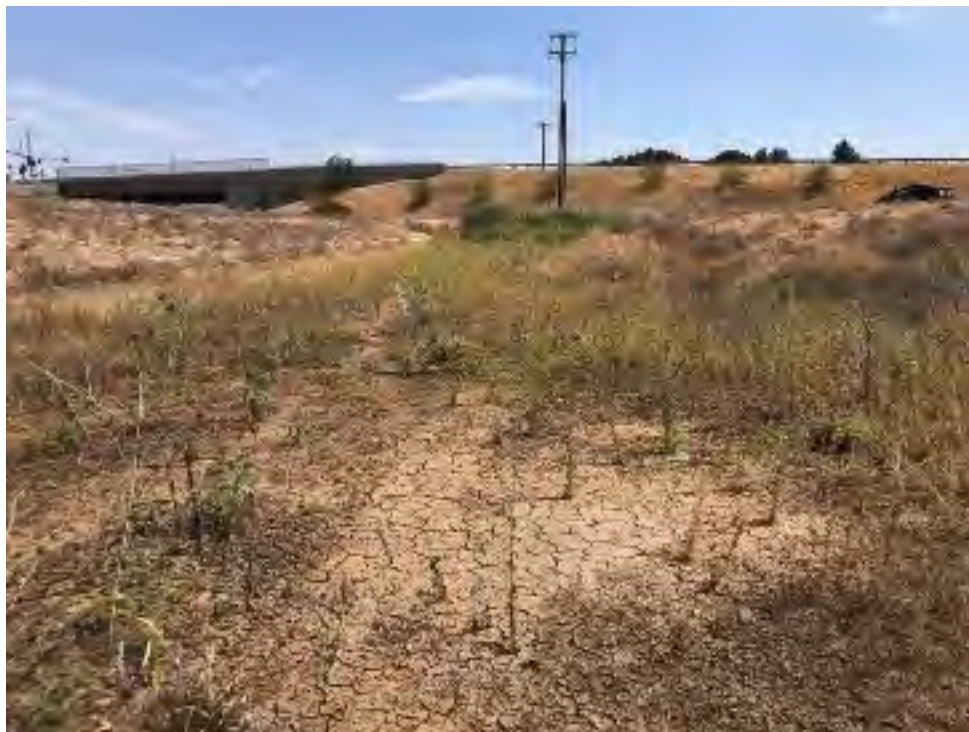
Photo 6. View of F1 at the location where Ordinary High Water Mark (OHWM) Data Point 1 was taken. The OHWM was defined by a slight break in slope and change in sediment texture, vegetation cover and vegetation species. Photo taken facing south, downstream, towards the wetland area and culverts. July 18, 2018

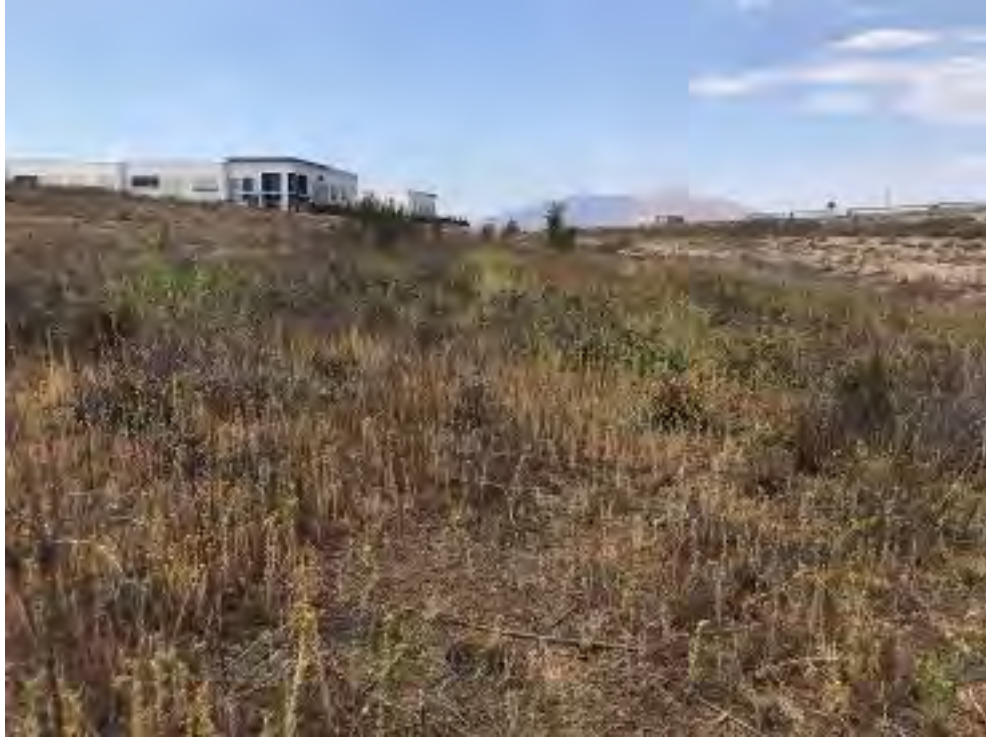
Photo 7. F1 at OHWM 1 facing north, upstream. Photo shows continuous soil cracks throughout feature and adjacent banks with vegetation cover change. July 18, 2018

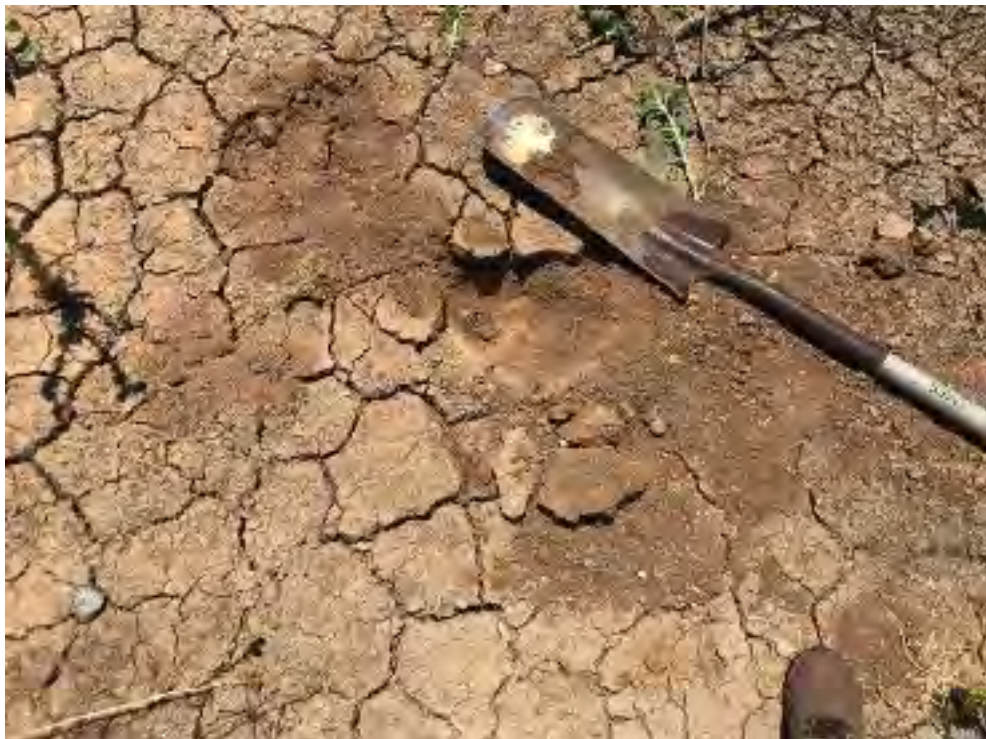
Photo 8. Wetland Sample Point 3 (WSP 3), taken within F1 given the presence of large soil cracks. The sample point met the hydrophytic vegetation and wetland hydrology parameters; however, hydric soil indicators were not observed. June 27, 2018

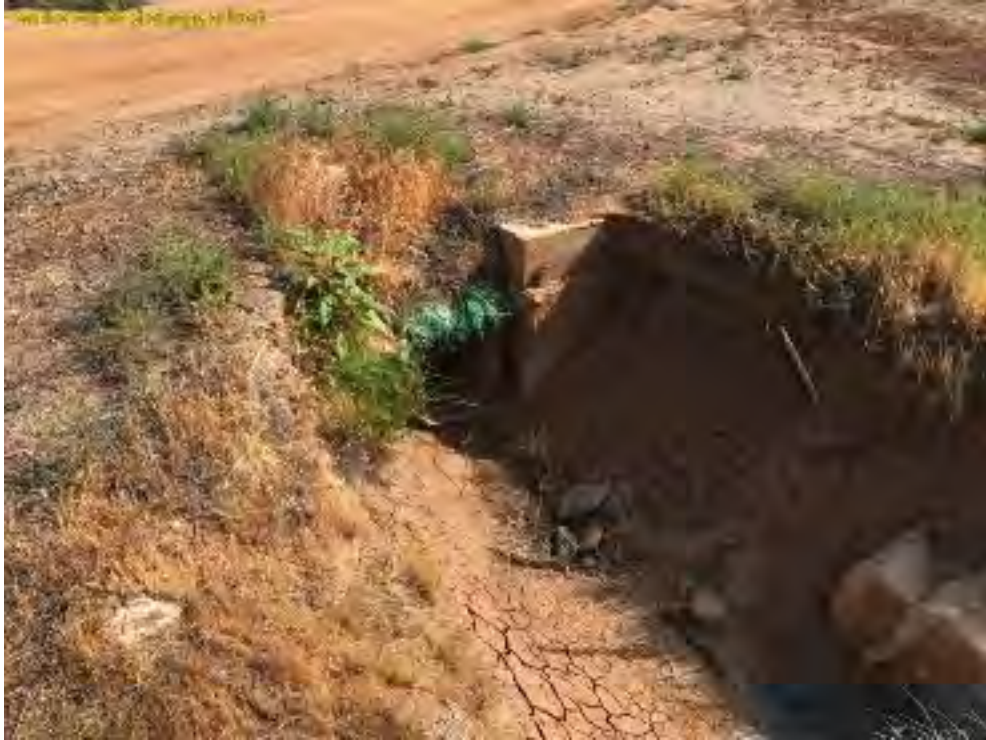
Photo 9. View of a culvert crossing under a dirt road within Feature 2 (F2).
Photo taken facing upstream, north. July 18, 2018

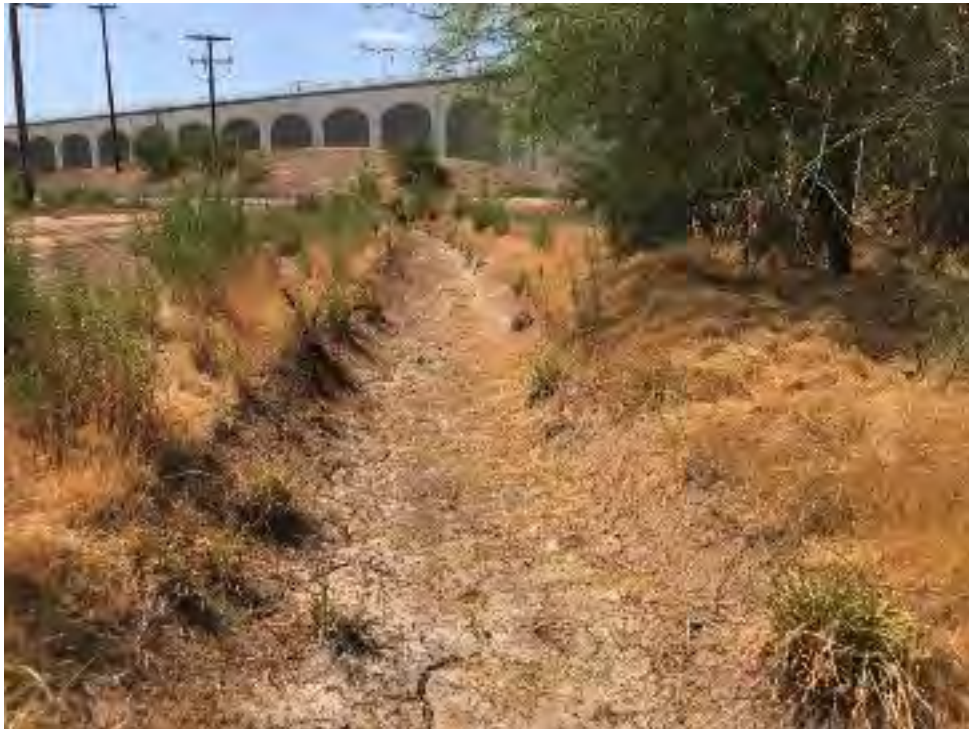
Photo 10. Upstream view of F2 at OHWM Data Point 2. The OHWM is defined by the presence of a break in slope with a bed and bank and change in vegetation cover and sediment. Photo taken facing north. July 18, 2018

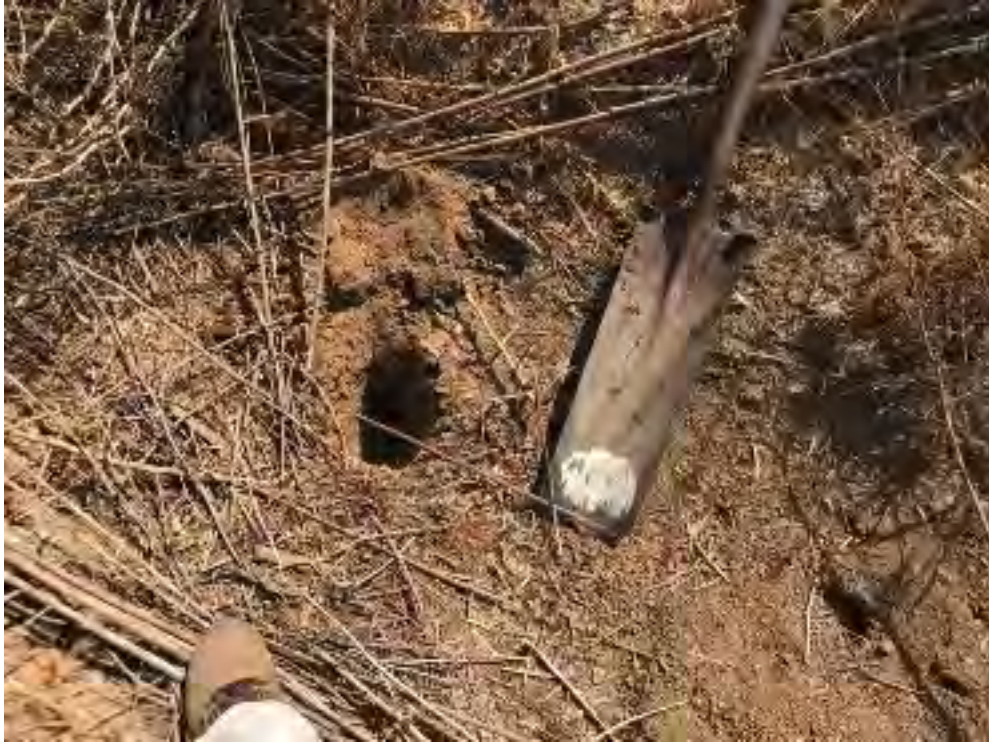
Photo 13. Wetland Sample Point 4 (WSP 4). The sample point met the hydrophytic vegetation and wetland hydrology parameters; hydric soils were not observed. July 18, 2018

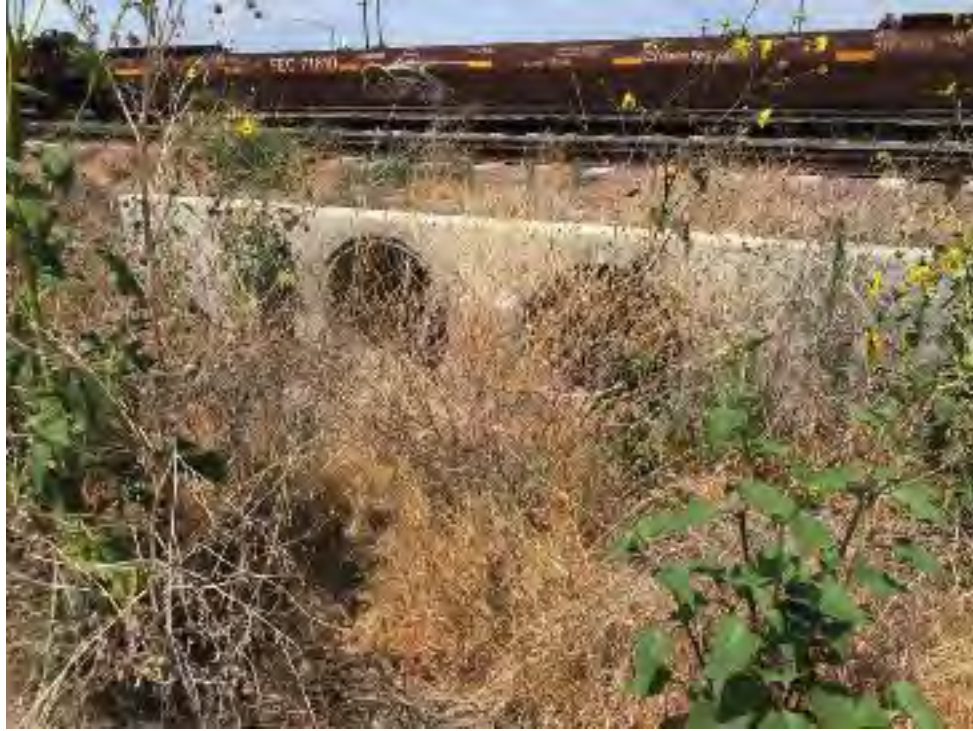
Photo 15. Downstream culverts at the end of F2. The culverts drain across I-215 to a canal within March Air Force Base. Photo taken facing east. July 18, 2018

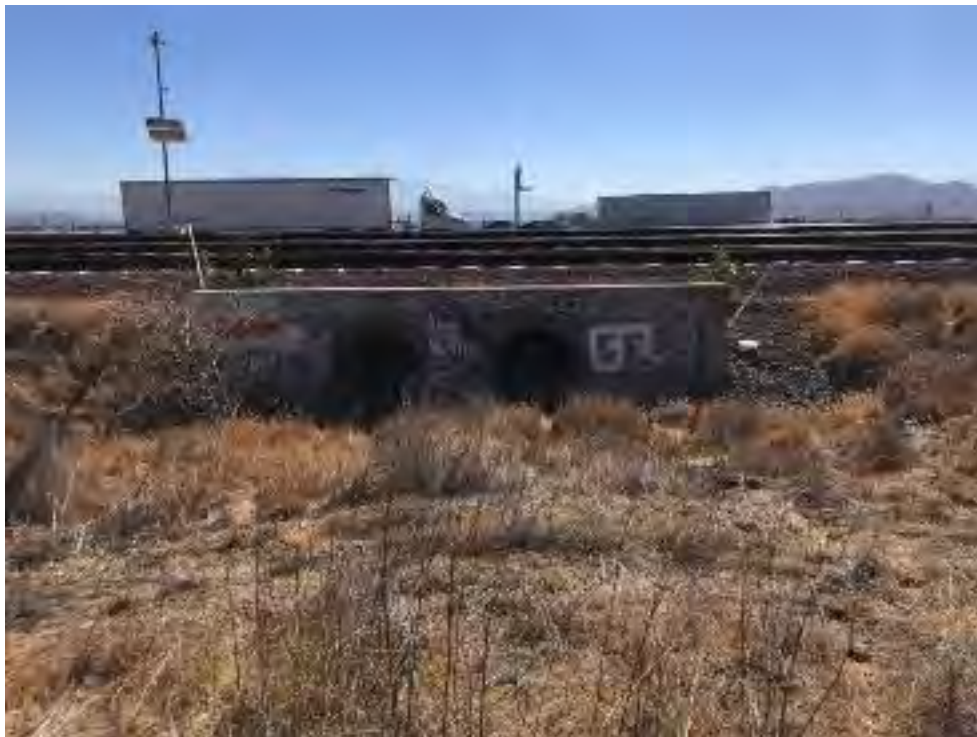
Photo 18. View of F3 downstream culverts. Culverts runs under the railroad track and I-215, draining into a large canal on the adjacent March Air Reserve Base.

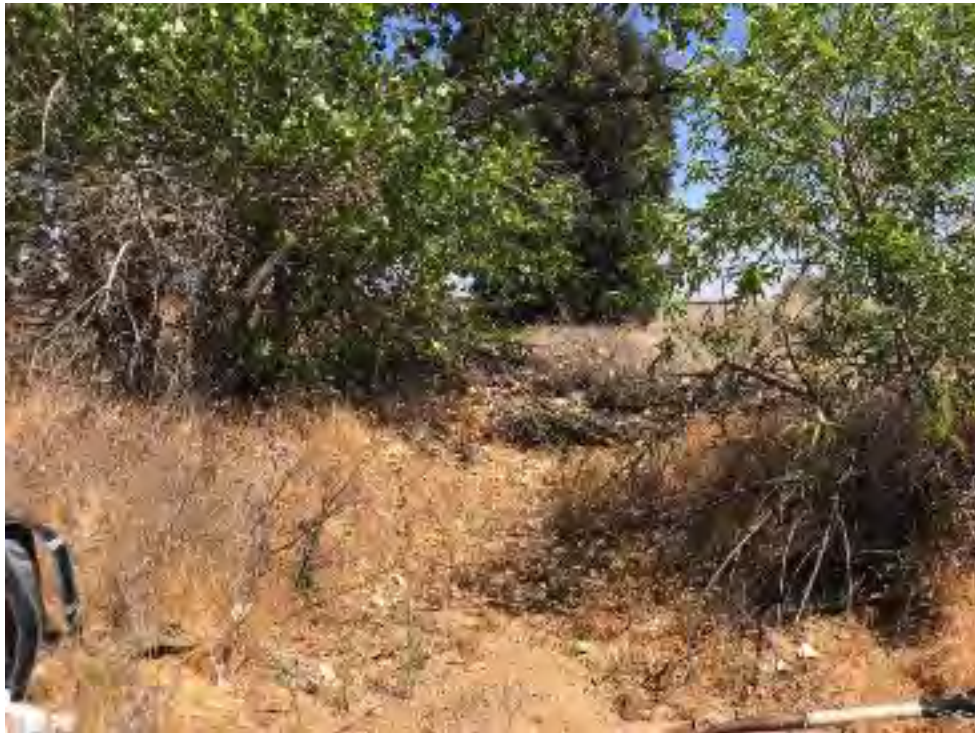
Photo 22. Downstream view of F3 at the location of OHRM Data Point 3 and Wetland Sample Point 3 (WSP 3). OHRM 3 is defined by a break in slope, change in sediment texture, vegetation species and cover. Photo taken facing southeast. June 27, 2018.

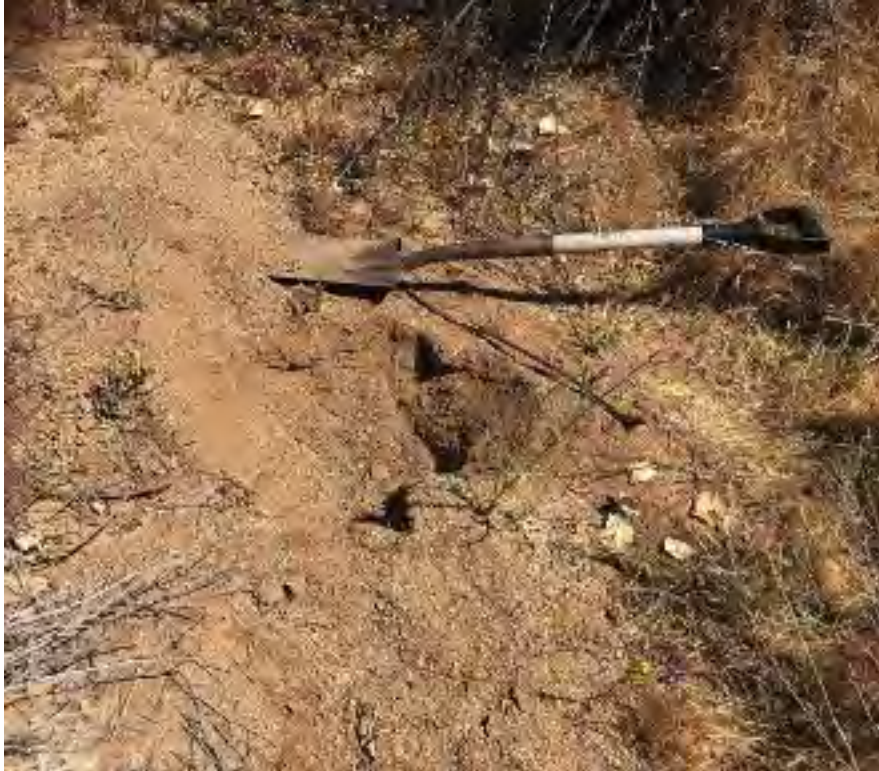
Photo 23. WSP 5, taken within F3. The sample pit met wetland hydrology indicators; however, hydrophytic vegetation and hydric soil indicators were not present. June 27, 2018

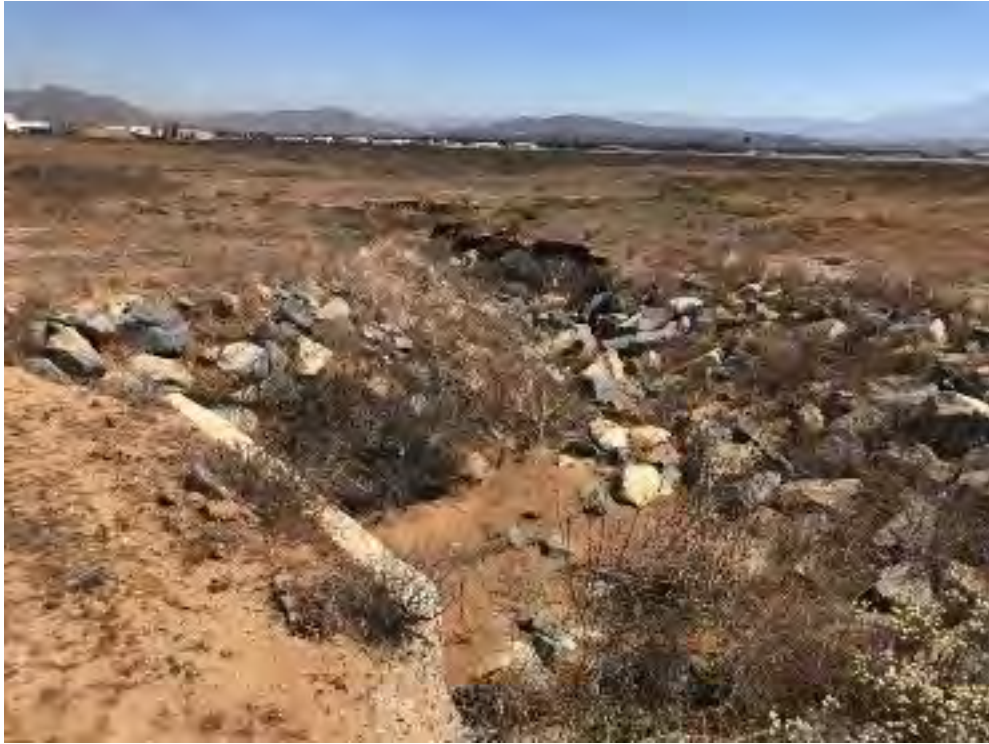
Photo 29. Downstream view at culvert within March Air Reserve Base. F3 appears to drain across I-215 into this culvert, which continues to connect with the larger canal (Photo 27). Photo taken facing east. June 27, 2018
