November 15, 2021

Project No. 024-21066

RE: Phase I Environmental Site Assessment
Agricultural Property - Lorenzi Property
NEC Pensinger and South Allen Roads
APNs 535-010-01, -03 and -04
Bakersfield, California 93311

**PHASE I ENVIRONMENTAL
SITE ASSESSMENT
AGRICULTURAL PROPERTY –
LORENZI PROPERTY
NEC OF PENSINGER AND SOUTH ALLEN ROADS
APNS 535-010-01, -03 AND -04
BAKERSFIELD, CALIFORNIA**

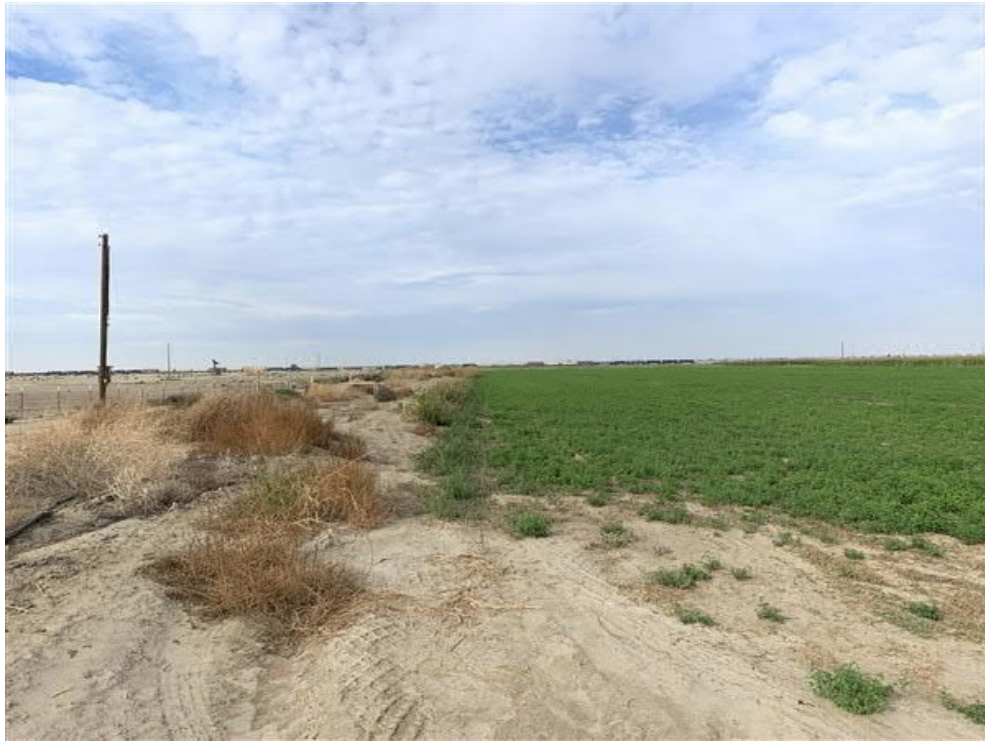
Photo 1: Northern-facing view along the western side of the subject site from the southwest corner of the subject site. This portion of the subject site is in agricultural production of alfalfa. The adjacent property to the west includes a crude oil pipeline. Undeveloped Allen Road is located adjacent to the west.

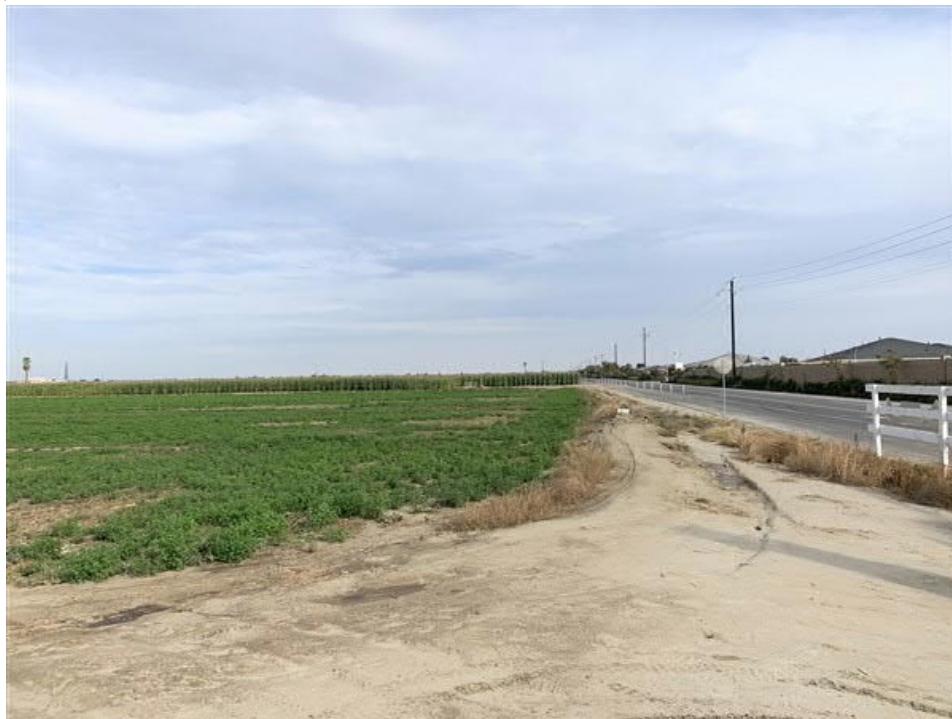
Photo 2 Eastern-facing view along the southern side of the subject site from the southwest corner of the subject site. Pensinger Road is pictured.

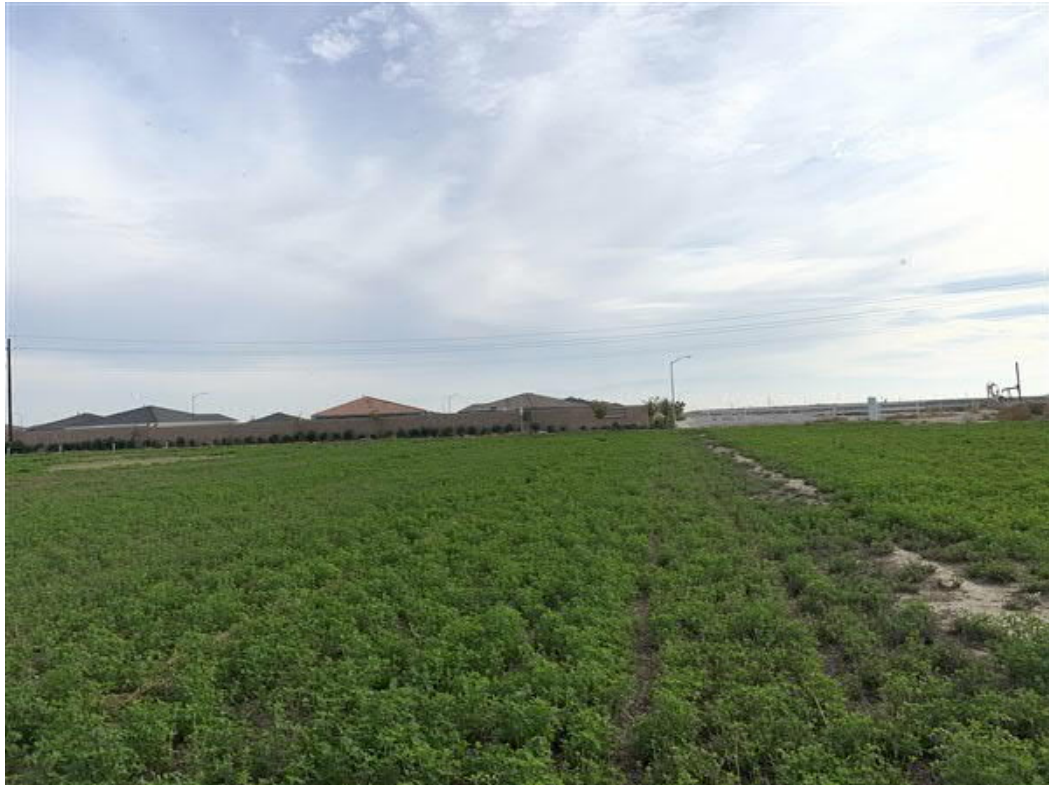
Photo 3: Southern-facing view of the southwestern part of the subject site. Residentially developed properties are pictured adjacent to the south of Pensinger Road.

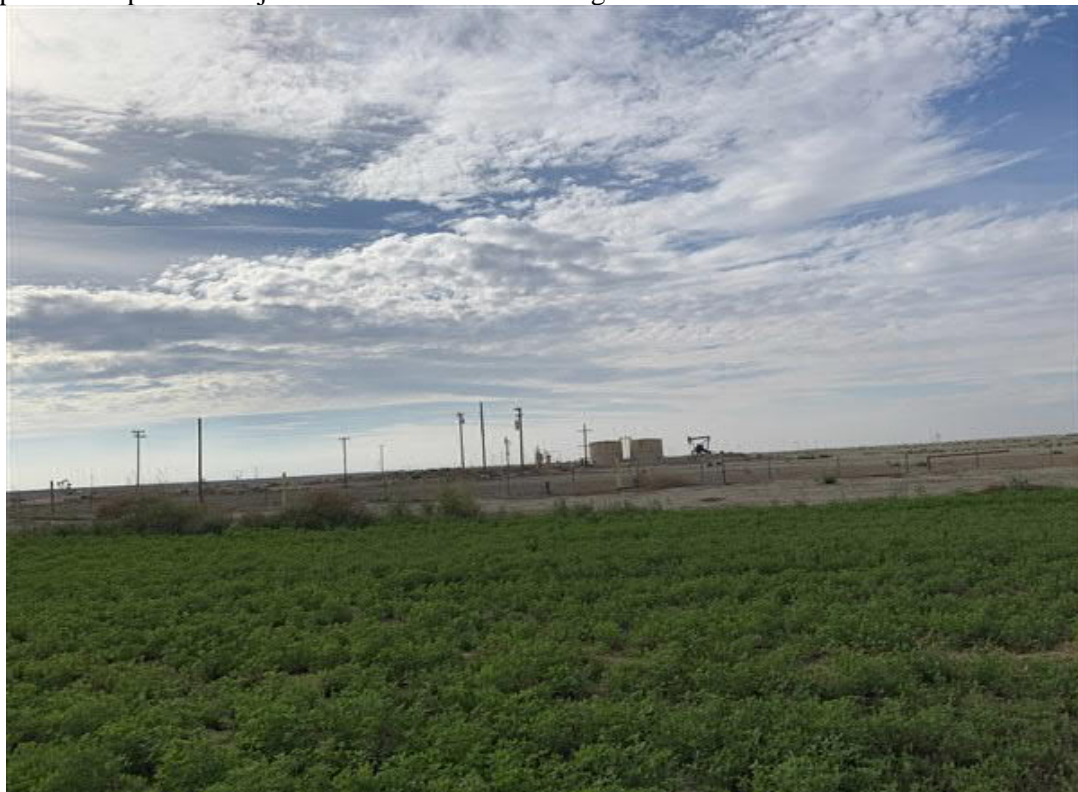
Photo 4: Western-facing view from the northwestern part of the subject site. An oilfield tank farm is pictured offsite in the distance to the west.

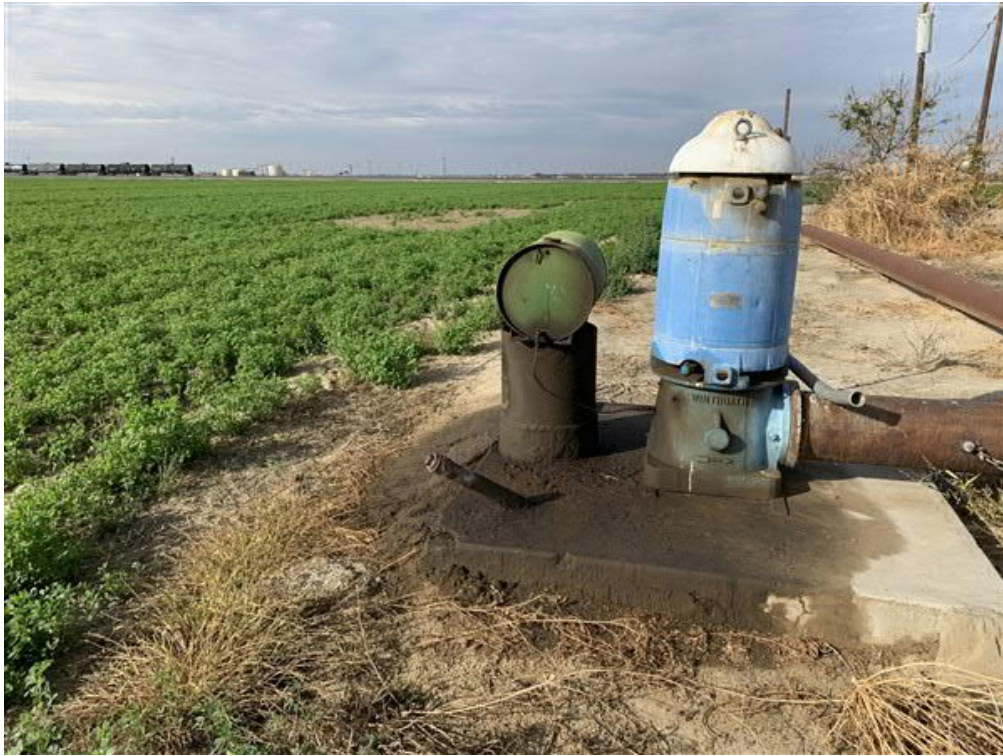
- An electrically powered water well is located within the northern portion along the eastern boundary of the subject site. The pump motor is lubricated via a stand-mounted drum adjacent to the motor. A minor amount of pump-motor oil has stained the concrete pad and adjacent surface soil at the wellhead. However, based on Krazan's observations, the impact has not significantly impacted the subsurface and the release is considered *de minimis* in nature. An adjacent pole-mounted transformer (PMT) owned and operated by PG&E supplies electrical power to the water well. The PMT casing displays a blue sticker indicating that the PMT does not contain PCB fluids.

Photo 5: View of the water well located along the eastern boundary within the northeastern part of the subject site. A lube-oil drum is present and the wellhead concrete pad is oil stained. Minor staining of the soil was noted around the concrete pad. A pole-mounted transformer (background right) provides electrical power to the water well.

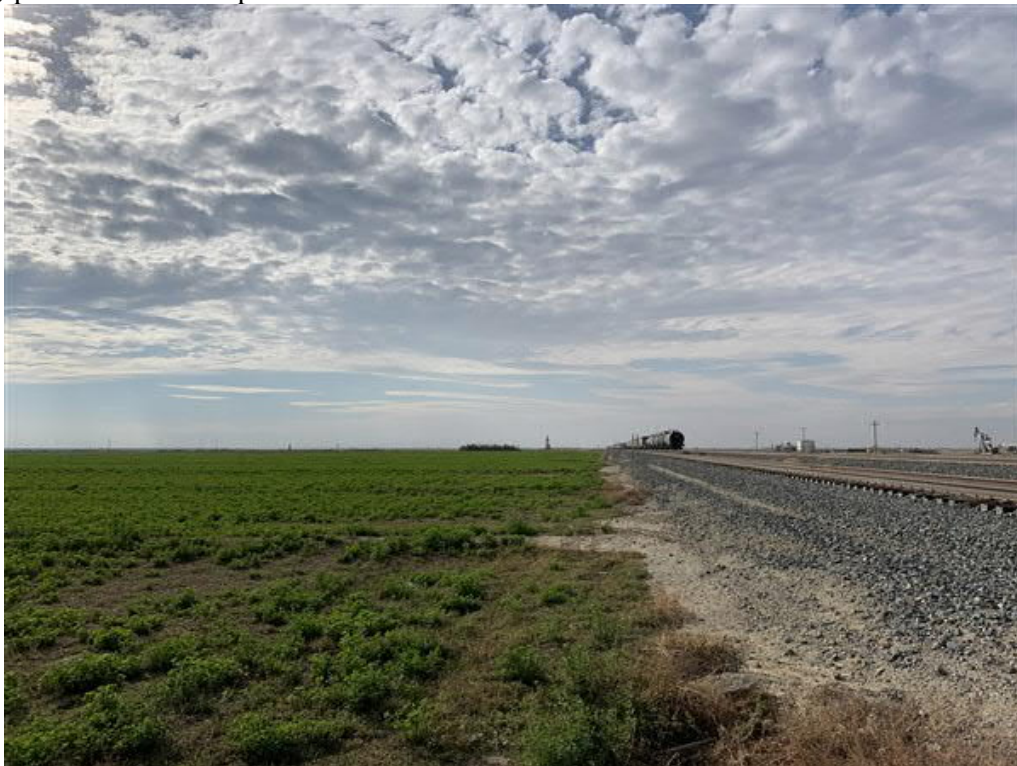
Photo 6: Western-facing view along the northern boundary; the Union Pacific Railroad line is pictured adjacent to the north.

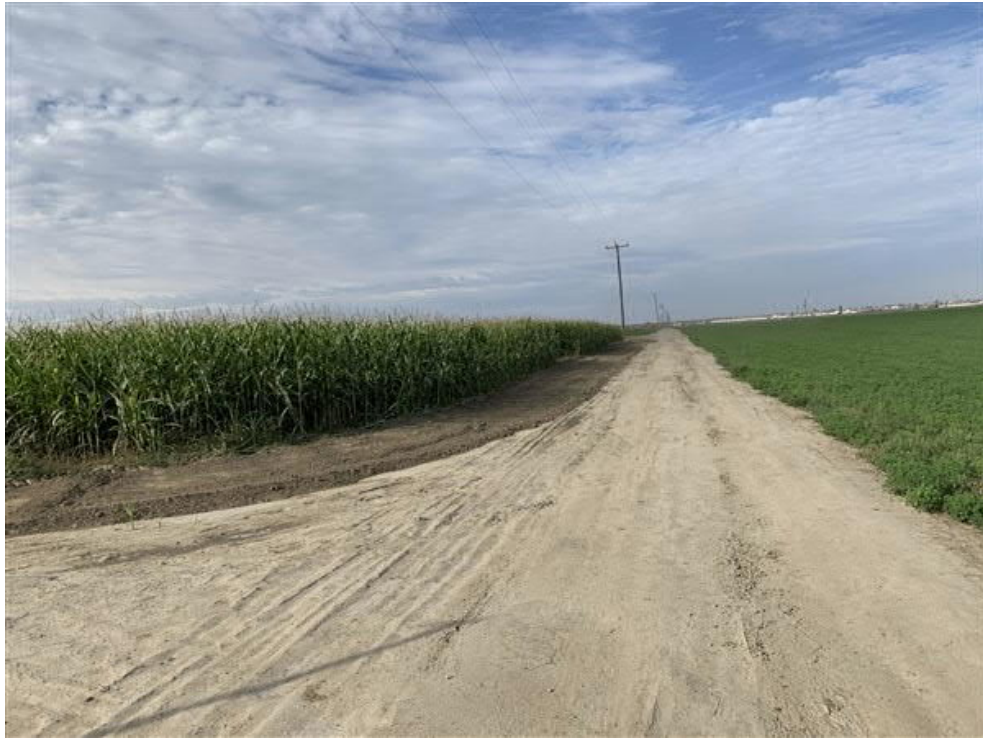
Photo 7: Northern-facing view along the eastern side of the subject site. The southeastern portion of the subject site is in agricultural production of corn.

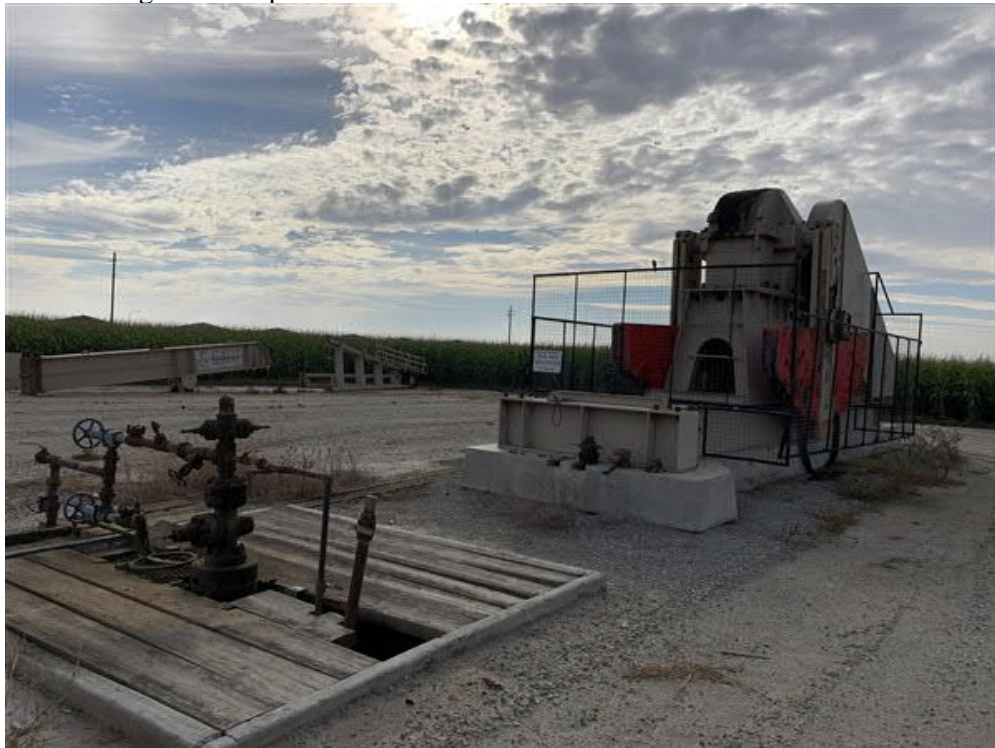
- One oil well that includes a pumping unit was observed idle at the subject site. The oil well is located within a cleared area of the cornfield within the southeastern part of the subject site and is identified as "Edgar" 24A-24. A gas separator apparatus is present approximately one hundred feet to the east of the idle oil well. No significant impacts to the surface were noted within the area of the oil well.

Photo 8: View of the idle oil well 24A-24 located within the southeastern part of the subject site.

Krazan recommends that CalGEM be contacted to determine if the oil wells are abandoned to current standards or if additional reabandonment or leak testing may be required for the plugged and abandoned oil wells prior to redevelopment of the subject site. CalGEM requires that the developer/property owner consult with the CalGEM prior to any work to uncover a known abandoned well, and CalGEM requires that property owners continue to provide access to any wells located on a property. Currently CalGEM requires that no buildings shall be constructed within 10 feet of an oil well on two adjacent sides and the third side of a well shall be no closer than 50 feet from buildings; the fourth side must remain open to allow for access of an abandonment rig in the event that the well requires abandonment or reabandonment in the future. Additionally, if any unknown oil wells are discovered or any known or unknown wells are damaged during work at the subject site, CalGEM must be contacted in order to evaluate the condition of the well.

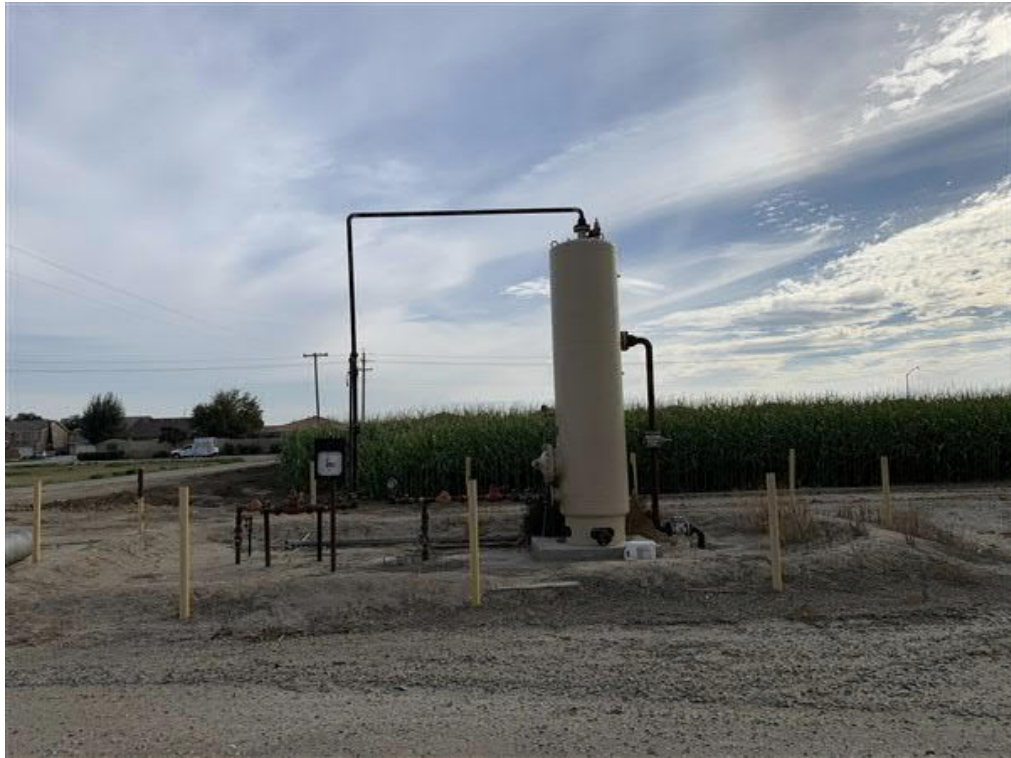
Photo 9: View of the gas separator apparatus that is located adjacent to the idle oil well 24A-24.

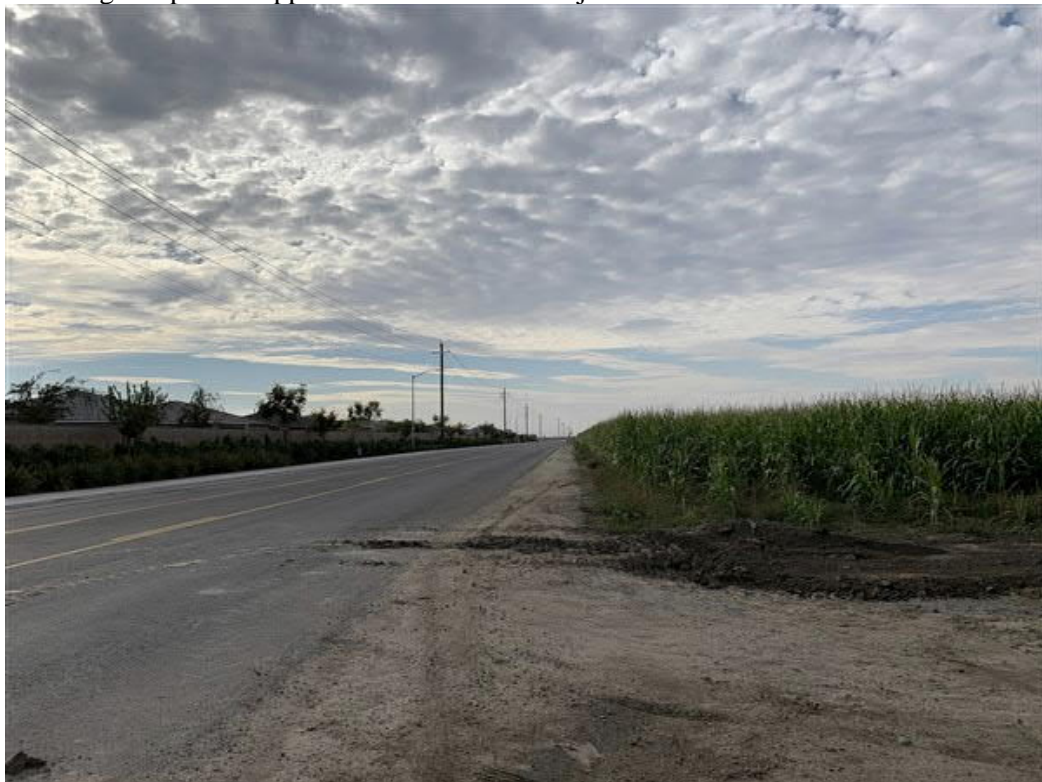
Photo 10: Western-facing view along the southern side of the subject site from the southeastern corner of the subject site. The southeastern portion of the subject site is in agricultural production of corn. The southern-adjacent properties are developed with residential homes.
