**Phase I Environmental Site Assessment**

**PHASE I ENVIRONMENTAL SITE ASSESSMENT**  
**ASTM Standard E 1527-13**

**PEDRICK ROAD PROPERTY**  
**APNs 0111-080-050 and 0111-040-010, -020, -030 and -040**  
**8405 Pedrick Road**  
**Dixon, Solano County, California**

*Brusca Project No. 347-001*

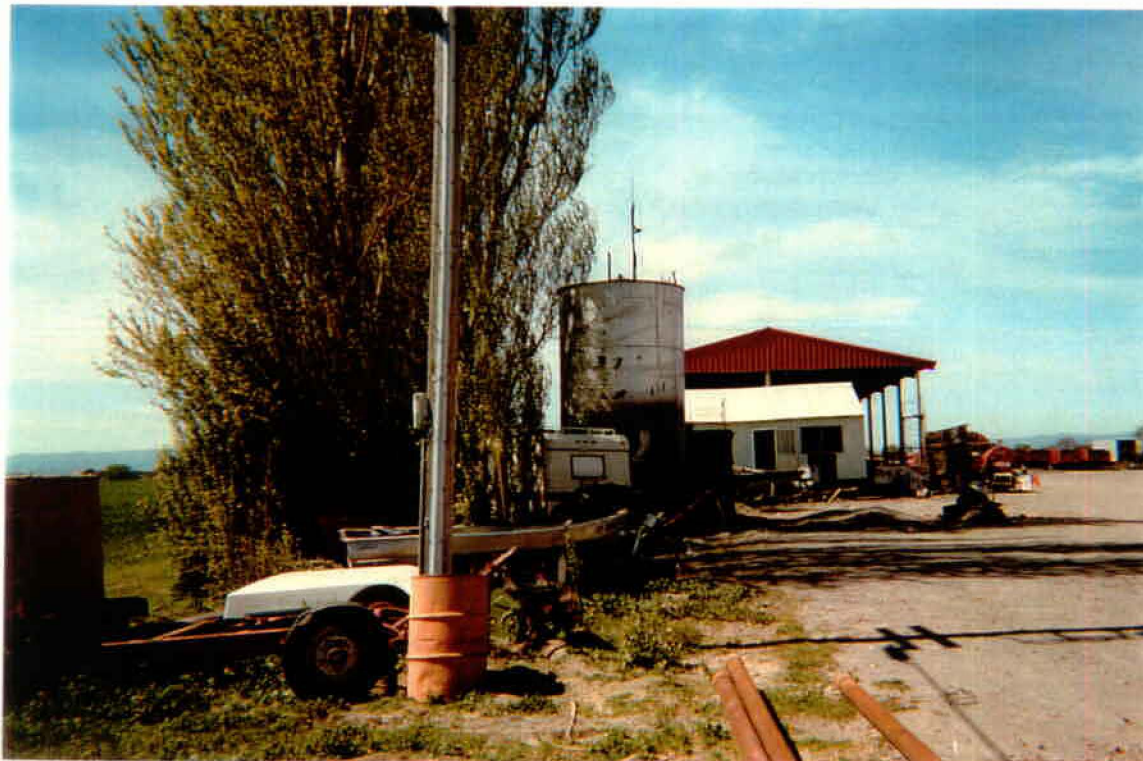
**Photograph No. 9.** View of diesel tanker trailer (AST) in center of Mistler property looking east. Tanker is currently being used to provide diesel fuel to the farm equipment. Notice large stain in soil behind trailer.

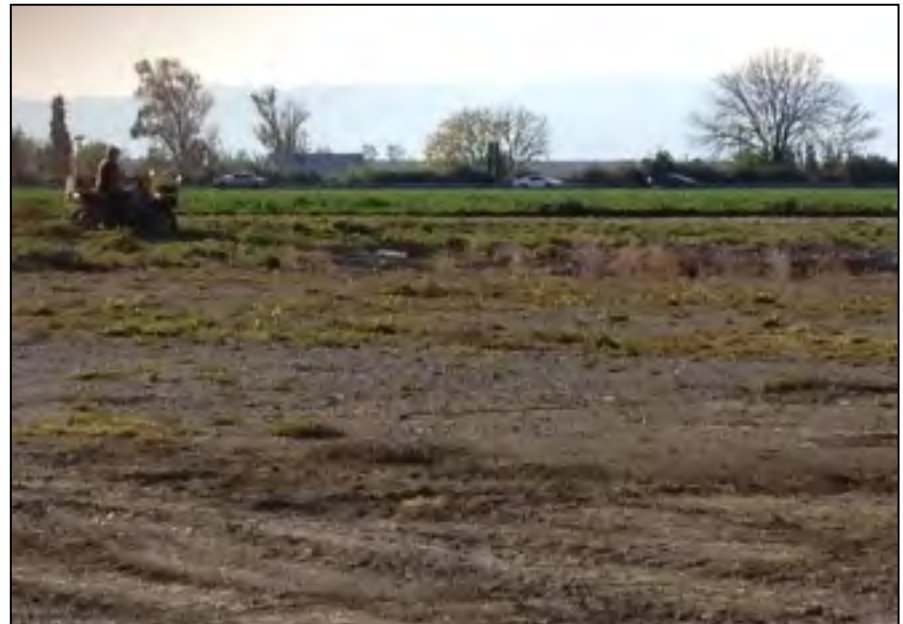
Figure 7. Surface Conditions at Time of Geophysical Survey

Surface Conditions: Dry and Barren

Surface covered with concrete roof tile fragments, gravel, and miscellaneous bits of metal, rubber, etc.

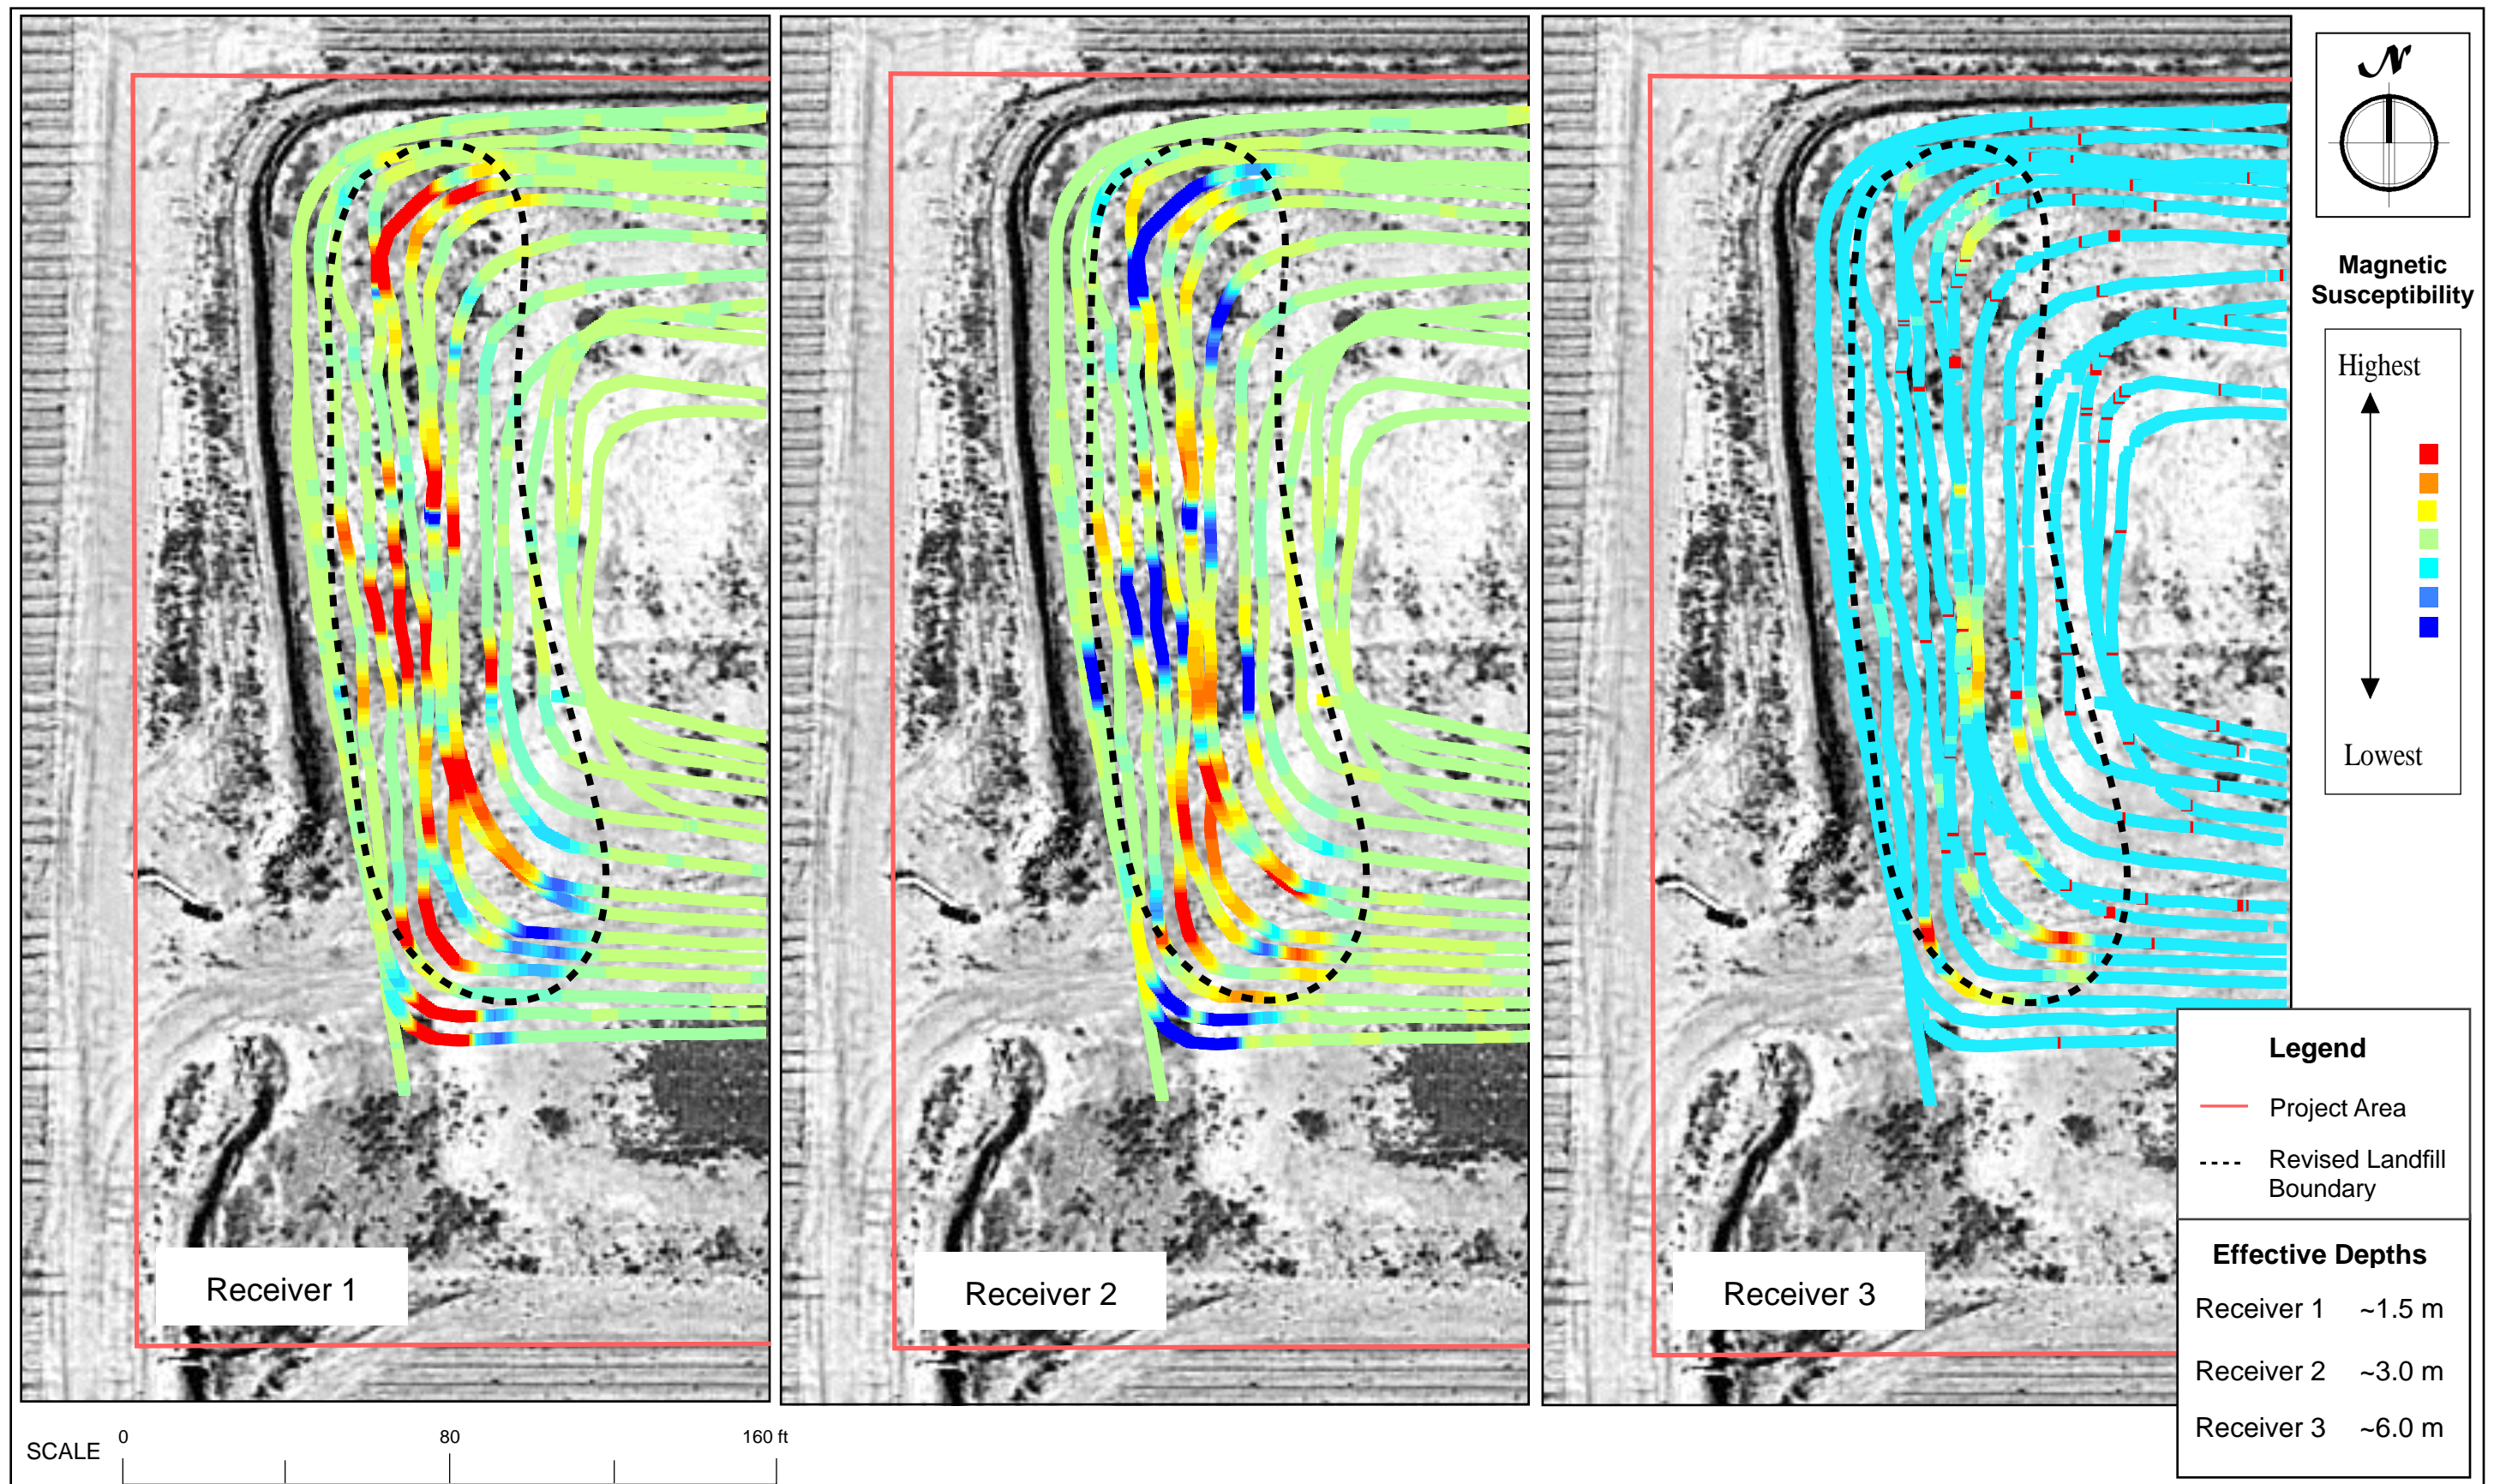
Figure 8. Magnetic Susceptibility, Sample Set 2, Receivers 1, 2, and 3, Over Aerial Photograph, Showing Revised Boundaries of Landfill Based on MS Responses

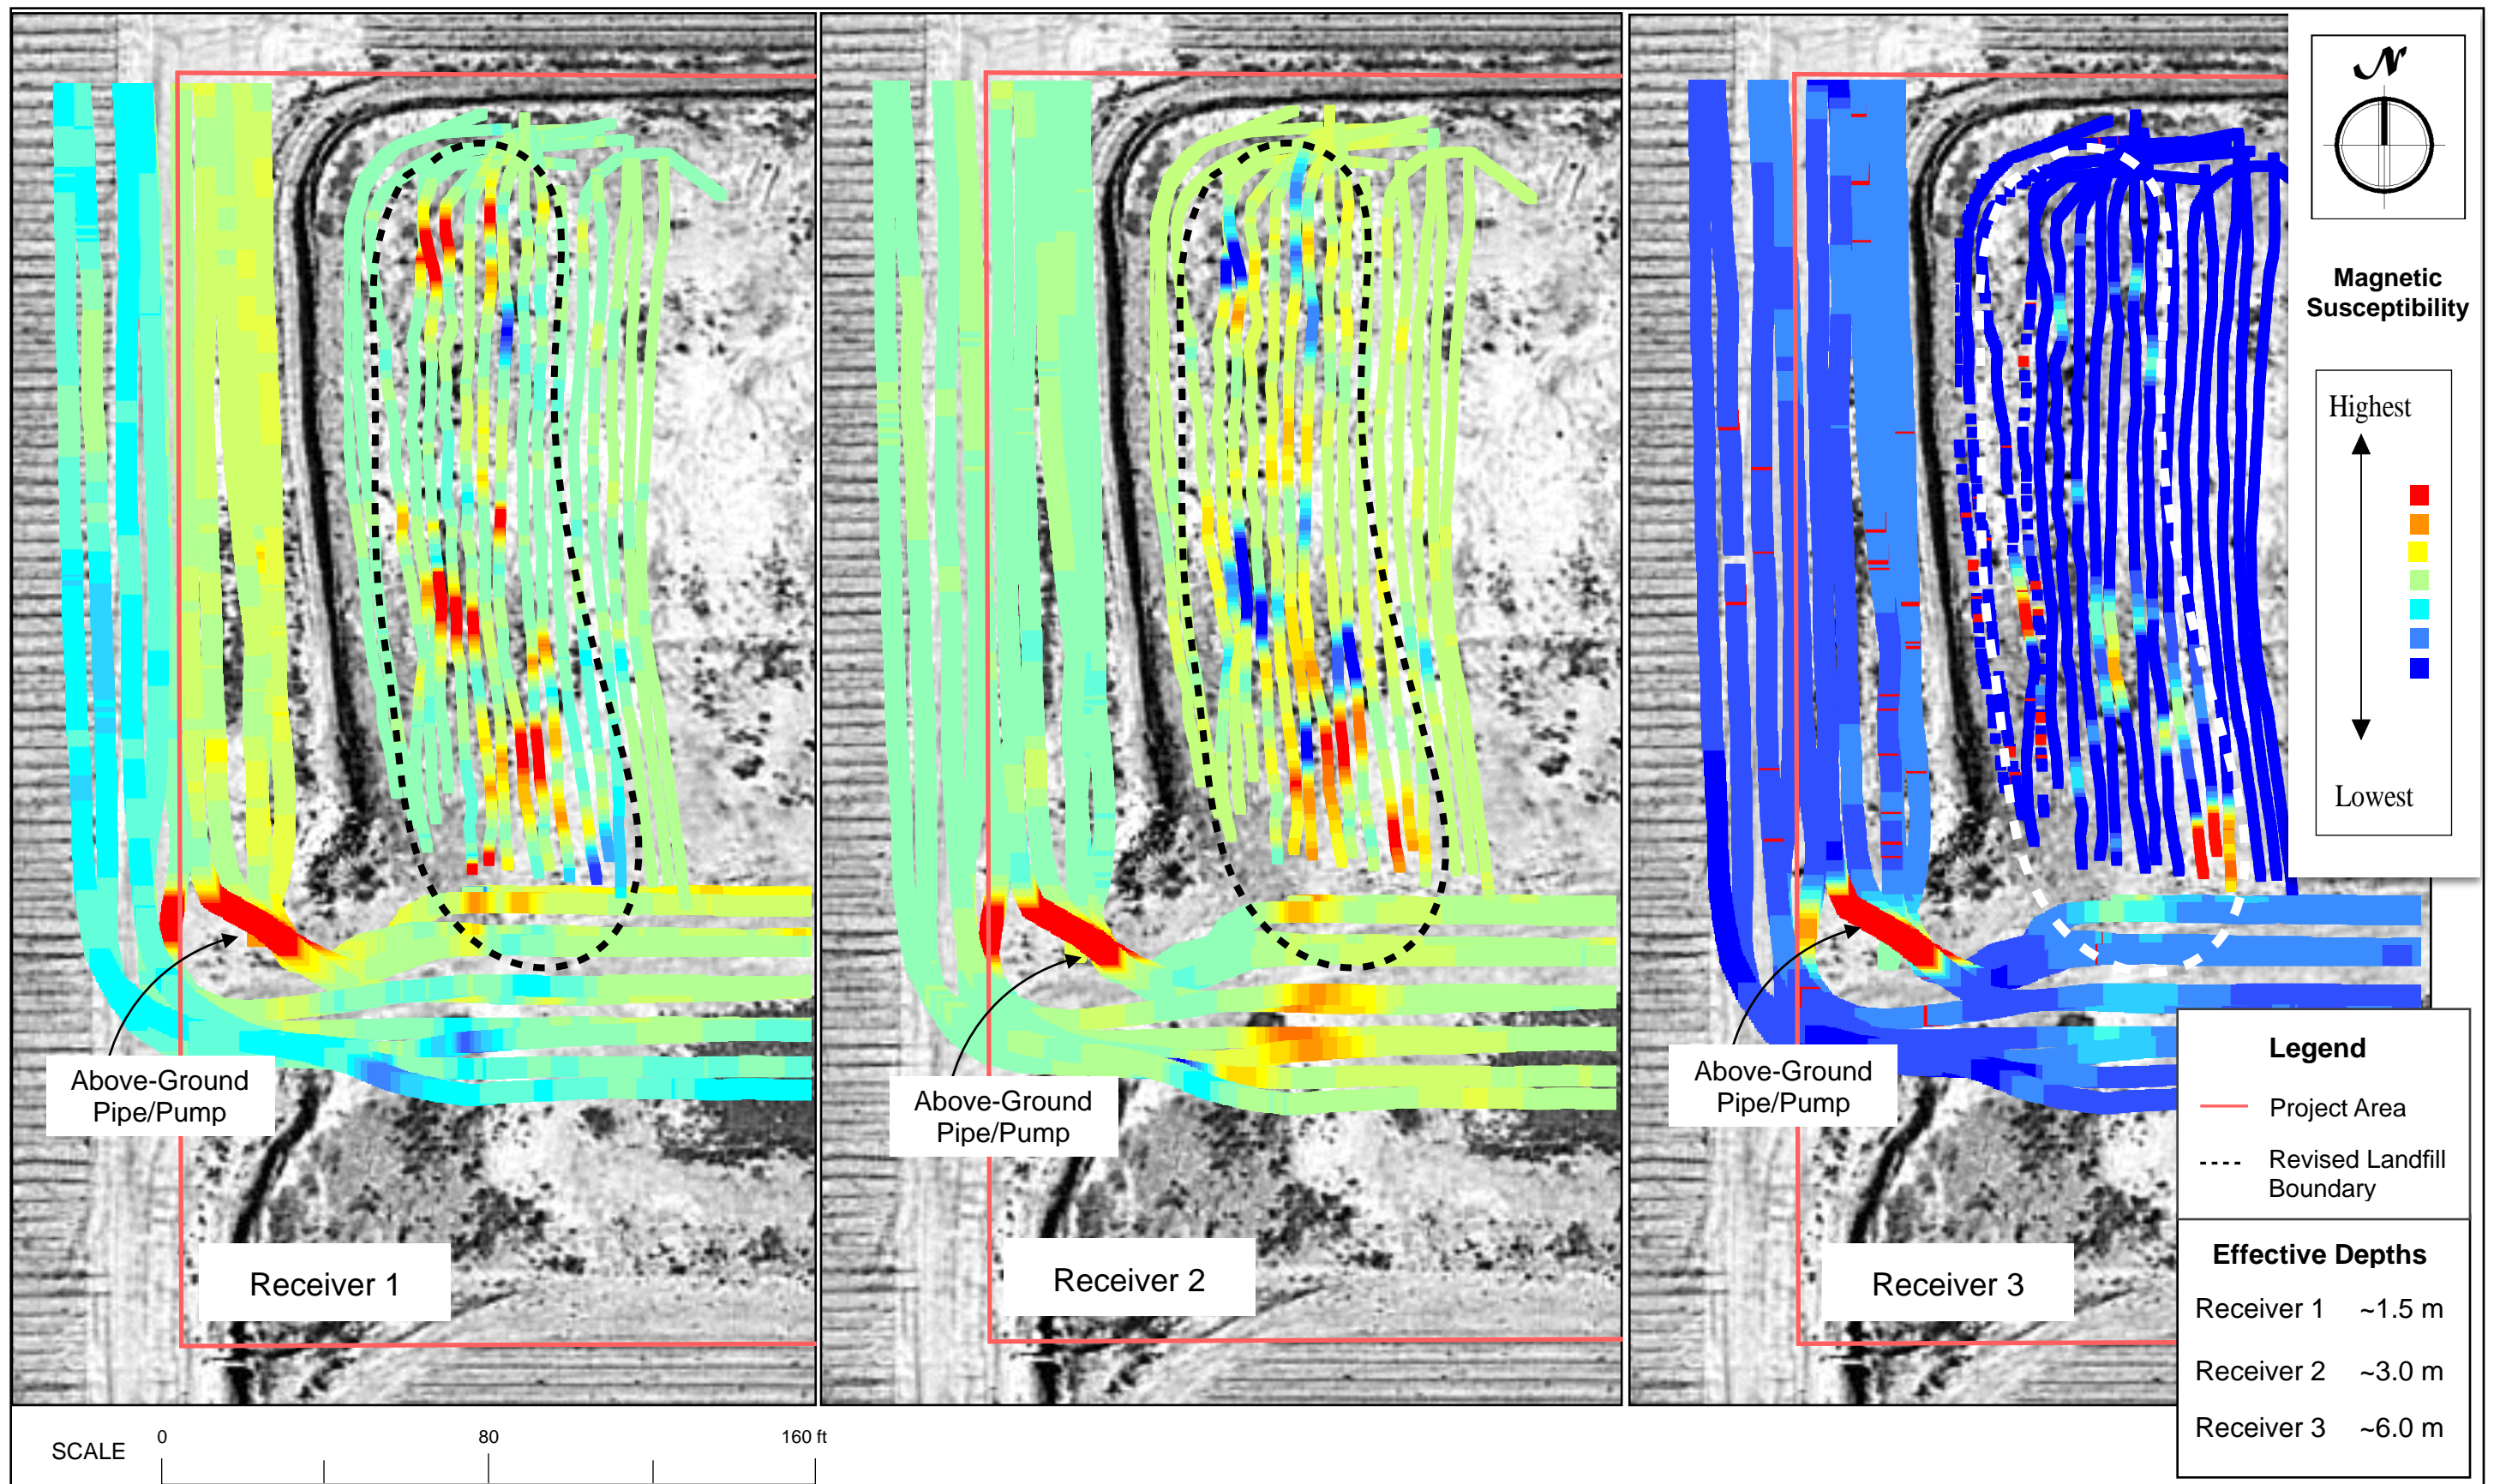
Figure 10. Magnetic Susceptibility, Sample Sets 1 and 4, Receivers 1, 2, and 3, Over Aerial Photograph, Showing Revised Boundaries of Landfill Based on Combined AC and MS Responses

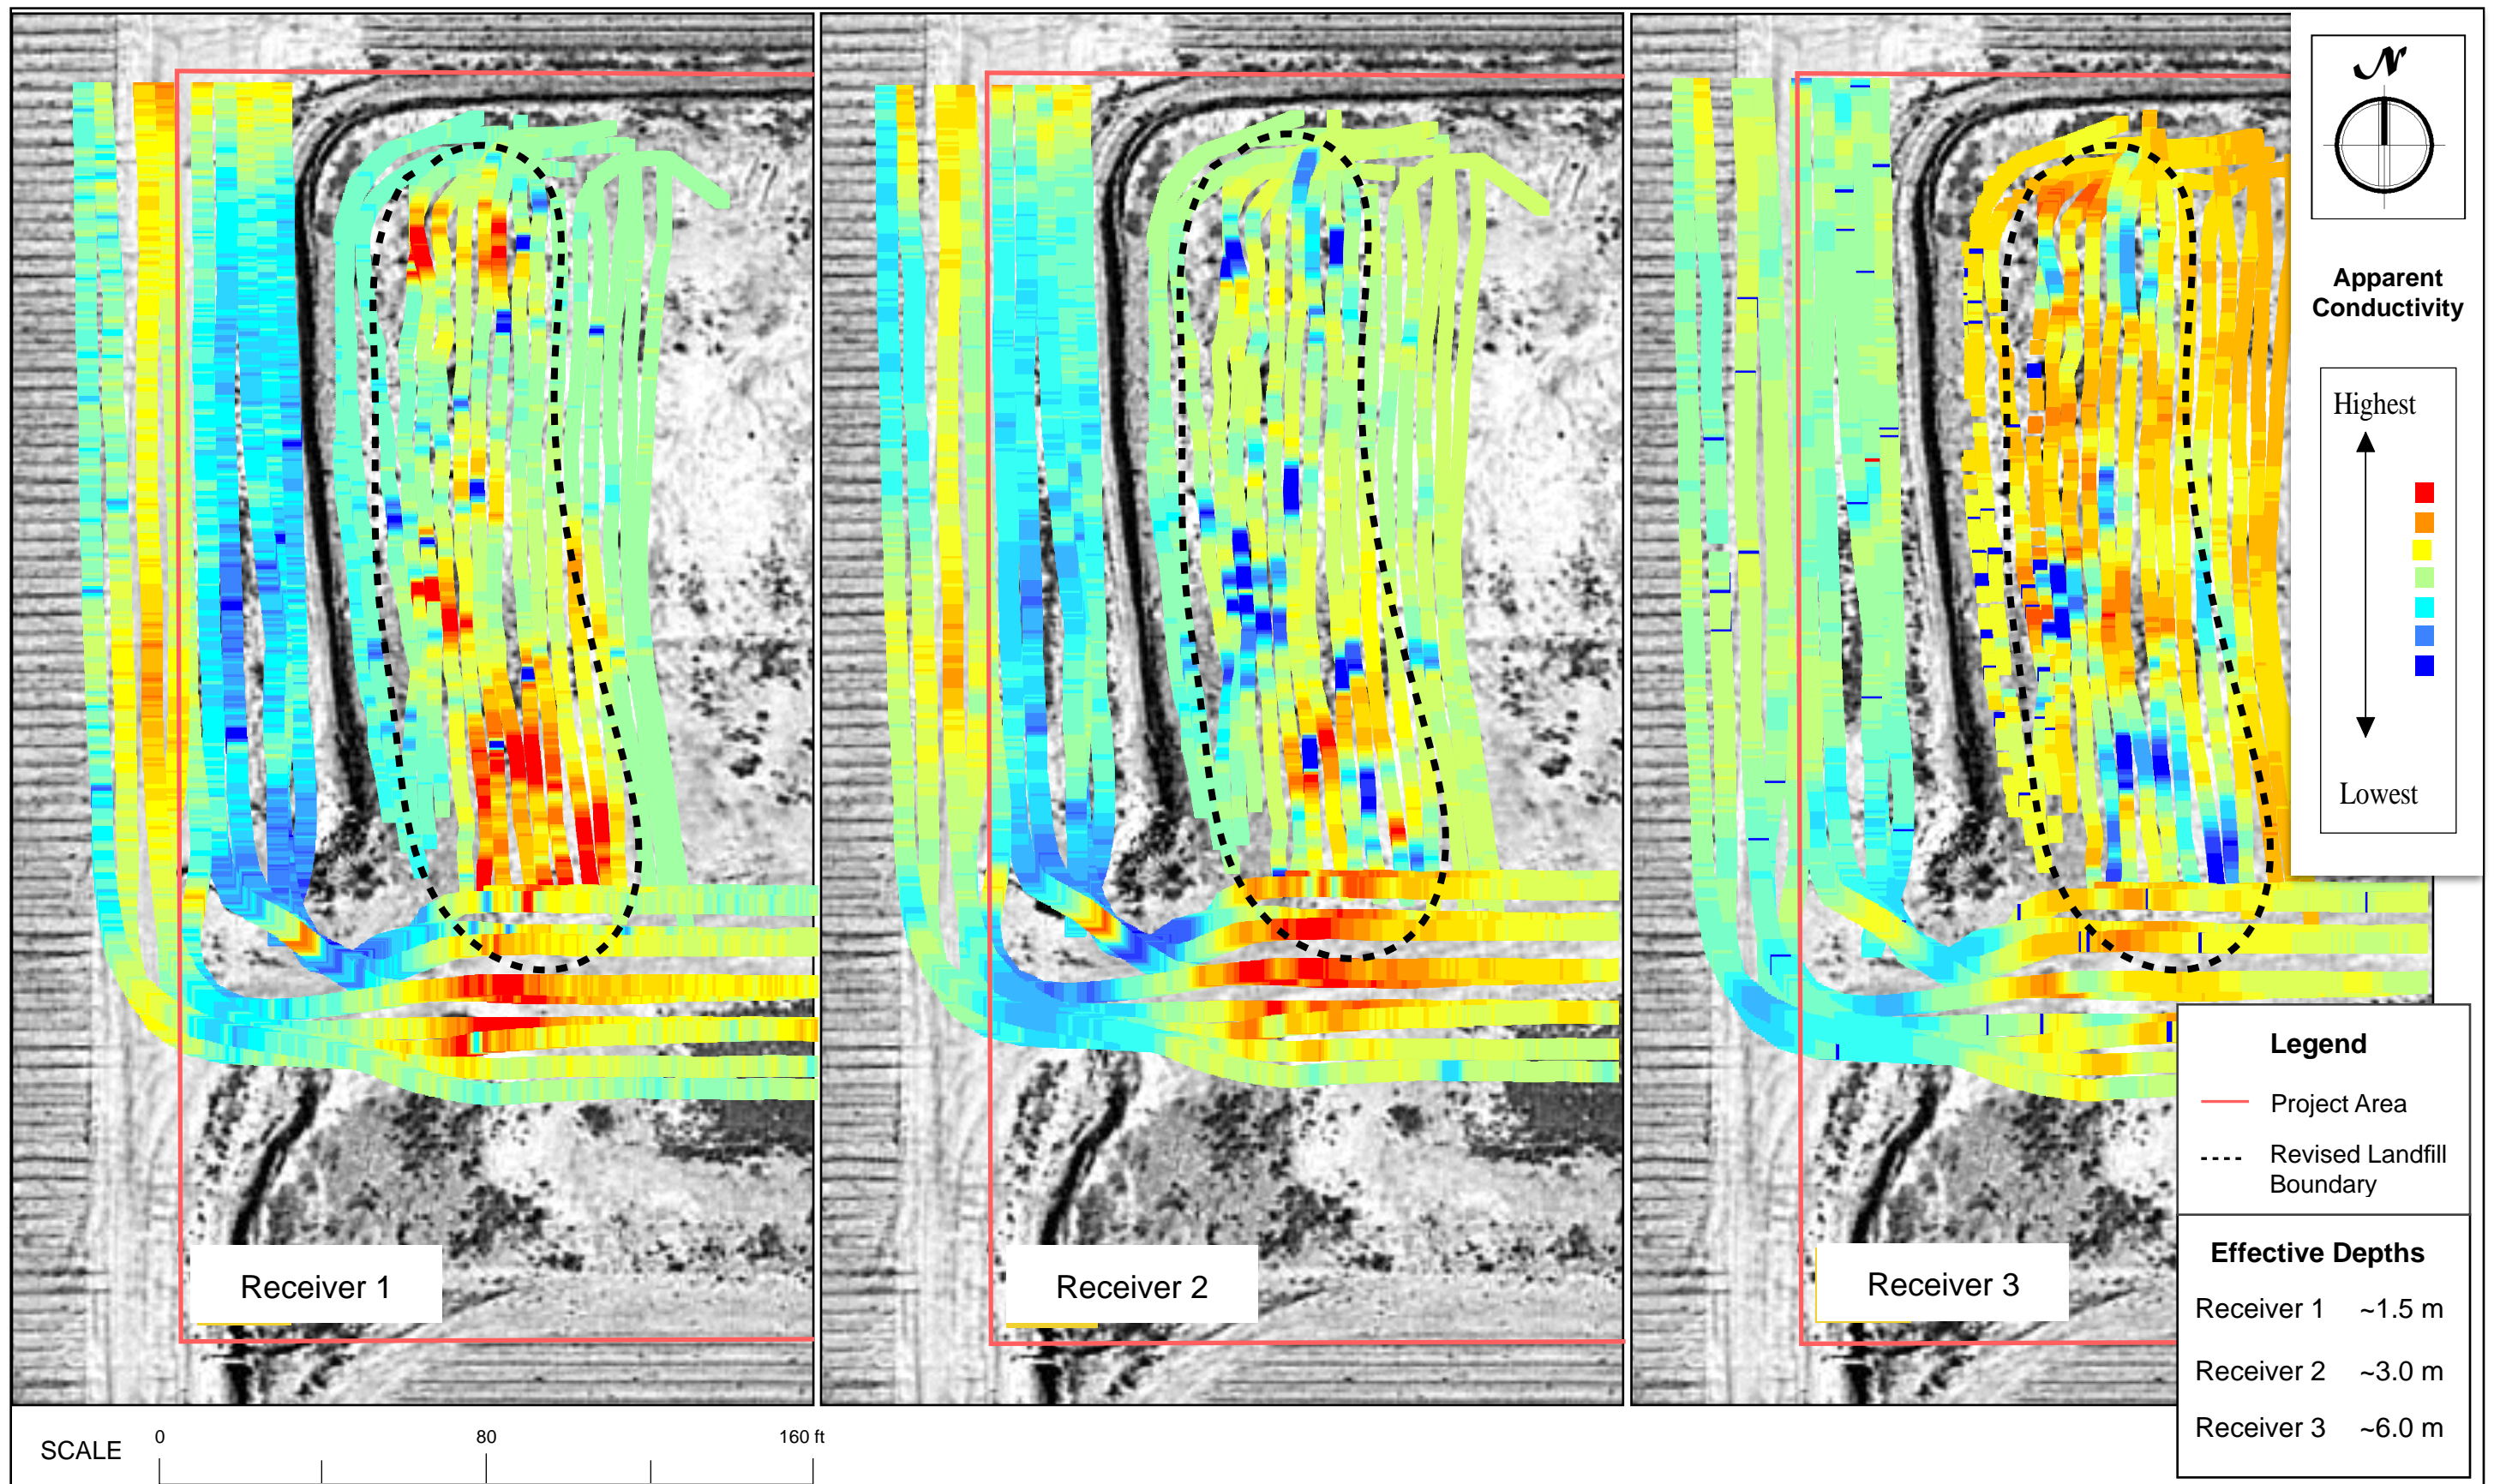
Figure 11. Apparent Conductivity, Sample Sets 1 and 4, Receivers 1, 2, and 3, Over Aerial Photograph, Showing Revised Boundaries of Landfill Based on Combined AC and MS

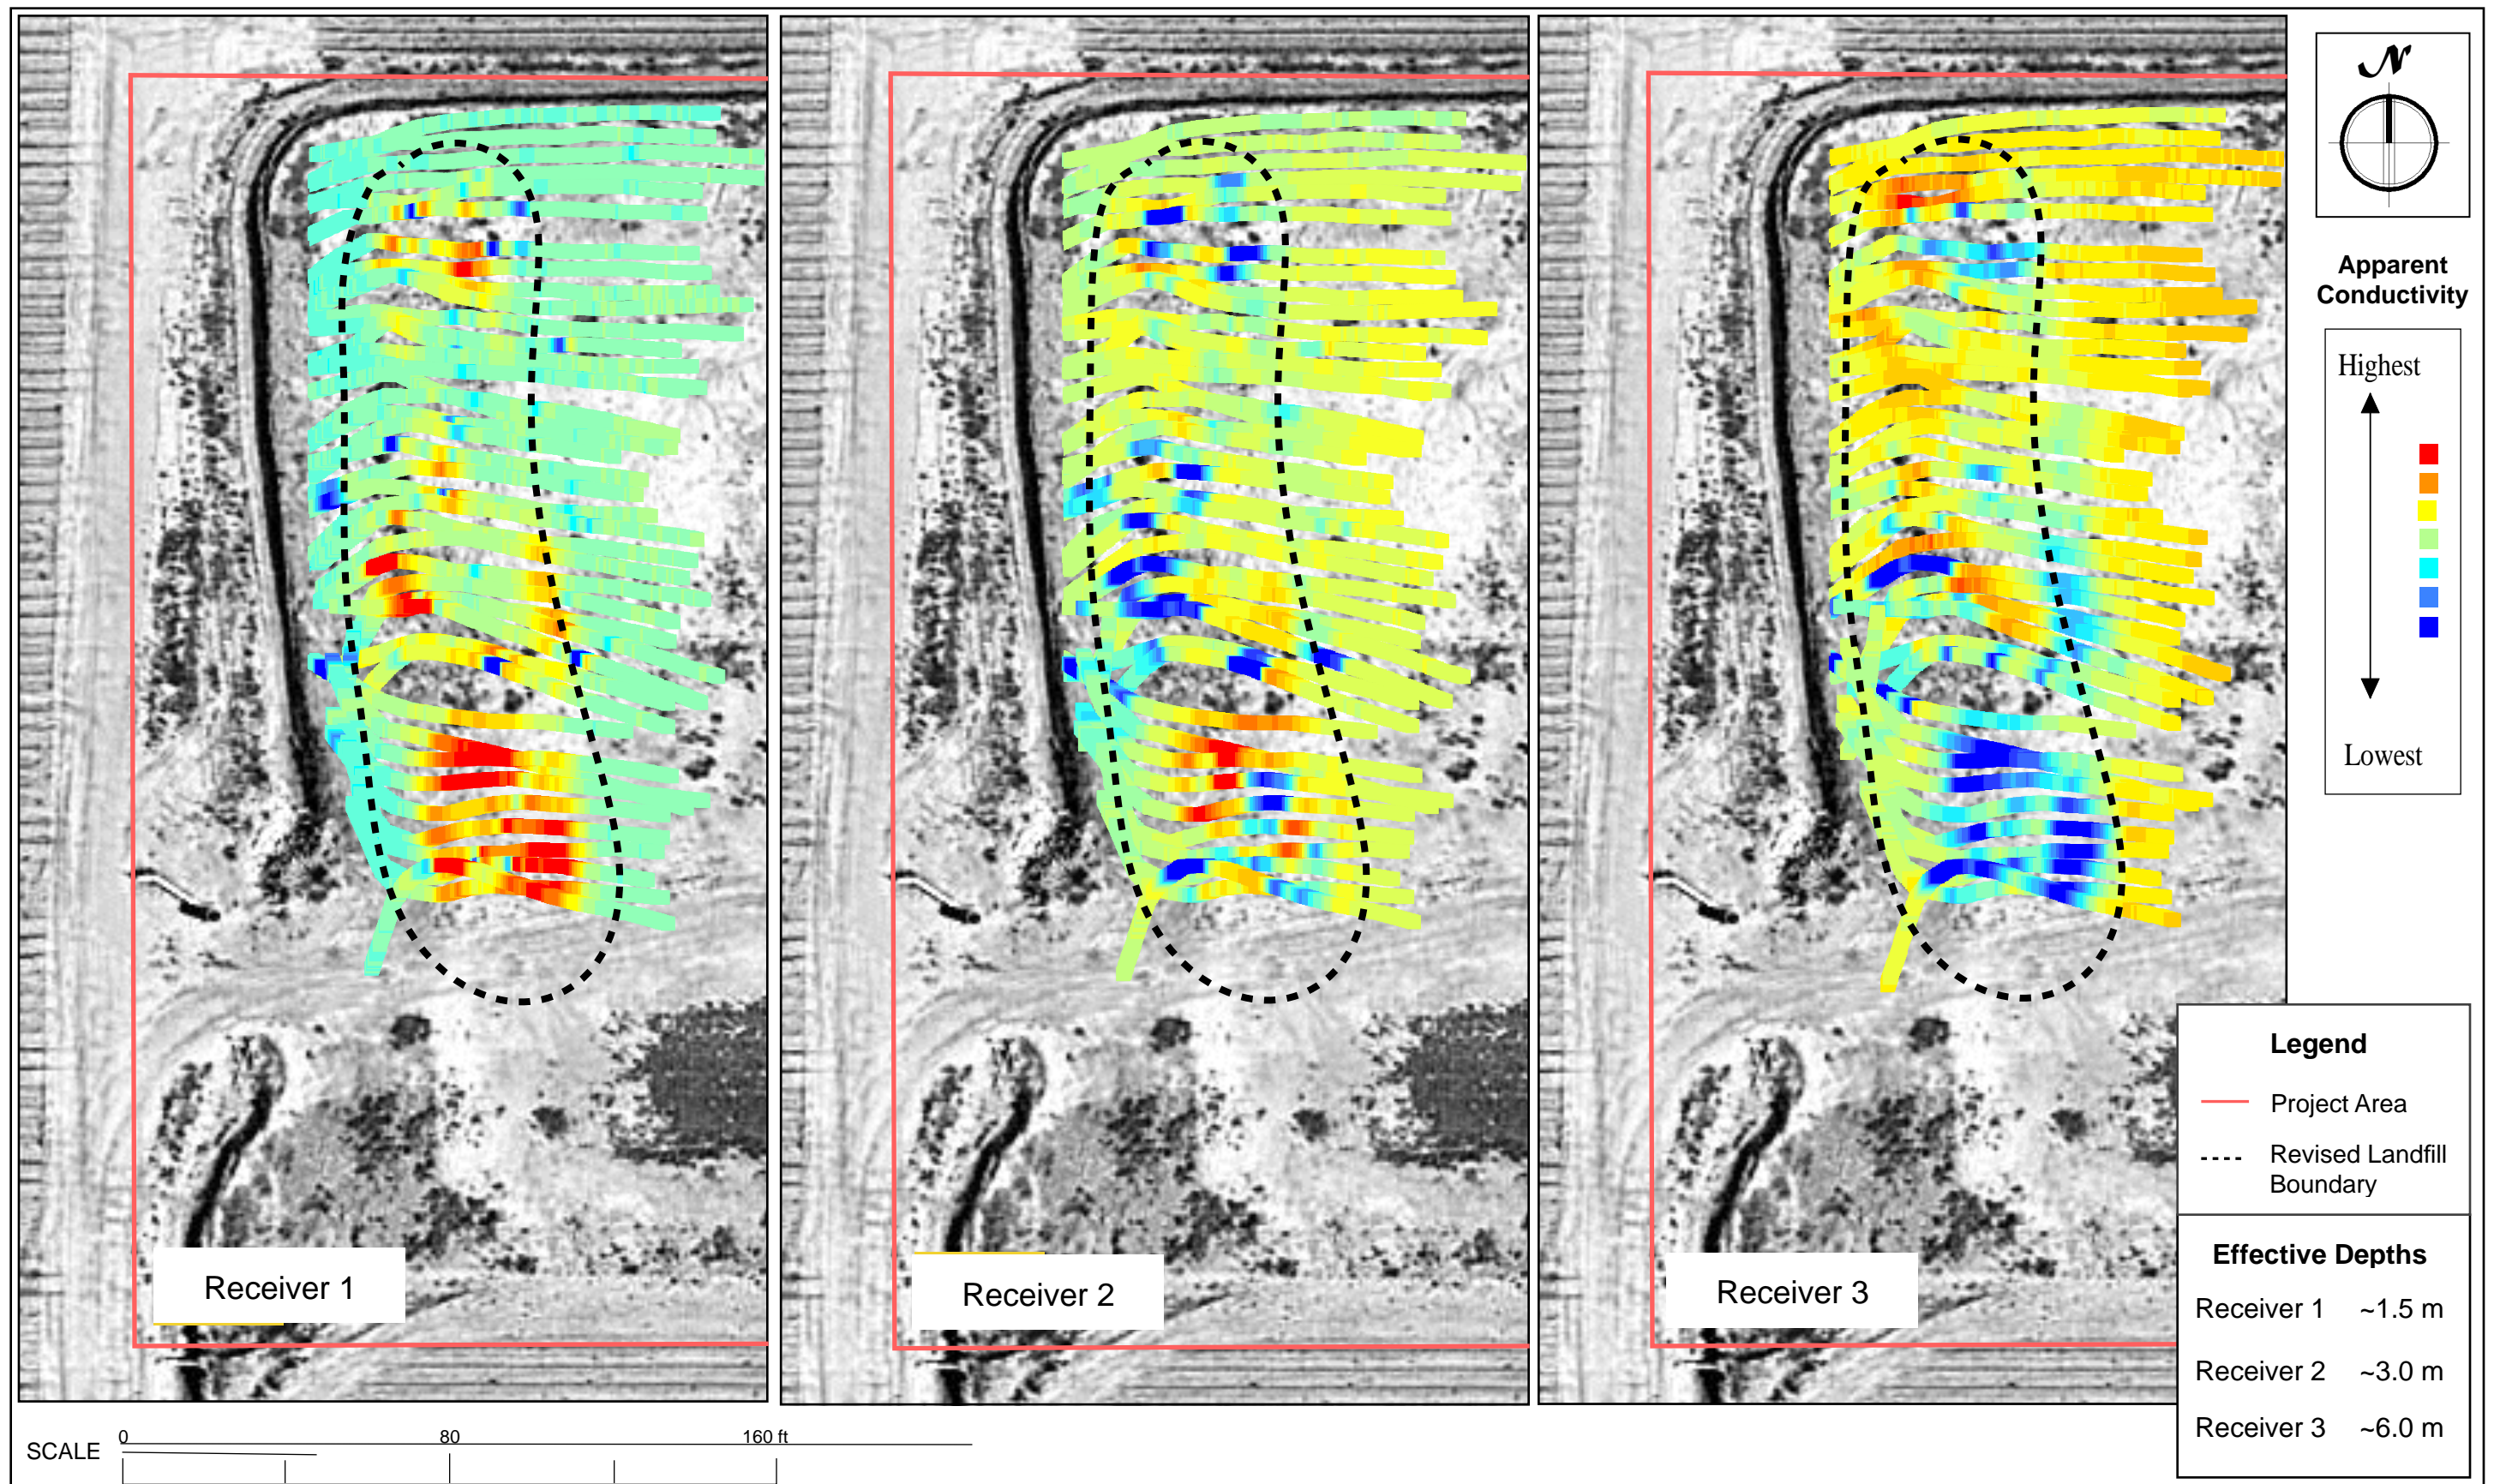
Figure13. Apparent Conductivity, Sample Set 5, Receivers 1, 2, and 3, Over Aerial Photograph, Showing Revised Boundaries of Landfill Based on MS Responses
