**County Road 200 Bridge over
Branch Salt Creek
Replacement Project**

Delineation of Waters of the
United States

March 13, 2018

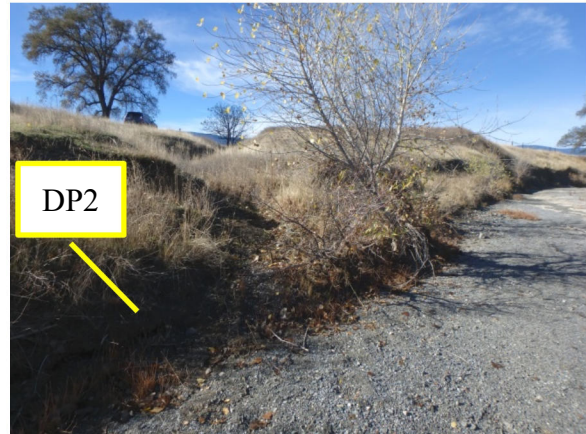
Photograph 3. Connection between ES-1 and Intermittent Stream (IS)-1. DP2 documents the uplands adjacent to IS-1. Orientation: northwest.

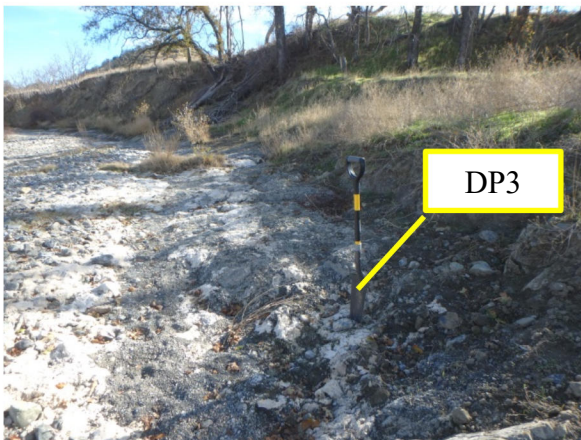
Photograph 2. IS-1. DP3 documents the OHWM of the feature. Orientation: southeast.

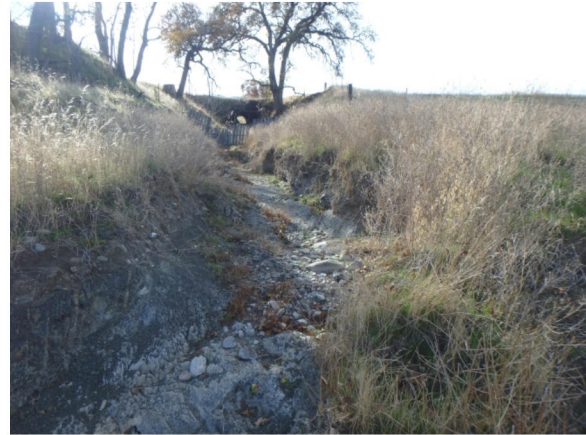
Photograph 4. ES-2 looking upstream from near IS-1. Orientation: west.
