WEST SANTA ANA BRANCH TRANSIT CORRIDOR PROJECT

**Draft EIS/EIR Appendix W
Final Cultural Resources
Survey Report—Rev 1
Part 3 of 3**

Los Angeles County
Metropolitan Transportation Authority

March 13, 2020

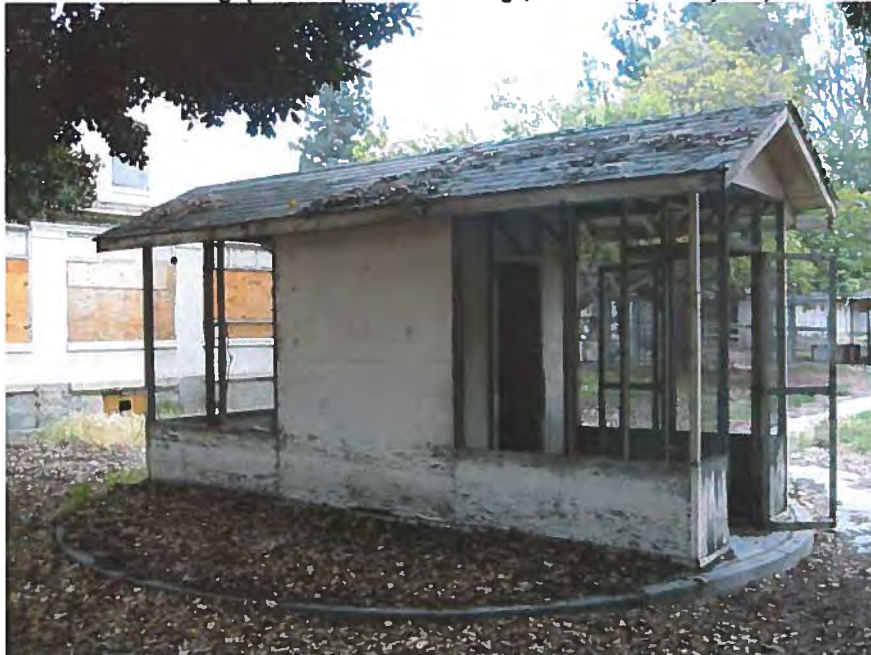
P5a. Photo or Drawing (Photo required for buildings, structures, and objects.)

The Aviary (LACO No. 1312) is located in the courtyard of the Men's Psychiatric Wards. The small structure is one-story in height and symmetrical in appearance. A rectangular structure that is longer than it is wide, it sits on a raised circular concrete slab foundation. The wood-framed structure consists of a central, enclosed space with screened-in spaces at each end. A front-gabled roof with moderately overhanging eaves caps the structure. Composition shingles cover the roof and plywood sheets cover the exterior walls. Two screen gates in succession, creating an entry cage, are located at the south end of the structure. Existing landscaping surrounding the Aviary consists of mature shrubs, trees and grass. The resource is in deteriorated condition.

P5b. Description of Photo: (View, date, accession #) Overview of South Façade and East Elevation, Facing Northwest, January 29, 2007

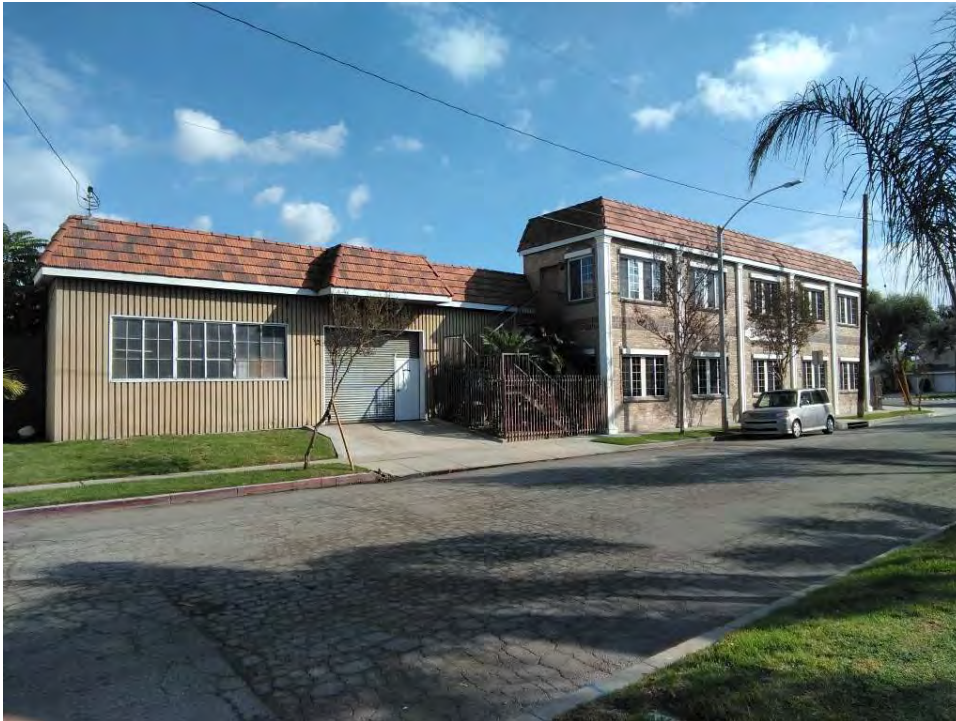
12508 Center Street, west elevation. Camera facing southeast.

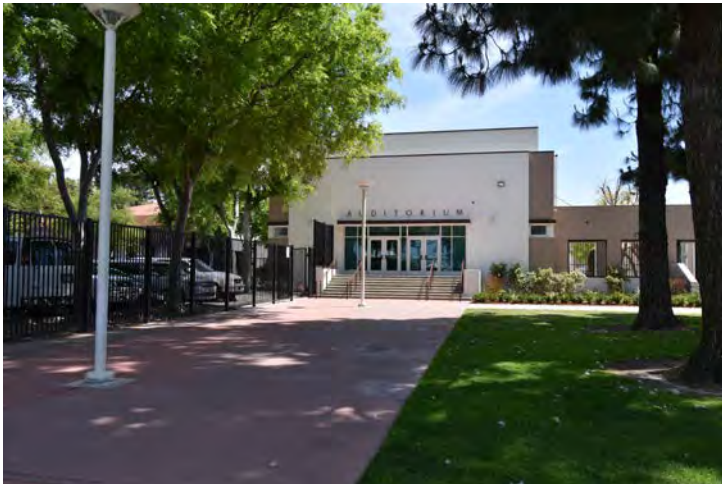
Paramount Park High School West Auditorium Building (Building #6), West (primary) Elevation; East-facing

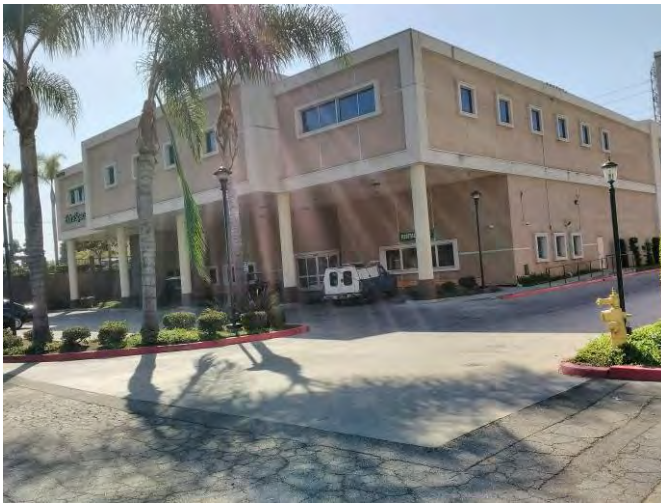
Extra Space Storage building, east & north elevations, view southwest
