PHASE I ENVIRONMENTAL SITE ASSESSMENT
APN 182-190-015, 016, 017, JURUPA VALLEY, CA

**PHASE I
ENVIRONMENTAL ASSESSMENT REPORT**

**APN 182-190-015, 016, 017
JURUPA VALLEY, CA**

PROJECT NO. 282821

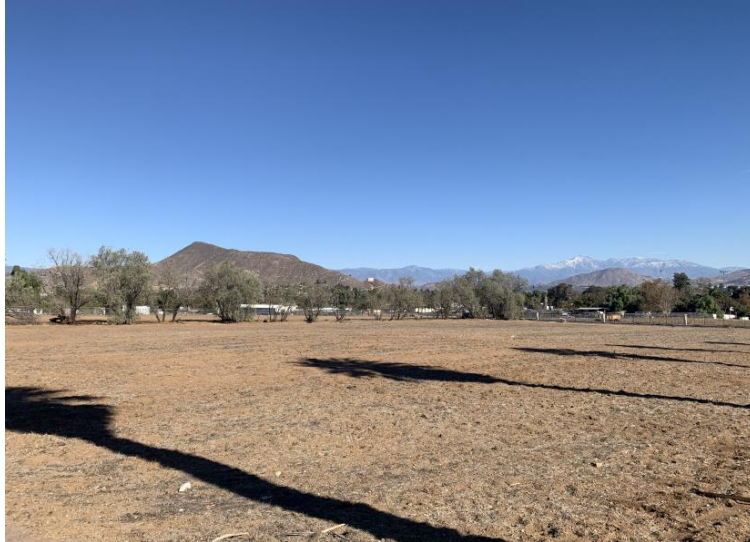
Photo 1

Viewing the site from near its southwestern corner; facing northeast

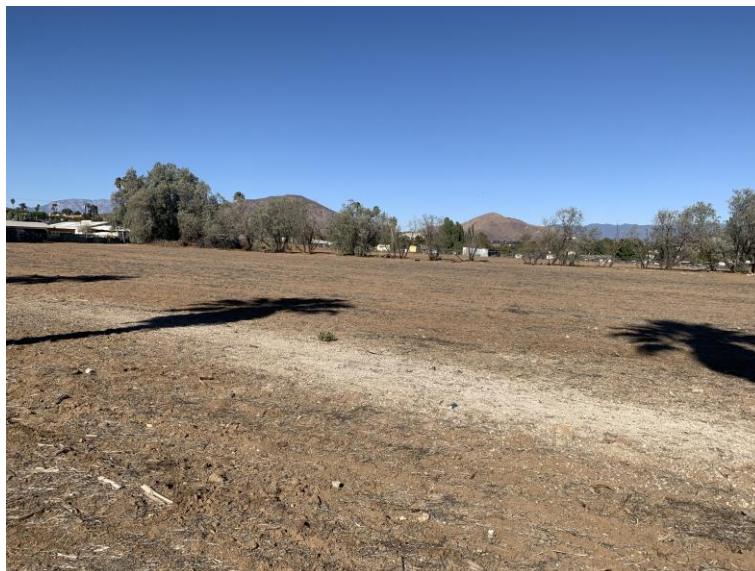
Photo 2

Viewing the site from near its southwestern corner; facing northeast
(facing northwest)

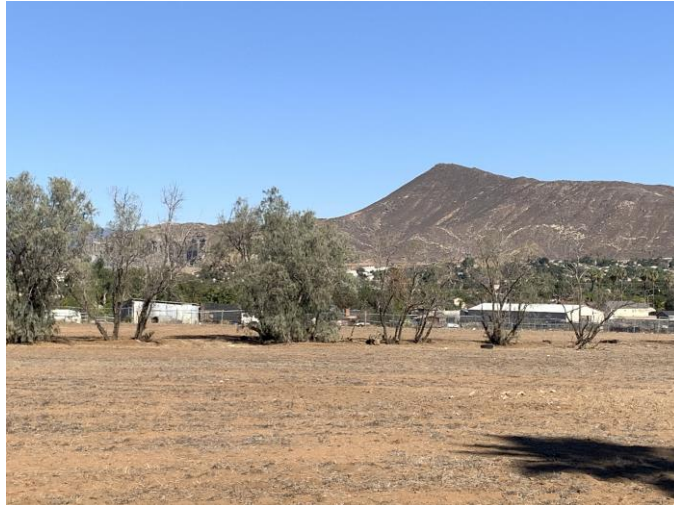
Photo 3

Viewing the northern portion of the site with a residential property to the north of the site on the back (facing north-northeast)

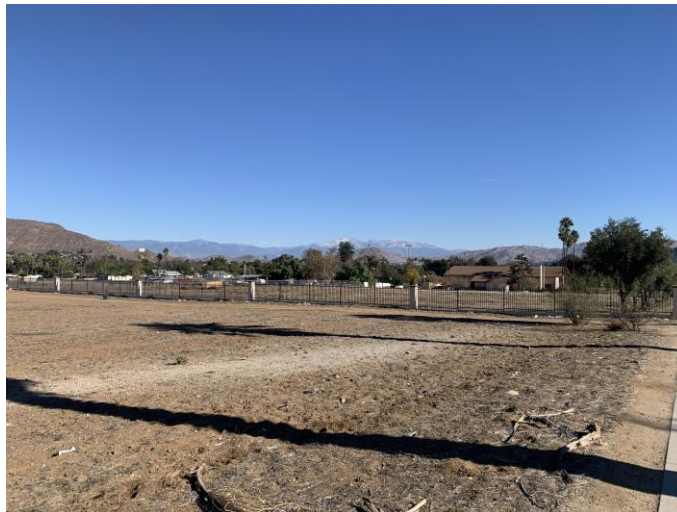
Photo 4

Viewing the eastern portion of the site with a residential property (on the left and to the north) and Free Church of Tonga (on the right and to the south) to the east of the site on the back (facing northeast)
