**Appendix A: Shoreline Golf Links Bridge  
Replacement Detailed Emissions  
Report**

# Shoreline Golf Links Bridge Replacement Detailed Report

**SHORELINE GOLF LINKS - BRIDGE (#25) REPLACEMENT  
CITY OF MOUNTAIN VIEW, CALIFORNIA**

CITY OF MOUNTAIN VIEW, CALIFORNIA PUBLIC WORKS DEPARTMENT 500 CASTRO STREET, MOUNTAIN VIEW, CA 94041		
<b>GOLF CART BRIDGE REPLACEMENT AT SHORELINE GOLF LINKS 1st FAIRWAY GENERAL PLAN</b>		
SCALE: AS NOTED	DATE: 12/13/2021	SHEET: S1

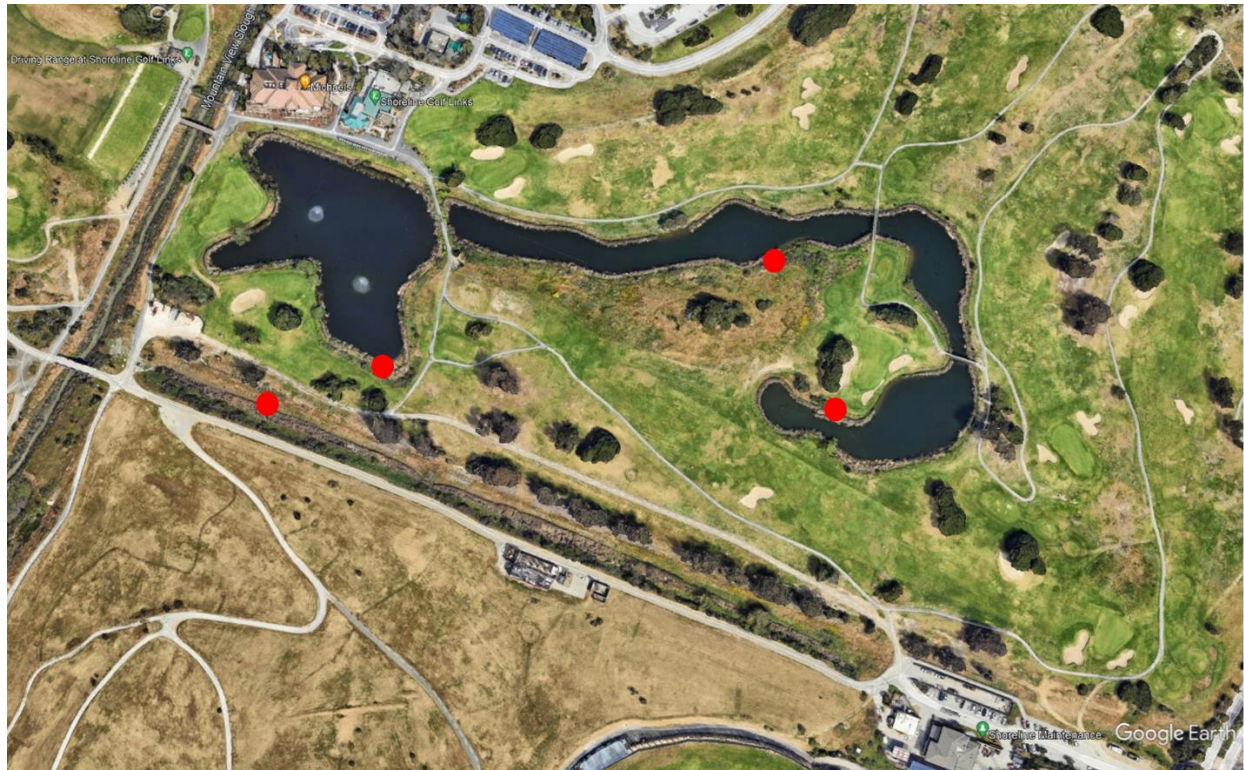
Figure 1: Map showing location of San Francisco Common Yellowthroats observed during the surveys on July 18<sup>th</sup> and 21<sup>st</sup> 2023, at Pond 4 of the Shoreline Golf Course

One State Species of Special Concern was observed: the San Francisco Common Yellowthroat (SFCY), this species has been observed breeding at Pond 4 and adjacent areas, (the high-level ditch to the east of the pond and along Permanente Creek) for several years now. This species is a wetland obligate species and inhabits the typical wetland flora (cattails and tules) of the pond year-round. Figure 1 shows the locations of where the SFCY were observed during the survey, while Figure 2 shows the historical locations of nesting SFCY at Shoreline including Pond 4.

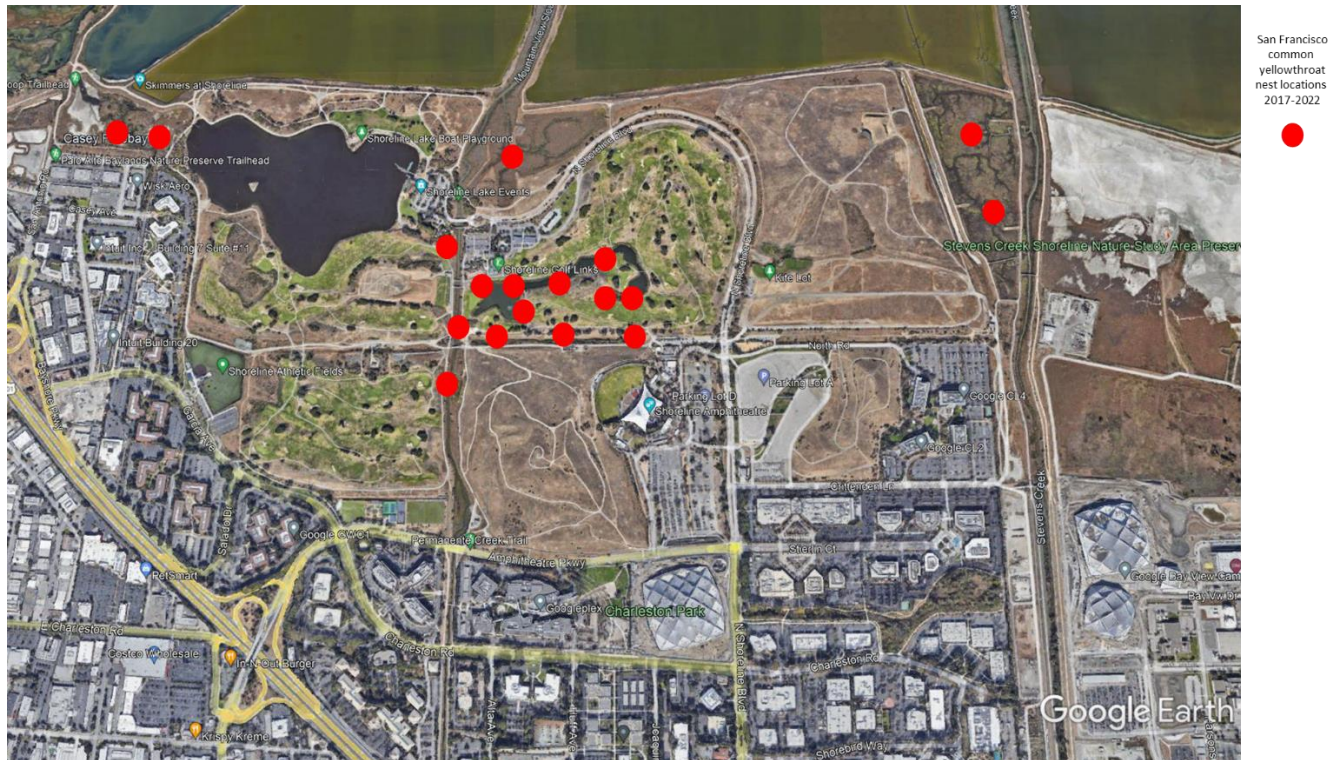
Figure 2: Map showing location of San Francisco Common Yellowthroat nesting locations at Shoreline 2017-2022

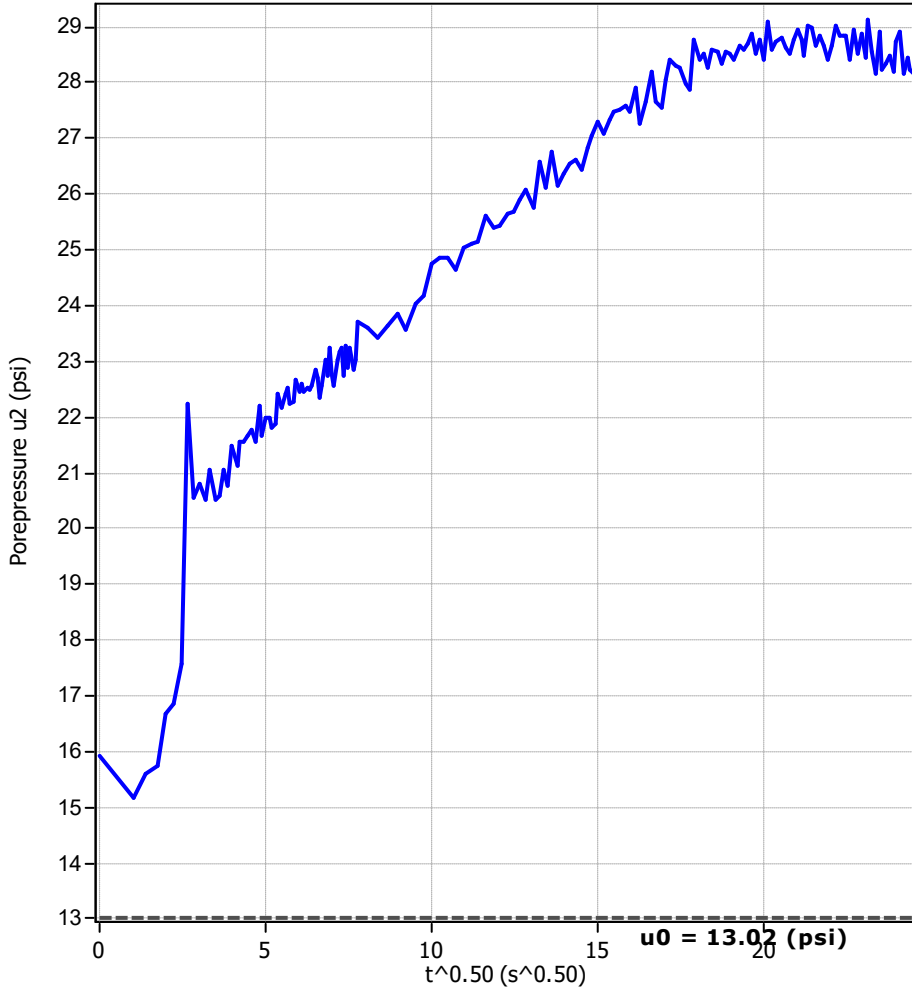
### Piezocone Dissipation Test: CPT-1 Depth: 30.02 (ft)

CPTU Borehole	Depth (ft)	$(t_{50})^{0.50}$	$t_{50}$ (s)	$t_{50}$ (years)	G/ $S_u$	$c_h$ (ft <sup>2</sup> /s)	$c_h$ (ft <sup>2</sup> /year)	M (tsf)	$k_h$ (ft/s)
CPT-1	30.02	0.0	0	0.00E+000	454775.75	0.00E+000	0	335.84	-1.00E+004
CPT-1	87.27	0.0	0	0.00E+000	901501.56	0.00E+000	0	86.43	-1.00E+004

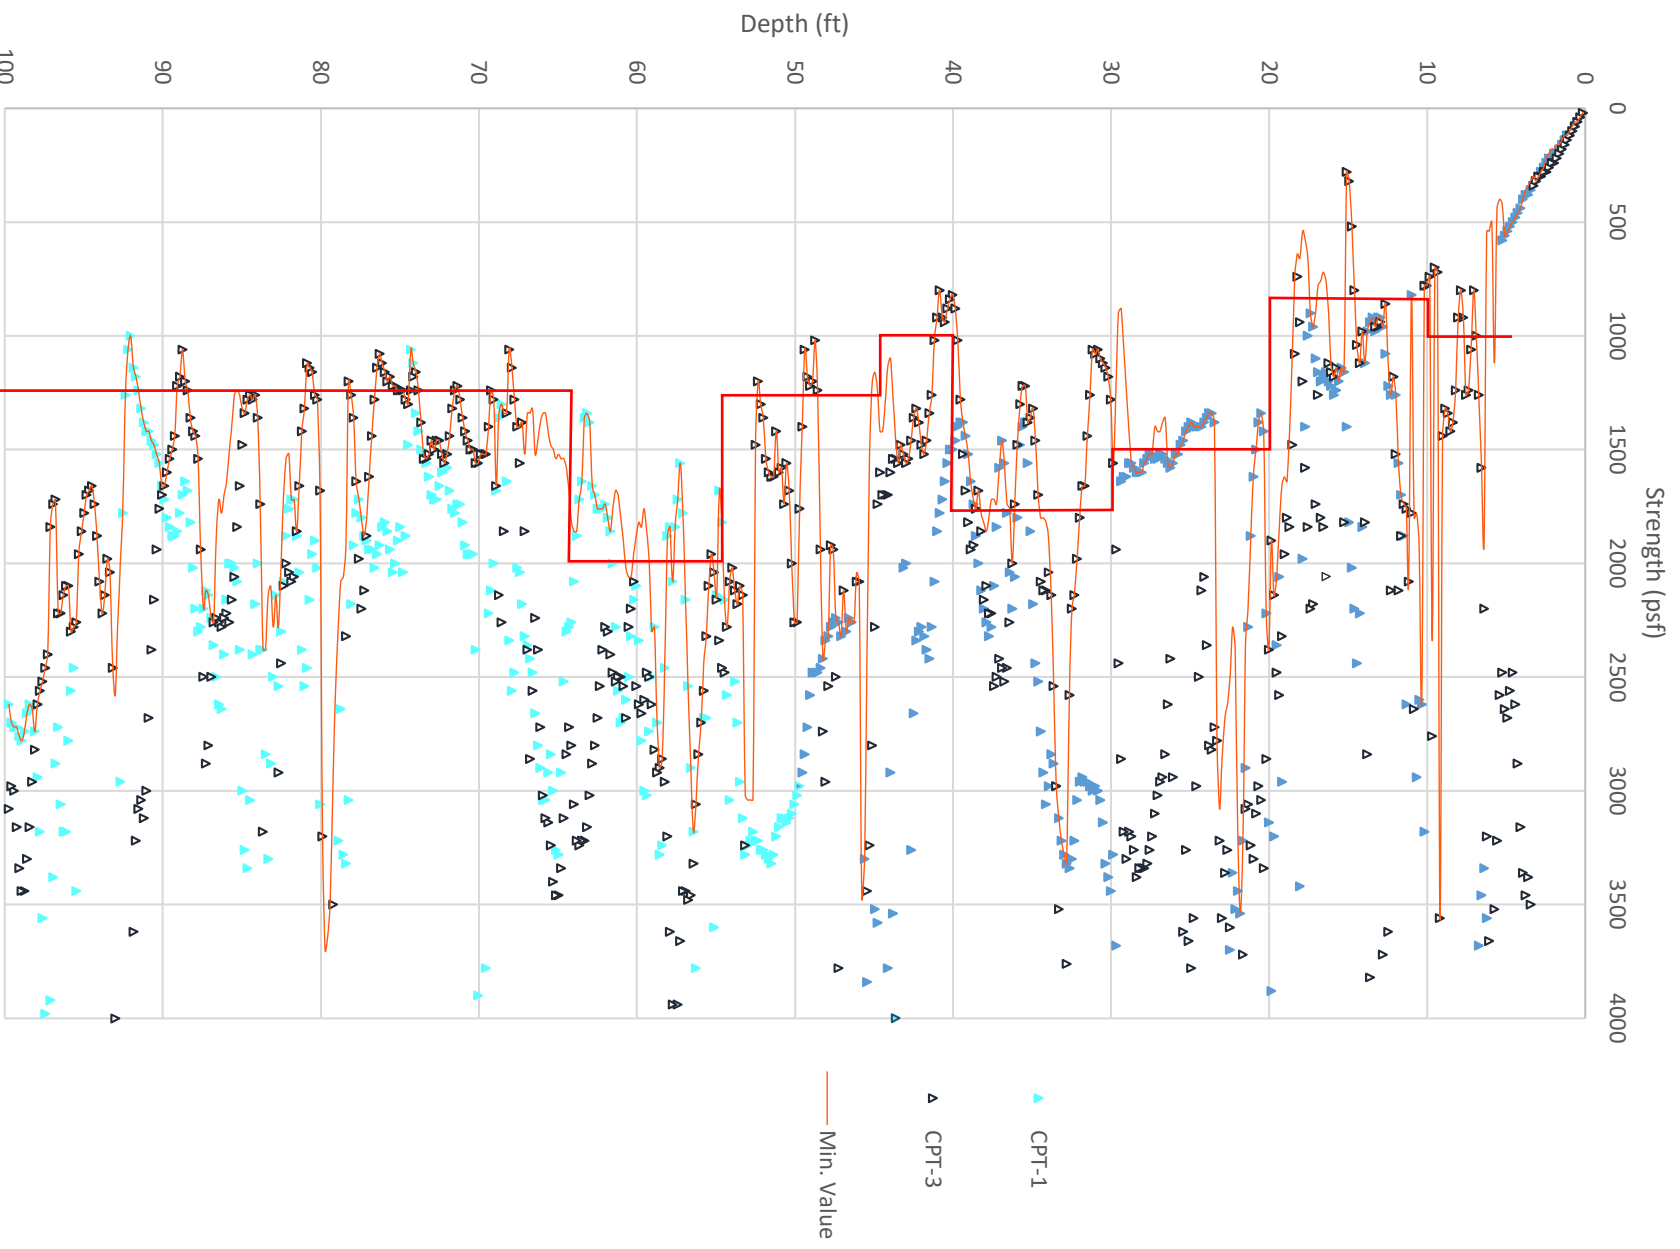
Appendix III-b

Strength vs Depth
