## **Appendix E2 Aquatic Resources Delineation**

# **Aquatic Resources Delineation for the Ontario Regional Sports Complex Project**

**City of Ontario  
San Bernardino County, California**

**December 2023**

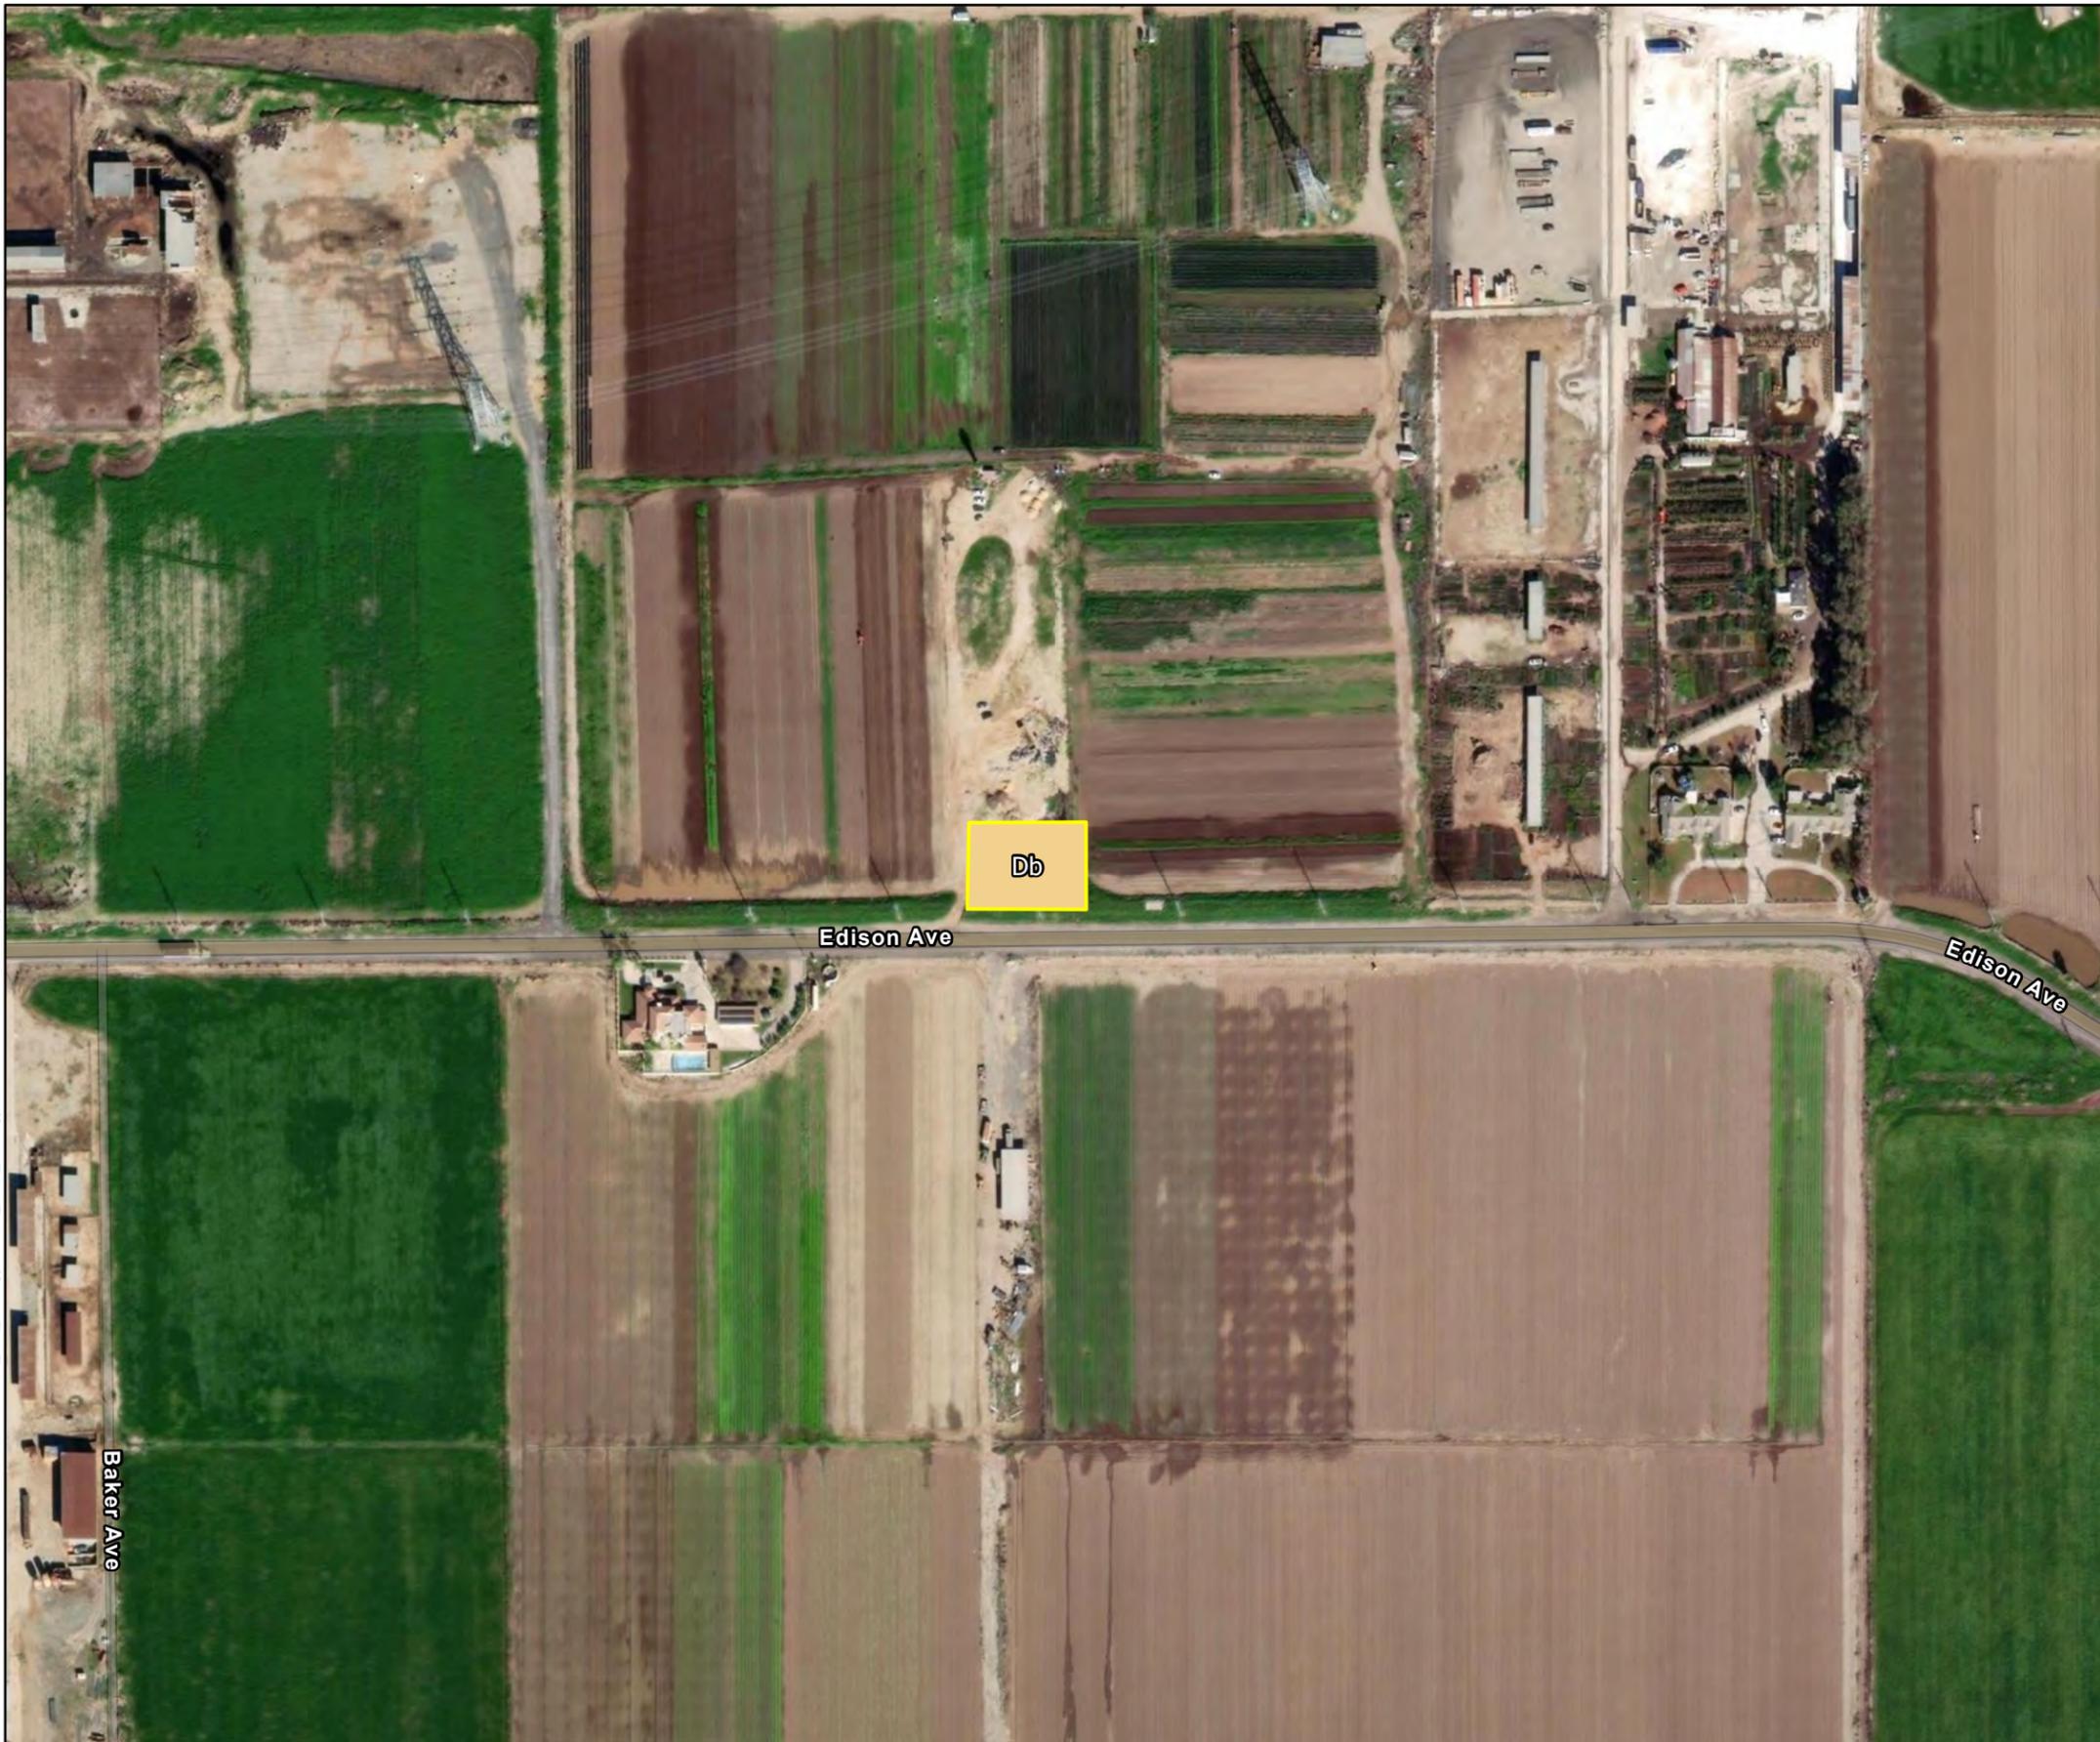
**Figure 3. Natural Resources Conservation Service Soil Types**

The Delhi series consists of very deep, somewhat excessively drained soils that formed in wind modified material weathered from granitic rock sources. Delhi soils are found on floodplains, alluvial fans, and terraces and have slopes of 0 to 15 percent (NRCS 2023b).

Db, Delhi fine sand

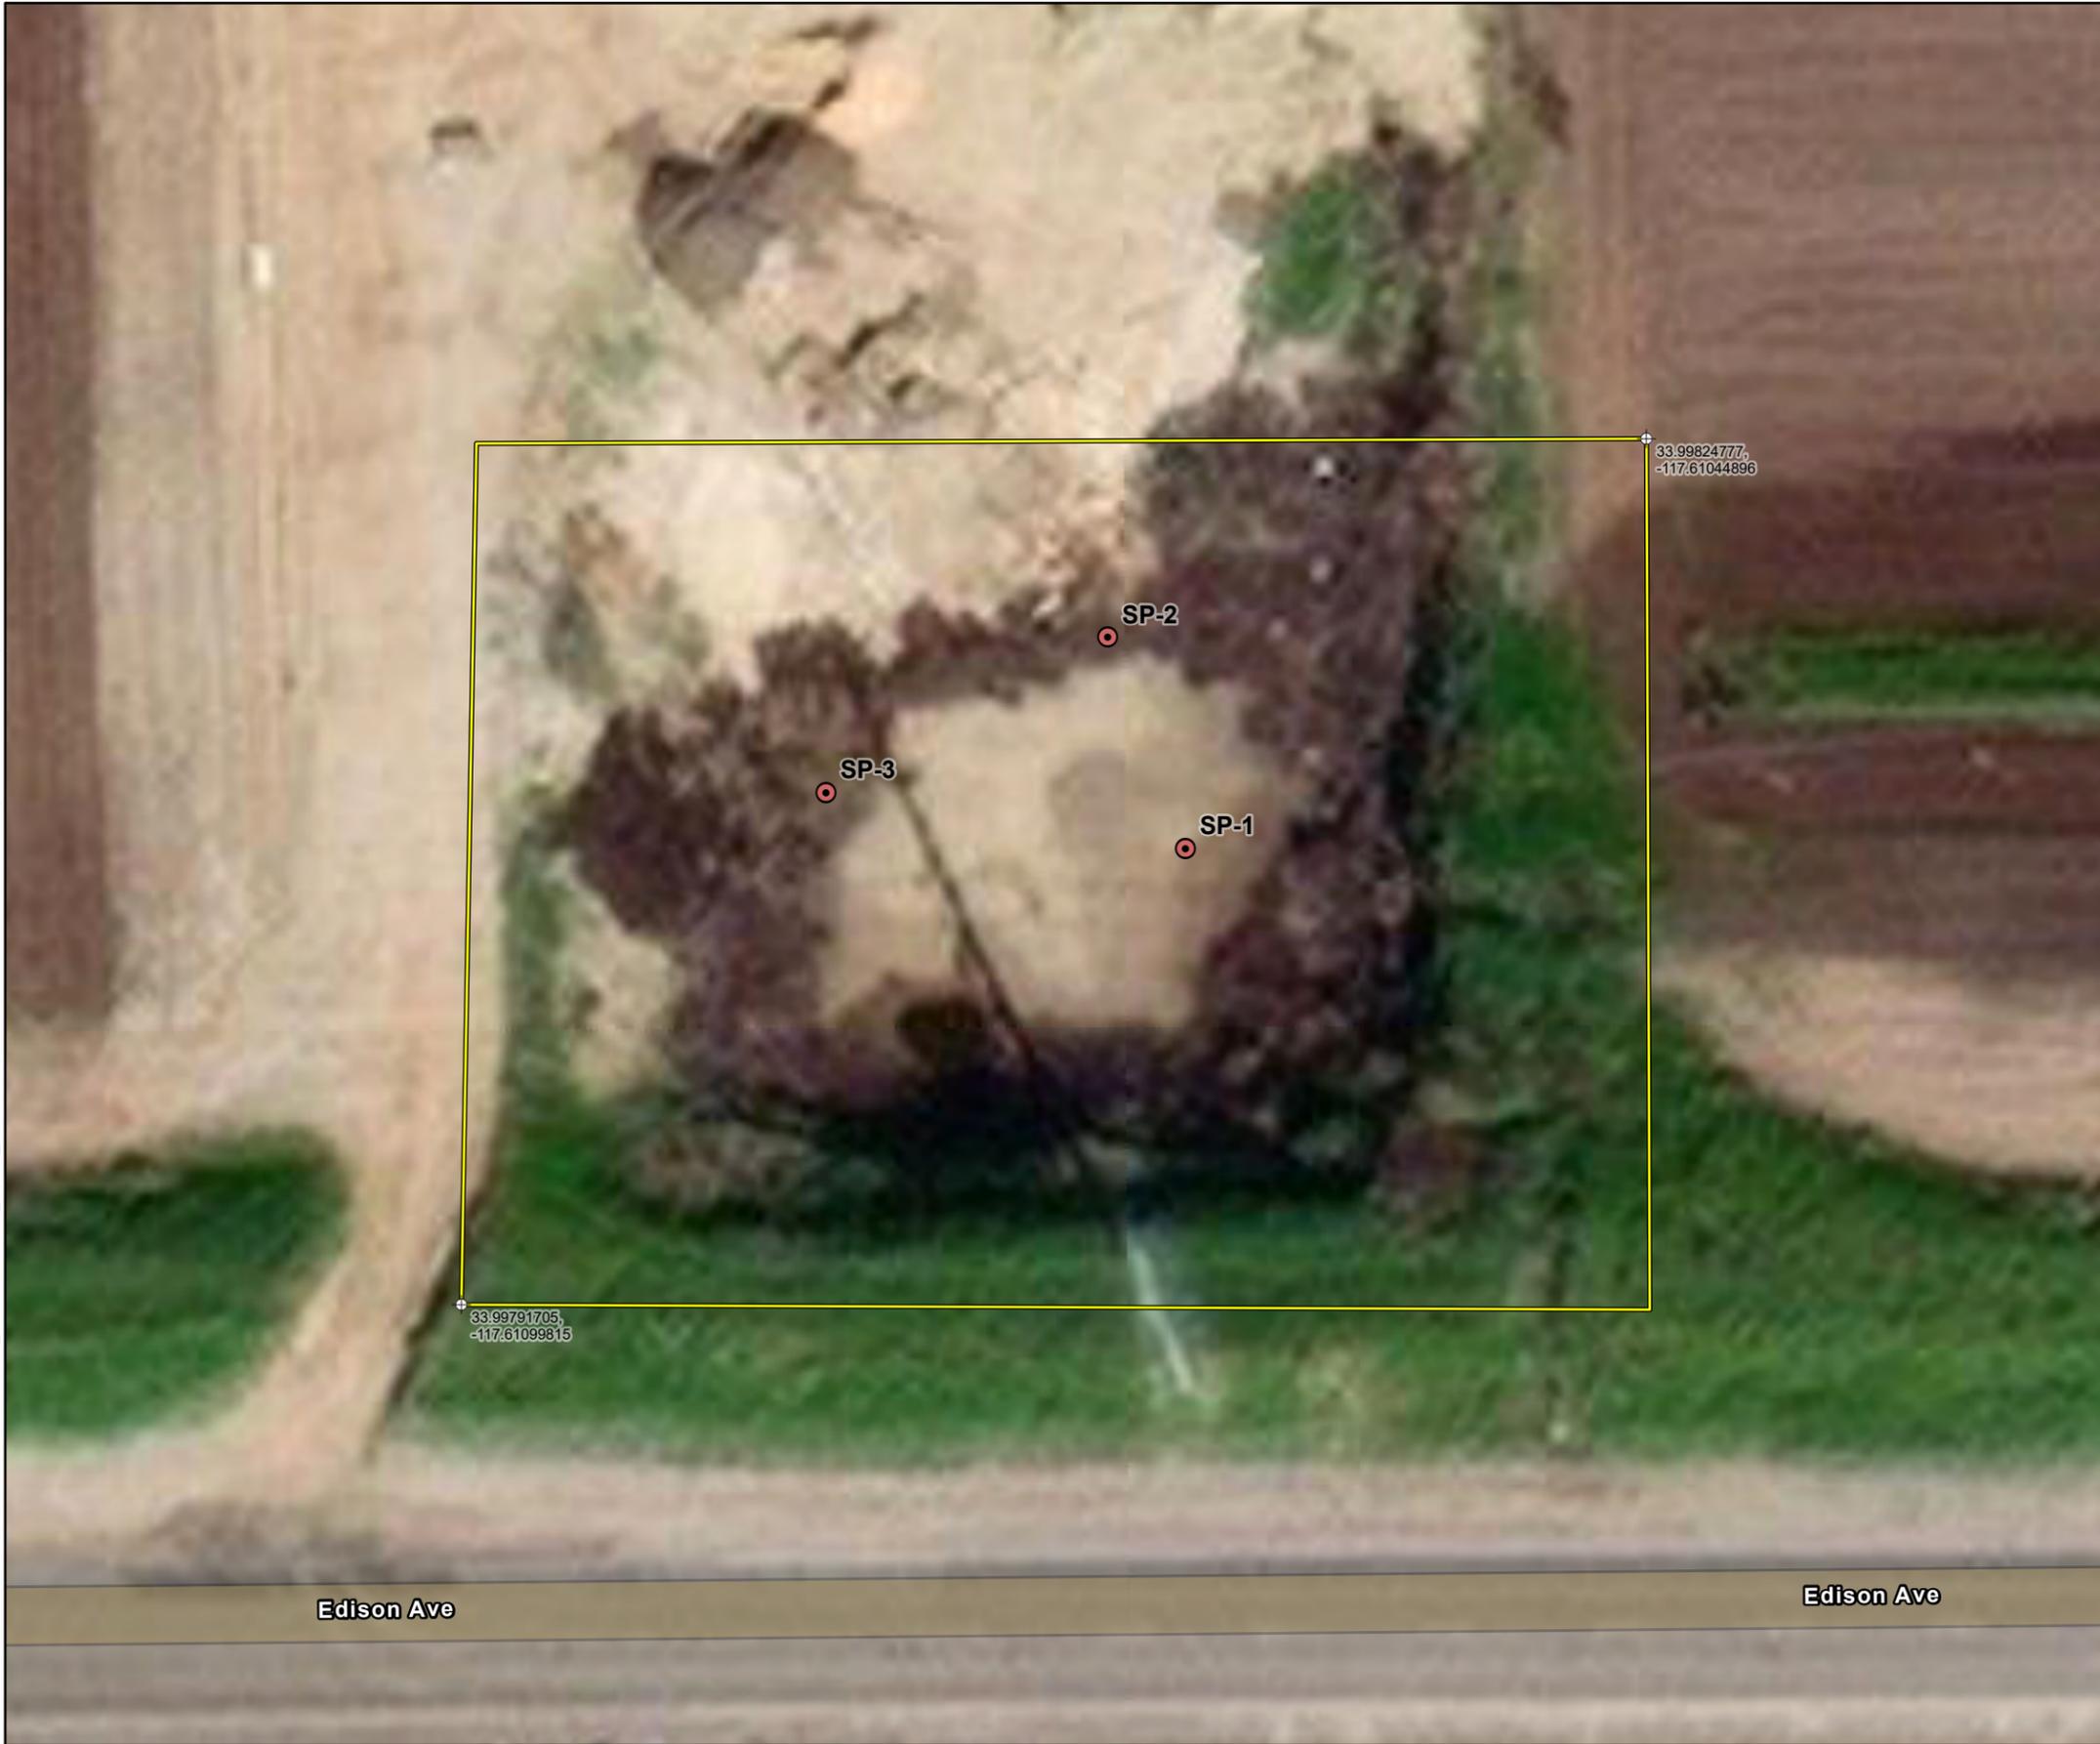
Figure 5. Aquatic Resources Delineation

No aquatic resources were identified within the Study Area. Three sample points were collected in the waste management basin within the Study Area (Figure 5). None of the sample points passed the three-criteria necessary to be a wetland. Soils were significantly disturbed throughout the bottom of the waste management basin and included fill material as well as runoff of soils from adjacent cropland.

Sample Point 1: The dominant plants at Sample Point 1 included peregrine saltbush (FACU) and lamb's quarters (FACU) and did not pass the dominance test or prevalence index for hydrophytic vegetation. The soil matrix colors were 10YR 2/2, 2.5Y 4/2, and 5Y 4/2, at depths of zero to three inches, three to five inches, and five to 18 inches, respectively, with no redox features present. The soil at Sample Point 1 did not meet the hydric soil criteria. Wetland hydrology indicators observed at Sample Point 1 included saturation (A3), surface soil cracks (B6), inundation visible on aerial imagery (B7), and biotic crust (B12). Saturation was present at Sample Point 1 from the soil surface to a depth of 5 inches.

Sample Point 2: Two plant species were dominant at Sample Point 2, including peregrine saltbush (FACU) and lamb's quarters (FACU). The plants did not pass the dominance test or prevalence index for hydrophytic vegetation. The soil at Sample Point 2 did not meet the hydric soil criteria. Soil matrix colors included 7.5YR 2.5/2 at a depth of zero to two inches, with no redox features present, and the matrix was colored 5Y 5/2 at a depth of two to 19 inches, with no redox features present. Sample Point 2's wetland hydrology indicators included surface soil cracks (B6) and inundation visible on aerial imagery (B9).

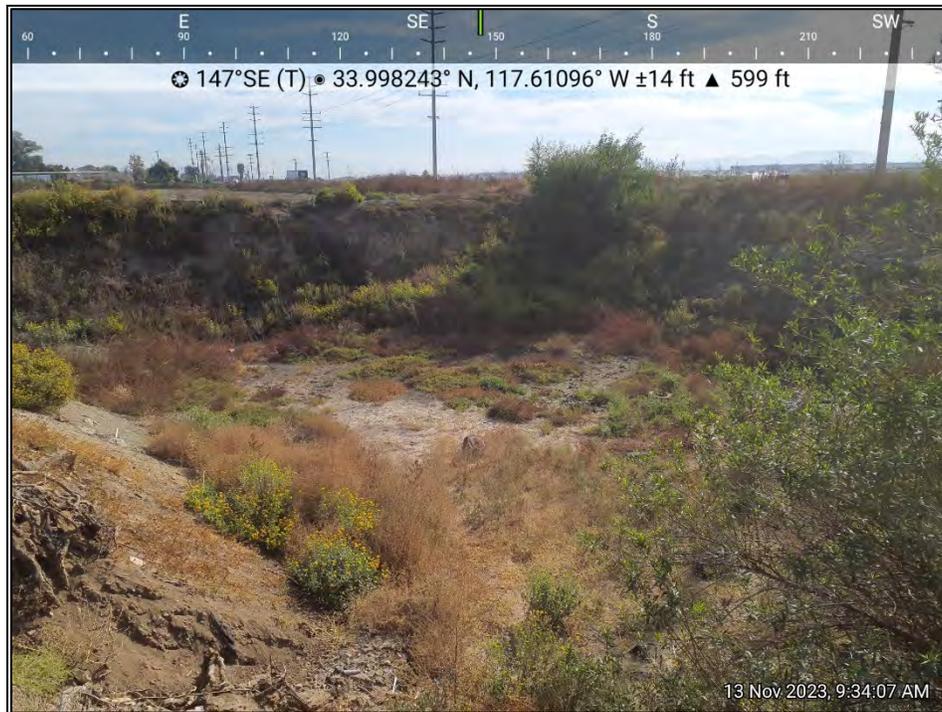
**Photo 1. Waste Management Basin Located within Study Area with a Few Mulefat Shrubs and Black Willows Present in the Southeast Corner (Far Distance).**

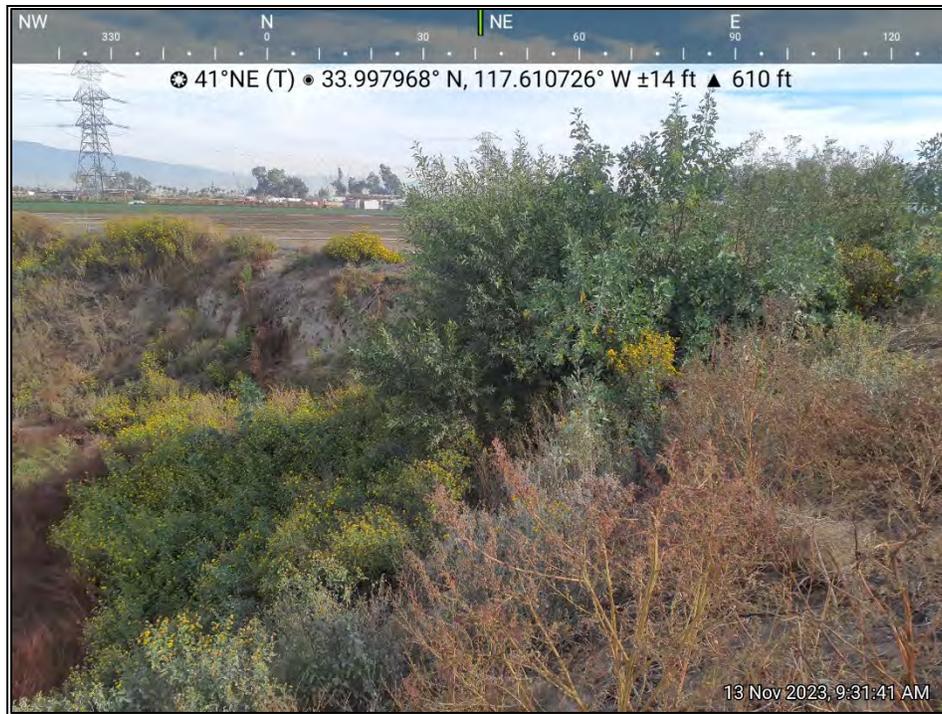
**Photo 2. Mulefat and Black Willow Individuals Present Along the Southeastern Banks of the Waste Management Basin.**

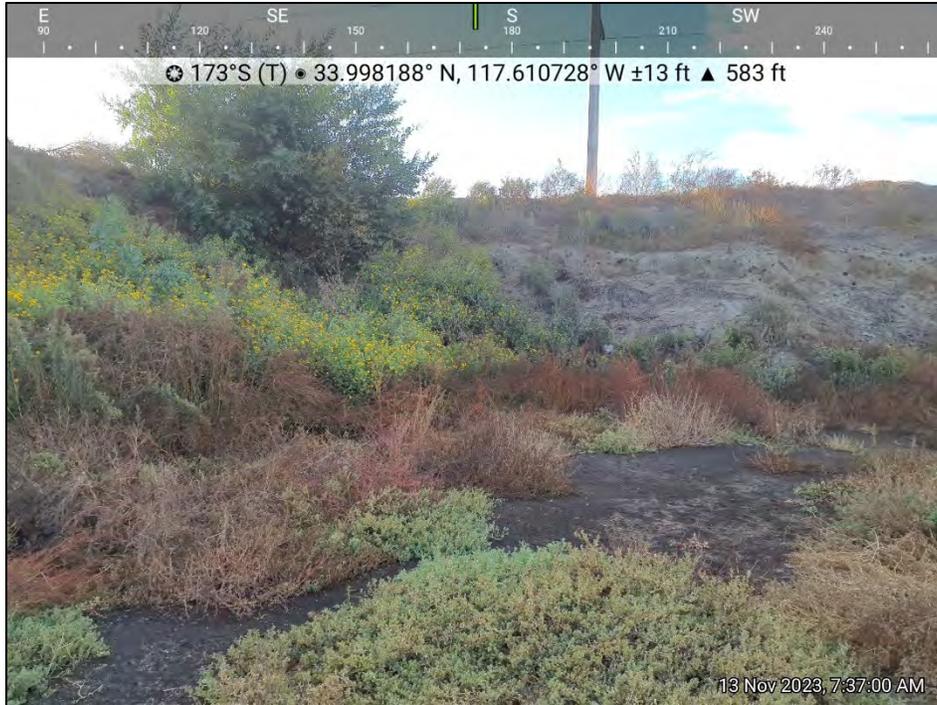
**Photo 3. Saturated Soils Present in Waste Management Basin at the Time of Field Survey.**

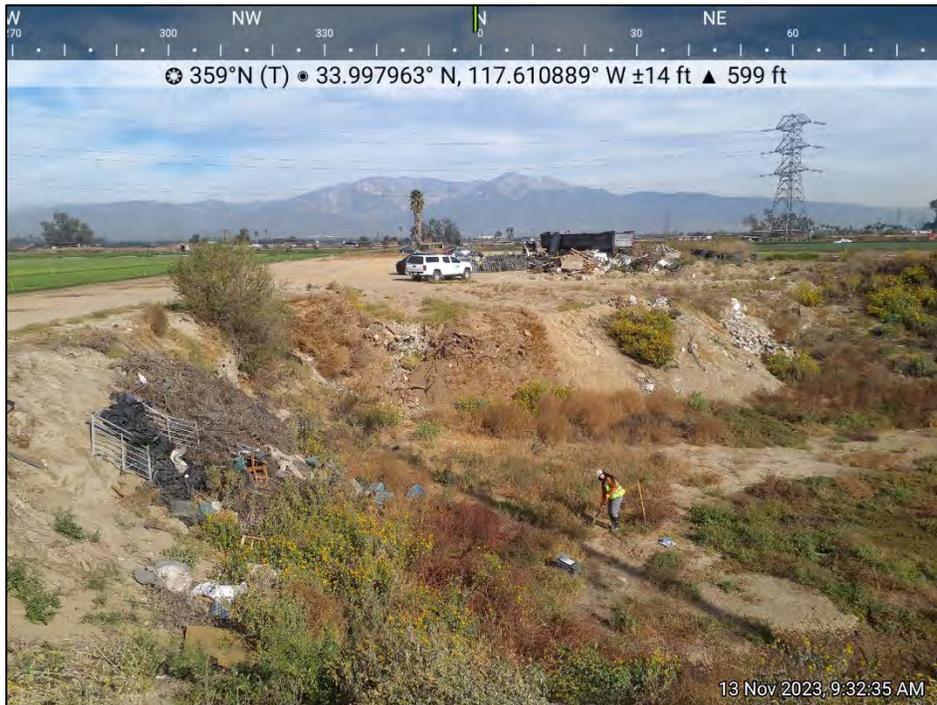
The bottom of the waste management basin is partially vegetated and dominated by peregrine saltbush and lamb's quarters. Pieces of old furniture, uprooted vegetation, dirt fill, and trash are observed along the northern and western banks of the basin. One to two individuals of mulefat (*Baccharis salicifolia*) and two to three individuals of black willow (*Salix gooddingii*) are present along the southeastern banks of the waste management basin. Surrounding land uses are primarily active agriculture and disturbed land. Cropland occurs immediately west and east of the Study Area. A paved road, Edison Avenue, occurs immediately south of the Study Area. Irrigation pipes run along the eastern boundary of the Study Area. The Study Area likely receives runoff from the adjacent cropland to the west and east and from the adjacent irrigation pipes to the east.

**Photo 4. Disturbances Present, including Pieces of Old Furniture, Uprooted Vegetation, Dirt Fill, and Trash Present Along the Northern and Eastern Walls of the Basin.**

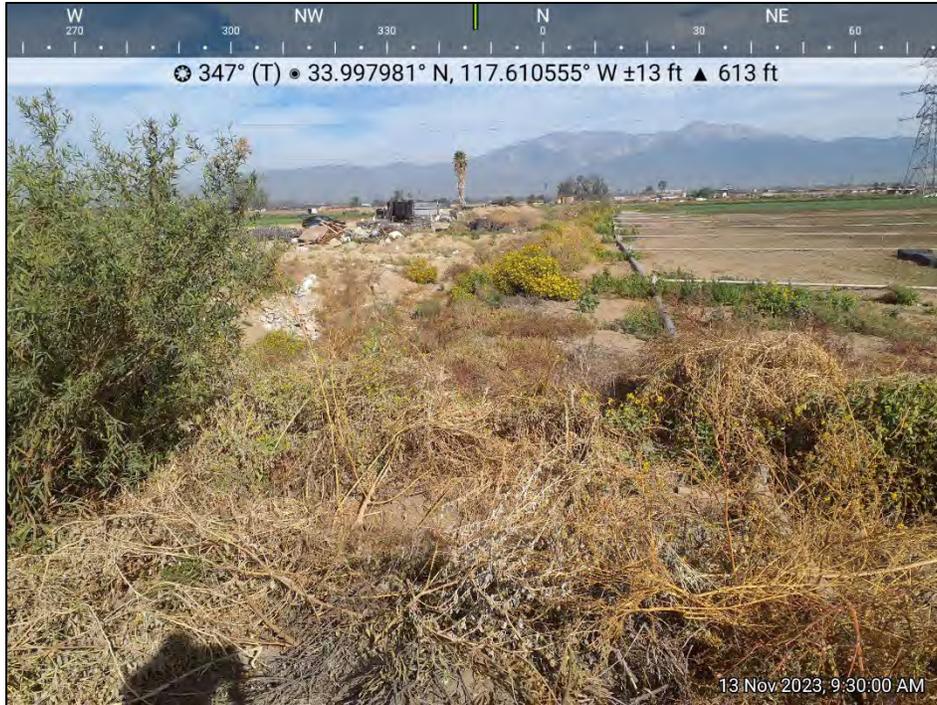
**Photo 5. Irrigation Piping Present Along the Eastern Boundary of the Study Area, Which Appear to Provide a Source of Hydrology to the Waste Management Basin.**
