PHASE I ENVIRONMENTAL SITE ASSESSMENT

~10 ACRE TRACT (UNDEVELOPED)
0.19-MILE WEST OF SIERRA HIGHWAY & WEST AVENUE L4
LANCASTER, LOS ANGELES COUNTY, CALIFORNIA 93535
CCG PROJECT #: CCG-5201

ISSUE DATE: JUNE 2, 2022

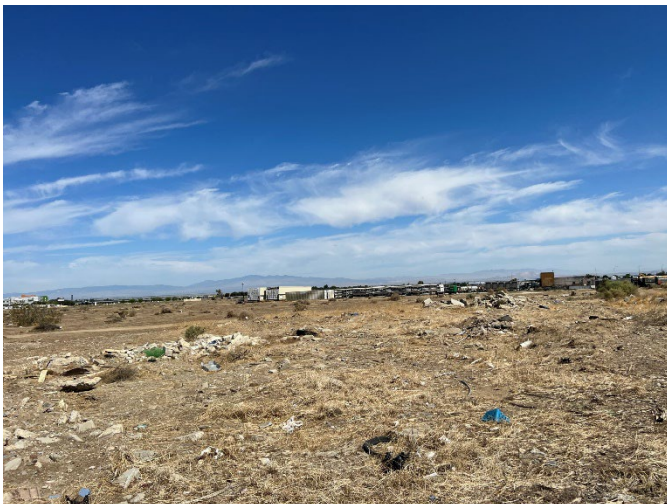
- CCG did not observe any evidence of current or historic landfill activity on the subject property. However, several debris piles / dump sites and scattered windblown debris were observed throughout the subject property, with the most concentrated area of debris / waste being observed along the fence of the adjacent east property. Observed debris generally consisted of municipal waste (paper, plastic, etc.), furniture, appliances and construction debris (lumber, concrete, asphalt / gravel, etc.). CCG observed more significant areas of dumped asphalt rubble in the southeast corner of the subject property and concrete rubble along the central east portion of the subject property. No staining or other obvious evidence of petroleum product / hazardous substance releases was observed in or around the debris. CCG considers the observed debris to represent a de minimis condition in connection with the subject property.

View of concrete piles in the northeast portion of the subject property

Recommendation: CCG recommends the observed debris, wastes and rubble be removed from the subject property, and properly disposed of in accordance with all applicable local, state and federal guidelines. If during future development activities visually impacted soils are identified, impacted soils should be excavated, removed and properly disposed of. Confirmatory soil samples should be collected during excavation to ensure that the extent of impacted soils has been removed.

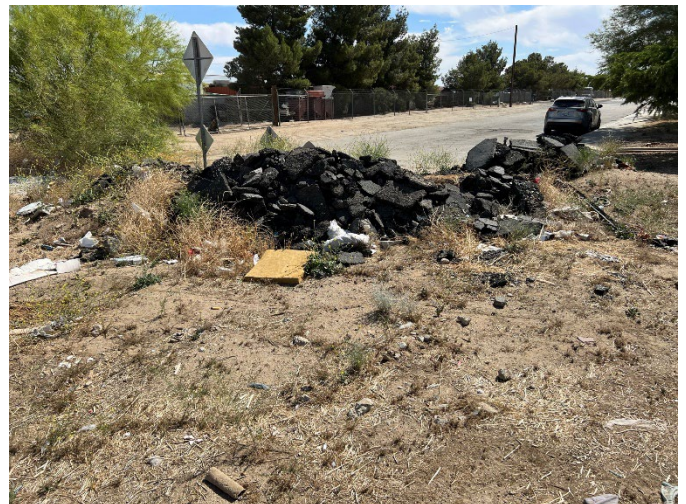
View of asphalt pile in the southeast portion of the subject property

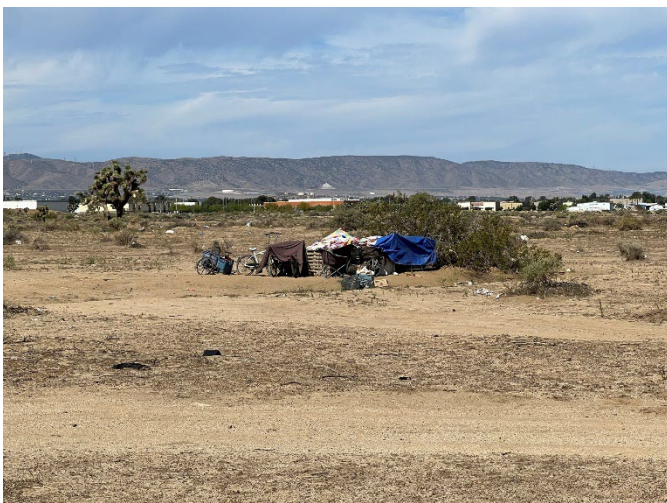
- CCG observed what appeared to be a small homeless encampment in the central portion of the subject property. No improper hazardous substance or petroleum product disposal was noted in the area, but observations of the area were made from a distance.
- Federally-listed threatened and endangered species and their habitats are protected under the Endangered Species Act of 1973, as amended. Individuals of state-listed species are protected under state law, although their habitats are not currently given regulatory protection. A review of endangered

View of homeless encampment in the central portion of the subject property

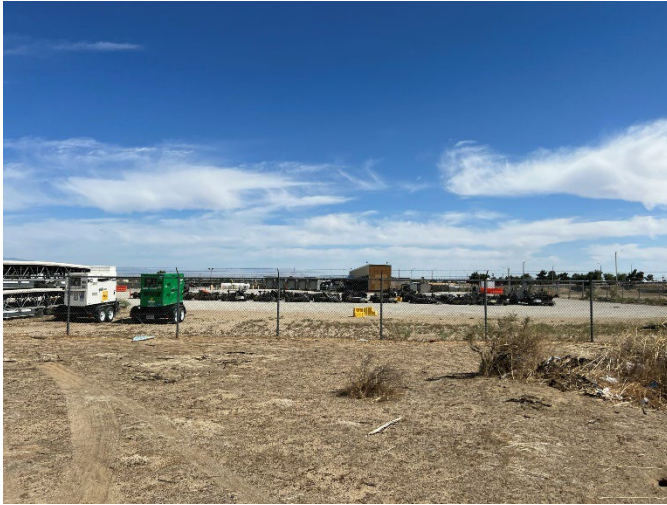
- CCG observed the adjacent north and east properties to be encroaching onto the subject property and the Client provided CCG with an exhibit of the encroachments dated May 19, 2022. Based on CCG’s review of the exhibit and site observations, the southern portion of the storage yard for the adjacent north UPS facility, located at 290 W Avenue L, encroaches onto the subject property, covering an area that measure approximately 350’ long and 41’ wide. CCG was unable to make detailed observations of the UPS facility, but based on perimeter observations, materials stored within the encroachment areas include semi-trailers (enclosed and flatbed), mobile generators and tractor under carriages. CCG did not observe evidence of the storage of significant quantities of hazardous materials or petroleum products or evidence of stained soil or past releases of hazardous materials or petroleum products within the UPS encroachment area. The UPS facility is listed on several environmental databases reviewed as a part of this assessment, most notably the Resource Conservation and Recovery Act (RCRA) Non-generator database and multiple underground storage tank (UST) related databases. None of the databases listings contain information indicative of significant releases of hazardous materials or petroleum products from the facility. Please refer to Section 4.4.1 “Mapped Database Records Search - Off-Site Facilities of Potential Concern” for additional information regarding the UPS database listings.

Adjacent North: UPS facility

Recommendations: If the Client intends to reclaim the encroachment areas, CCG recommends all storage items be removed and the underlying soils be inspected for signs of staining or past releases. If stained soil or indications of past releases are identified soil sampling, removal, and/or disposal and regulatory reporting may be warranted.

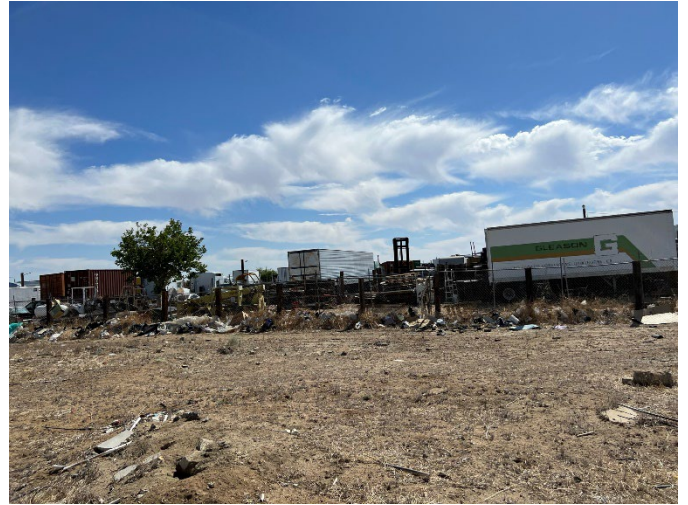
Adjacent East: Tractor/trailer parking
