OAK TREE REPORT

Proposed 4-Lot Subdivision Tentative Parcel Map 80287

Between Triumph Ave. & Tannahill Ave.
Santa Clarita, Ca 91387

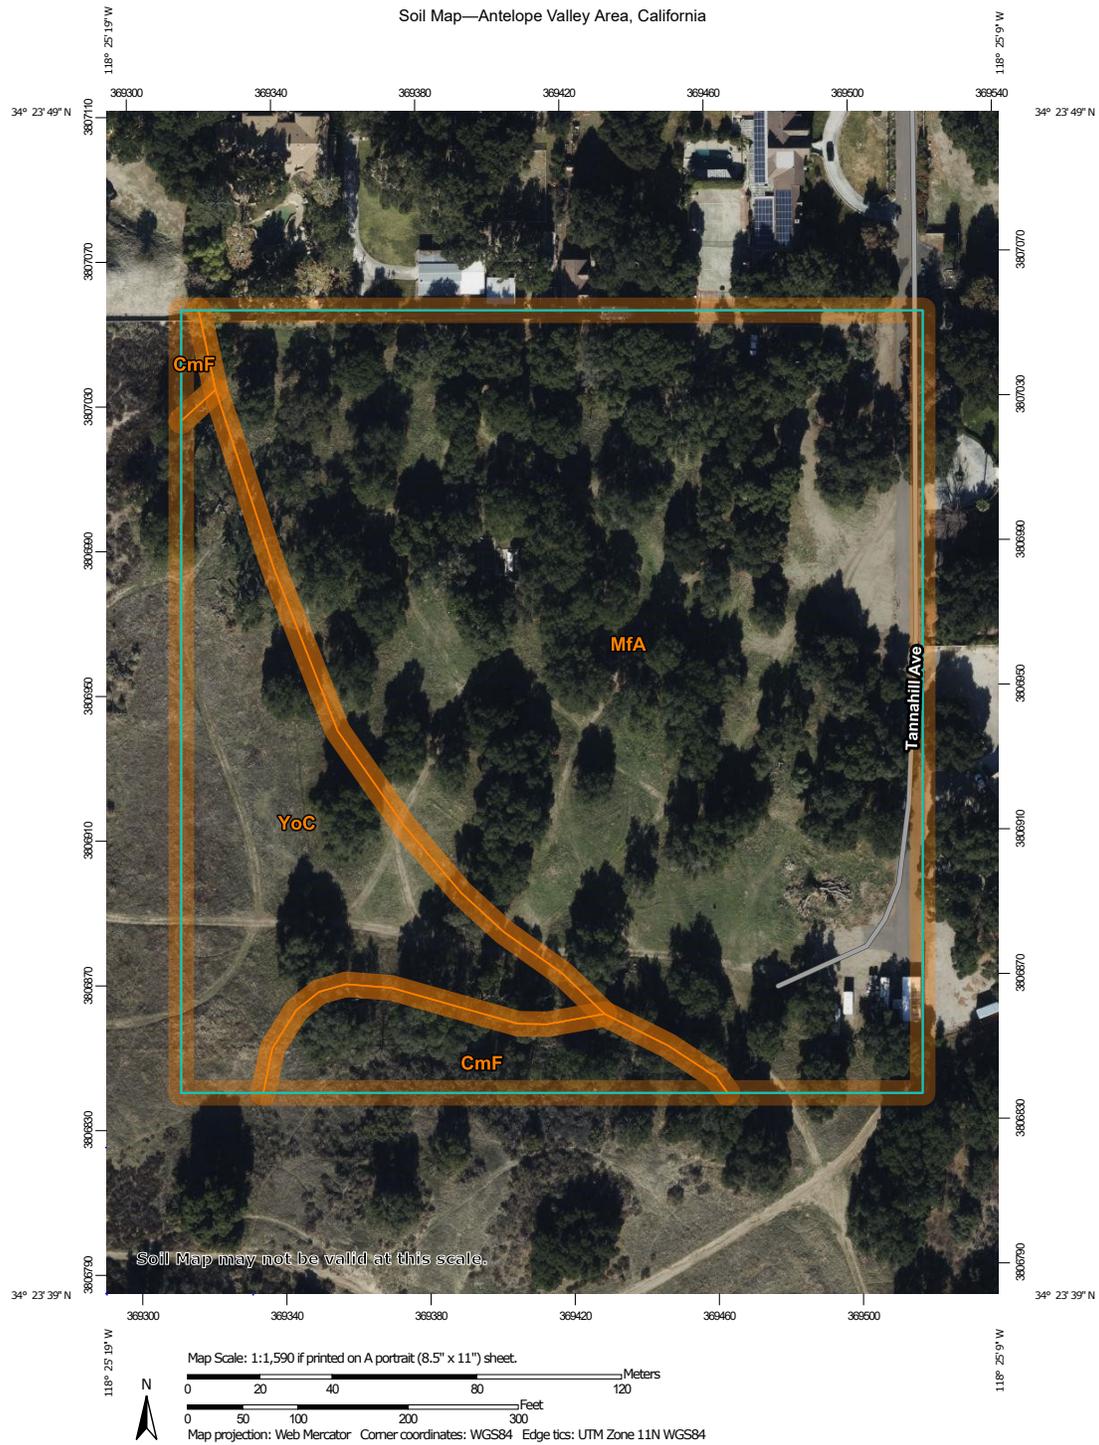
Figure A-5. Soil map of the project site (USDA, Natural Resources Conservation Service 2023).

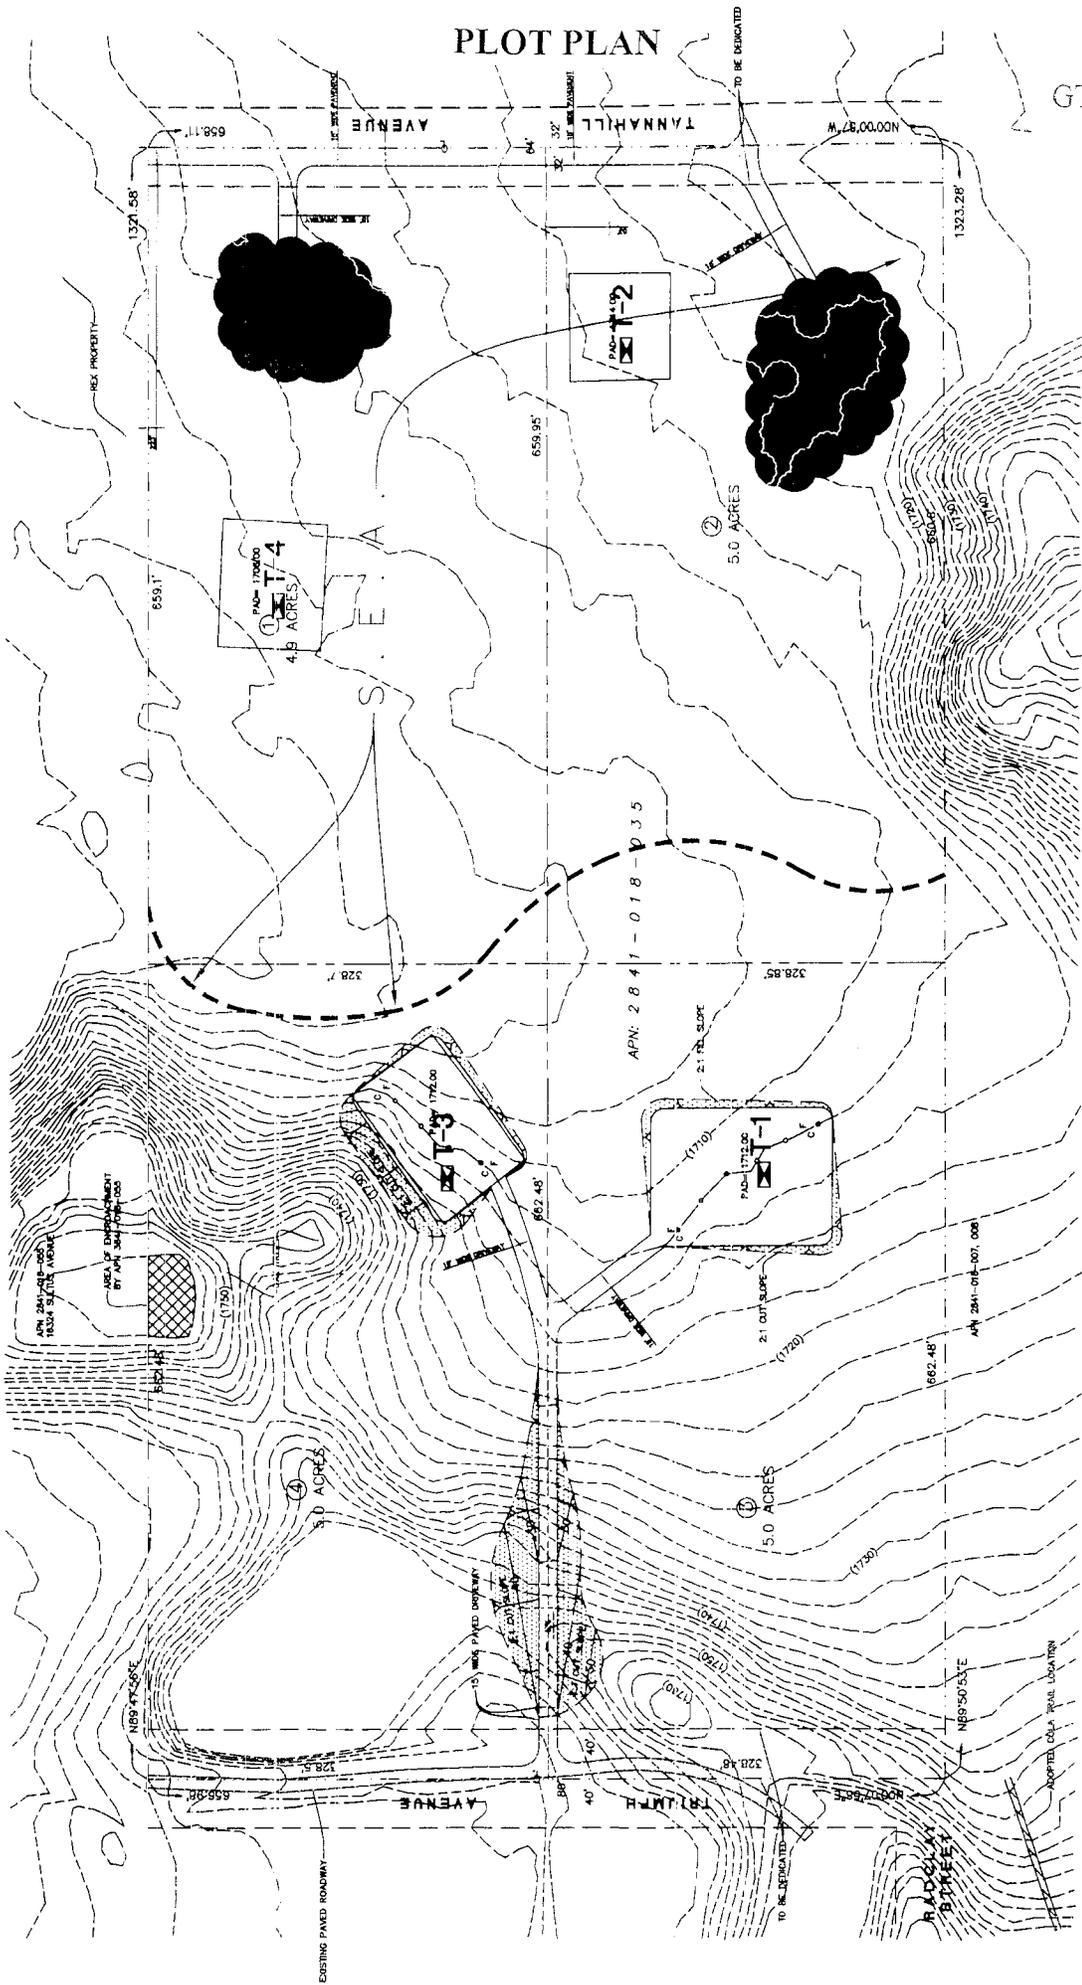
PLOT PLAN

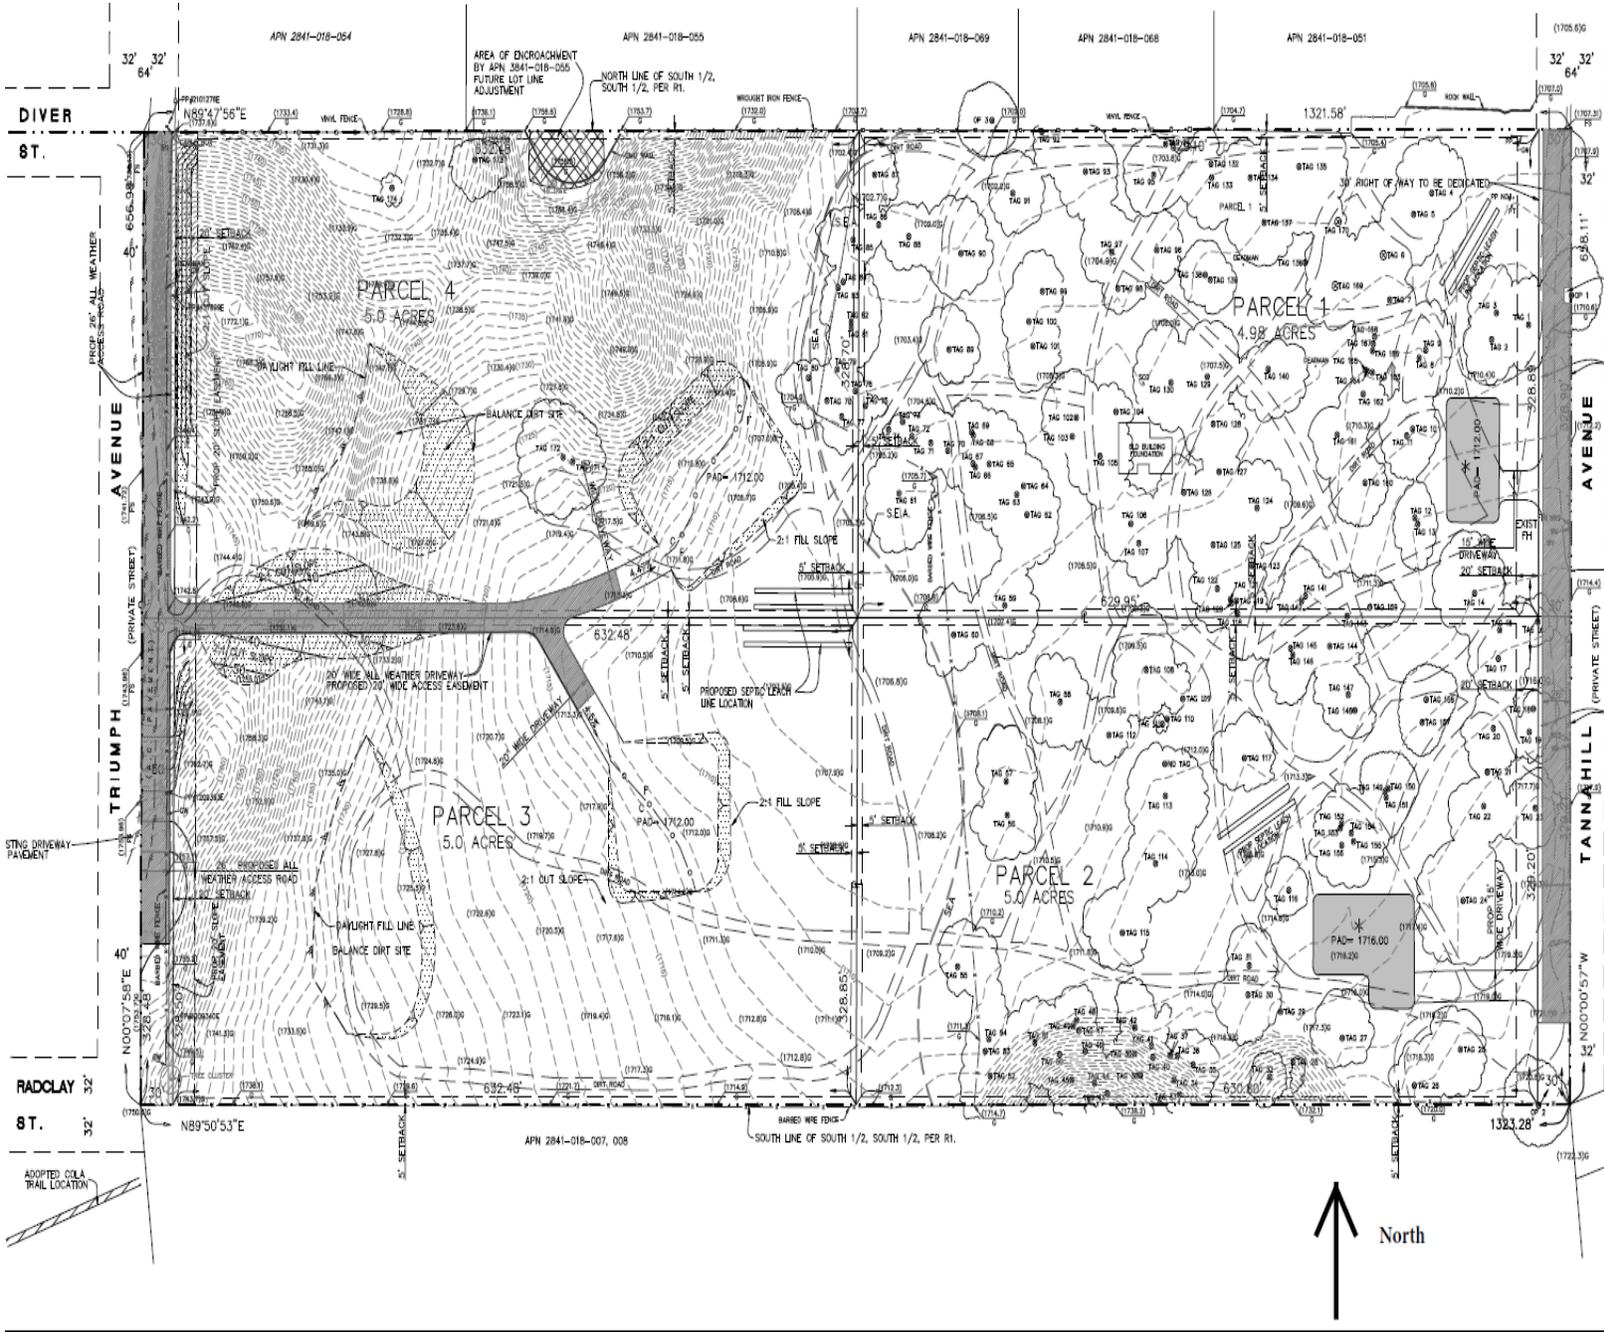
LEACH LINE LOCATION PLAN

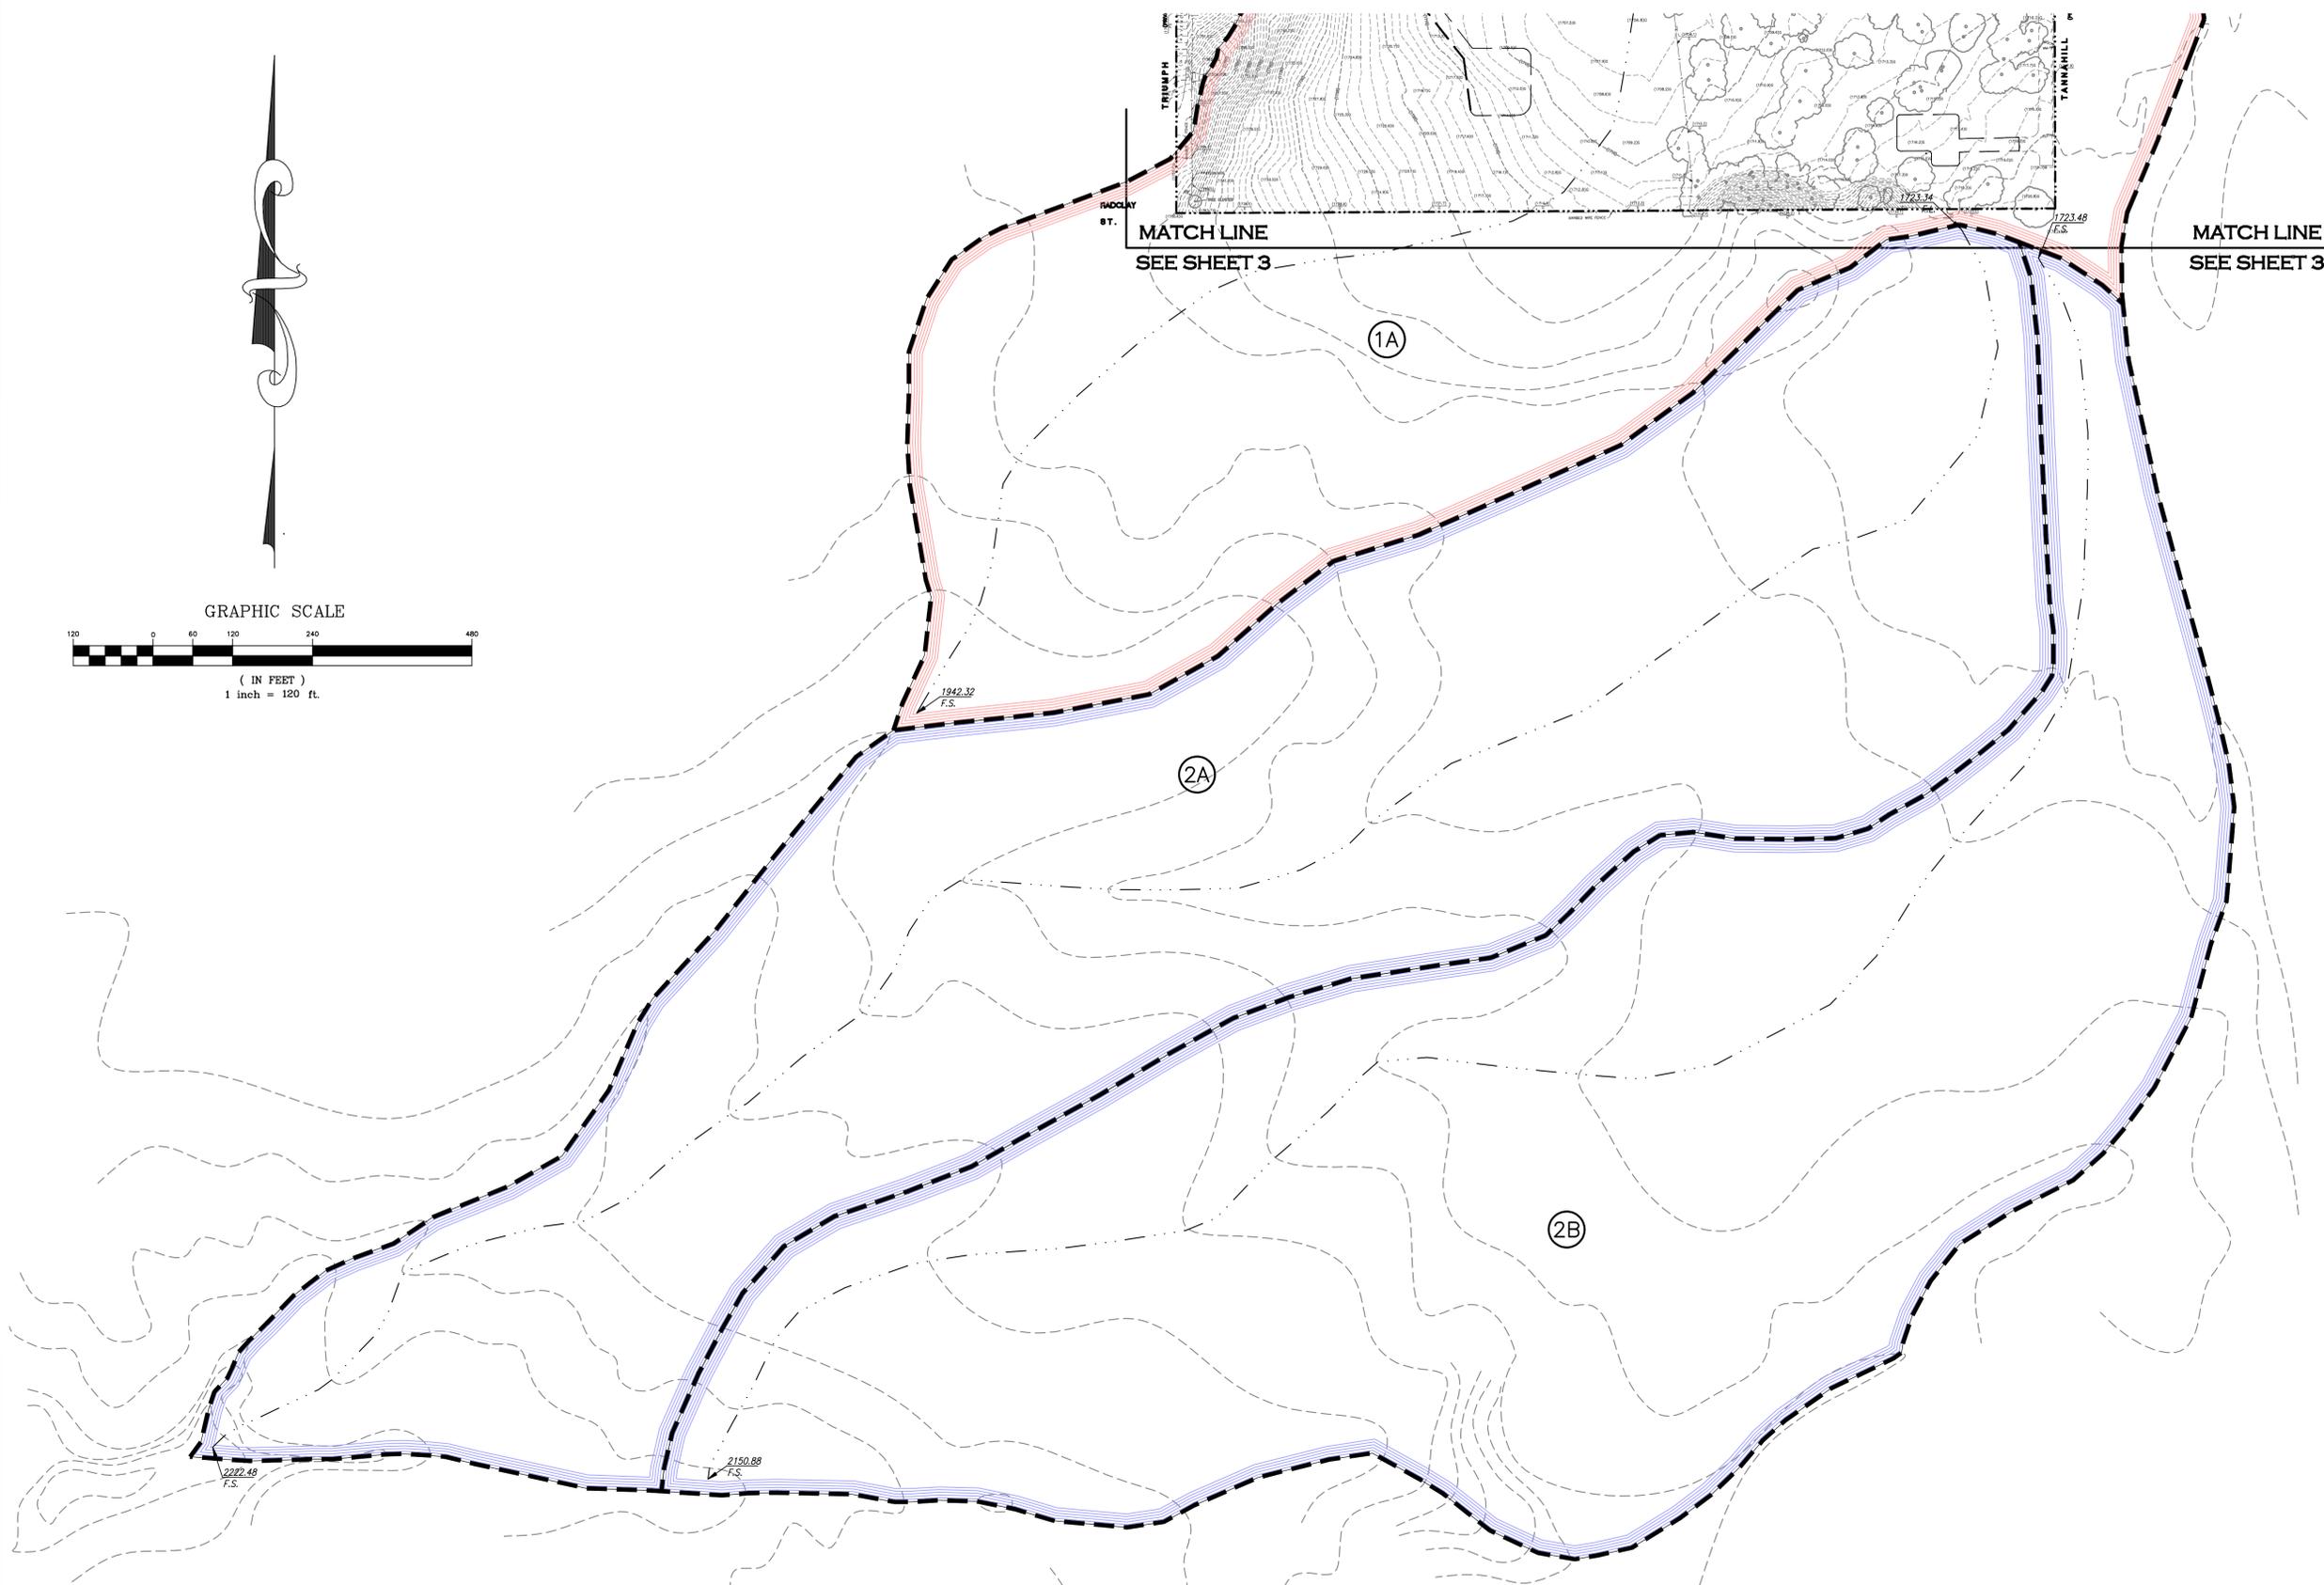
SHEET 1 OF 4 SHEETS

EXISTING CONDITIONS HYDROLOGIC TABLE

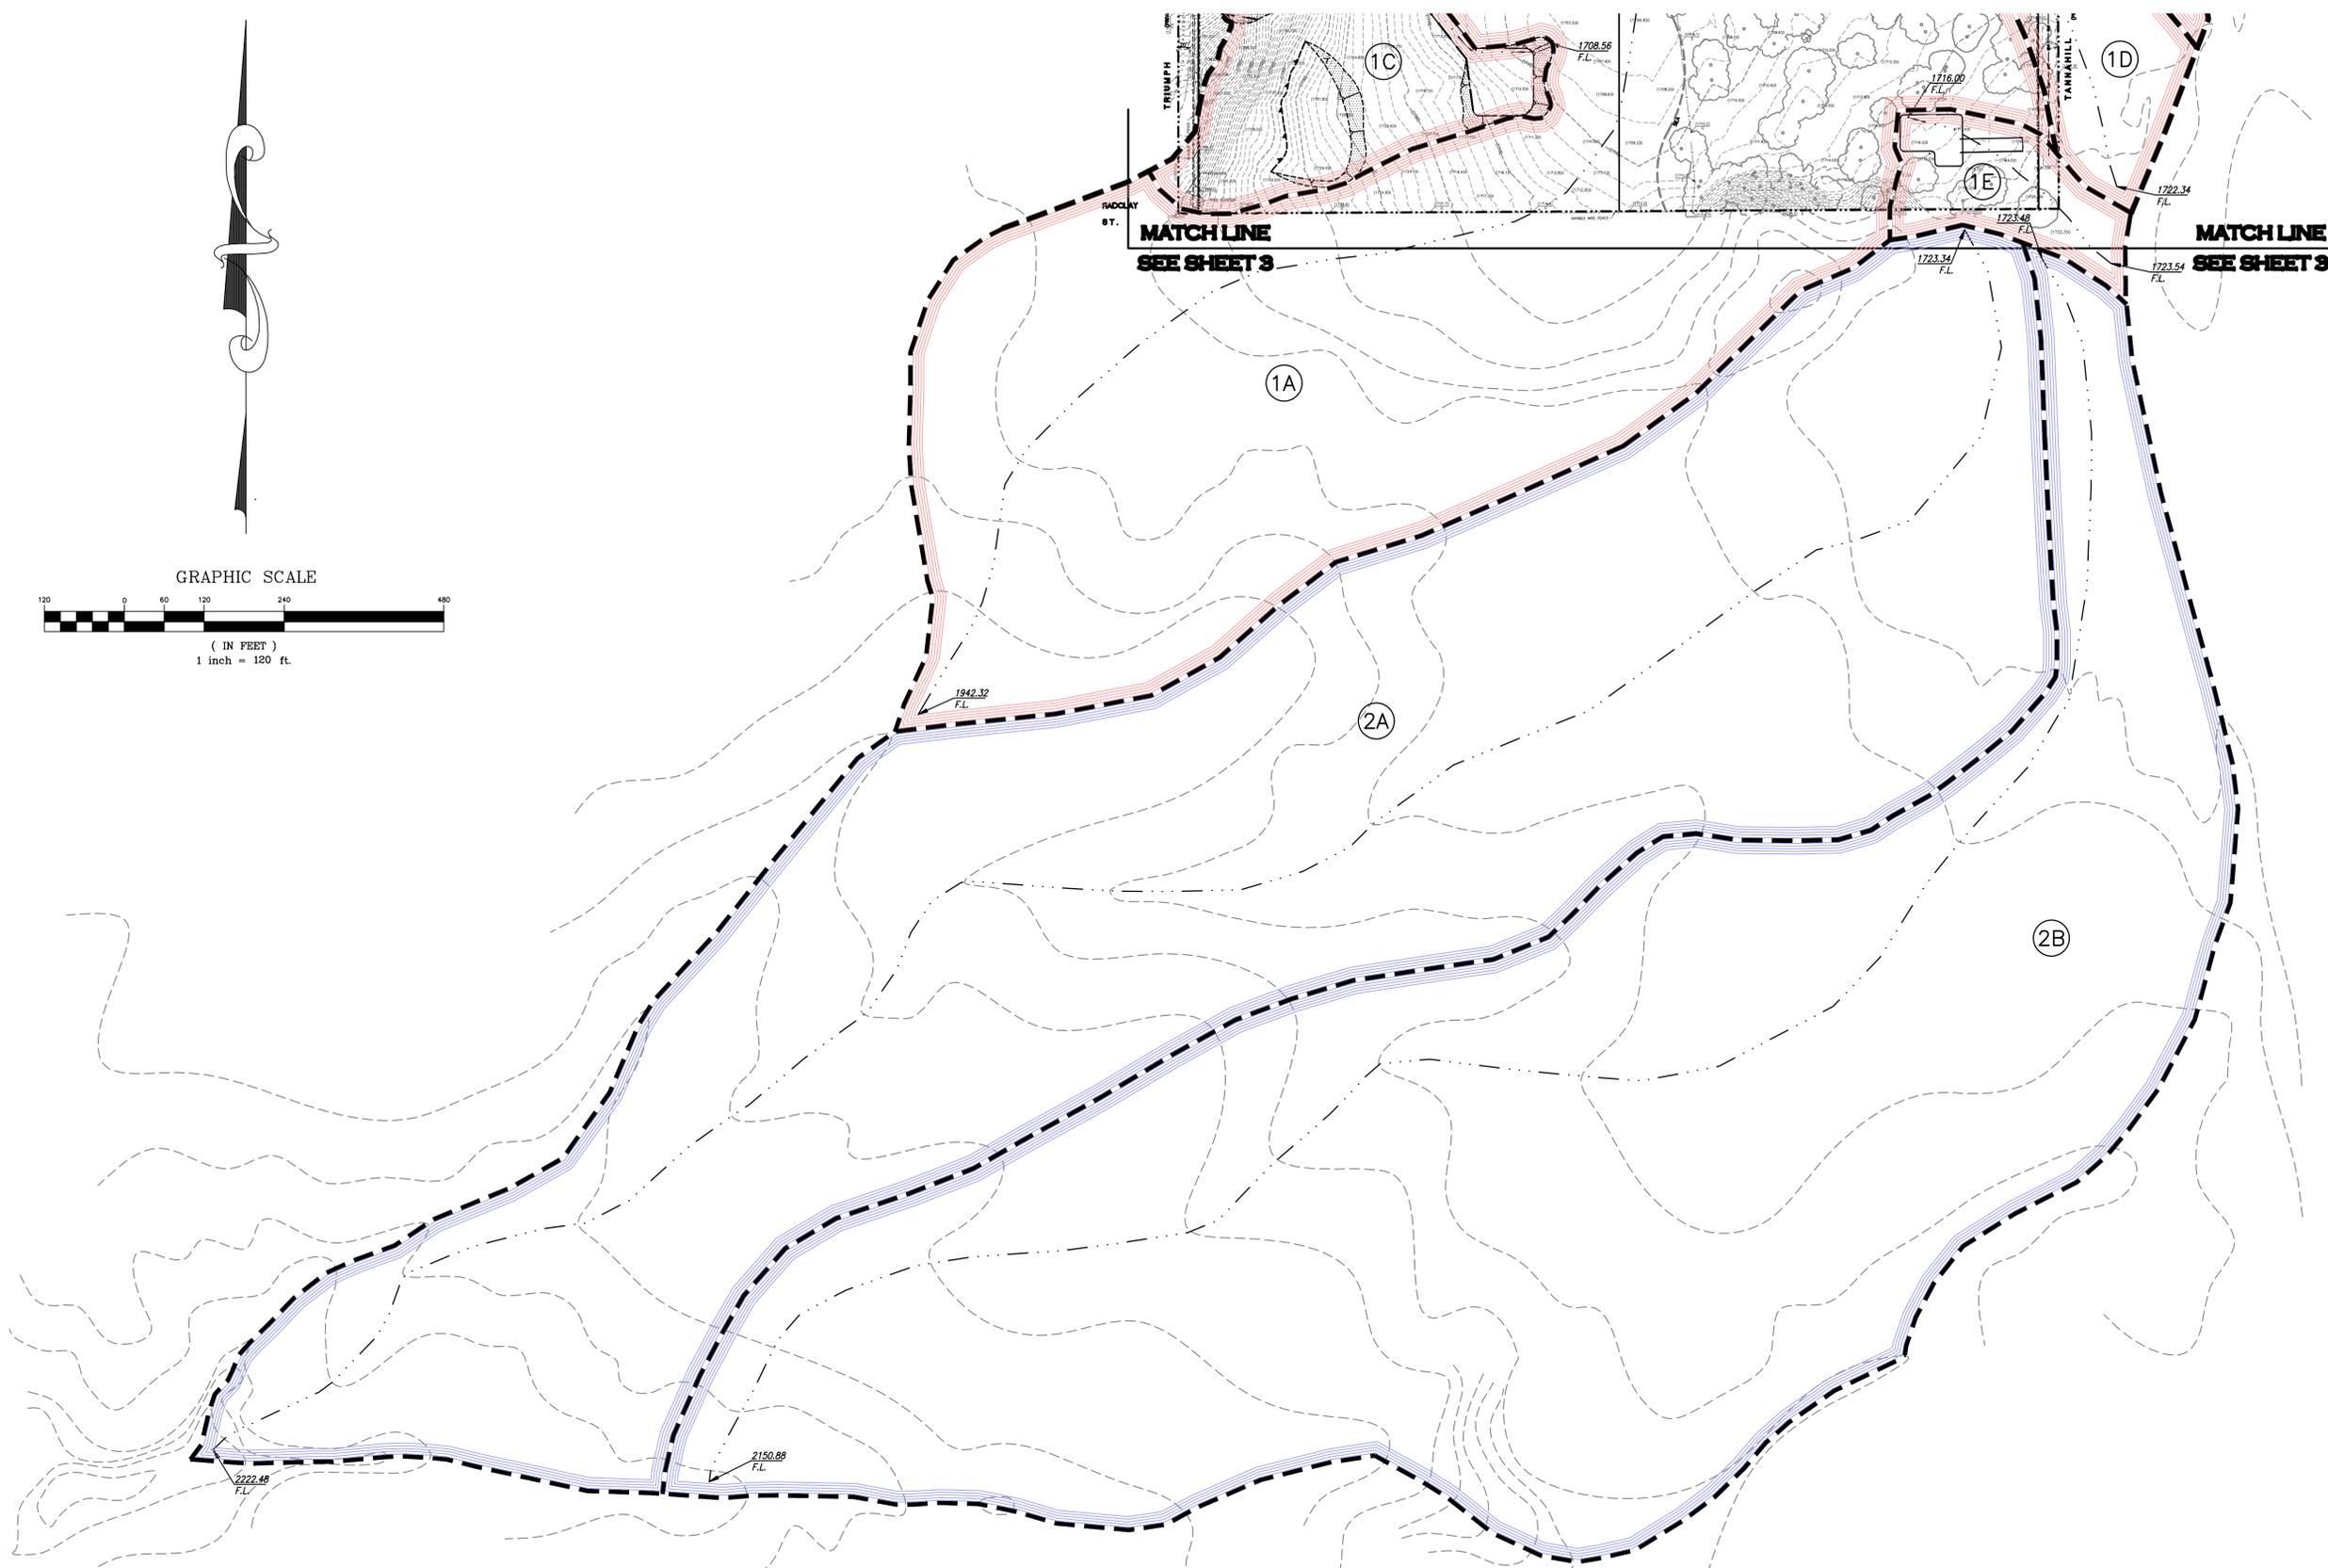
SHEET 3 OF 4 SHEETS

EXISTING CONDITIONS HYDROLOGIC TABLE
