# Dry Creek Trail, Phase II Arborist Report

Sacramento County  
Office of Planning and Environmental Review

August 2, 2022

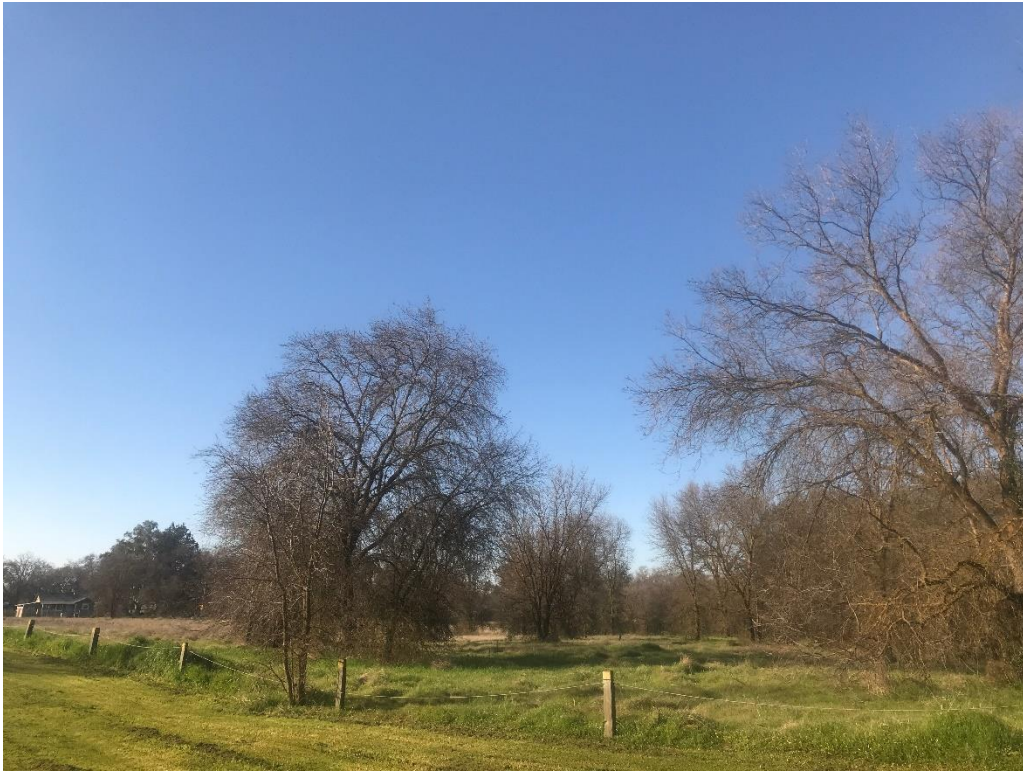
**Photo 1.** Small and medium-sized valley oak trees in southwest portion of survey area, between Cherry Island Soccer Complex to the east and Dry Creek to the west. Looking southwest. 01 March 2021.

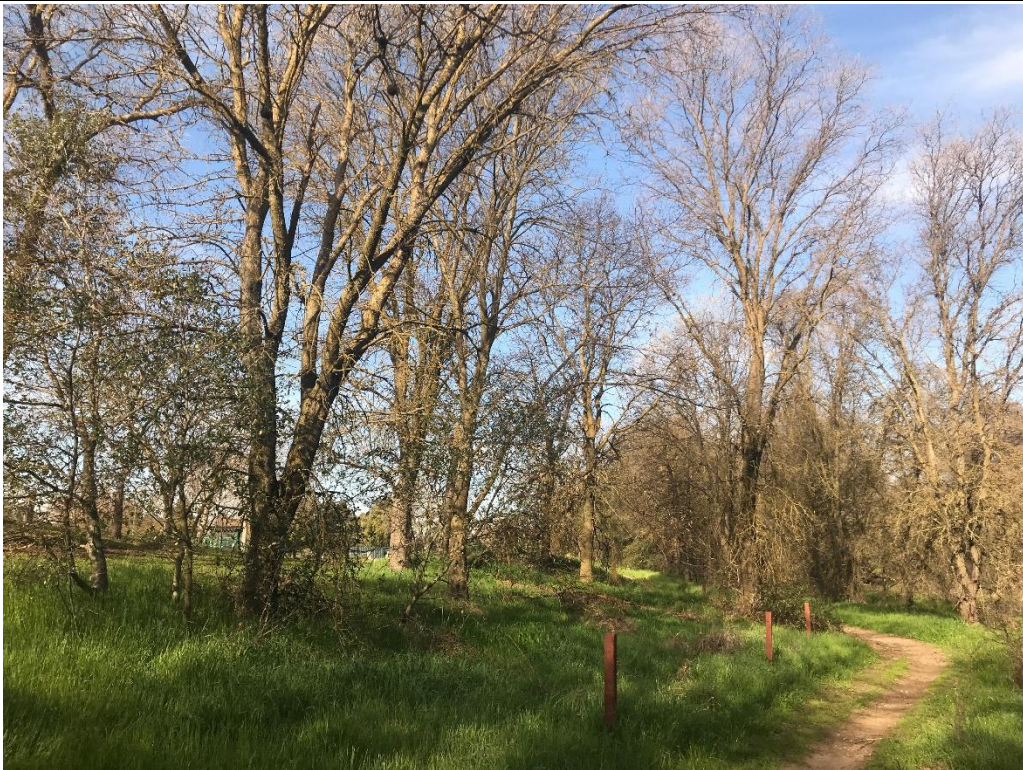
**Photo 2.** Medium-sized oak trees in riparian woodland habitat north of the Cherry Island Soccer Complex. Looking northwest. 02 March 2021.

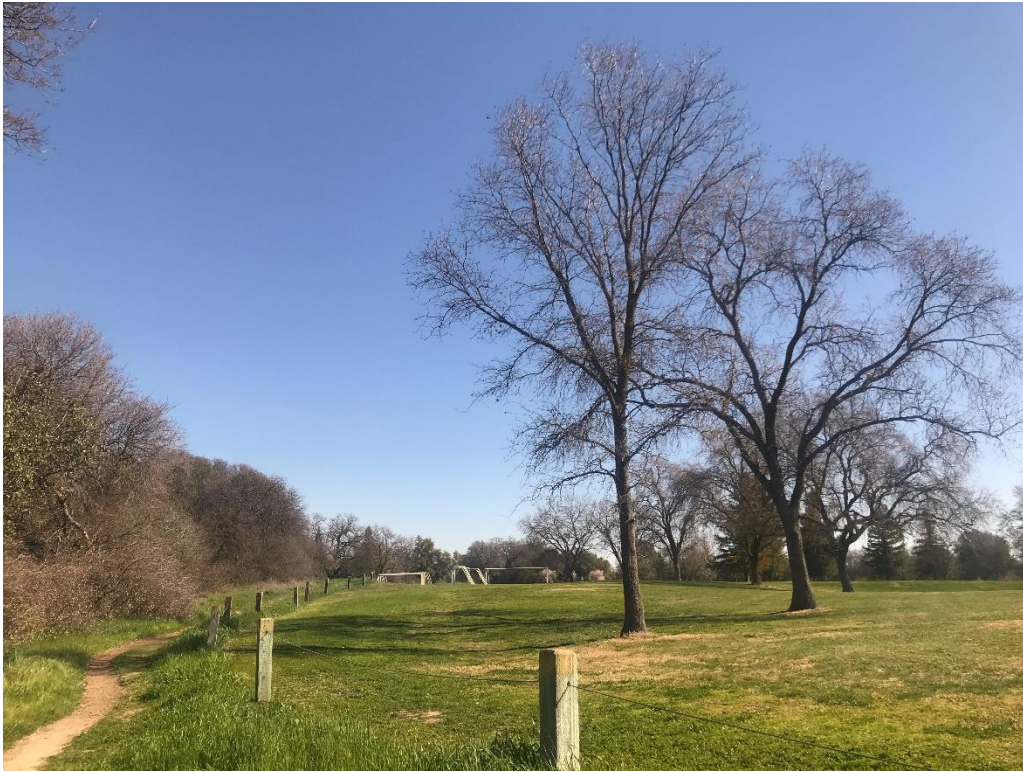
**Photo 3.** North side of Cherry Island Soccer Complex, with native oak trees to the north (left side of photo) and planted landscape trees to the south (right side of photo and in background). Looking northeast. 01 March 2021.

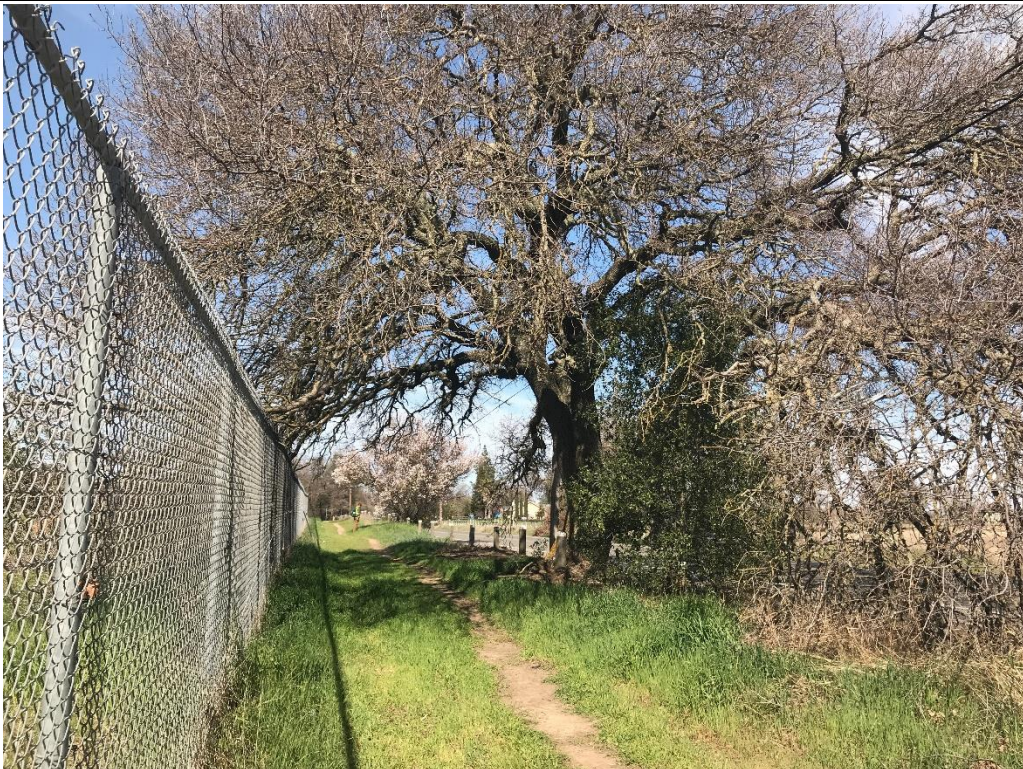
**Photo 4.** Large valley oak (foreground) and almond trees (background) along 28<sup>th</sup> Street. Looking north. 02 March 2021.

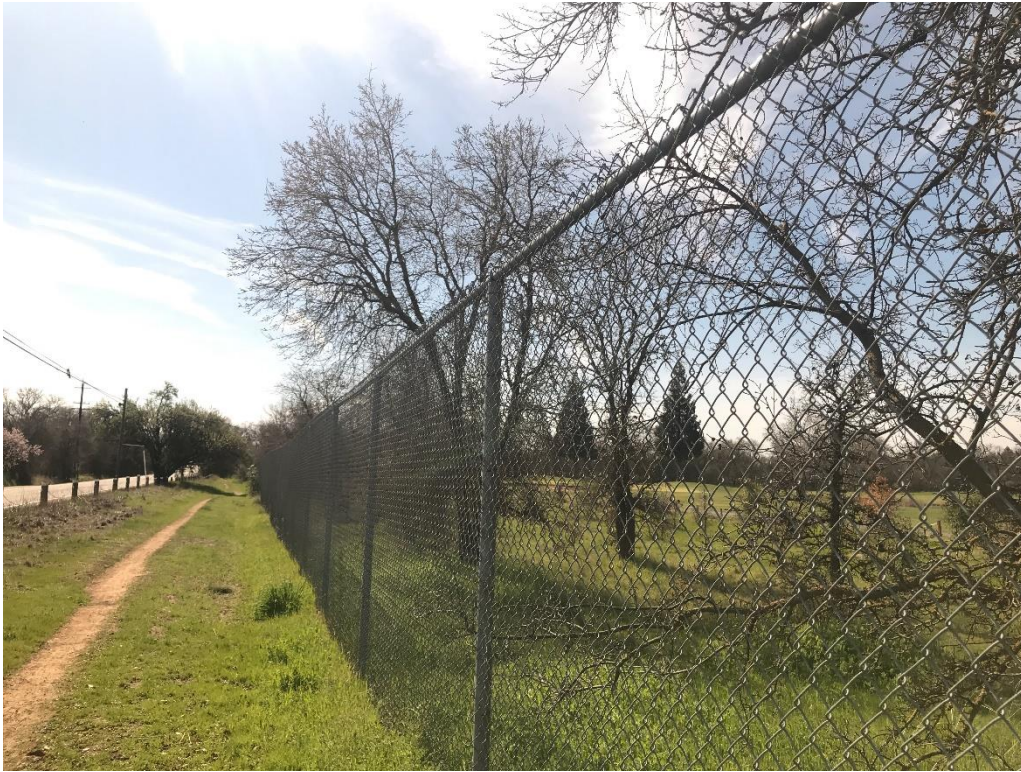
**Photo 5.** Planted native oak trees along edge of Cherry Island Golf Course, west of 28<sup>th</sup> Street. Looking south. 02 March 2021.

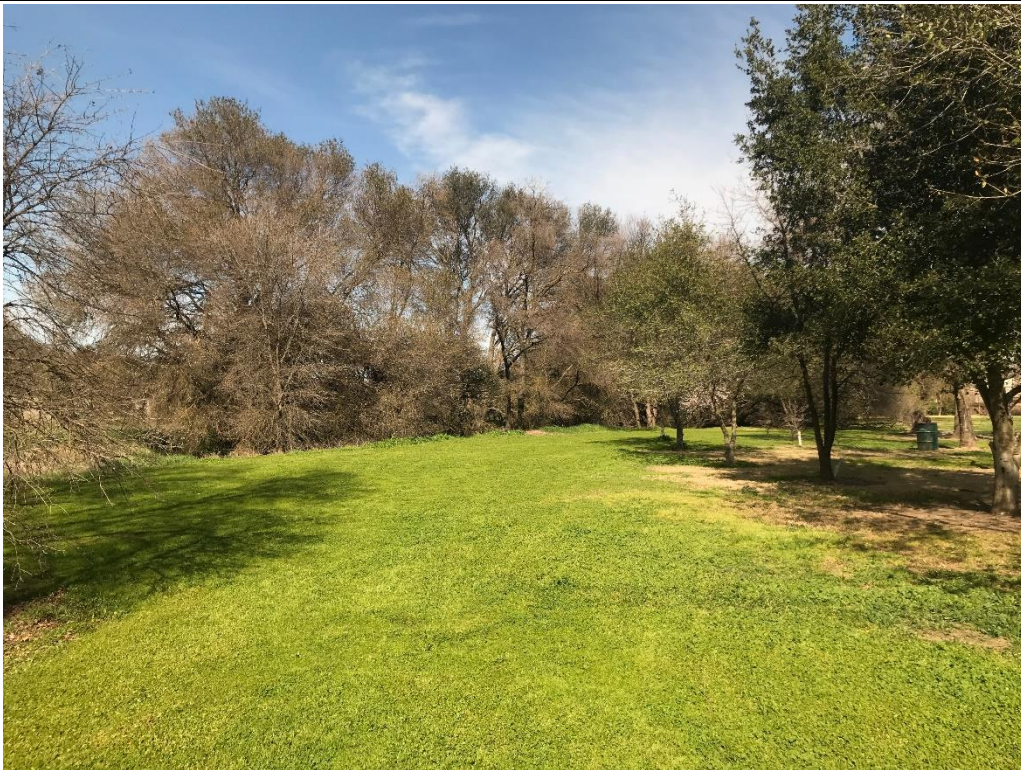
**Photo 6.** Western edge of Northbrook Park, with planted landscape trees to the east (right side of photo) and native oak woodland along Dry Creek to the west (left side of photo). Looking northeast. 02 March 2021.

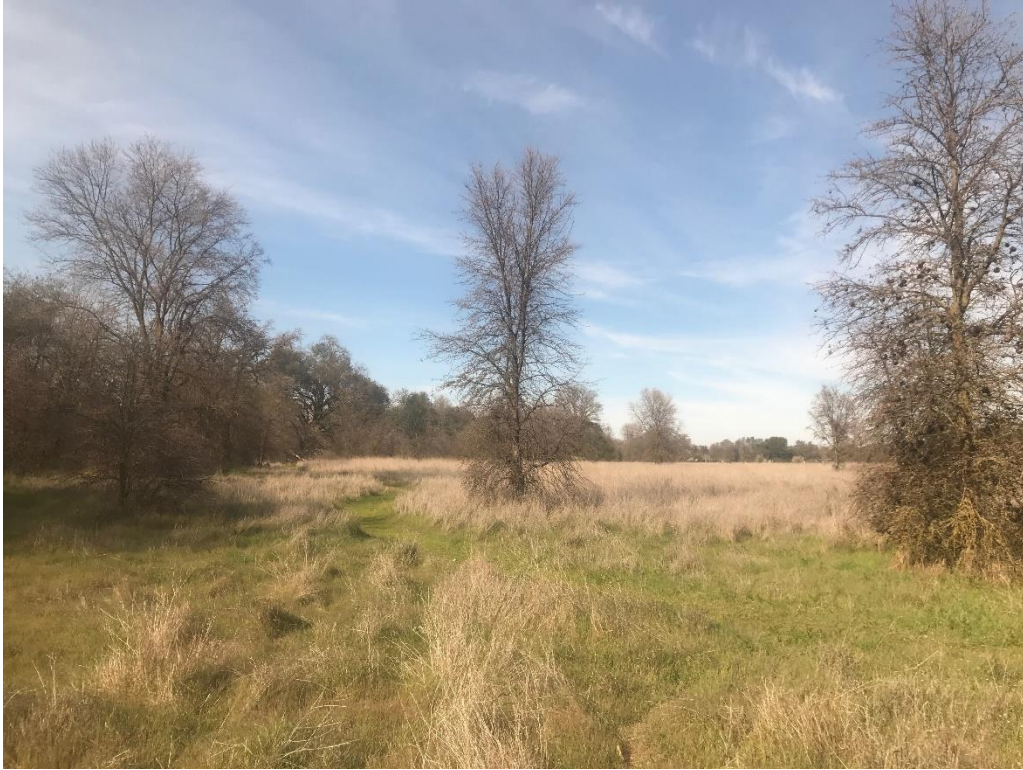
**Photo 7.** Native oak trees in open space area to the north of Northbrook Park (foreground), and oak riparian woodland along Dry Creek to the west (left side of photo). Looking north. 02 March 2021.

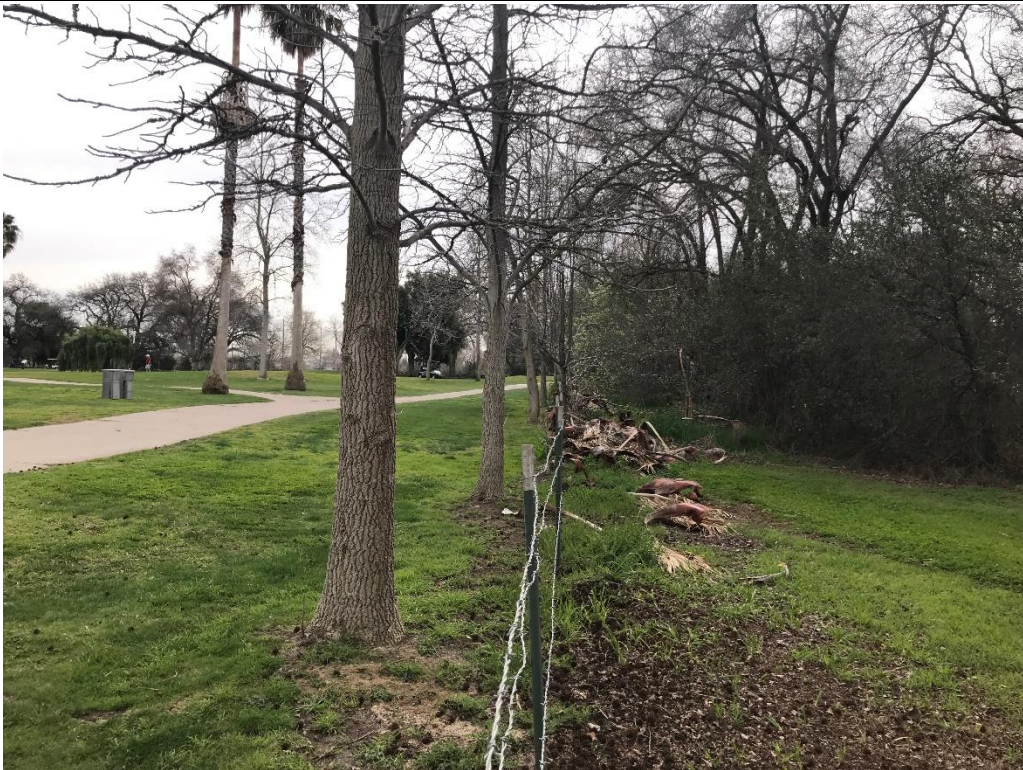
**Photo 8.** Planted landscape trees in Antelope Greens Golf Course (left side of photo) and oak riparian woodland along Dry Creek (right side of photo) along the proposed trail alignment. Looking south. 03 March 2021.

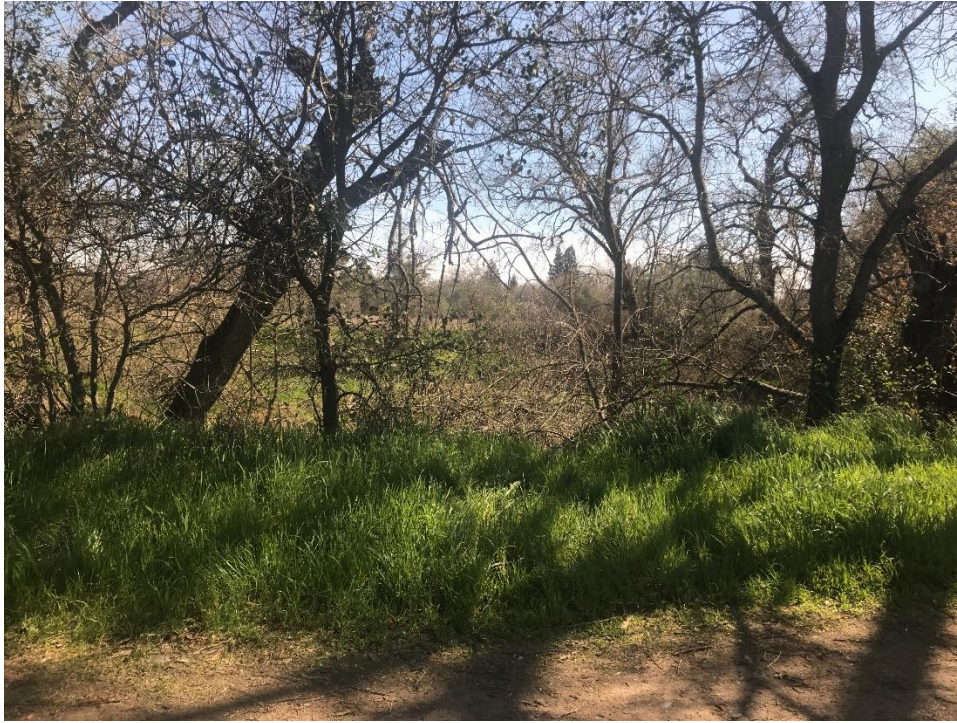
**Photo 9.** Valey oak and interior live oak trees along Dry Creek at proposed bridge crossing location connecting Gibson Ranch Park to the proposed trail alignment. Looking east, from Gibson Ranch hiking trail, toward proposed project site to the east. 03 March 2021.

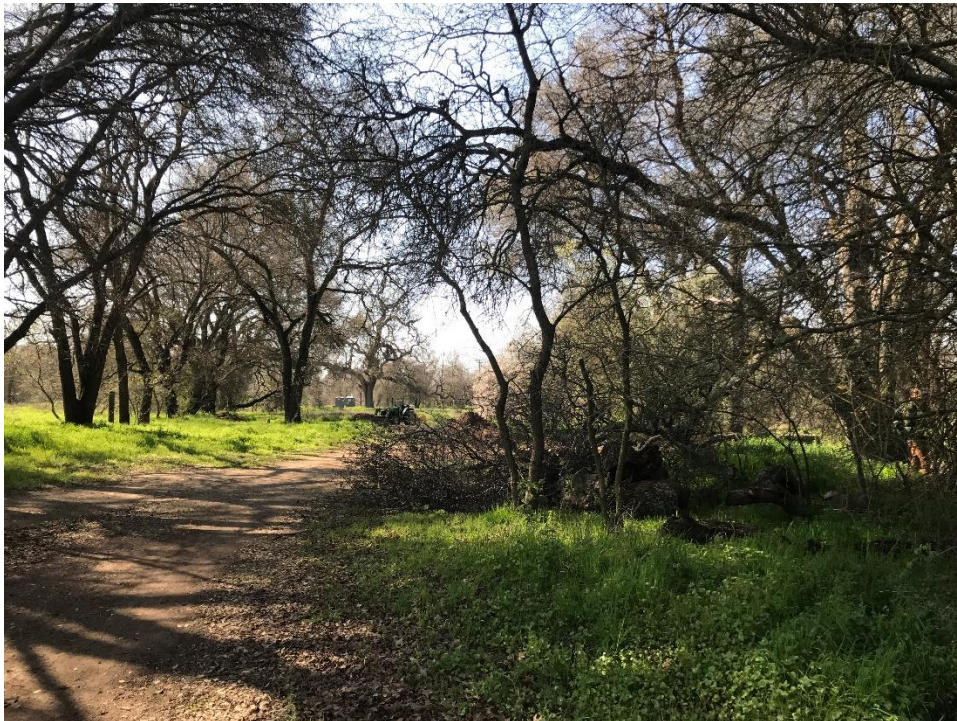
**Photo 10.** Large and medium-sized valley oaks and interior live oaks in riparian oak woodland habitat near Elverta Road. Looking southwest. 04 March 2021.
