Aquatic Resources Report for Dry Creek Parkway Trails, Phase II

Sacramento County, CA

July 2021
Revised July 2022

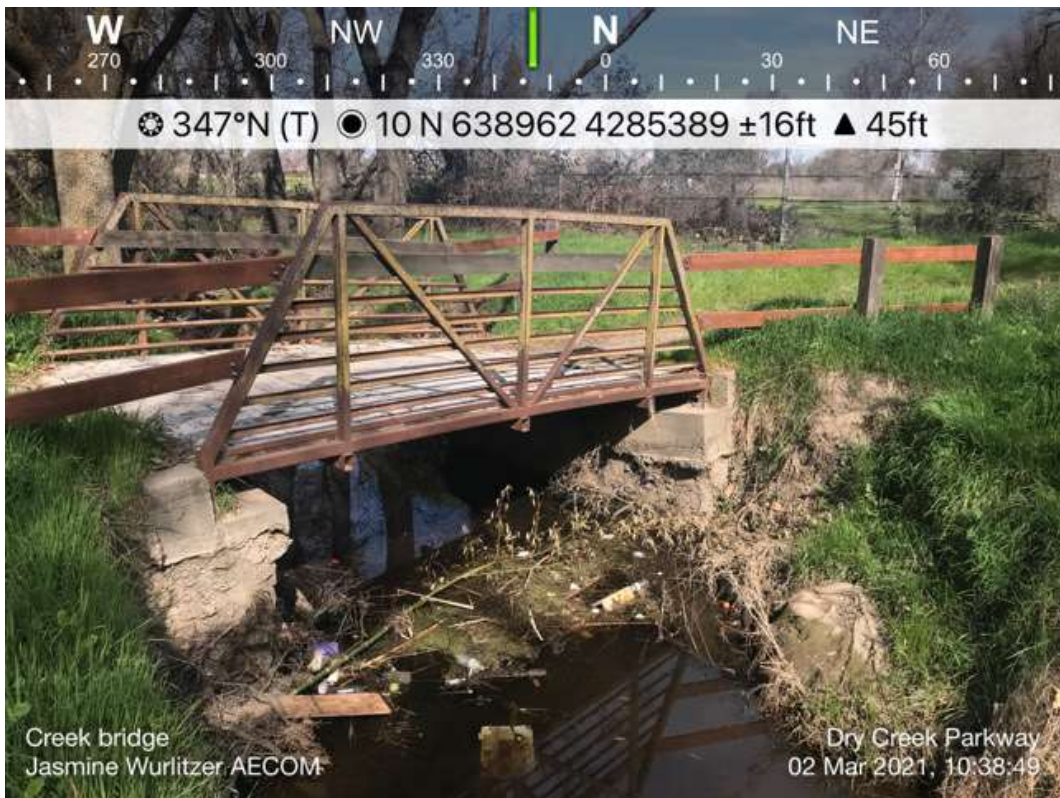
The Sierra/Goat Creek channel bottom and banks consist of unconsolidated fines. The area surveyed was approximately 8 feet wide and 2 to 3 feet deep. Channel banks are steep, incised, and generally densely vegetated by grasses and forbs including common bog rush, valley sedge, and miner's lettuce. The tops of banks are heavily vegetated with valley oak trees and Himalayan blackberry in the valley oak woodland vegetation community (CNPS 2021). Dead fish, downed branches, and trash were abundant in the portion surveyed during the 2021 and 2022 surveys.

Photo 1. Aquatic Feature PR1 – Sierra/Goat Creek, existing bridge crossing.

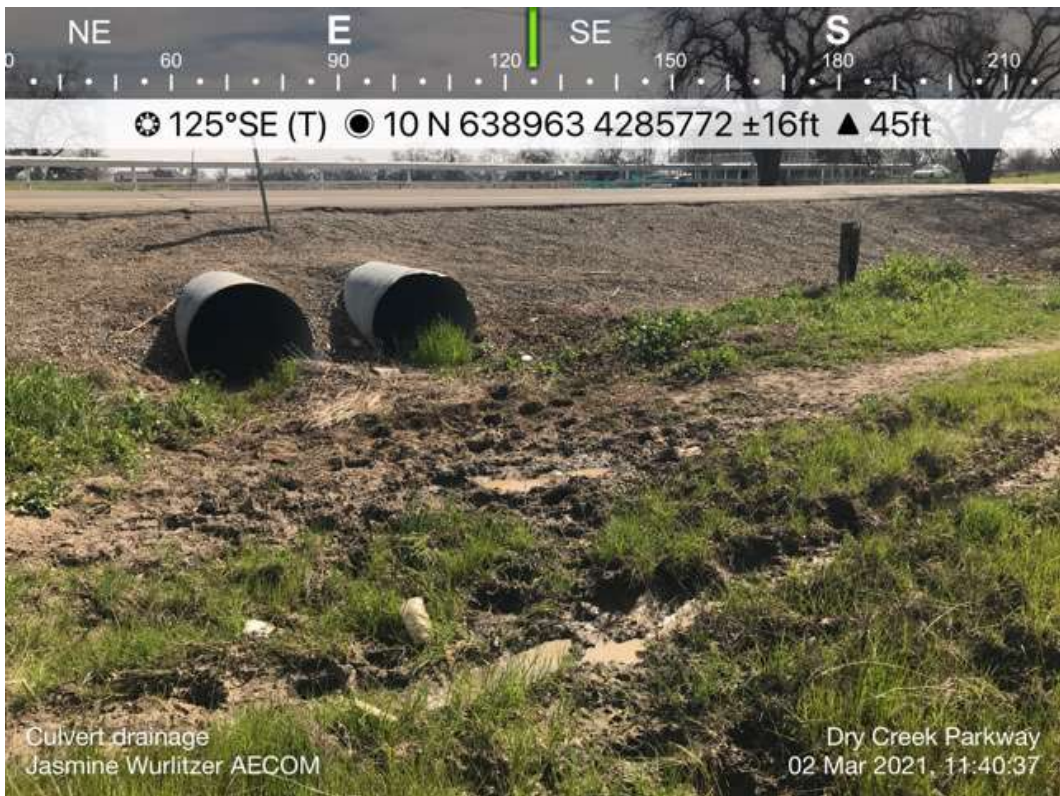
Photo 2. Aquatic Feature Ditch 1 – an existing pathway crosses through this ditch, which is adjacent to the western boundary of Cherry Island Golf Course.

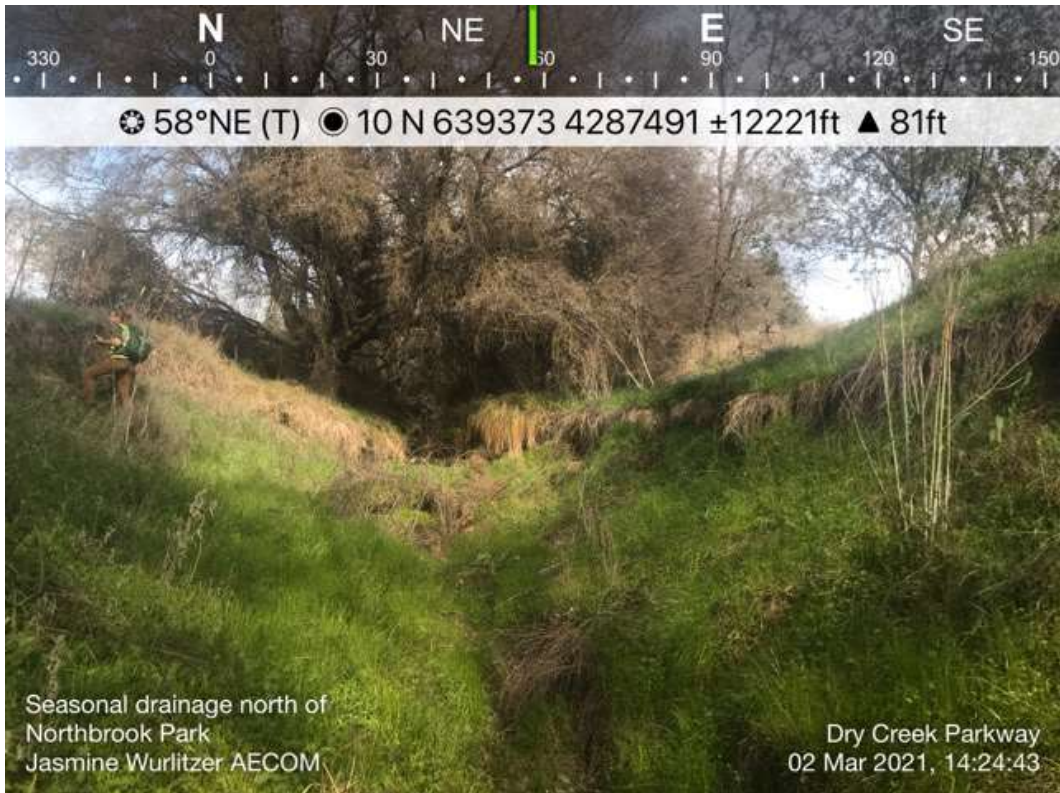
The area surrounding Feature IRD1 is developed for recreational use and thus experiences frequent human disturbance including mowing, sporting events, and horseback riding. Water in the channels is likely only present immediately following rainfall events resulting from high-water levels in Dry Creek. The feature class's vegetation community can be best described as a *Brassica nigra – Centaurea (solstitialis, melitensis)* Herbaceous Semi-Natural Alliance with open to continuous canopy, according to the Manual of California Vegetation (CNPS 2021). This vegetation alliance typically is dominated by field mustard (*Brassica rapa*) and yellow star thistle. In the study area, the intermittent drainages are dominated by cut leaf geranium (*Geranium dissectum*) (NL), field mustard (*Brassica rapa*) (FACU), fringed willowherb, sour grass (*Oxalis stricta*) (FACU), rough cocklebur (*Xanthium strumarium*) (FAC), and yellow star thistle.

Photo 3. Aquatic Feature IRD1 – steep drainage north of Northbrook Park. View is of location where parkway is proposed to cross through or across this drainage.

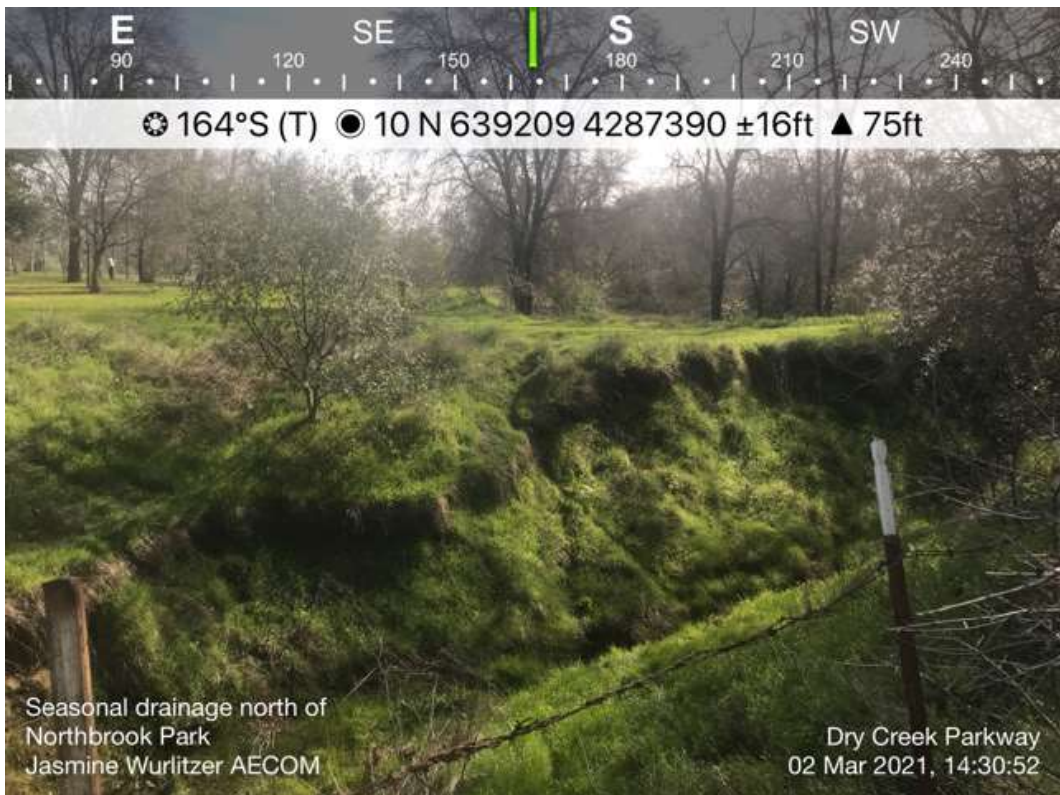
Photo 4. Aquatic Feature IRD1 – steep drainage north of Northbrook Park. View is of location where parkway is proposed to cross through or across this drainage.

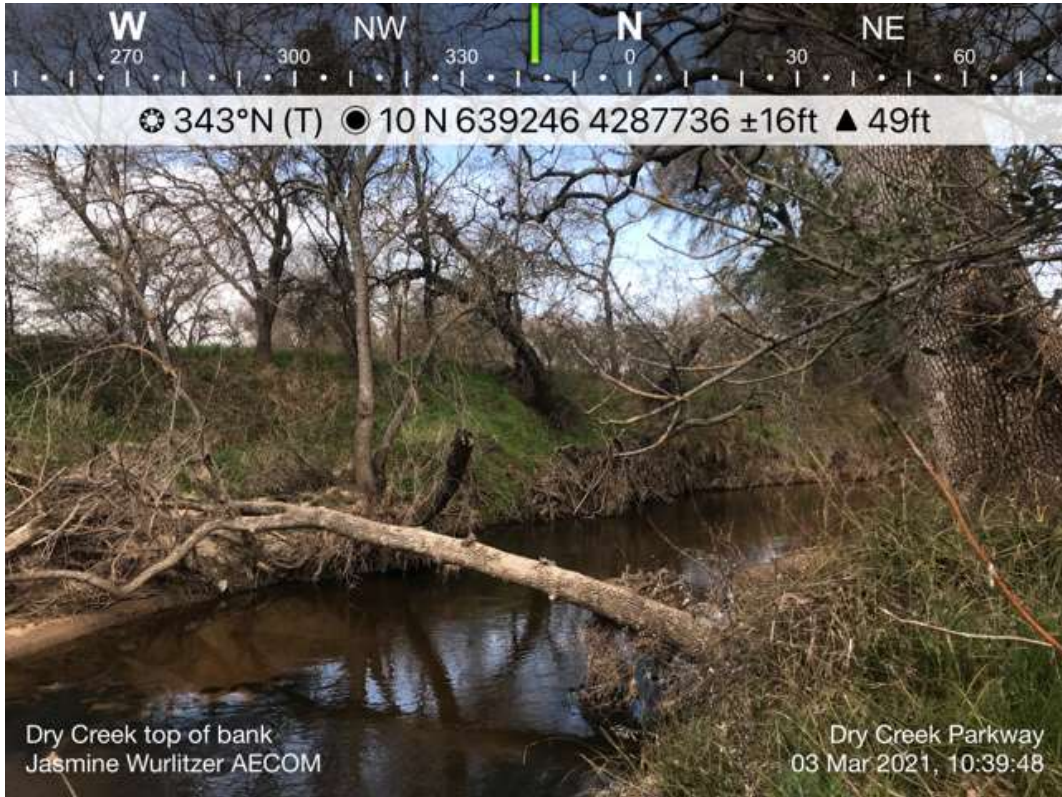
Photo 5. Aquatic Feature PR2 (Dry Creek) – view is of location of the proposed bridge crossing to Gibson Ranch Park as taken from eastern bank.

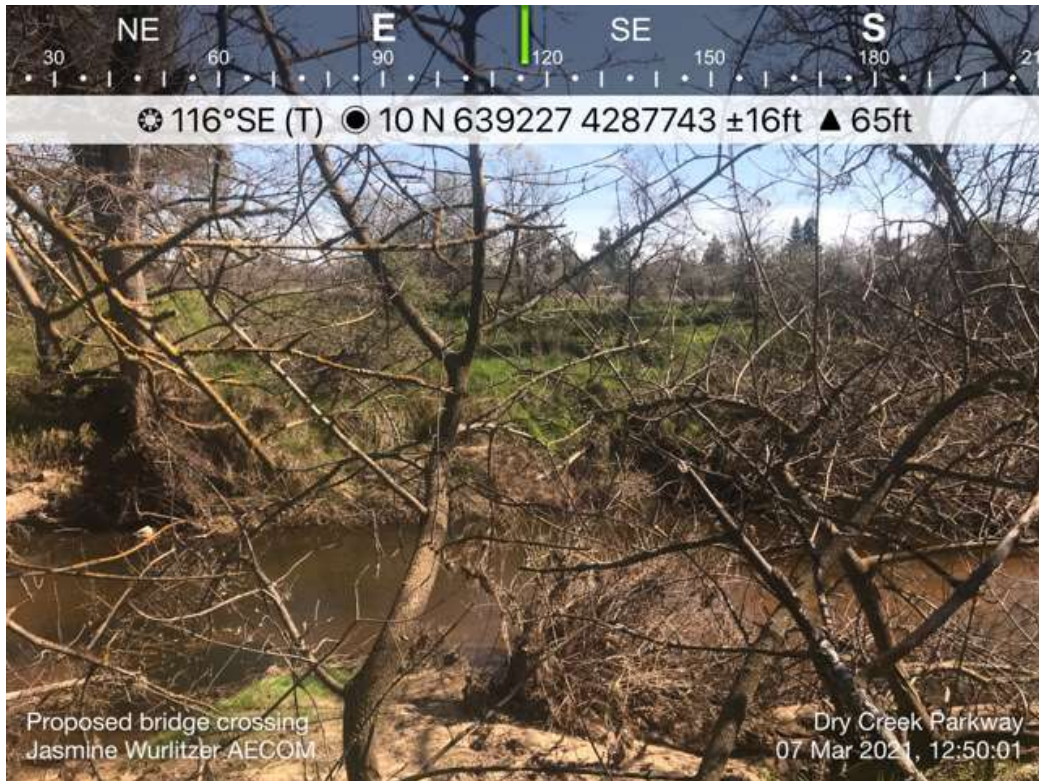
Photo 6. Aquatic Feature PR2 (Dry Creek) – view is of location of the proposed bridge crossing to Gibson Ranch Park as taken from western bank.

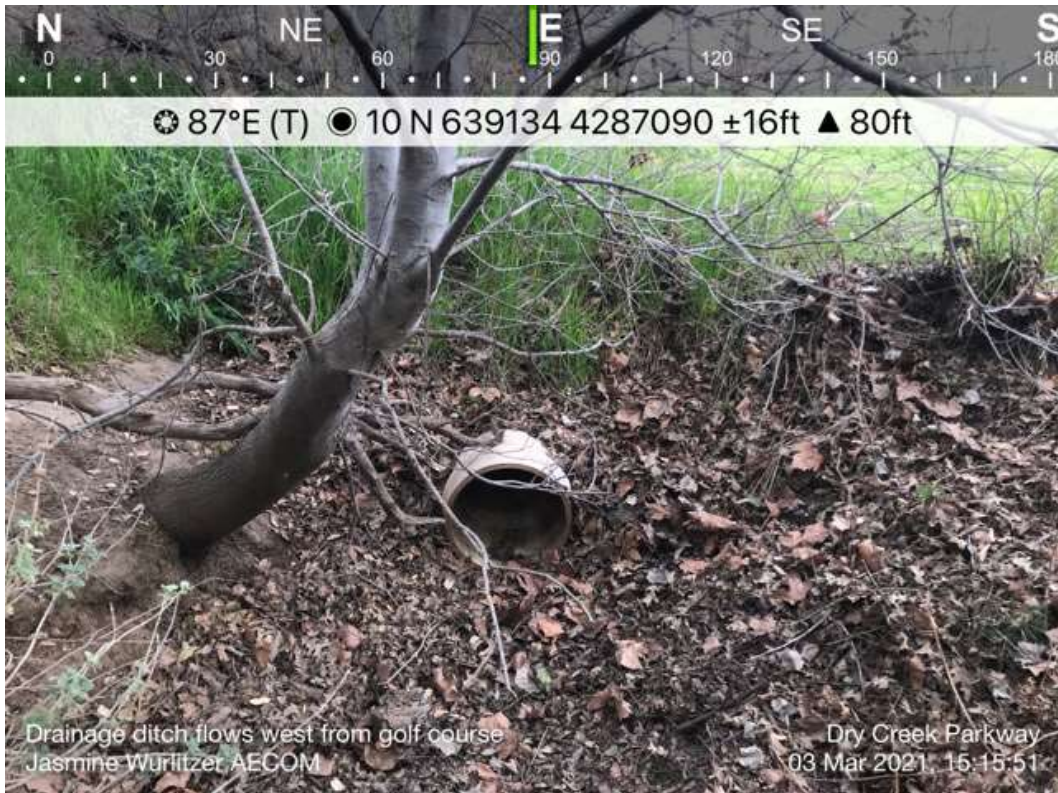
Photo 7. Aquatic Feature Ditch 2 – small ditch with culvert that conveys runoff from Antelope Greens Golf Course to the west.

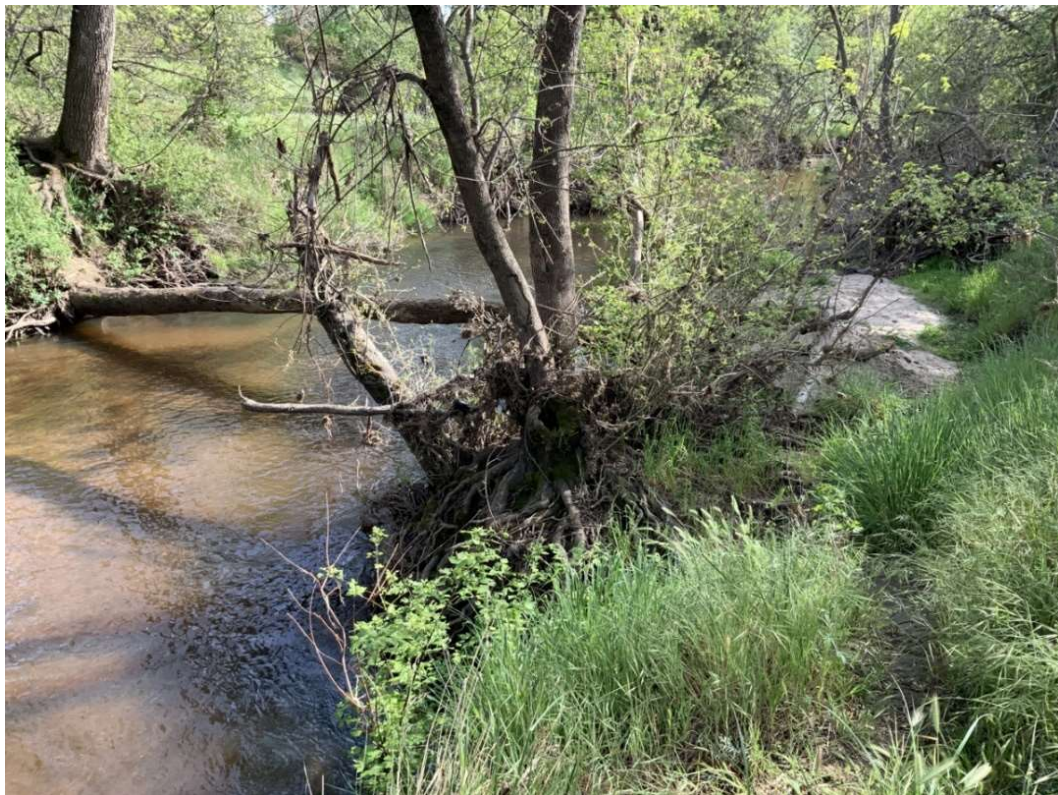
Photo 8. Segment of Dry Creek (PR2). This is the first of two potential locations for the proposed Dry Creek crossing. Photo taken on the east bank, looking north.

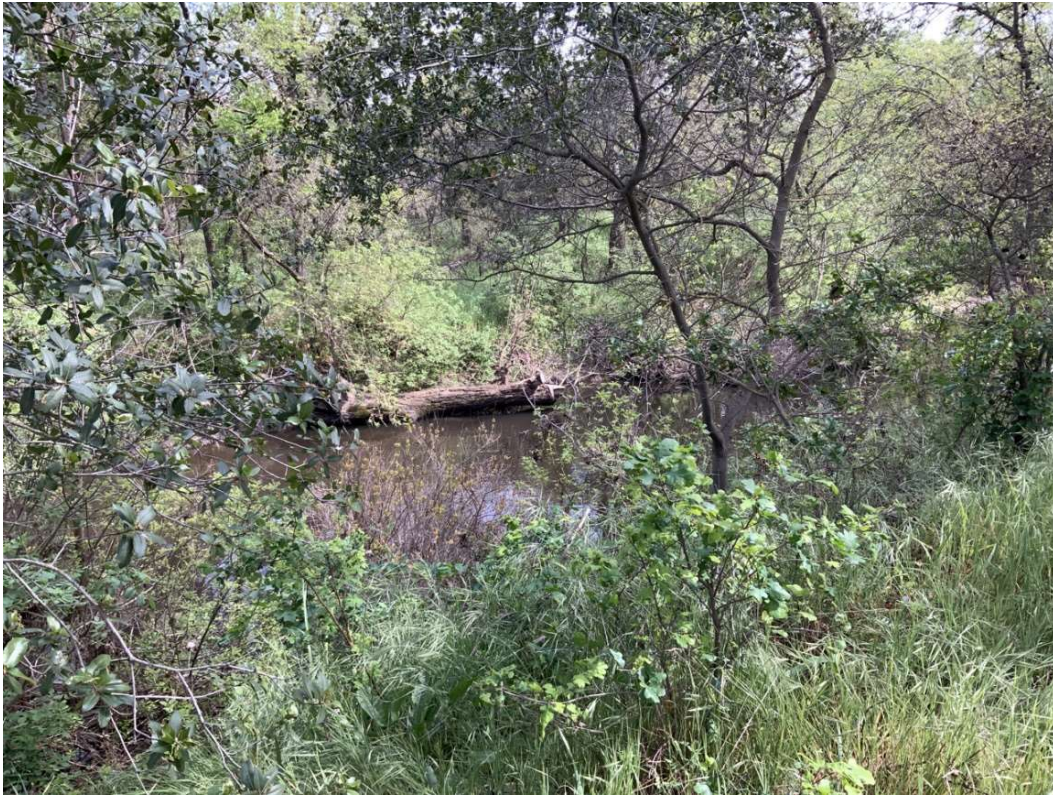
Photo 9. Segment of Dry Creek (PR2). This is the second of the two potential locations for the proposed Dry Creek crossing, approximately 900 feet south of the first tentative placement (see photo 9). Photo taken on the east bank looking west.
